# Evaluation of Thin Polymer Overlays for Bridge Decks

OCTOBER 24, 2023

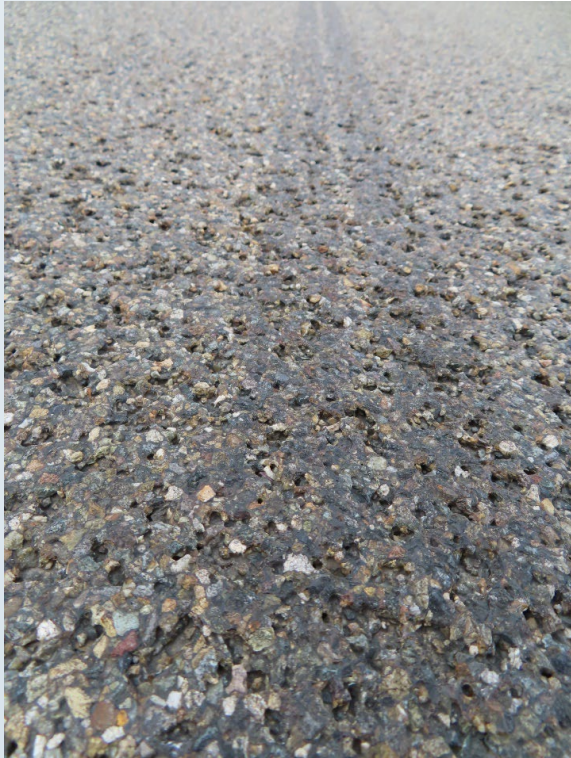
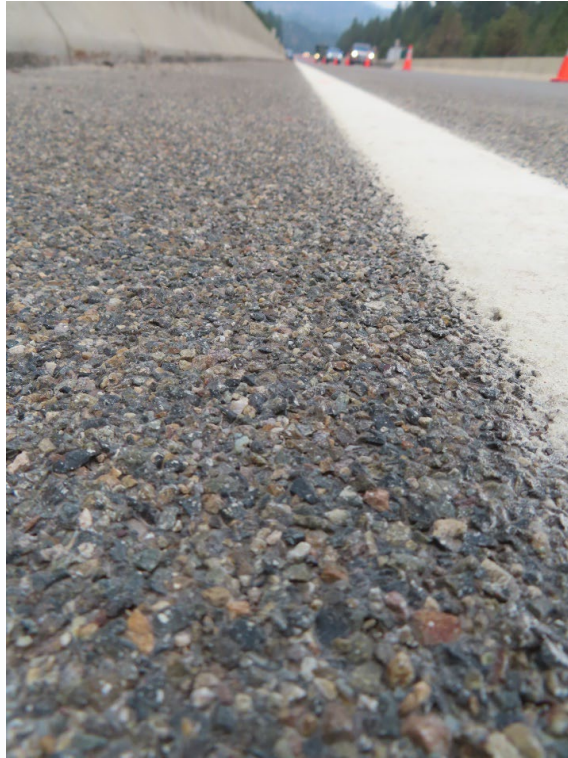
Bridge 1367

# Wear and Aggregate Pop-Out (Year 1)

Driving lane on left  
Shoulder on right

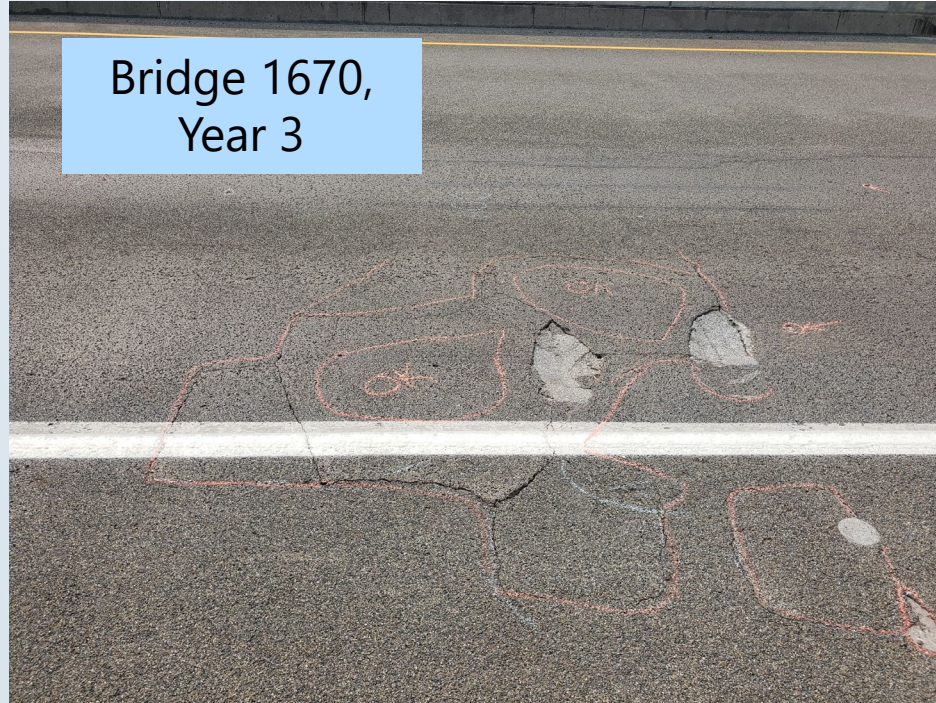
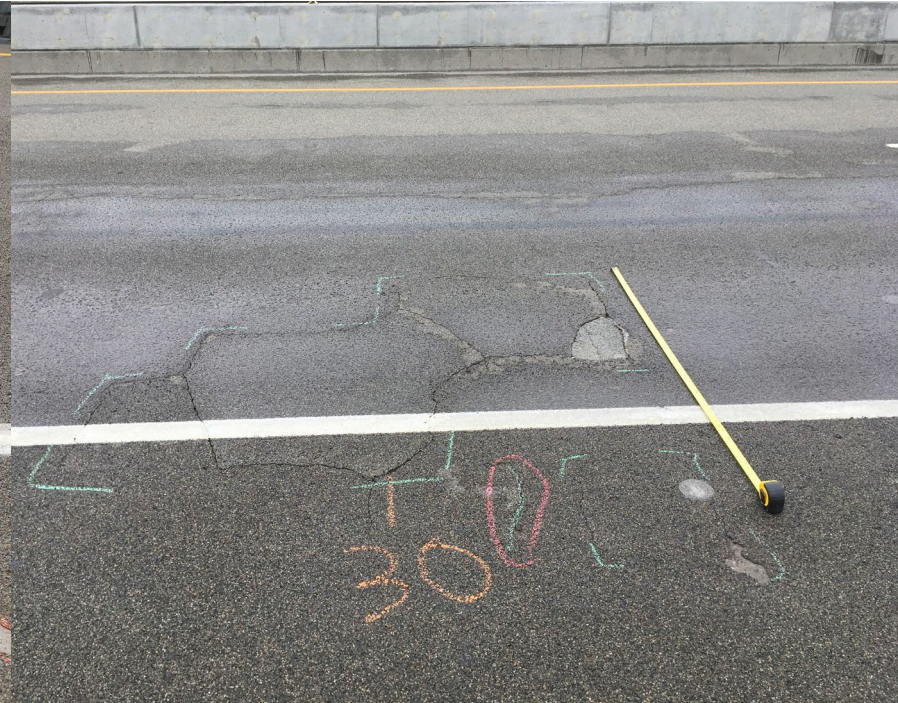
Bridge 1670,  
Year 2

# Reflective Cracking and Spalling

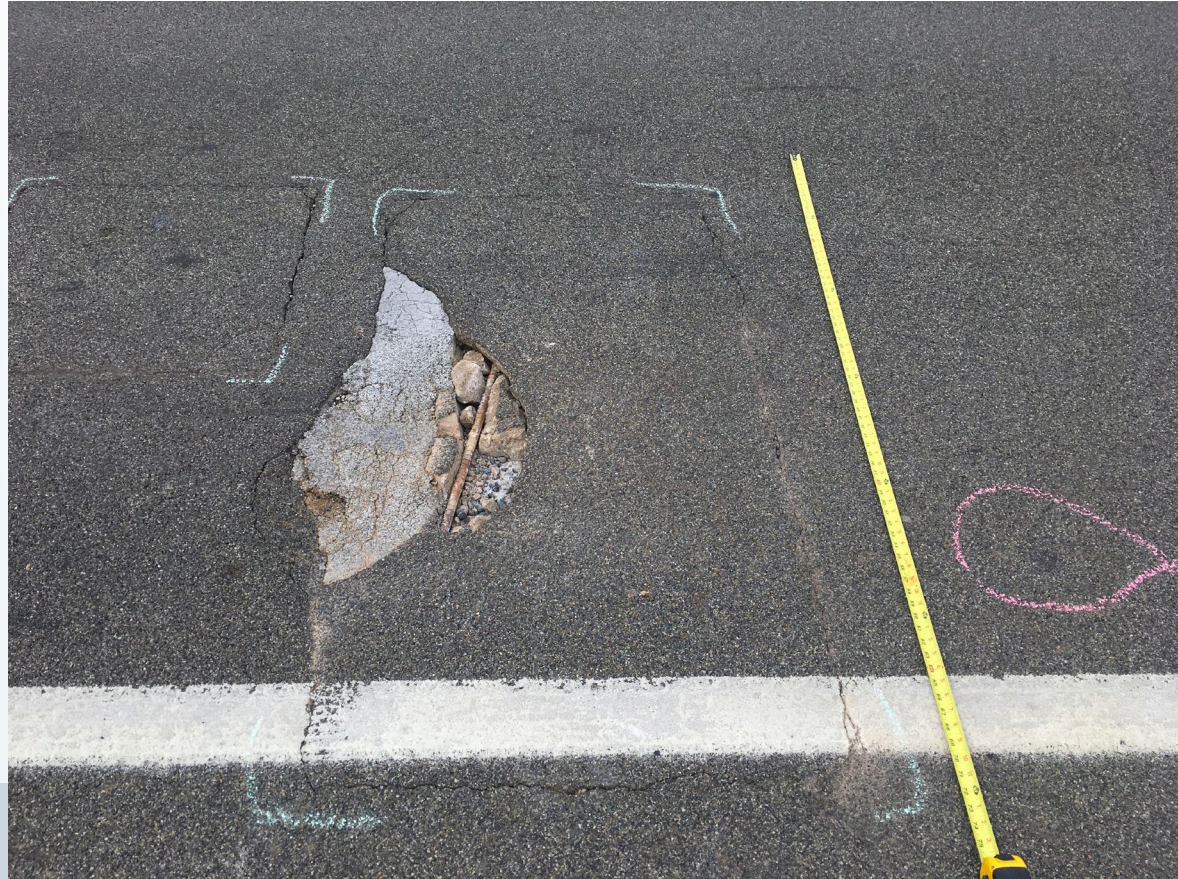
Bridge 1682,  
Year 2

# Cracking and Spalling

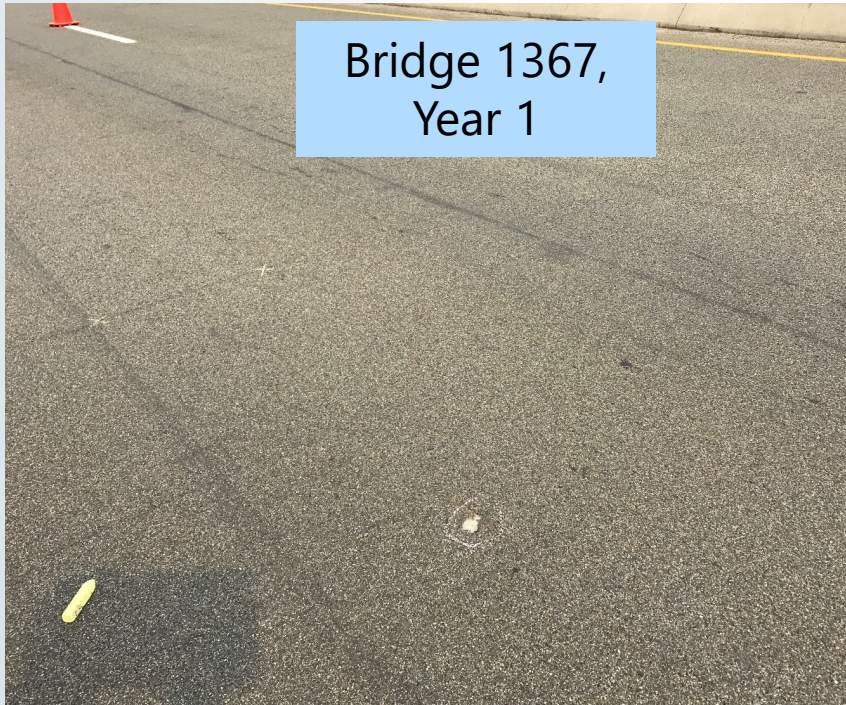
# Pop-out Spalling in Year 1

- Noted on three bridges
  - 1367
  - 1670
  - MM49.39

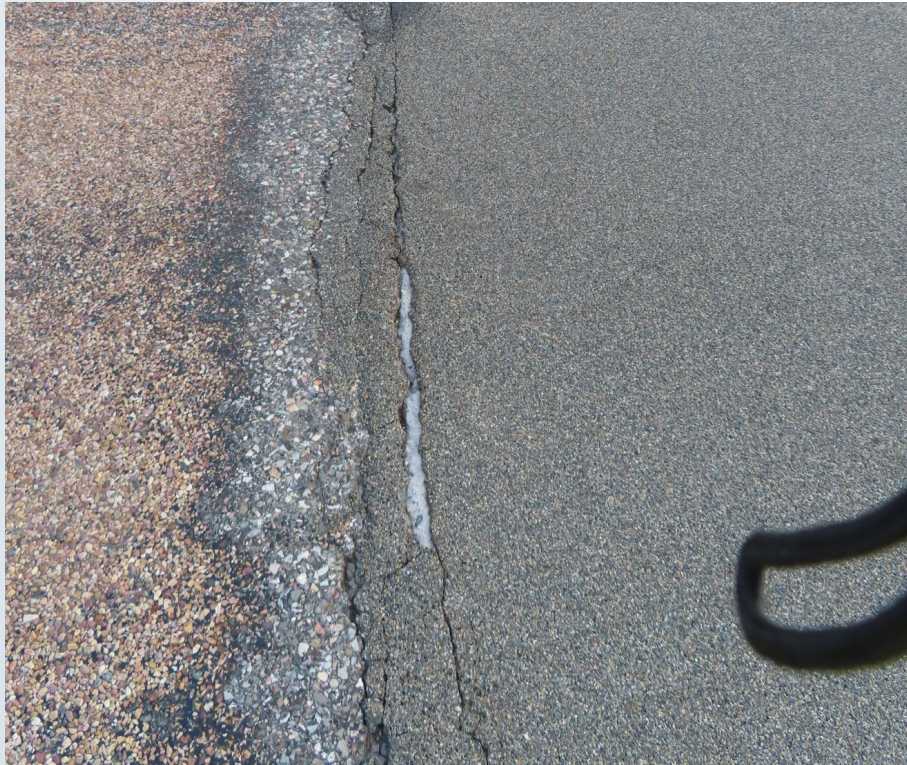
Bridge 1459

# Cracking at Bridge Ends

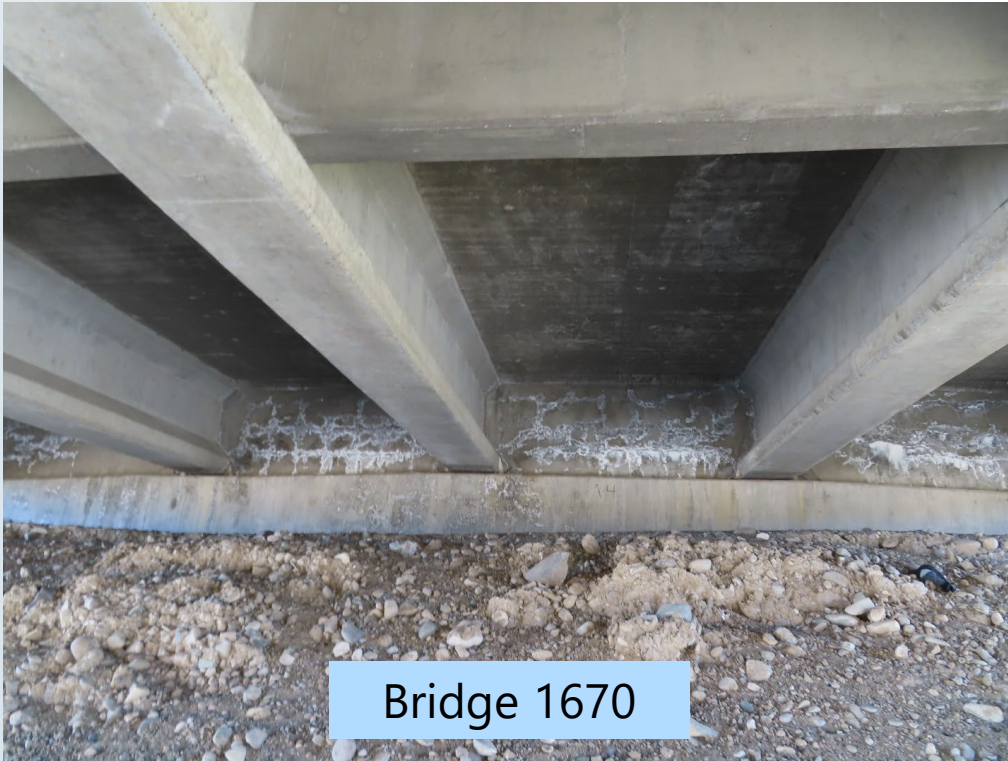
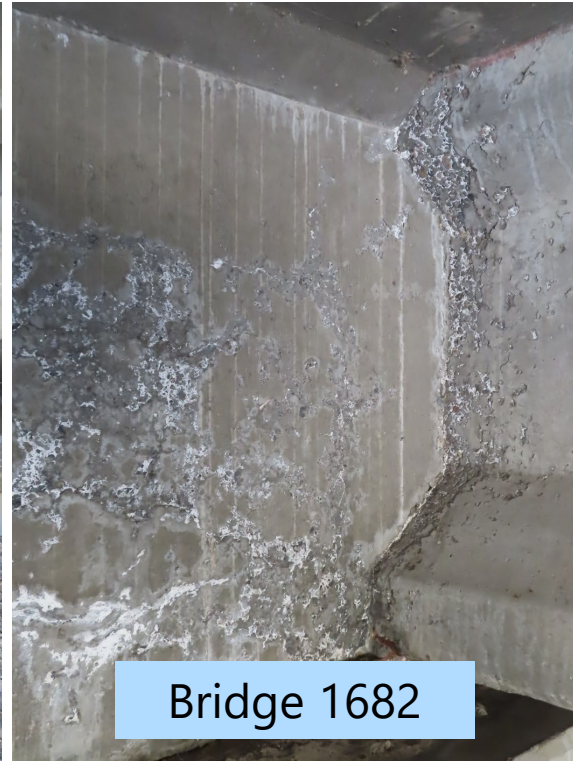
# Abutment Distress at Billings Bridges

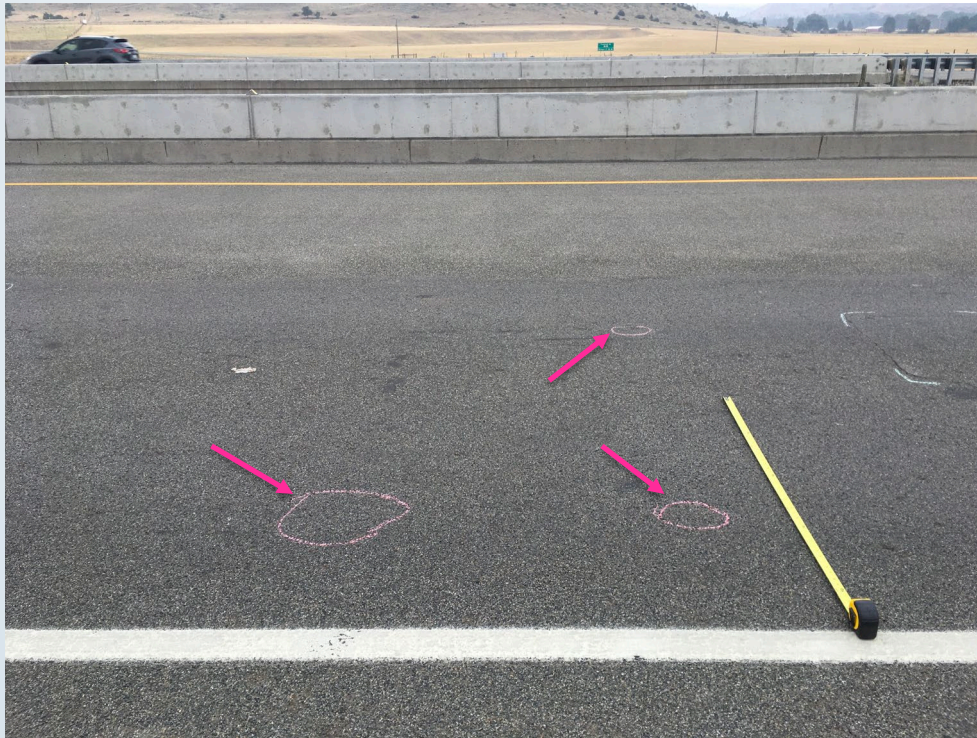
- Looked at 1670 and 1682 (Image from 1682)
- No significant changes noted. Small areas of debonding (pink arrows) had started to form but these delams made up a small percentage of the HFST area
- Overall, HFSTs appeared to still be performing well

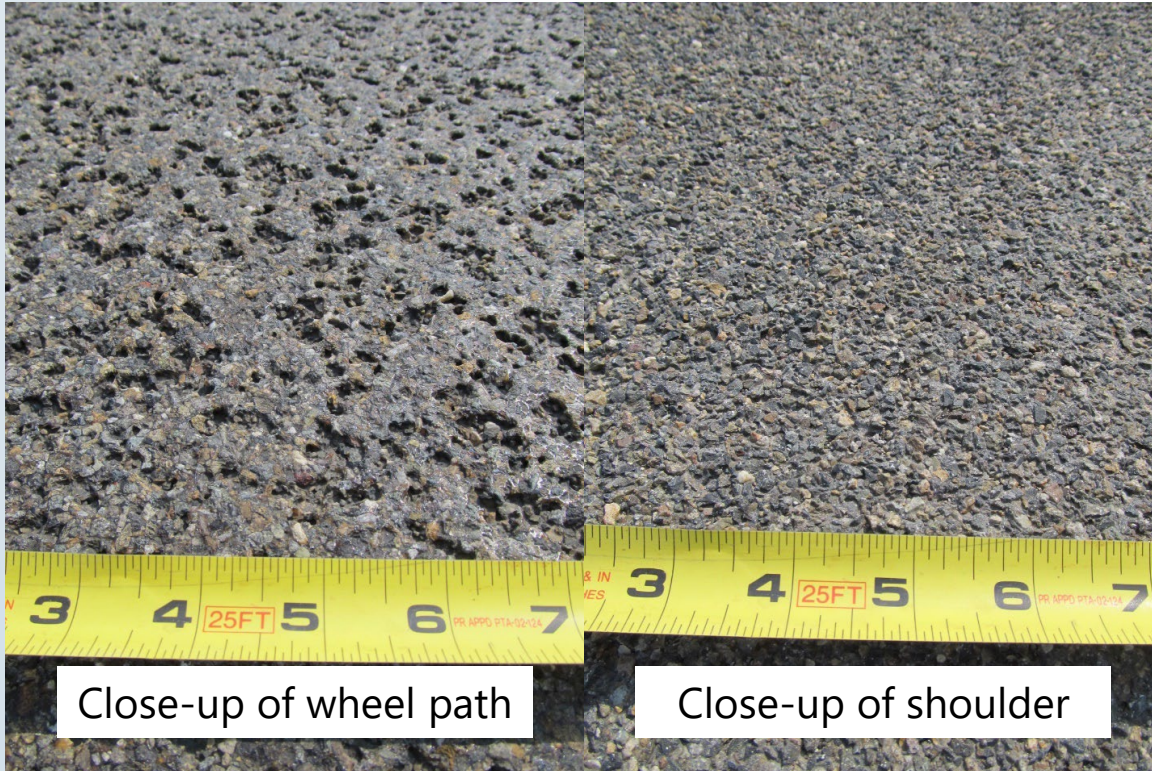
- Aggregates well-bonded to resin (Billings & Missoula)
- Entrapped air voids (Missoula); loss of agglomerations
- Wear typically did not appear to have progressed
  - 14/25 exception – brand new in 2020 vs. 2 years of age in 2022
  - Bridge 1670 some microscopic cracks in binder

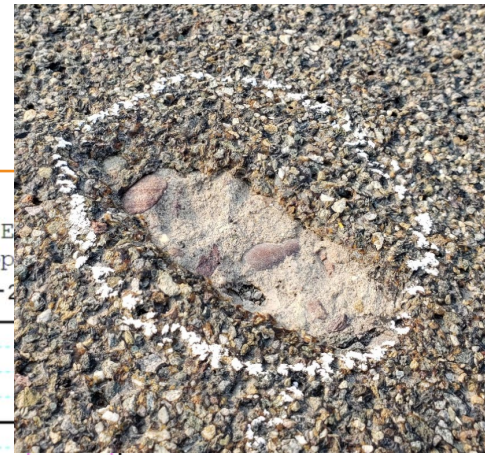
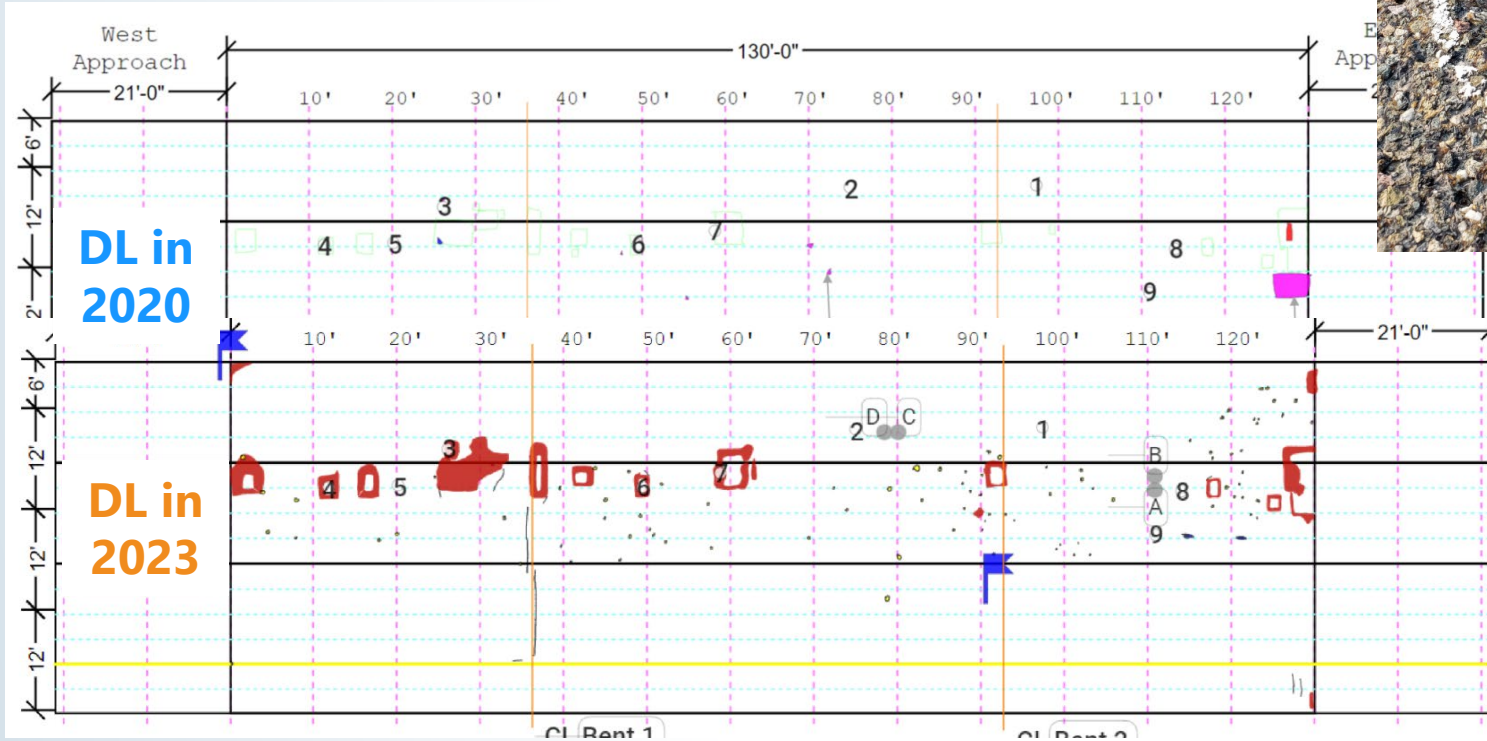
# Bridge 1670 – Pop-out Spalls

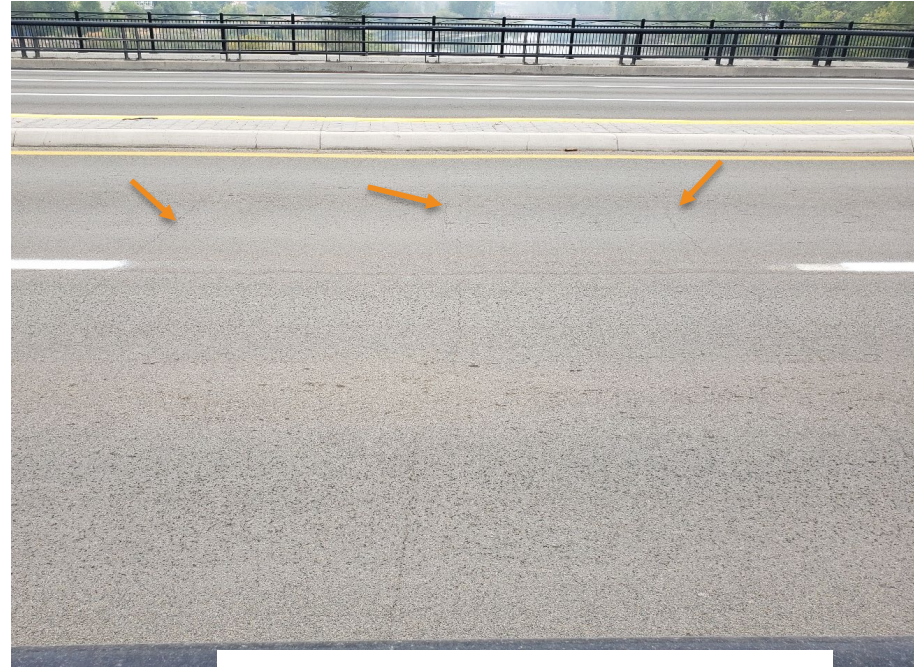
- Transverse cracks over bents that were not noted in 2020
  - Bridges 1670 and 1682
  - Bridge 1392
- Regularly-spaced cracks
  - Bridges 14/25 – avg. spacing 5 to 10 ft
  - Bridge 1428
- Longitudinal crack in 1459
- Above cracking may be new, or cracks may have been more visible in 2022

*Transverse cracking in 14/25*

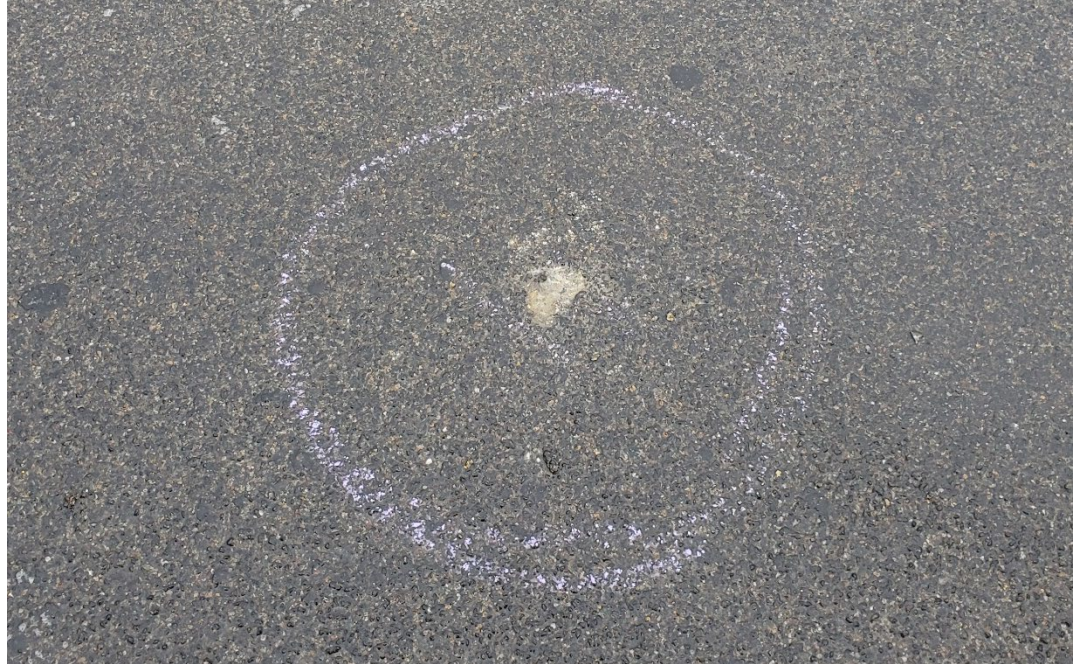
- Bridge 1682 – areas in shoulder; no patch present
- Bridge 3734 – delaminations at rebar due to active corrosion found; no cracks present

*Delaminated area identified on Bridge 3734*

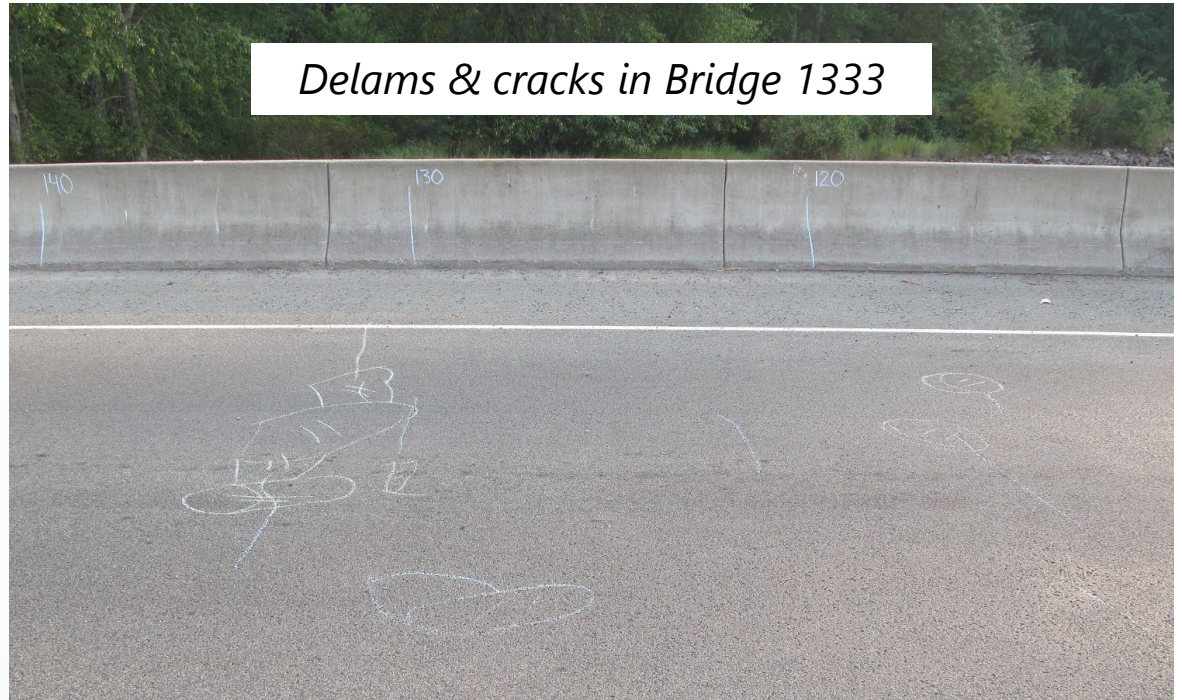
# Delaminations at Cracks (Year 3)

- Bridges 1333 & 1336

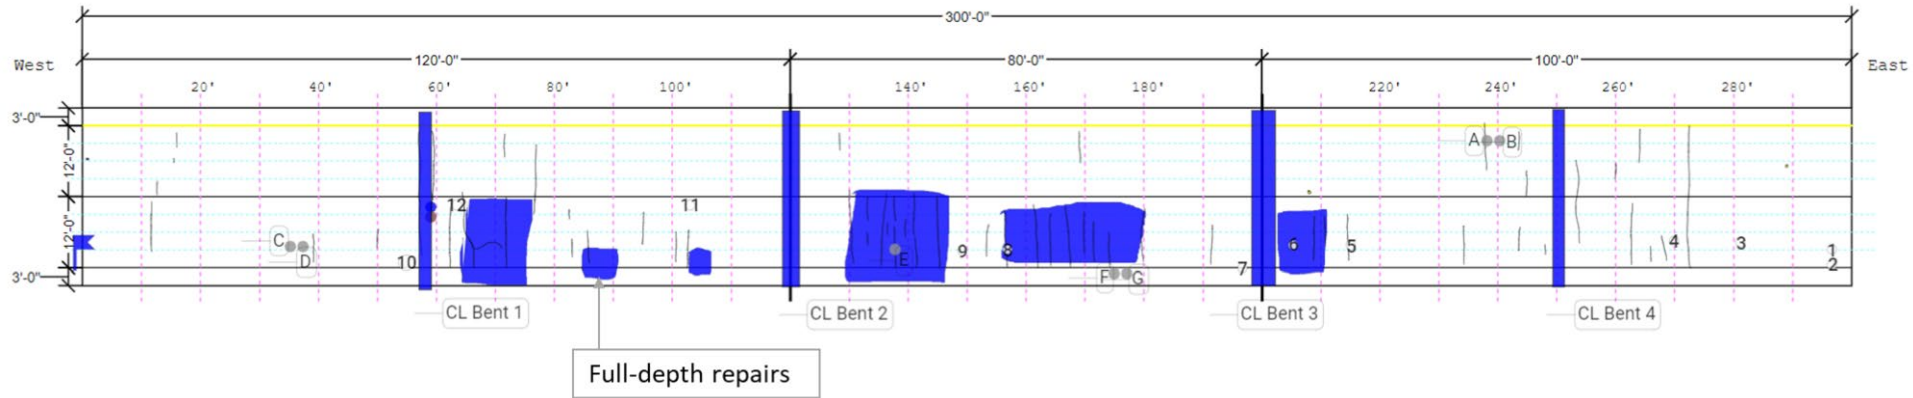
# Cracks in HFST on Bridge 1367

- Black lines represent cracks observed in HFST in 2022
- Blue areas represent Full Depth Repairs observed on underside in 2020
- No delaminations found in 2022

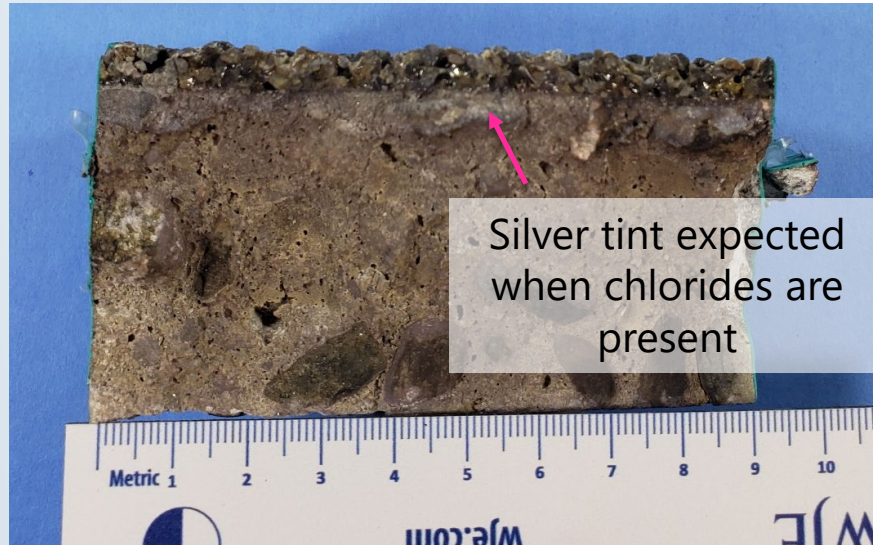
Core 1367-2

- Results were inconclusive, likely due to pre-existing chloride contamination, potentially carbonation as well

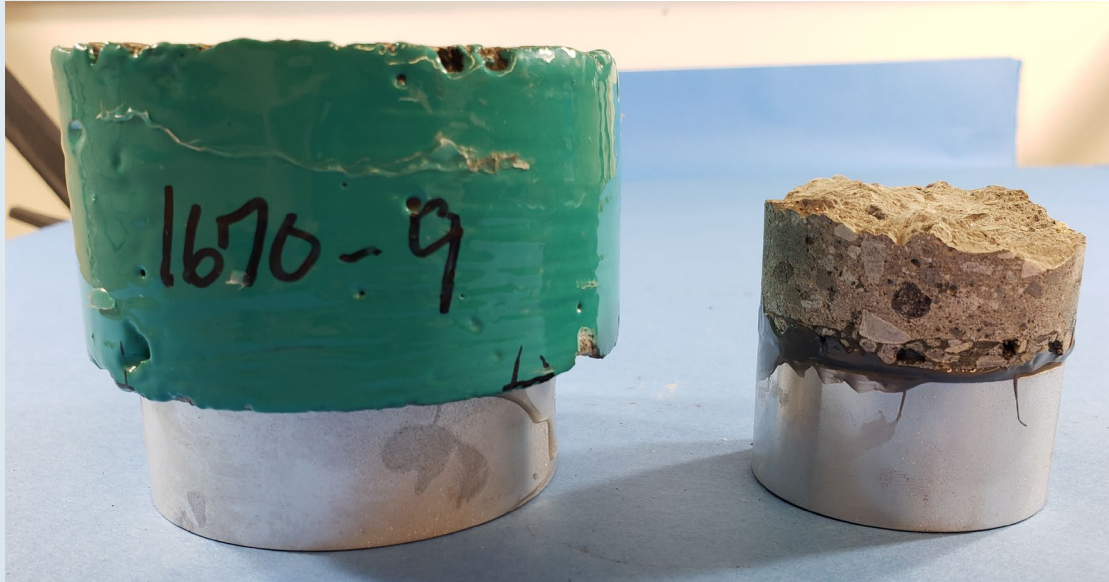
Core 1670-9

- Typically at least 400 psi except Bridge 1367, which varied from 268 psi to 394 psi
- Failure occurred in substrate for all cores tested except 1367-12, where about 15% of area failed at interface between HFST and deck
