MONTANA DEPARTMENT OF TRANSPORTATION STREAM MITIGATION MONITORING REPORT

STREAM MITIGATION MONITORING REPORT:

YEAR 2013

*Mill Creek
Granite County, Montana*

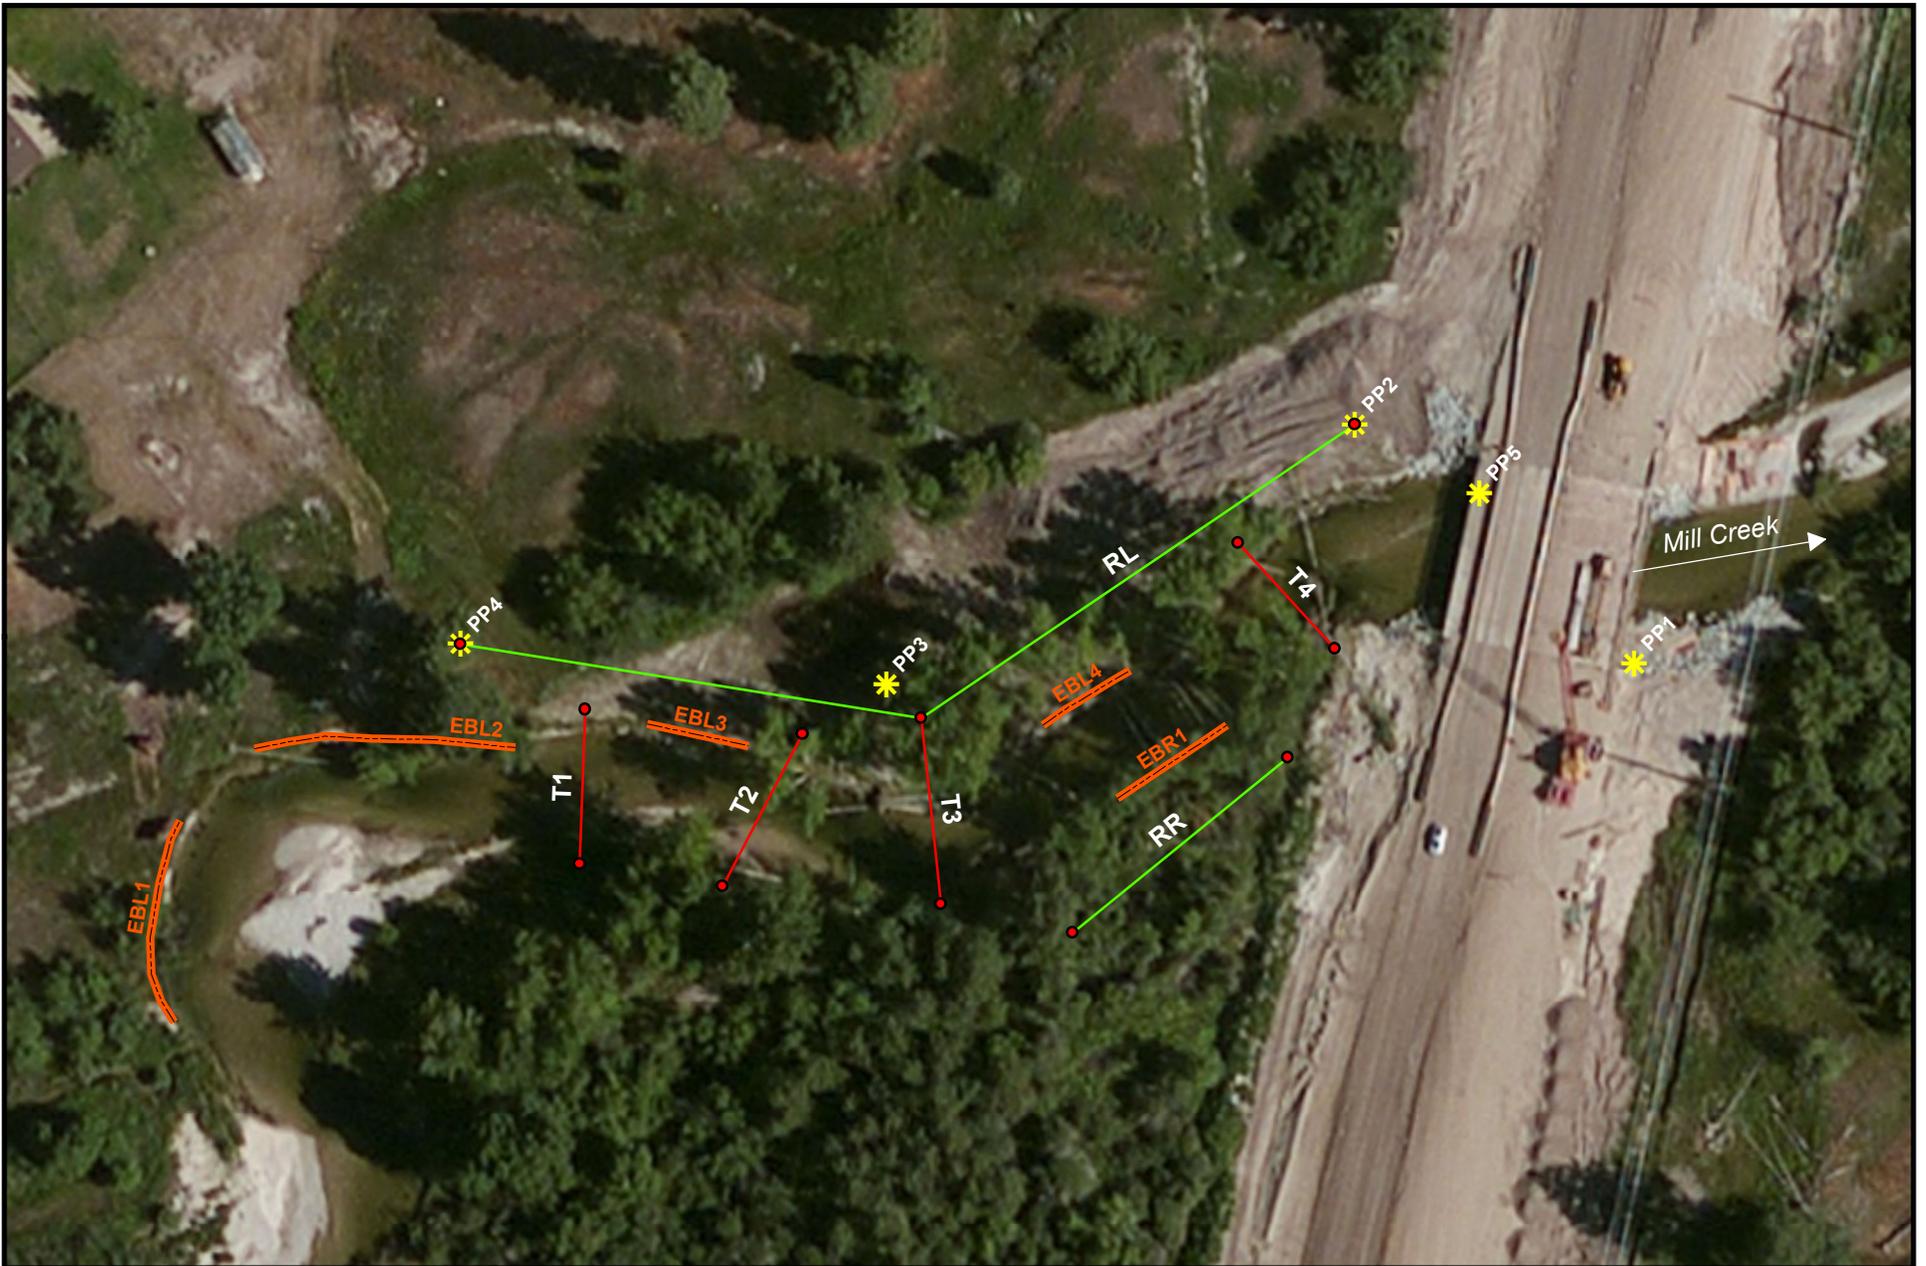
Five eroding banks were observed within the project reach, and are illustrated on Figure 2 in Appendix A. Table 2 provides information for each eroding bank, including photo numbers, bank length, a qualitative bank erosion severity rating of each bank within the project site, and potential causes of erosion. A qualitative erosion severity rating was generated by observing substrate composition of the bank, vegetation composition, and whether depositional features such as point bars were developing near the erosional area. The bank identification number in Table 2 matches those displayed on Figure 2.

Three eroding streambanks were observed in the project area, while two additional eroding banks were identified immediately upstream of the project area (Table 2 and Figure 2, Appendix A). The eroding banks upstream of the project area were included in the bank inventory.

Bank erosion within the project site was limited to relatively short bank segments (45-58'). Eroding bank EBL3 (north streambank) occurs along the plug placed at the upstream end of the deactivated channel segment, and is due to localized scour produced by a downed tree. Erosion at this location is not severe, does not compromise downstream stability, and does not jeopardize any infrastructure.

Eroding bank EBL4 (north streambank) occurs along a bank with several tree stumps that appear to have either calved off of the adjacent stream bank, or were placed there in an attempt to protect the bank from erosion. The stumps are not secured to the bank

and will likely wash downstream during future flood events. The bank exhibits a native alluvial cobble and gravel toe, occurs along a relatively straight segment of the channel, and does not appear to jeopardize overall channel stability. As a result, of these observations, erosion at this location is considered minor.

Eroding bank EBR1 (south streambank) is similar to EBL4, in that it occurs along a relatively straight channel segment. Based on the location of this eroding bank being directly across the channel from EBL4, it appears the channel has slightly adjusted following construction. The bank exhibits a native cobble and gravel toe that appears to have mobilized during the last flood event, as evidenced by adjacent downed trees. Erosion at this location should be monitored to determine whether future protective measures are warranted to prevent lateral adjustments toward the highway.

Two eroding banks (EBL1 and EBL2) were observed upstream of the project reach. Relatively tall bank height, sparse woody riparian vegetation, and establishment of a large adjacent point bar contribute to erosion at these locations. The channel makes a near 180-degree turn at this location, placing erosive stress along the entire meander bend. It is likely erosion will continue at this location until the channel has reached a stable planform configuration. Future movement of the channel may also result in alignment modifications within the project reach, depending on where bedload and woody debris deposits occur.

The approved 404 permit for the Mill Creek project states, "If any unstable stream banks are visible within the relocated channel, corrective measures will be required." Three eroding banks occur within the relocated channel segment of the project reach (EBL3, EBL4, and EBR1), but should not be considered "unstable". These banks exhibit minor bank sloughing, resulting in recruitment of gravel and woody debris to the channel, both of which are beneficial to maintaining trout habitat. These banks should be allowed to adjust laterally until such time as the channel configuration potentially threatens stability of the bridge or highway.

Two eroding banks occur on the same meander bend upstream of the relocated channel segment (EBL1 and EBL2). The landowner estimates the bank has retreated between 20 and 30 feet following construction of the project. This bank occurs on a very sharp bend of Mill Creek, where the channel turns approximately 135 degrees over a length of about 200 feet. This sharp turn in the channel will likely continue to result in lateral movement of the channel to the north until a stable meander radius is established. The landowner has attempted to slow the erosion by cabling a tree and placing large boulders along the bank; however, neither of these efforts is likely to successfully reduce the rate of lateral bank movement at this location. Erosion along these banks could be reduced with bioengineering techniques including installing a stone toe, resloping the vertical bank, and installing dense woody riparian vegetation.

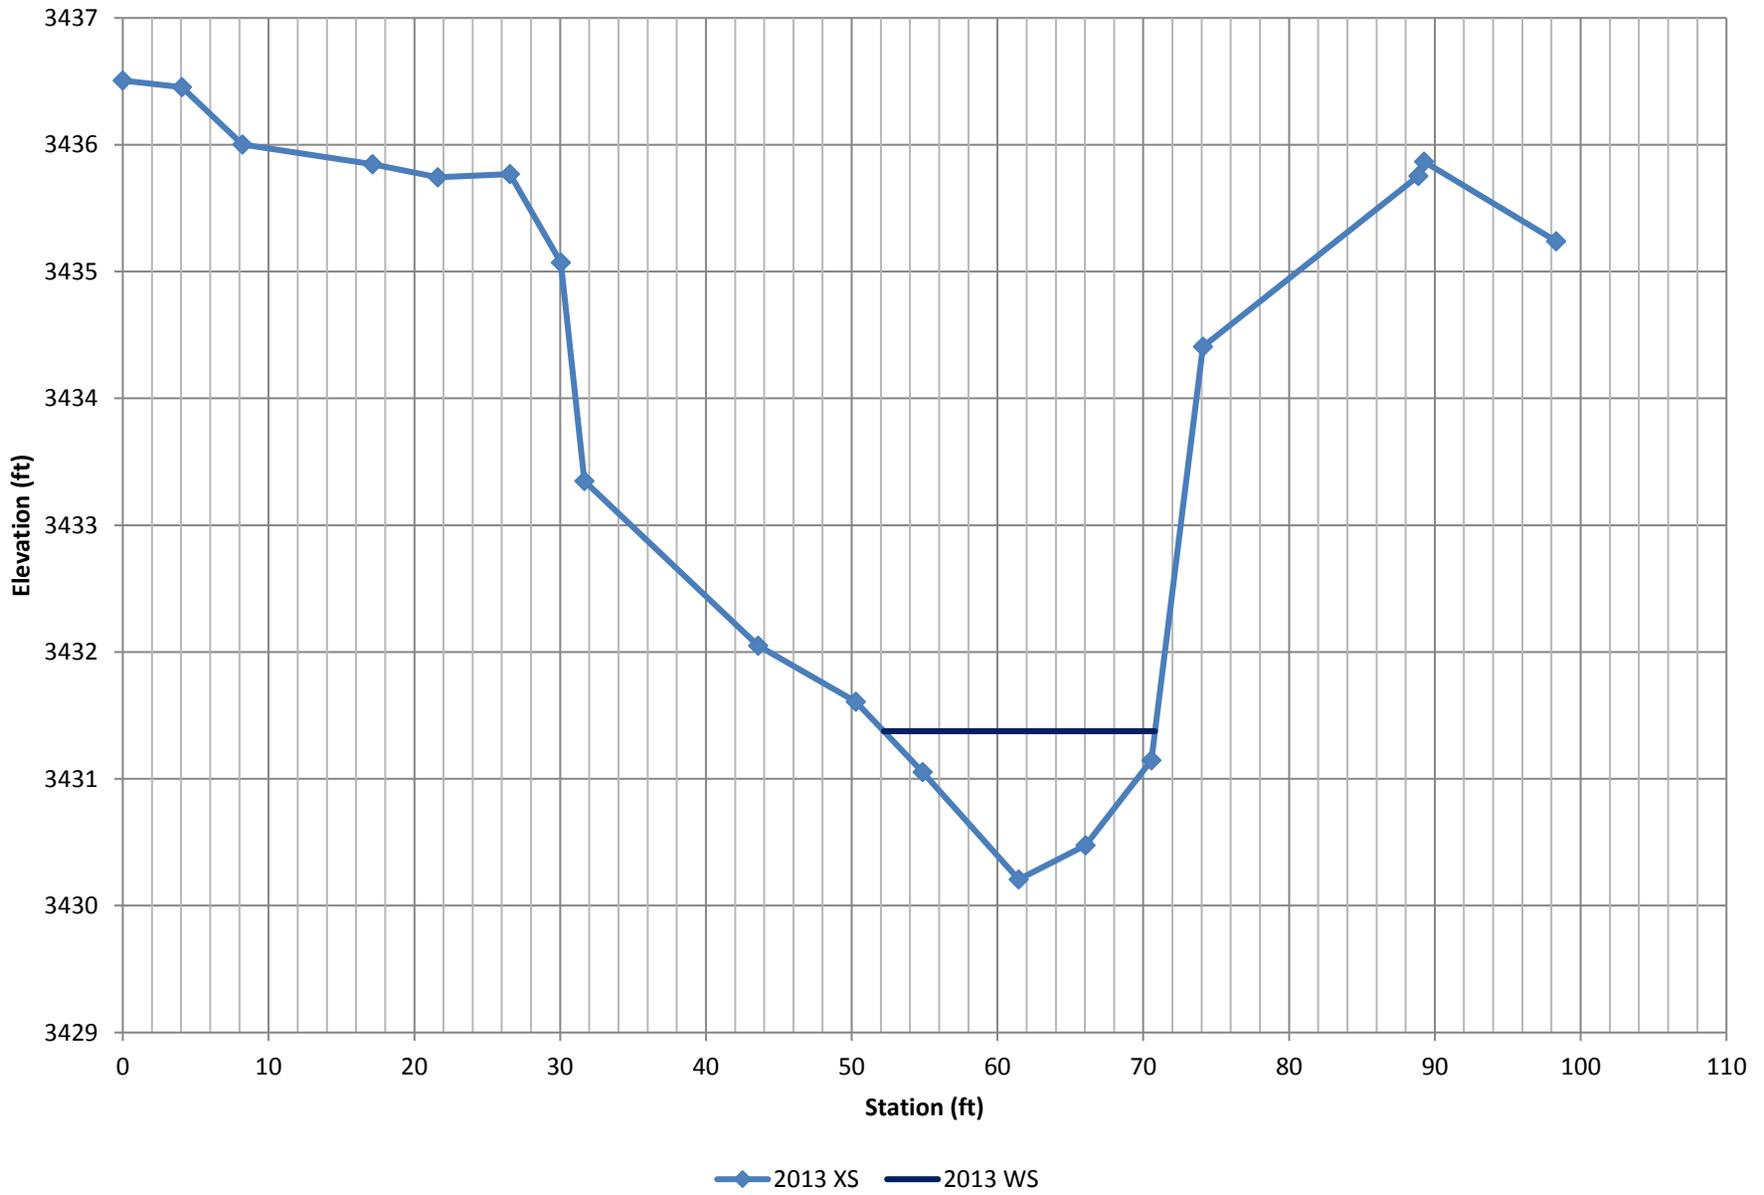
Mill Creek Transect #1 - Riffle

Four perpendicular transects were surveyed, including two pools and two riffles, to document potential channel movement at each perpendicular transect. Plots for each surveyed transect are included in Appendix B. Transect #2 and #3 were surveyed at scour pools formed by woody debris jams. Woody debris jams may move during future flood events, creating new pool habitats in other locations. Average riffle depths were actually greater than the pool depths, indicating localized woody pool scour formations are relatively shallow. All transects will be re-surveyed during subsequent monitoring events to document substrate deposition, pool scour, and whether the channel is laterally moving at any of these locations.

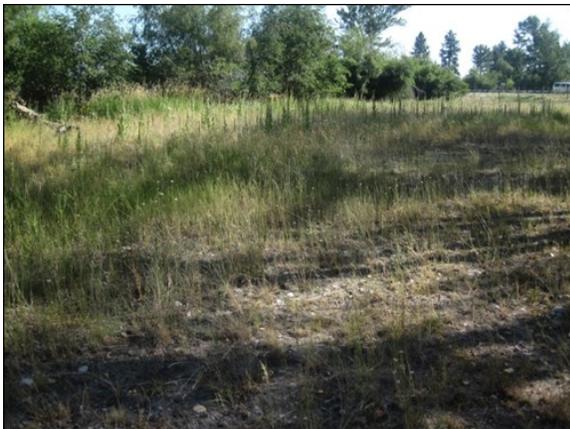
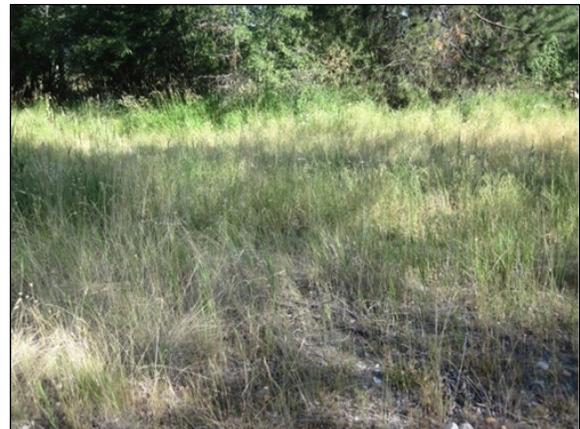
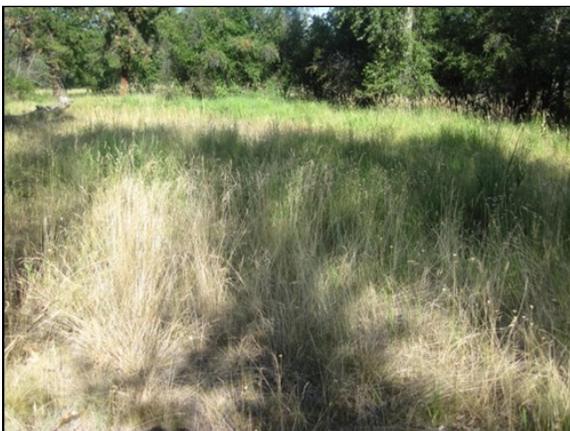
Photo Point 3.2
Description: View of deactivated channel plug from Photo Point 3. **Compass:** 45 (East)

Photo Point 3.3
Description: View of deactivated channel plug from Photo Point 3. **Compass:** 0 (North)

Photo Point 3.4
Description: View of deactivated channel plug from Photo Point 3. **Compass:** 315 (Northwest)

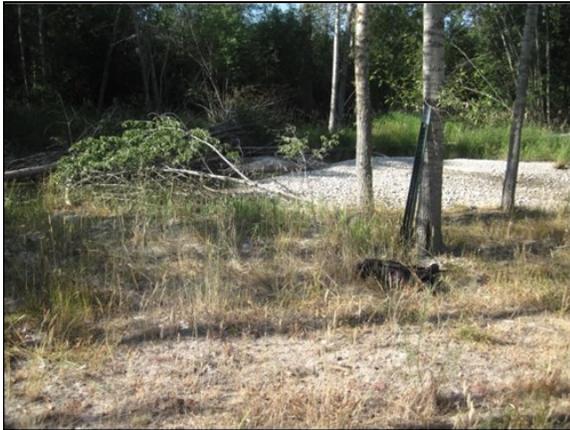
Photo Point 3.6
Description: View of north bank (foreground) and woody debris in the channel. **Compass:** 248

Several woody debris jams have formed in the channel upstream of the bridge. These woody debris jams include trees that have been cut down, as well some that have naturally fallen into the creek. These debris jams are currently providing good aquatic habitat features, but should be monitored to ensure they do not create a large constriction upstream of the highway bridge. The bridge has been designed to convey a large flood event and will likely be successful at passing woody debris as well; however, periodic inspection of this bridge during and immediately following greater than bankfull flood events is recommended.

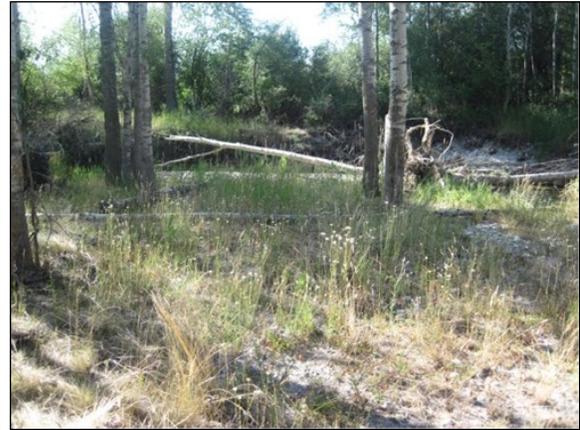
Photo Point 3.7
Description: View of north bank (foreground) and woody debris in the channel. **Compass:** 180 (South)

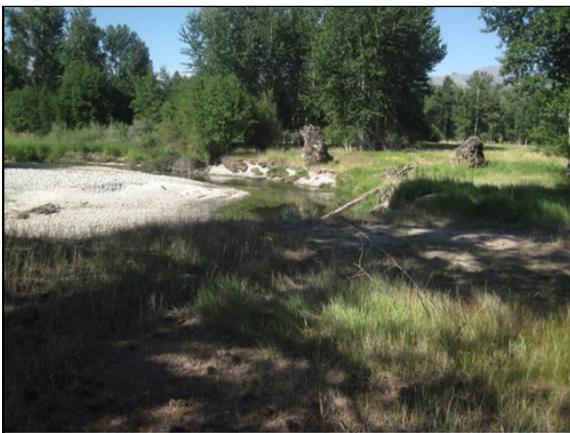
Photo Point 4.3 T1 Finish (North Bank)
Description: View of point bar formation from Photo Point 4. **Compass:** 225 (Southwest)

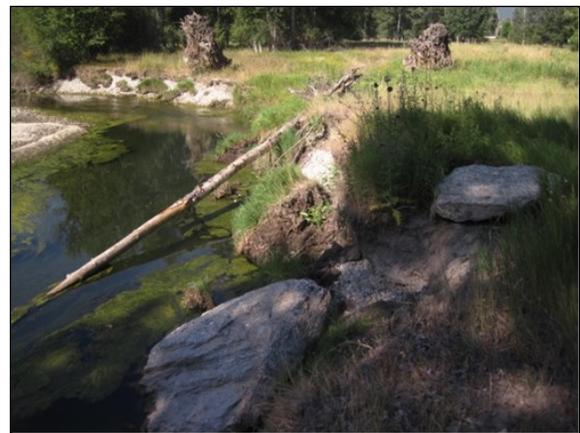
Photo Point 4.4 T1 Finish (North Bank)
Description: View of boulders, root wads and logs placed along the north bank. **Compass:** 248
