MONTANA DEPARTMENT OF TRANSPORTATION STREAM MITIGATION MONITORING REPORT

*North Fork Bear Creek
Ravalli County, Montana*

YEAR 2013

MDT Project Number: NH-7-1(114)56
Control Number: 2015 003

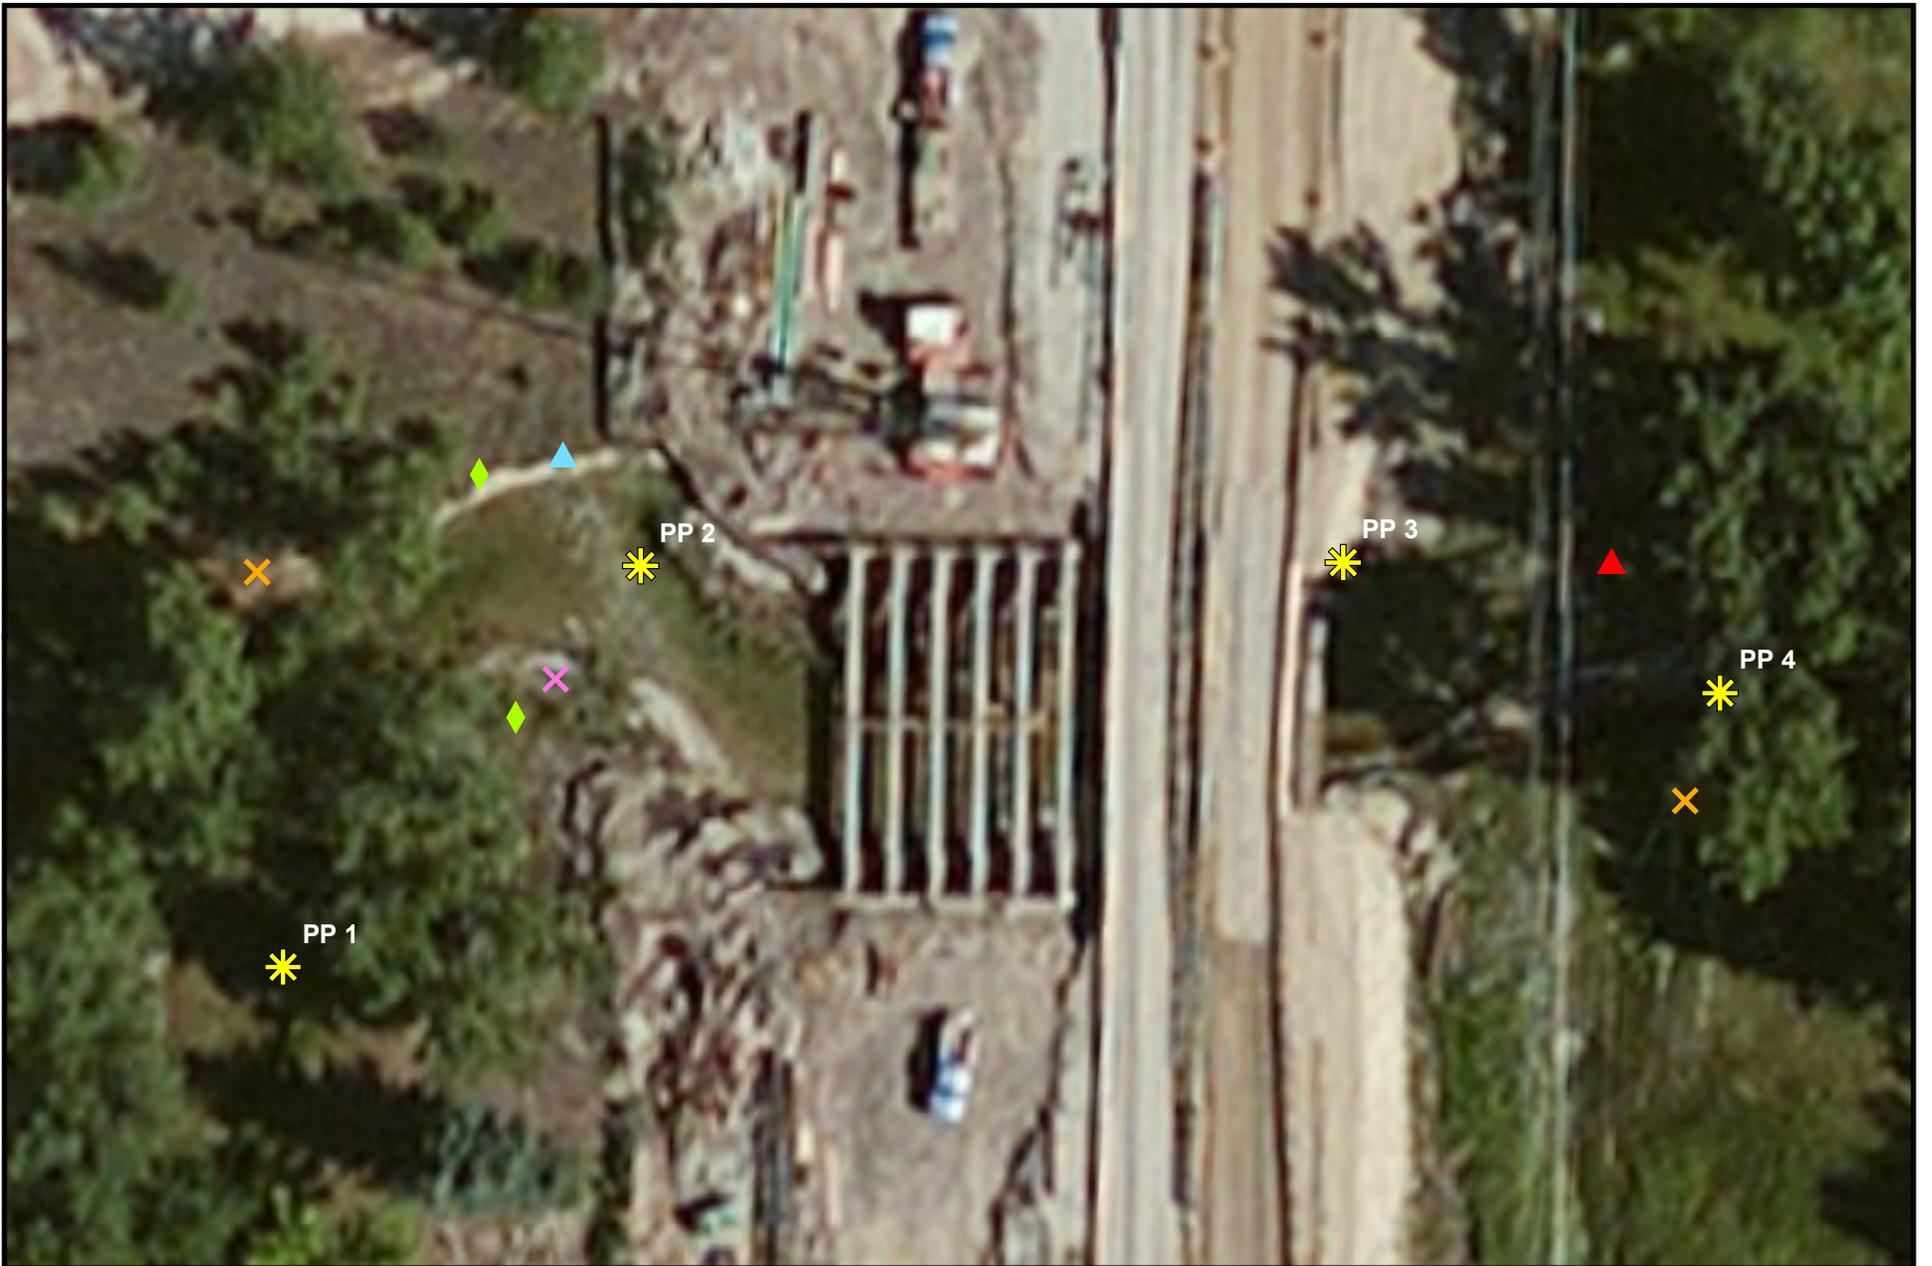
Visual observations estimated 35% of the project site exhibits weed colonization. Weeds were observed on both stream banks, and were primarily concentrated upstream of the Highway 93 bridge.

Noxious weeds were estimated at 35% aerial coverage of the project site, which does not meet the performance standard of less than 10% aerial coverage. Five weeds listed on the Montana Noxious Weed list (MDT 2008) were identified including spotted knapweed, Canadian thistle, oxeye daisy, common tansy, and Japanese knotweed. All noxious species were distributed along both banks of the project reach, and were primarily concentrated upstream of the Highway 93 Bridge.

This monitoring event documented relatively high occurrences of five noxious weeds within the project site, causing an overall decline in the percent cover for desirable species. Implementation of a weed control plan at this project site would improve the likelihood of achieving the performance standards established for a) total vegetative cover of desirable species, and b) noxious weed cover. Noxious weeds were observed on both banks, and were primarily concentrated on the upstream side of the Highway 93 Bridge. Locations of specific species infestations are included on Figure 2 in Appendix A.

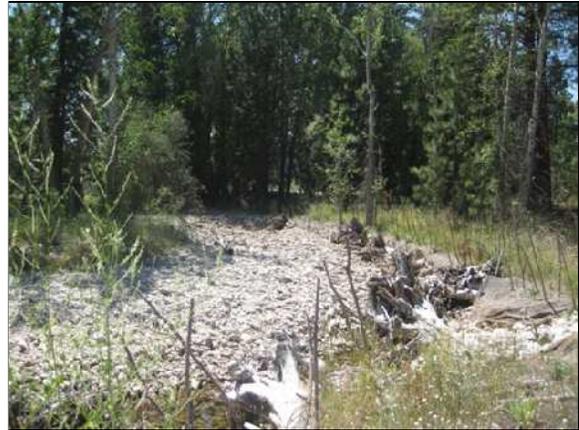
No streambank erosion was noted along the reconstructed banks within North Fork Bear Creek Stream Mitigation Site. Root wads placed along the north bank appear to be stable, with no excessive scour or lateral bank movement. As a result, no measures are necessary to improve bank stability within the project reach.

Photo Point 2.1
Description: Left streambank root wads.
Compass: 225 (Southwest)

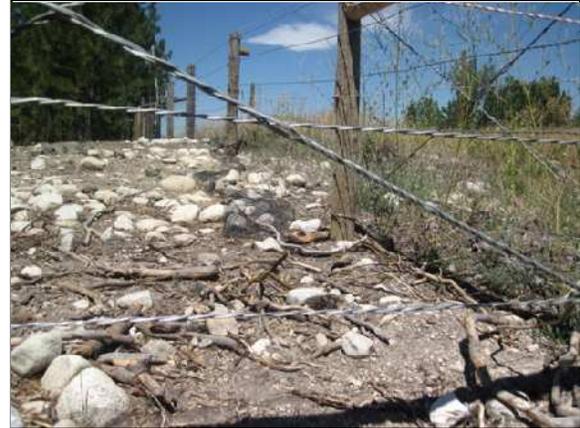
Photo 3

Several straw logs used for stormwater erosion control were used adjacent to the bridge abutments. Remnants of several straw logs remained, with plastic webbing remaining along the stream banks. Photo 4 in Appendix B shows the remnant netting materials in a horse corral adjacent to the stream channel. Plastic webbing used to reinforce straw logs and woven fabrics along stream banks typically do not photo-degrade and end up as trash caught in debris jams and may act as gill nets. Straw logs and coir fabrics made with biodegradable or photodegradable materials are recommended for erosion control of future projects adjacent to stream channels.

Description: Plastic remnants from coir logs in corral.
Compass: 0 (North)

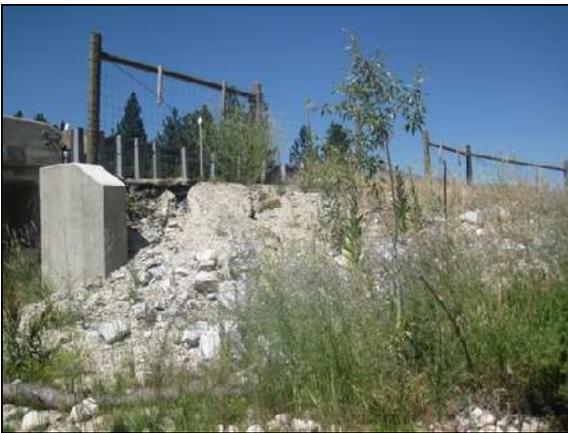
Photo 1

Description: Erosion rills on downstream side of bridge
Compass: 315 (Northwest)

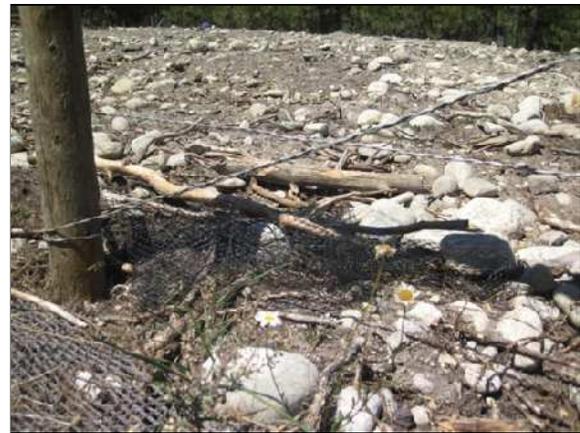
Photo 4

Description: Non-biodegradable plastic remnants.
Compass: 335 (North-Northwest)

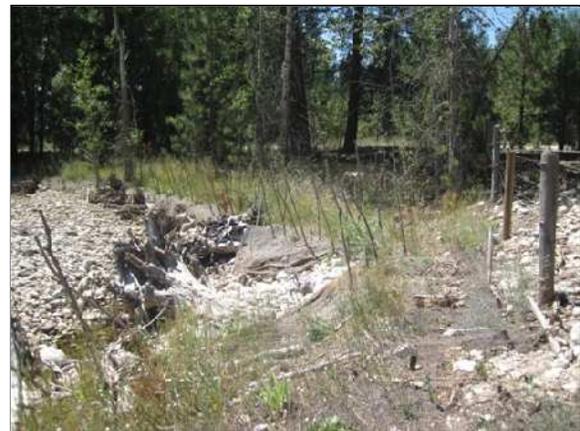
Photo 5

Attempts at establishing woody riparian vegetation within the project reach included installing cuttings along the banks upstream and downstream of the bridge. Cottonwood and willow cuttings installed along the banks were largely unsuccessful (4 of approximately 90 cuttings were found alive). Upon inspection, all cuttings were installed to a depth of approximately one foot, with 4 to 5 feet of the stem extending above ground (Photo 5, Appendix B). High mortality rates were attributed to the inability of the cuttings to extend roots to the low water table elevation.

Channel restoration details specified placing coir erosion control netting along the reconstructed stream banks to protect the upper banks from erosion during high water events. Inspections revealed the leading edge of the coir fabric was exposed after being draped over the top of the bank and staked down with wood stakes. Design details called for backfilling 4.5 feet (1.5 meters) of the leading edge of the coir, followed by wrapping the remaining coir around the fill material to create an encapsulated soil lift. It appears the contractor did not follow this procedure, as evidenced by the installation of cuttings within one foot of the edge of the exposed fabric (Photo 5, Appendix B). As constructed, the coir fabric provides little protection from soil erosion along the top of the bank, particularly along the rootwads placed upstream of the bridge. Downstream of the bridge, herbaceous vegetation has established through the coir, and is providing some degree of protection against soil losses along the upper bank.

Description: Dead willow cuttings with coir fabric.
Compass: 245 (West-Southwest)

Monitoring observations revealed many of the cuttings were approximately 2-3" in diameter. Cutting survival and ease of installation may be improved by harvesting cuttings that are no more than 1" in diameter. It is highly recommended to harvest cuttings only while they are dormant, typically between October 15 and April 15. Following installation of un-rooted cuttings, exposed stems should be trimmed to allow exposure of approximately 12" of the stem. This technique focuses the energy of the cutting toward establishing roots rather than leaves and stems, and improves long term survival rates.

Mortality rates of woody cuttings at the North Fork Bear Creek site may have been reduced if channel restoration details included planting specifications for un-rooted cuttings. Based on the poor survival rates encountered at this site, the alternative planting techniques described above, and the incorporation of more detailed planting specifications is recommended for future MDT projects involving bioengineered stream bank stabilization projects.

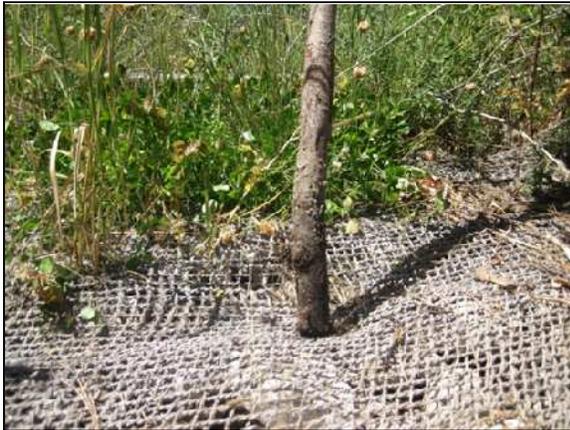
Photo 6
Description: Dead willow cutting with small, dry roots.
Compass: 0 (North)

Successfully establishing woody vegetation from un-rooted cuttings requires the cuttings be installed to a depth that allows newly established roots to reach the low water table elevation. The North Fork of Bear Creek was dry during the site visit, with water only visible in an isolated pool created by root wads downstream of the bridge. This observation indicates the low water table elevation in the North Fork of Bear Creek may actually be below the stream bed elevation during some years.

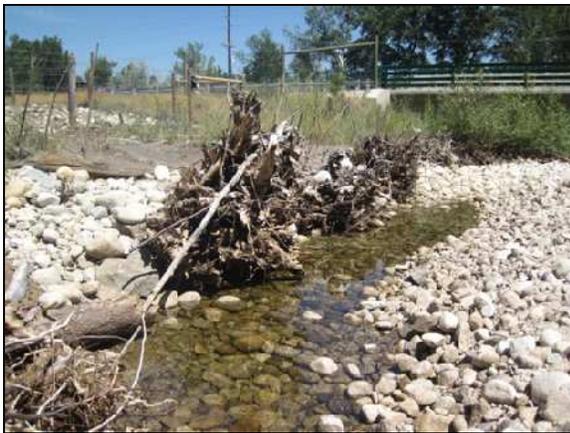
Photo 7
Description: Root wads along left streambank.
Compass: 68 (East-Northeast)

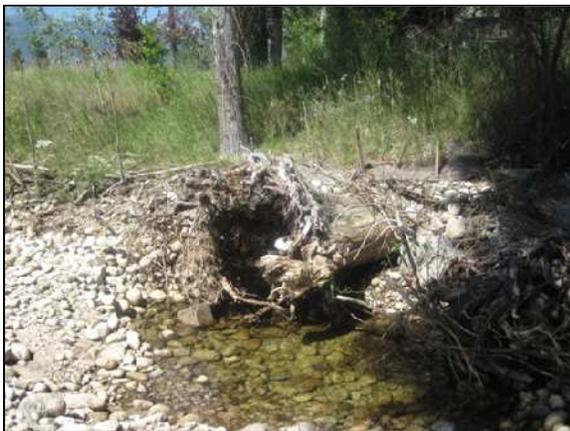
Photo 8
Description: Root wads downstream of bridge.
Compass: 6 (North)

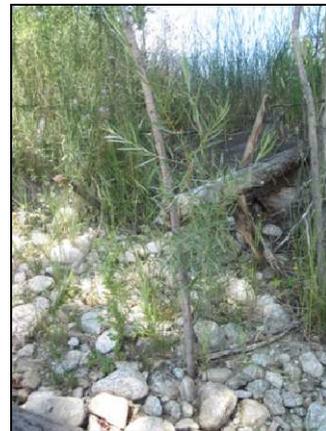
Photo 11
Description: Sprouting willow cutting.
Compass: 0 (North)
