MONTANA DEPARTMENT OF TRANSPORTATION STREAM MONITORING REPORT

*Little Rock Creek at Judith Slide Repair
Fergus County, Montana*

*Project Completed: 2013
Monitoring Report #2: December, 2015*

MDT Project Number: STPS 426-2(12) 15
Control Number: 7726000

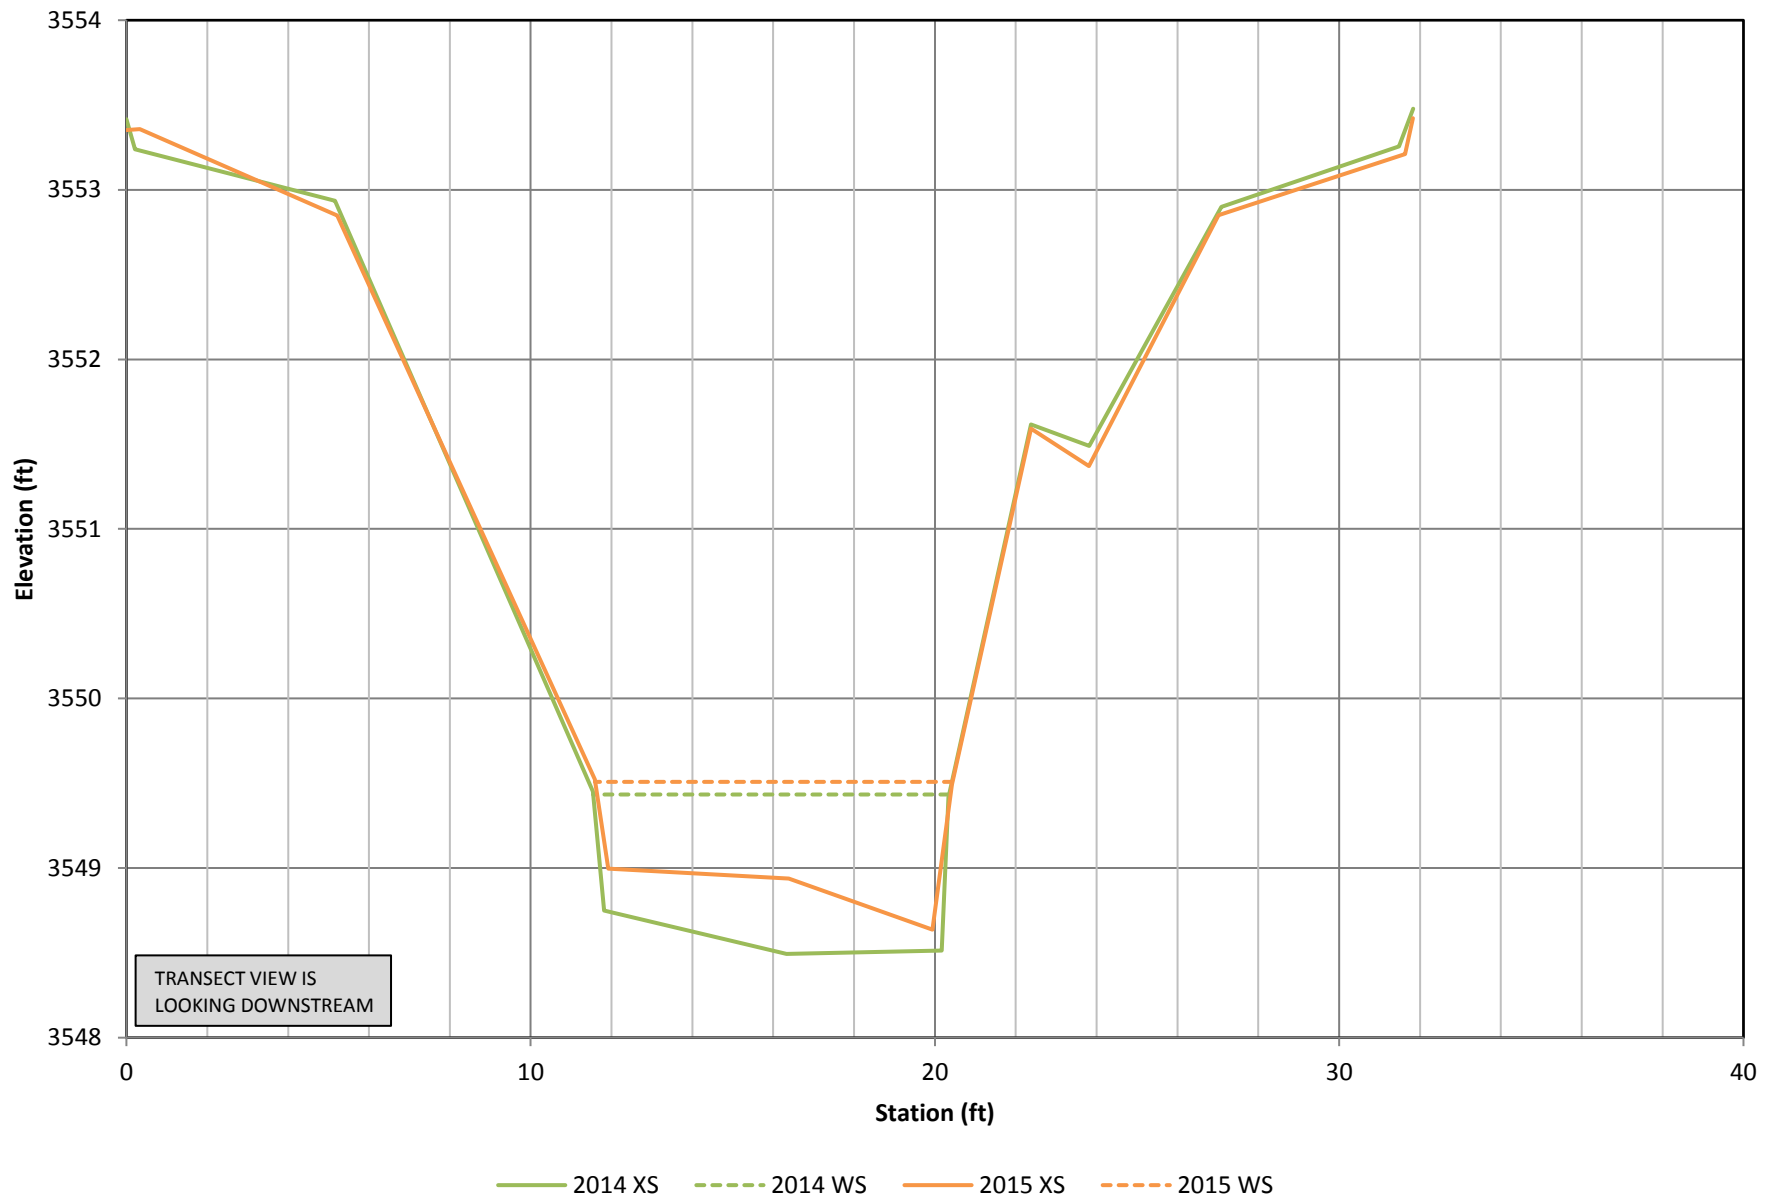
Judith Slide Transect #1 - Riffle

Repeated surveys in 2014 and 2015 indicates some deposition has occurred through the riffle transects. Although only two riffle features were surveyed, both showed higher bed elevations by approximately 0.25'. Results of the longitudinal profile (discussed in next section) and perpendicular transects through pools do not indicate excessive scour through pool habitats that would generate bed material depositing in riffles. It remains to be seen whether the slightly higher bed elevations observed in 2015 may be considered aggradation of the channel bed or temporary deposits of finer material during a below average runoff year. This material may flush out of the channel if a bankfull or larger flood event occurs and lower the bed elevation again. Continued monitoring of all perpendicular transects will assist in determining whether this observation is a trend or a temporary depositional feature.

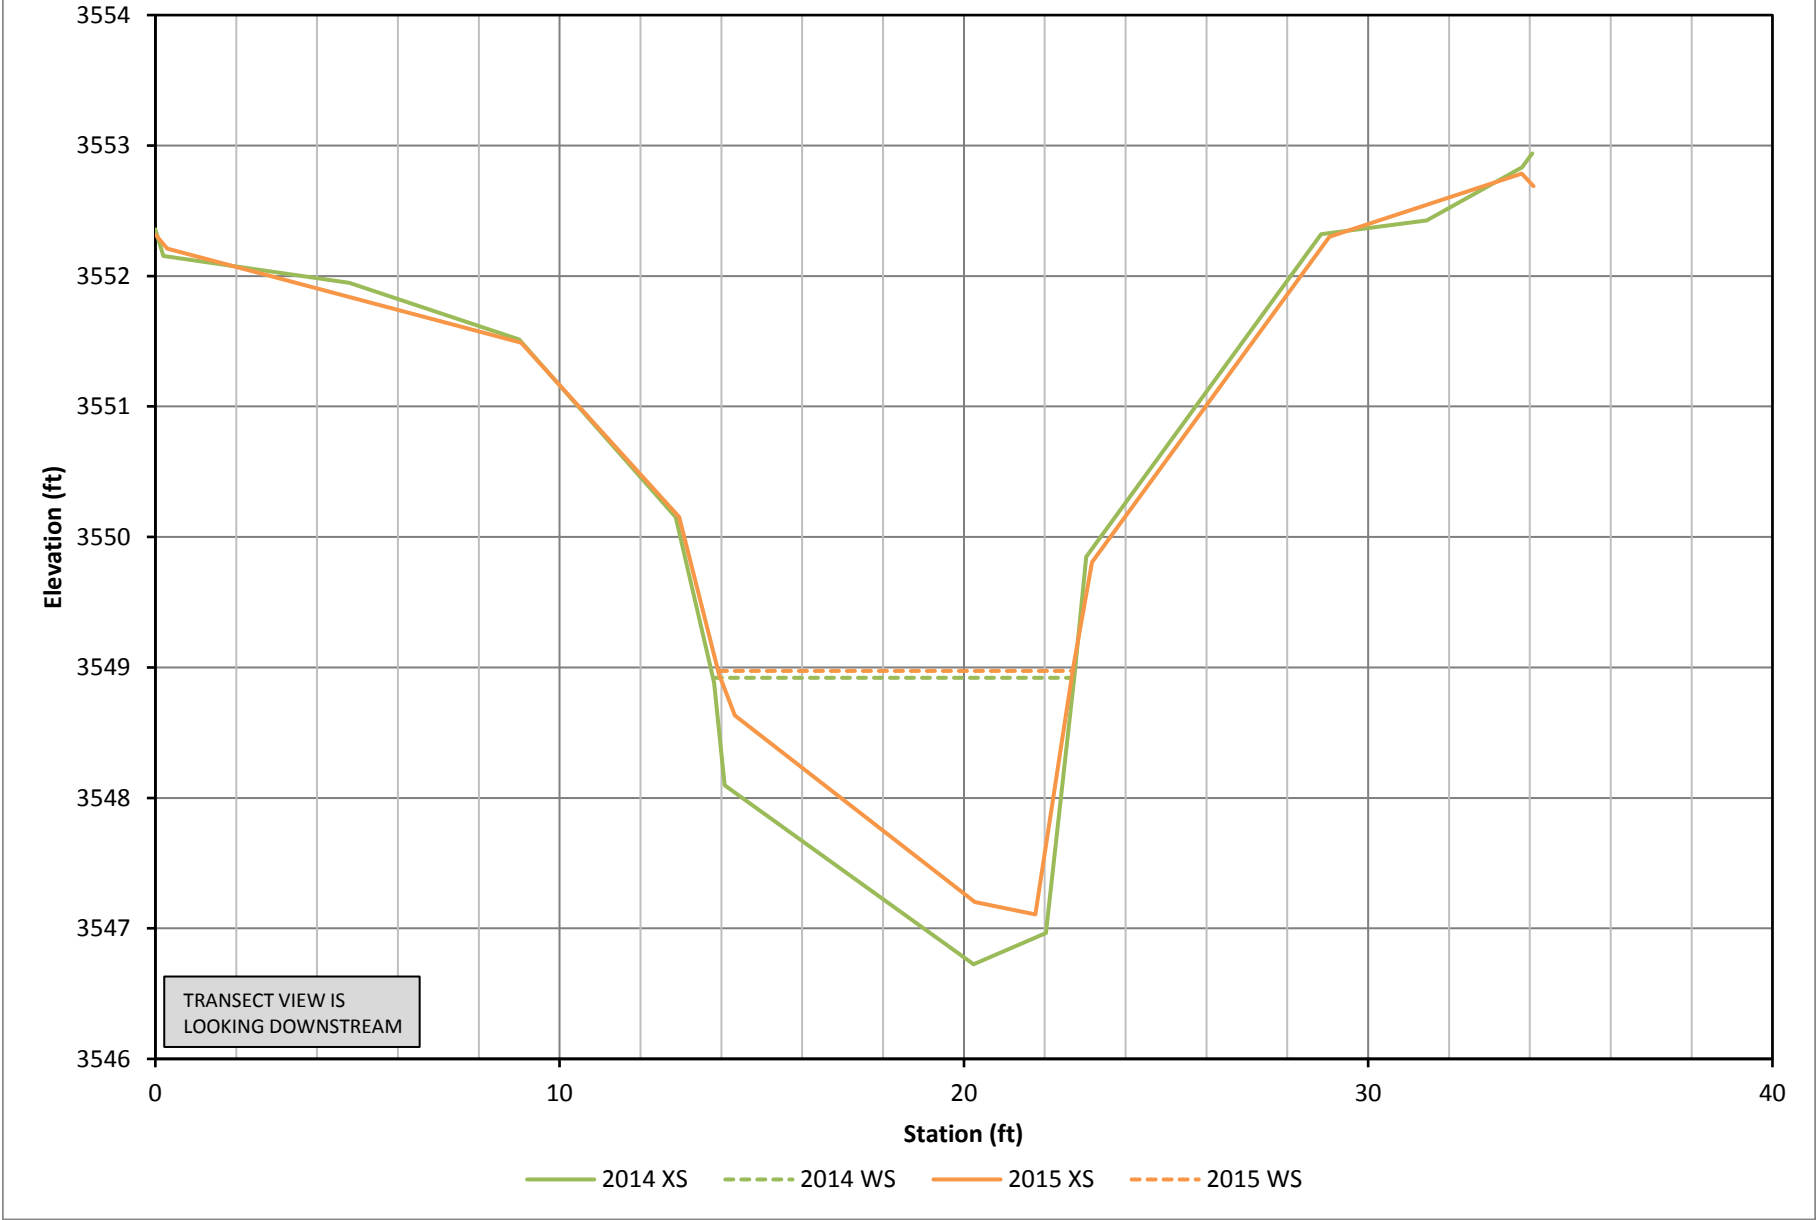
Judith Slide Transect #2 - Pool

Repeated surveys in 2014 and 2015 through the two pool transects indicates the development of point bars on the inside of each meander bend. Point bars extended between 1 and 2 feet into the channel at both pools. This bar development is likely to increase scour along the opposite banks and maintain pool habitat on the outside of each meander bend. As the coir fabric begins to biodegrade over the next few years,

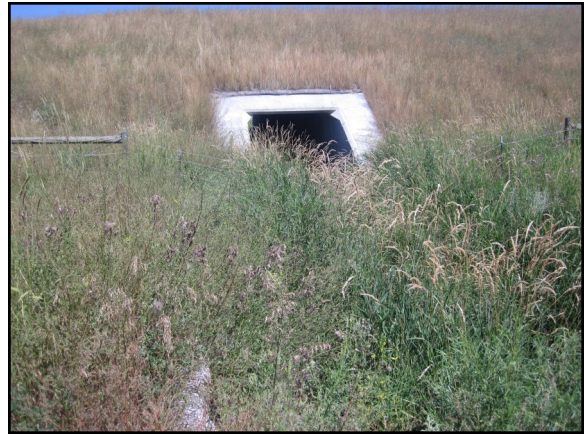
Photo Point 1—2015

Table 1 summarizes the areal percent cover of total vegetation, woody vegetation, and noxious weeds observed along each riparian and stream bank transect during the 2014 and 2015 monitoring events. Total percent cover of vegetation increased from 58% in 2014 to 83% in 2015. Total percent woody cover increased from 7% in 2014 to 14% in 2015. Percent cover of noxious weeds increased from 0.2% in 2014 to 3% in 2015. These vegetation transects were both located downstream of the box culvert, and are representative of the reconstructed channel and associated riparian zones below the culvert outlet. Vegetation upstream of the culvert is establishing well with a diversity of stream bank and riparian vegetation developing on both sides of the channel (See Photo Point 1 and Additional Photo #11 in Appendix A).

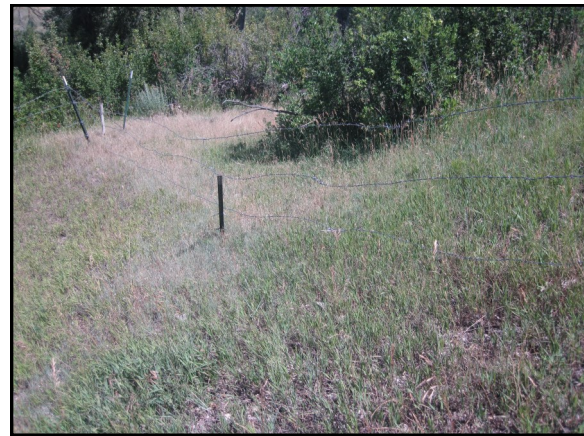
Additional Photo 2

fences. The barbed wire fence crossing Little Rock Creek at the downstream end and along the northeast corner of the project is in poor condition and allows livestock to cross into/out of the project reach (See additional Photo 2 in Appendix C). The segments of fence in poor condition were installed well prior to the 2013 MDT project.

Description: Poor fence on NE side of project area
Taken in 2015

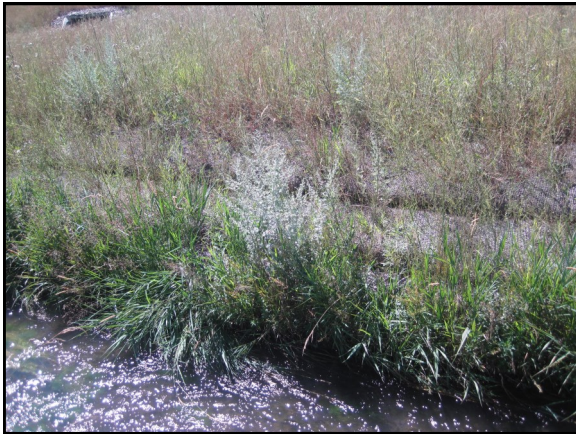
3. Vegetation establishment along the upper coir fabric lifts remains relatively limited. Much of the coir fabric surfaces remain bare or have been colonized by undesirable and weedy species (See additional Photos 3-13 in Appendix C). It is difficult to determine the cause for lack of vegetation in these areas; however, potential causes include 1) below average precipitation in 2015, 2) an improper seed mix, or 3) no seeding applied to this area. The design calls for seeding the area above the uppermost lift with a wetland seed mix, which may have been inappropriate for such a dry zone. The design does not call for seeding of native fill material placed within the upper two coir lift layers, which is most likely the cause of poor vegetation establishment in this area.

Additional Photo 5
Description: Unvegetated upper soil lift
Taken in 2015 looking across channel @ STA 11+00

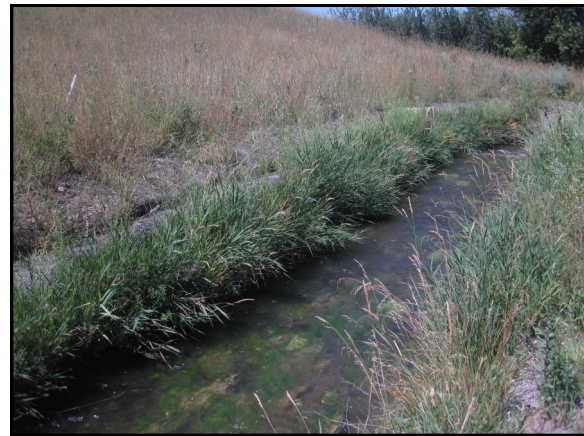
Additional Photo 8
Description: Unvegetated upper soil lift
Taken in 2015 looking downstream @ STA 11+00

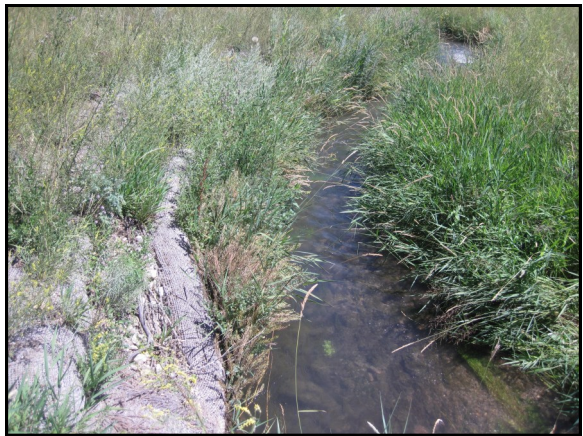
The reconstructed channel alignment includes a relatively sharp bend approximately 250' downstream of the newly installed culvert. This bend was constructed using multiple coir wrapped soil lifts over a native gravel toe. The stream has undercut beneath the soil lifts, causing them to begin slumping into the void created. A 10' segment of the left stream bank along this bend is beginning to erode as the coir fabric has begun to degrade and no longer has the strength to hold the bank together (See Additional Photos 13 and 14 in Appendix C). A thin band of vegetation has begun to establish along the toe of the bank, but may not be capable of maintaining the undercut bank over the long term. In general, vegetation establishment along the upper coir fabric lifts is relatively sparse; as a result, this bank may continue to slough into the channel over the next several years until the bank slope stabilizes.

Additional Photo 14
Description: Eroding Bank EBL1
Taken in 2015 looking downstream from STA 11+50

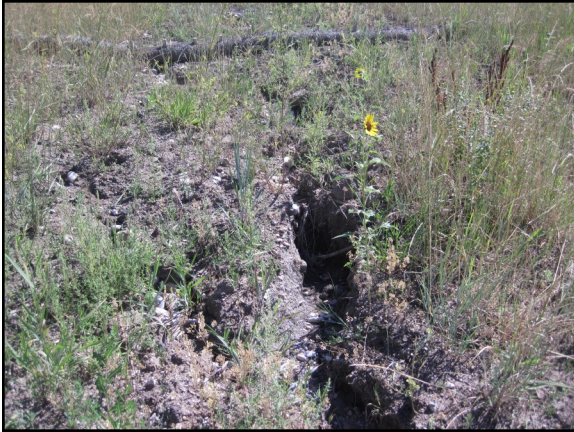
Additional Photo 17
Description: Gully forming east of new channel
Taken in 2015
