MONTANA DEPARTMENT OF TRANSPORTATION STREAM MITIGATION MONITORING REPORT

*Sweathouse Creek
Ravalli County, Montana*

*Year Project Completed: 2011
Monitoring Report #3: Submitted December, 2015*

MDT Project Number: NH 7-1(114)59
Control Number: CN 201 5004

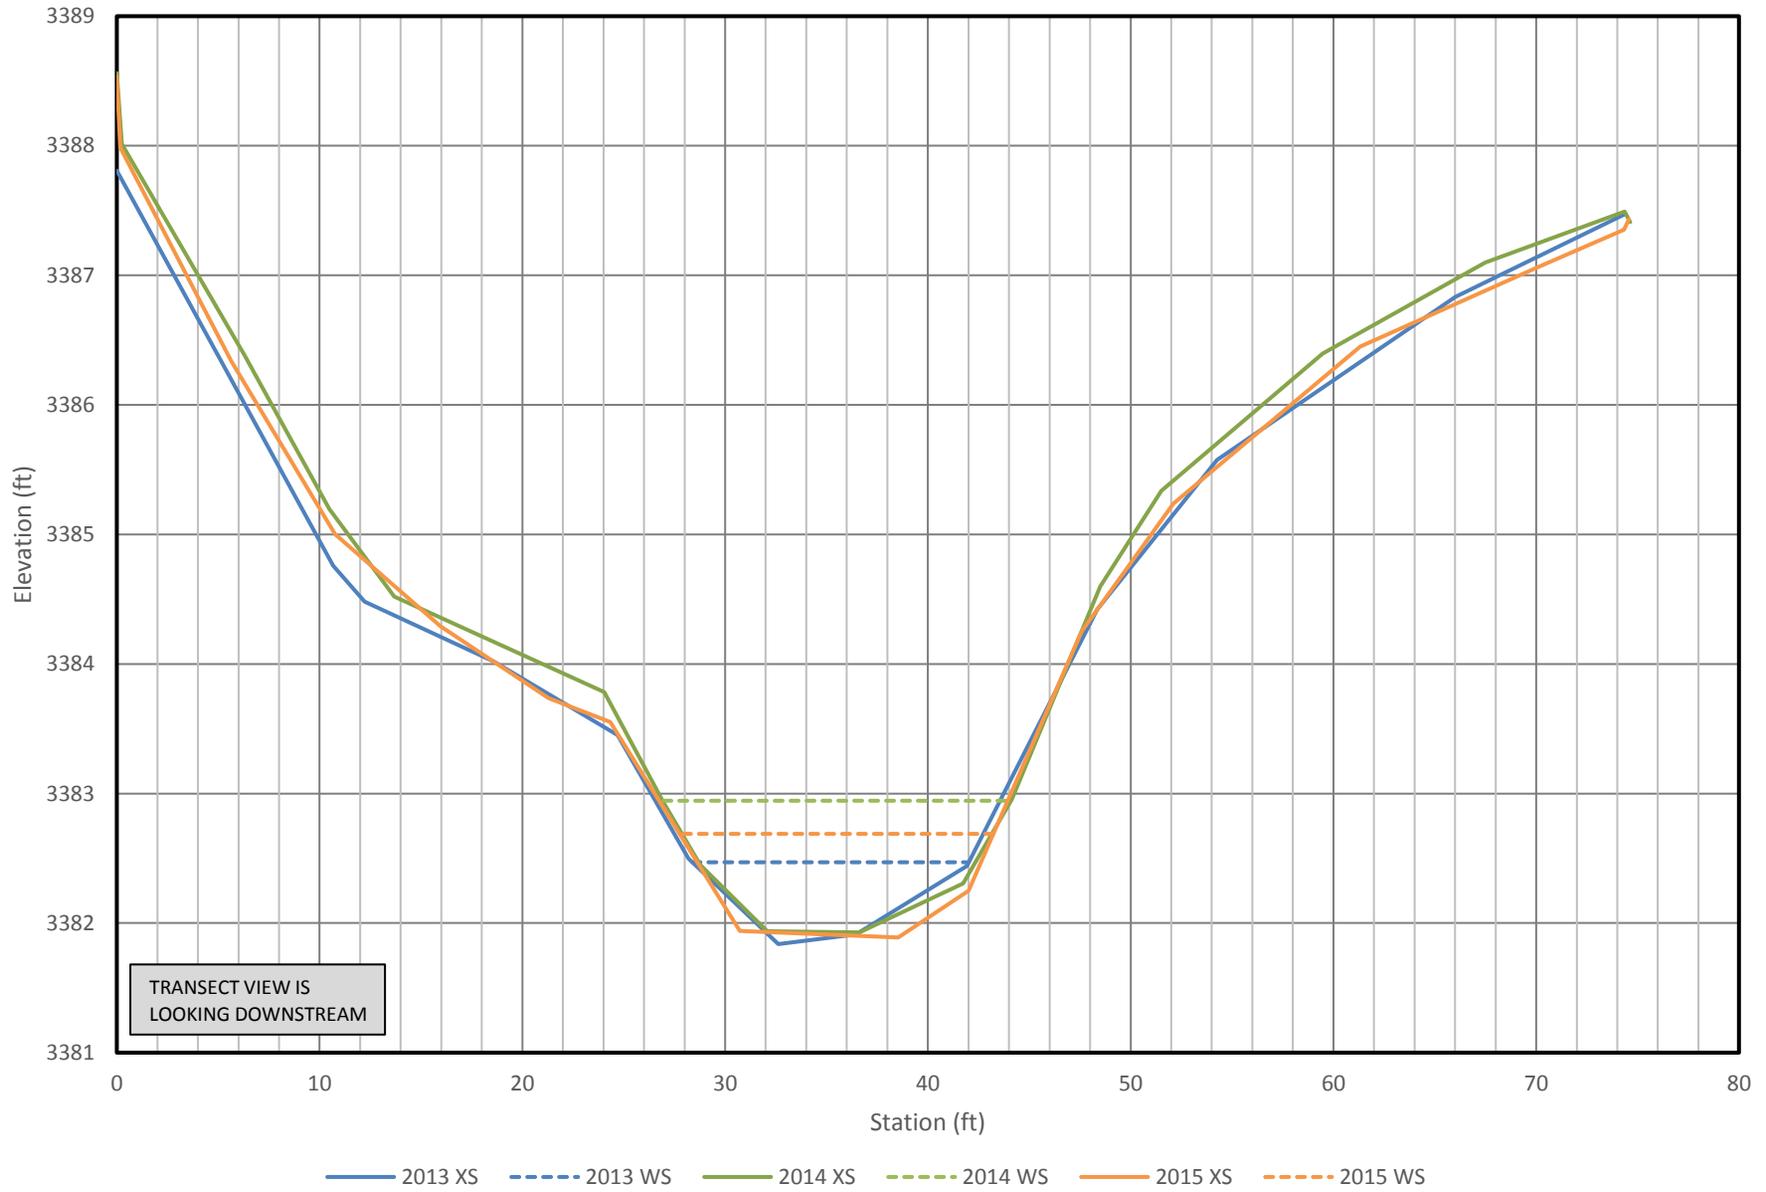
Sweathouse Creek Transect #1 - Riffle

included in Appendix B, and are plotted from left to right looking downstream. Repetition of these transects over the past 3 years indicates relatively minor adjustments to the bed and banks. Both pool transects indicate the channel is maintaining deeper water habitat by scouring against wood structures installed on the right bank. Riffles also largely maintained bed elevations and channel dimensions, indicating relatively good sediment and bedload transport. The point bar along the left (north) bank appears to adjust from year to year, but has maintained its overall slope. No evidence of erosion was noted at any of the surveyed transects. Perpendicular transects will be re-surveyed during subsequent monitoring events to continue documenting bar formation, pool depths, or lateral channel movements.

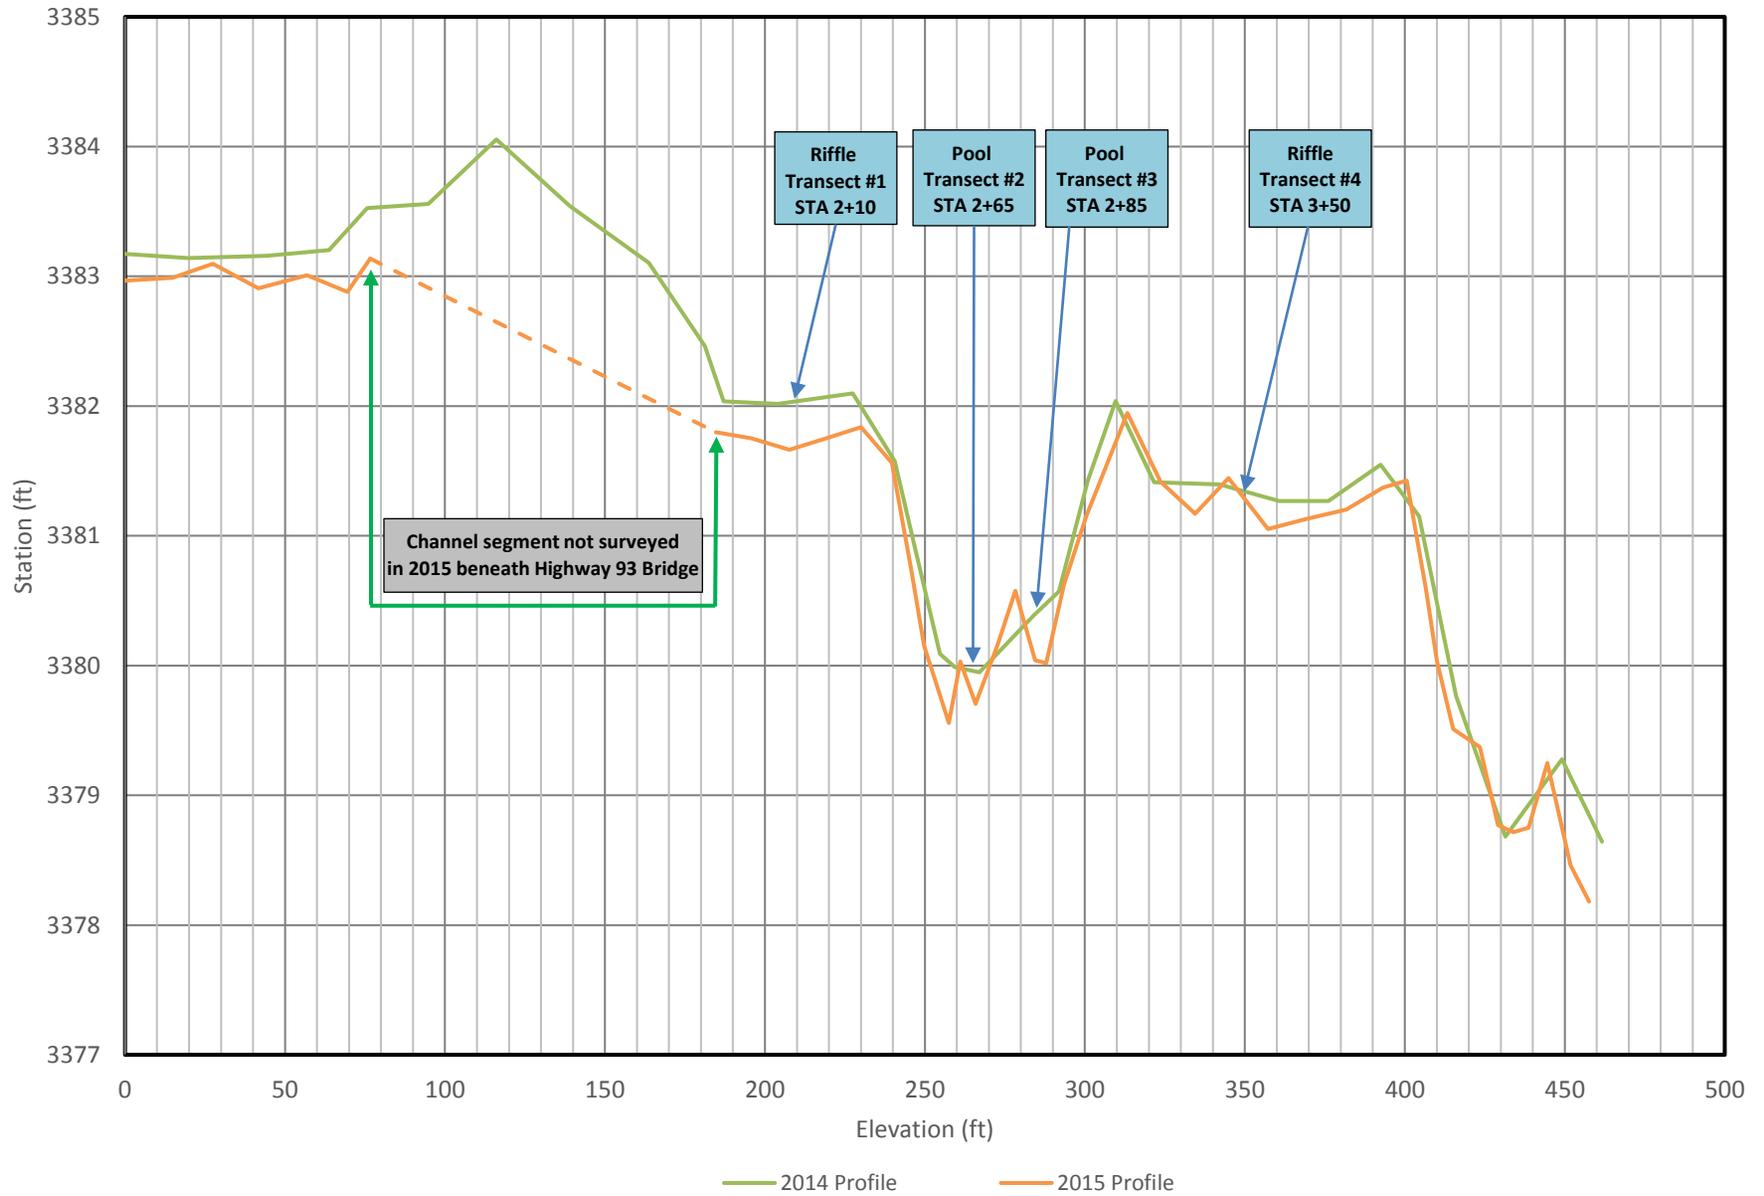
Sweathouse Creek Longitudinal Profiles: 2014 and 2015

A longitudinal profile surveyed down the length of the channel thalweg in 2014 and 2015 are also included in Appendix B. In 2015, the profile survey did not include points beneath the Highway 93 Bridge due to a malfunctioning total station survey instrument; however, the remaining profile length indicates the stream bed maintained relatively consistent elevations. One long pool is evident within the profile, extending from STA 2+30 downstream to STA 3+10. This section of the channel occurs along the meander bend downstream of the bridge and has several root wads and logs installed along the bank to encourage scour and pool development. Juvenile and small trout up to 8" have been observed utilizing this pool. Both pool transects surveyed lie within this segment of the channel. A second pool is developing on the next meander bend downstream, where the longitudinal profile ends. Continued monitoring of the channel bed elevation will document whether aggradation or degradation is occurring within the project reach.

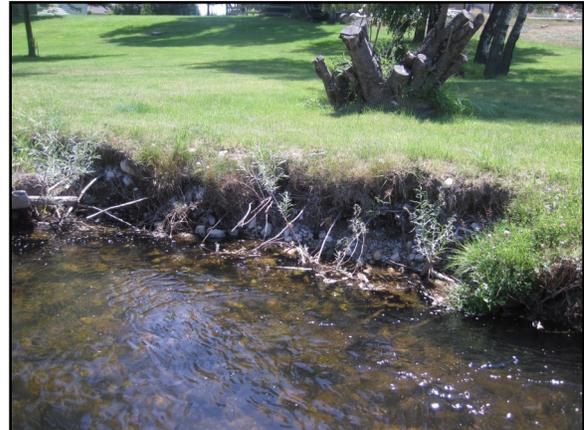
The erosion inventory conducted in 2015 did not reveal any new bank erosion within the project reach. A 15-foot long eroding stream bank documented in 2014 along the right (south) bank between the first and second root wads downstream of the Highway 93 Bridge (see Additional Photo 4 on page 8 of Appendix C) does not appear to have eroded further laterally in the past year. Erosion along this bank appeared due to scour of gravels and cobbles that had been placed beneath the coir logs to construct the bank. Movement of these cobbles has resulted in a 15-foot segment of the bank to undercut, loss of one coir log, and bank calving adjacent to a second coir log. Erosion along this bank is considered moderate due to the relatively short segment exhibiting erosion and no evidence of continued lateral migration one year following its initial discovery.

Additional Photo 4 - 2015
Description: Eroding bank EBR1 along right (south bank). **Compass:** 90 (East)

the erosion occurring along this bank, corrective actions may be necessary to maintain 100% stability within the project reach.

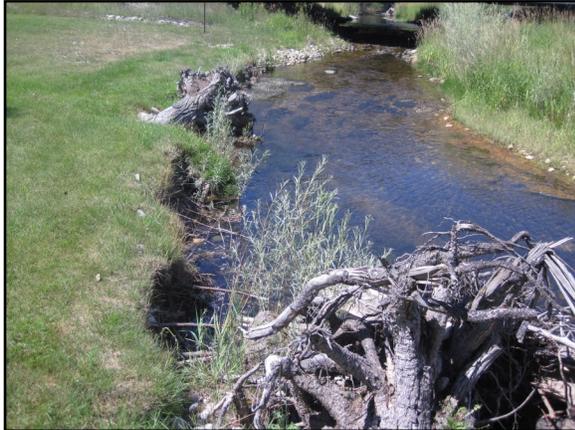
The 15-foot section of eroding bank along Sweathouse Creek identified in 2014 did not erode further in 2015 and is not currently jeopardizing any woody structures installed along the south bank. This moderately eroding bank occurs between two root wads installed to protect the bank from lateral erosion. One of the coir logs placed to protect the upper bank washed out, exposing the upper bank to active flows. Vegetation along this bank has been consistently mowed, and woody vegetation planted during the project's construction has only sparsely established along the bank toe. As a result of

Additional Photo 9: Eroding Bank EBR1 - 2015
Description: Looking upstream toward Highway 93 bridge from north bank.

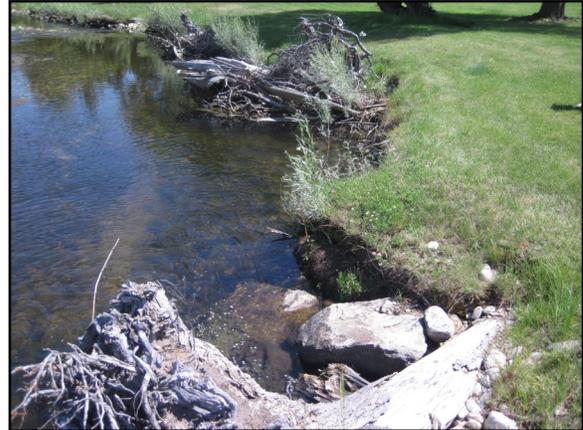
Additional Photo 10: Eroding Bank EBR1 - 2015
Description: Looking downstream from north bank.

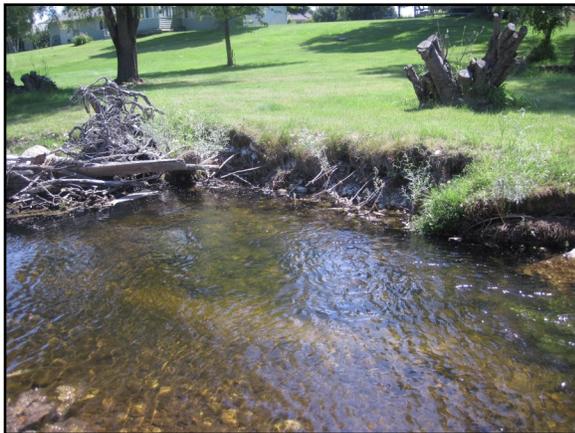
Additional Photo 11: Eroding Bank EBR1 - 2015
Description: Looking across the channel at eroding bank.

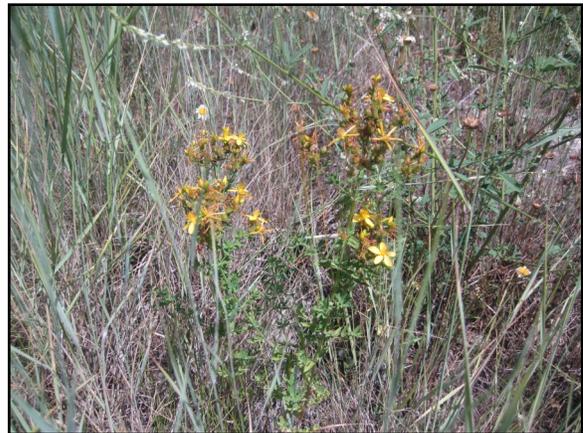
Additional Photo 12: Noxious Weed - 2015
Description: St. Johnswort observed on north bank
