Montana Department of Transportation Stream Mitigation Monitoring Report

MILL CREEK MITIGATION SITE

Monitoring Year: 2020

Monitoring Conducted By: Confluence Consulting Inc.

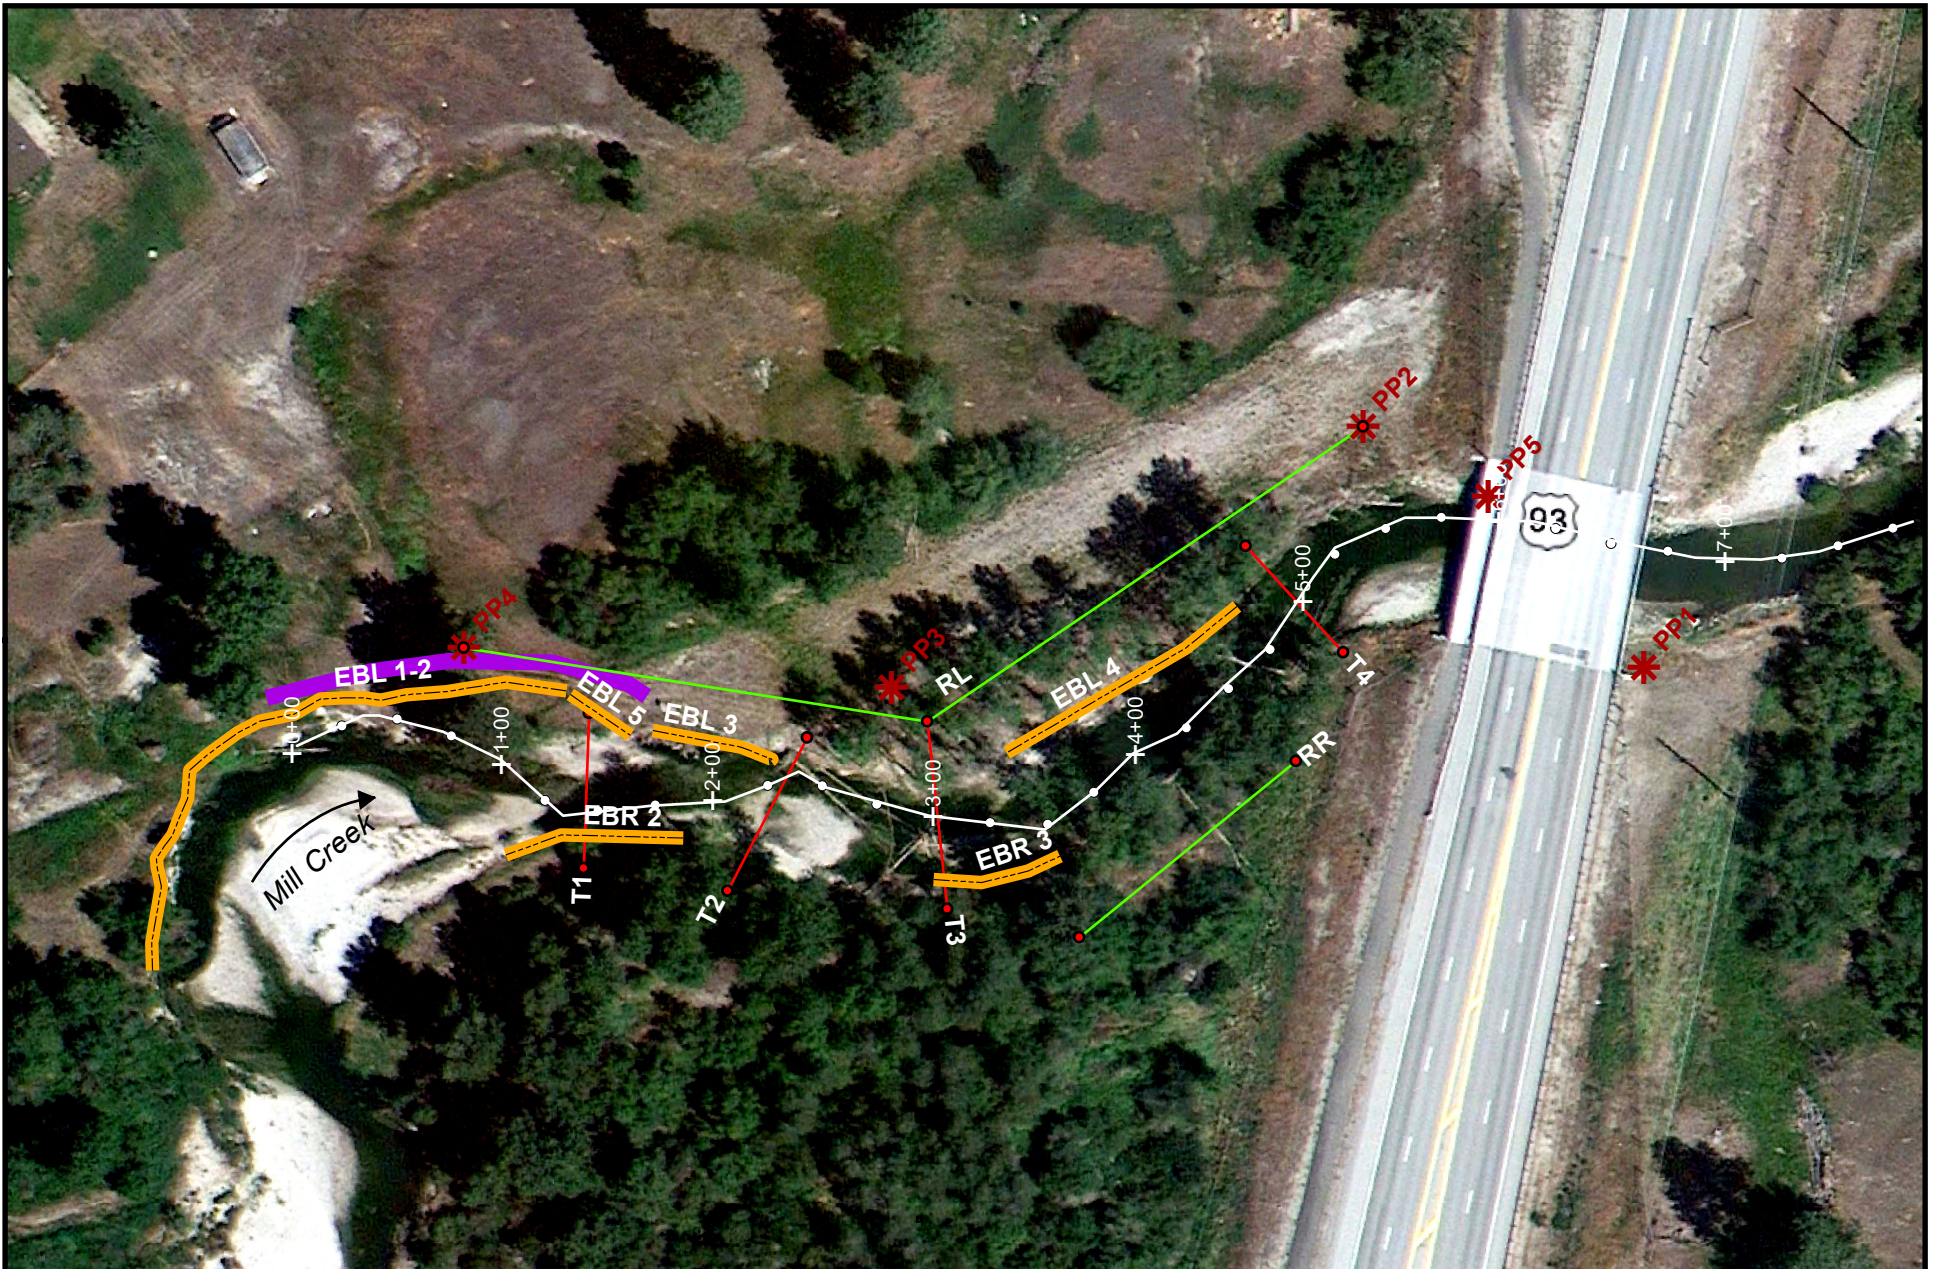
In 2020, continued bank erosion was noted in five locations (Table 4) within the monitoring reach and continues to occur along a sharp meander bend immediately upstream of the monitoring reach. Descriptions of erosion at these eroding banks are provided below, while locations are illustrated on Figure 2 in Appendix A.

Bank erosion within the project reach – As with previous years, several eroding banks were observed within the project area in 2020 (Figure 2, Appendix A). In 2018, bank erosion was observed on the left bank of the monitoring reach just downstream of EBL1-2. This bank (EBL5) is located at the upstream end of the monitoring reach at the mouth of the channel that was backfilled during construction. Erosion along this bank increased from 20 feet in 2018 to 30 feet in 2020 as a result of increased scour along the bank. This bank has retreated by approximately 5 feet between 2019 and 2020, and approximately 24 feet since 2013 (Appendix D Transect #1). EBL5 is now connected to the long eroding bank (EBL1-2) described above, but was mapped separately, as it lies within the project reach as opposed to EBL1-2, which lies upstream of the mitigation area. While the creek has begun to erode into the former channel that was plugged during construction, it is not threatening to abandon its existing configuration and overtake the former alignment. The former alignment has been completely backfilled to the height of the surrounding floodplain and is not a preferential flow path for Mill Creek's current alignment.

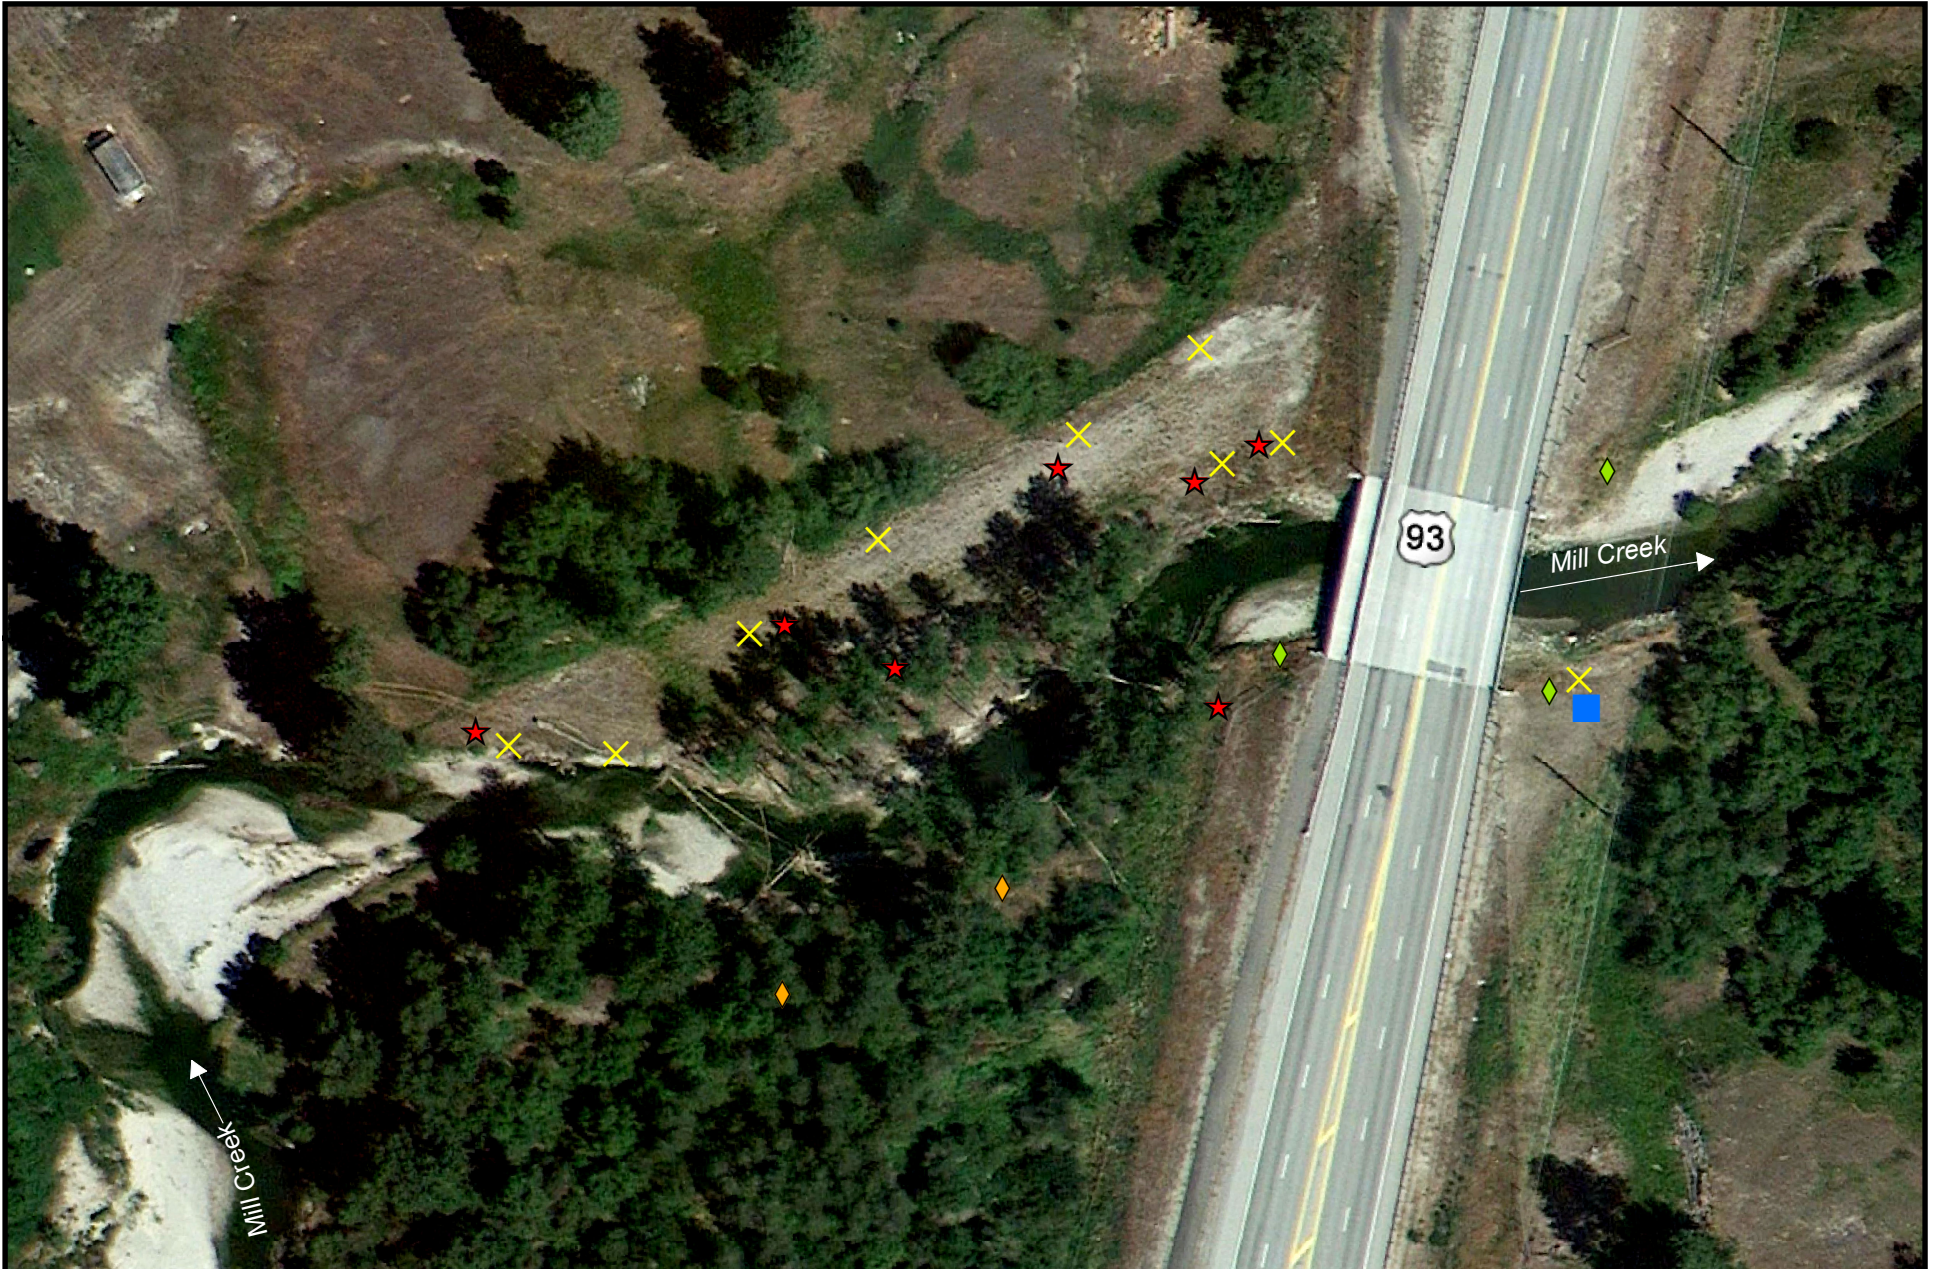
2020 Monitoring Noxious Weeds Mill Creek
Figure 3
Date: 10/04/2020
MillCreek_Weeds2020.mxd

The vegetation inventory along Mill Creek identified eight noxious species (Table 3). Isolated occurrences of houndstongue (*Cynoglossum officinale*), St. Johnswort (*Hypericum perforatum*), and leafy spurge (*Euphorbia esula*) were observed within the project area during the 2020 monitoring events but were not mapped. Noxious weed infestations mapped within the project area were within the trace (less than 1 percent) and low (1 to 5 percent) cover classes. Locations of all noxious weed infestations, with the exception of isolated weed occurrences, are shown on Figure 3 of Appendix A. Many of these infestations occur on private properties outside of the road right-of-way and are therefore inaccessible to MDT weed control contractors without landowner permission.

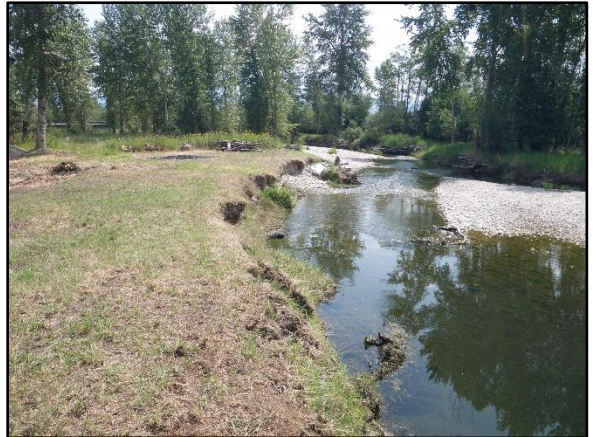
Photo Point 4.3: View of point bar formation from Photo Point 4. Compass: 225° (Southwest)

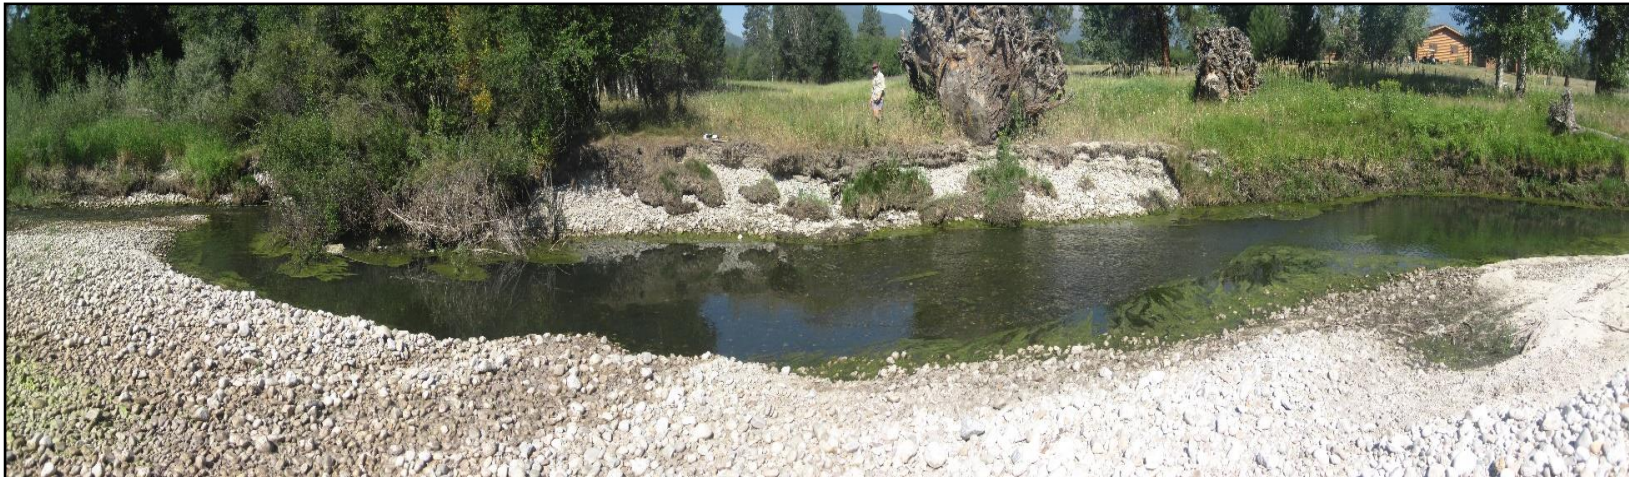
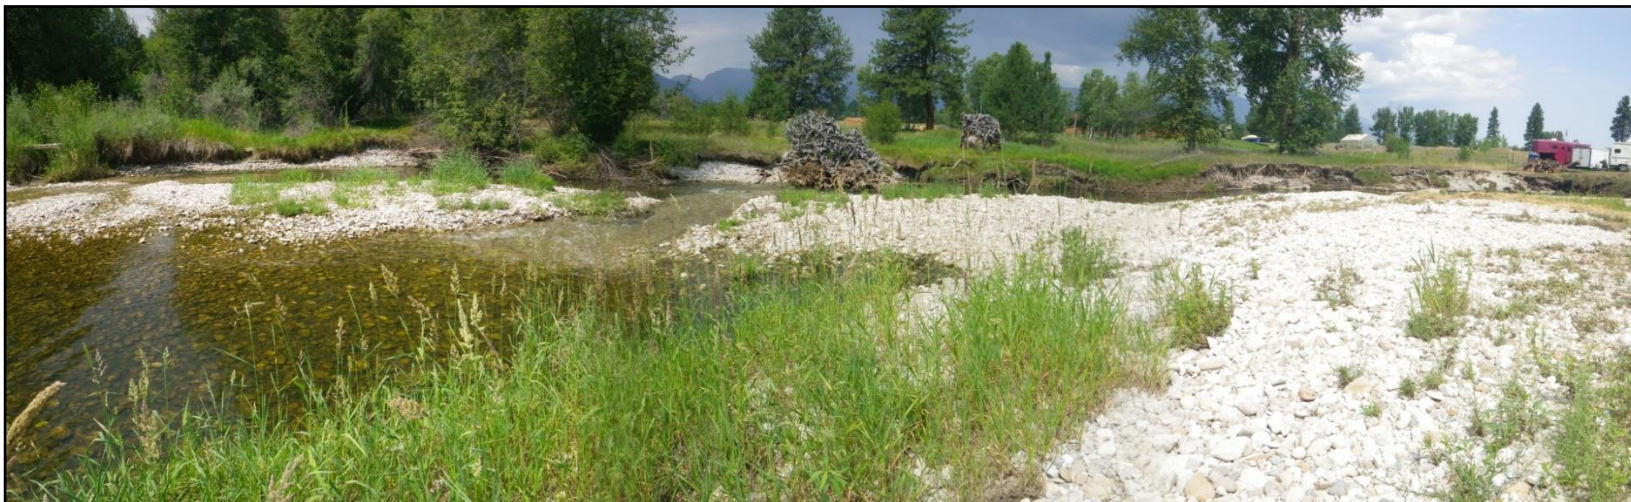
Bank erosion upstream of the project reach - Banks EBL1 and EBL2 were originally documented as two separate eroding bank segments that combined into one long, 247-foot eroding bank in

2014 (herein referred to as EBL1-2). This eroding bank occurs on private land upstream of the project reach but has been documented in previous monitoring reports due to the potential of continued erosion affecting the project reach. The upper 150 feet of EBL1-2 has shown relatively little change over the past five monitoring years and has shown a bank retreat rate of between 0.2 and 0.6 feet per year (see Additional Photo 1 in Appendix B). The lower 100 plus feet of the bank has migrated northward at a more rapid pace than the upper bank segment, especially in the vicinity of a large ponderosa pine tree that fell into the channel in 2016 which can be seen in the photos. The bank has migrated to the north at a rate of 6-7 feet/year for the past four years (see Additional Photo 10 in Appendix B). Severity of the erosion along EBL1-2 is considered very high, particularly along the lower end of the bank.

EBL1-2 is eroding due to extensive gravel deposition just upstream of and across the channel from the eroding bank. Mid-channel bars and an advancing point bar on the right bank are forcing the thalweg up against an exposed, unstable stream bank that runs along a relatively sharp meander bend. Root wads and large rocks that were placed on, but not keyed into the toe of the banks are now in the middle of the channel and are causing increased scour against the bank toe. Lateral migration of this bank has been noted along this bank since 2013, and the erosion rates have increased steadily over time.

Additional Photo 1: Upper end of eroding Bank EBL1-2.

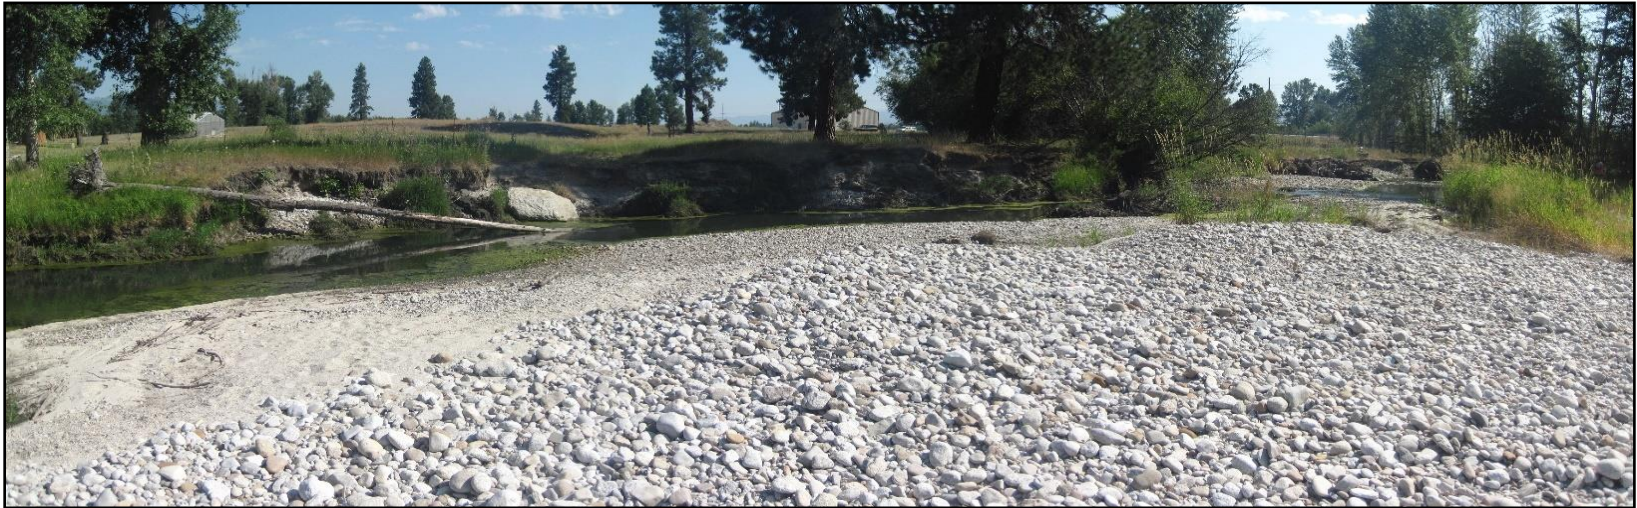
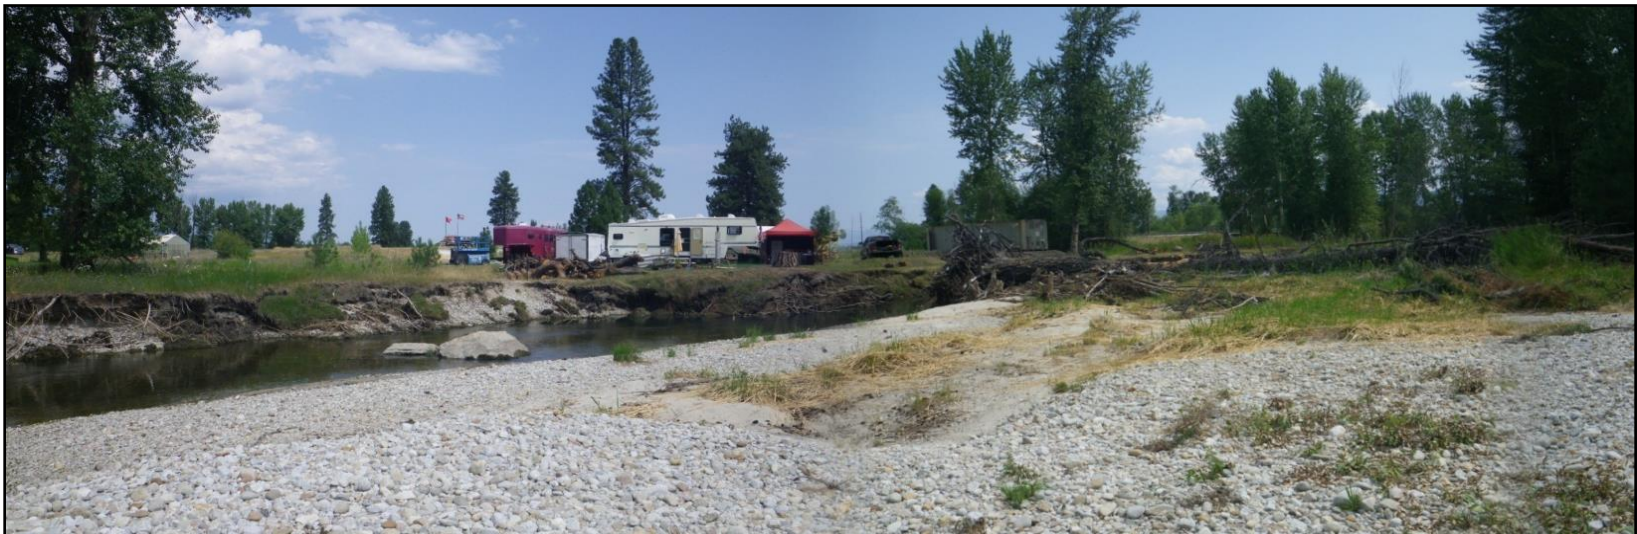
Additional Photo 2: Lower end of eroding Bank EBL1-2.

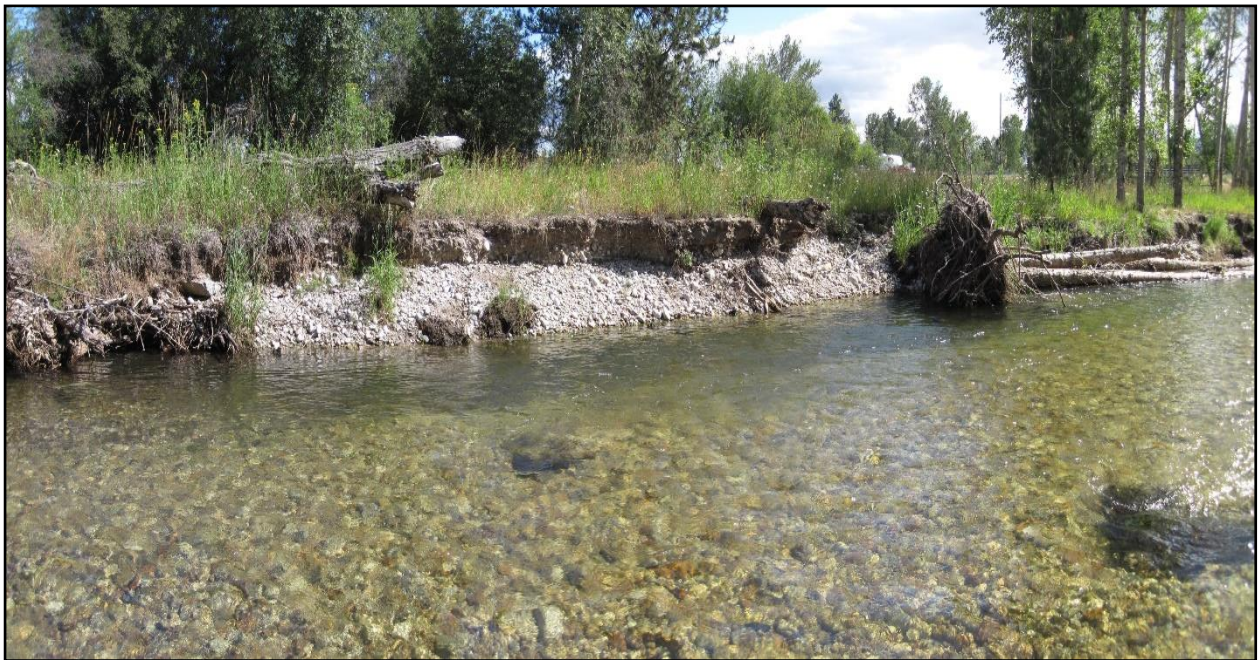
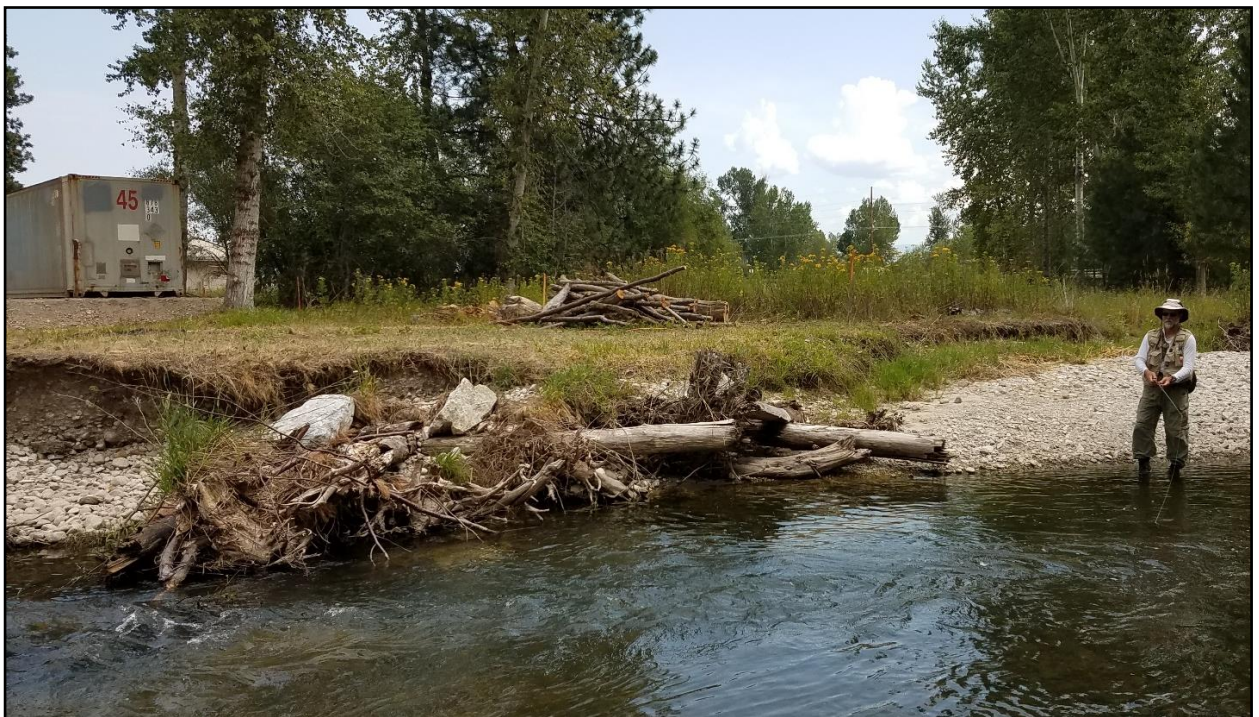
Erosion has been observed just downstream of EBL5 in a location previously numbered as EBL3. This eroding bank was originally observed in 2014 but was removed from the eroding bank inventory in 2019 because it had stabilized following the development of an inset floodplain. However, in 2020, this inset floodplain had been washed away by high flow events and EBL3 was again eroding. The severity of the erosion on this bank is low and the potential for redevelopment of an inset floodplain exists.

Additional Photo 3: Upper section of Eroding Streambank EBL3.

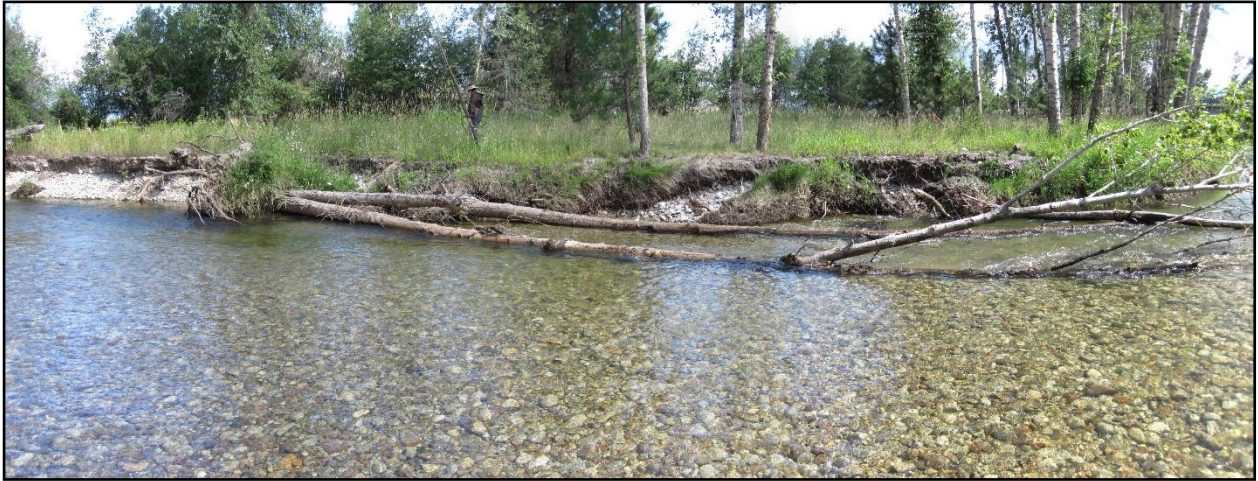
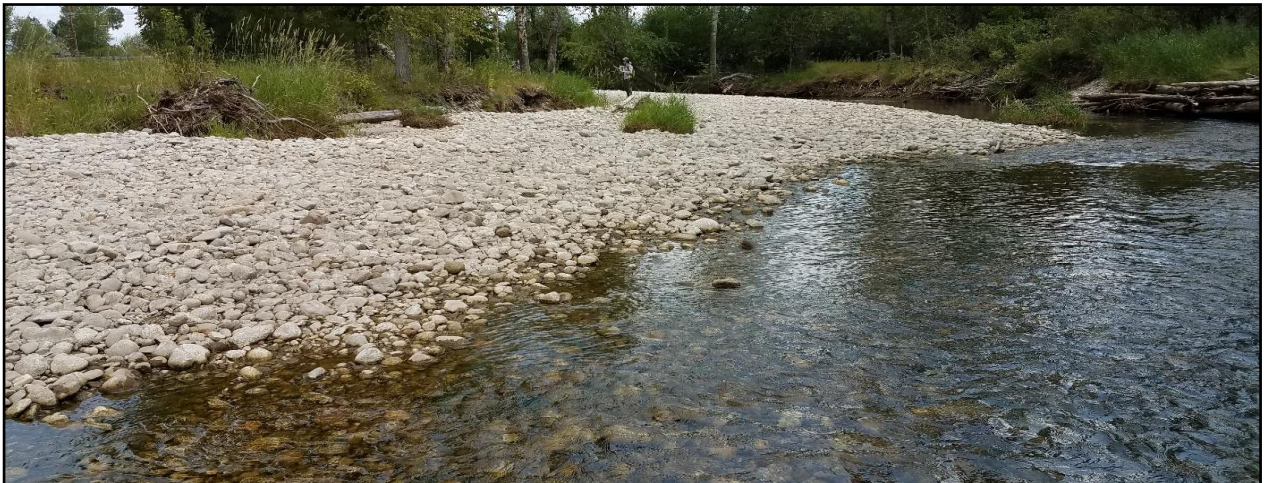
Additional Photo 4: Lower section of Eroding Streambank EBL3.

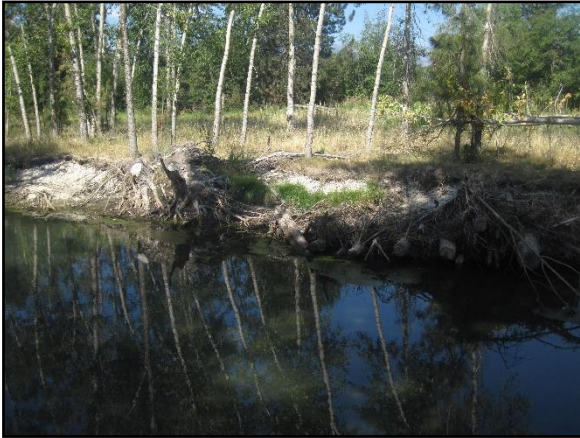
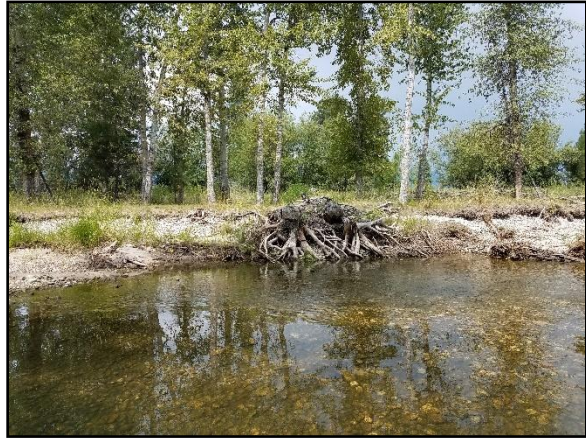
Lateral erosion at bank EBL4 has been observed over the last five years and is likely being perpetuated by a log jam forming adjacent to the bank causing localized scour (see Additional Photo 5 in Appendix B). The bank has retreated approximately two feet in the past year and 10-12 feet in the past six years. Bank instability at this location was potentially caused by natural channel adjustments and debris jams that formed following construction. These debris jams are considered beneficial to the restored channel alignment, as they improve habitat complexity

and generate pool scour features to the benefit of fish. The dominant vegetation along the bank includes reed canary grass and smooth brome, the former of which offers dense roots capable of withstanding erosion more effectively than most species. Erosion severity along this bank is considered low, as it does not jeopardize any infrastructure elements or the newly installed bridge downstream.

Additional Photo 5: Eroding streambank EBL4.

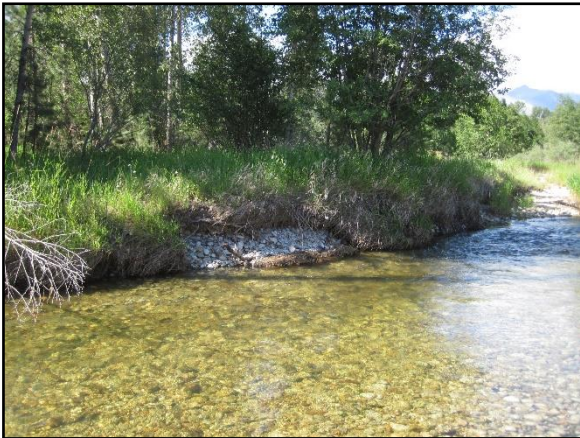
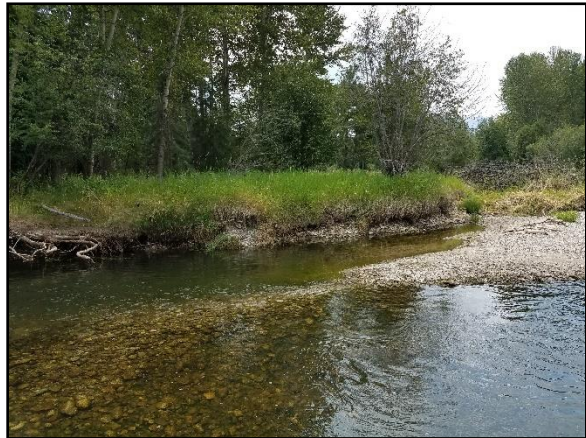
Erosion at EBR2 was originally noted in 2014 along 65 feet of the channel across from the head of the deactivated (backfilled) stream channel. Erosion at this location is tied to sediment deposition leading to channel adjustments, and scour along the outside of a meander. Additional erosion along this bank segment was not observed between 2015 and 2017; however, the bank showed signs of erosion again beginning in 2018, including undercutting, slumping sod mats, and root exposure (see Additional Photo 7 in Appendix B). The eroding bank length increased from 40 to 80 feet between 2018 and 2019 and remained around 80 feet in length in 2020. This bank appears to be stabilizing, likely due to the development of a large point bar upstream of and adjacent to the bank (Photo Point 4.3 and Additional photo 6, Appendix B) which is forcing the stream away from the bank, resulting in a reduction of erosive forces.

Additional Photo 6: Eroding streambank EBR2.

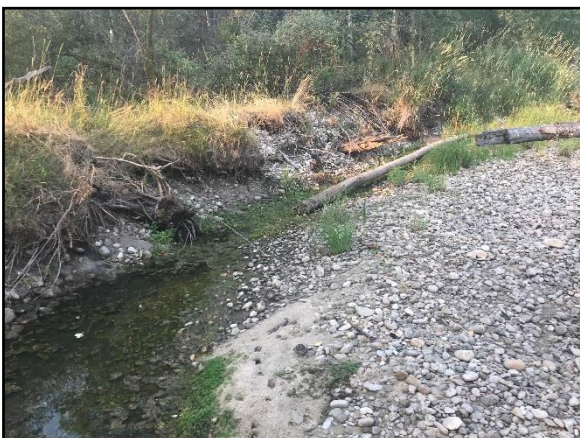
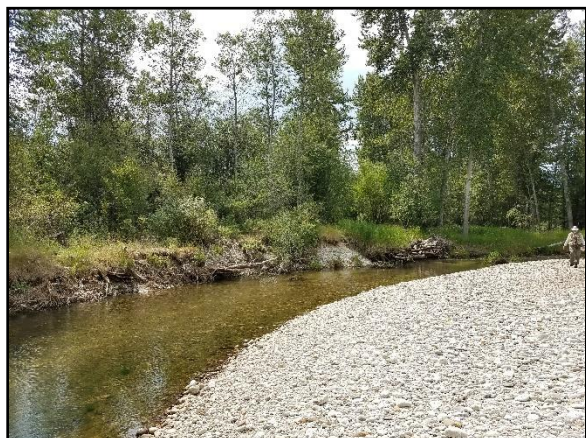
Eroding bank EBR3 was observed in 2017 adjacent to a woody debris jam on the right bank and was characterized by upper bank sloughing and toe scour. Vegetation along the upper bank includes reed canary grass, oxeye daisy, woods rose, wheatgrass, brome, small cottonwood saplings, and young willows. While the bank did not retreat between the 2019 and 2020 monitoring events and the length of bank erosion has remained the same, the bank does not appear to have stabilized (Additional Photo 8, Appendix B). During high flow events, stream flow is direct at this bank and is likely prohibiting stabilization. However, a mid-channel bar has developed in front of this bank and is high enough in elevation that vegetation is establishing on the bar (Additional Photo 7, Appendix B). Should the bar persist over time and vegetation continue to establish, EBR3 will likely become stable over time.

Additional Photo 7: Eroding streambank EBR3.

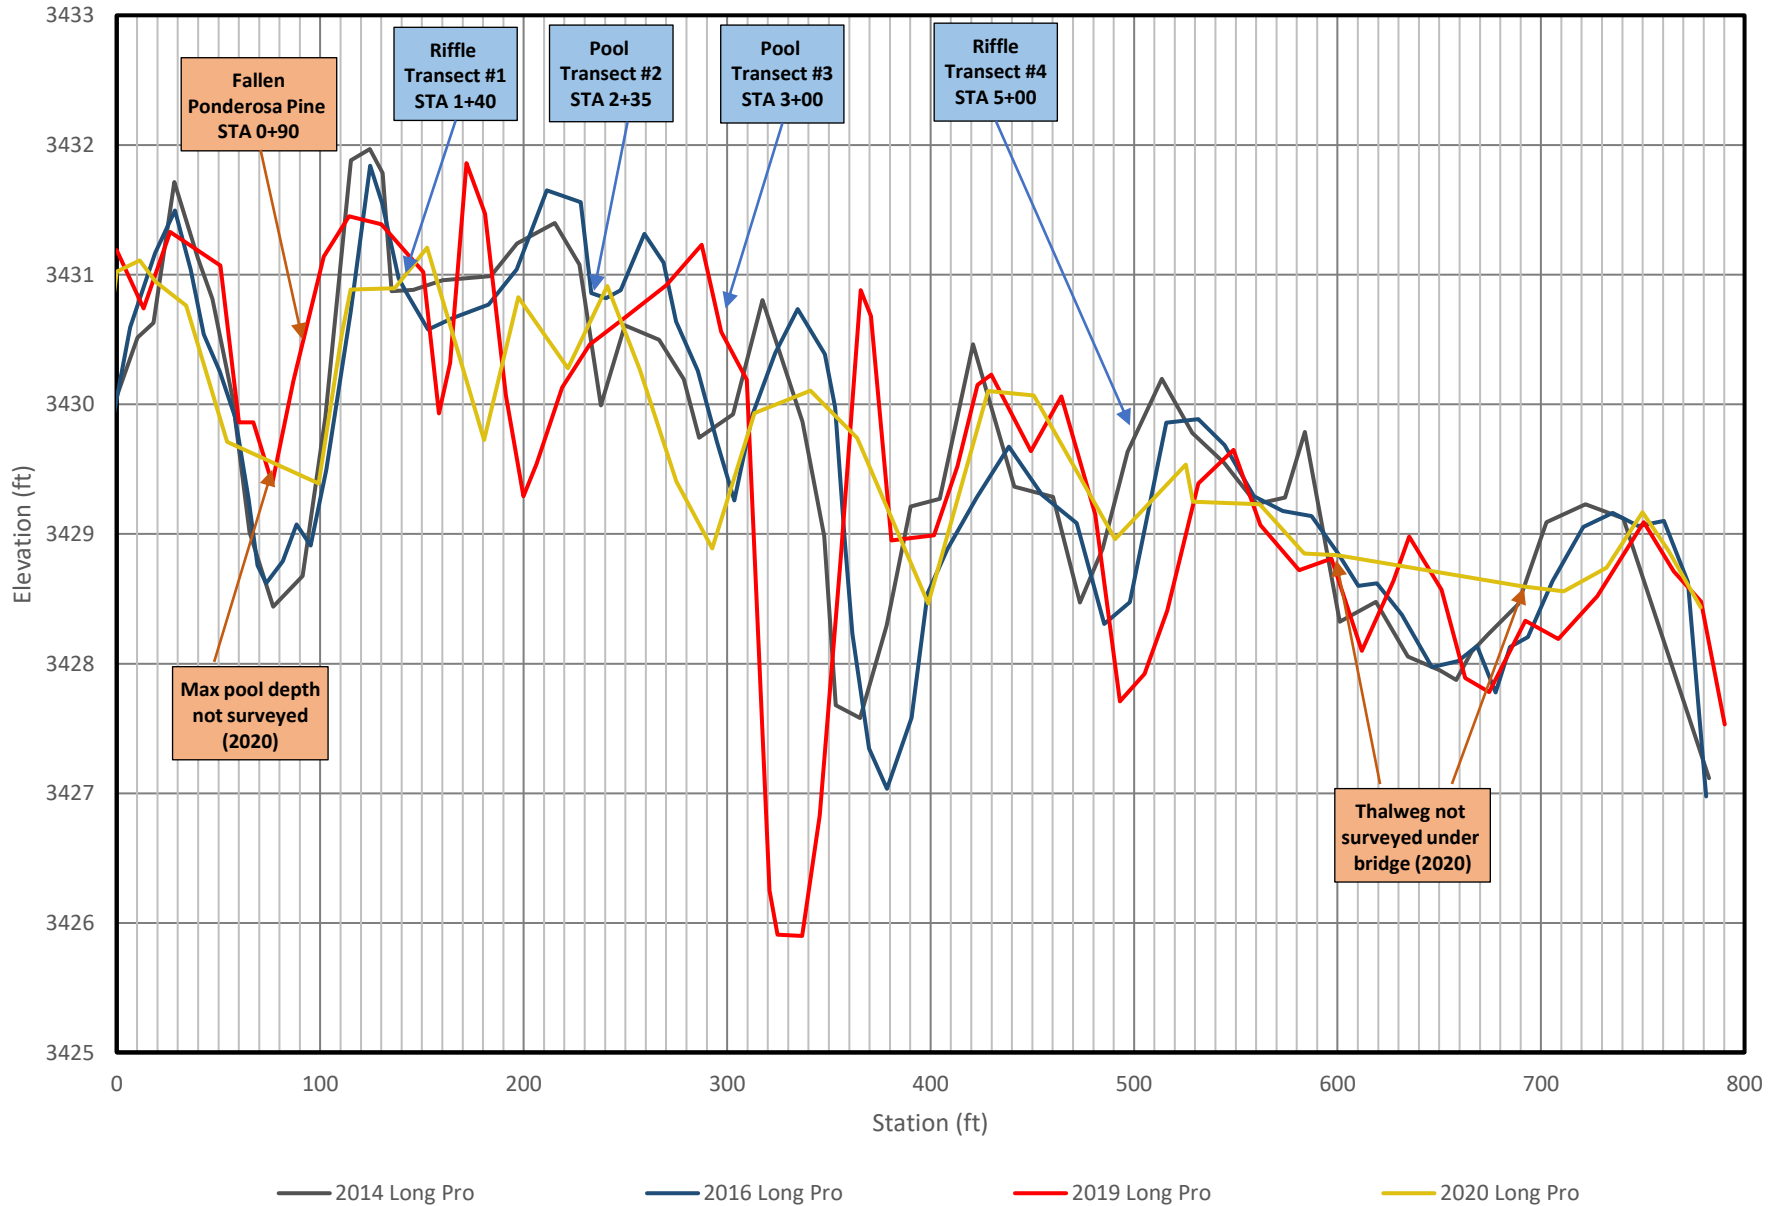
Mill Creek Longitudinal Profiles: 2014 - 20

Longitudinal Profile - A longitudinal profile has been surveyed annually from 2014 to 2020 and a plot which includes the 2020 longitudinal survey results as compared to previous years is included in Appendix D. As would be expected in a highly dynamic system, the 2020 longitudinal profile indicates that the thalweg has shifted laterally and that large amounts of sediment have been redistributed within the reach, thus raising the bed elevation in some places and lowering it in others. Though the longitudinal profile has changed significantly over the years, the 2020 data indicate that the reach continues to support several pool and riffle sequences. Five pools are being maintained with riffle structures between the pools; thus indicating that the mitigation reach is supporting a healthy diversity of aquatic habitat types.

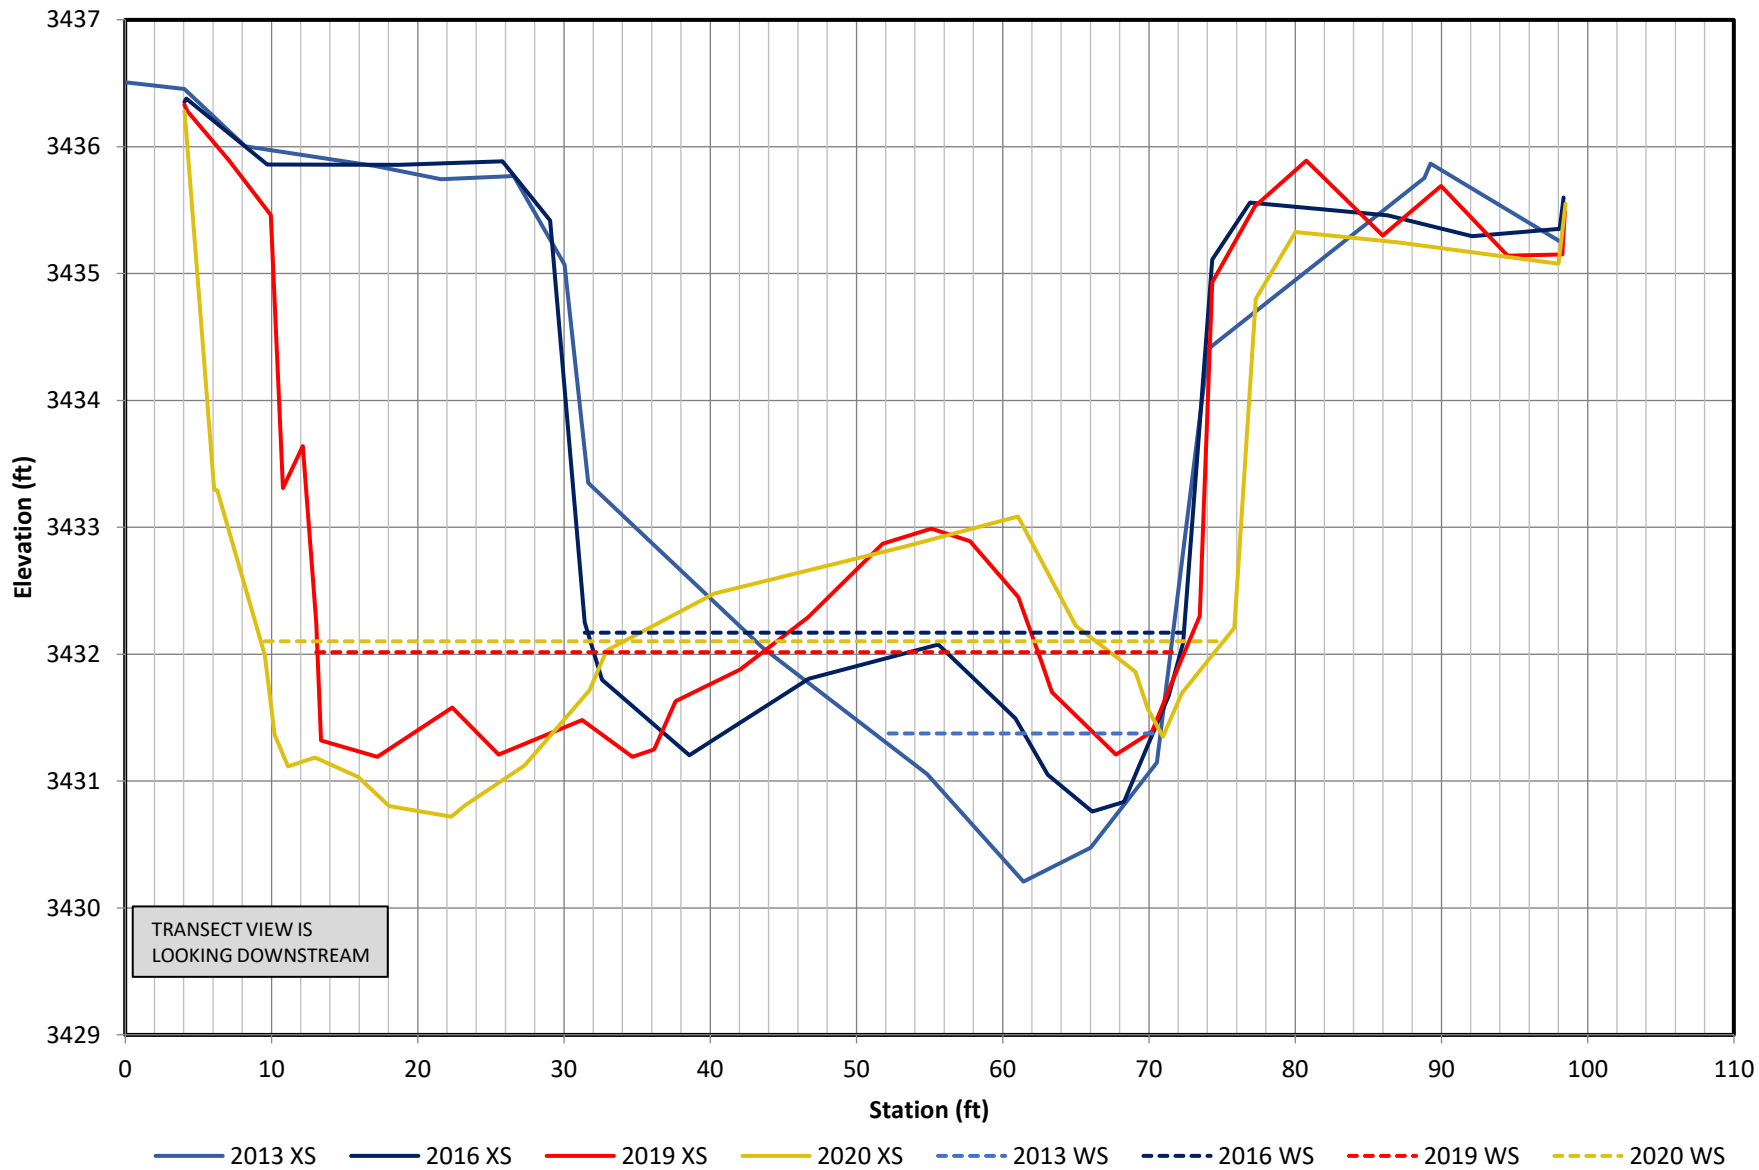
Mill Creek Transect #1 - Riffle

While transect #1 was originally positioned at a riffle, survey data from 2013-2015 indicated that a pool had formed in this location; likely caused by a point bar that developed on the right side of the channel. In 2016, a large ponderosa pine tree fell into the channel just upstream from transect #1, and a mid-channel gravel bar developed in the vicinity of tree which has persisted over the last four years. Over the last 2 years, additional deposition closer to the right bank has forced more flow against the left bank, where a deep pool has developed, and increased bank erosion has been observed. Additionally, the channel width has gradually increased across transect #1 as a result of erosion on the left bank. Plots of this transect indicate that the channel is actively adjusting in this location due to scour and deposition across the transect (Appendix D).

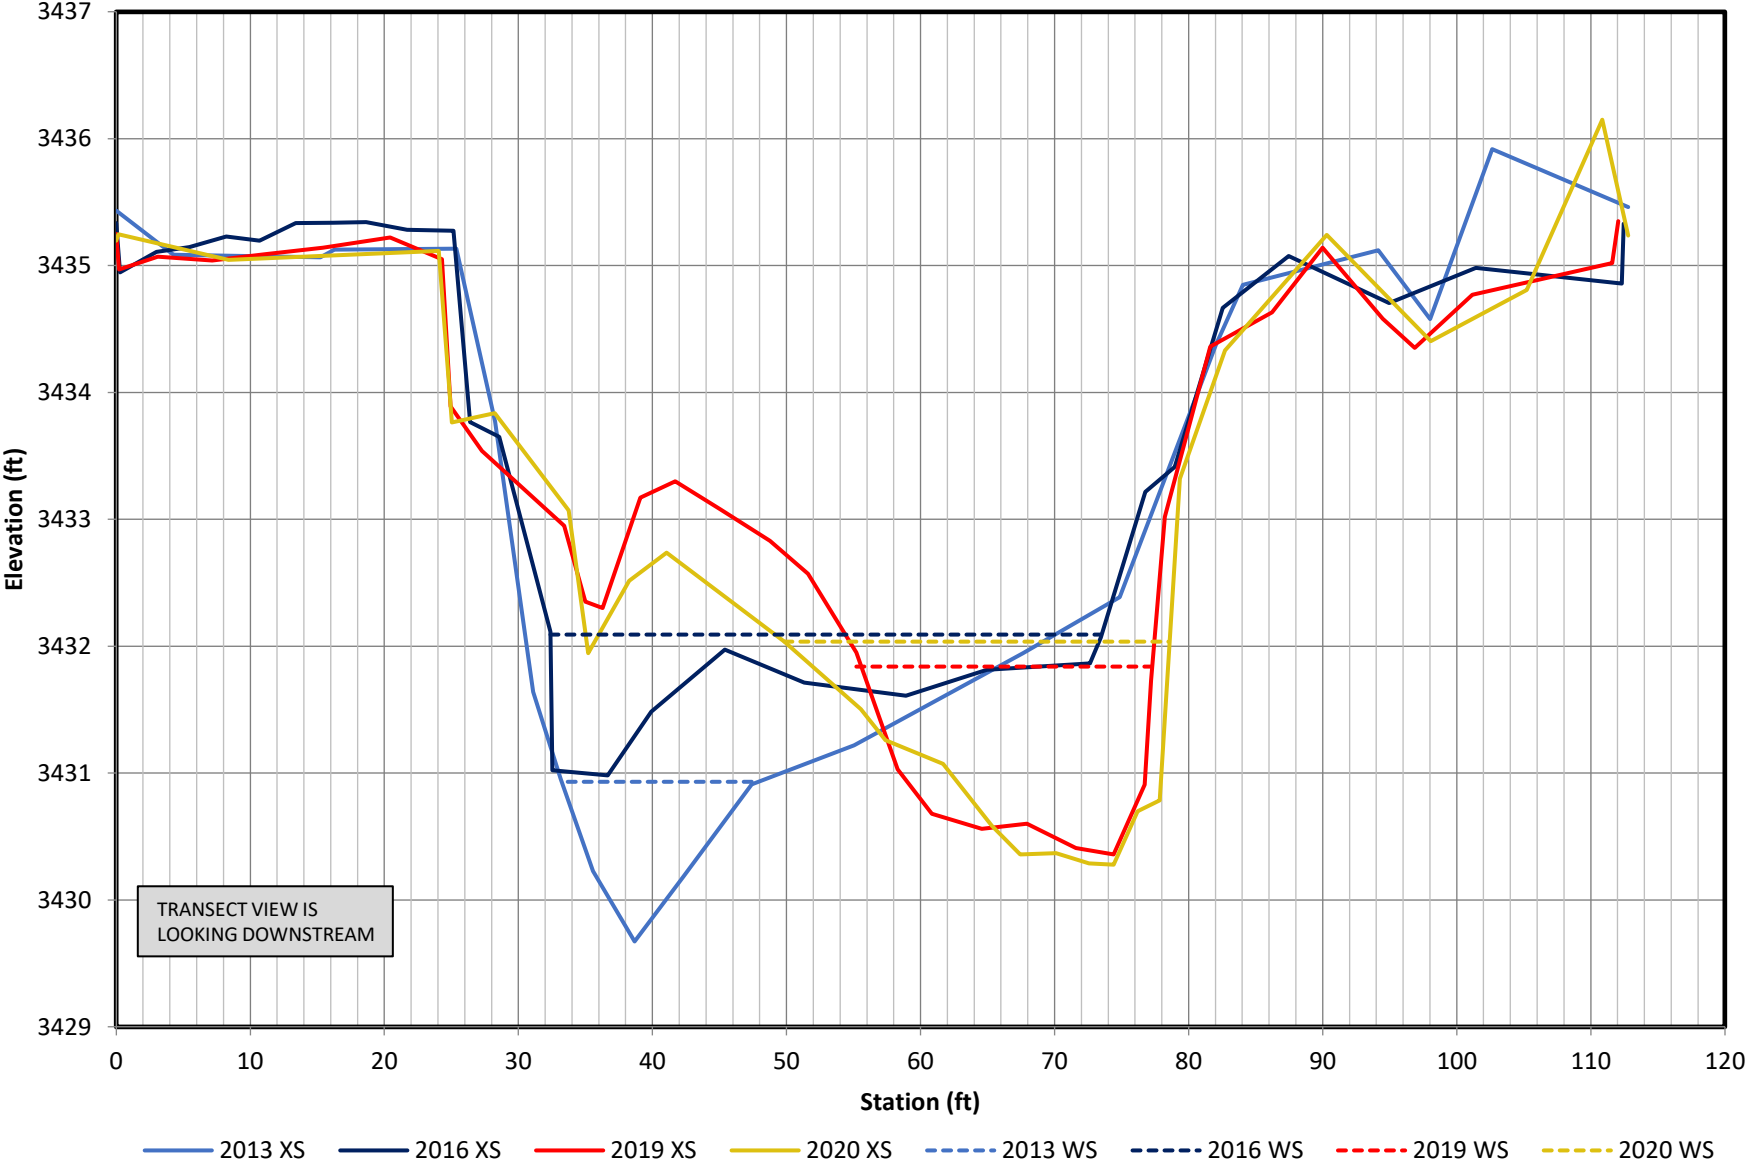
Mill Creek Transect #2 - Pool

Transect #2 was originally established at a pool adjacent to a woody debris jam along the left bank. Since 2015, gravel deposition has been observed adjacent to the left bank which has caused the thalweg to shift toward the right bank over time. This gravel bar has enlarged, creating a pool on the right side of the channel (see photos of Transect #2, Appendix B).
