Montana Department of Transportation Stream Mitigation Monitoring Report

MILL CREEK MITIGATION SITE

Monitoring Year: 2020

Monitoring Conducted By: Confluence Consulting Inc.

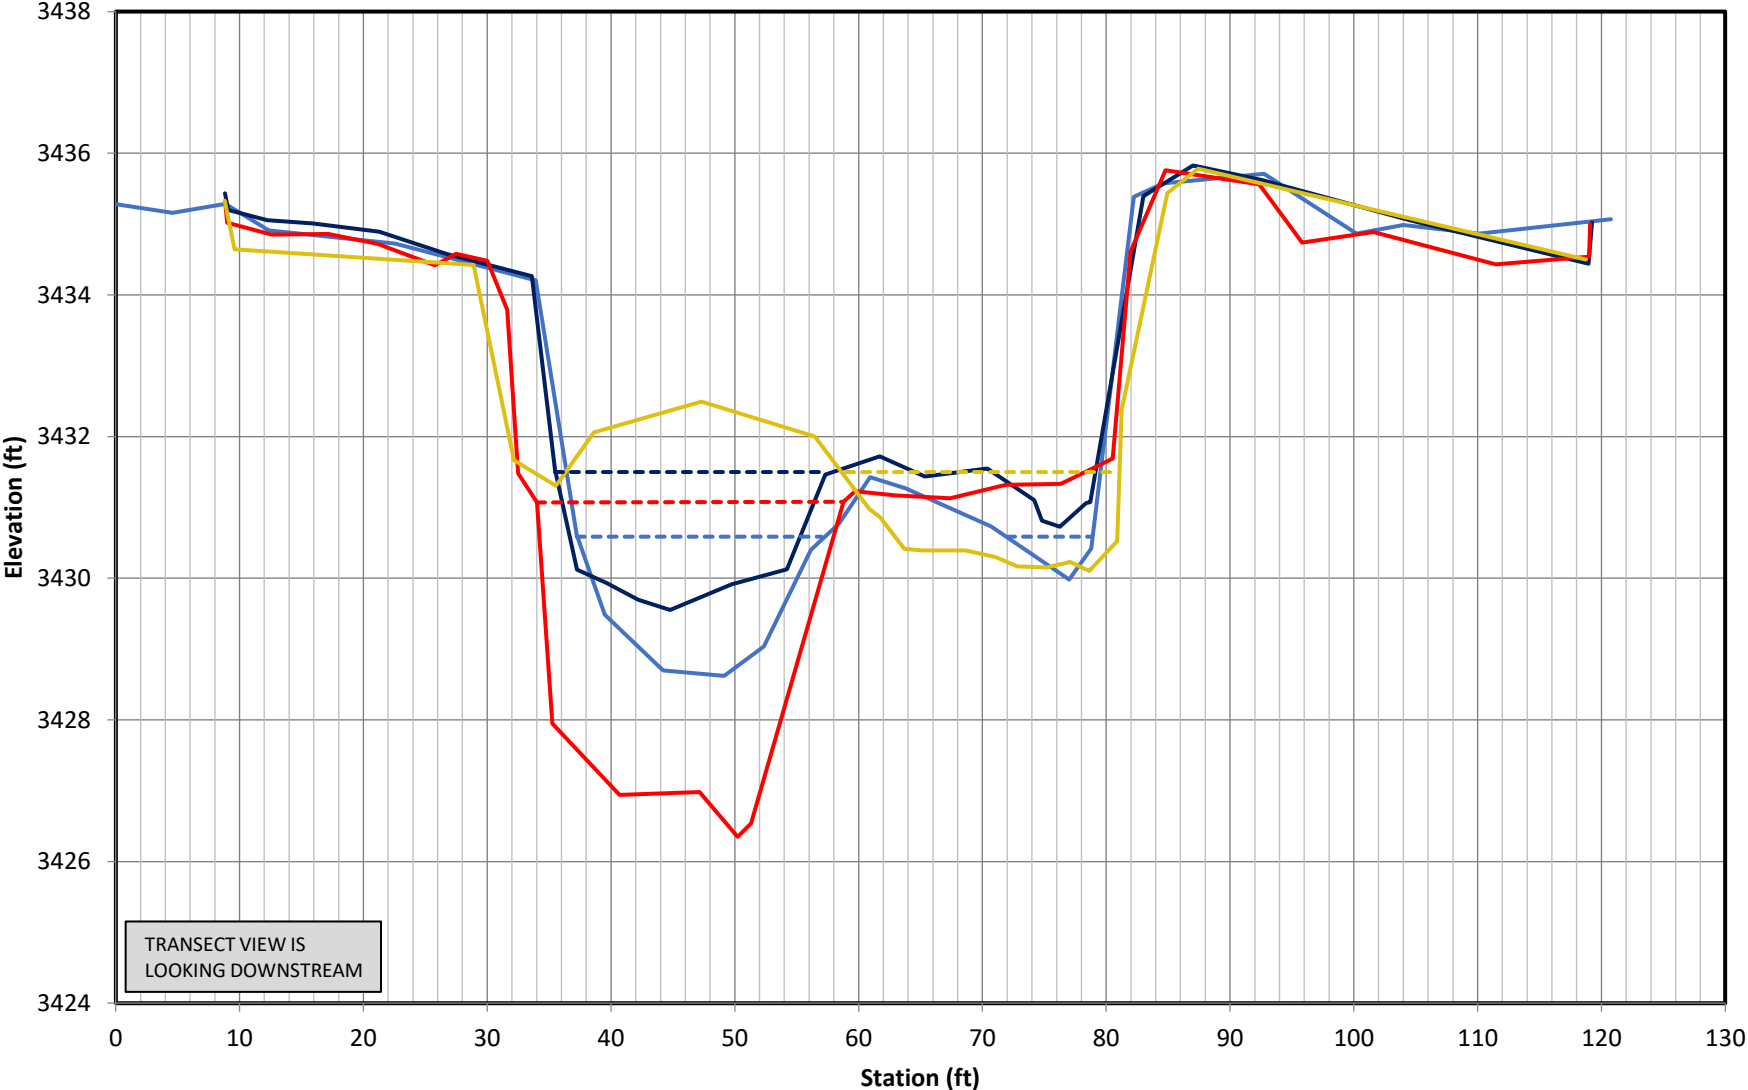
Mill Creek Transect #3 - Pool

Mill Creek has recently developed several depositional features, including mid-channel and point bars, and the stream banks have shown signs of increased erosion within the last year (see bank erosion section above). The point bar adjacent to the right bank on the upstream end of the project reach has increased in height and width in the last year (Additional photo 2, Appendix B), and a mid-channel bar has deposited on the left side of the channel adjacent to EBL4 (Additional photo 5, Appendix B). The point bar on the upstream end of the project area is forcing the thalweg against the left bank and is thus contributing to the erosion on EBLs 1-2 and 5. The dimensions of the mid channel bar adjacent to EBL4 were captured in the Transect #3

cross sections survey (Appendix D). This gravel bar is increasing water surface elevations at higher flows and forcing higher velocity water against both banks, thus placing erosive forces on EBL3 and EBL4 (See photo of T3 looking East, Appendix B). Such features are commonly observed in streams that transport large bedloads, and Mill Creek is one of the many tributaries that flow east out of the Bitterroot Mountains which contain a high bedload.

Transect #3 generally maintained the same geometry from 2013 to 2019, although increased pool depth was observed in 2019. However, between the 2019 and 2020 monitoring events, a large gravel bar developed along the left bank, forcing the thalweg and the majority of the flow to shift to the right side of the channel. A secondary flow path now runs along the left bank (Appendix D).

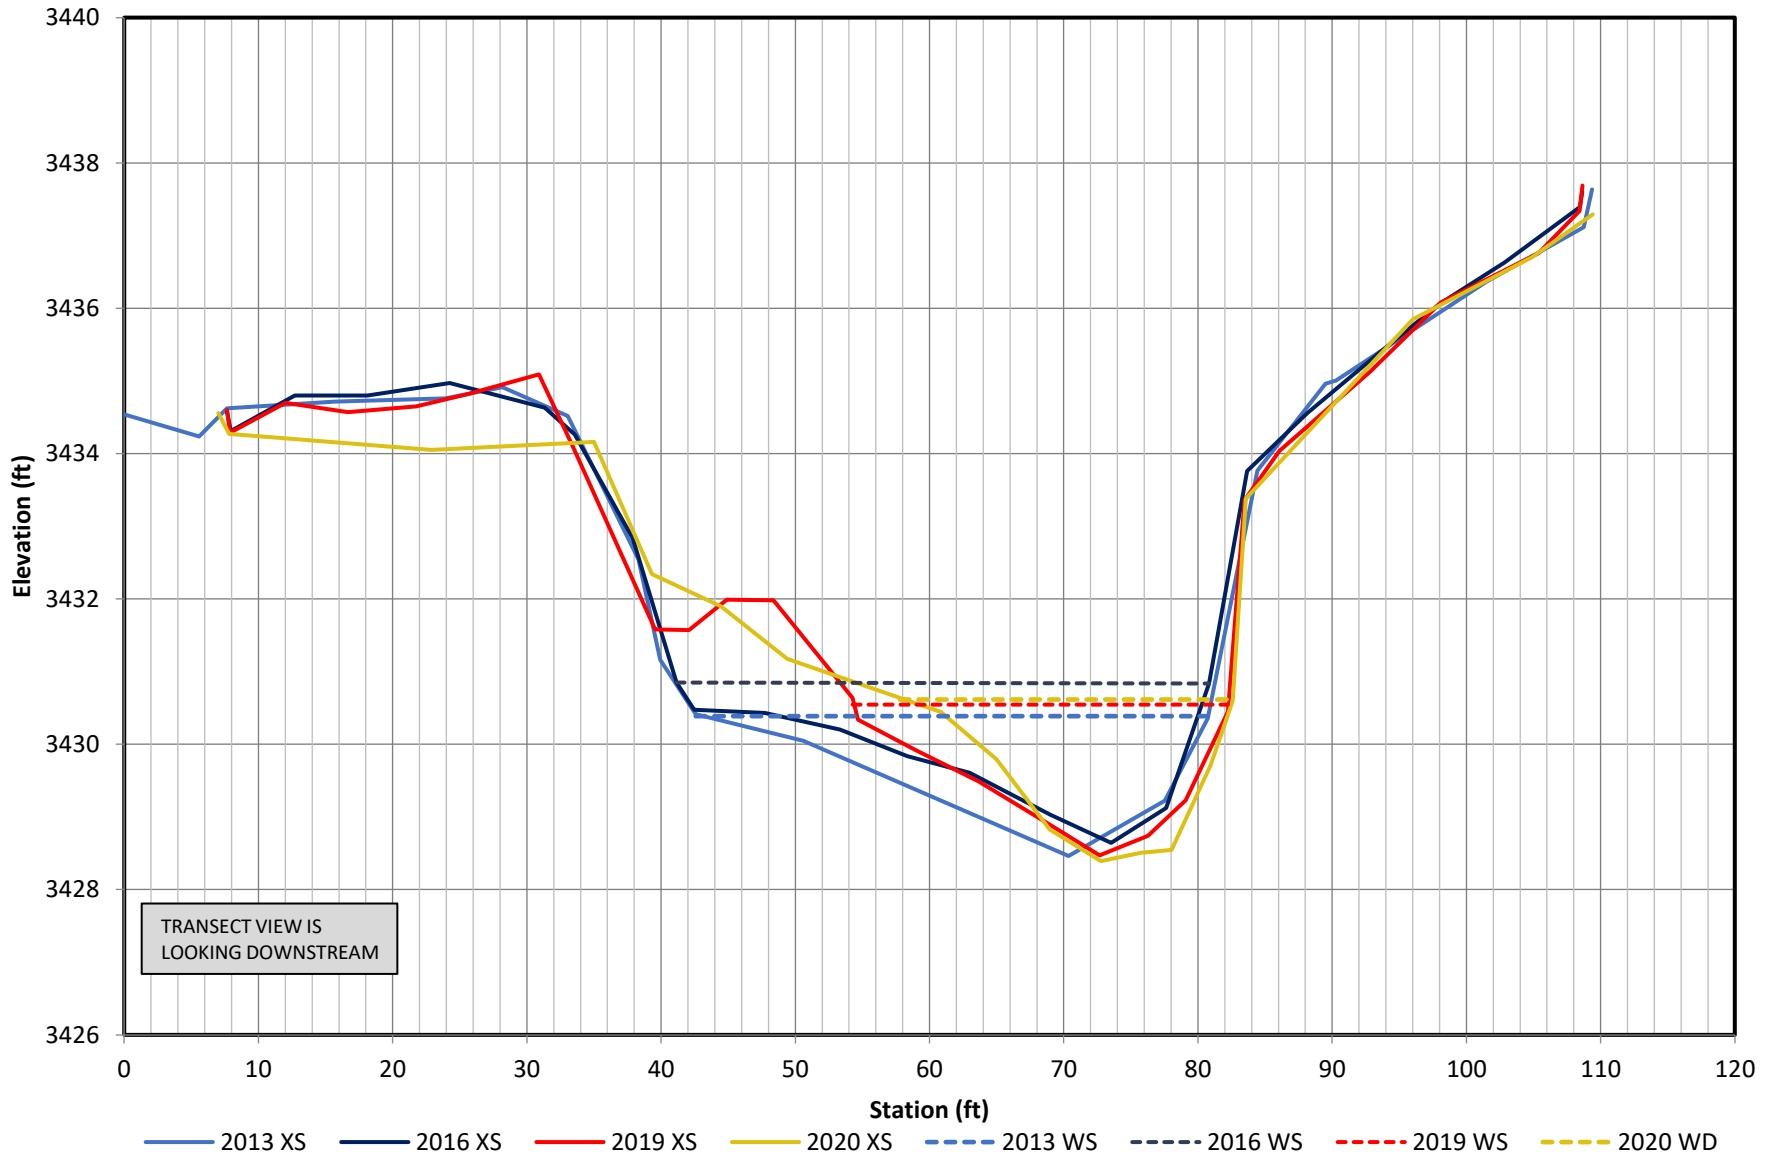
Mill Creek Transect #4 - Riffle

Transect #4 is located at a riffle just upstream of the U.S. Highway 93 Bridge. Channel geometry has remained relatively consistent at this location since 2013. A point bar has gradually

developed along the left bank, and the thalweg has moved closer to the right bank. Bar development along the left bank may eventually result in erosion along the right bank; however increased erosion has not been observed in the vicinity of transect #4 to date (see photos of T4, Appendix B and transect Figures in Appendix D).
