Montana Department of Transportation
Research Programs
April 2016

EXPERIMENTAL PROJECTS CONSTRUCTION REPORT AND ANNUAL EVALUATION

CONTECH® A-2000 POLYVINYL CHLORIDE (PVC) PLASTIC PIPE

Project Name: Checkerboard - Martinsdale (CN 4803000)

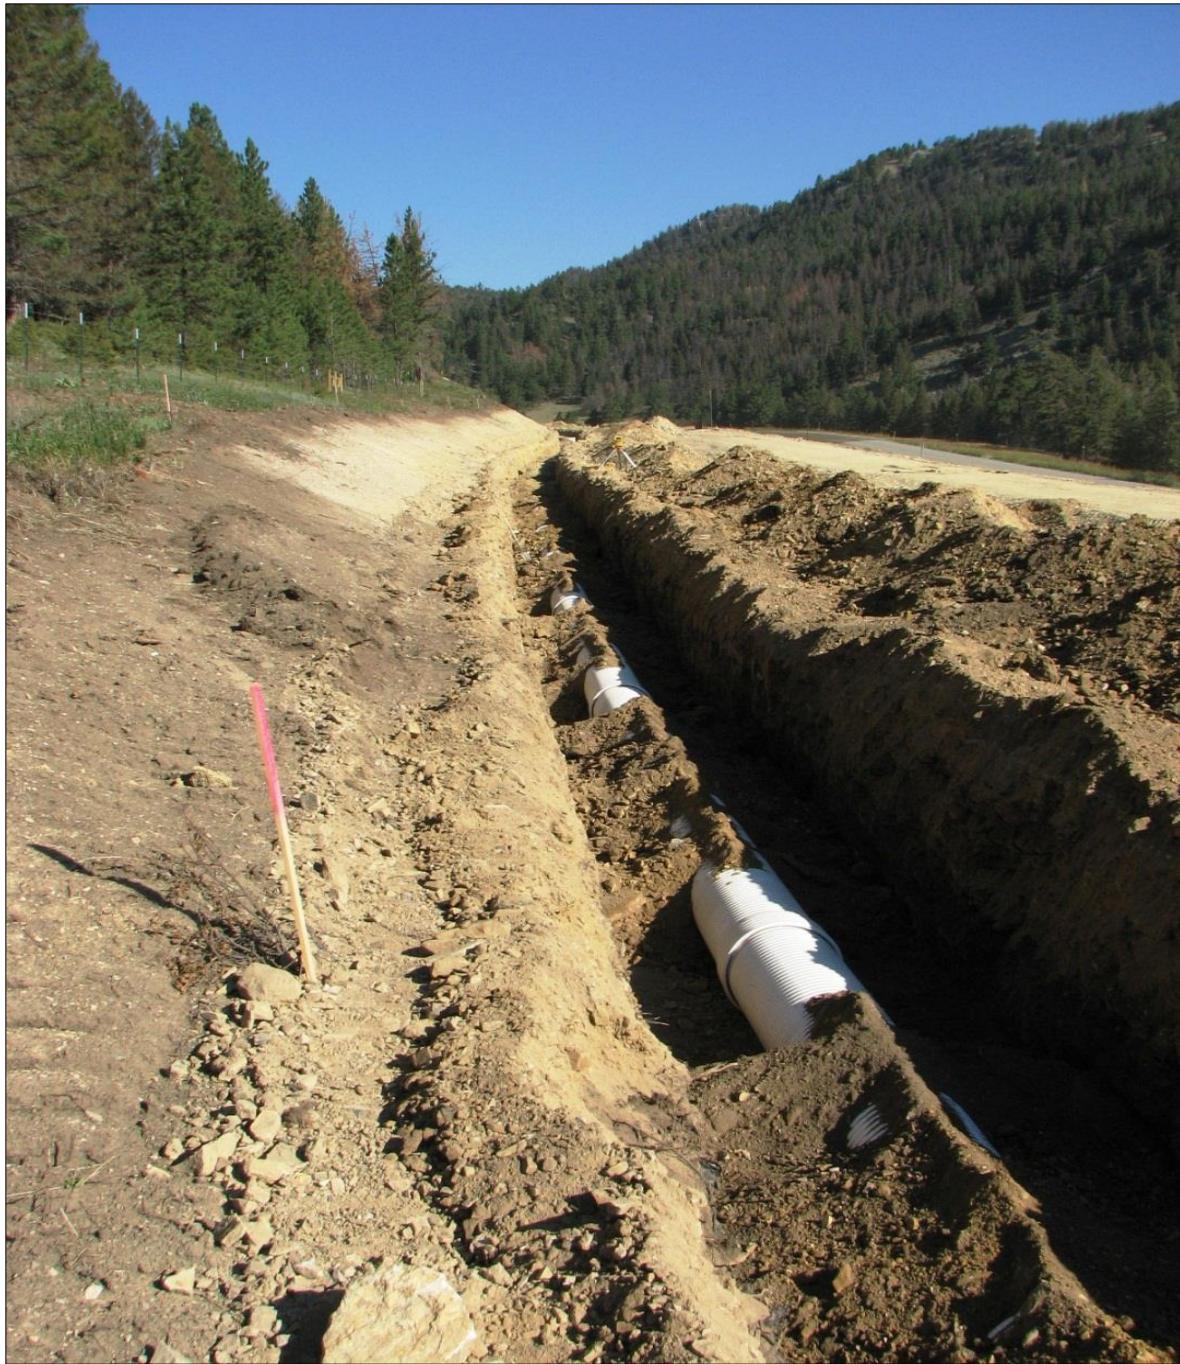
- ↑ As stated earlier in this report, the contractor was using the excavated trench material as fill for the A-2000 pipe. No bedding was prepared or haunching process observed during installation.

The Contech representative on-site was concerned that there may not be sufficient haunching to insure proper density and side wall support to prevent deflection of the PVC pipe once the fill and compaction was complete.

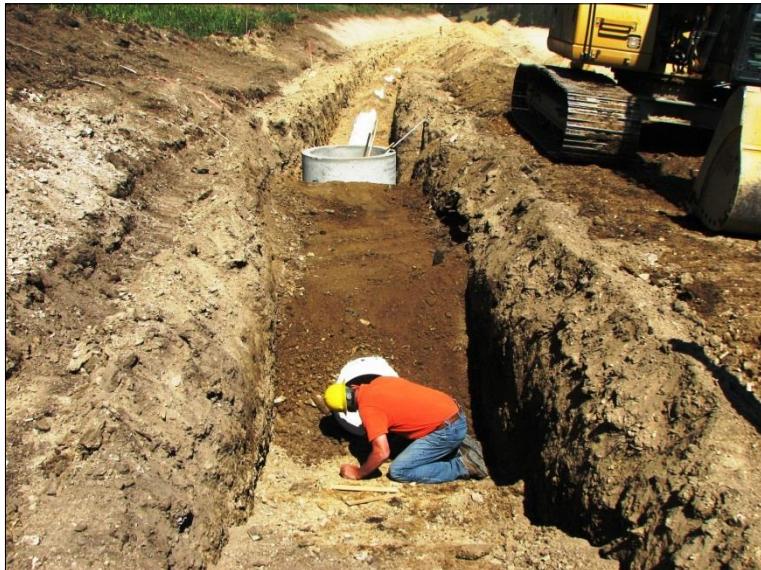
◀ In order to determine if using the trenched material as fill, and with the contractors planned method of compaction which may affect the integrity of the pipe, the Contech representative asked if a 20' section of the trench be filled as it would for the entire project to determine if any deflection may be observed. Here the contractor has placed the fill and internal measurements are taken prior to compaction.

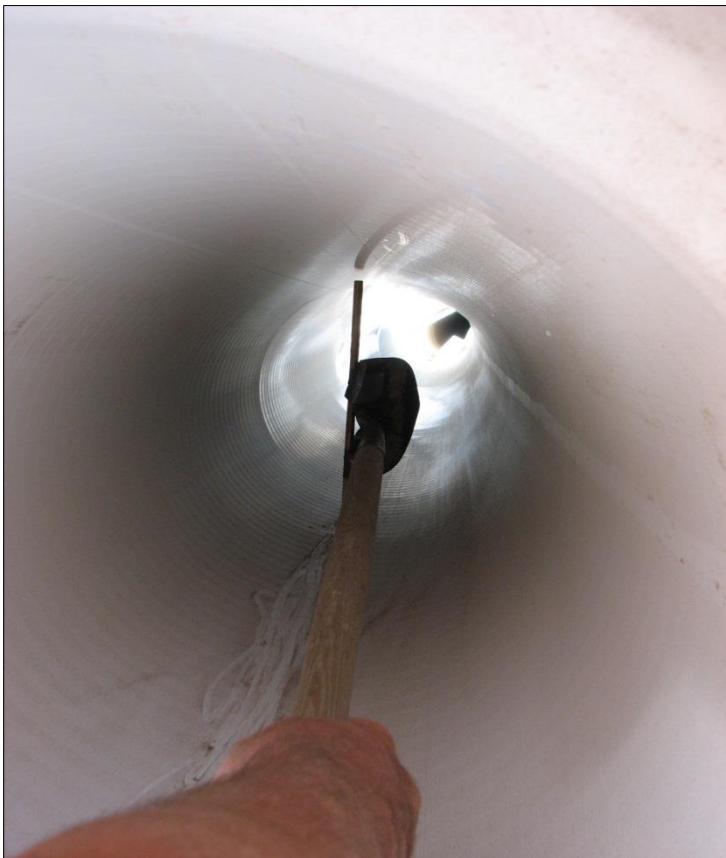
In this image the survey stick (affixed to the blade of a shovel) which was measured and cut to detect deflection up to 1.5% (approximately .27"/7mm) of the inside diameter of 18"; is run through the pipe to a depth of approximately 7 ft. No visual indication of deflection was observed.

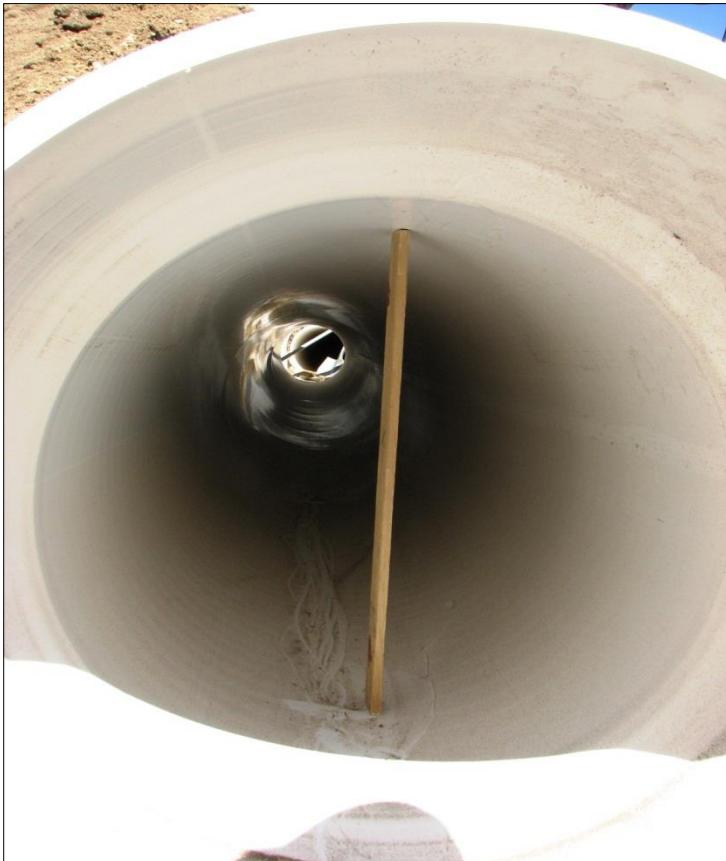
◀ This section of survey stick was cut to approximate 18" and run through the pipe in the same manner as indicated in the previous image. No visual deflection was observed.

Note: This was a very simplistic method to test for deflection and representative of a very small fraction of the entire length of the pipe layout and may not be indicative of current or long-term performance of the pipe in this application.

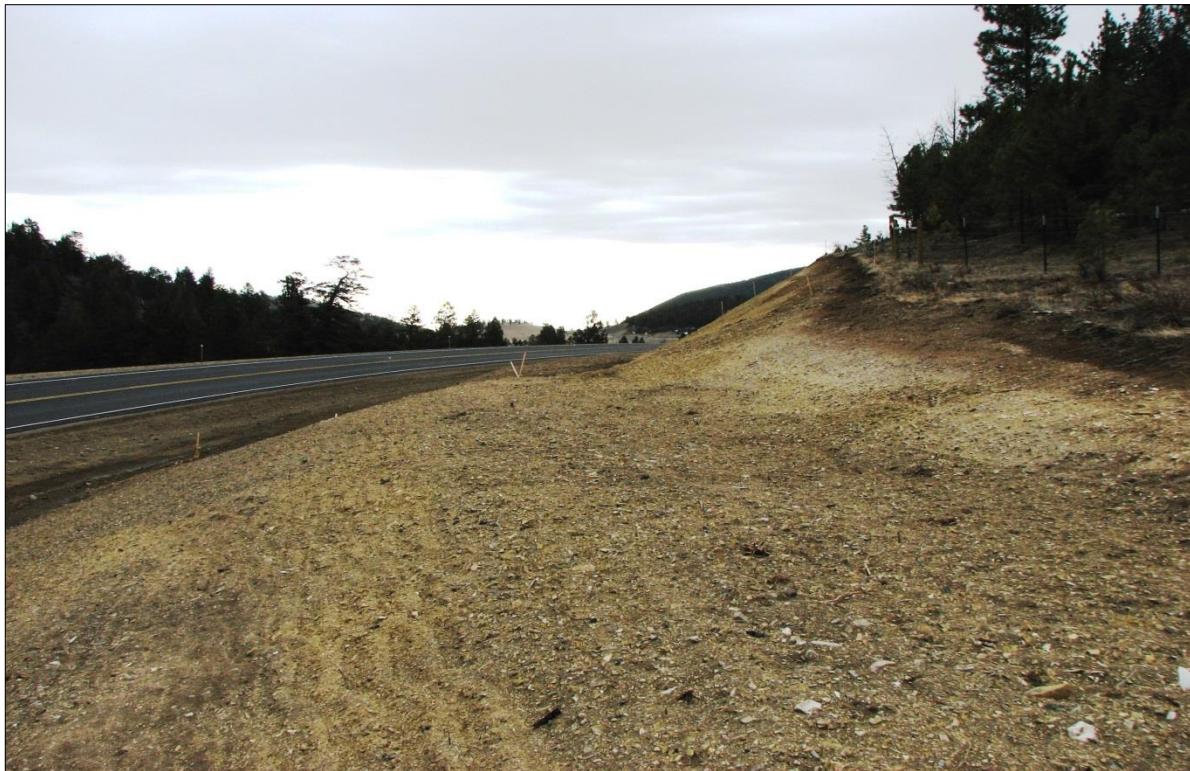
A site inspection of the 18" (46 cm) A-2000 was conducted on April 2, 2013 by research staff. A walk through of the approximately 2084 ft. length section showed no evidence of visual disturbance on the surface or surrounding area of the irrigation line or the manhole connections. Page 18 of this report has representative images of the April 2013 inspection.

↑ View east: Start of approximate location at the west end of the 18" A-2000.

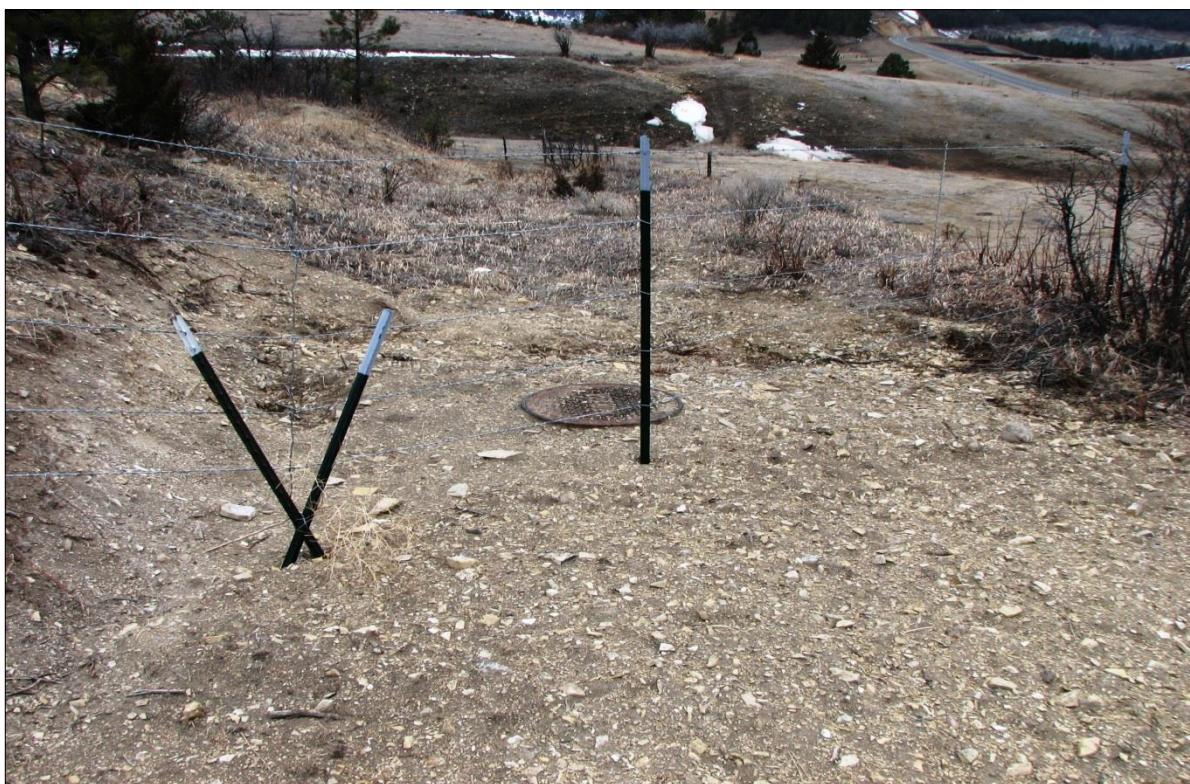
↓ View west: Manhole connection at the existing 15" PVC and 18" A-2000 pipes.

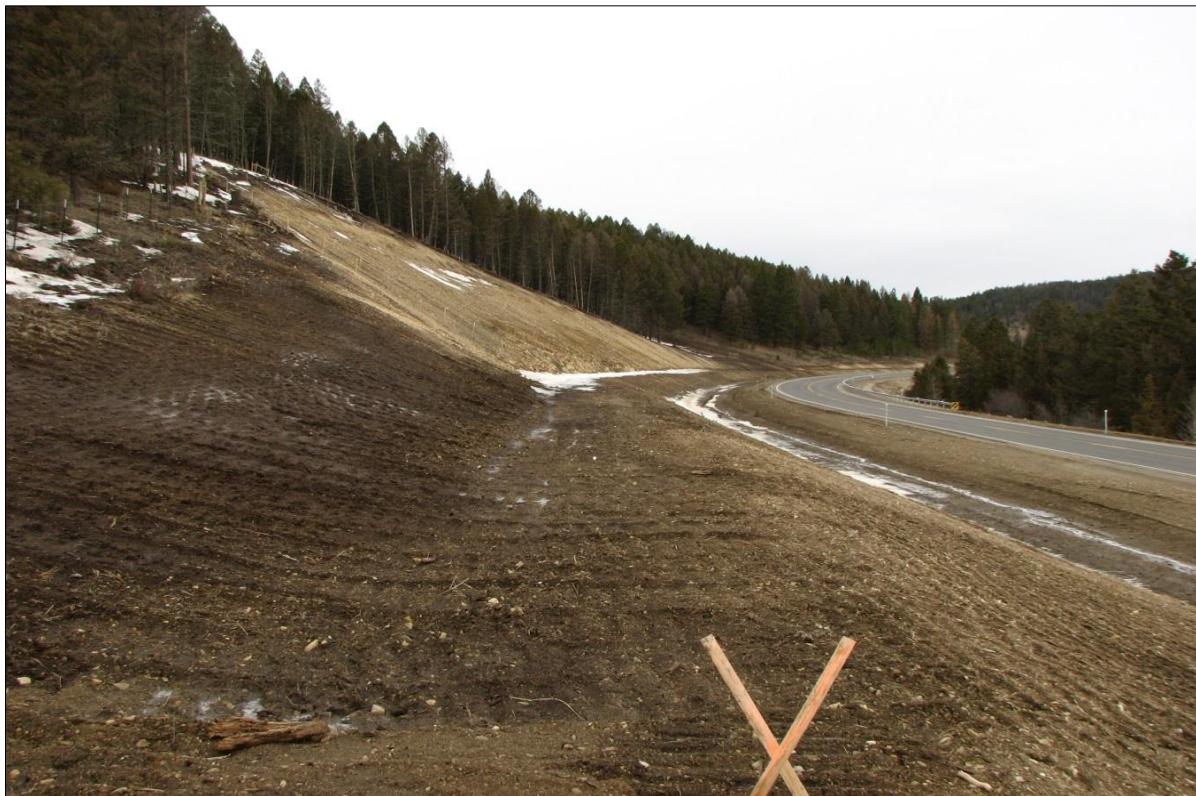
↑ View west: Start of approximate location at the east end of the 18" A-2000.

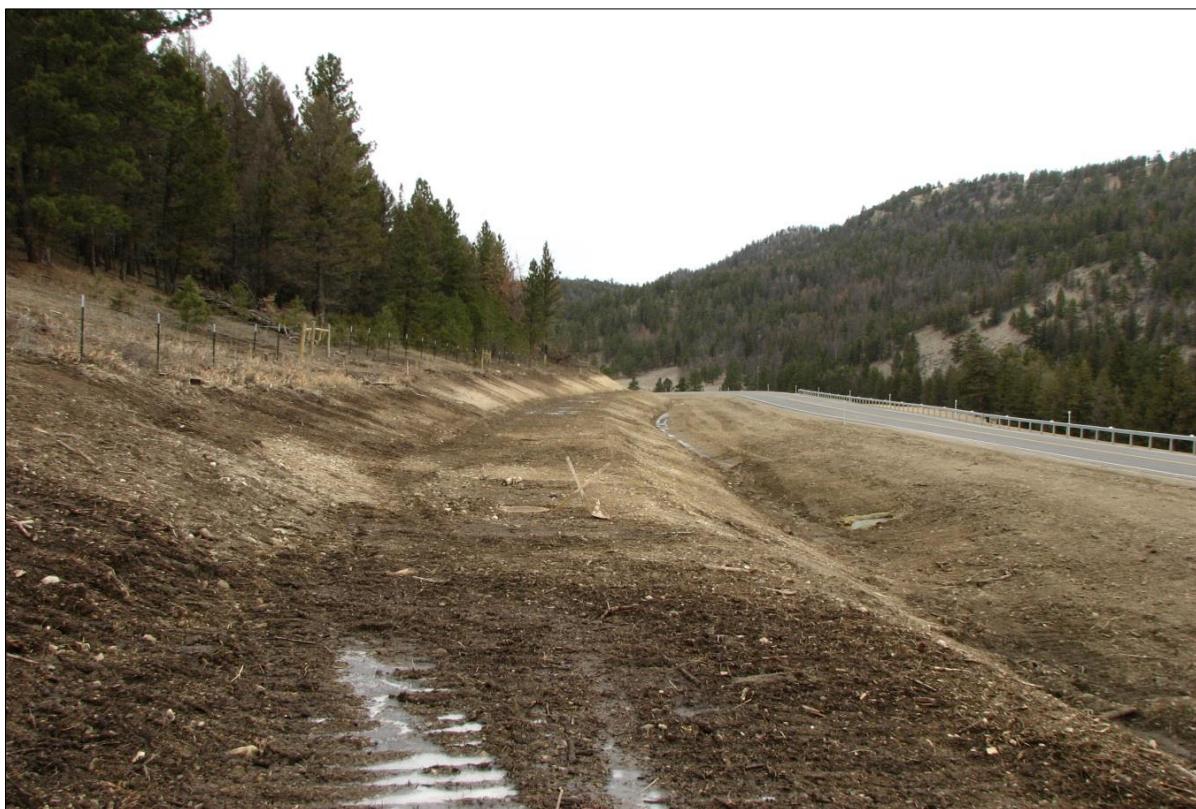
↓ View west: Midway point of the 18" A-2000 section.

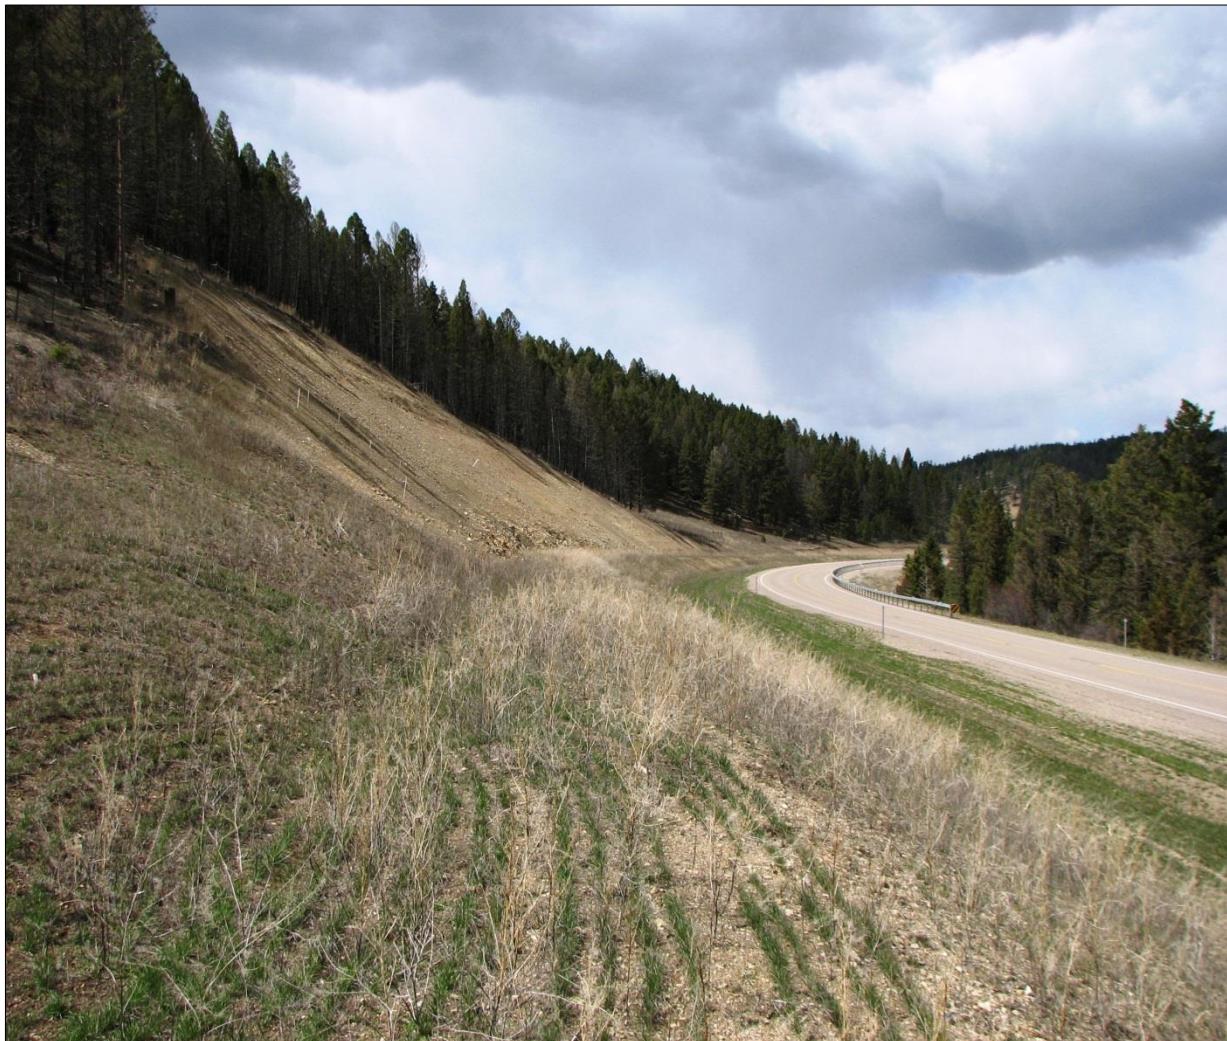
A site inspection of the 18" (46 cm) A-2000 was conducted on May 15, 2104 by research staff. A walk through of the approximately 2084 ft. length section showed no evidence of visual disturbance on the surface or surrounding area of the irrigation line or the manhole connections. Page 20 of this report has representative image of the 2014 inspection. District staff has reported no incident involving pipe performance since installation.

↑ View west: Start of approximate location at the east end of the 18" A-2000.

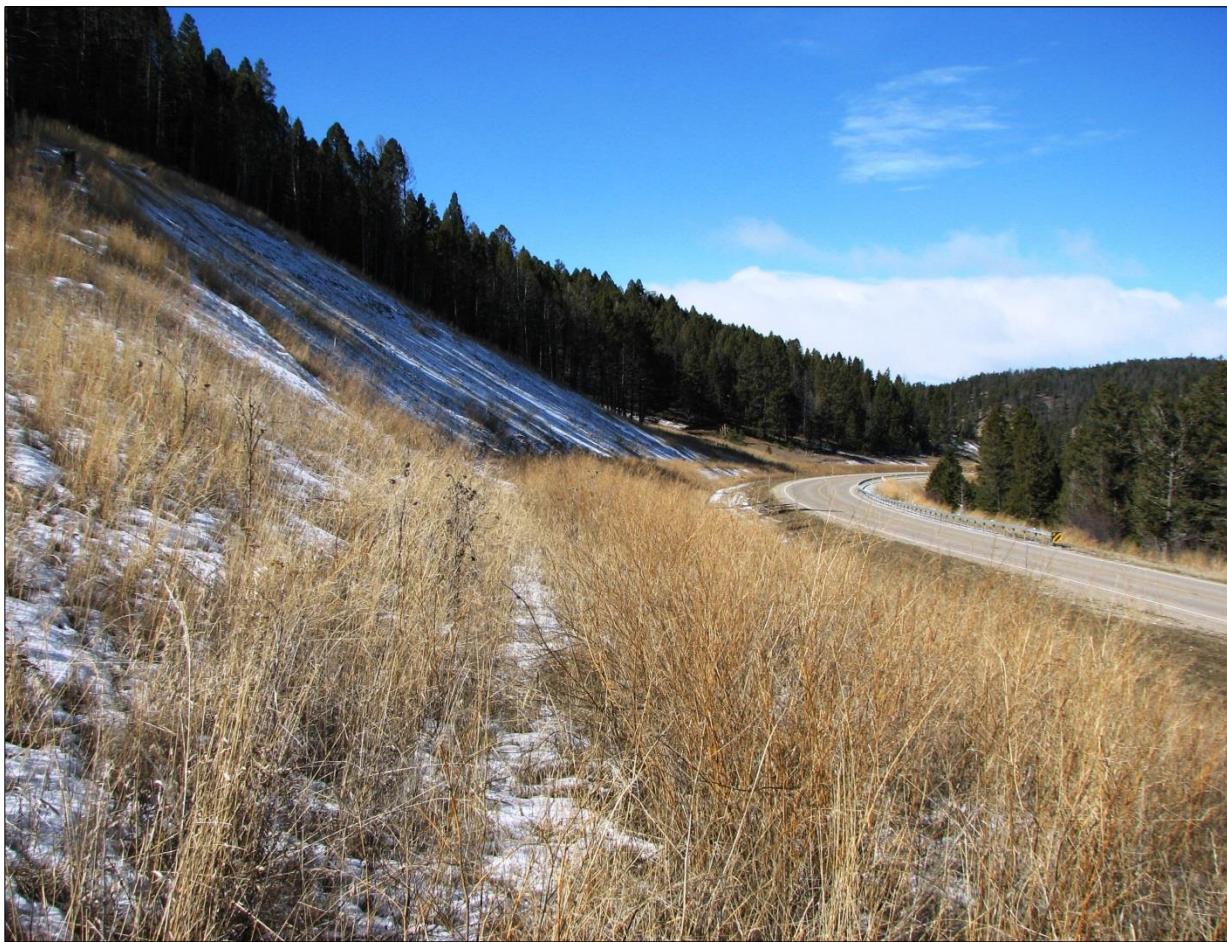
Same report as stated in May 2014. Page 21 of this report has representative image of the 2015 inspection. District staff has reported no incident involving pipe performance since installation.

↑ View west: Start of approximate location at the east end of the 18" A-2000.

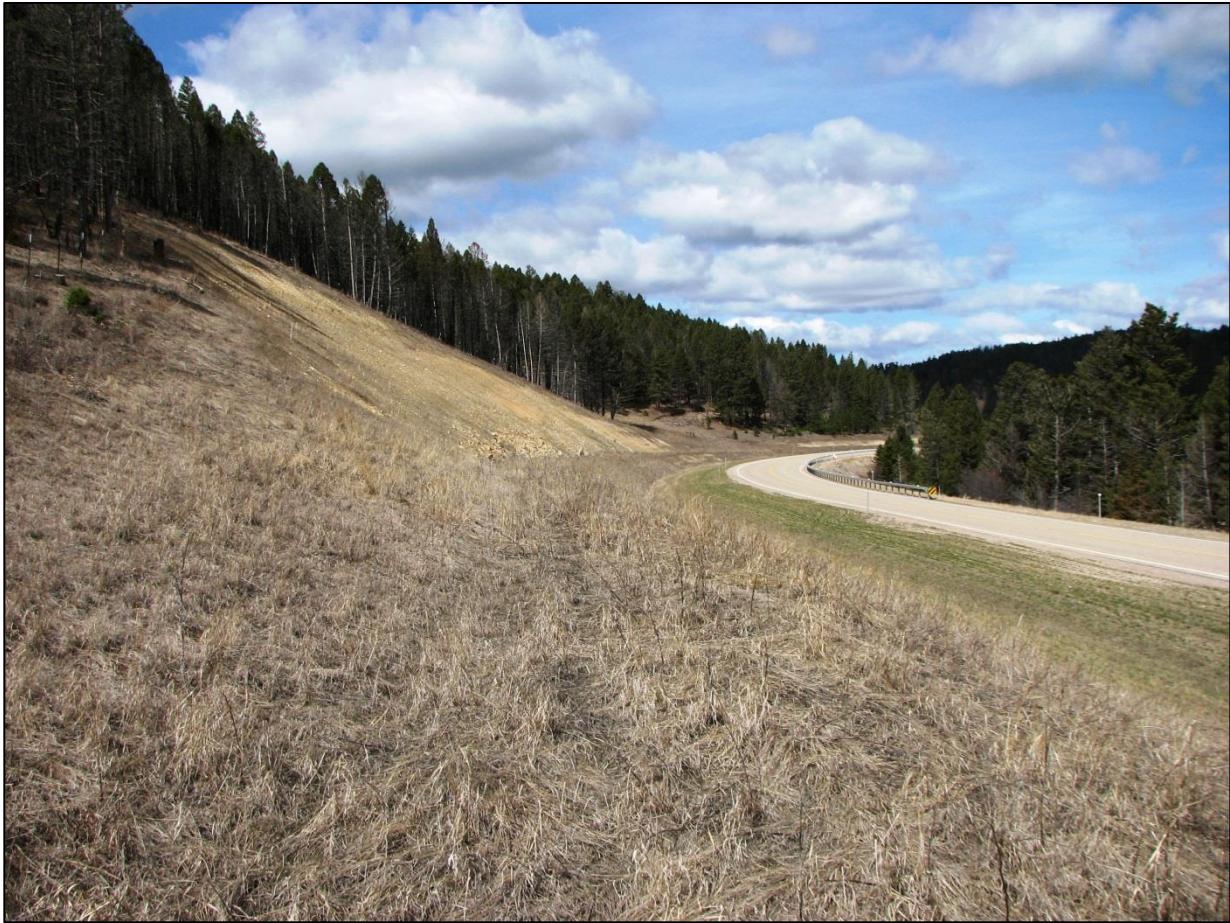
Same report as stated in May 2014. Page 22 of this report has representative image of the 2015 inspection. District staff has reported no incident involving pipe performance since installation.

↑ View west: Start of approximate location at the east end of the 18" A-2000.
