**EXPERIMENTAL PROJECT CONSTRUCTION REPORT AND ANNUAL EVALUATION**

**CONTECH RIBBED ALUMINUM BOX CULVERT (ABC)**

**Project Name:** Jct. US 2 – North Belknap Crossing

**Experimental Project No.** MT-12-01

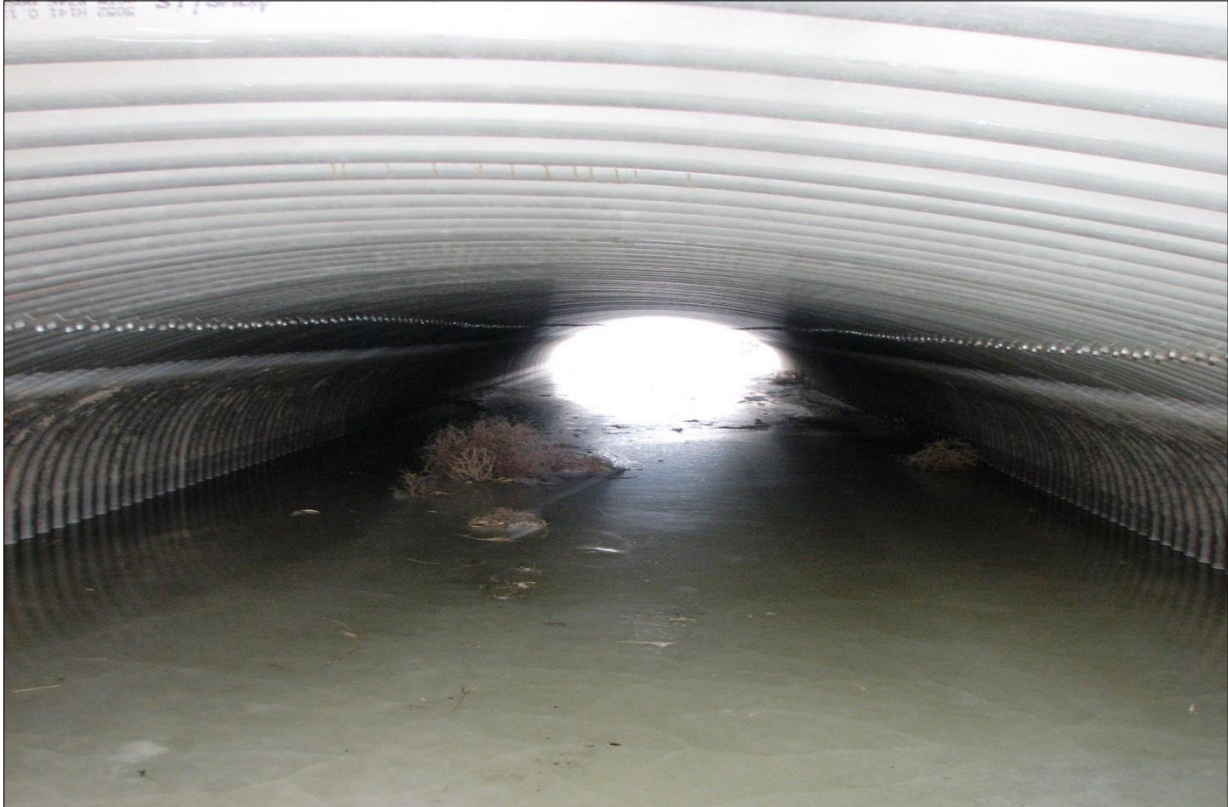
↑ Interior view of the culvert on west end looking east.

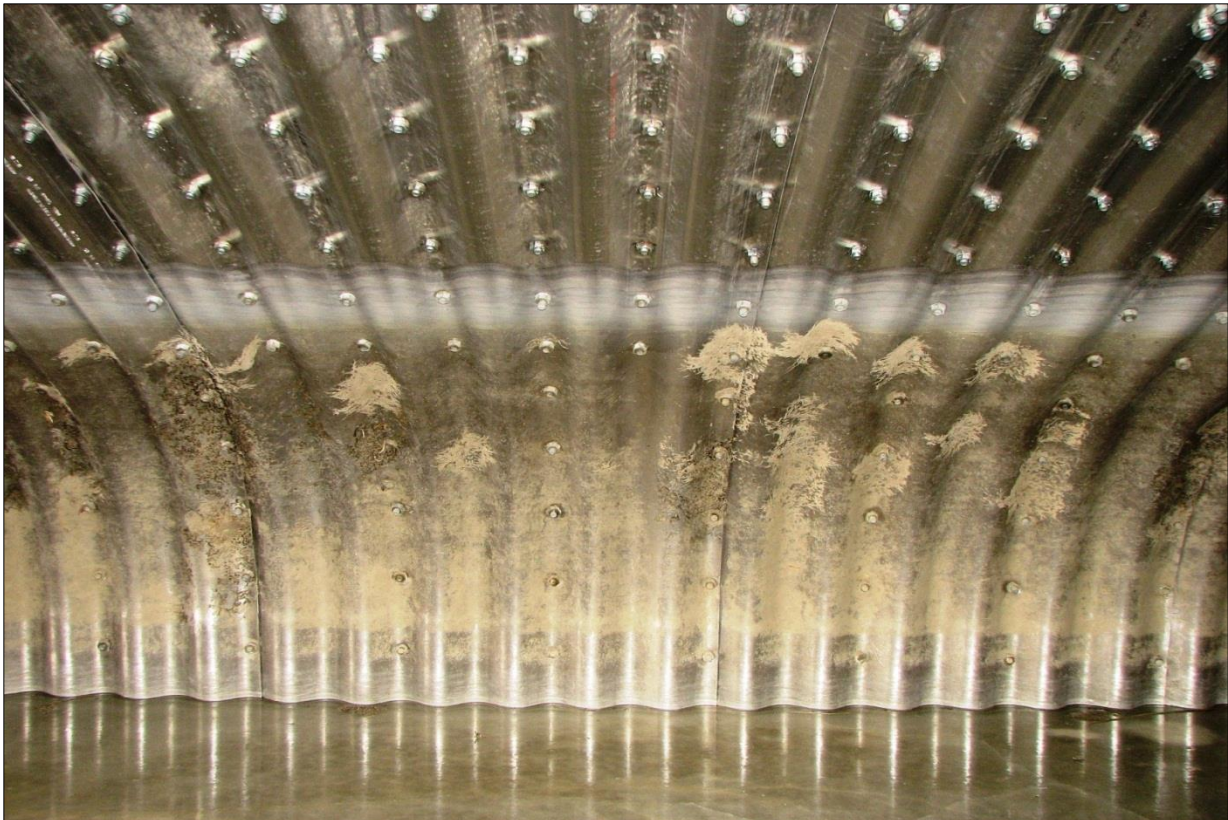
↓ View of interior side wall. Water level stain is clearly seen near top of culvert.

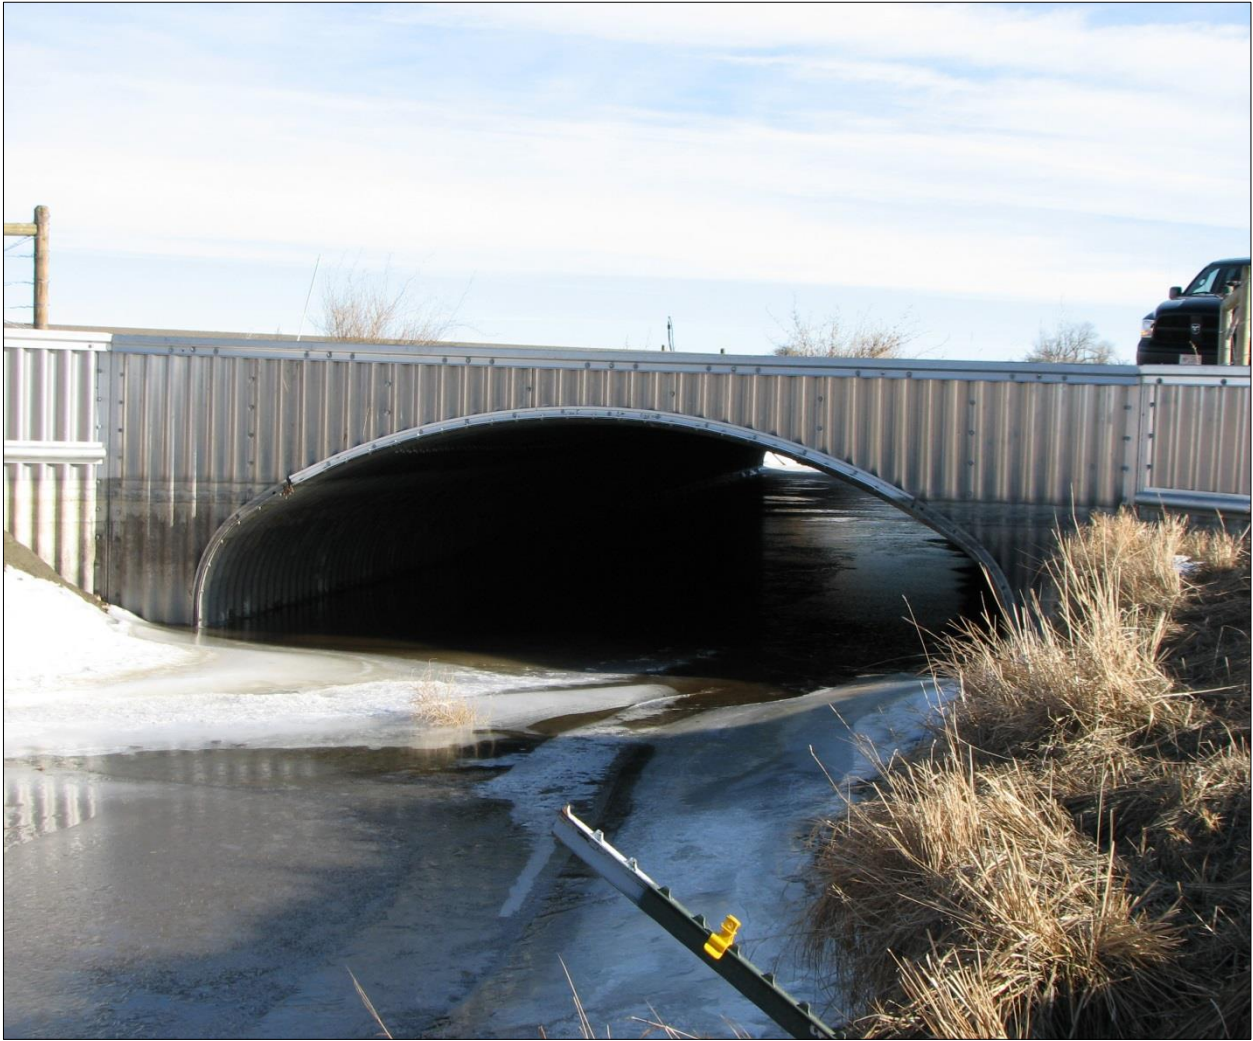
↑ View inlet; west side of culvert.

Due to the thinness of the ice a walk-in interior inspection was not possible. However the researcher was able to gain bank access (inlet and outlet) to see within the culvert to ascertain if any distress (bending or buckling of the shell plate) was noticeable.

No issues were detected in this inspection, all components were visually intact.

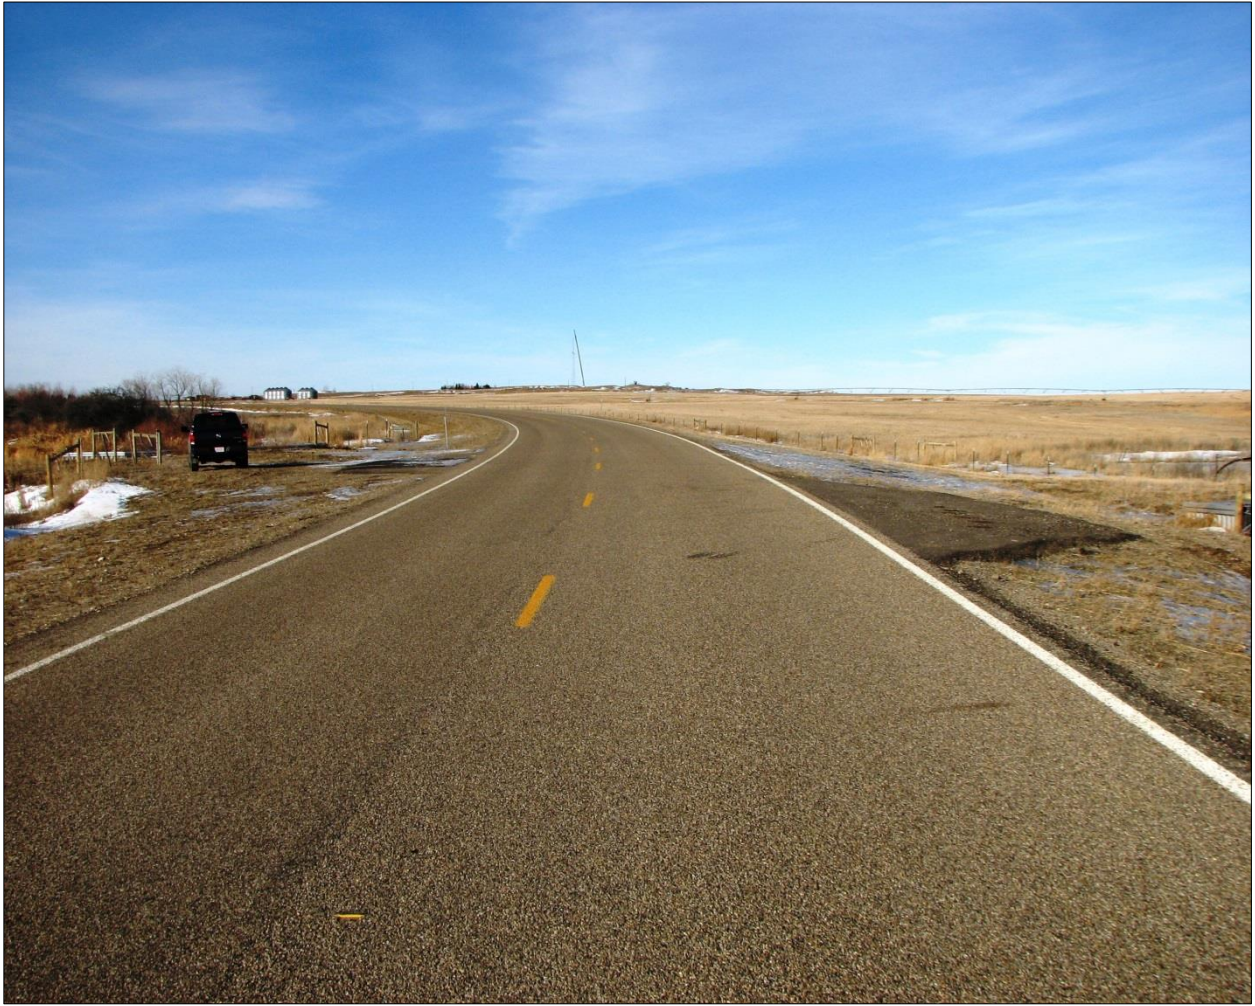
↑ View north. No issues with the roadbed were observed.

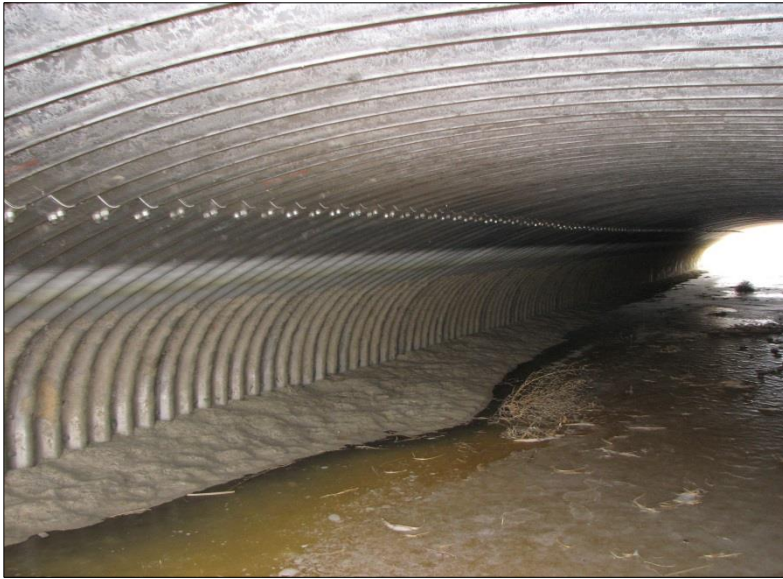
← Interior view of culvert at inlet.

The light colored material at the side wall of the culvert is accumulated sediment.

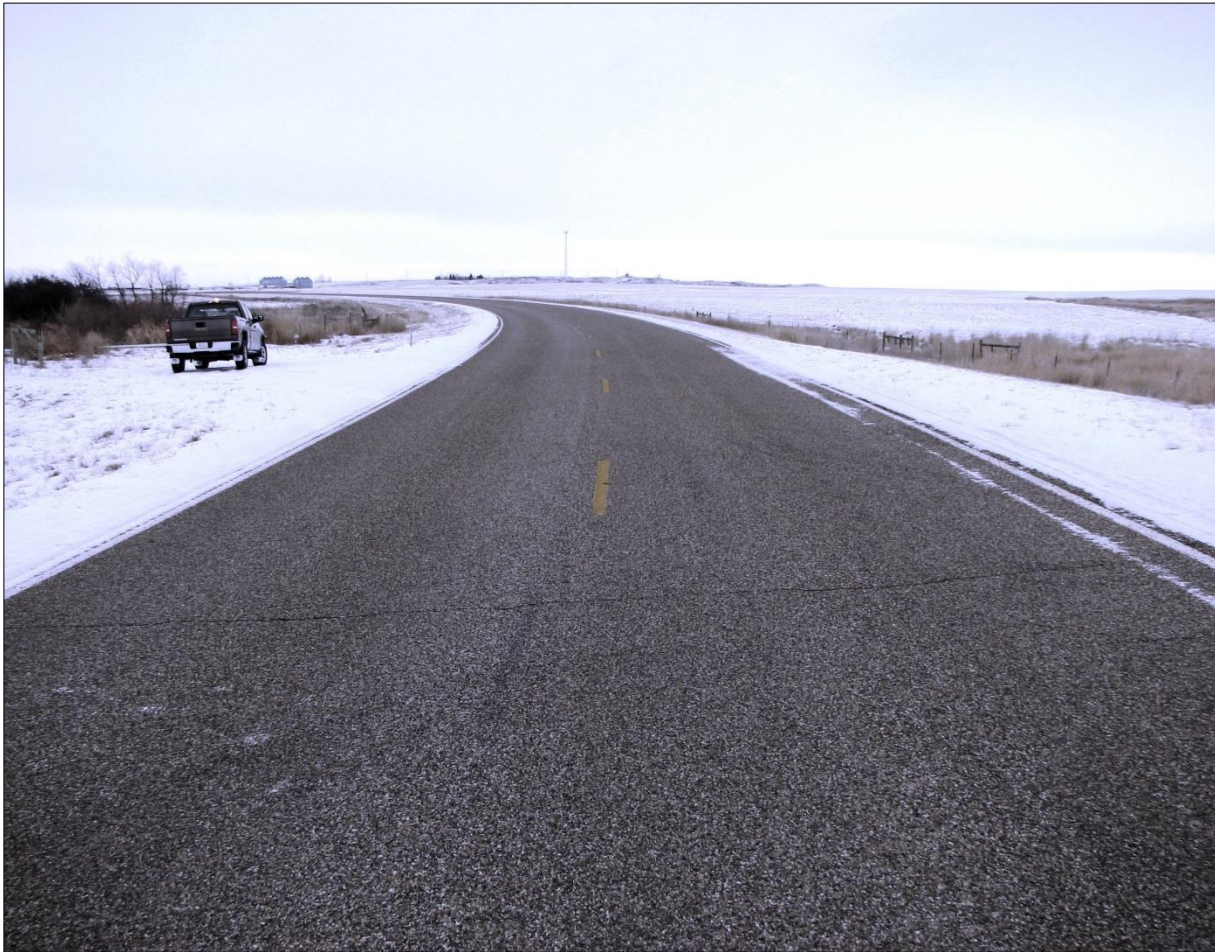
↑ View north. No issues with the roadbed were observed.

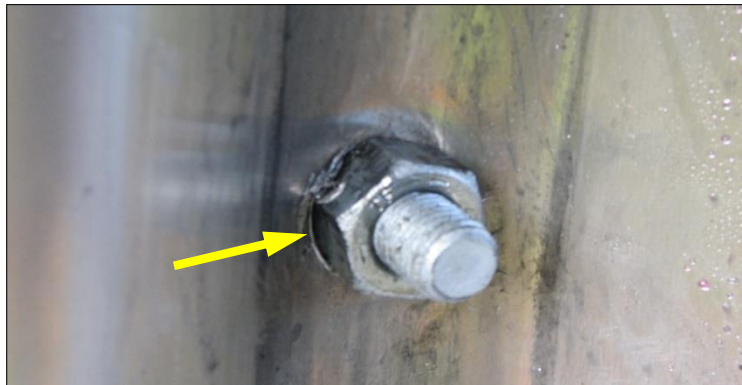
← Over torquing the nut has punched through the soft skin of aluminum shell plate.

Note that this condition was very minor in occurrence. Once the Contractor and crew were aware of the over-torquing problem, they quickly rectified the situation by applying the correct torque application.

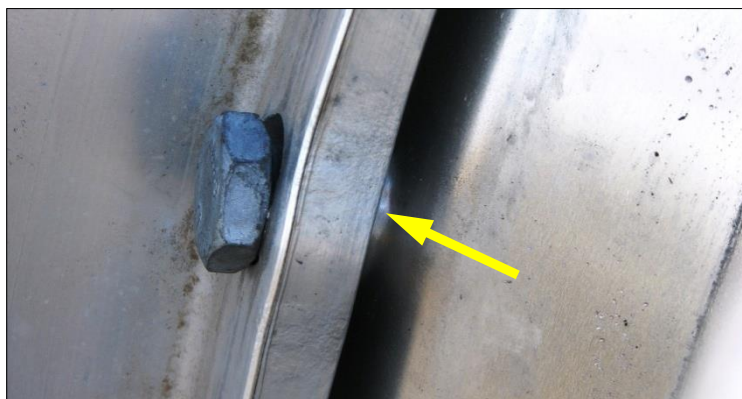
← Here you can see the aluminum skin extruding due the excess torque of the nut (exterior view of shell plate to rib attachment).

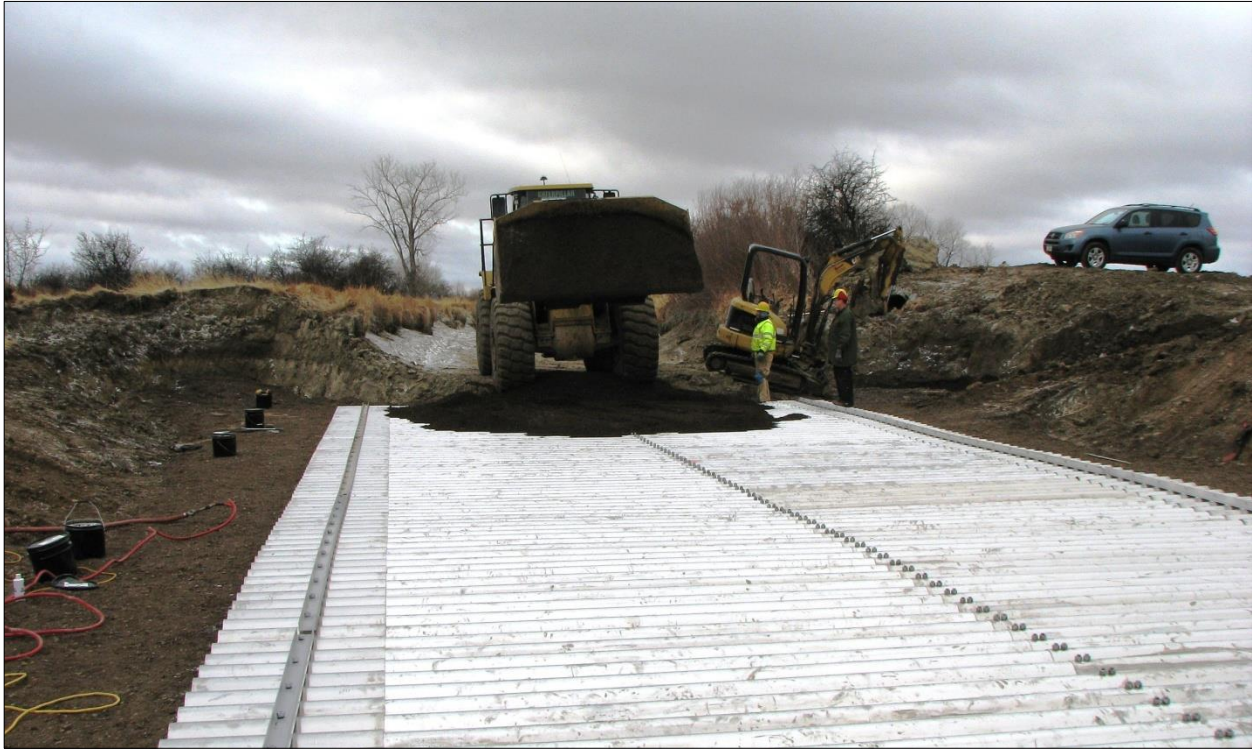
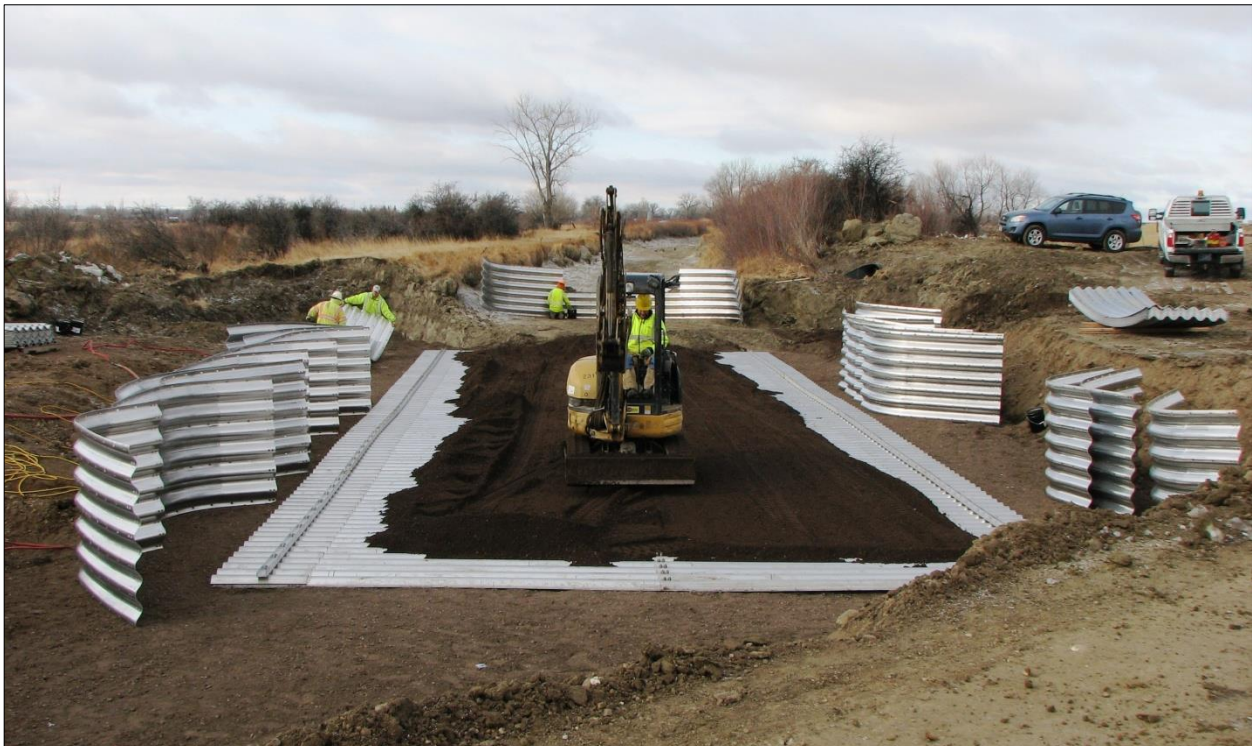
↑↓ The contractor elected to cover the base of the invert plate with a 4-5" layer of bedding. This was done to provide a safer work surface for the installers than walking on the deep corrugation of the plate, and (as a minor point) to add weight for a more stable base for installation.
