**Montana Department of Transportation
Research Programs**

**EVALUATION OF CRACK-SEALING MILLED PAVEMENT IN THE EFFORT
TO REDUCE TRANSVERSE CRACKING**

Annual Report 2016

Project Number: Dutton N & S IM 15-6(35)309

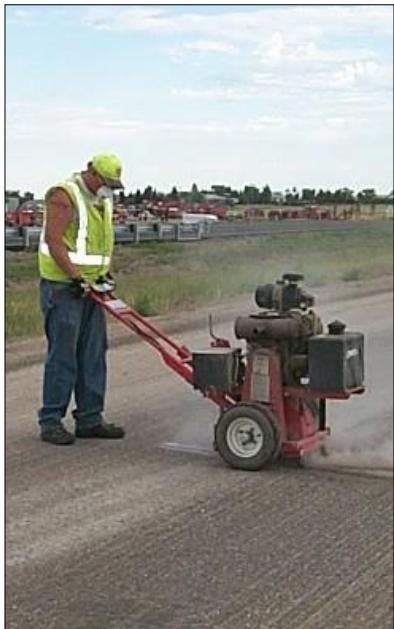
Grinding in process

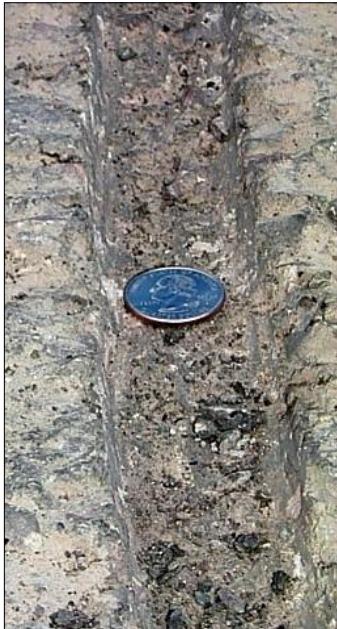
Depth and width of
grind

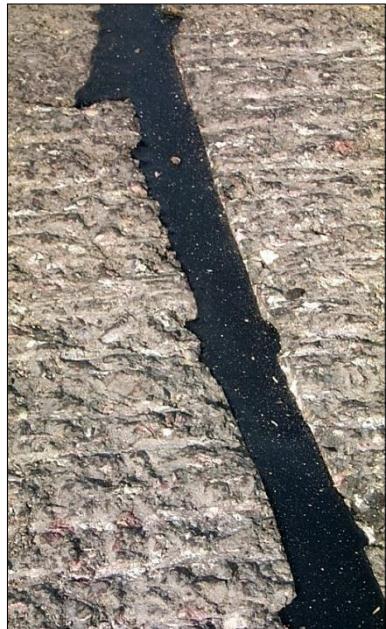
Sealed with Crafco
Hot-applied Modified
Asphalt Sealant

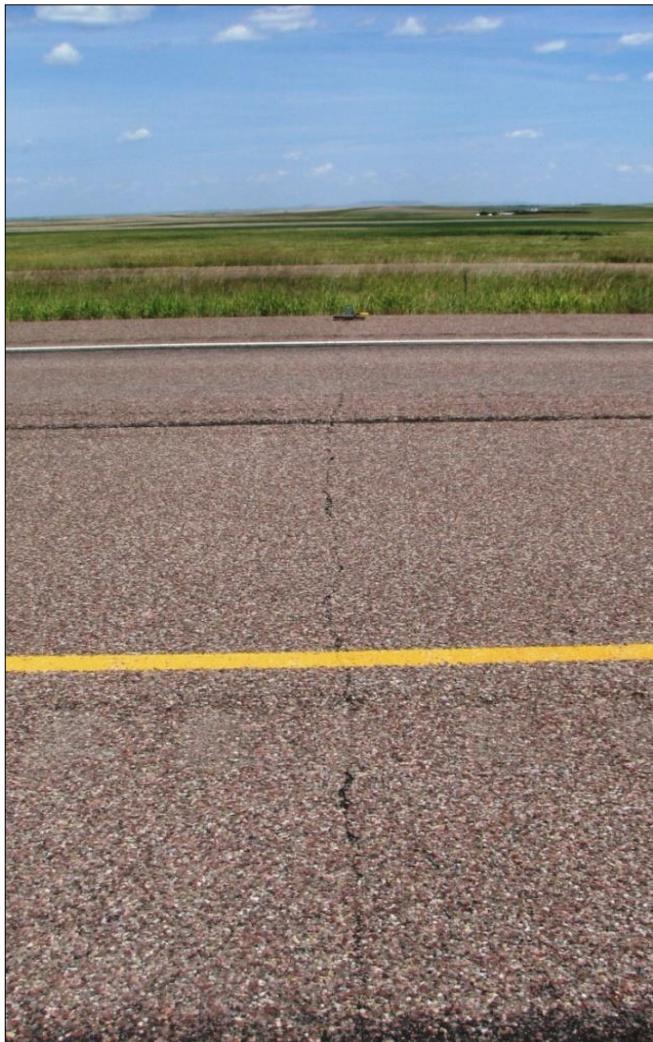
◀ Example of low-severity cracking on sealed north section (2009)

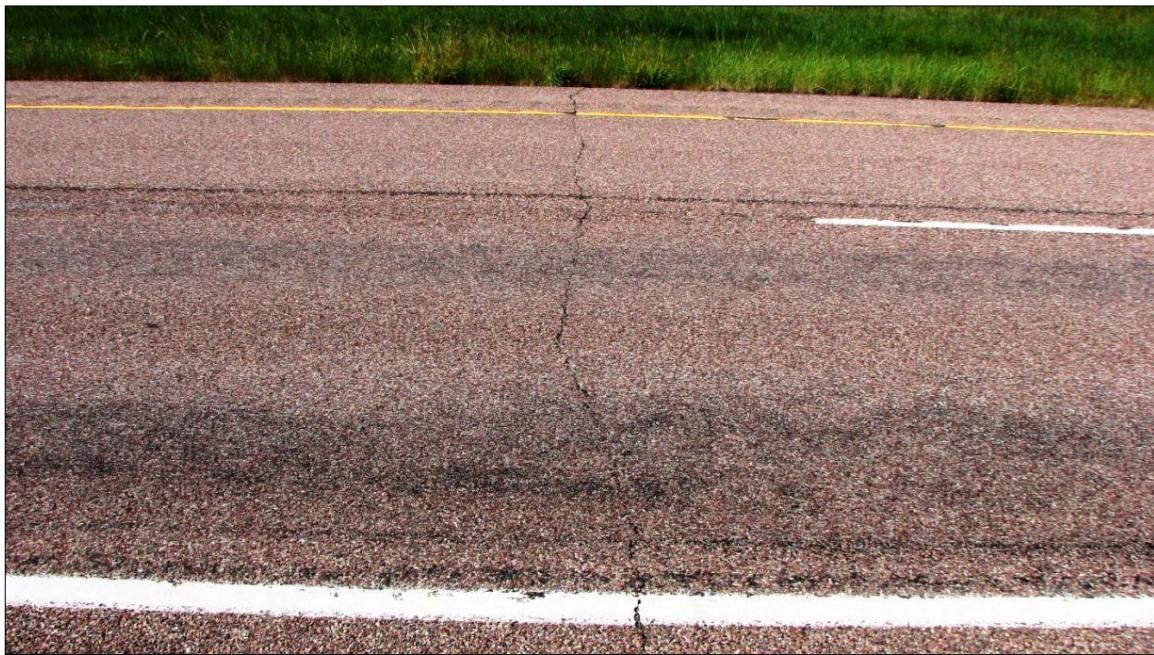
▼ Example of low-severity cracking on un-sealed south section (2011)

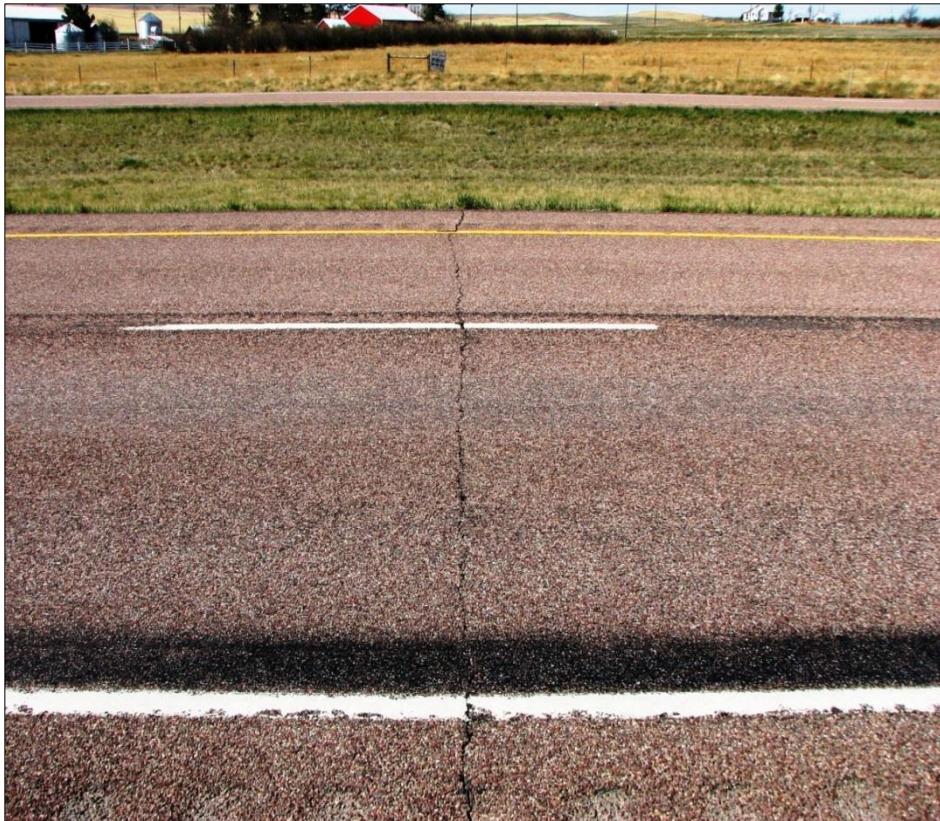
◀ Example of low-severity cracking on un-sealed south section (2012)

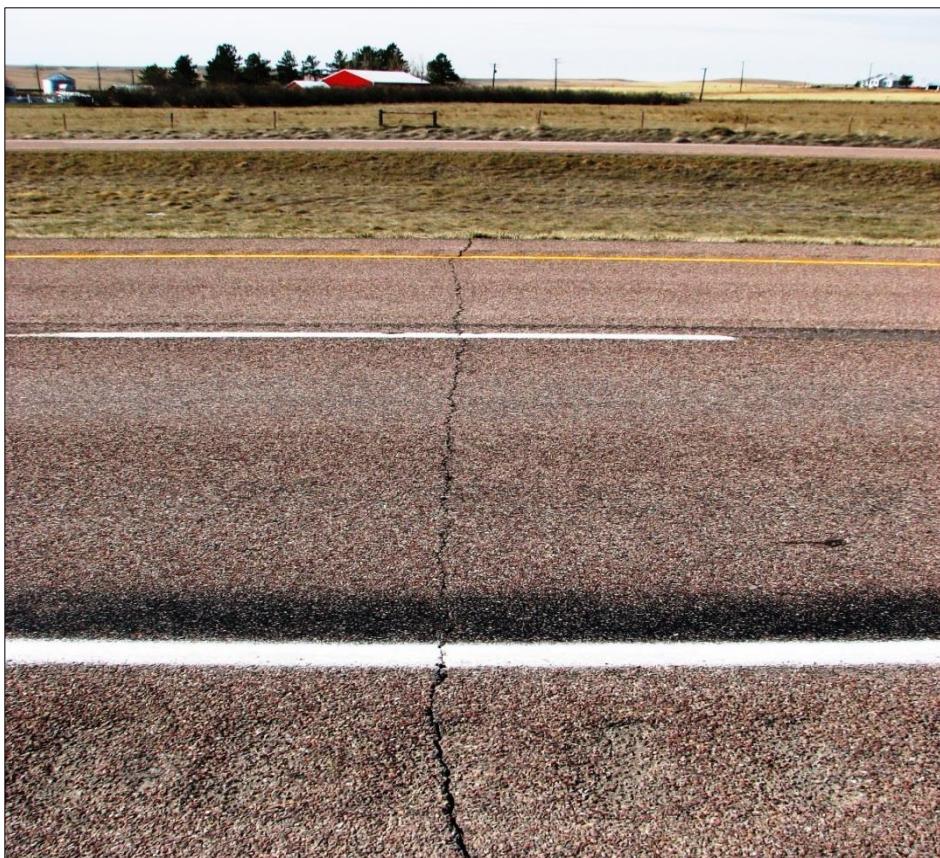
◀ Example of low-severity cracking on un-sealed south section (2013)

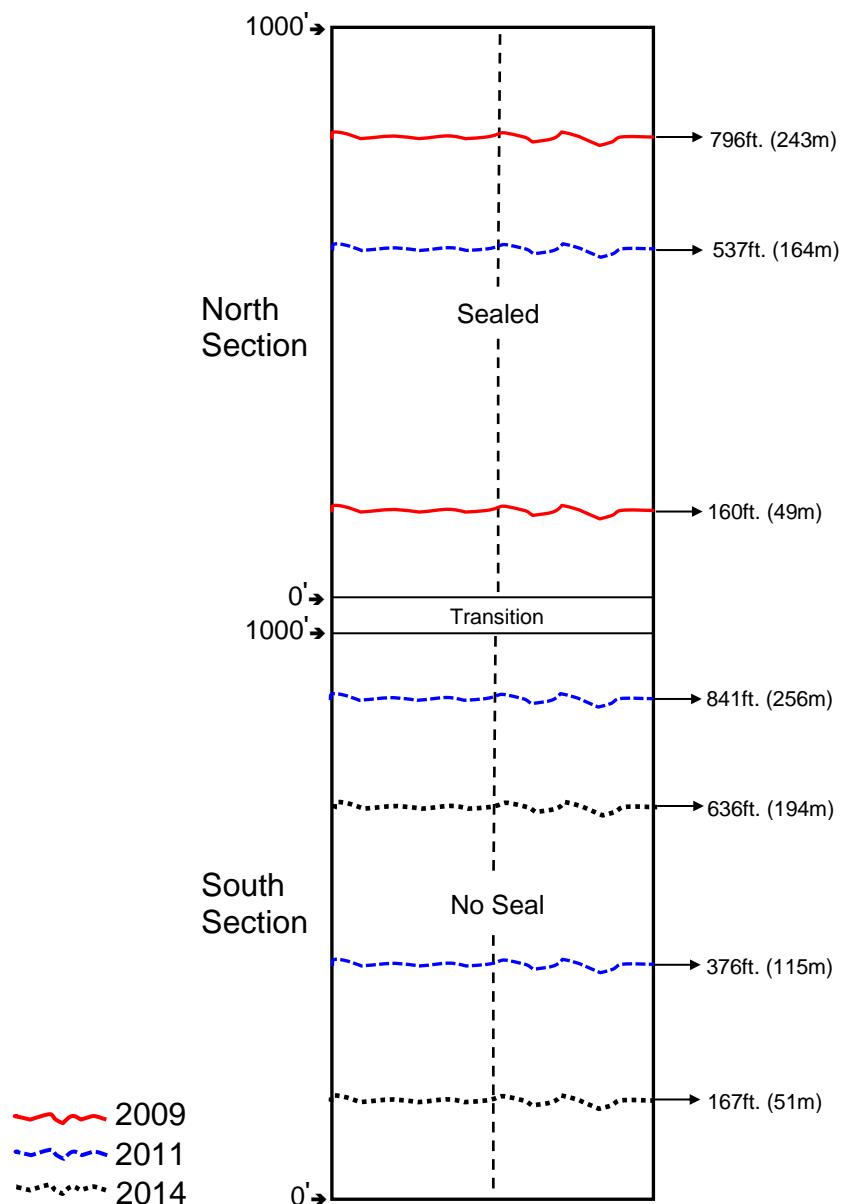
Documented Cracking – Interstate 15/Northbound lanes: Mile Point 312

The south and north sections were initially chosen due to the homogeneous condition and identical number of cracking on both sites. No transverse cracking occurred from construction date of 2005 to 2008. During the 2009 inspection the sealed north section had developed two low-severity cracks (red lines). The blue lines represent cracking to date (low-severity) documented with the 2011 site inspection; with two additional cracks appearing in the no-seal section between 2013 & 2014. To date all cracks on both sections have been crack sealed.

No additional cracking was observed since the 2014 site inspection. The graph depicts the approximate location and distance from the start of each test section, (crack locations approximate; not to scale).
