EXPERIMENTAL EVALUATION REPORT

Thin-Whitetopping Bonded Composite

Location: Glendive, Montana – Dawson County

Project No.: STPP 20-1(6)0 P-20, Highway 16, Milepost 0-0.6

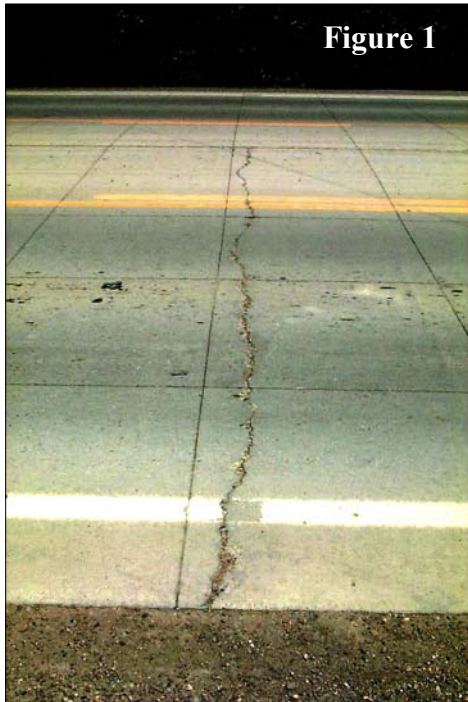
Figure 1

A visual inspection of the entire project was performed to document all types of surface cracking and distress. Photographic documentation of some of the cracks as well as a representative crack map is included in this report. Currently three transverse cracks are present on this project, all in the southbound lane. Location as follows (footage counted from the south end of the project going north), #1 at 1244' (541m), #2 at 1380' (420m), and #3 at 1480' (451m), see crack map at end of document. Note that these cracks developed soon after placement during construction. These cracks have widened since construction and are rated as severe in nature (example of crack in figure 1). Incompressible debris (rocks, friables etc.) is entering the cracks and will accelerate the deterioration of the fracture with freeze thaw events. It is suggested that these cracks be sealed in some manner to delay further damage.

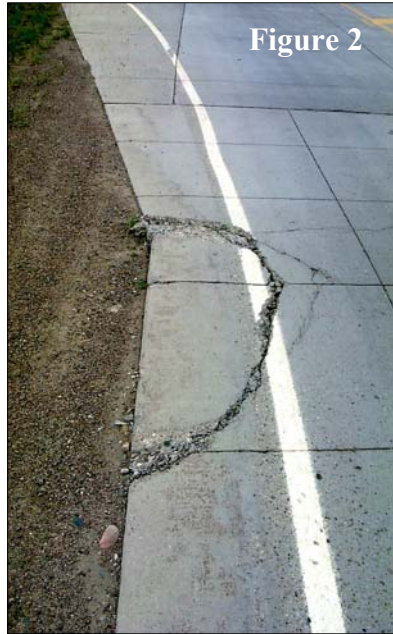
Additional panel cracking was located on the north end of the southbound lane on the west side of the road. It was originally observed that large truck traffic exiting off the interstate (due to the angle of turn) would roll over this section half on the pavement and partially on the gravel shoulder. The main reason for cracking at this location may be due to the lack of supporting shoulder and heavy loadings. The cracking pattern also reflects lack of support. Figure 2 shows the most recent area of cracked panel that was first documented in the 2002 evaluation. Truck tire imprints were seen in the gravel. Figure 3 is the condition of the panel as seen in 2003. This area has expanded into one additional

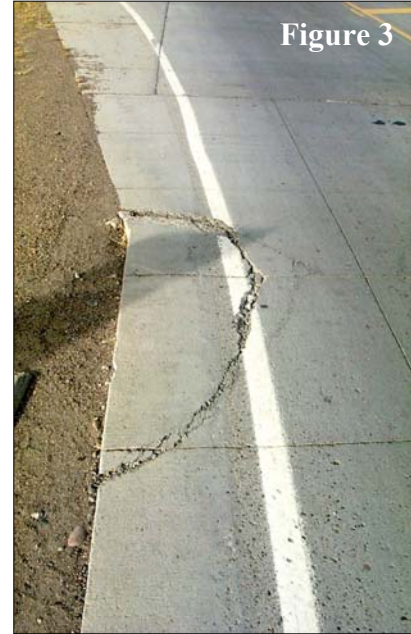
damaged panels (figure 4). The new cracks have been superimposed with a dark line for better visibility. No panel deflection was seen as heavy trucks passed over. However, due to the nature and location of the cracking, this area will most likely deteriorate to the point in which it will require repair of the pavement.

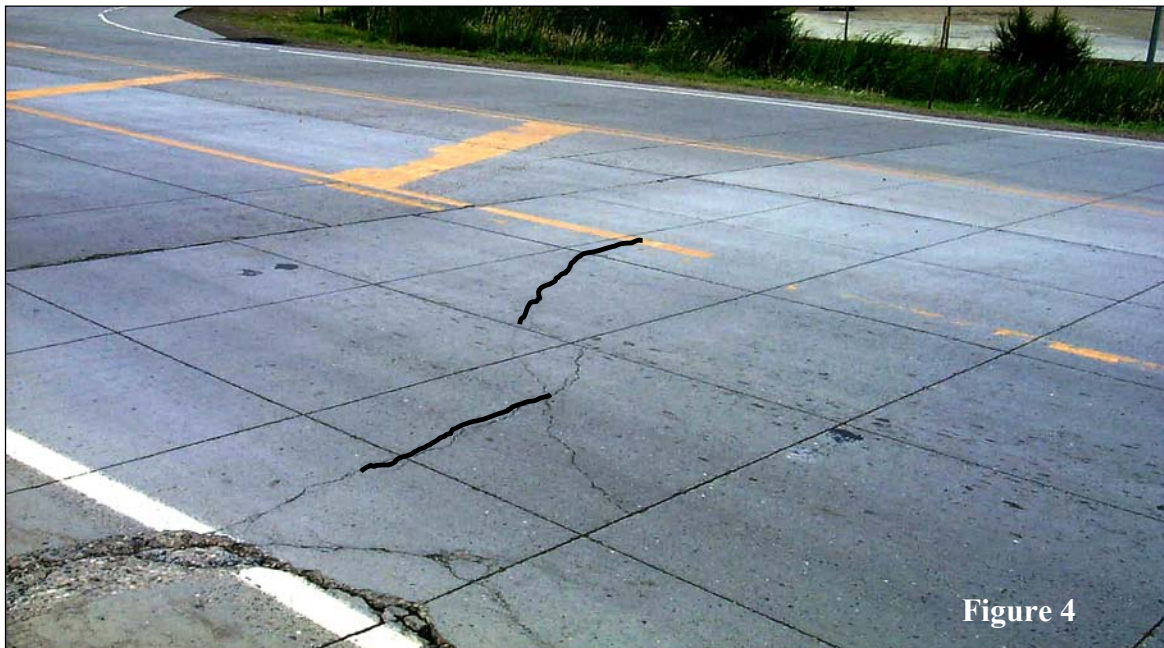
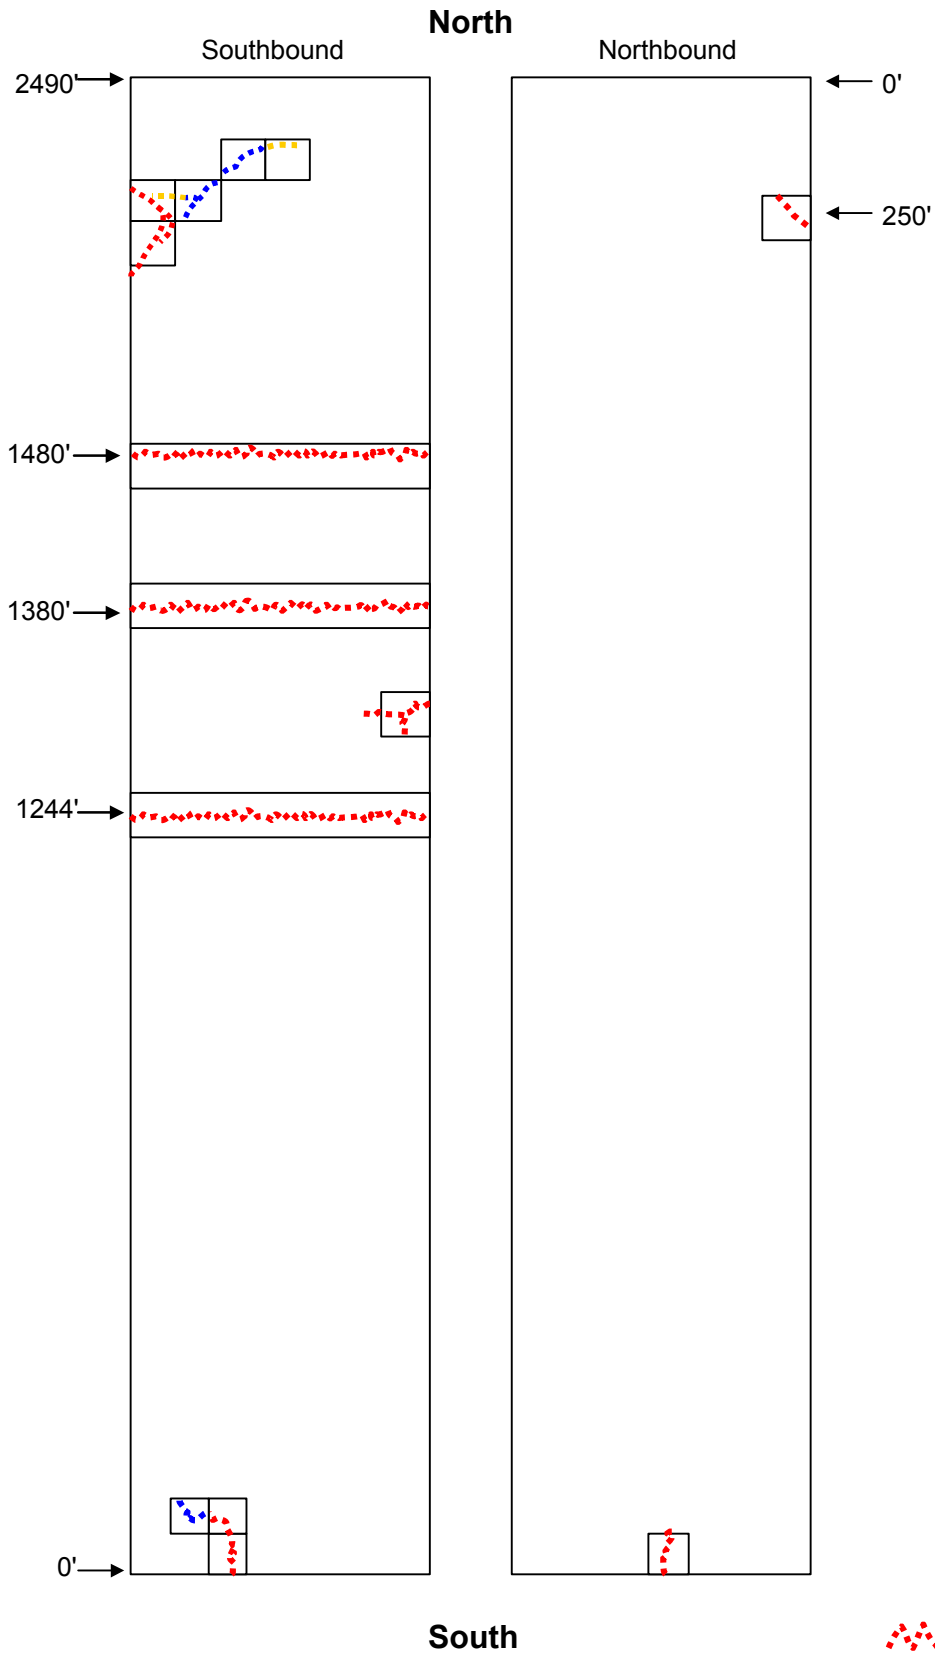
Glendive Whitetopping Representative Crack Map

The rest of the project displayed minimal additional panel cracking. A total of eleven panels have cracked since construction. A cracked panel does not necessarily mean a failure of the bond between the AC and PCCP layers. No panel movement or deflection was noticed on any of the panels as traffic moved over them.

Ten panels are affected at the north and south end of the project and one panel midway in the southbound lane. In this type of cracking which is indicative of this kind of pavement treatment, without an autopsy of the panel, it is difficult to determine the various causes of cracking. It could entail debonding of the PCCP from the asphalt concrete, structural failure of the underlying AC layer, overloading of the composite panel or sympathy cracking. In addition, some panels that have cracked are at the curb edge. The lack of support may have allowed cracking at these locations (refer to the crack map at the end of this document). The mid-way crack in the southbound lane located at about 1322' (0' starting at the south-end of the lane) has the same characteristics as the other cracked panels; save the fact, it is located at the southbound, east edge of the pavement. The east edge of the southbound pavement supported the paver for the northbound placement of the PCCP. This may have exacerbated the cracking of the panel.
