EXPERIMENTAL PROJECTS CONSTRUCTION REPORT

HIGH FRICTION SURFACE TREATMENTS (HFSTs) FOR BRIDGE DECKS

Location: •¹Kalispell-Flathead River: Highway 35
•²Roundup-Musselshell River: Highway 87
•³Big Timber-Yellowstone River: Highway 191
•⁴Bigfork-Swan River Bridge: Highway 35

Date of Inspections: March 2015/April-May 2016

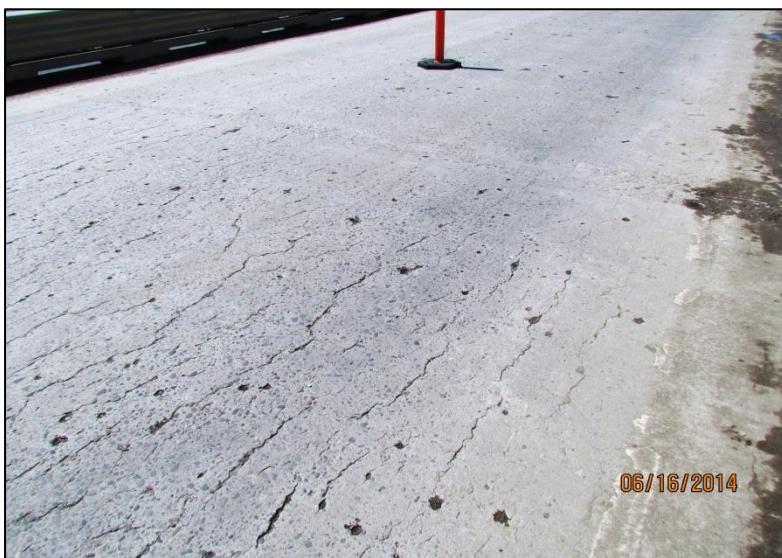
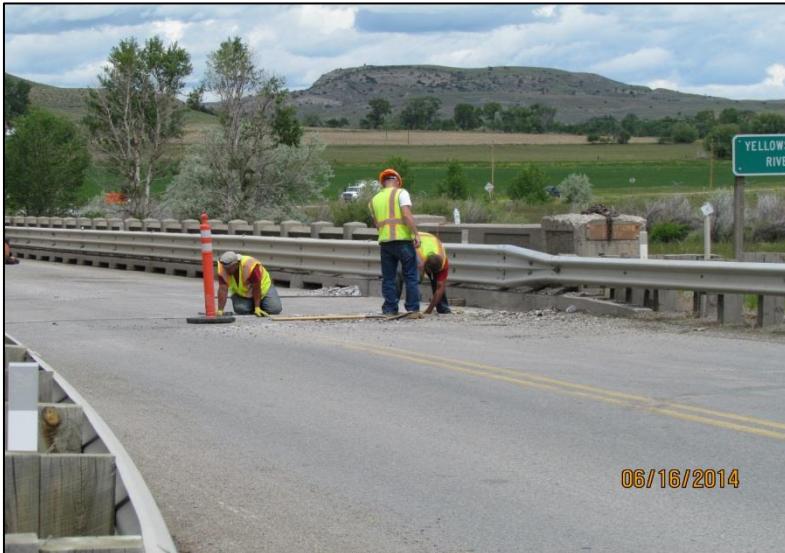
◀↓ Sample images of average deck surface condition. Most of the deck exhibited polished aggregate, minor popouts and longitudinal cracking.

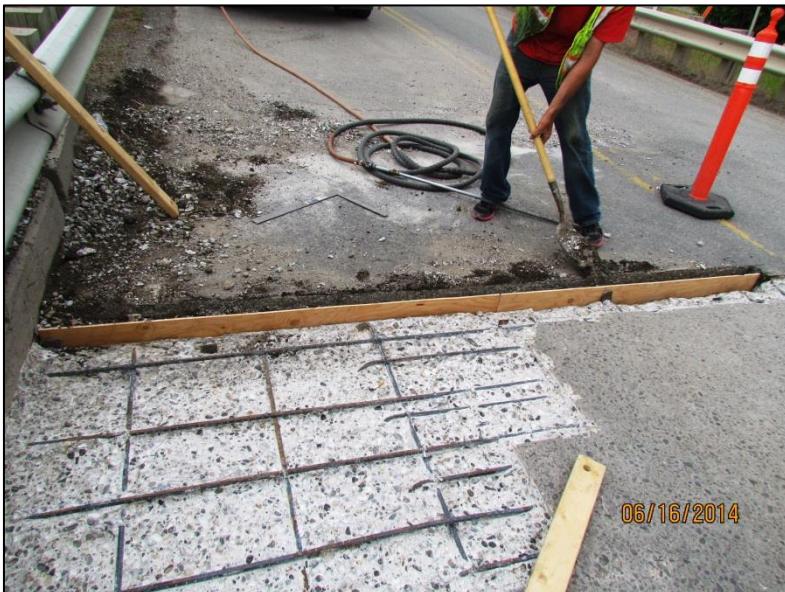
← Portions of the deck (mainly on the south end) needed repair due to deterioration of the deck surface.

← Areas that needed repair (class A) were delineated by concrete saw cut; damaged concrete was removed to the first layer of rebar.

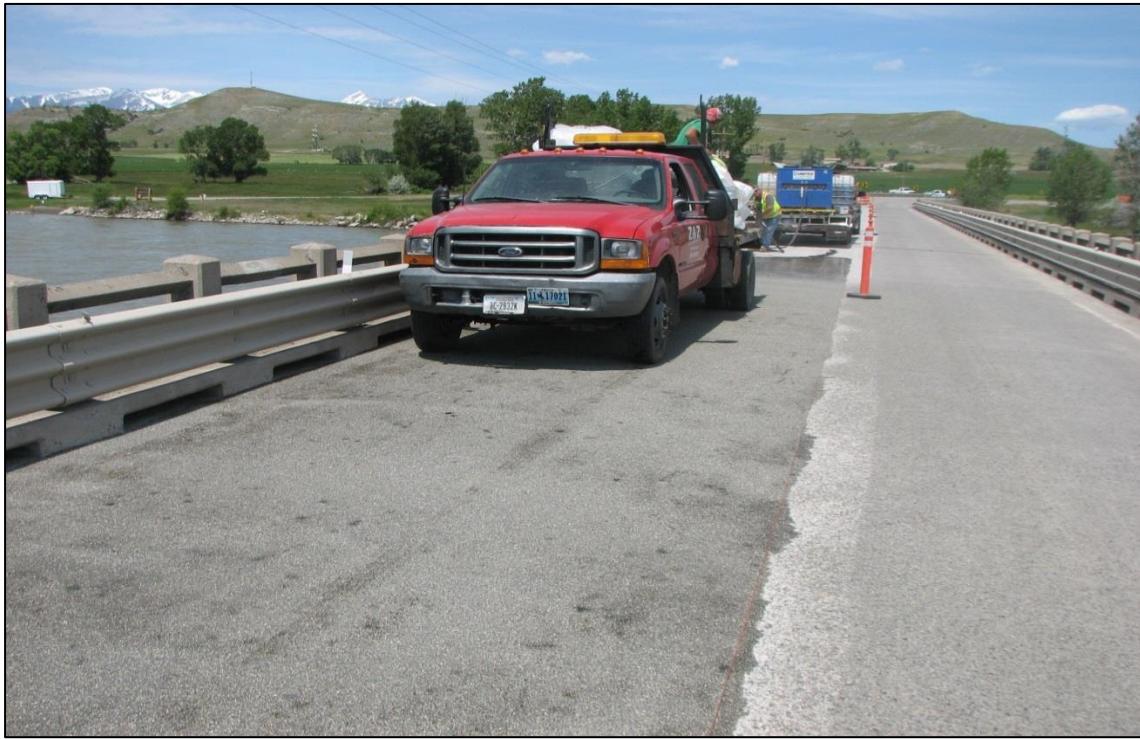
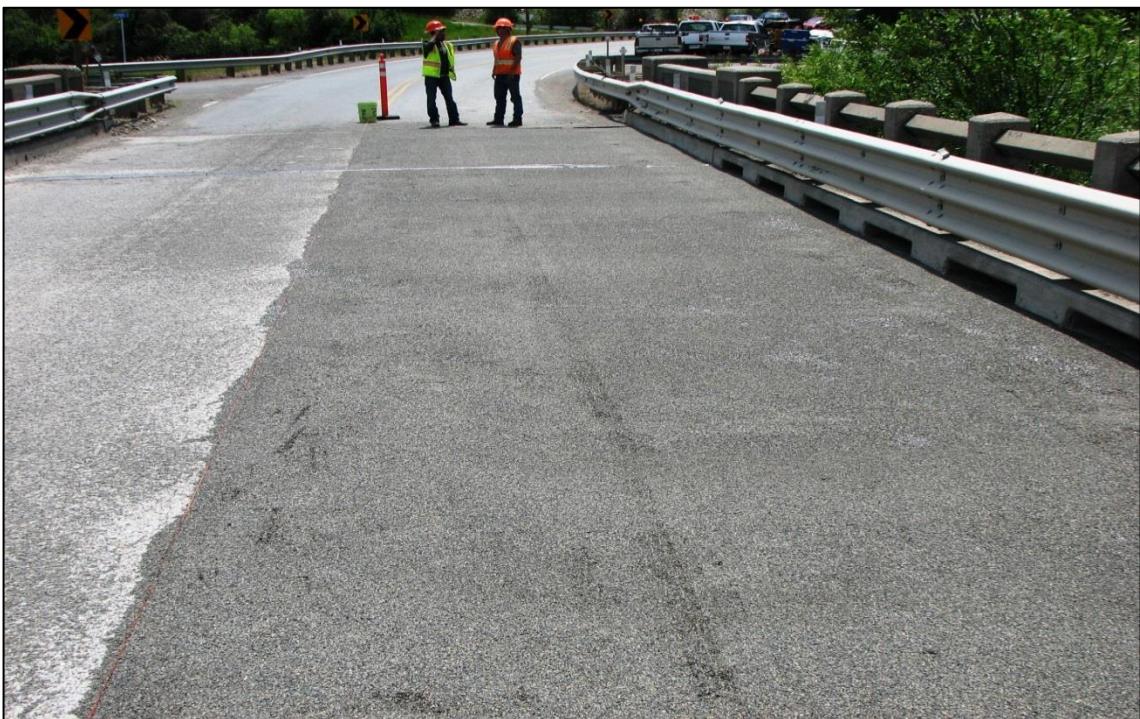
↑↓ These images show the level of aggregate layer with the first of run about midway through the length of the bridge. Note there are areas of epoxy bleeding through the aggregate. The contractor was not concerned since it was stated that they apply a very heavy first coat and material bleed through was common. The second lift will create a more uniform appearance.

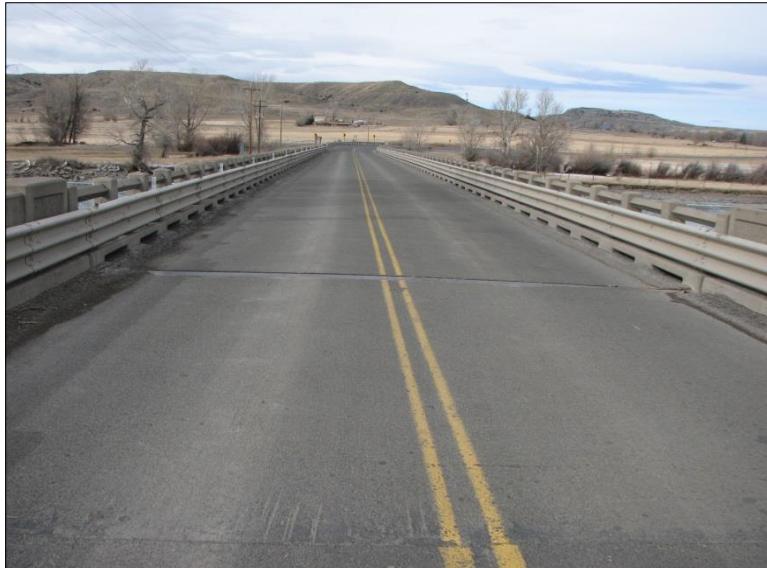
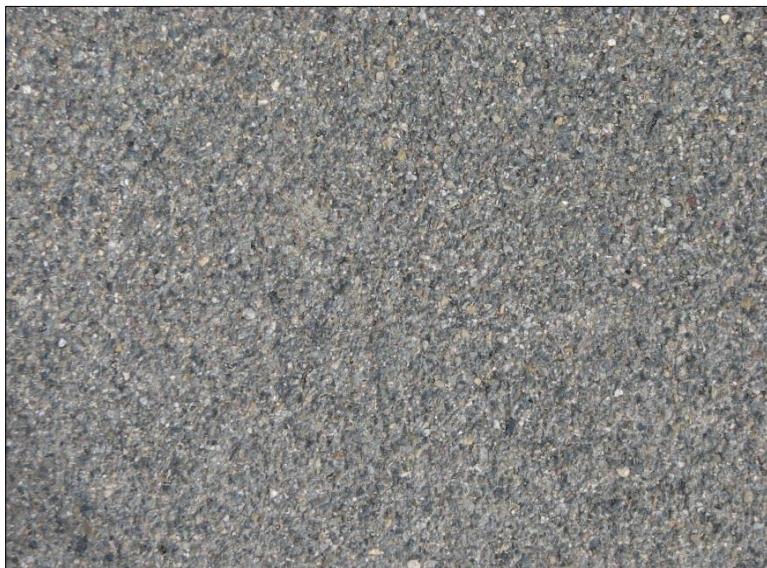
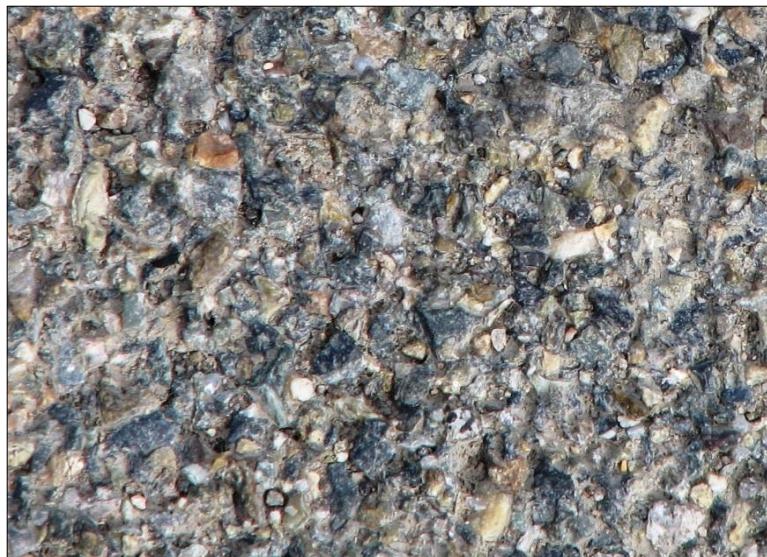
Big Timber – Dayton Superior Unitex: March 2015

◀↓ The following are images (deck overview and surface texture) depicting the general condition of the HFST.

No issues to date to report; aggregate surface has uniformity in texture and appearance. No areas of raveling or debonding visible.

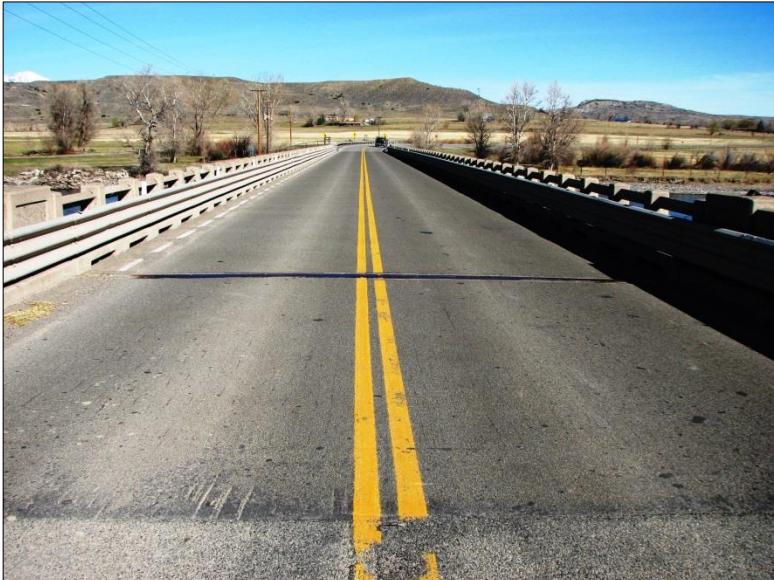
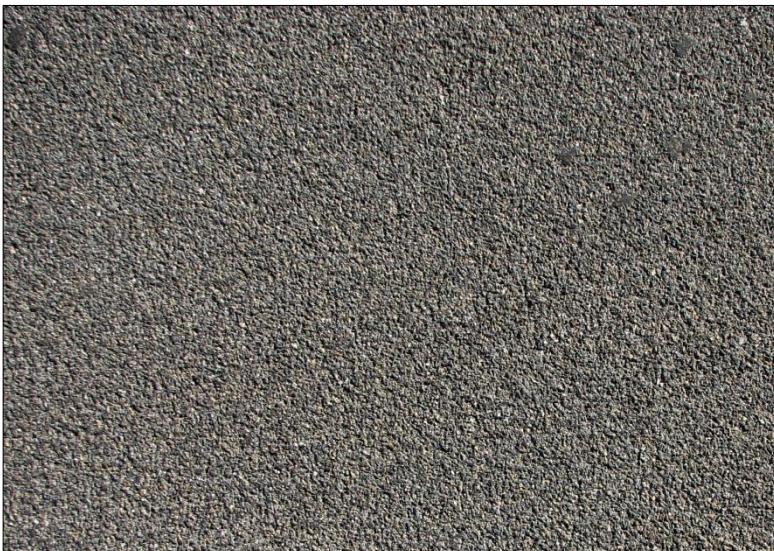
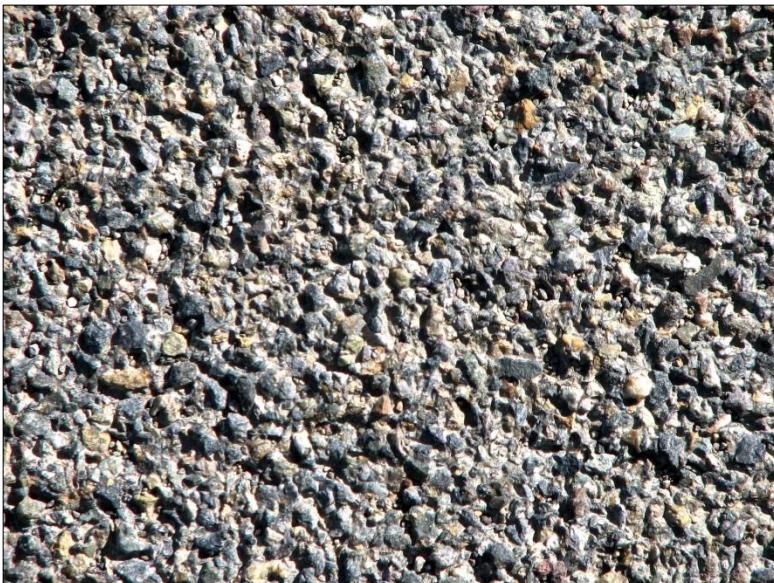
Big Timber – Dayton Superior Unitex: April 2016

◀▼ The following are images (deck overview and surface texture) depicting the general condition of the HFST.

No issues to date to report; aggregate surface has uniformity in texture and appearance. No areas of raveling or debonding visible.

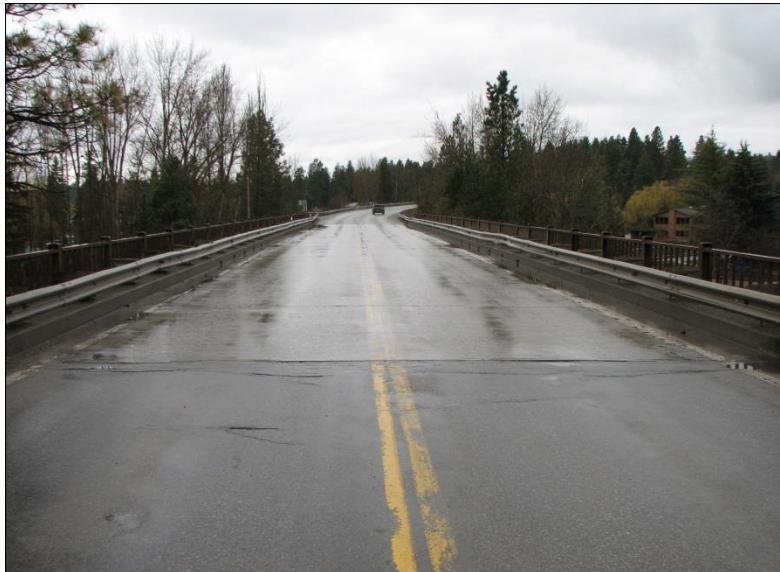
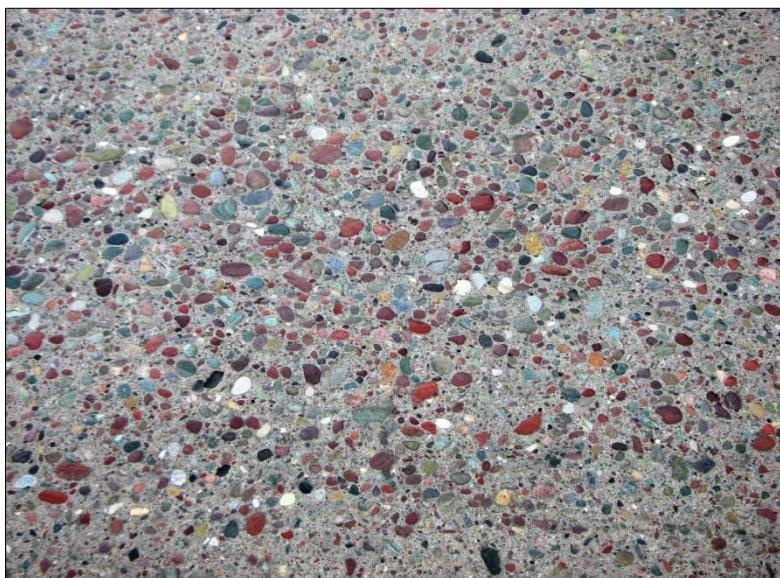
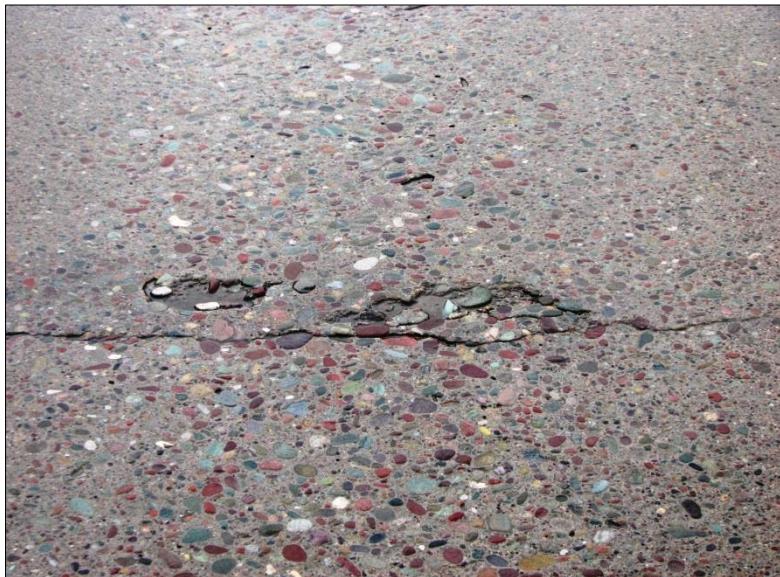
Bigfork – Swan River Bridge: Dayton Superior Unitex: May 2015

◀▼ Images of deck prior to repairs and overlay. Exposed, polished aggregate is apparent, with areas of cracking and spalling.

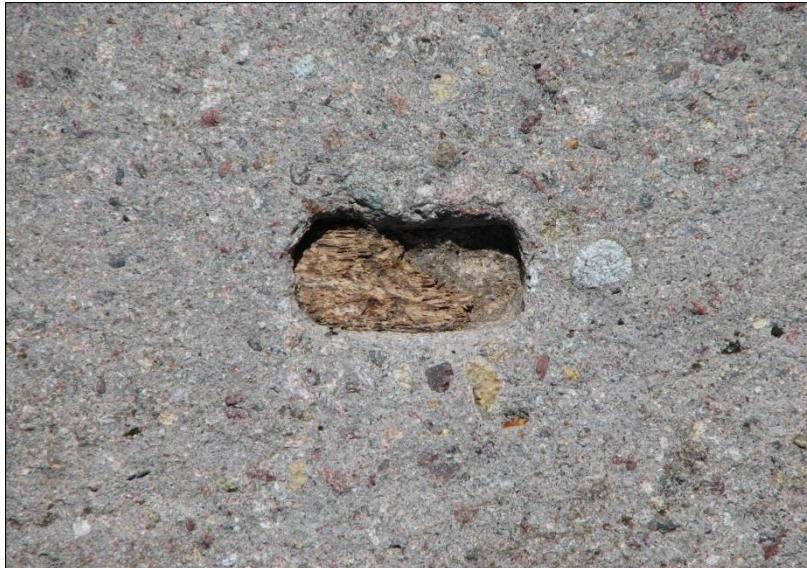
◀↓ Wood fragments were seen embedded in the deck concrete of enough quantity to be noted in this report.

MDT project staff assumed the aggregate for the deck (constructed in 1954), was dredged from the old Flathead River bed.

At this time, this issue is not considered detrimental to the polymer performance.

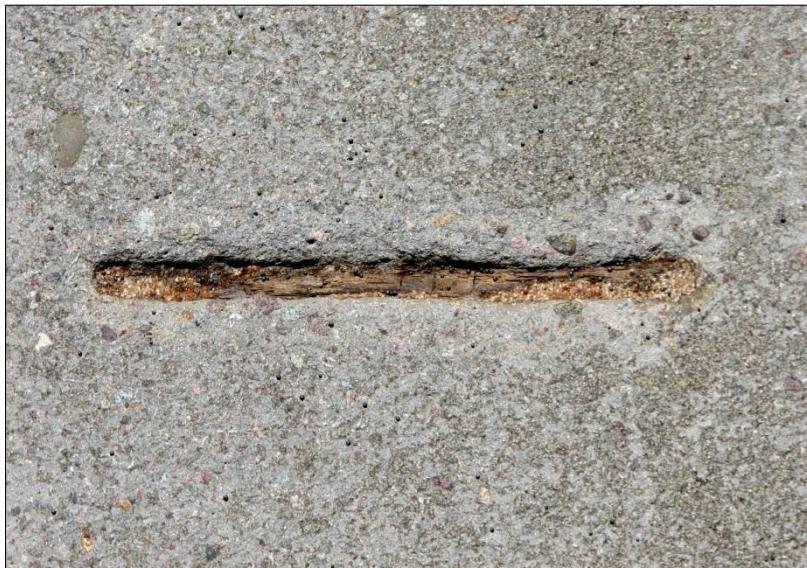
◀ After the first course had cured and cleaned, this hole (assuming a wood chip) did not have any stone embedded on the surface.

To date, no explanation can be found for this anomaly.

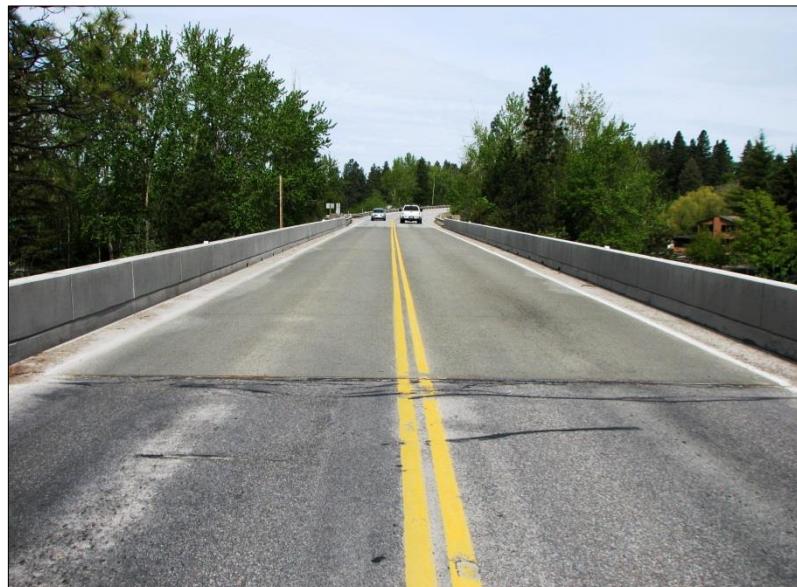
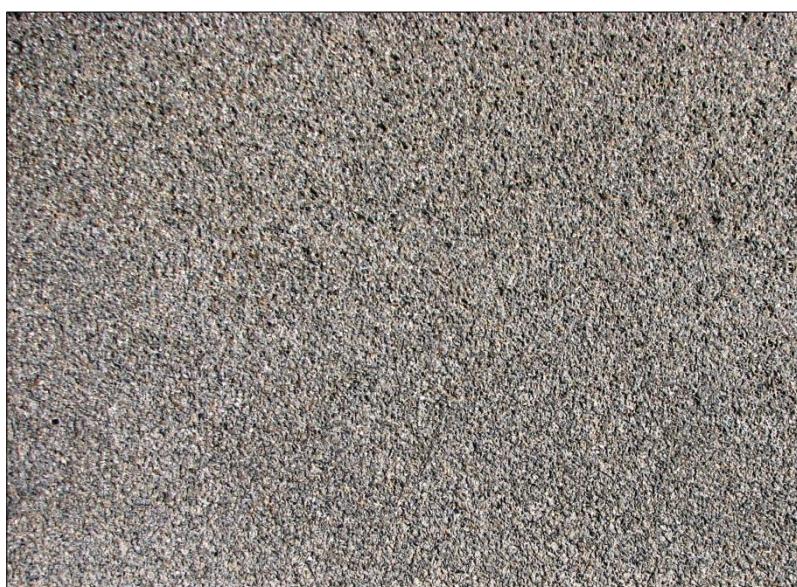
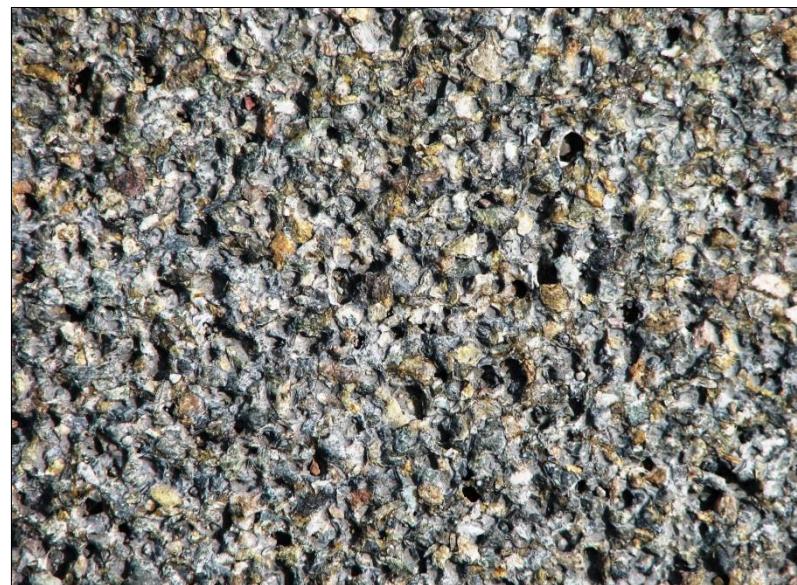
Bigfork Project/Dayton Superior – June 2016:

◀▼ The following are images (deck overview and surface texture) depicting the general condition of the HFST.

No issues to date to report; aggregate surface has uniformity in texture and appearance. No areas of raveling or debonding visible.

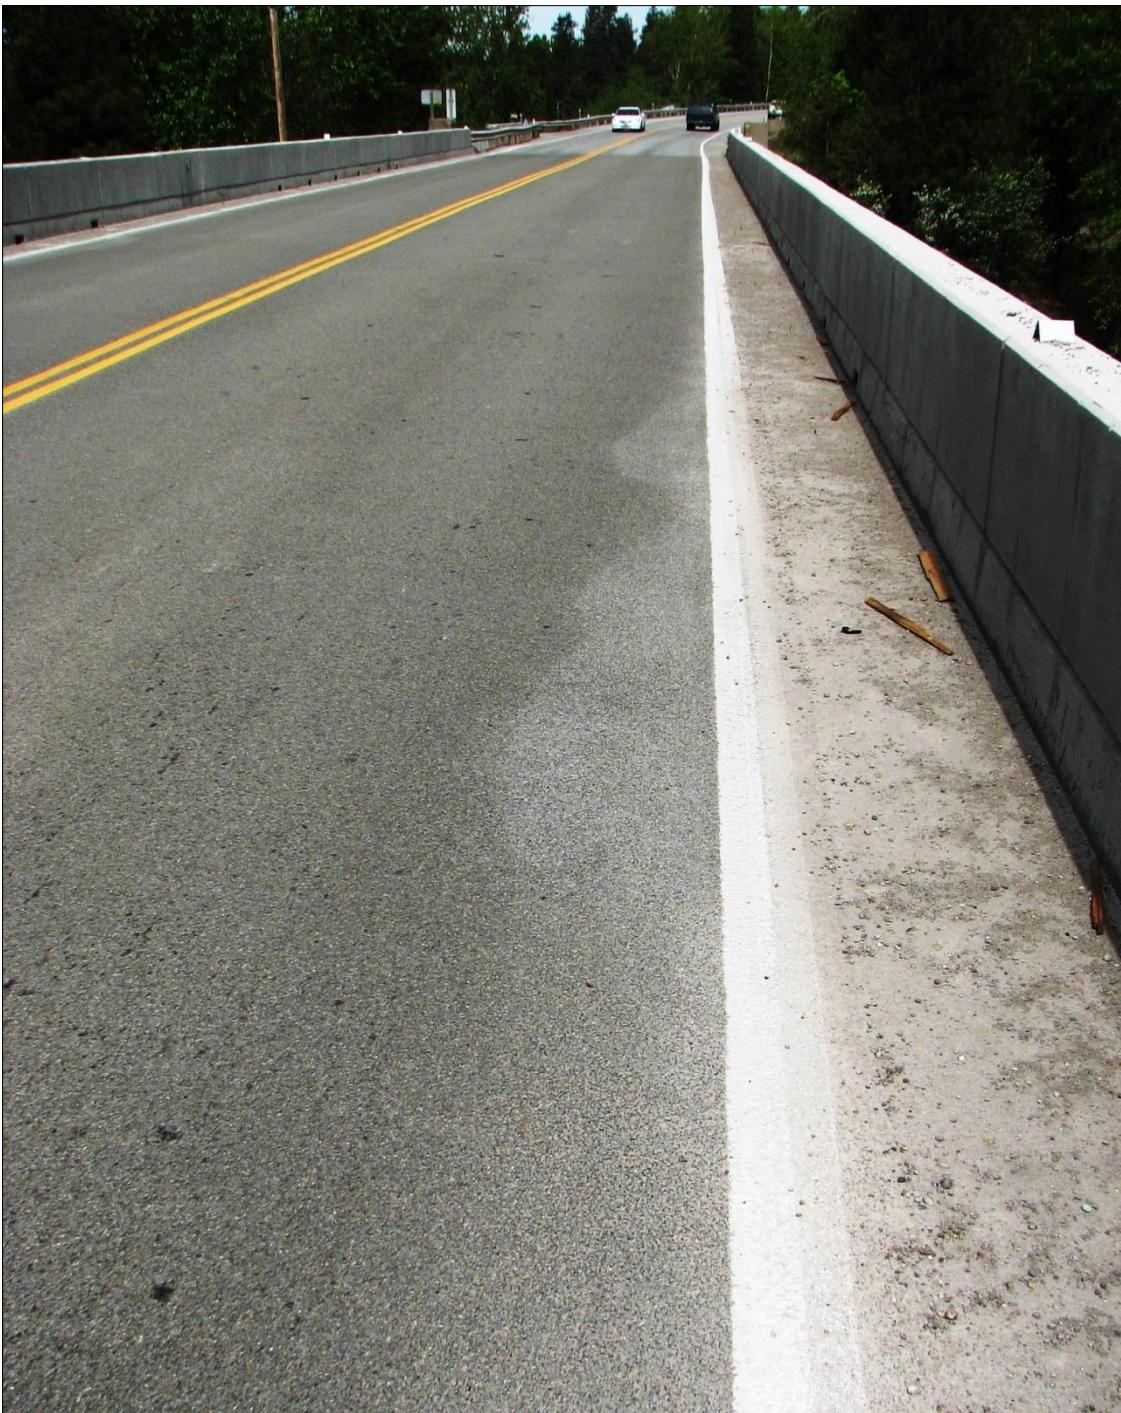
↑ June 2016; view north.

Deck surface condition on all sites reflect the same condition as noted in 2015; aggregate treatments are tight with no apparent distress to document to date other than some areas of plow abrasion as noted on the Bigfork project (see page 31).

Several areas on the deck, mainly at the shoulder, displayed minor abrasion (assuming from snow plow passes); most likely due to an excessive layer of epoxy and aggregate during application.

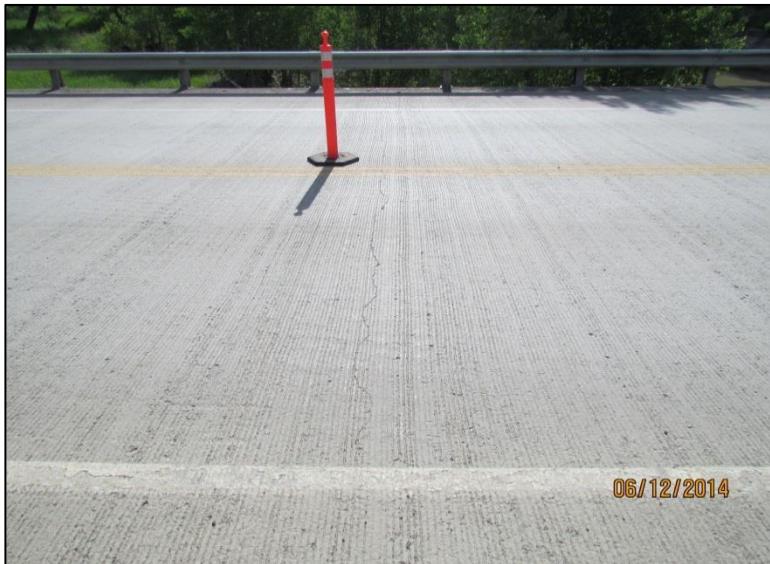
◀ Representative image of condition of deck surface prior to treatment.

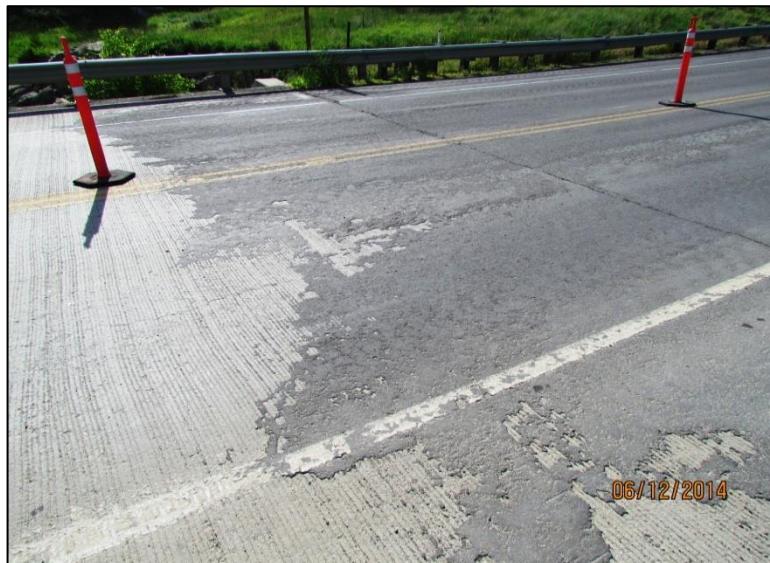
◀ A previous maintenance patch placed a layer asphalt cement (AC) beyond both approaches of the PCCP deck which will require removal prior to the HFST.

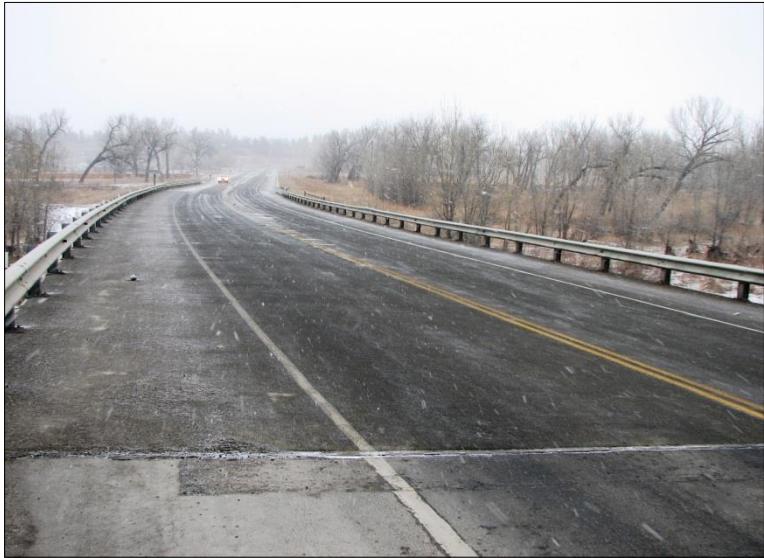
Roundup – Poly-Carb 135 Safe-T-Seal/163 Flexogrid Overlay: March 2015

◀↓ The following are images (deck overview and surface texture) depicting the general condition of the HFST (view north).

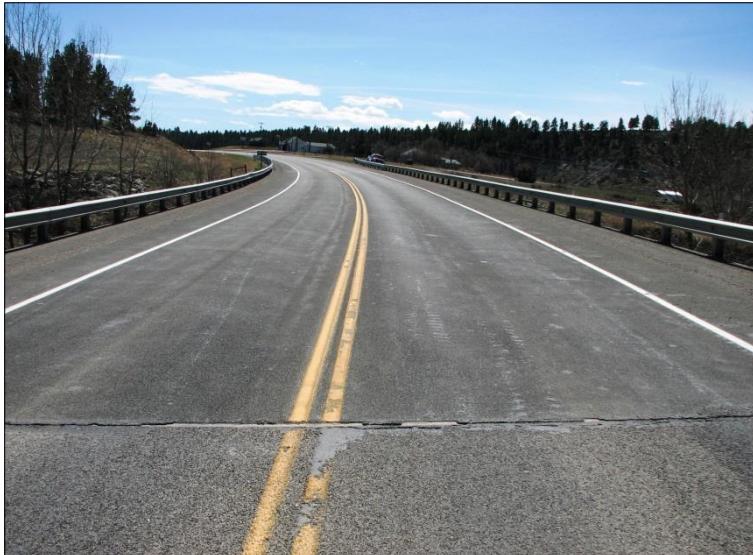
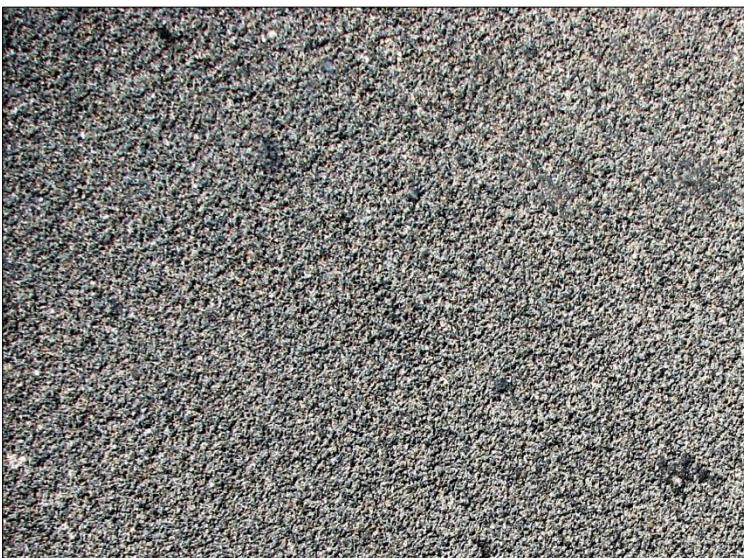
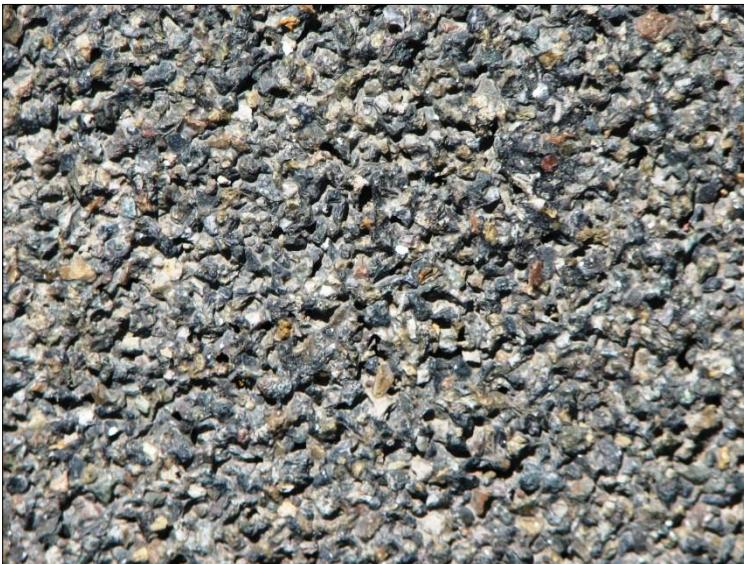
Roundup – Poly-Carb 135 Safe-T-Seal/163 Flexogrid Overlay: April 2016

◀↓ The following are images (deck overview and surface texture) depicting the general condition of the HFST (view south).

No issues to date to report; aggregate surface has uniformity in texture and appearance. No areas of delamination or debonding visible.

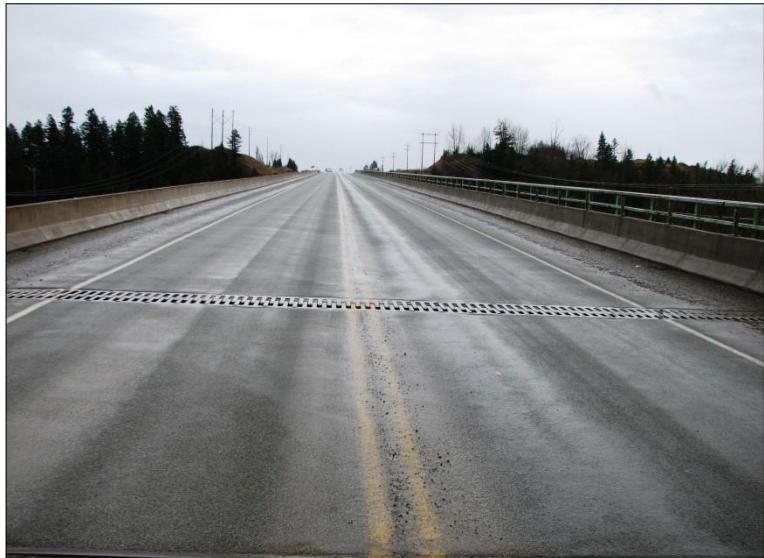
Kalispell – Poly-Carb 135 Safe-T-Seal/163 Flexogrid Overlay: March 2015

◀↓ The following are images (deck overview and surface texture) depicting the general condition of the HFST (view east).

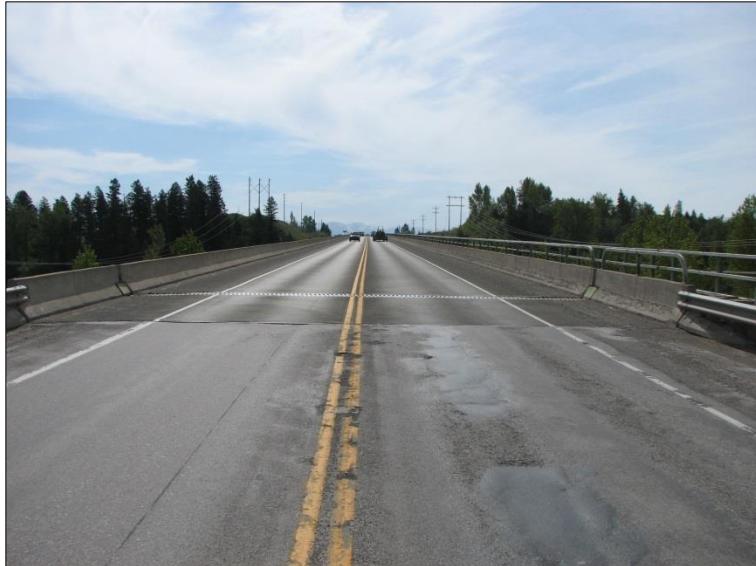
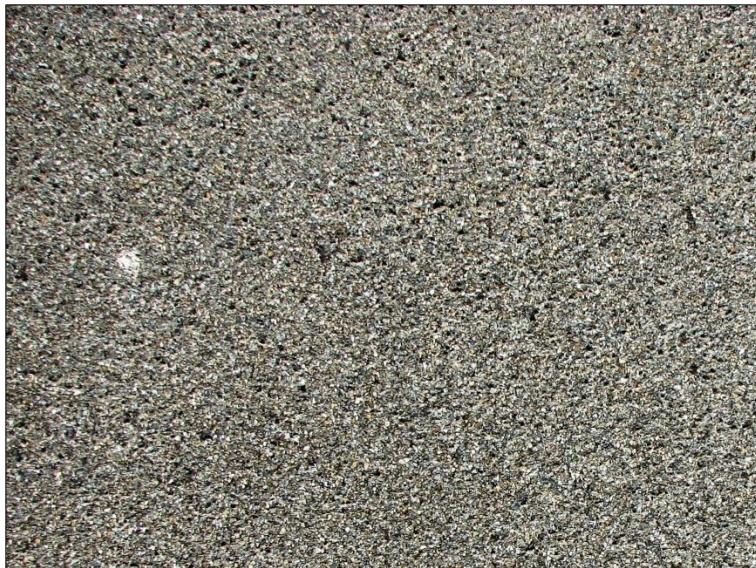
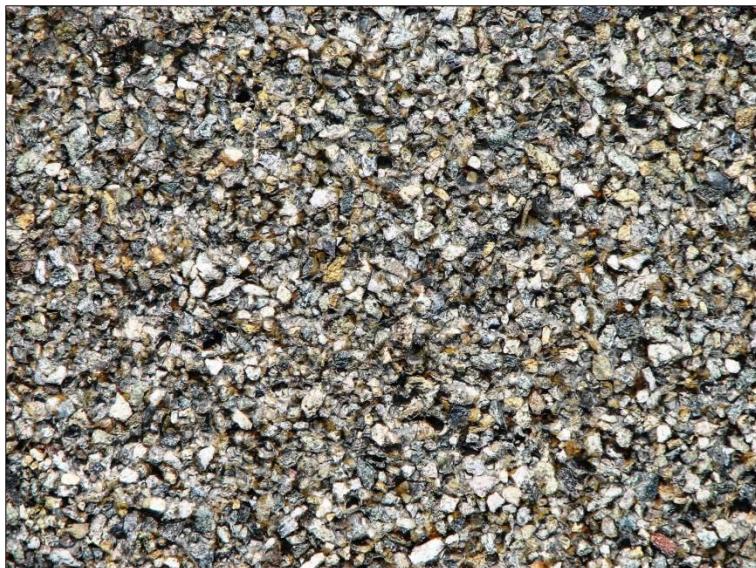
Kalispell – Poly-Carb 135 Safe-T-Seal/163 Flexogrid Overlay: May 2016

◀↓ The following are images (deck overview and surface texture) depicting the general condition of the HFST (view east).

No issues to date to report; aggregate surface has uniformity in texture and appearance. No areas of delamination or debonding visible.
