## EXPERIMENTAL PROJECTS CONSTRUCTION REPORT

### HIGH FRICTION SURFACE TREATMENTS (HFSTs) FOR BRIDGE DECKS

| <b>FHWA Project Number:</b> | MT-12-10/13-01/14-05 |
| <b>Date of Inspections:</b> | March 2015 |

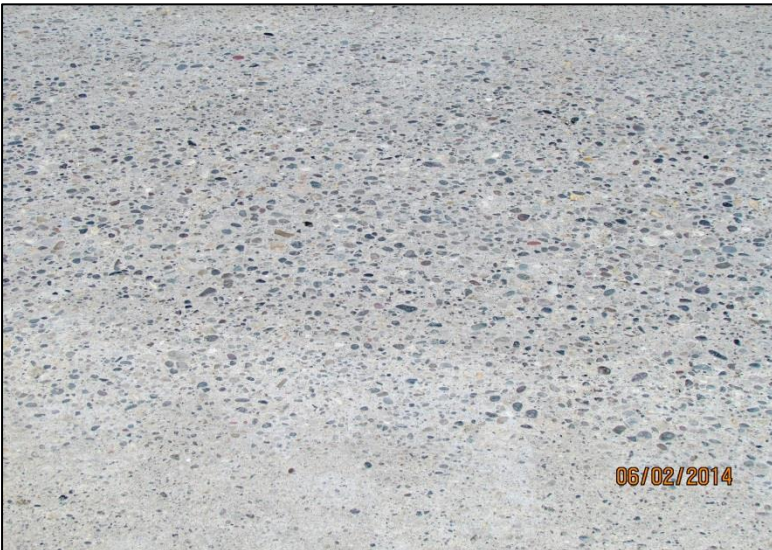
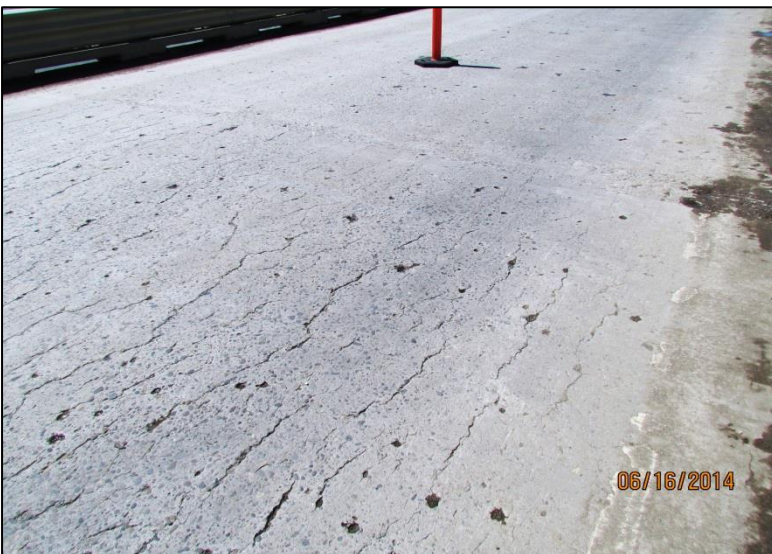
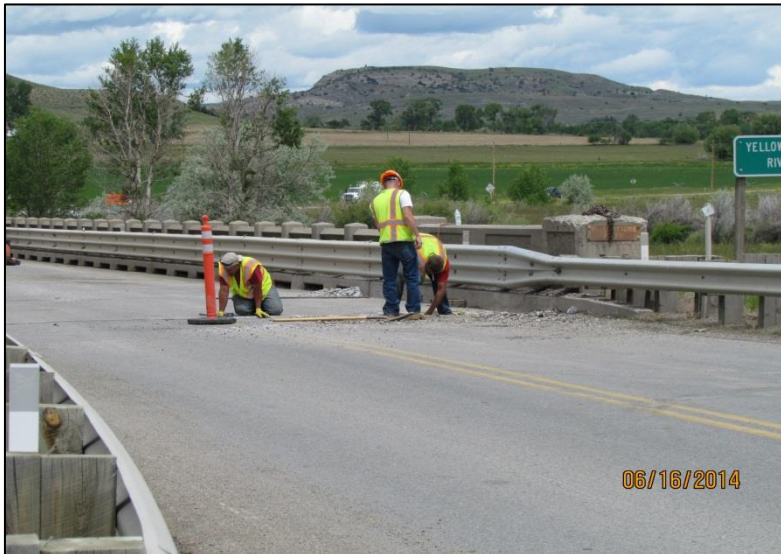
↙ Sample images of average deck surface condition. Most of the deck exhibited polished aggregate, minor popouts and longitudinal cracking.

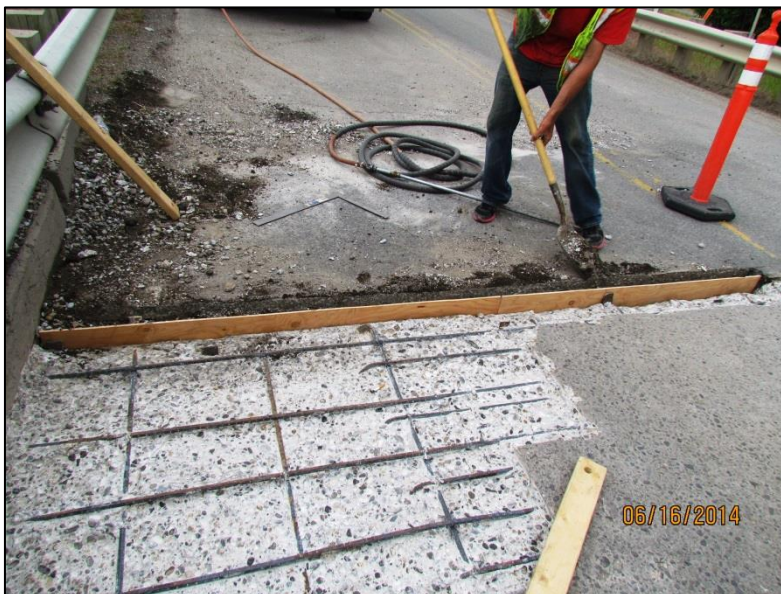
← Portions of the deck (mainly on the south end) needed repair due to deterioration of the deck surface.

← Areas that needed repair (class A) were delineated by concrete saw cut; damaged concrete was removed to the first layer of rebar.

The exposed patch is sandblasted and blown free of loose material and dust.

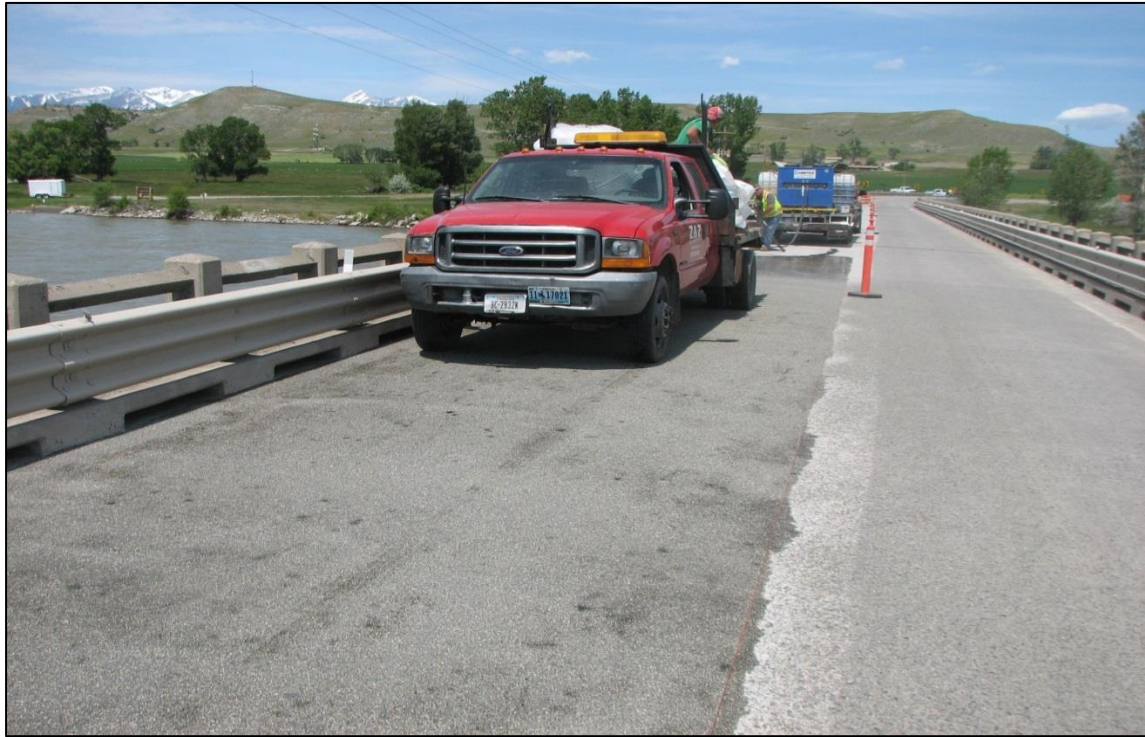
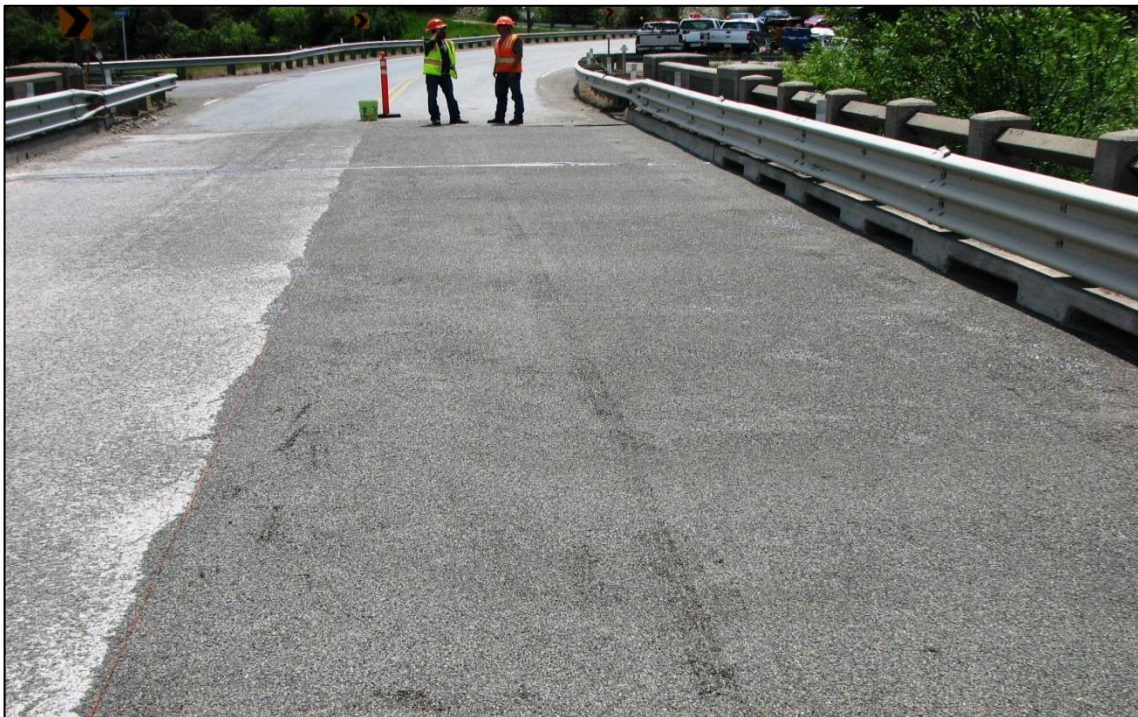
↑↓ These images show the level of aggregate layer with the first of run about midway through the length of the bridge. Note there are areas of epoxy bleeding through the aggregate. The contractor was not concerned since it was stated that they apply a very heavy first coat and material bleed through was common. The second lift will create a more uniform appearance.

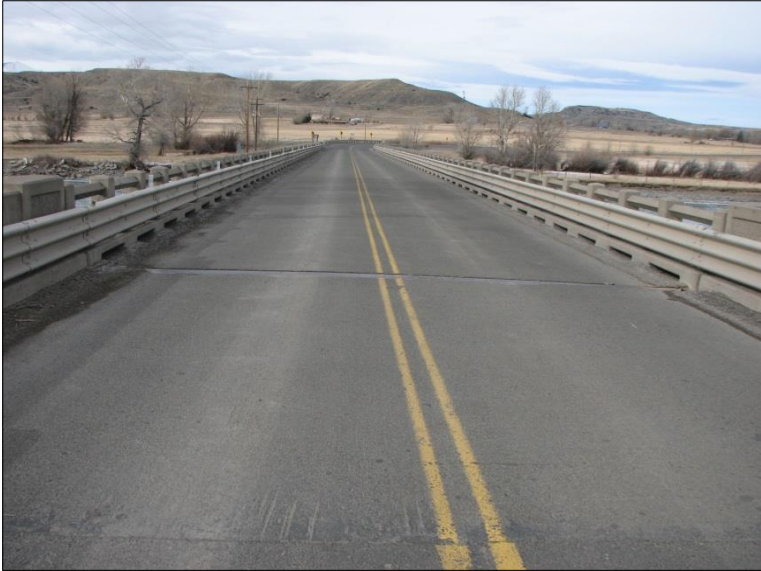
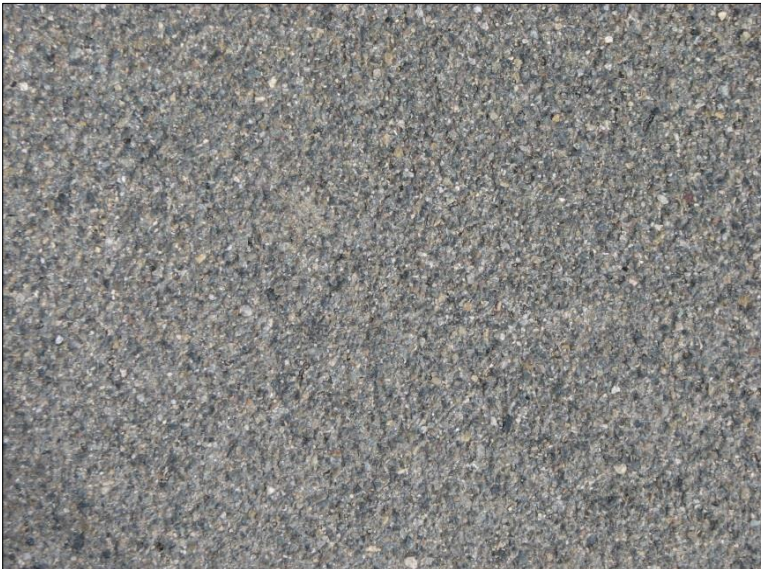
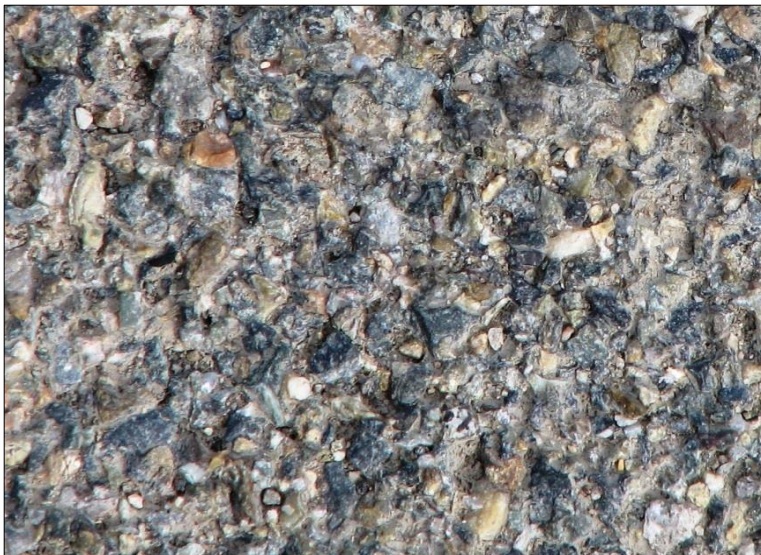
**Big Timber – Dayton Superior Unitex: March 2015**

↩↓ The following are images (deck overview and surface texture) depicting the general condition of the HFST.

No issues to date to report; aggregate surface has uniformity in texture and appearance. No areas of raveling or debonding visible.

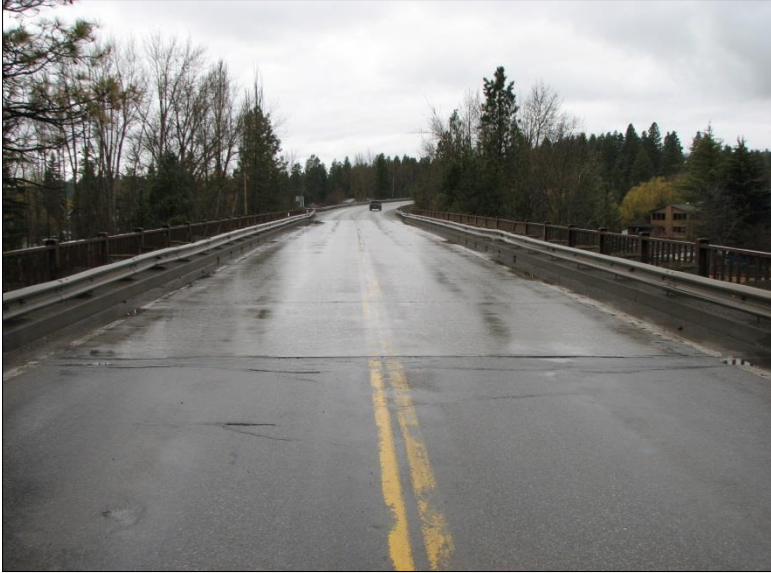
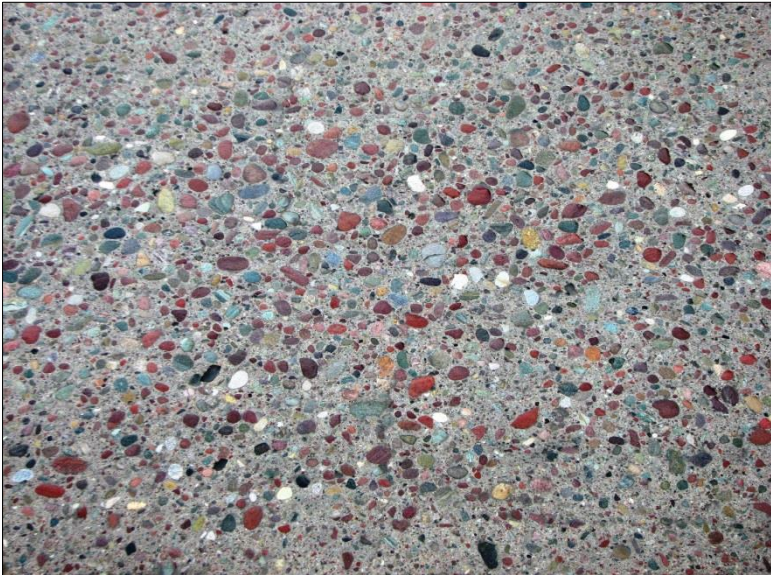
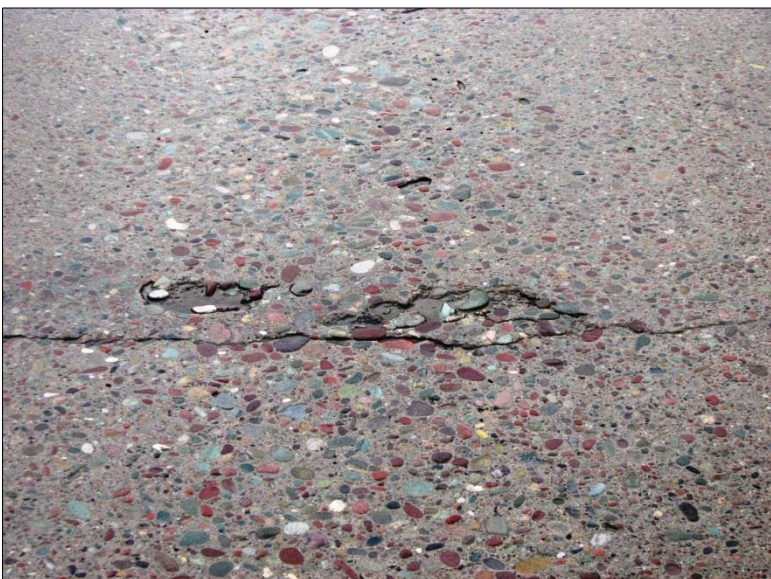
**Bigfork – Swan River Bridge: Dayton Superior Unitex: May 2015**

↩↓ Images of deck prior to repairs and overlay. Exposed, polished aggregate is apparent, with areas of cracking and spalling.

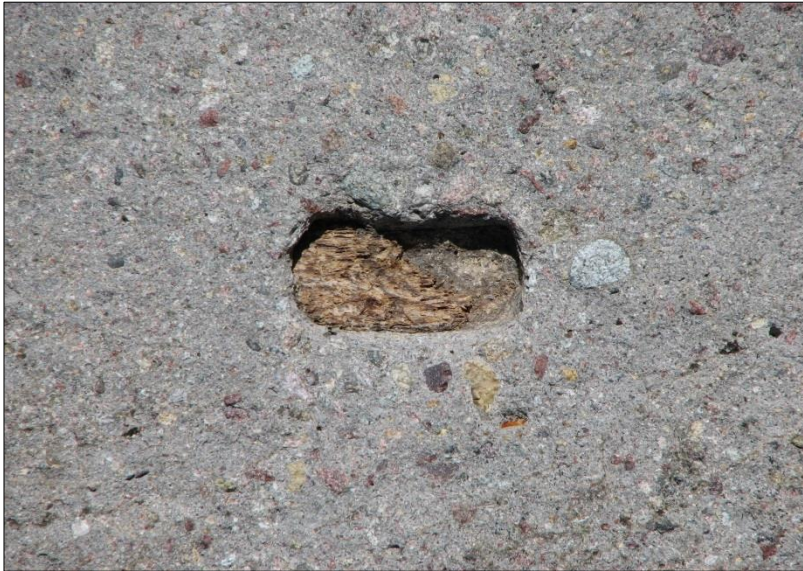
↩️ Wood fragments were seen embedded in the deck concrete of enough quantity to be noted in this report.

MDT project staff assumed the aggregate for the deck (constructed in 1954), was dredged from the old Flathead River bed.

At this time, this issue is not considered detrimental to the polymer performance.

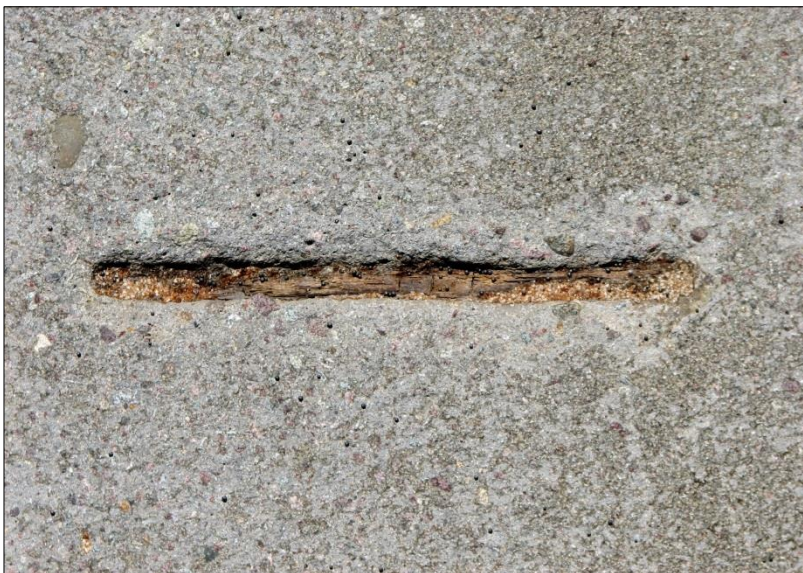
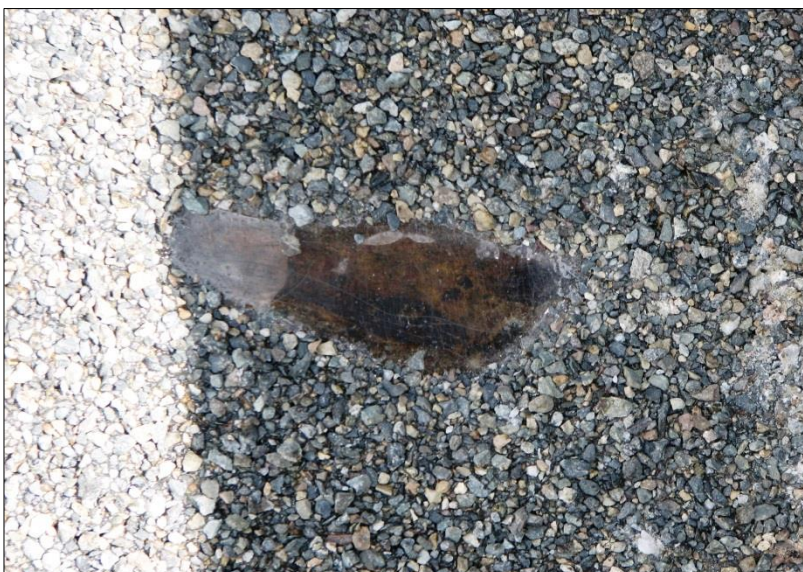
↩️ After the first course had cured and cleaned, this hole (assuming a wood chip) did not have any stone embedded on the surface.

To date, no explanation can be found for this anomaly.

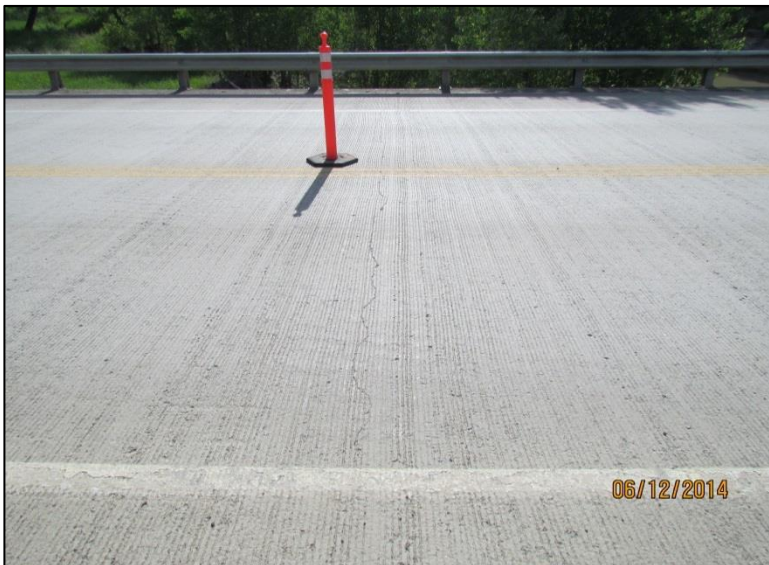
◀ Representative image of condition of deck surface prior to treatment.

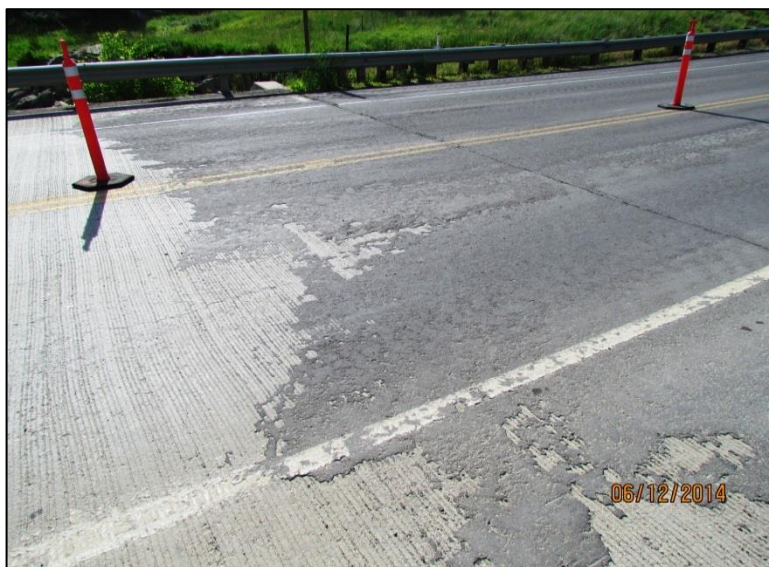
◀ A previous maintenance patch placed a layer asphalt cement (AC) beyond both approaches of the PCCP deck which will require removal prior to the HFST.

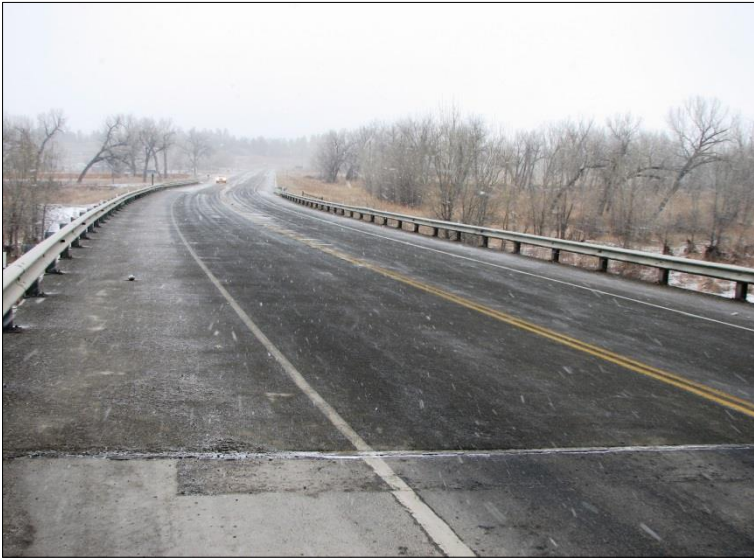
## **Roundup – Poly-Carb 135 Safe-T-Seal/163 Flexogrid Overlay: March 2015**

↩↓ The following are images (deck overview and surface texture) depicting the general condition of the HFST.

No issues to date to report; aggregate surface has uniformity in texture and appearance. No areas of delamination or debonding visible.

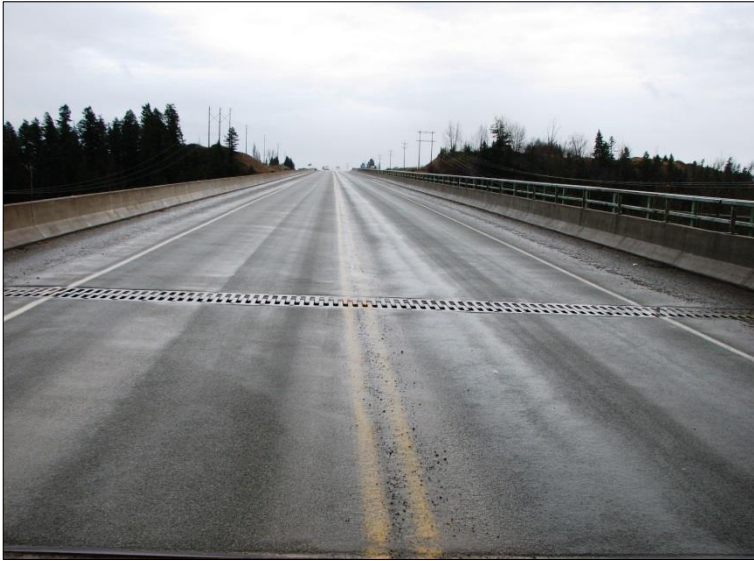
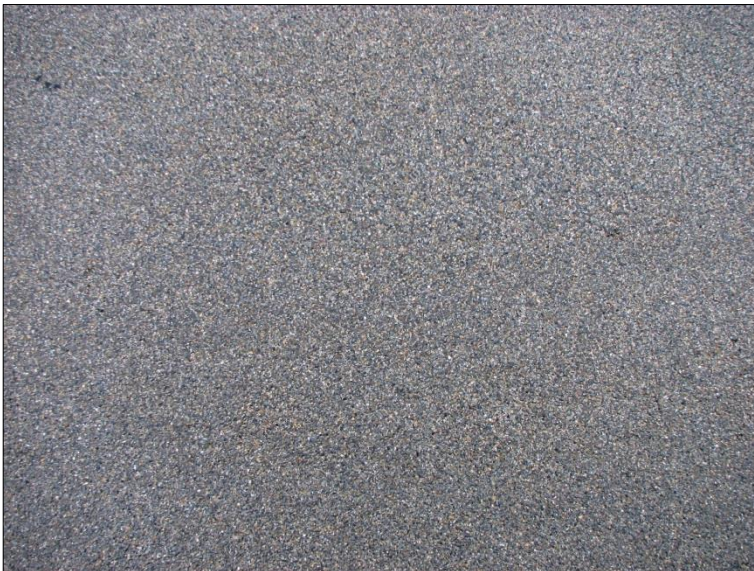
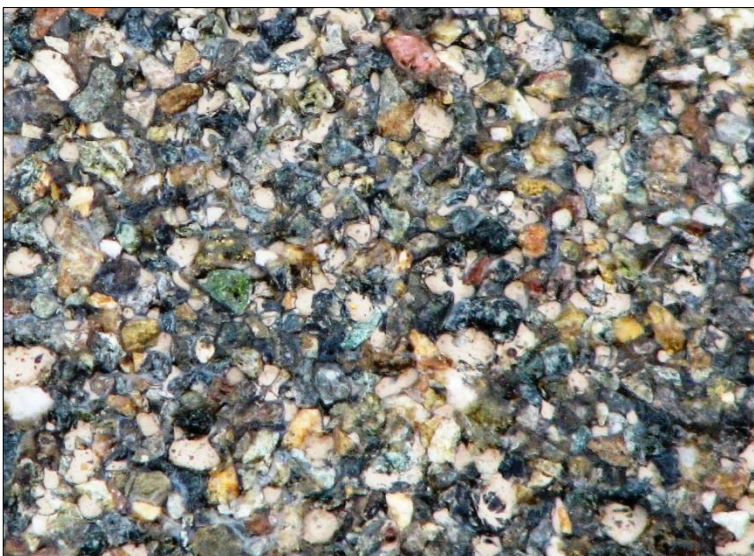
## Kalispell – Poly-Carb 135 Safe-T-Seal/163 Flexogrid Overlay: March 2015

↩↓ The following are images (deck overview and surface texture) depicting the general condition of the HFST (view east).

No issues to date to report; aggregate surface has uniformity in texture and appearance. No areas of delamination or debonding visible.
