FINAL REPORT

EVALUATION OF STAY-TUFF WOVEN FENCE

Project Name: I-15 Augusta Interchange to Craig (UPN 6531001)

Project Number: IM 15-4(129)229

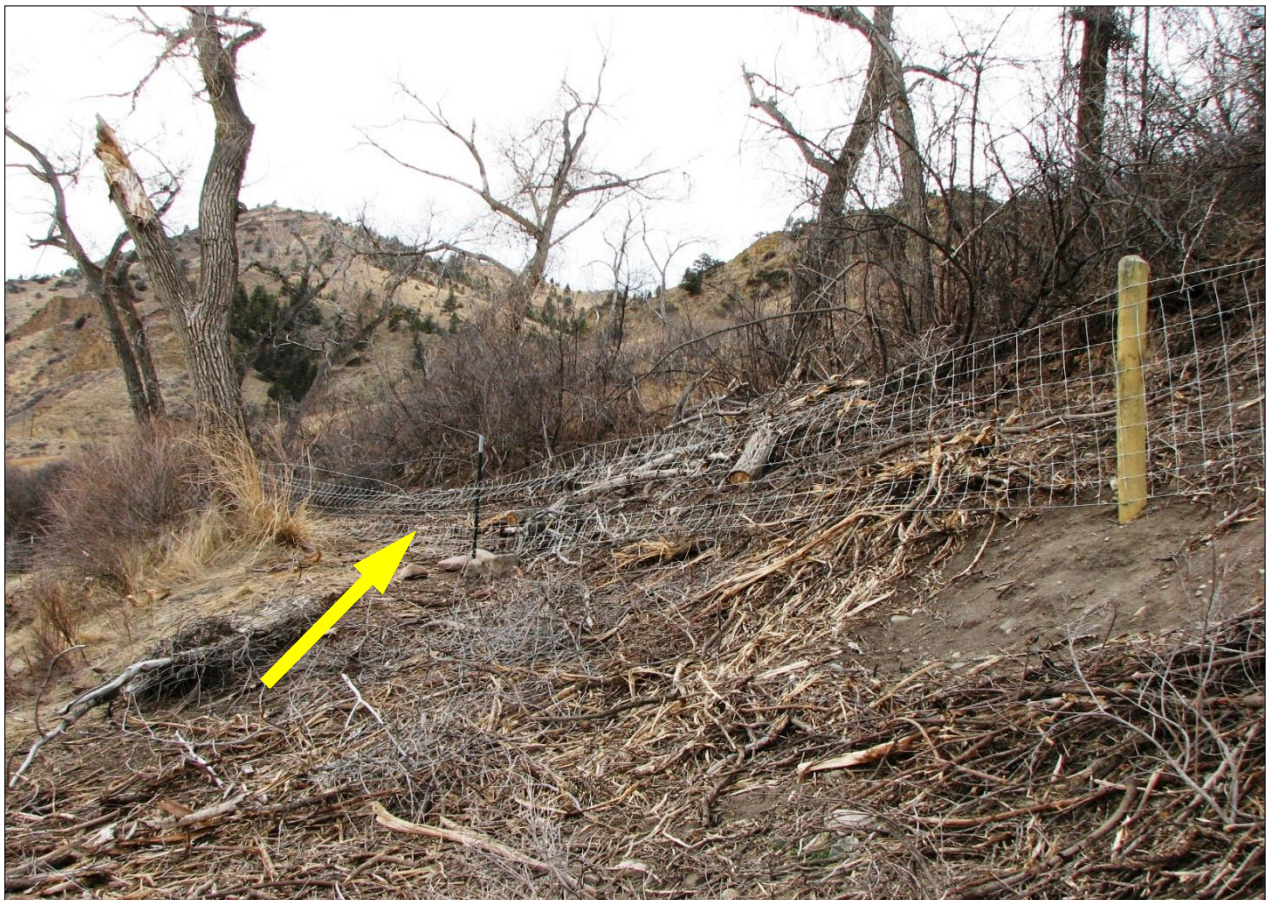
During the March 8, 2012 site inspection of the Stay-Tuff fencing a local rancher informed Research staff that a cottonwood tree had recently fallen over a section of the fence. The rancher had since cut the tree up for firewood. He did state the tree was about twenty (20) inches in diameter and had completely flattened the fence section to the ground. The location of the damaged section is approximately 4.9 miles (7.9 kilometers) north on the Craig River Rd. starting at the I-15 and Highway 287 interchange.

The image below shows the extent of damage by the fallen tree. The yellow arrow depicts the approximate location of where the main trunk hit the fence.

The section was repaired in early April. Bob Cloninger (Great Falls Maintenance Staff who supervised the repair) stated that normally with this sort of damage (regardless of the type of fence) they would have cut that section out and installed new material. Since at the time the Stay-Tuff product was not available, and the fencing section seemed fairly intact, they elected to keep the existing fence section in place. Mr. Cloninger remarked that due to its apparent stiffness and rigidity the material adapted well in being refitted to the fence supports. At this time Maintenance will leave the current repair as is.

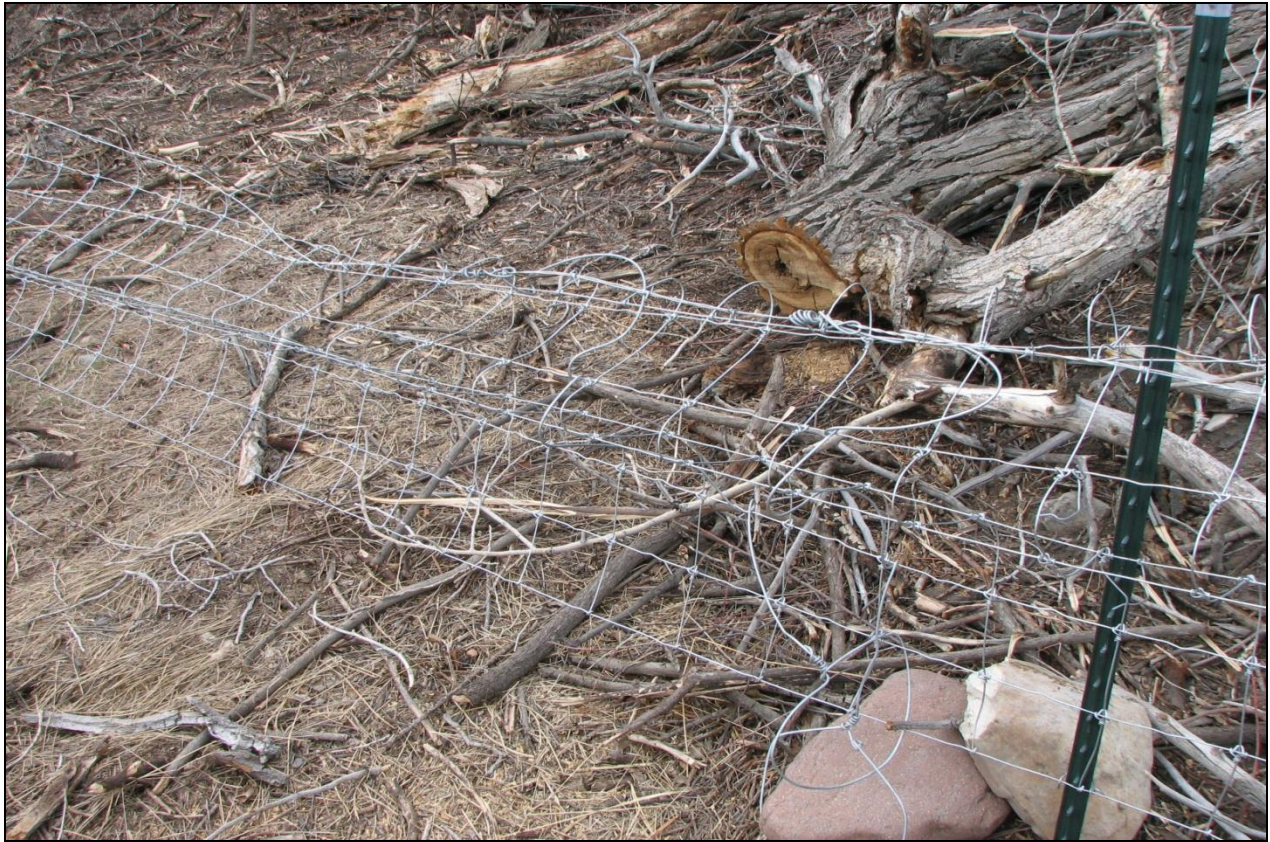
↑ Close-up of damaged fencing. Note that once the trunk was removed the woven fence recovered some flexibility as seen in its position relating to the metal post.

Maintenance stated no breakages of the wire strands were noticed.

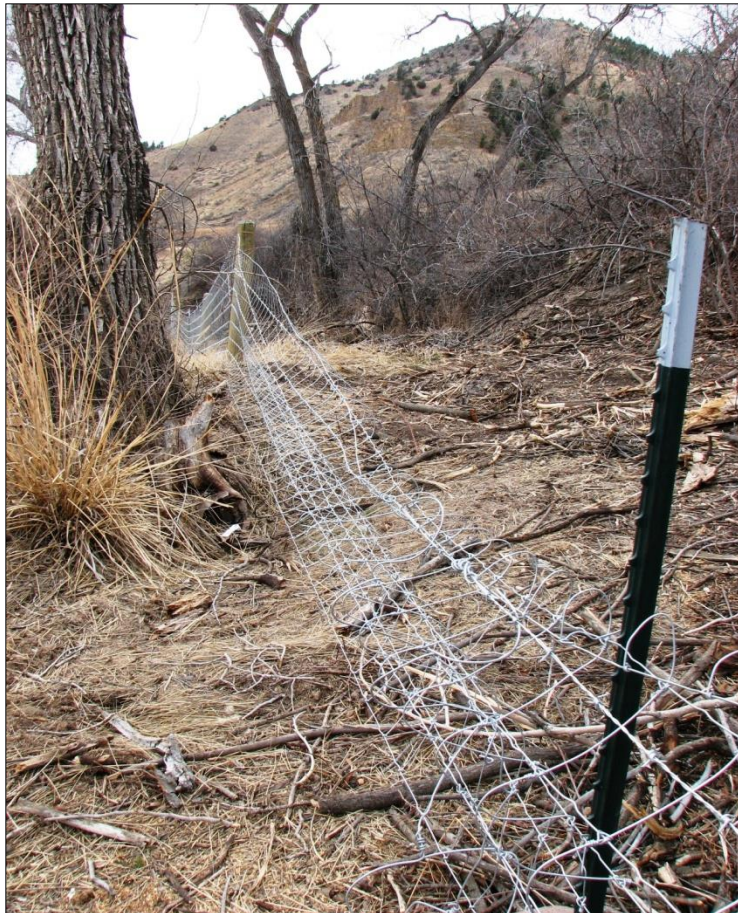
← South view of damaged fence section.

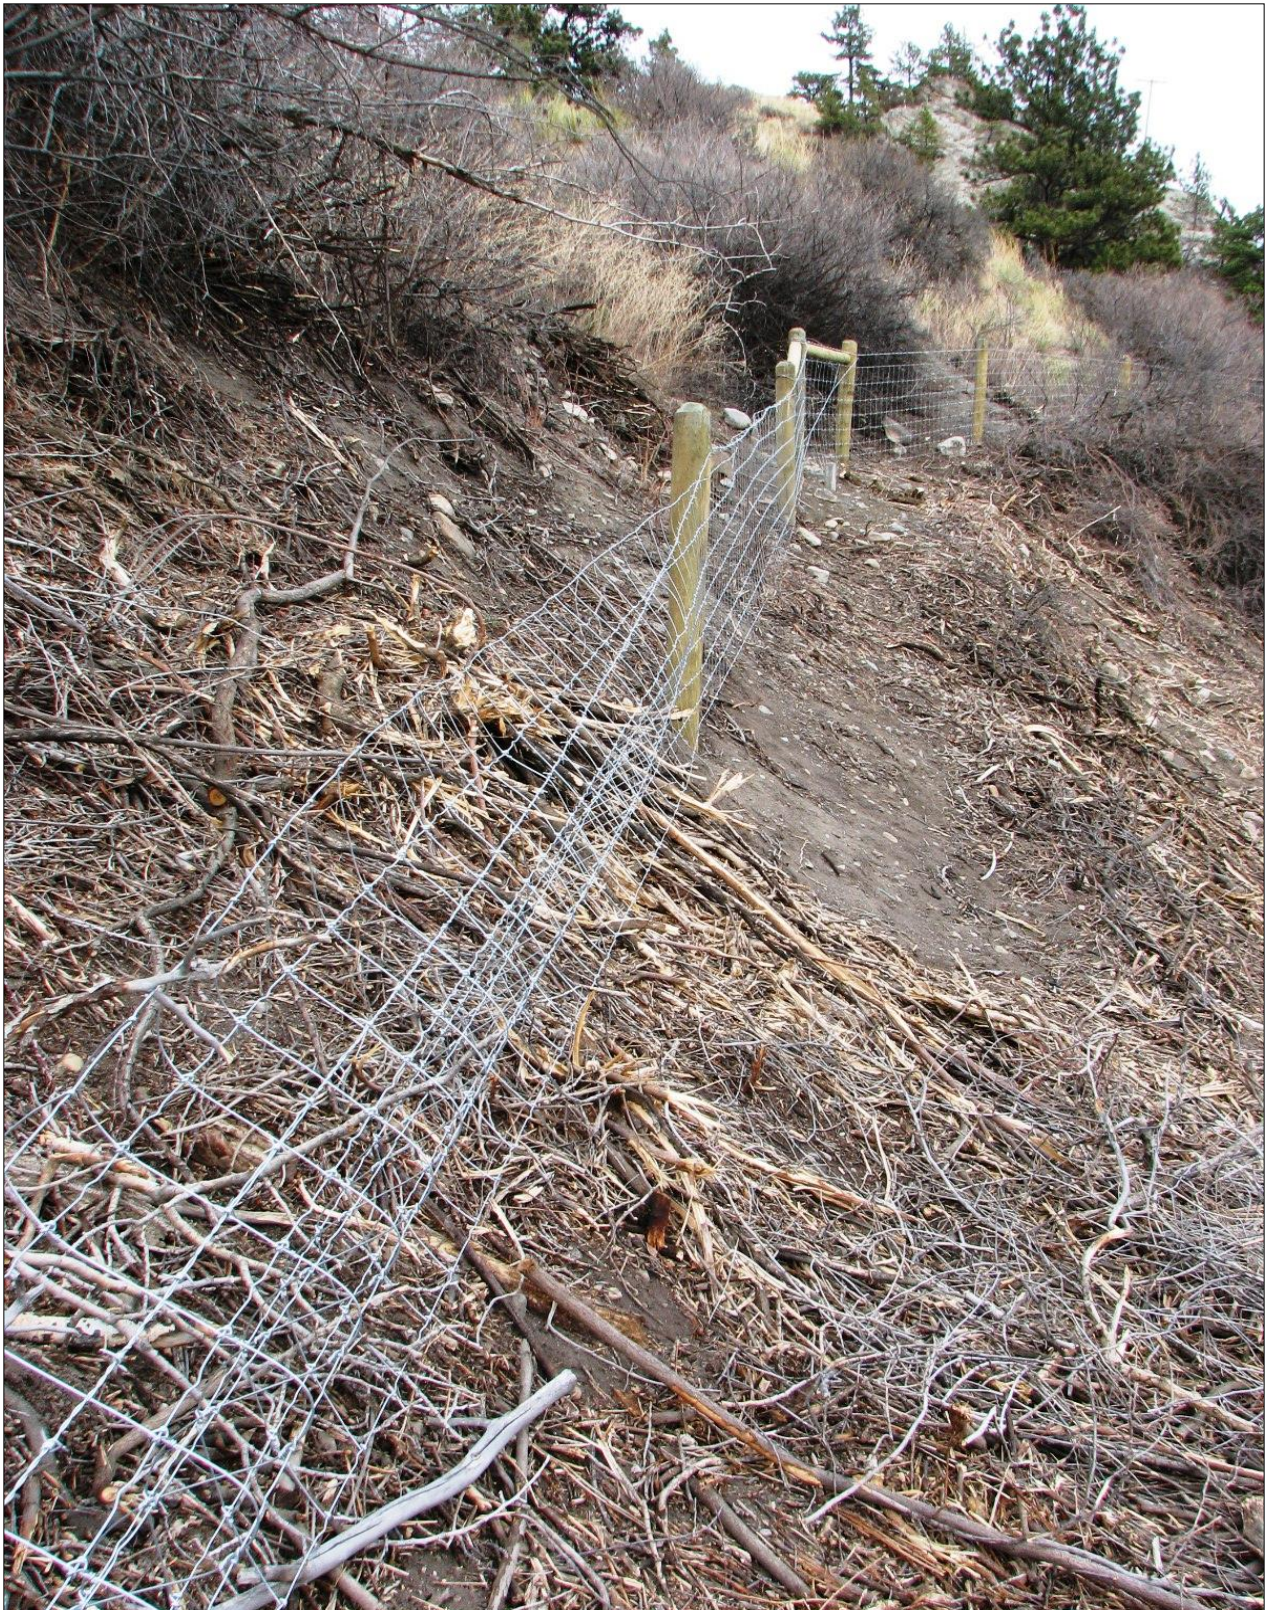
↑ View north of damaged fence section.

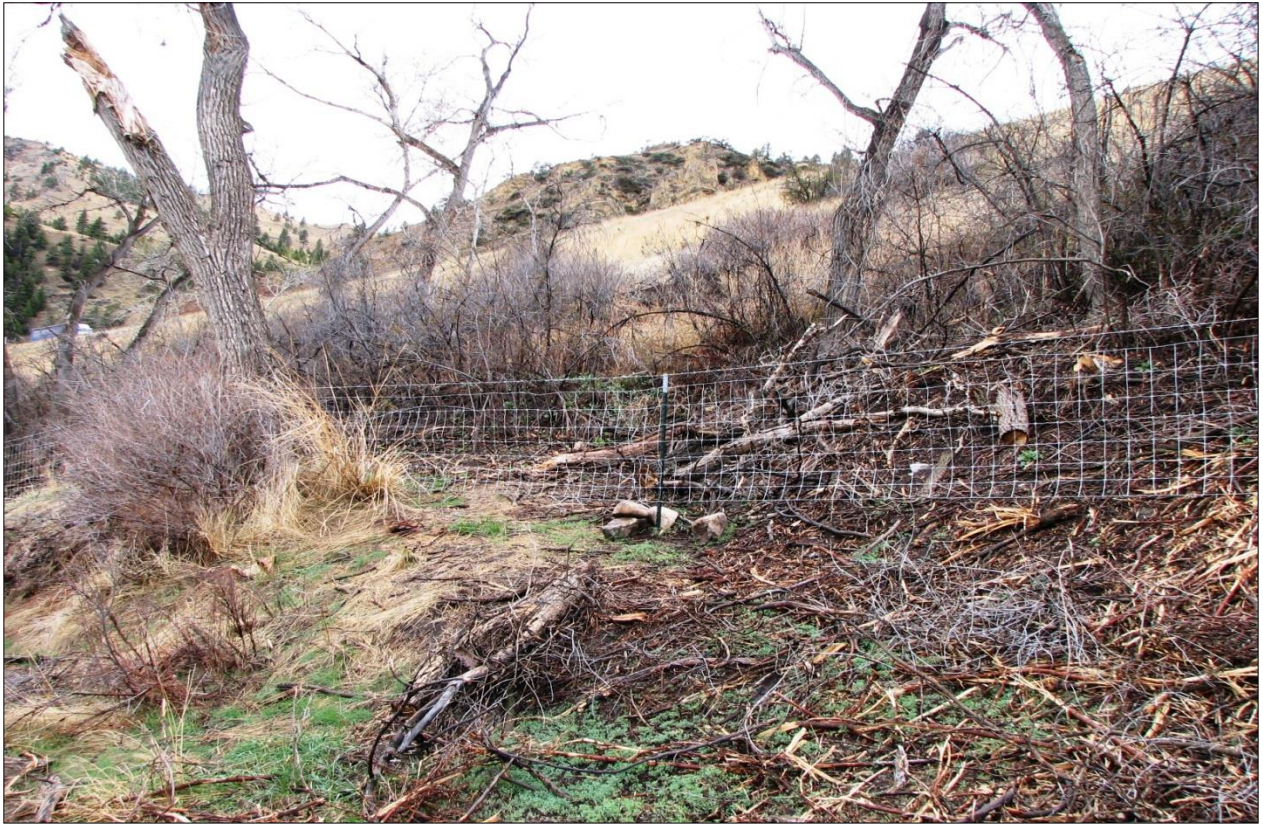
↑ Overview of repaired Stay-Tuff fence section.

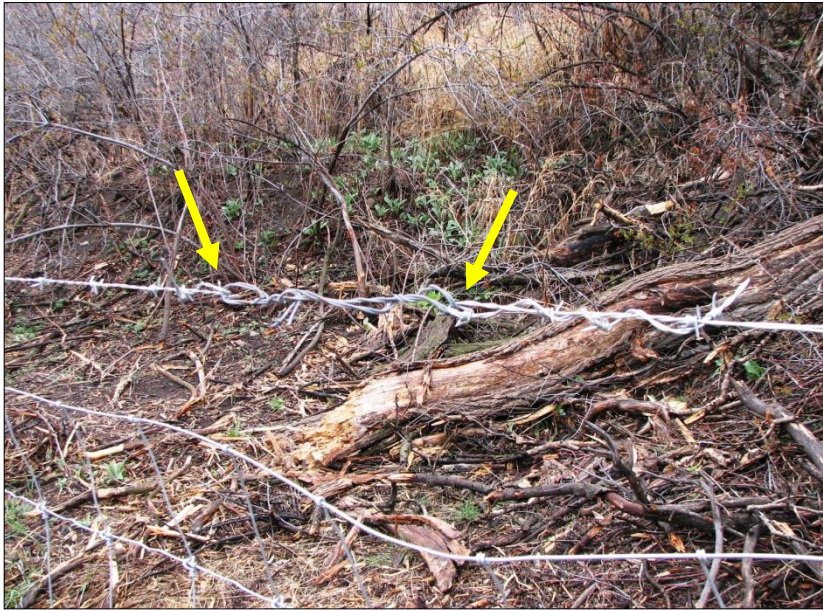
← Maintenance reported the top barbed wire strand had stretched and needed to be cut and retightened with a supplement wire.

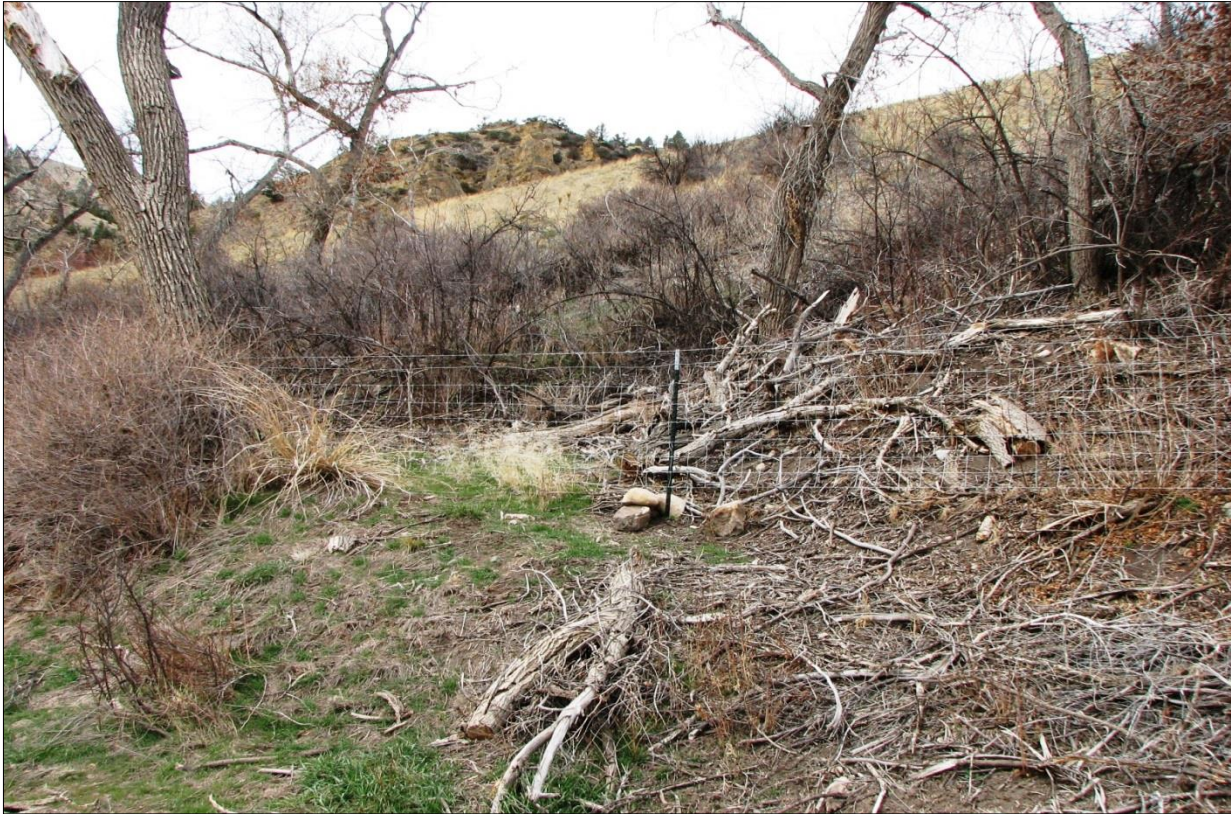
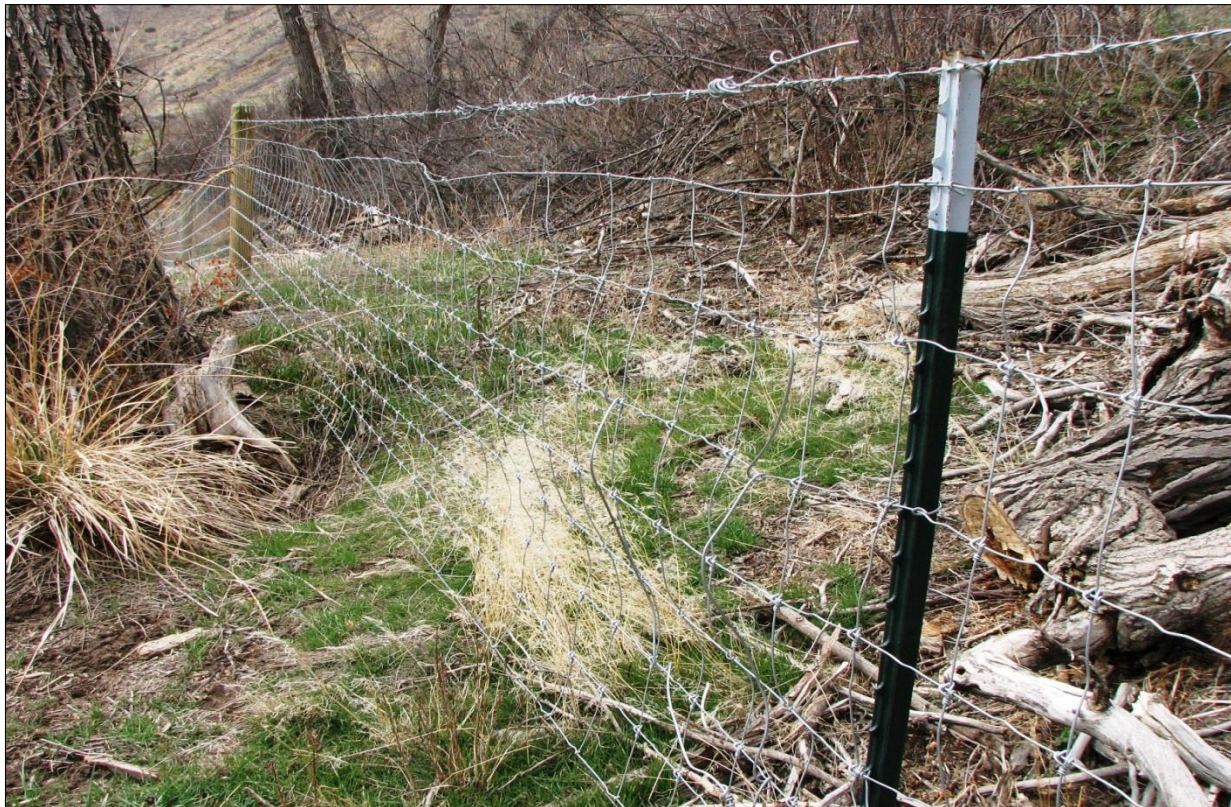
↑ ↓ Images of the repaired Stay-Tuff fence section as document in March 2012, (page eight (8)).

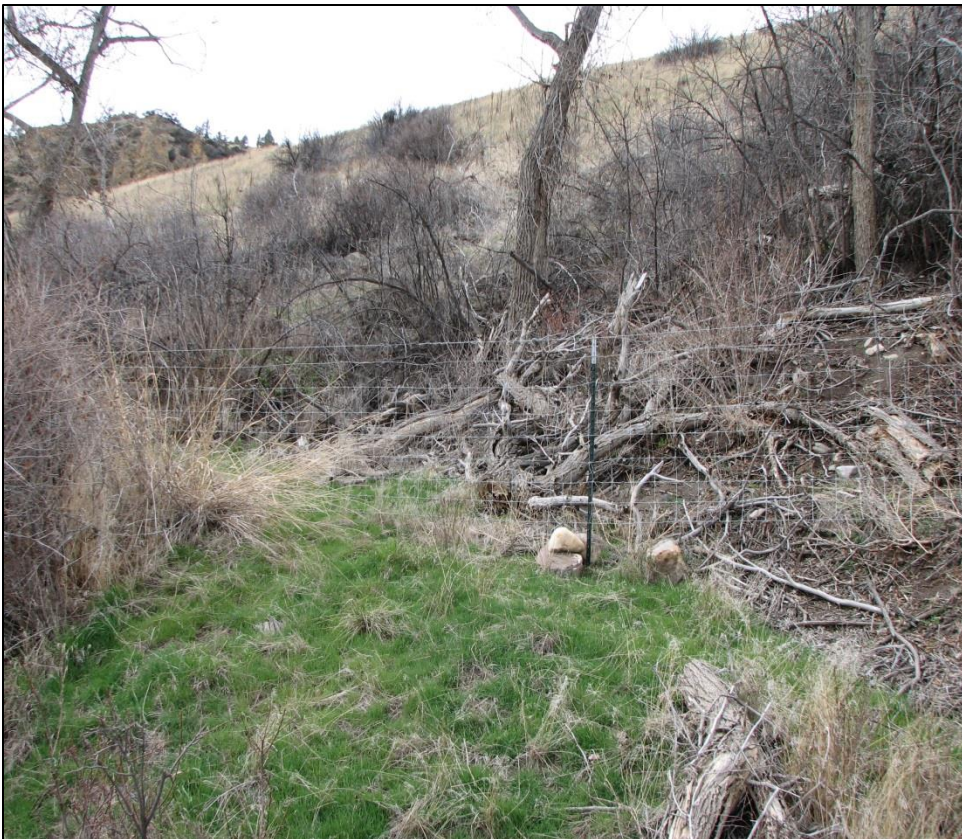
← Image of fence damaged in March 2012 (refer to page 8) in good condition as of April 2014.

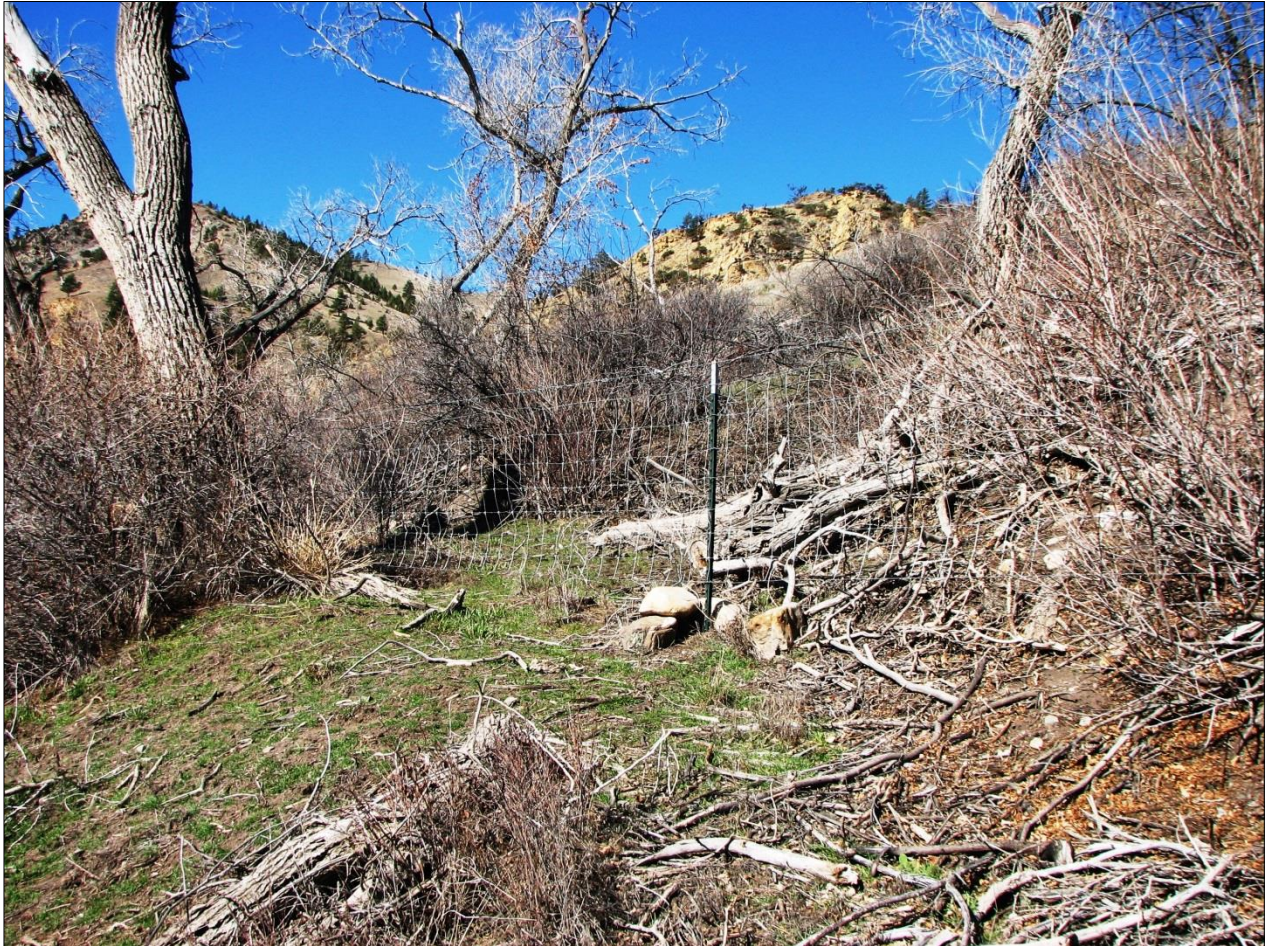
↑ Damaged section as reported in March 2012: No issues to report; repair still intact.

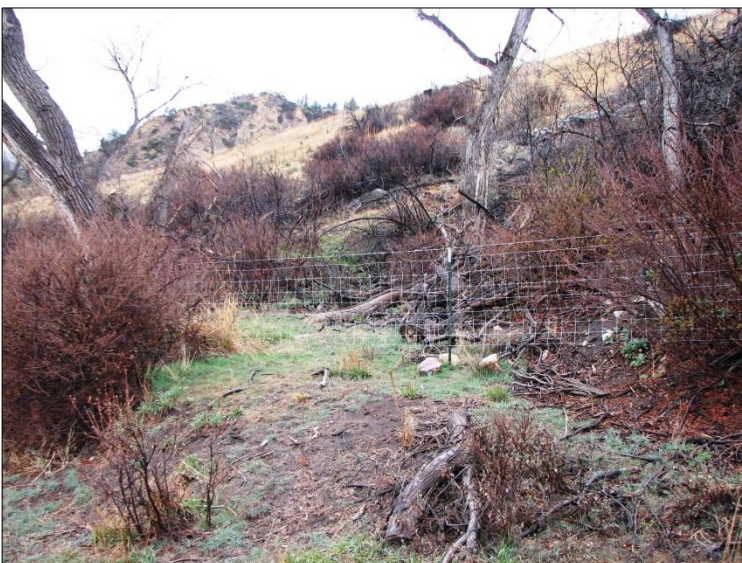
↙ Section of fence flattened by a tree in the spring of 2012. The repair was to simply pull the fence back to the original shape and rewire to post. No issue to date.
