**INSTALLATION REPORT/SITE INSPECTIONS**

**EVALUATION OF STAY-TUFF WOVEN FENCE**

**Project Name:** I-15 Augusta Interchange to Craig (UPN 6531001)

**Project Number:** IM 15-4(129)229

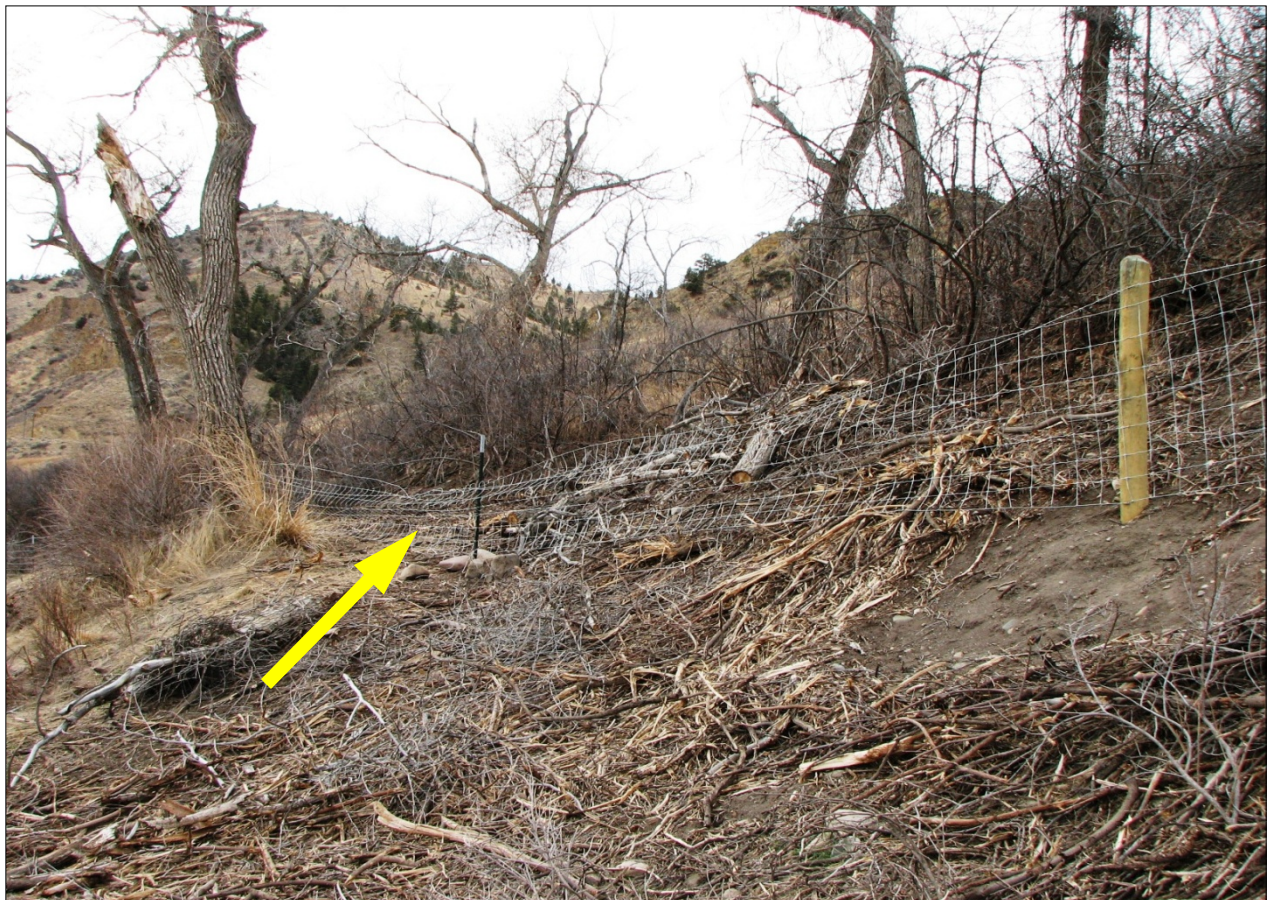
During the March 8, 2012 site inspection of the Stay-Tuff fencing a local rancher informed Research staff that a cottonwood tree had recently fallen over a section of the fence. The rancher had since cut the tree up for firewood. He did state the tree was about twenty (20) inches in diameter and had completely flattened the fence section to the ground. The location of the damaged section is approximately 4.9 miles (7.9 kilometers) north on the Craig River Rd. starting at the I-15 and Highway 287 interchange.

The below image shows the extent of damage by the fallen tree. The yellow arrow depicts the approximate location of where the main trunk hit the fence.

The section was repaired in early April. Bob Cloninger (Great Falls Maintenance Staff who supervised the repair) stated that normally with this sort of damage (regardless of the type of fence) they would have cut that section out and installed new material. Since at the time the Stay-Tuff product was not available, and the fencing section seemed fairly intact, they elected to use the existing fence for repair. Mr. Cloninger remarked that due to its apparent stiffness and rigidity the material adapted well in being refitted to the fence supports. At this time Maintenance will leave the current repair as is.

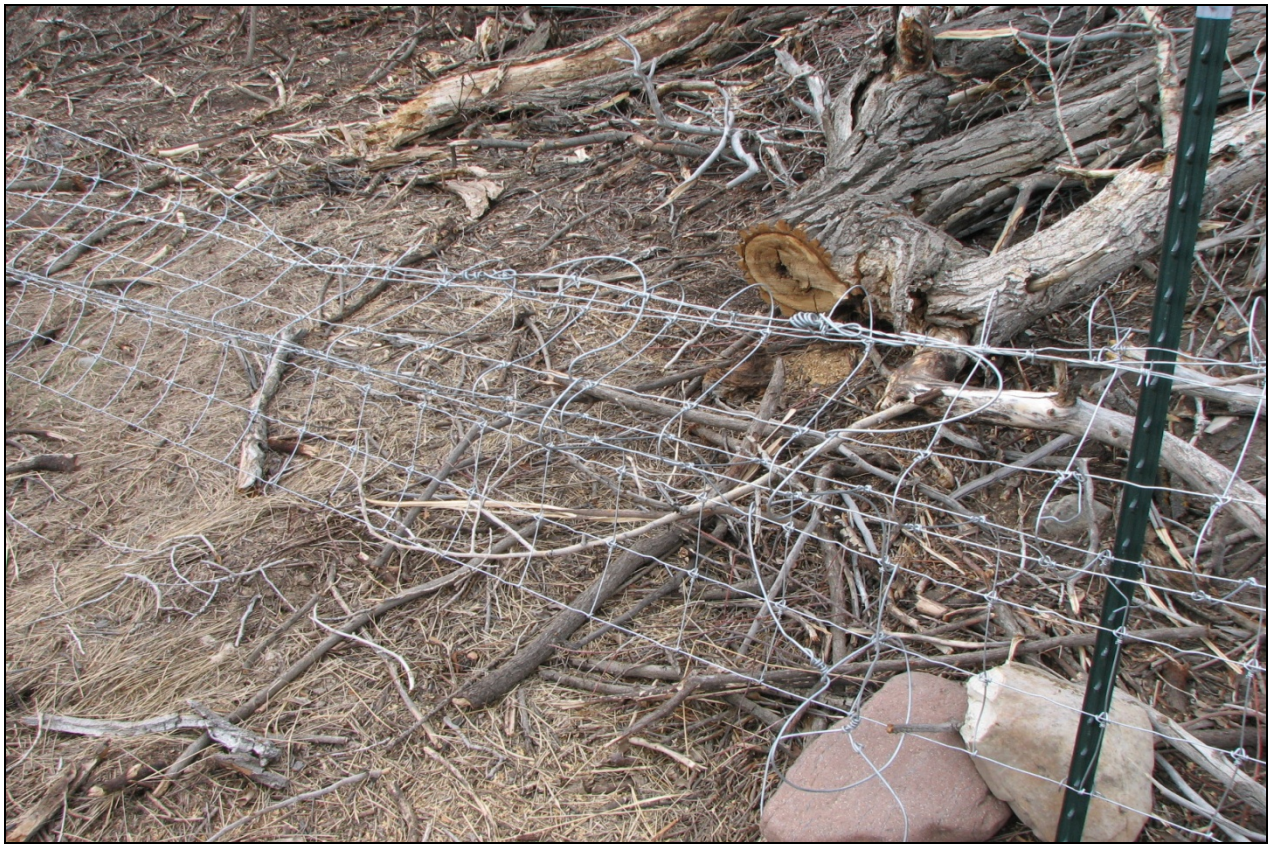
↑ Close-up of damaged fencing. Note that once the trunk was removed the woven fence recovered some flexibility as seen in its position relating to the metal post.

Maintenance stated no breakages of the wire strands were noticed.

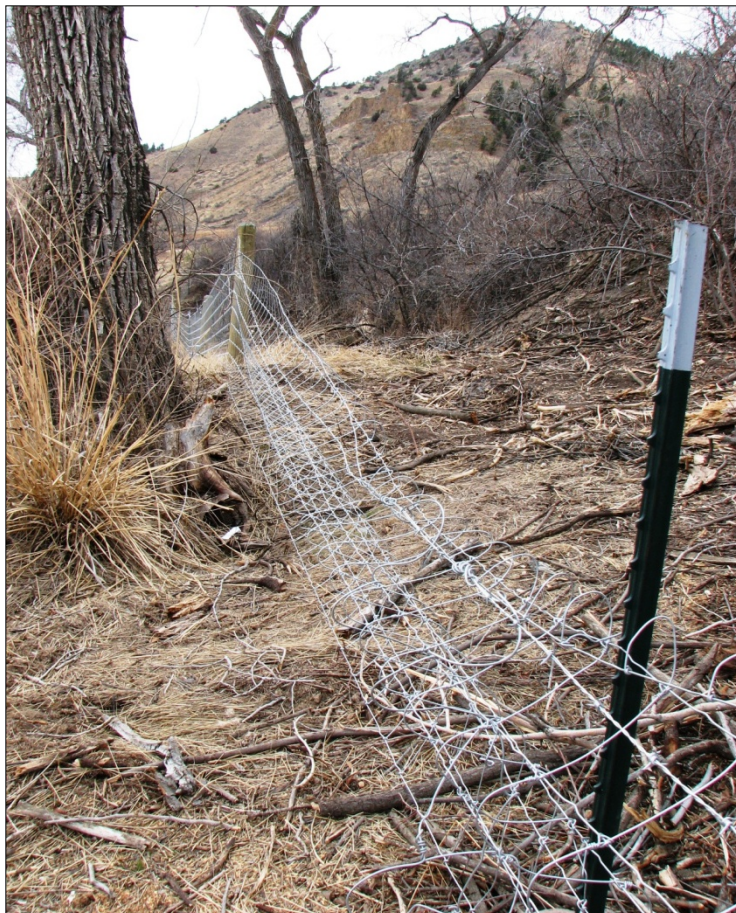
← South view of damaged fence section.

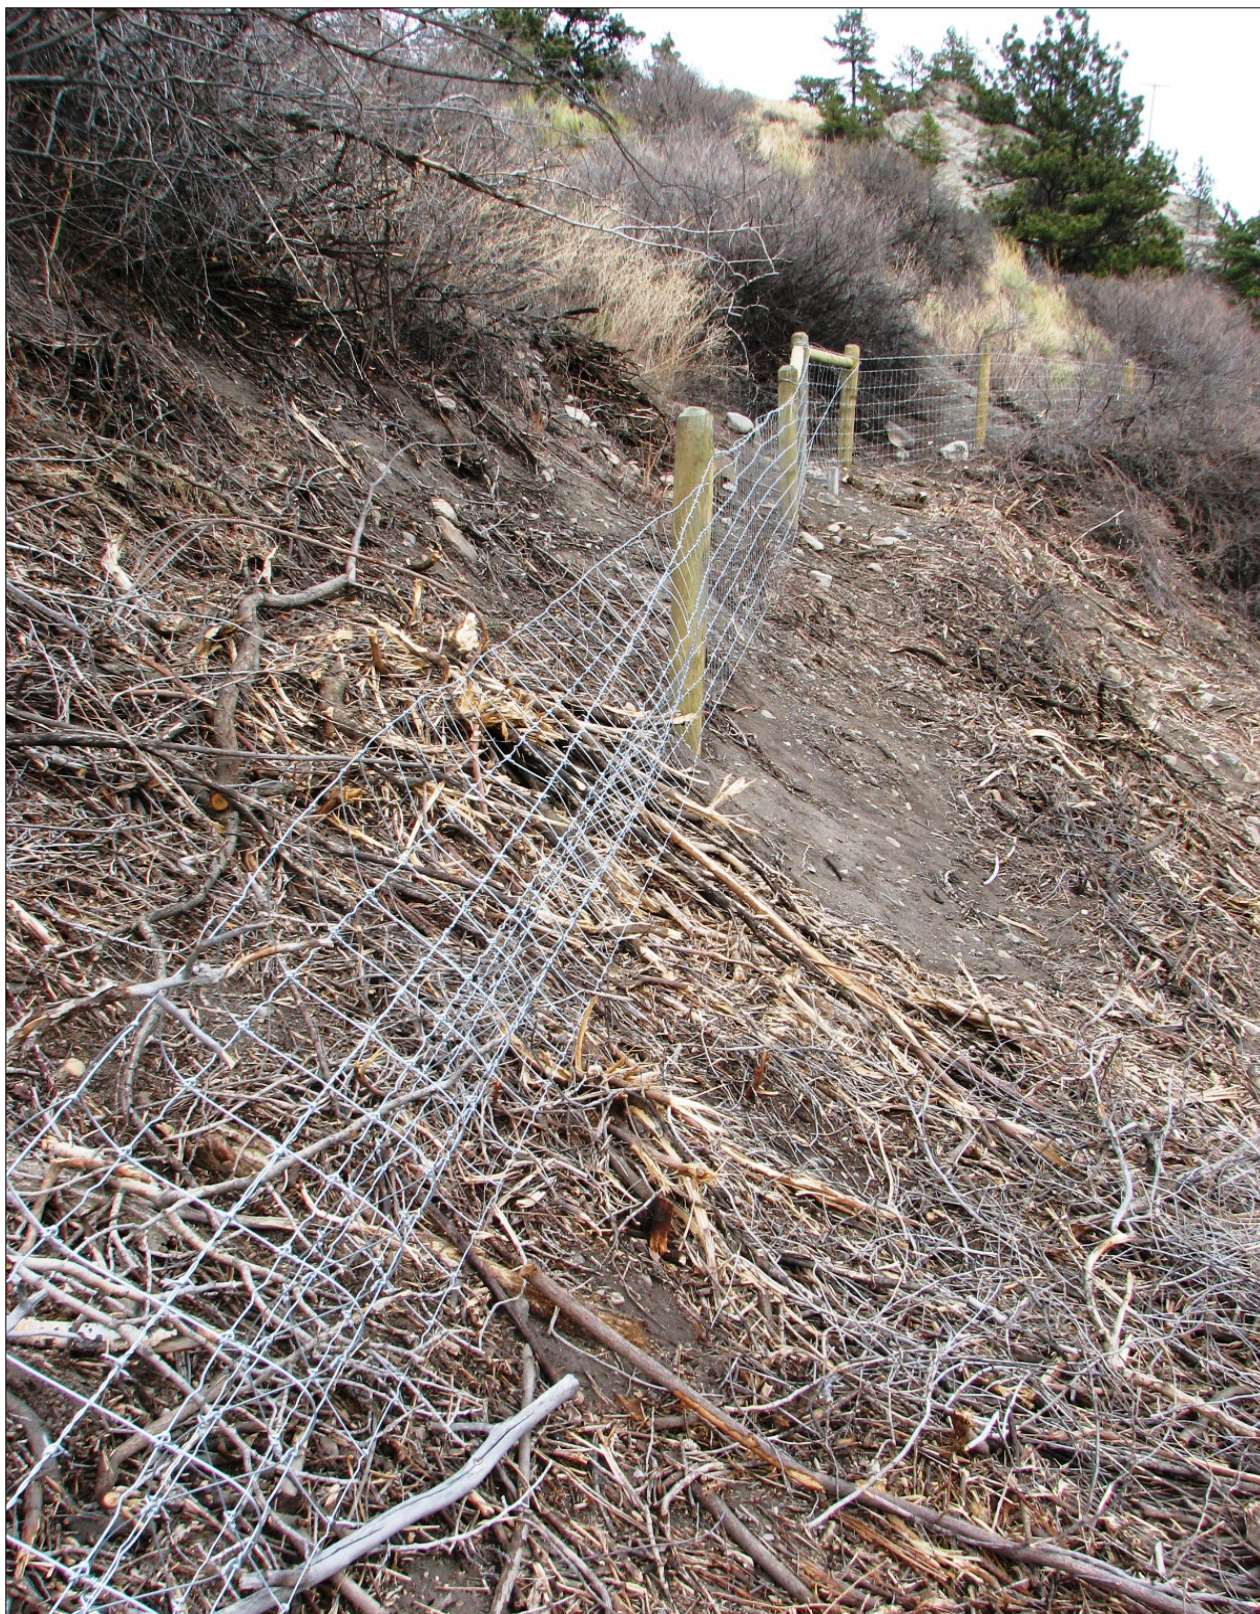
↑ View north of damaged fence section.

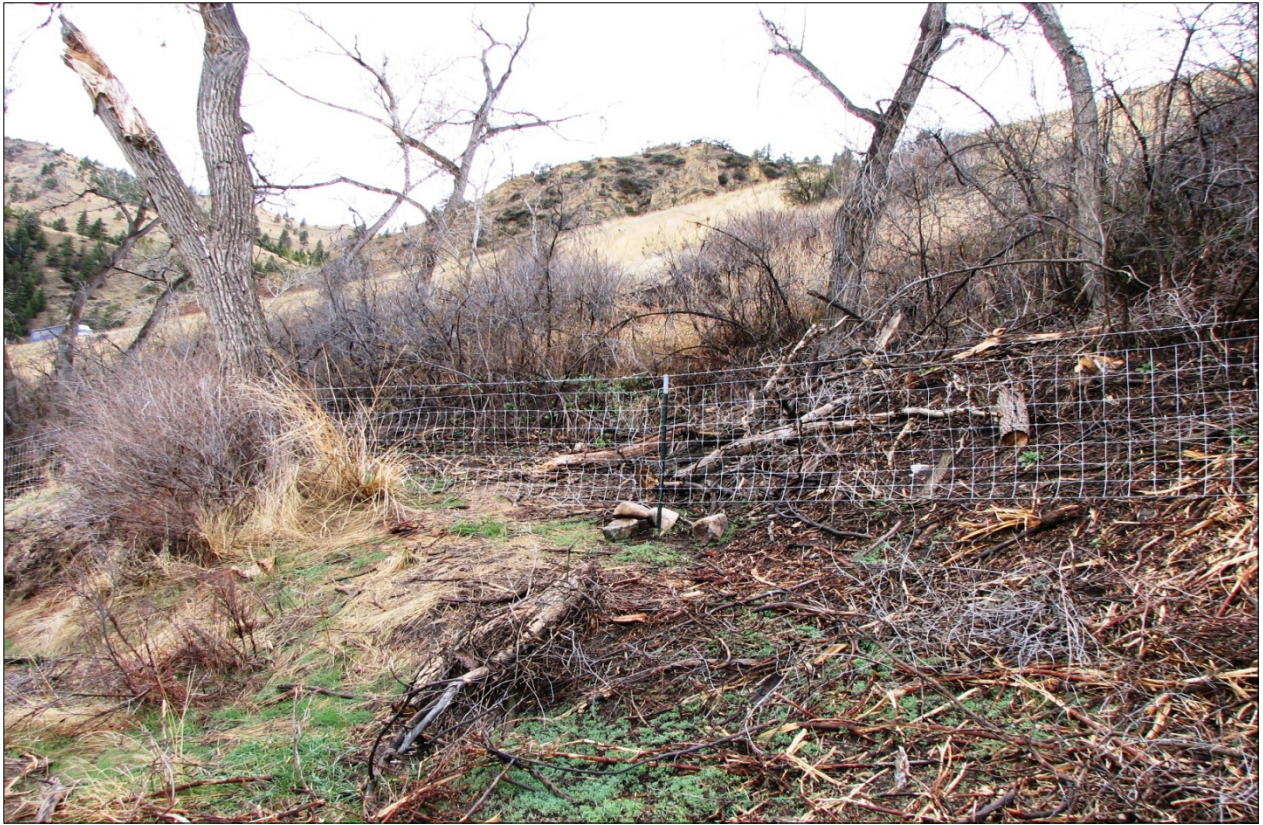
↑ Overview of repaired Stay-Tuff fence section.

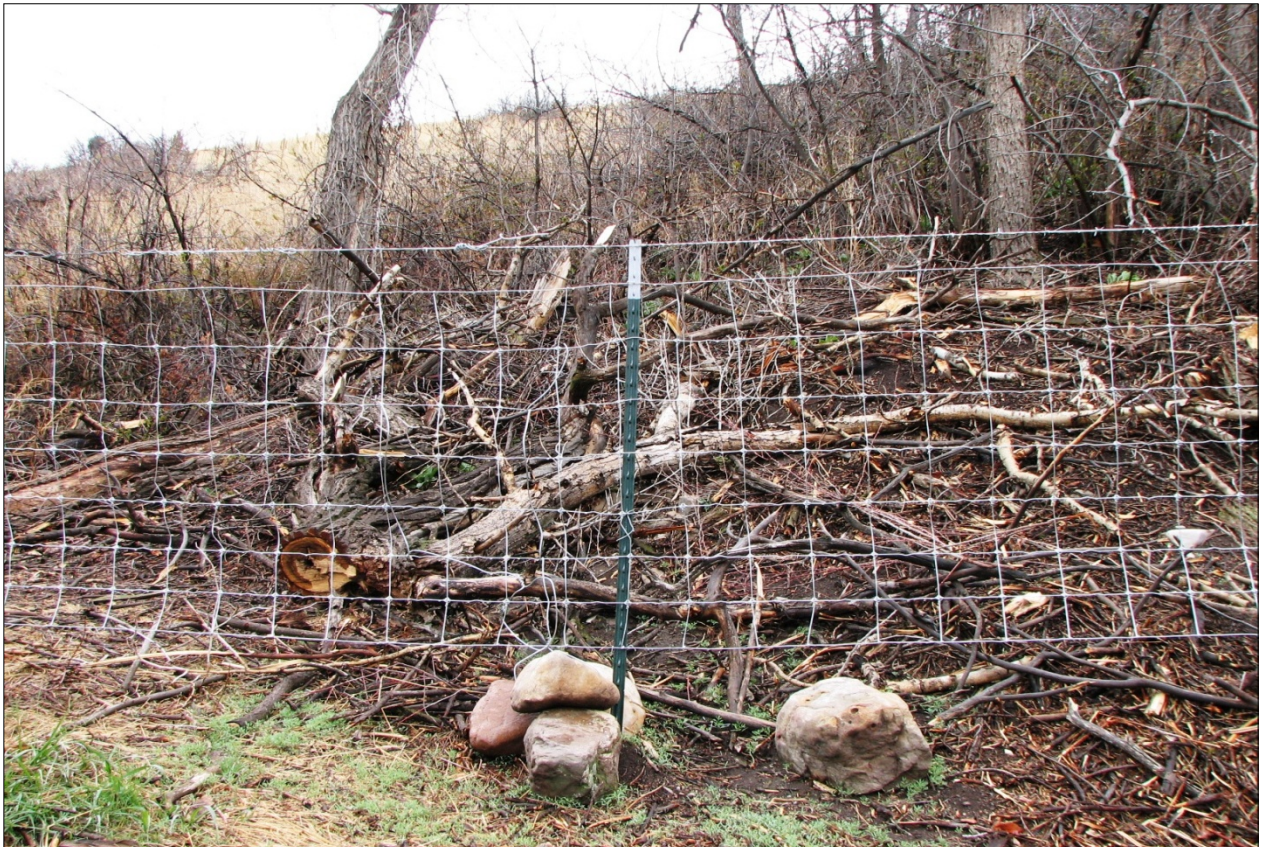
↓ Closer view of section at metal post support.

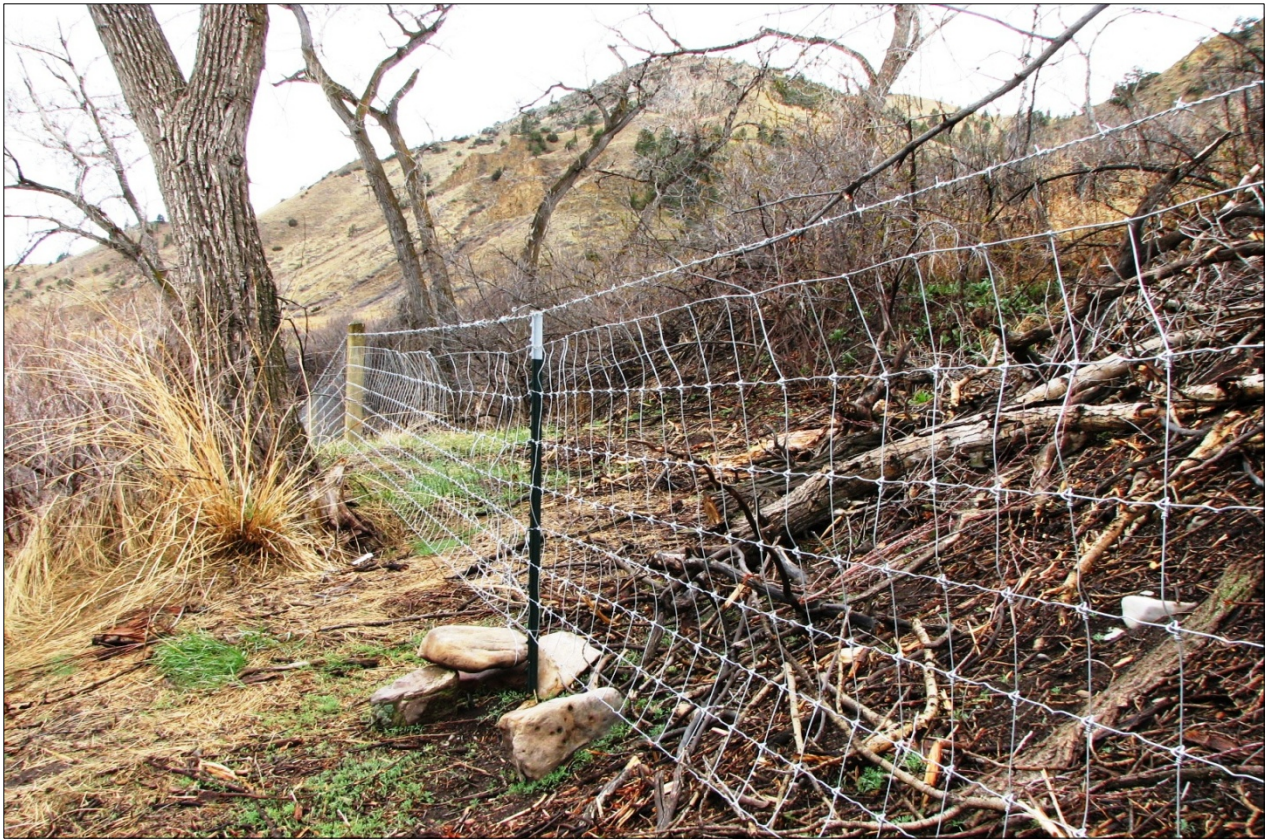
↑ View south of repaired fence.

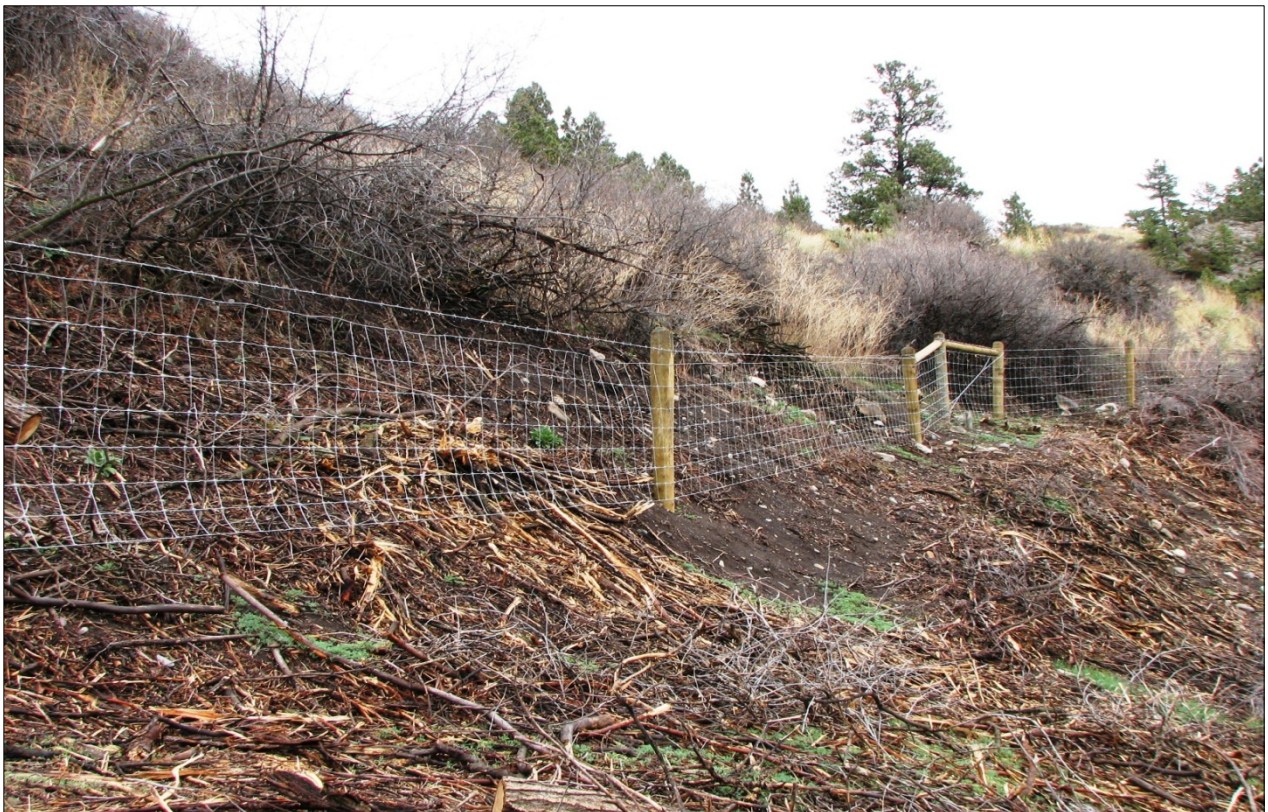
↓ View north of repaired fence.

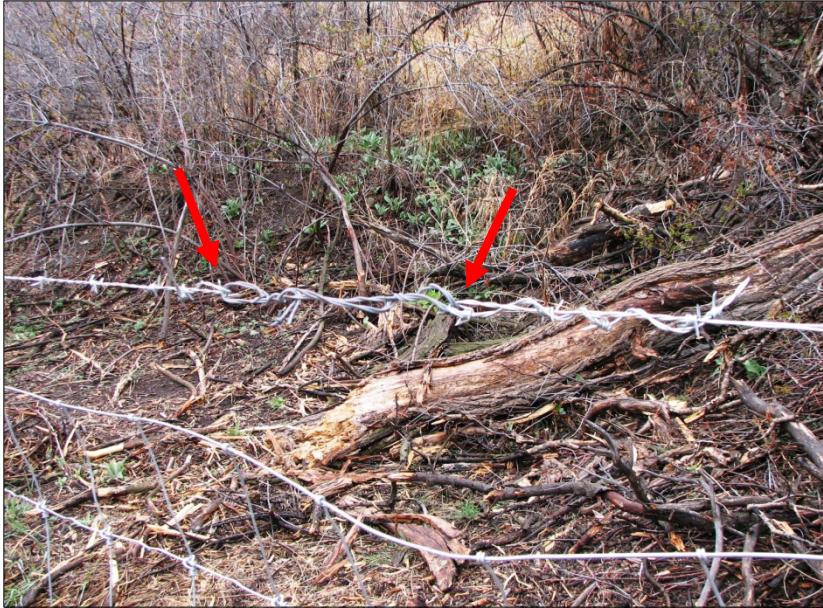
← Maintenance did report the top barbed wire strand had stretched and needed to be cut and retightened with a supplement wire.

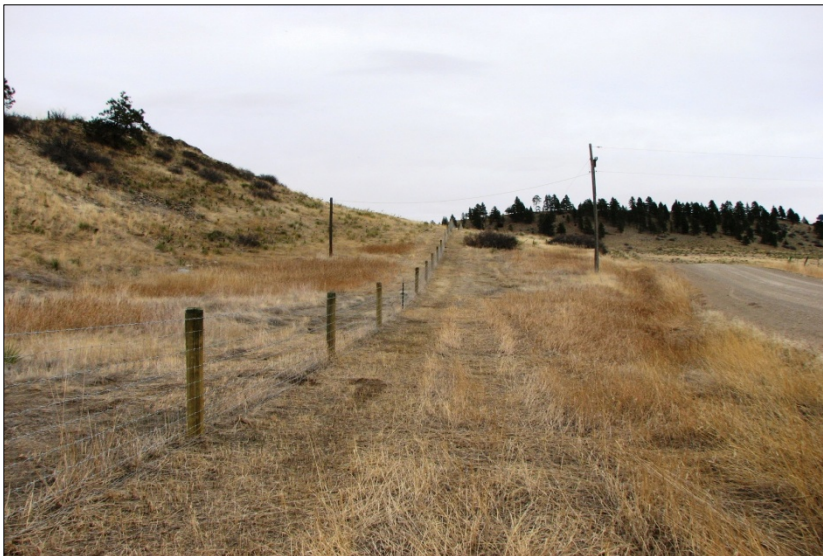
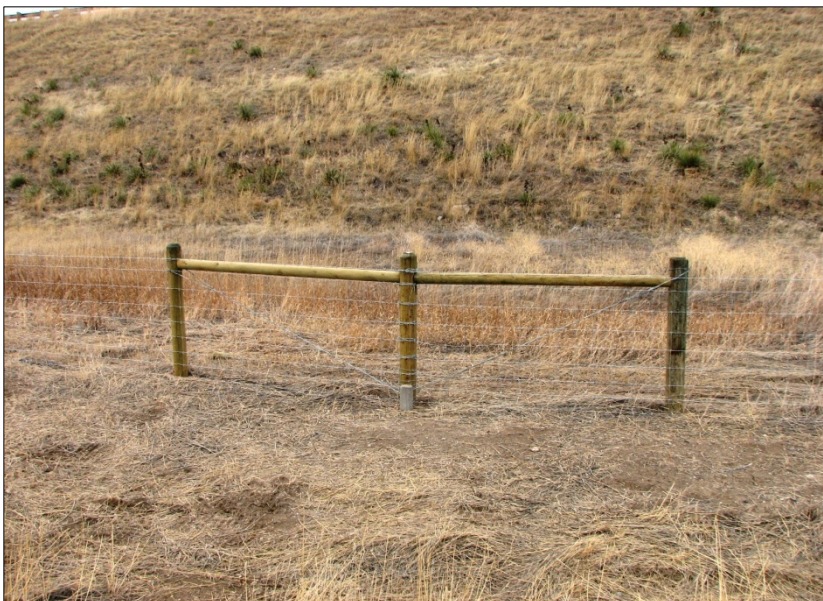
← ↓ Representative images of the Stay-Tuff fence taken in early April.
