Rope Access Climbing Bridge Inspection Report

Asset #: 03719

Bridge #: L32101000+01001

Location: Maclay Truss Bridge over Bitterroot River

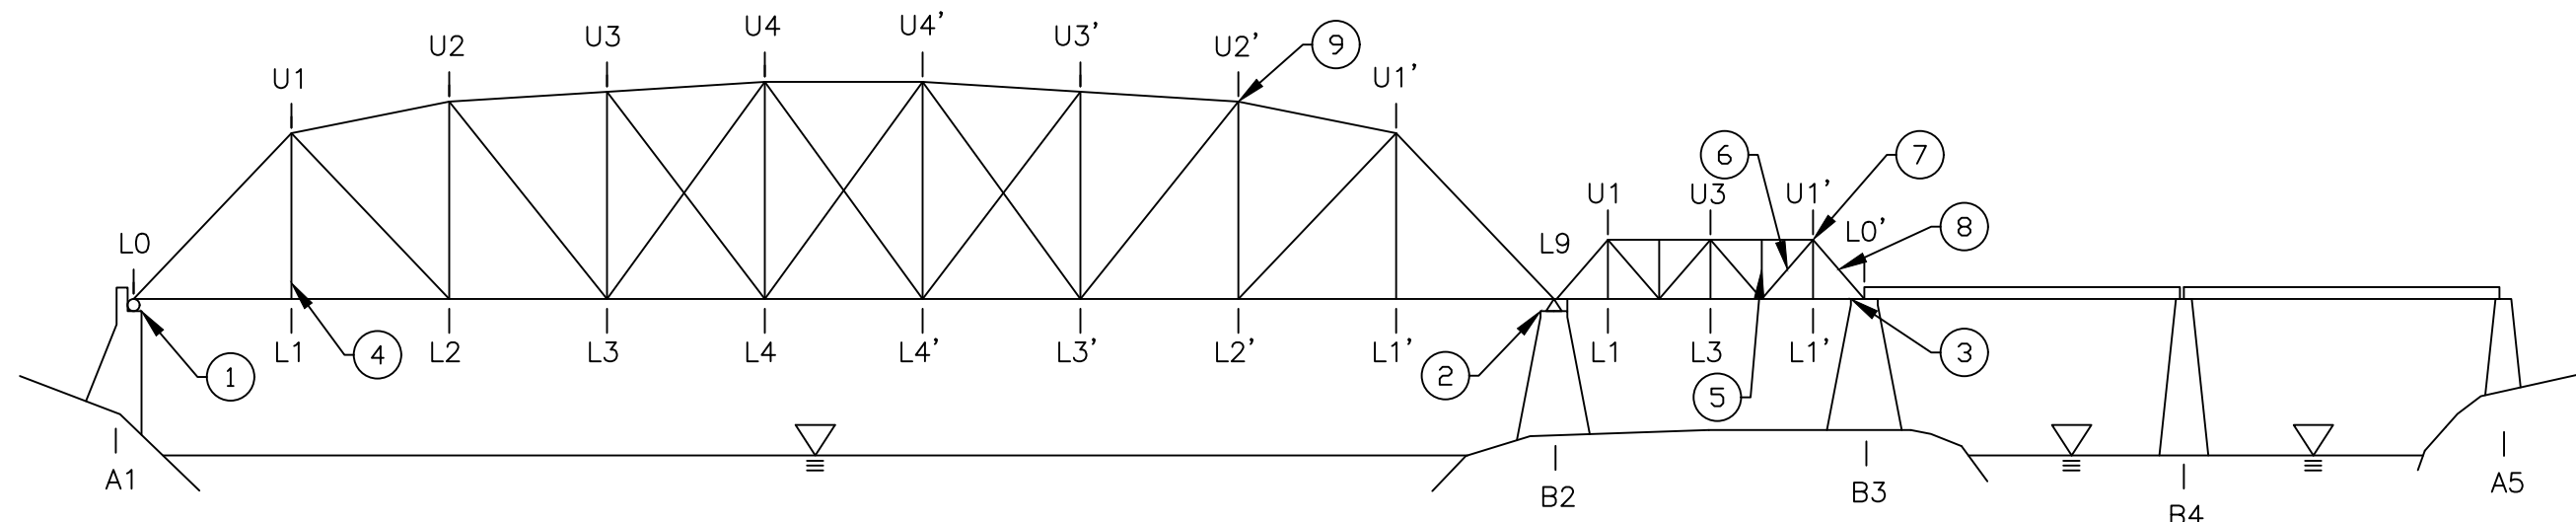
② NORTH TRUSS LOOKING NORTH

1. ROLLER BEARING AT ABUTMENT 1 HAD FAILED PAINTED COATING ON APPROXIMATELY 25 PERCENT OF THE SURFACE AREA WITH MODERATE CORROSION AND PITTING UP TO $\frac{1}{16}$ IN. TO THE STEEL UNDERNEATH, 10 PERCENT HAD FAILED WITH EXPOSED PRIMER UNDERNEATH, AND THE REMAINING PAINT WAS CHALKING. HEAVY CORROSION UNDER THE ROLLERS AND ROLLER KEEPER RESULTING IN THE ROLLER KEEPER SPLITTING. THE NESTED ROLLER KEEPER HAD FAILED. TWO OF THE ROLLERS ALONG WITH A PORTION OF THE KEEPER WERE OUT FROM UNDERNEATH THE TRUSS TO THE WEST OF THE BEARING AND ONE ROLLER WAS STICKING OUT FROM UNDERNEATH THE BEARING TO THE EAST. THE ANCHOR RODS HAD UP TO 25 PERCENT SECTION LOSS AT THE CONCRETE INTERFACE DUE TO HEAVY CORROSION. THE TOP PLATE WAS DISPLACED 1.75 IN. TO THE WEST (IN EXPANSION) IN RELATION TO THE BOTTOM PLATE.

2. THE NORTH SPAN FIXED BEARINGS HAD A FAILED PAINTED COATING ON APPROXIMATELY 5 PERCENT OF THE SURFACE AREA WITH MINOR SURFACE CORROSION AND NEGLIGIBLE SECTION LOSS, 10 PERCENT HAD FAILED WITH EXPOSED PRIMER UNDERNEATH, AND THE REMAINING PAINTED COATING WAS CHALKING.

3. THE SLIDING BEARINGS AT BENT 3 OF THE NORTH TRUSS WAS UNPAINTED AND HAD MODERATE CORROSION WITH PITTING UP TO $\frac{1}{16}$ IN. DEEP. THE TOP PLATE WAS DISPLACED $1-\frac{1}{2}$ IN. TO THE EAST (IN EXPANSION) IN RELATION TO THE UPPER FLANGE OF THE BEARING.

4. THE EXTERIOR FLANGE OF VERTICAL L1-U1 WAS BENT 1 IN. TO THE NORTH DUE TO IMPACT DAMAGE APPROXIMATELY 5 FT. ABOVE THE BRIDGE DECK.
5. THE INTERIOR FLANGE OF VERTICAL L2'-U2' WAS BENT 1 IN. OVER A 6 IN. HEIGHT DUE TO IMPACT DAMAGE.

6. THE INTERIOR FLANGE OF DIAGONAL L2'-U1' WAS BENT $1-\frac{3}{8}$ IN. OVER A 24 IN. LENGTH DUE TO IMPACT DAMAGE.
7. THE EXTERIOR GUSSET PLATE AT U1'N HAD TWO MISDRILLED $\frac{3}{4}$ IN. DIAMETER HOLES.

8. DIAGONAL U1'-L0' HAD (7) AREAS OF IMPACT DAMAGE UP TO $\frac{3}{4}$ IN. LONG AND $\frac{1}{4}$ IN. OF DEFLECTION SPACED OVER A 15 IN. LENGTH.
9. 2 LOOSE BOLTS AT UPPER HORIZONTAL STRUT CONNECTION U2'N.

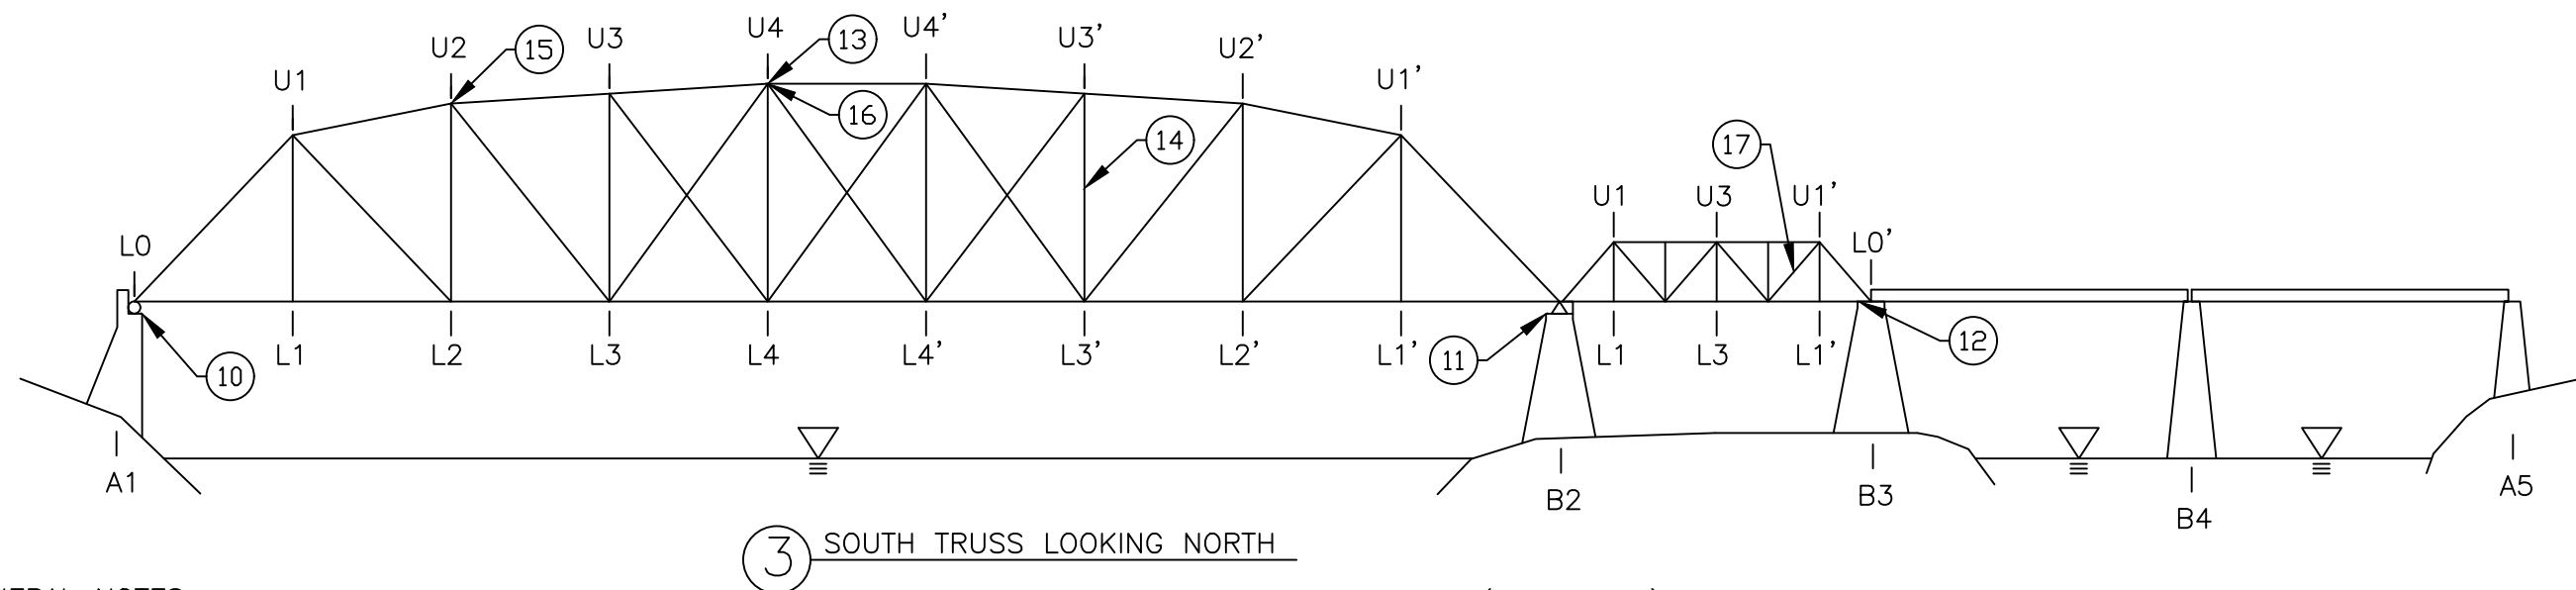
10. ROLLER BEARING AT ABUTMENT 1 HAD FAILED PAINTED COATING ON APPROXIMATELY 25 PERCENT OF THE SURFACE AREA WITH MODERATE CORROSION AND PITTING UP TO $\frac{1}{16}$ IN. IN THE STEEL UNDERNEATH, 10 PERCENT HAD FAILED WITH EXPOSED PRIMER UNDERNEATH, AND THE REMAINING PAINT WAS CHALKING. HEAVY CORROSION UNDER THE ROLLERS AND ROLLER KEEPER RESULTING IN THE ROLLER KEEPER SPLITTING. THE NESTED ROLLER KEEPER HAD FAILED. THE ROLLER KEEPER HAD BROKEN AWAY FROM THE BEARING DUE TO HEAVY CORROSION AND WAS PUSHED AGAINST THE ABUTMENT BACKWALL. ONLY HALF OF THE ROLLERS WERE STILL WITHIN THE BEARING BUT NOT FULLY IN CONTACT WITH THE BEARING PLATES. THE TOP PLATE WAS DISPLACED $1-\frac{1}{2}$ IN. TO THE WEST (IN EXPANSION) IN RELATION TO THE BOTTOM PLATE.

11. THE SOUTH SPAN FIXED BEARINGS HAD A FAILED PAINTED COATING ON APPROXIMATELY 5 PERCENT OF THE SURFACE AREA WITH MINOR SURFACE CORROSION AND NEGLIGIBLE SECTION LOSS, 10 PERCENT HAD FAILED WITH EXPOSED PRIMER UNDERNEATH, AND THE REMAINING PAINTED COATING WAS CHALKING.

12. THE SLIDING BEARINGS AT BENT 3 OF THE SOUTH TRUSS WAS UNPAINTED WITH MODERATE CORROSION AND PITTING UP TO $\frac{1}{16}$ IN. DEEP. THE TOP PLATE WAS DISPLACED $1-\frac{3}{4}$ IN. TO THE EAST (IN EXPANSION) IN RELATION TO THE UPPER FLANGE OF THE BEARING.

13. ONE BOLT WAS SHEARED OFF AT UPPER HORIZONTAL STRUT TO TOP CHORD U4S CONNECTION PLATE.
14. THE LOWER HORIZONTAL SWAY BRACING AT U3' WAS BENT 2 IN. TO THE EAST, AND UPWARD AND DOWNWARD 1 IN. DUE TO IMPACT DAMAGE.

15. ONE BOLT WAS LOOSE AT UPPER HORIZONTAL STRUT TO TOP CHORD U2S CONNECTION PLATE.
16. ONE BOLT WAS LOOSE AT UPPER HORIZONTAL STRUT TO TOP CHORD U4S CONNECTION PLATE.

17. DIAGONAL L2'-U1' WAS BENT $\frac{3}{4}$ IN. OVER 12 IN. AT L2'.

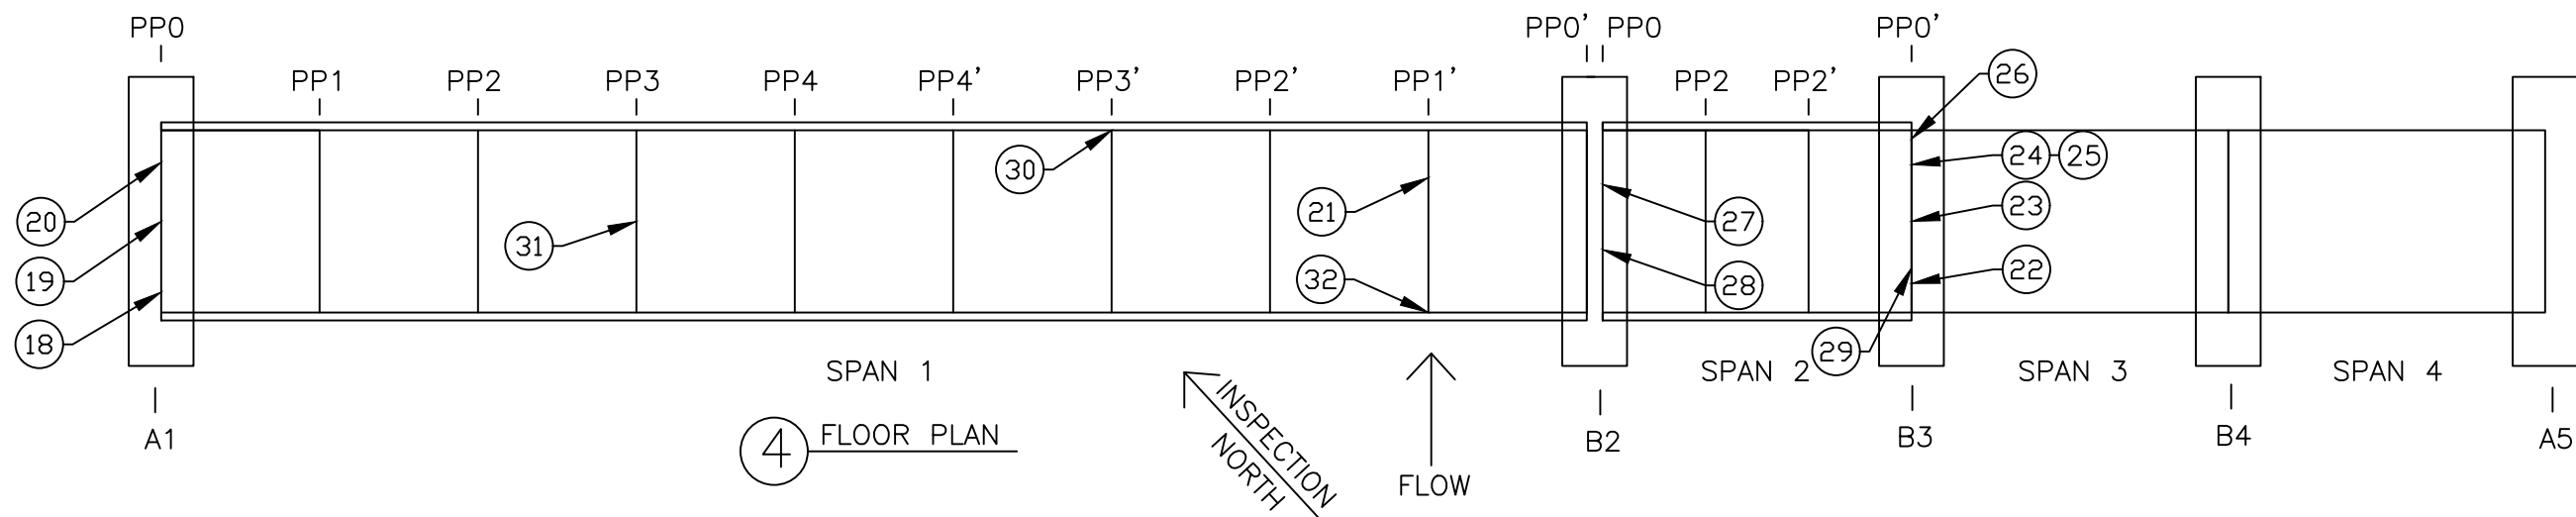
- (18) STRINGER 7, ABUTMENT 1, HEAVY CORROSION AND SECTION LOSS IN THE WEB 17 IN. LONG BY 2 IN. HIGH WITH A 1 IN. HIGH BY 10 IN. LONG HOLE CENTERED 10 IN. FROM THE STRINGER END.
- (19) STRINGER 5, ABUTMENT 1, HEAVY CORROSION AND UP TO 50 PERCENT SECTION LOSS 10 IN. LONG BY 1 IN. HIGH ADJACENT TO TO STRINGER END.
- (20) STRINGER 2, ABUTMENT 1, HEAVY CORROSION AND SECTION LOSS IN THE WEB 14 IN. LONG BY 2 IN. HIGH WITH A 2.5 IN. LONG BY $\frac{3}{4}$ IN. HIGH HOLE CENTERED 2 IN. FROM THE STRINGER END.
- (21) FB8, SPAN 1, BOTTOM WEST FLANGE BENT UPWARDS $\frac{1}{2}$ IN. OVER A 6 IN. LENGTH APPROXIMATELY 16 IN. FROM THE NORTH END.
- (22) STRINGER 8, BENT 3, HEAVY CORROSION AND SECTION LOSS IN THE WEB WITH (3) HOLES RANGING IN SIZE FROM $\frac{1}{4}$ - $\frac{1}{2}$ IN. IN DIAMETER LOCATED AT WEB TO LOWER FLANGE INTERFACE AT THE STRINGER END.

- (23) STRINGER 7, BENT 3, HEAVY CORROSION AND UP TO 50 PERCENT SECTION LOSS 10 IN. LONG BY 2 IN. HIGH ADJACENT TO THE STRINGER END AND HAD A $\frac{1}{2}$ IN. DIAMETER HOLE LOCATED 6 IN. FROM THE STRINGER END.

- (24) STRINGER 5, BENT 3, HEAVY CORROSION AND SECTION LOSS IN THE WEB WITH A 6 IN. LONG BY 1 IN. HIGH HOLE NEAR STRINGER END. BOTTOM FLANGE WAS KNIFE-EDGED IN THIS AREA.

- (25) STRINGERS 4, 5, AND 7, BENT 3, GAP BETWEEN THE BOTTOM FLANGE AND THE SUPPORTING BEARING SEAT OF THE BENT. MOVEMENT OBSERVED WHEN TRAFFIC PASSED OVER (GAP CLOSED).

- (26) STRINGER 2, BENT 3, HEAVY CORROSION AND UP TO $\frac{1}{8}$ IN. THICK RUST SCALE ON BOTH SIDES OF WEB AT WEB TO BOTTOM FLANGE INTERFACE ADJACENT TO STRINGER END.

- (27) STRINGER 2, BENT 2 (PONY TRUSS), HEAVY CORROSION AND SECTION LOSS IN WEB WITH (2) HOLES: 10 IN. LONG BY 1.5 IN. HIGH HOLE AND A 6 IN. LONG BY 1 IN. HIGH HOLE CENTERED 16 IN. FROM THE STRINGER END.

- (29) BENT 3, SPAN 2, THE HOLLOW STRINGER BEARING PIPE TYPICALLY MOVED UP TO $\frac{1}{4}$ IN. WHEN VEHICLES PASSED OVER. THE SOUTH ANCHOR ROD WAS BROKEN AND THIS END MOVED UP TO $\frac{1}{2}$ IN.

- (30) 2 OF 2 BOLTS LOOSE AT STRINGER 1 TO FB6 CONNECTION.
- (31) 2 OF 2 BOLTS LOOSE AT STRINGER 5 TO FB3 CONNECTION.
- (32) STRINGER 8 FROM FB2' TO FB1' WAS ROTATED APPROXIMATELY 1 IN. TO THE
