**STRUCTURE INSPECTION REPORT**

MDT ID - 03719

Feature Intersected - BITTERROOT RIVER 010

Inspection Type - Fracture Critical

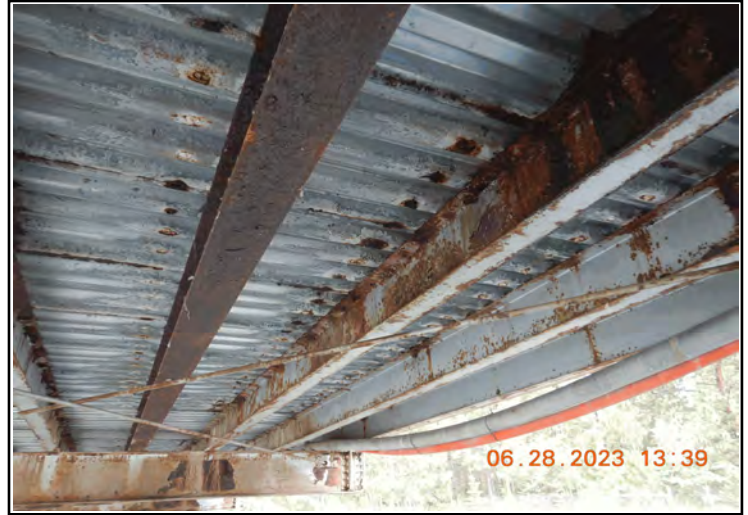
Approximately 5% of the Span 1 soffit had lamellar corrosion due to significant seepage through deck. Approximately 5% of the Span 1 soffit had welding burn holes.

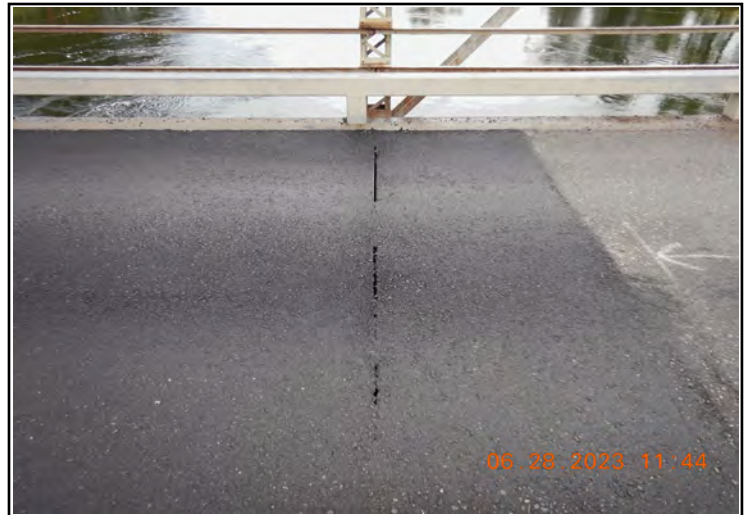
Wearing surface at Floor Beam 2' had failed for 50% of the deck width and had a gap up to 1 in. wide allowing water to drain onto floor beam below.

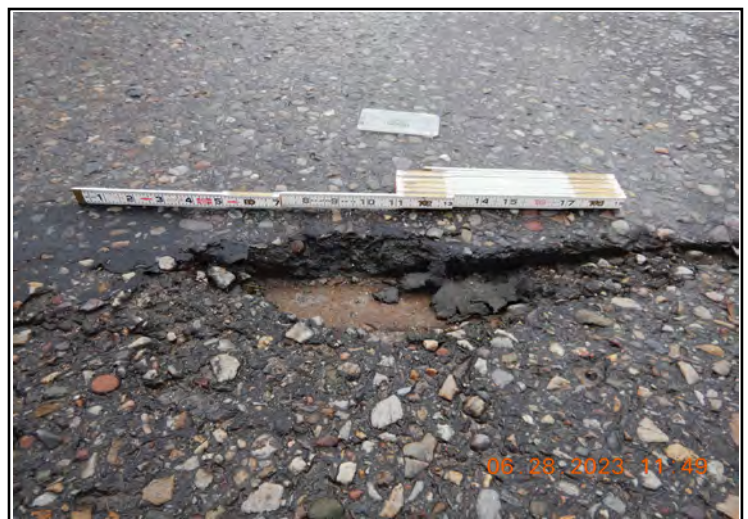
Wearing surface had a 12 in. wide by 4 in. long spall up to 2 in. deep in the north wheel path near Floor Beam 1' exposing steel deck underneath.

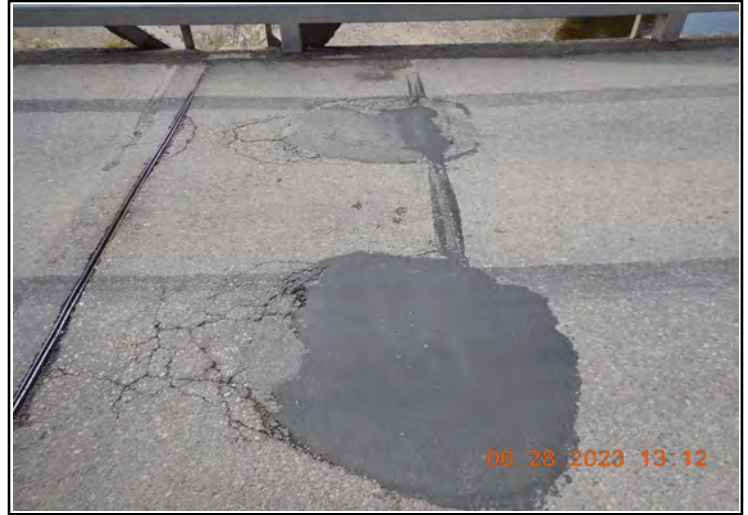
East end of wearing surface had two 3 ft. diameter potholes that had been patched but were still up to 1 in. deep in the wheel paths and had map cracking and delamination extending from patches.

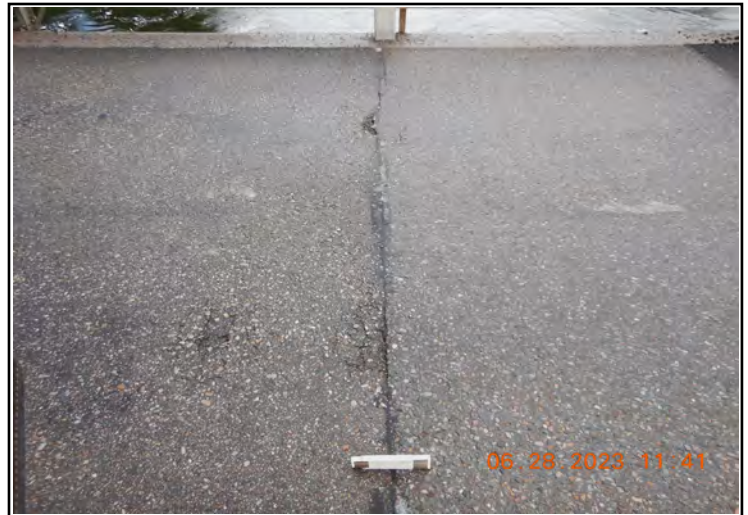
Wearing surface had full width transverse cracking up to 1/8 in. wide spaced approximately 20 ft. at the floor beam locations. Most cracks had been sealed previously, but seals were failed.

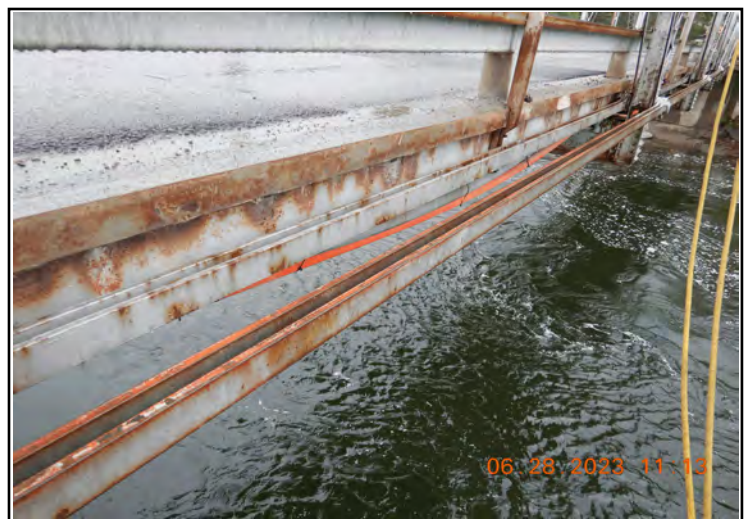
Span 1 exterior stringers typically had heavy corrosion with pitting up to 1/16 in. deep.

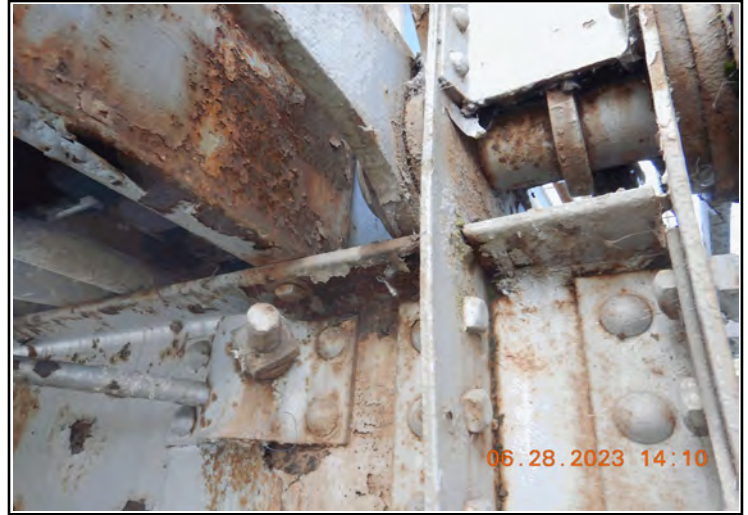
Two of two bolts loose at Floor Beam 3' to Stringer 1 and Floor Beam 3 to Stringer 6 connections.

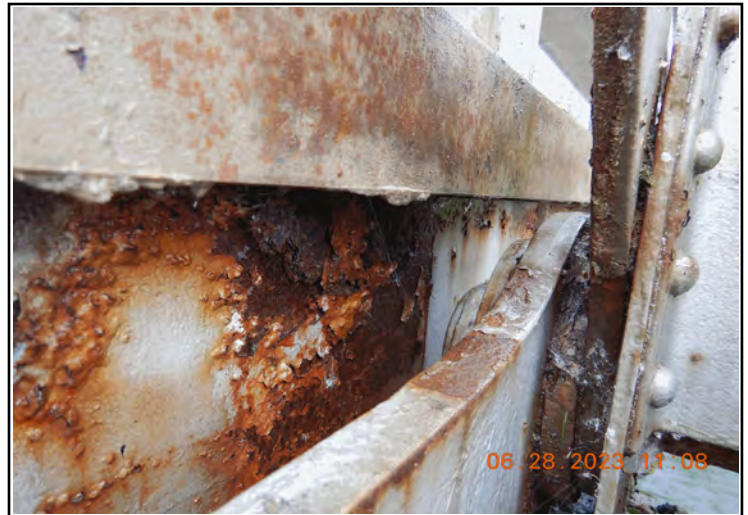
Stringer 1, between Floor Beams 3' and 2', had lamellar corrosion up to 1/4 in. thick with 1/8 in. section loss underneath.

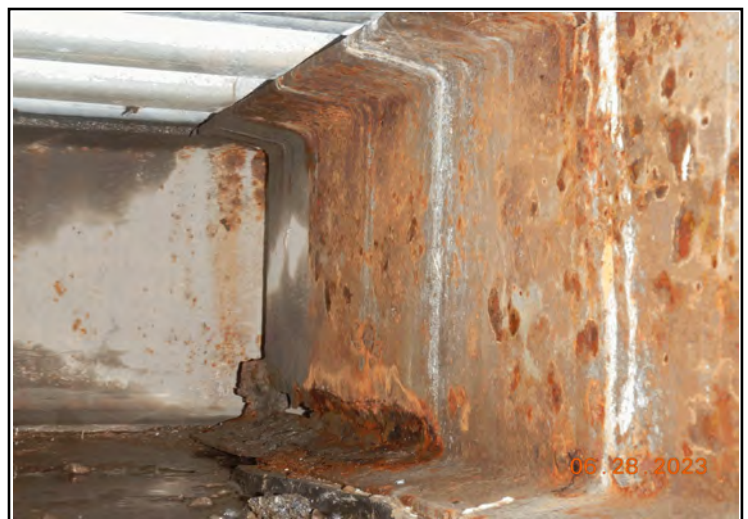
Stringer 2, at Abutment 1, had heavy corrosion and section loss over a 14 in. long by 2 in. high area with a 2-1/2 in. long by 3/4 in. high through hole centered 2 in. from the stringer end.

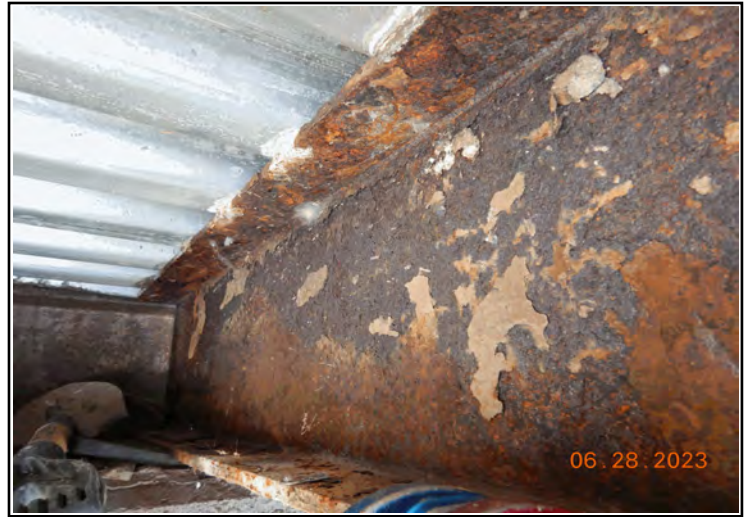
Stringers 4, 5, and 6, at Abutment 1, had lamellar corrosion up to 1/8 in. thick from the west end to midspan.

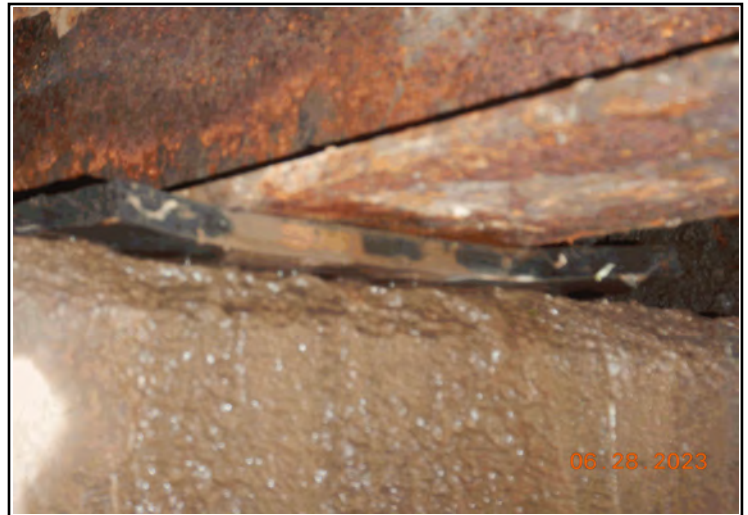
Stringer 5, at Abutment 1, had a 1/4 in. gap between its bottom flange and the Abutment 1 beam seat, and the stringer deflected under live load.

<b>Recommended By:</b>	<b>Date Recommended</b>	<b>Type</b>	<b>Status</b>	<b>Suggested Priority</b>
	11/09/2017	Superstructure Rehabi	Repair Suggestion	High
<b>Comments</b>				
Shim stringer ends at Abutment 1 and Bent 3 to prevent vertical movement.

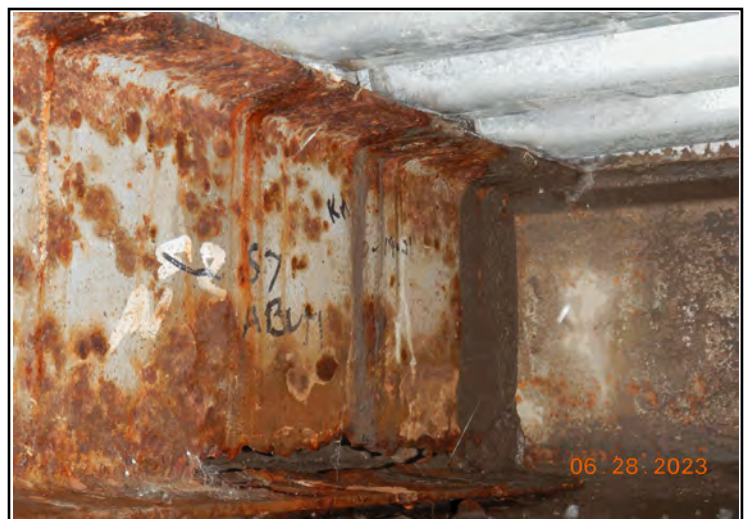
Stringer 7, at Abutment 1, had heavy corrosion and section loss in the web over a 17 in. long by 2 in. high area with a 1 in. high by 10 in. long through hole centered 10 in. from the stringer end. Stringer beam seat was unsupported by up to 1/2 in. on the north edge.

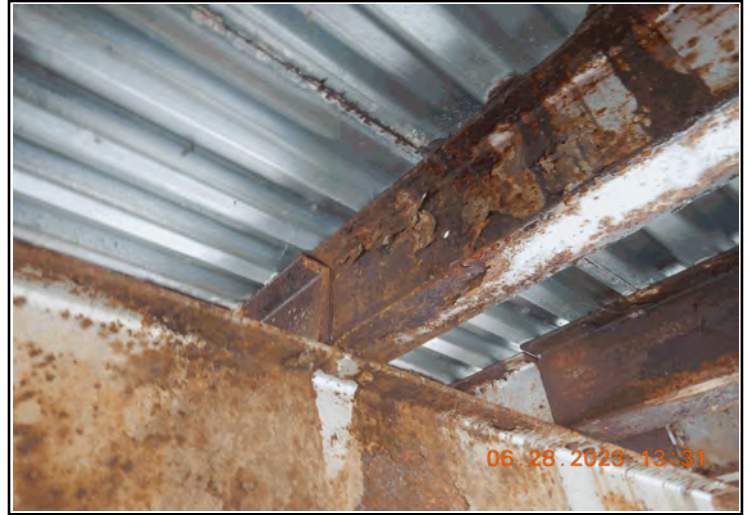
Span 1 stringers had active corrosion for the full length. Approximately 25% had laminating corrosion with pitting up to 1/64 in. deep, heavier near floor beam locations. Seepage through deck at seams and weld burn through locations was accelerating corrosion to stringers.

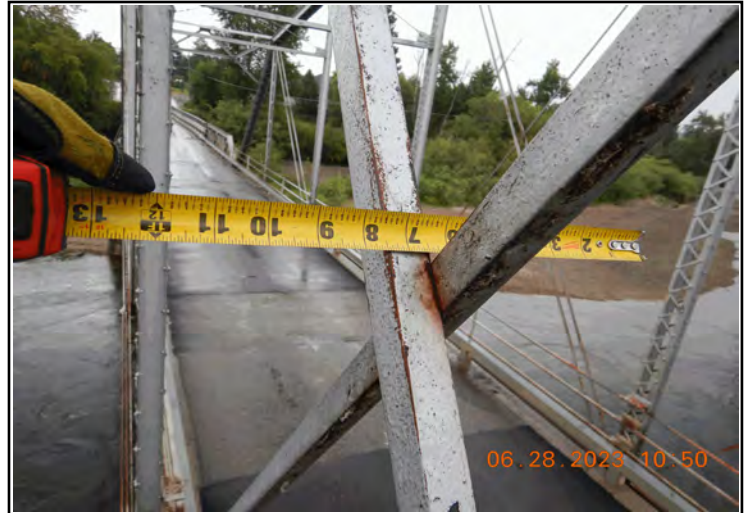
South and North Trusses, minor abrasion at the intersection between L4-U4' and U4-L4' with negligible section loss.

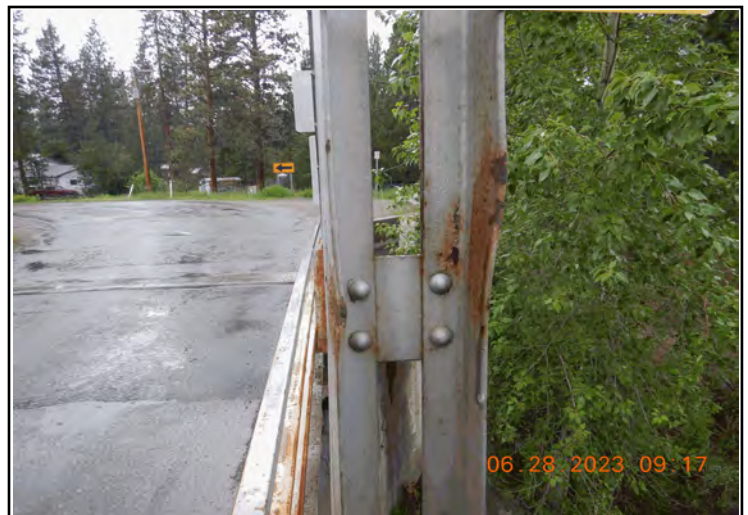
North Truss, Vertical U1-L1, east interior and exterior flanges of vertical were bent 1 in. to the north due to impact damage approximately 5 ft. above the deck.

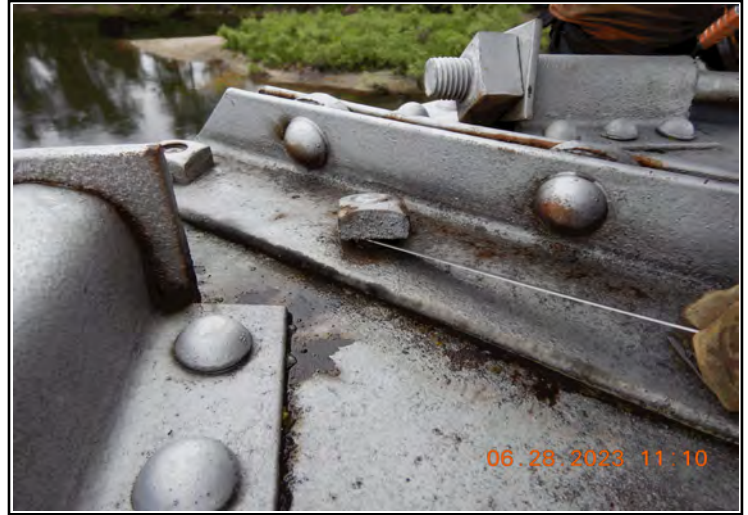
North Truss, Panel Point U2', two loose bolts at upper horizontal strut to top chord connection plate.

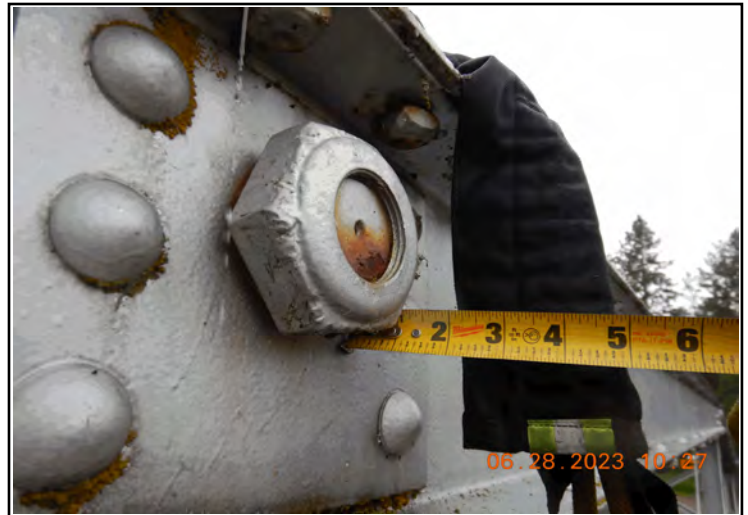
North Truss, Panel Point U3. outboard pin nut had a 3/8 in. gap between nut and chord web.

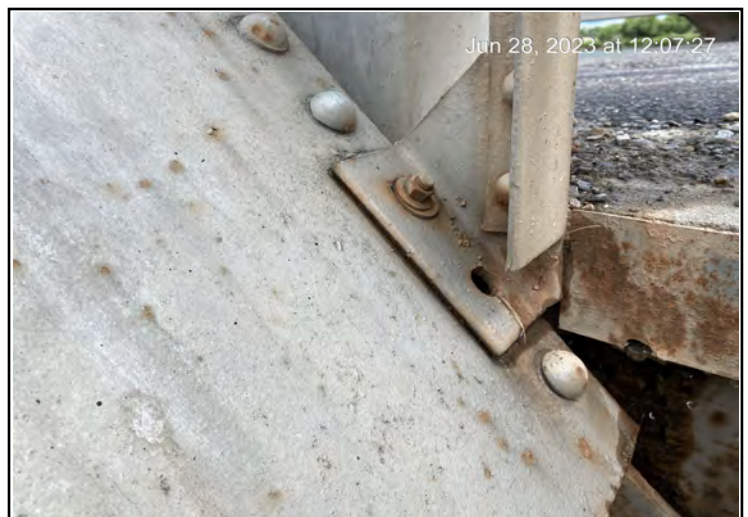
South Truss, End Diagonal U1'-L0', one bolt was missing at top flange plate to rail post angle connection.

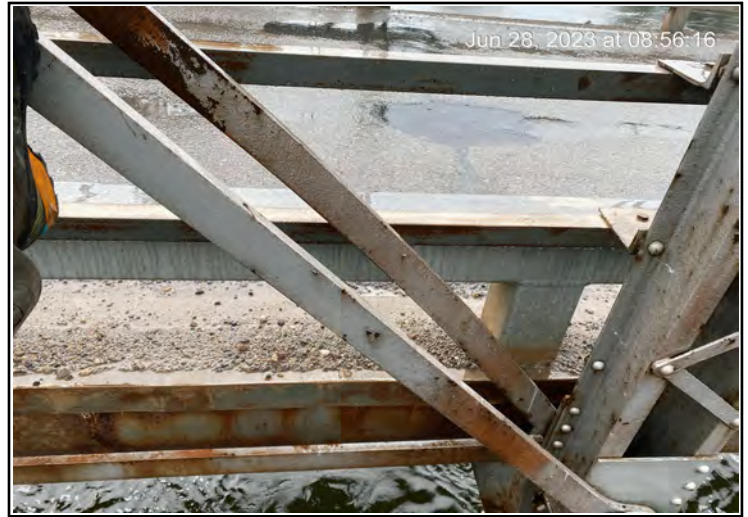
South Truss, Diagonal U1-L2 inboard eyebar was bent 3 in. upwards over a 3 ft. length.

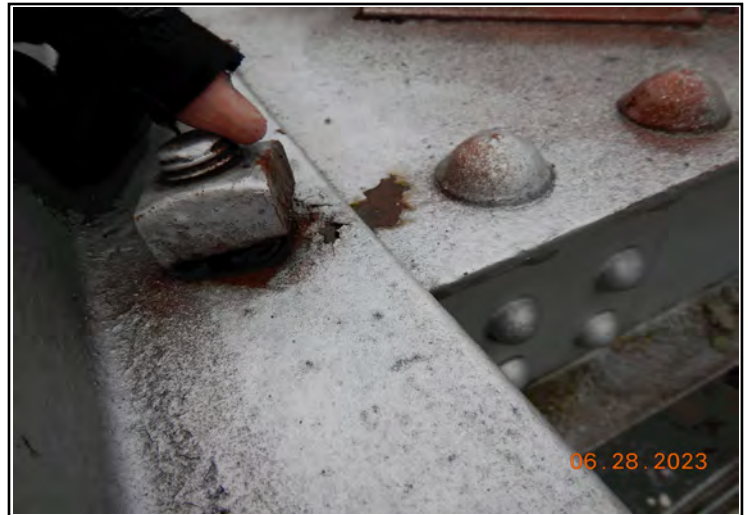
South Truss, Panel Point U2, one bolt was loose at upper horizontal strut to top chord connection plate.

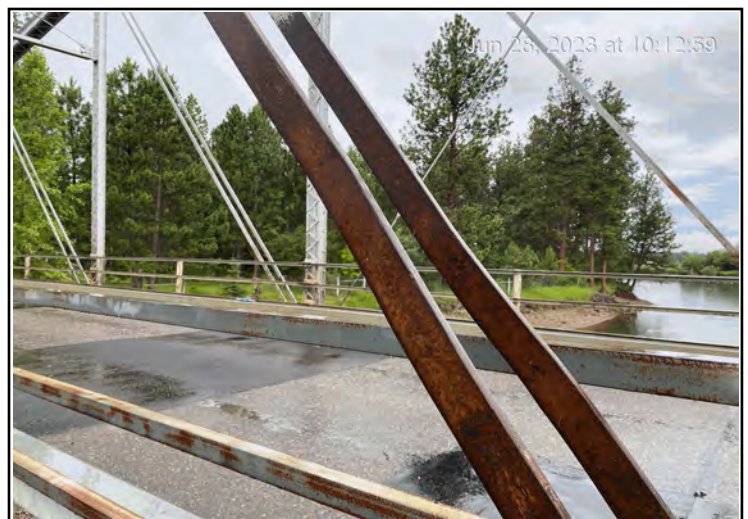
South Truss, Diagonal U3-L4 inboard eyebar was bent 1 in. to the north over a 2 ft. length.

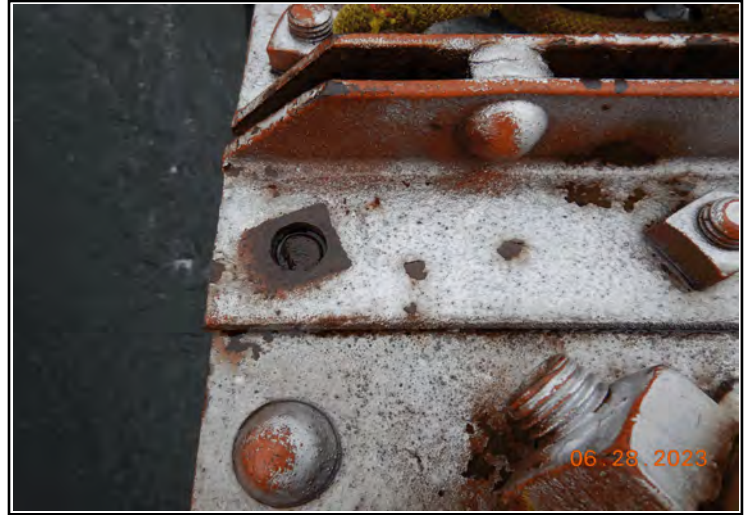
South Truss, Panel Point U4, one bolt was sheared off at upper horizontal strut to top chord connection plate.

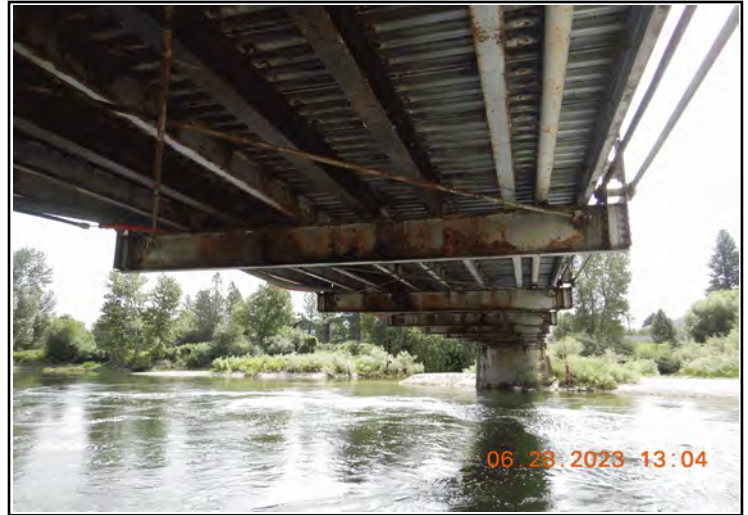
Floor Beams 1, 3', 2' and 1' had lamellar corrosion with pitting up to 1/64 in. deep underneath for approximately 25% of length. Remaining length had moderate corrosion with negligible section loss.

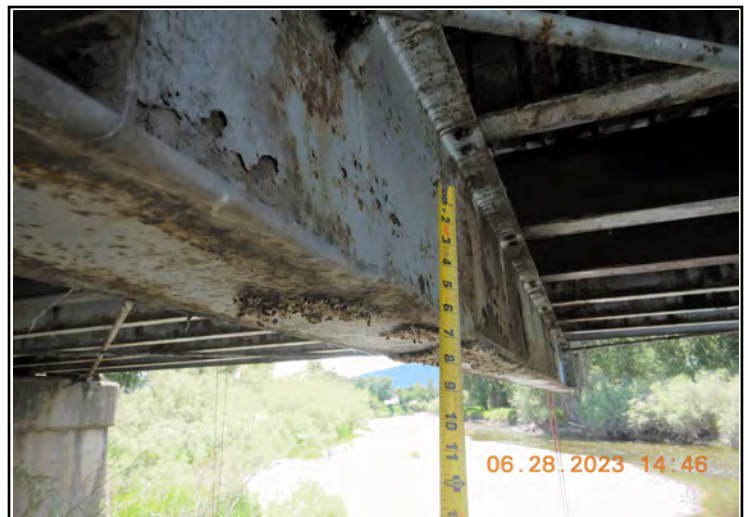
Floor Beam 1' bottom west flange was bent upwards 1/2 in. over a 6 in. length approximately 16 in. from the north end.

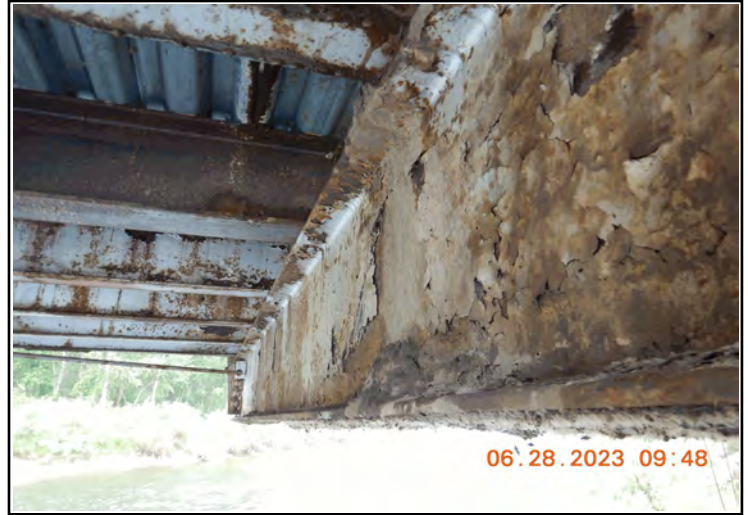
Floor Beam 2, north 8 ft. of east web face had lamellar corrosion up to 1/4 in. thick with section loss when removed. Heaviest corrosion under Stringer 3 with only 0.430 in. remaining (approximately 14% section loss). Floor beam had lamellar corrosion along top and bottom flanges but section loss could not be accurately measured due to tapered member.

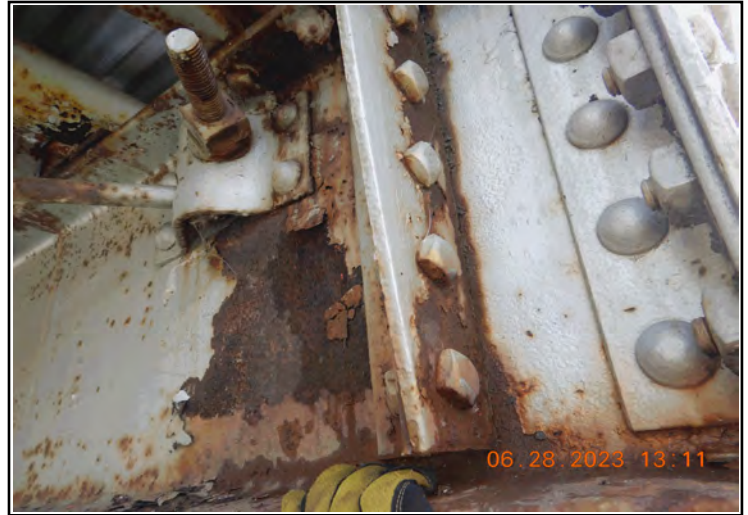
Floor Beams 3, 4, and 4' had lamellar corrosion with pitting up to 1/64 in. deep for approximately 75% of length. End 2 ft. on both ends had areas with less than 0.470 in. remaining (approximately 7% section loss).

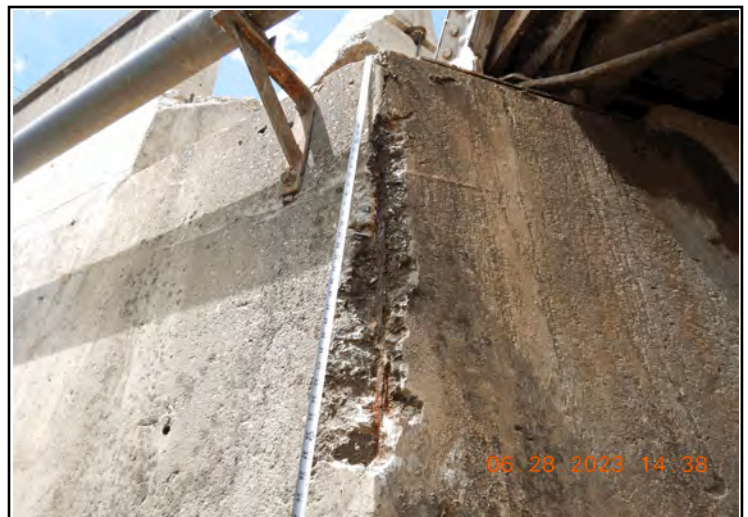
Abutment 1, south end had a 3 ft. high by 5 in. wide spall with up to 2 in. of penetration and exposed rebar with up to 10% section loss.

<b>Recommended By:</b>	<b>Date Recommended</b>	<b>Type</b>	<b>Status</b>	<b>Suggested Priority</b>
	11/09/2017	Other	Repair Suggestion	Low
<b>Comments</b>				
Repair spalls with exposed steel reinforcement on curbs and bents on approach spans.

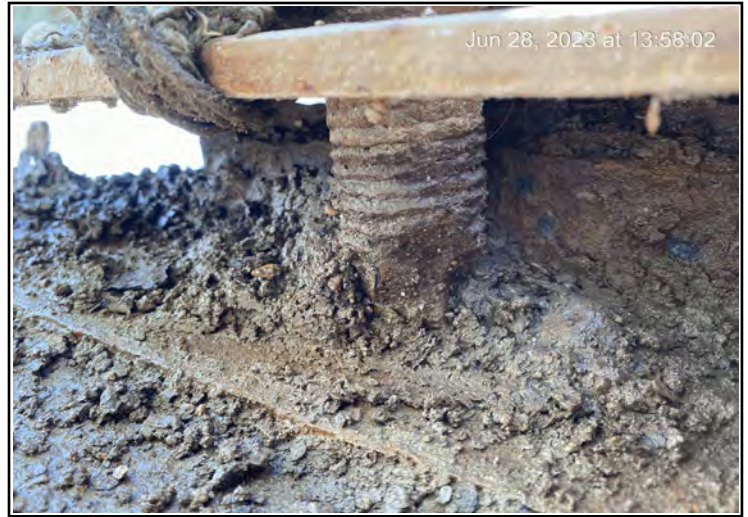
Both moveable bearings at Abutment 1 had heavy corrosion with up to 50% section loss to the anchor rods.

<b>Recommended By:</b>	<b>Date Recommended</b>	<b>Type</b>	<b>Status</b>	<b>Suggested Priority</b>
	10/17/2017	Bearings	Repair Suggestion	High
<b>Comments</b>				
Both movable bearings on Abutment 1 need to be replaced/reset.

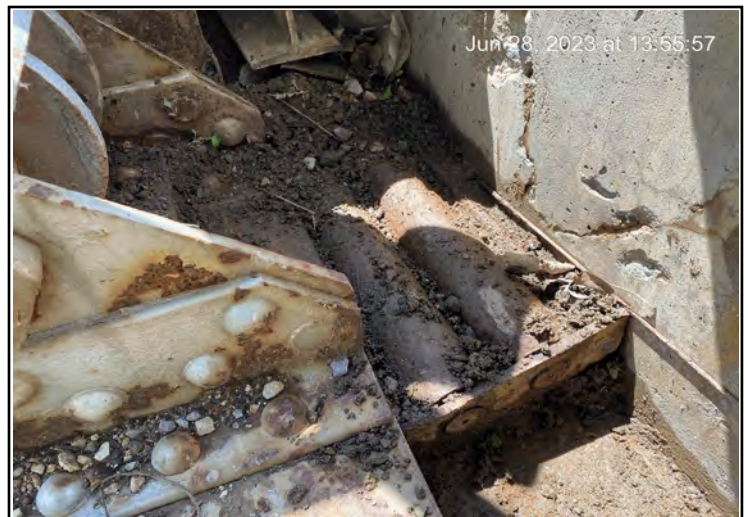
North Moveable Bearing, the nested roller keeper had failed. Two rollers had worked out from underneath the bearing and were pushed against the abutment backwall. One roller was sticking out on the east side of the bearing.

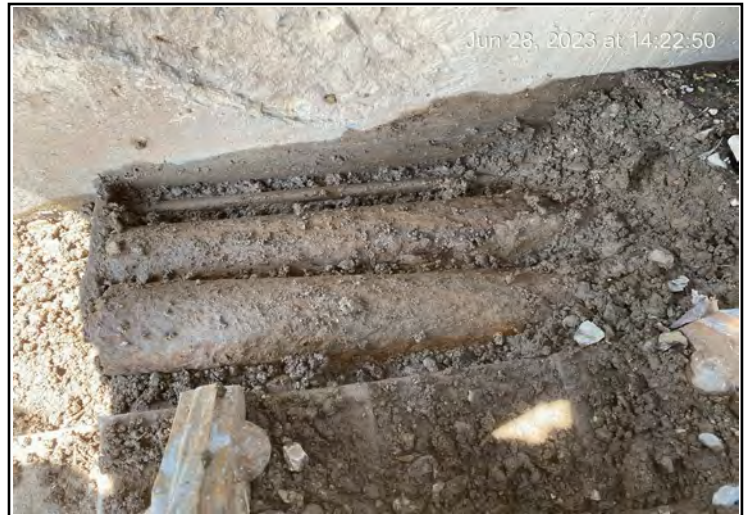
South Moveable Bearing, the rollers had worked out from underneath the bearing and were pushed against the abutment backwall. Two rollers were no longer under the sole plate.

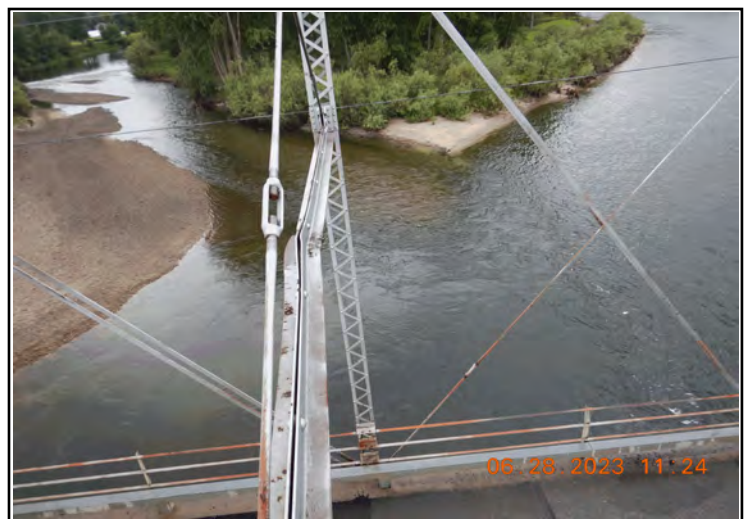
Lower horizontal sway bracing at U3' was bent 2 in. to the east, and upward and downward 1 in. due to impact damage.

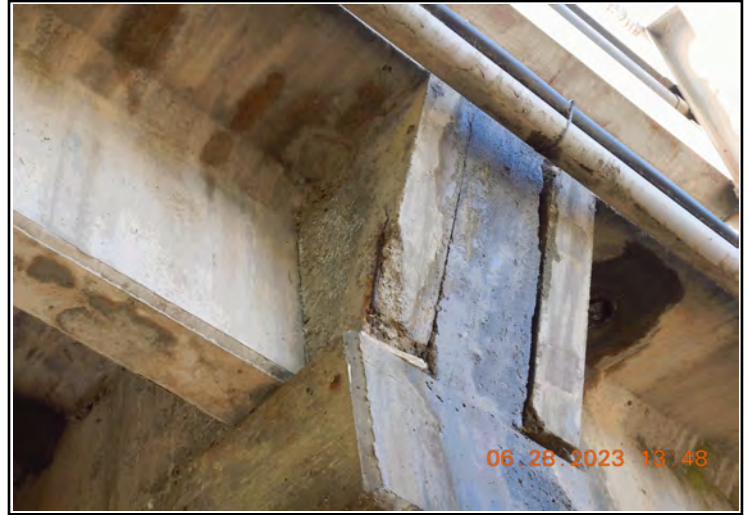
Bent 4 Cap northeast corner had a 12 in. high by 3 in. wide spall with up to 1/2 in. of penetration and exposed rebar with up to 10% section loss.

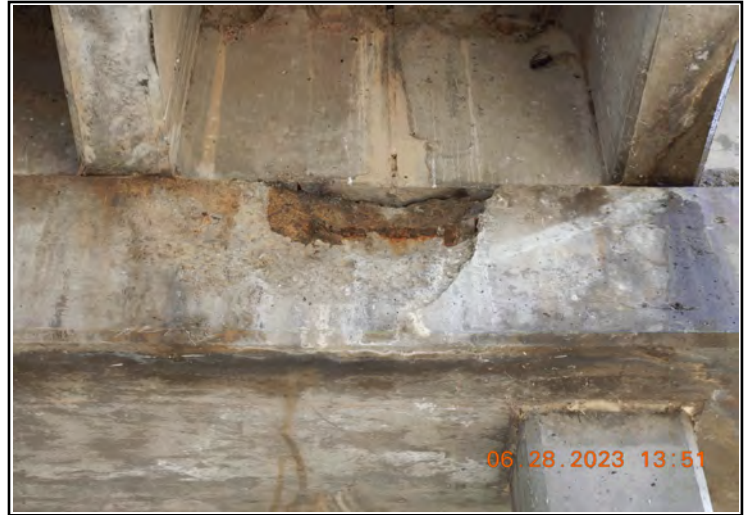
Bent 4 Cap west face had a 3 ft. wide by 2 ft. high spall with up to 3.5 in. of penetration and exposed rebar with up to 10% section loss.

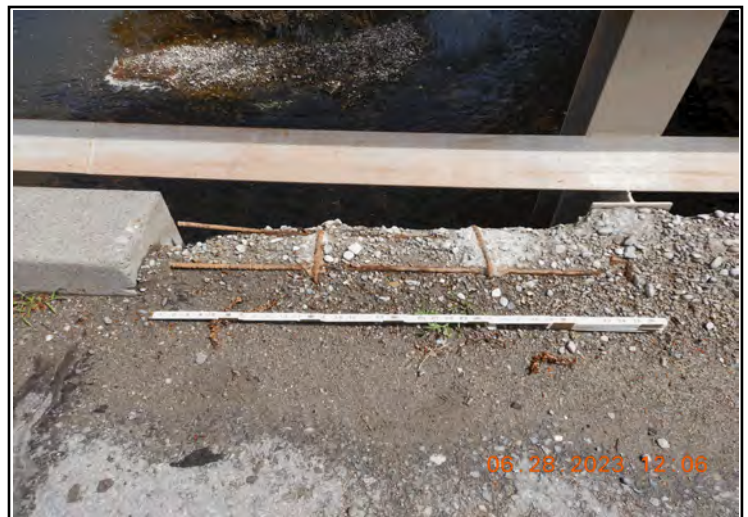
Span 4 North Curb had an area of spalling over Bent 4 measuring 3 ft. long by full width and height with exposed rebar.

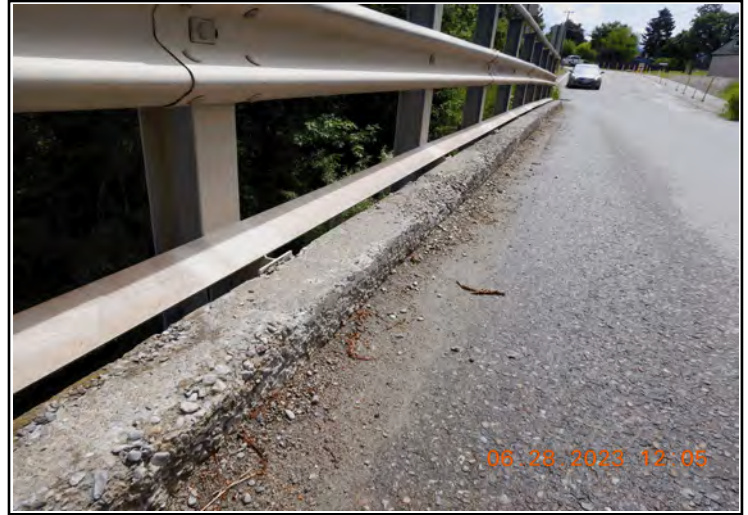
**Comments:**  
North Curb had spalling up to 2 in. deep on the top and interior faces for the full length of Span 4 with areas of exposed rebar.

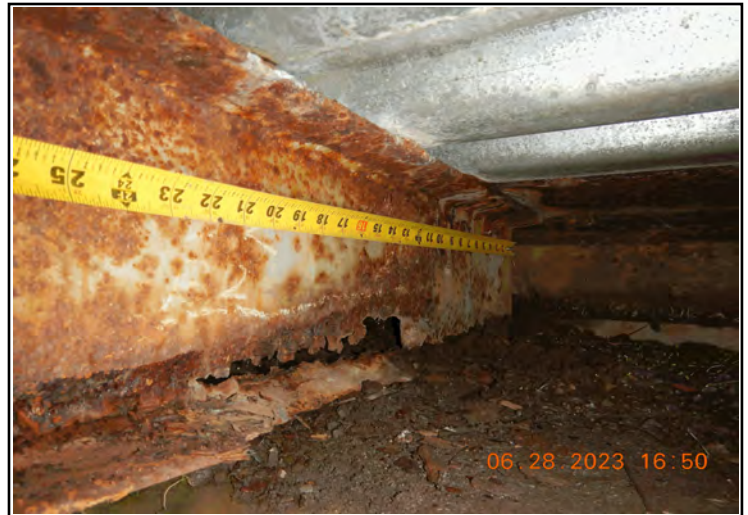
**Comments:**  
Stringer 2, at Bent 2, had heavy corrosion and section loss in the web with a 22 in. long by 2 in. high through hole and knife edging to the bottom, north flange.

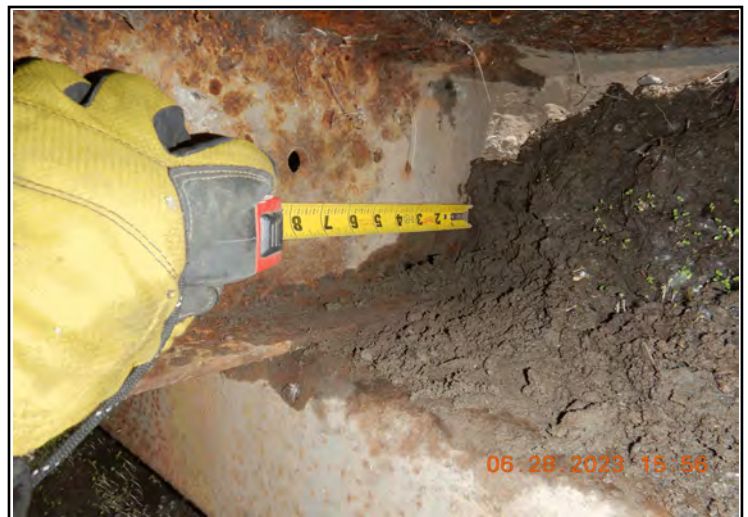
**Comments:**  
Stringer 2, at Bent 3, had heavy corrosion with a 4 in. long by 1 in. high through hole at the web to bottom flange interface.

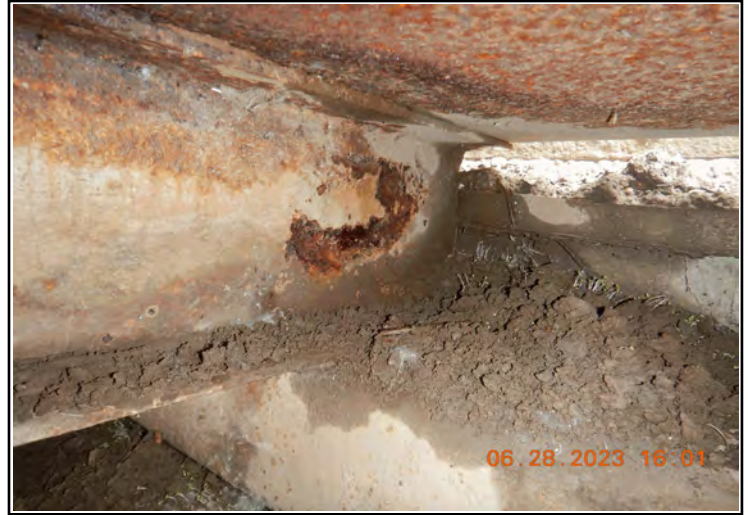
Stringer 3, at Bent 3, had heavy corrosion and up to 1/8 in. thick rust scale on both sides of web at web to bottom flange interface adjacent to stringer end.

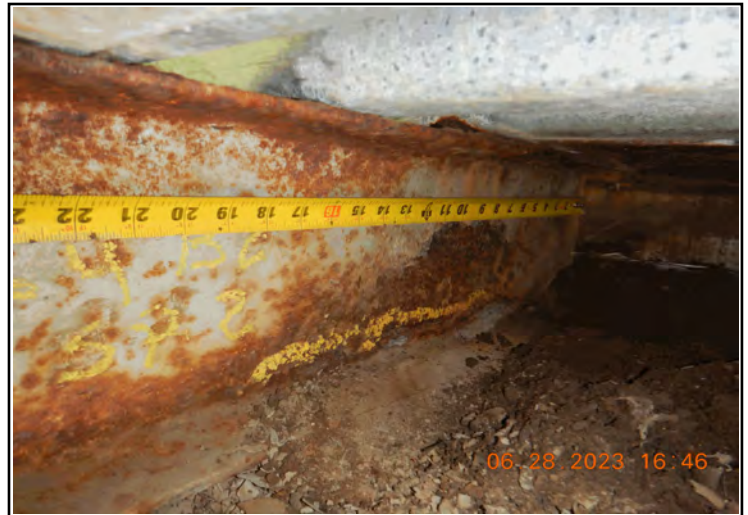
Stringer 4, at Bent 2, had an 18 in. long by 2 in. high area of lamellar corrosion up to 1/4 in. thick on the bottom of the north face at the west end of the stringer.

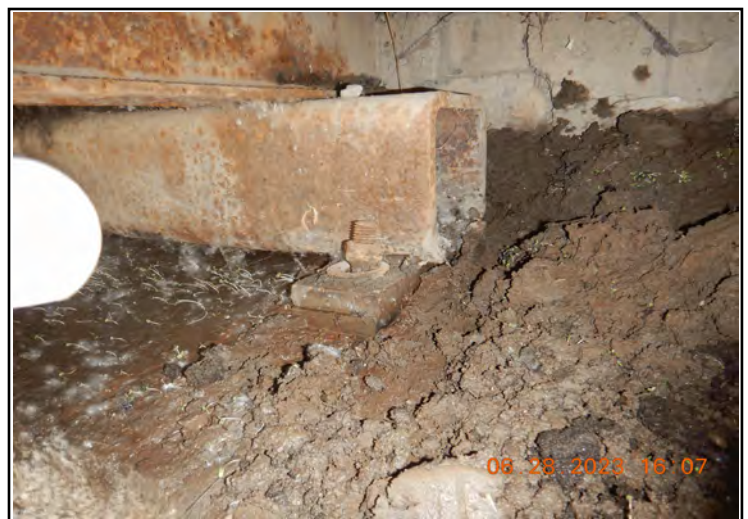
Stringers 4, 5, 7, and 8 had a gap between the bottom flange and the hollow bearing pipe at Bent 3. Movement of the stringers was observed under live load. The east anchor rod of the bearing pipe at Stringer 4 was sheared off. The west anchor rod at Stringer 4 had up to 50% section loss and was loose on concrete. The bearing pipe moved up to 1/2 in. vertically under live load.

<b>Recommended By:</b>	<b>Date Recommended</b>	<b>Type</b>	<b>Status</b>	<b>Suggested Priority</b>
	06/27/2019	Superstructure Rehabi	Repair Suggestion	Medium
<b>Comments</b>				
Replace the broken stringer bearing tube anchor rod at the south end of Bent 3 (see Span 2 Stringer Connection Defect for photo).

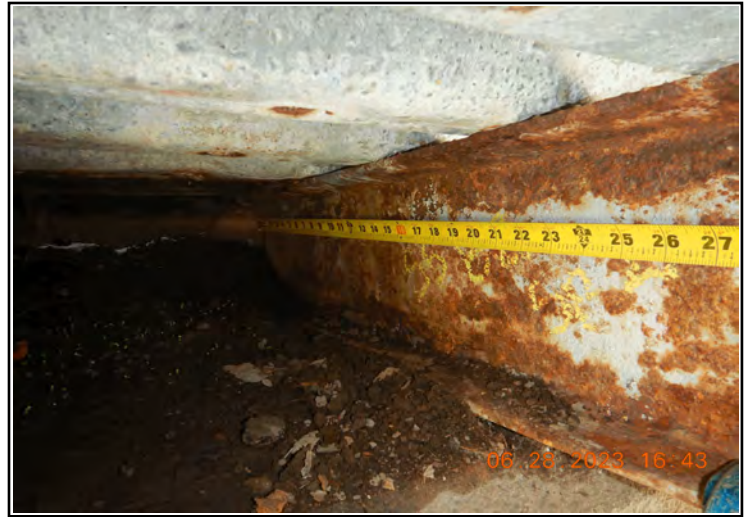
Stringer 5, at Bent 2, had a 16 in. long by 2 in. high area of lamellar corrosion up to 1/4 in. thick on the bottom of the web located 12 in. from the end of the stringer on the south face.

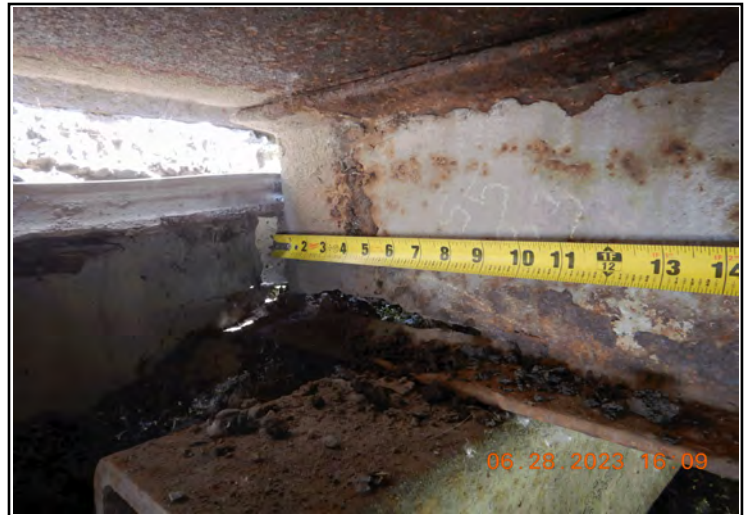
Stringer 5, at Bent 3, had heavy corrosion and section loss in the web with an 8 in. long by 1 in. high through hole near stringer end. Bottom flange was knife-edged in this area.

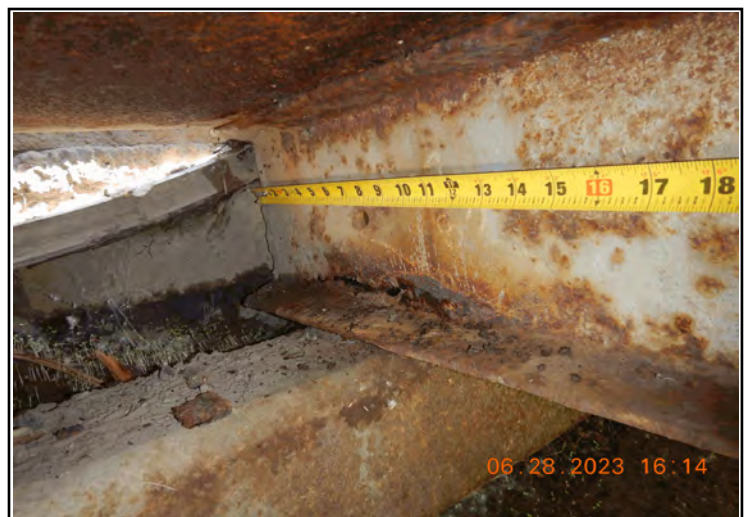
Stringer 7, at Bent 3, had heavy corrosion with up to 50% section loss over a 10 in. long by 2 in. high area adjacent to the stringer end that had a 5 in. long by 1 in. high through hole at the web to lower flange interface.

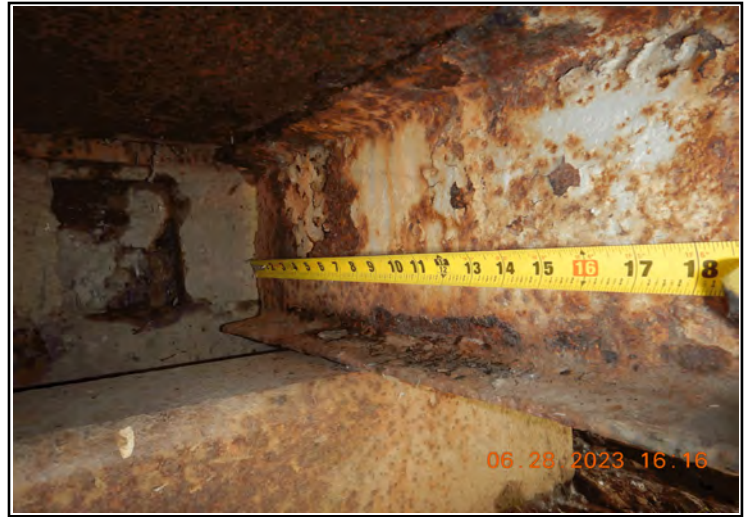
Stringer 8, at Bent 3, had heavy corrosion and section loss in the web for the end 14 in. with a 7 in. long by 1 in. high through hole at the web to bottom flange interface at the stringer end.

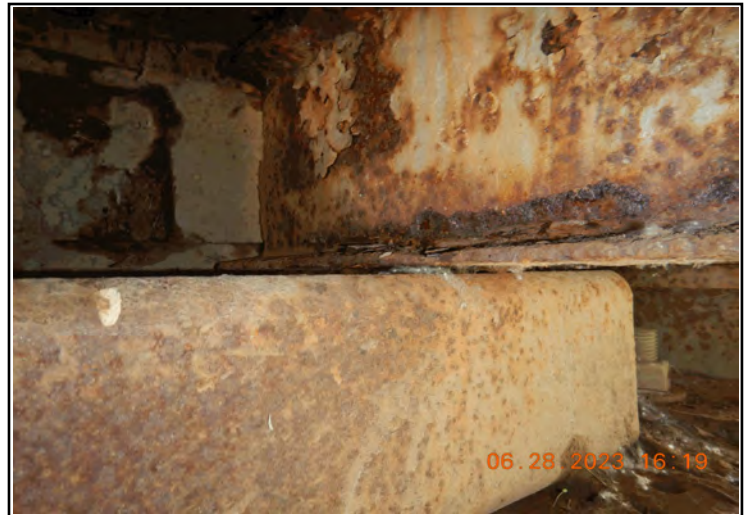
Stringers 4, 5, 7, and 8 had a gap between the bottom flange and the hollow bearing pipe at Bent 3. Movement of the stringers was observed under live load. Both anchor rods of the bearing pipe at Stringer 8 were sheared off. The bearing pipe moved up to 1/2 in. vertically under live load. Imprints in debris on top of bent showed up to 2 in. of lateral movement.

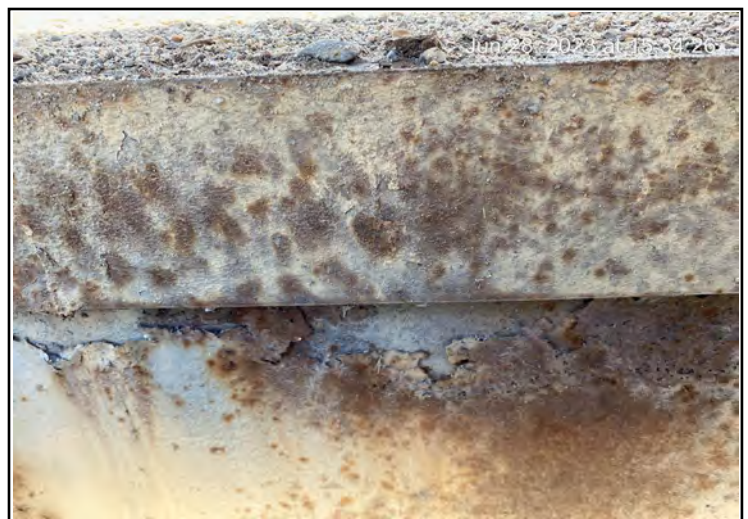
Pony Truss had random areas of laminating corrosion up to 1/8 in. deep along the inboard channel of the bottom chord.

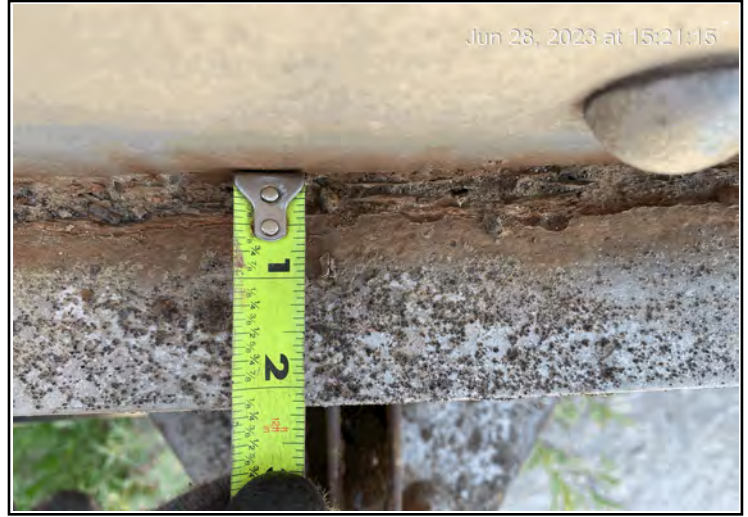
South Truss, Panel Points L2 and L2' had pack rust up to 1/4 in. thick between bottom chord and both interior and exterior gusset plates. North Truss, Panel Points L2 and L2' had pack rust up to 3/8 in. thick between bottom chord and both interior and exterior gusset plates. Pack rust up to 3/4 in. thick between lower strut angles of exterior sway brace frames.

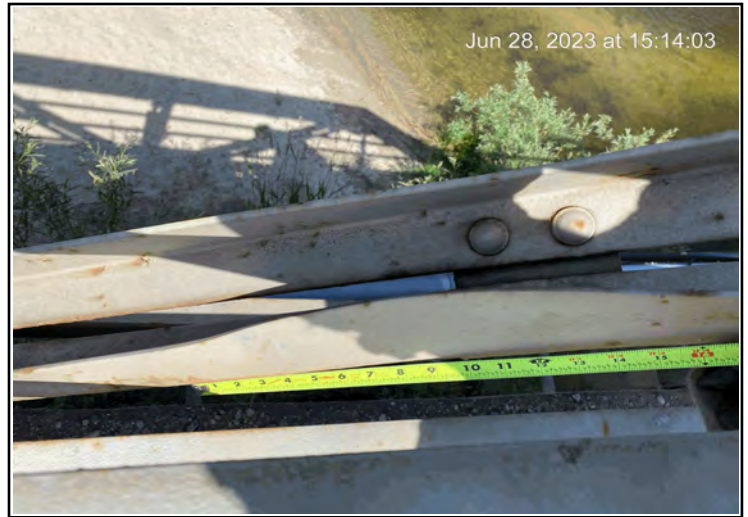
North Truss, Diagonal L2'-U1' interior flange was bent 1-3/8 in. out-of-plane over a 24 in. length due to impact damage.

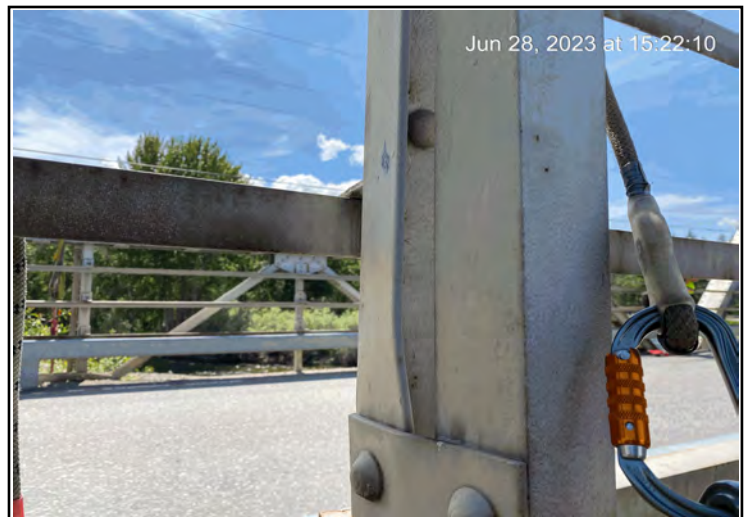
North Truss, Vertical L2'-U2' interior flange was bent 1 in. out-of-plane over a 6 in. height due to impact damage.

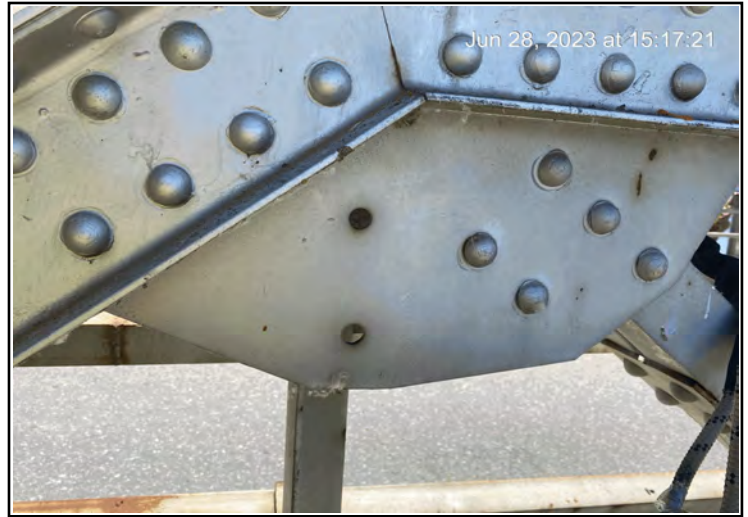
North Truss, U1' exterior gusset plate had two misdrilled 3/4 in. diameter holes.

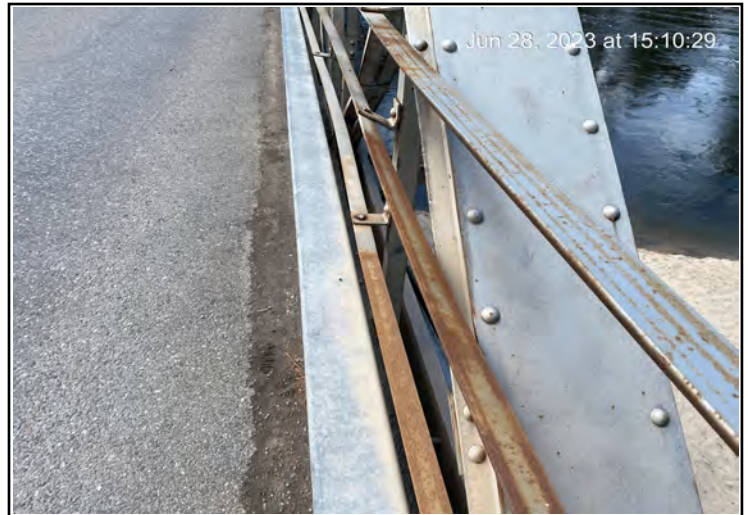
North Truss, End Diagonal U1'-L0' had seven areas of impact damage up to 3/4 in. long with up to 1/4 in. of deflection spaced over a 15 in. length.

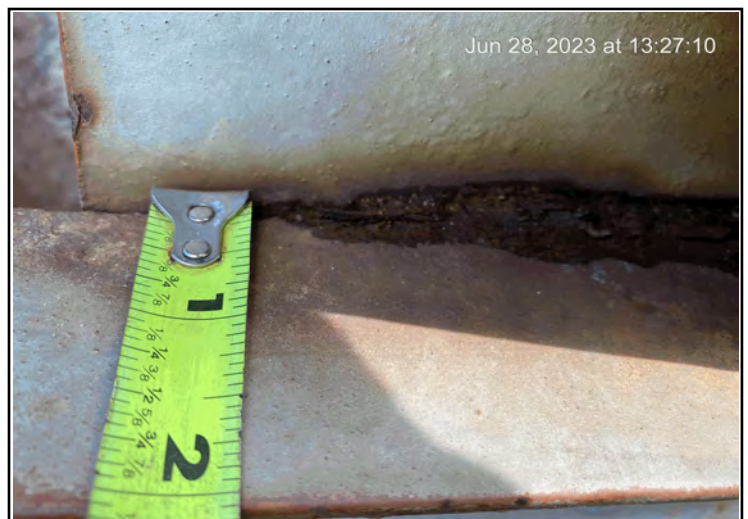
South Truss, Bottom Chord at L0' had pack rust up to 3/16 in. thick between outboard channel and gusset plate.
