**STRUCTURE INSPECTION REPORT**

MDT ID - 03719

Feature Intersected - BITTERROOT RIVER 010

Inspection Type - Fracture Critical

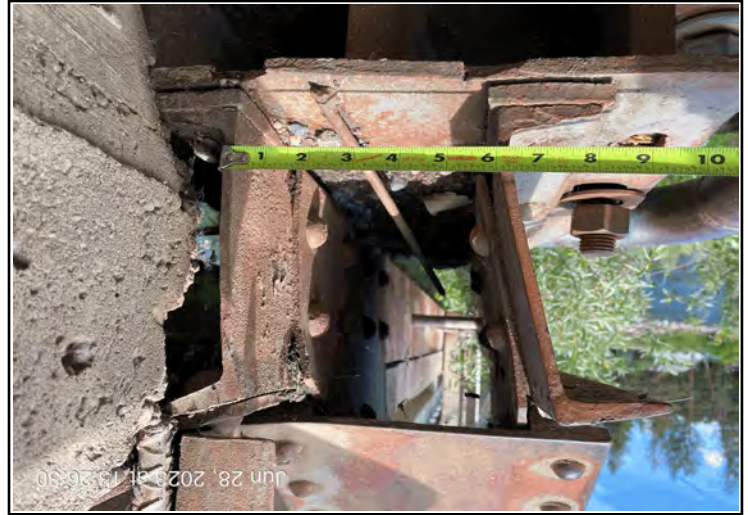
South Truss, Bottom Chord at L0' channel members were deflected up to 1-1/2 in. out-of-plane over the moveable bearing.

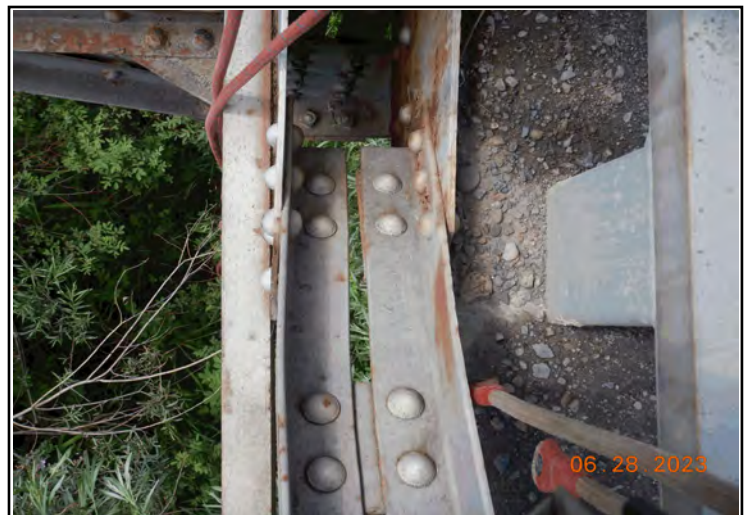
South Truss, Diagonal L2'-U1' was bent 3/4 in. out-of-plane over a 12 in. length.

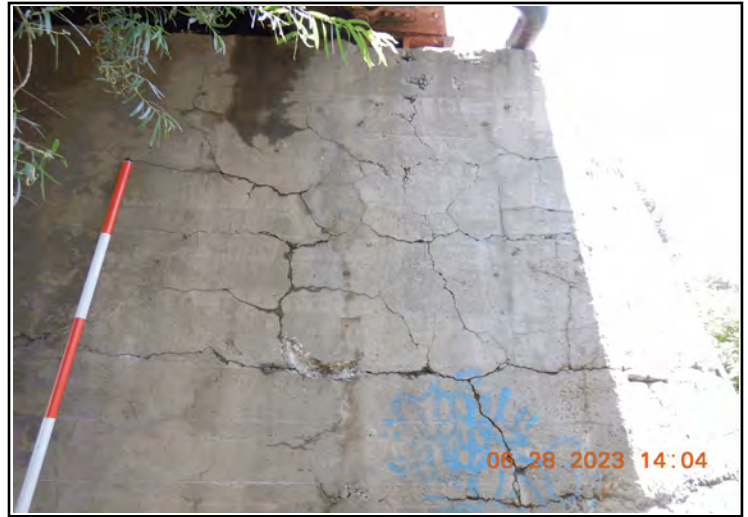
Bent 3 west face, south end 10 ft., and east face, south end 4 ft. had map cracking up to 1/8 in. wide with delamination and spalls with up to 1 in. of penetration.

<b>Recommended By:</b>	<b>Date Recommended</b>	<b>Type</b>	<b>Status</b>	<b>Suggested Priority</b>
	11/09/2017	Other	Repair Suggestion	Low
<b>Comments</b>				
Repair spalls with exposed steel reinforcement on curbs and bents on approach spans.

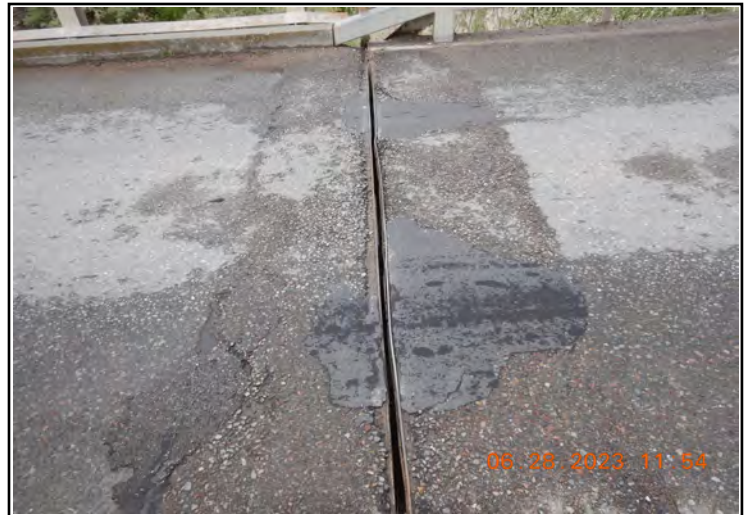
Joint had separated from Span 2 deck up to 3/4 in. over a 4 ft. length. Joint had a 1/2 in. bend over a 6 in. length in the south wheel path. Joint was moving under live load. Rubber seal had failed over 90% of its length.

<b>Recommended By:</b>	<b>Date Recommended</b>	<b>Type</b>	<b>Status</b>	<b>Suggested Priority</b>
	11/09/2017	Compression Joint	Repair Suggestion	Low
<b>Comments</b>				
Replace joint seal above Bent 3
