MONTANA DEPARTMENT OF TRANSPORTATION STREAM MITIGATION MONITORING REPORT

*Bowser Creek
Flathead County, Montana*

YEAR 2013

MDT Project Number: NH 15(93)
Control Number: 2038-011

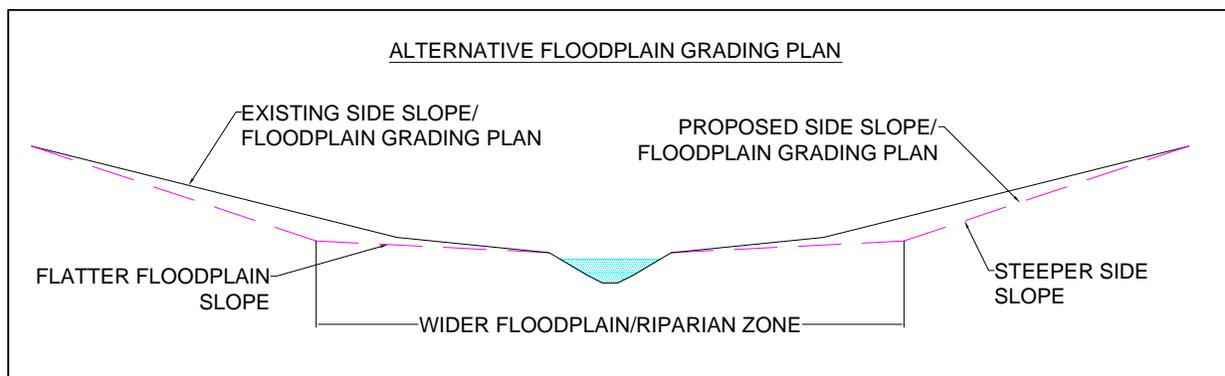
Figure 2. Alternative grading plan to increase floodplain and riparian areas.

Side slope designs along Bowser Creek provide room for a very narrow, 14 foot wide riparian and floodplain zone. Perpendicular transect survey results (Appendix B) illustrate a narrow bankfull bench adjacent to the creek has been constructed for flood inundation and wetland/riparian vegetation establishment. Integrating a slightly steeper upland side slope design would provide for a wider, more functional floodplain and riparian zone by allowing the stream to access a larger, flat zone adjacent to the active channel (Figure 2). Constructing steeper side slopes and a wider floodplain area requires additional excavation; therefore a cost/benefit analysis of creating additional floodplain and wetland features, and the associated mitigation credits, is potentially worth consideration for future stream and riparian mitigation designs.

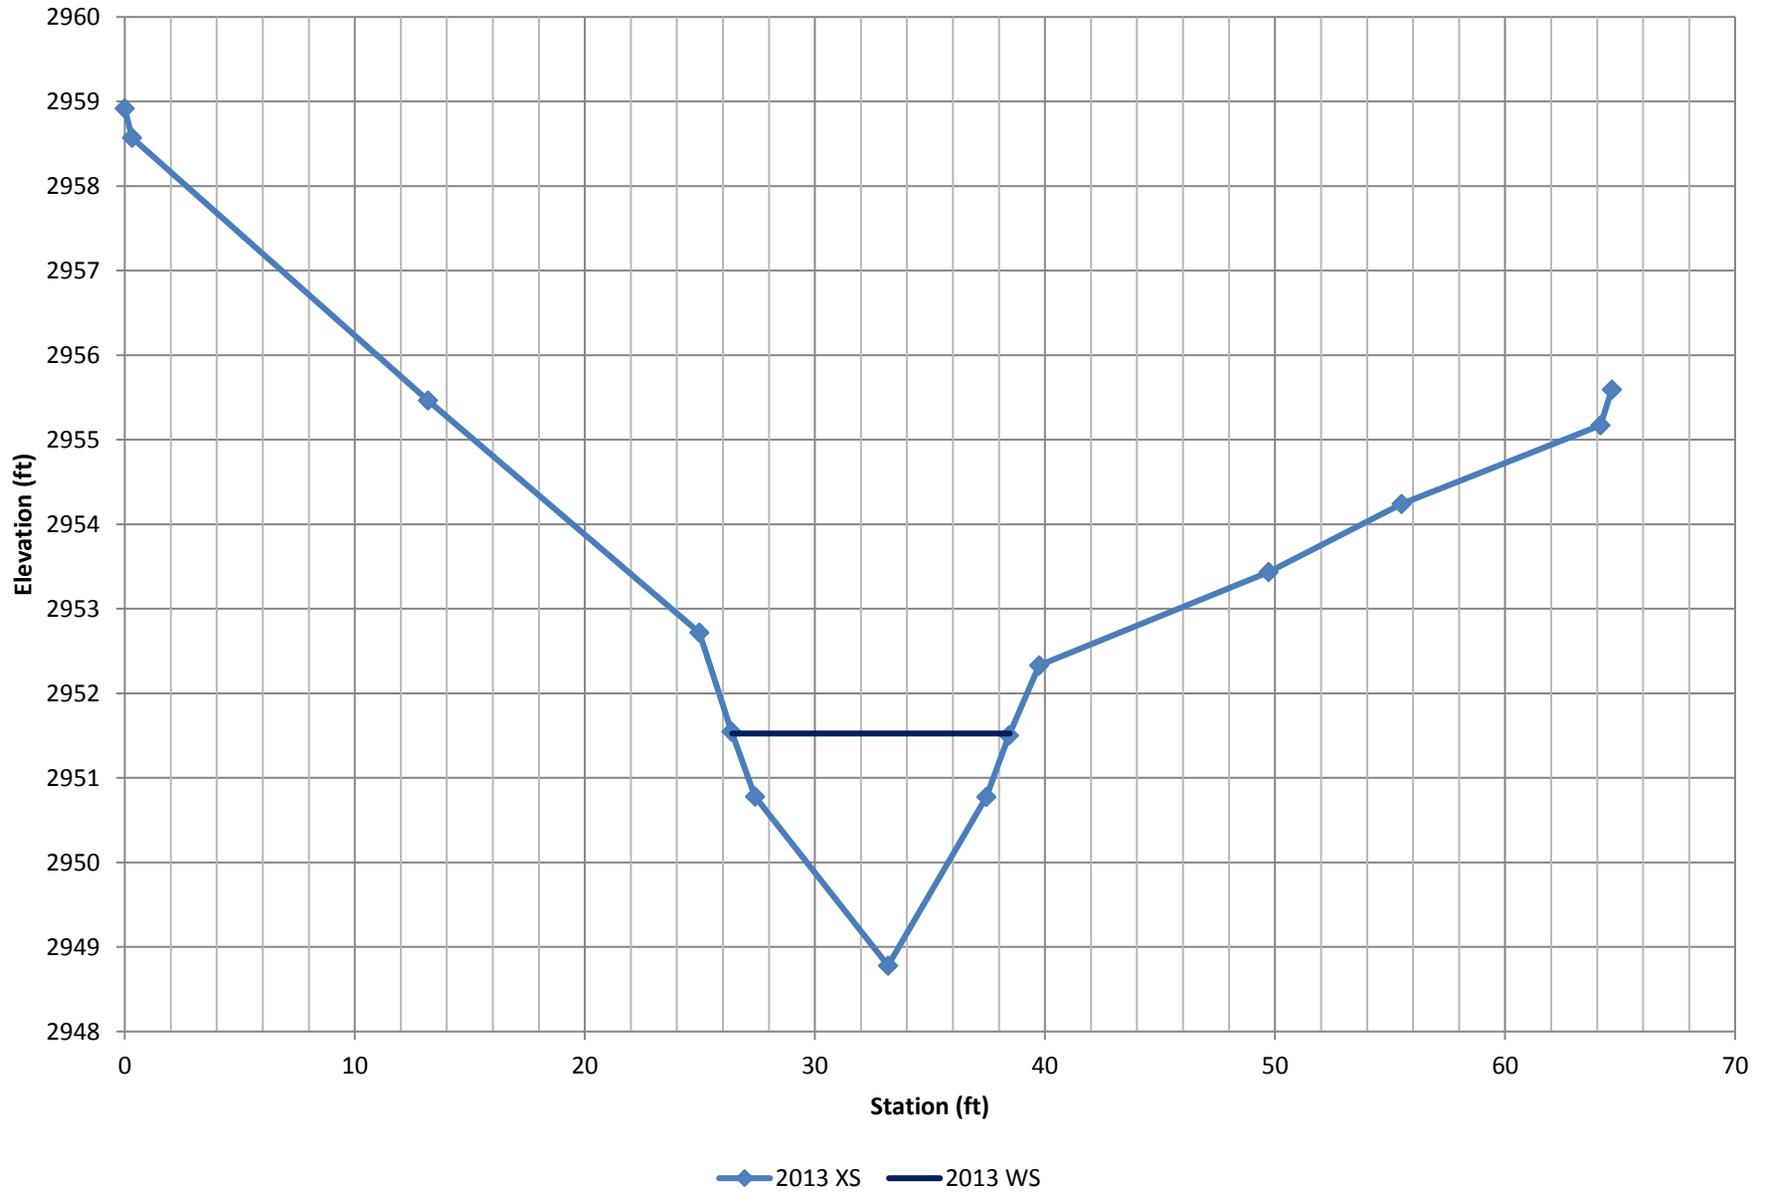
Bowser Transect #3 - Pool

Results of the perpendicular transect surveys indicate the channel currently exhibits variability in both channel width and depth, with at least one relatively deep pool formation documented at transect #3. The channel cross section shape appears to be relatively uniform, with no point bars or other depositional features noted. This cross sectional shape is often observed in channels similar to the reconstructed segment of Bowser Creek with relatively straight planform geometry, low sinuosity, and gently meandering planform. As a result of these design parameters, the development of sustained, deep pool habitat is not expected within the project reach, although sediment transport has been improved over pre-construction conditions. Continued monitoring at pool and riffle features will provide evidence if the channel maintains habitat variability, stability, and develops any depositional features at these monitoring locations over time.

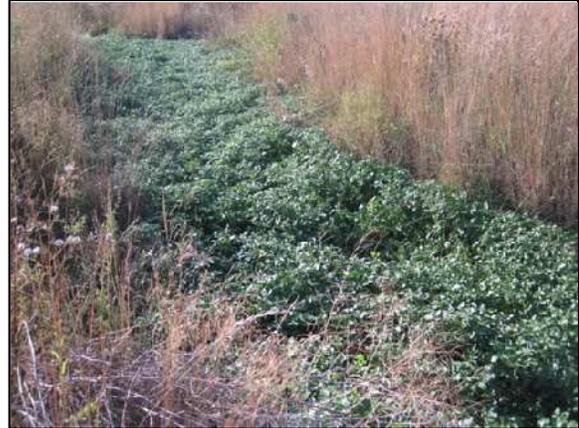
Photo 1
Description: Instream vegetation on Bowser Creek. **Compass:** 90 (East)

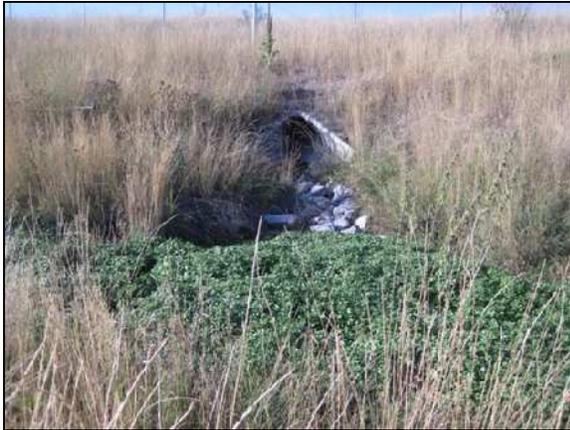
Photo 2
Description: View across Bowser Creek of culvert on north side of channel. **Compass:** 0 (North)
