# MONTANA DEPARTMENT OF TRANSPORTATION STREAM MITIGATION MONITORING REPORT

*Sweathouse Creek  
Ravalli County, Montana*

*Year Project Completed: 2011  
Monitoring Report #2: Submitted December, 2014*

MDT Project Number: NH 7-1(114)59  
Control Number: CN 201 5004

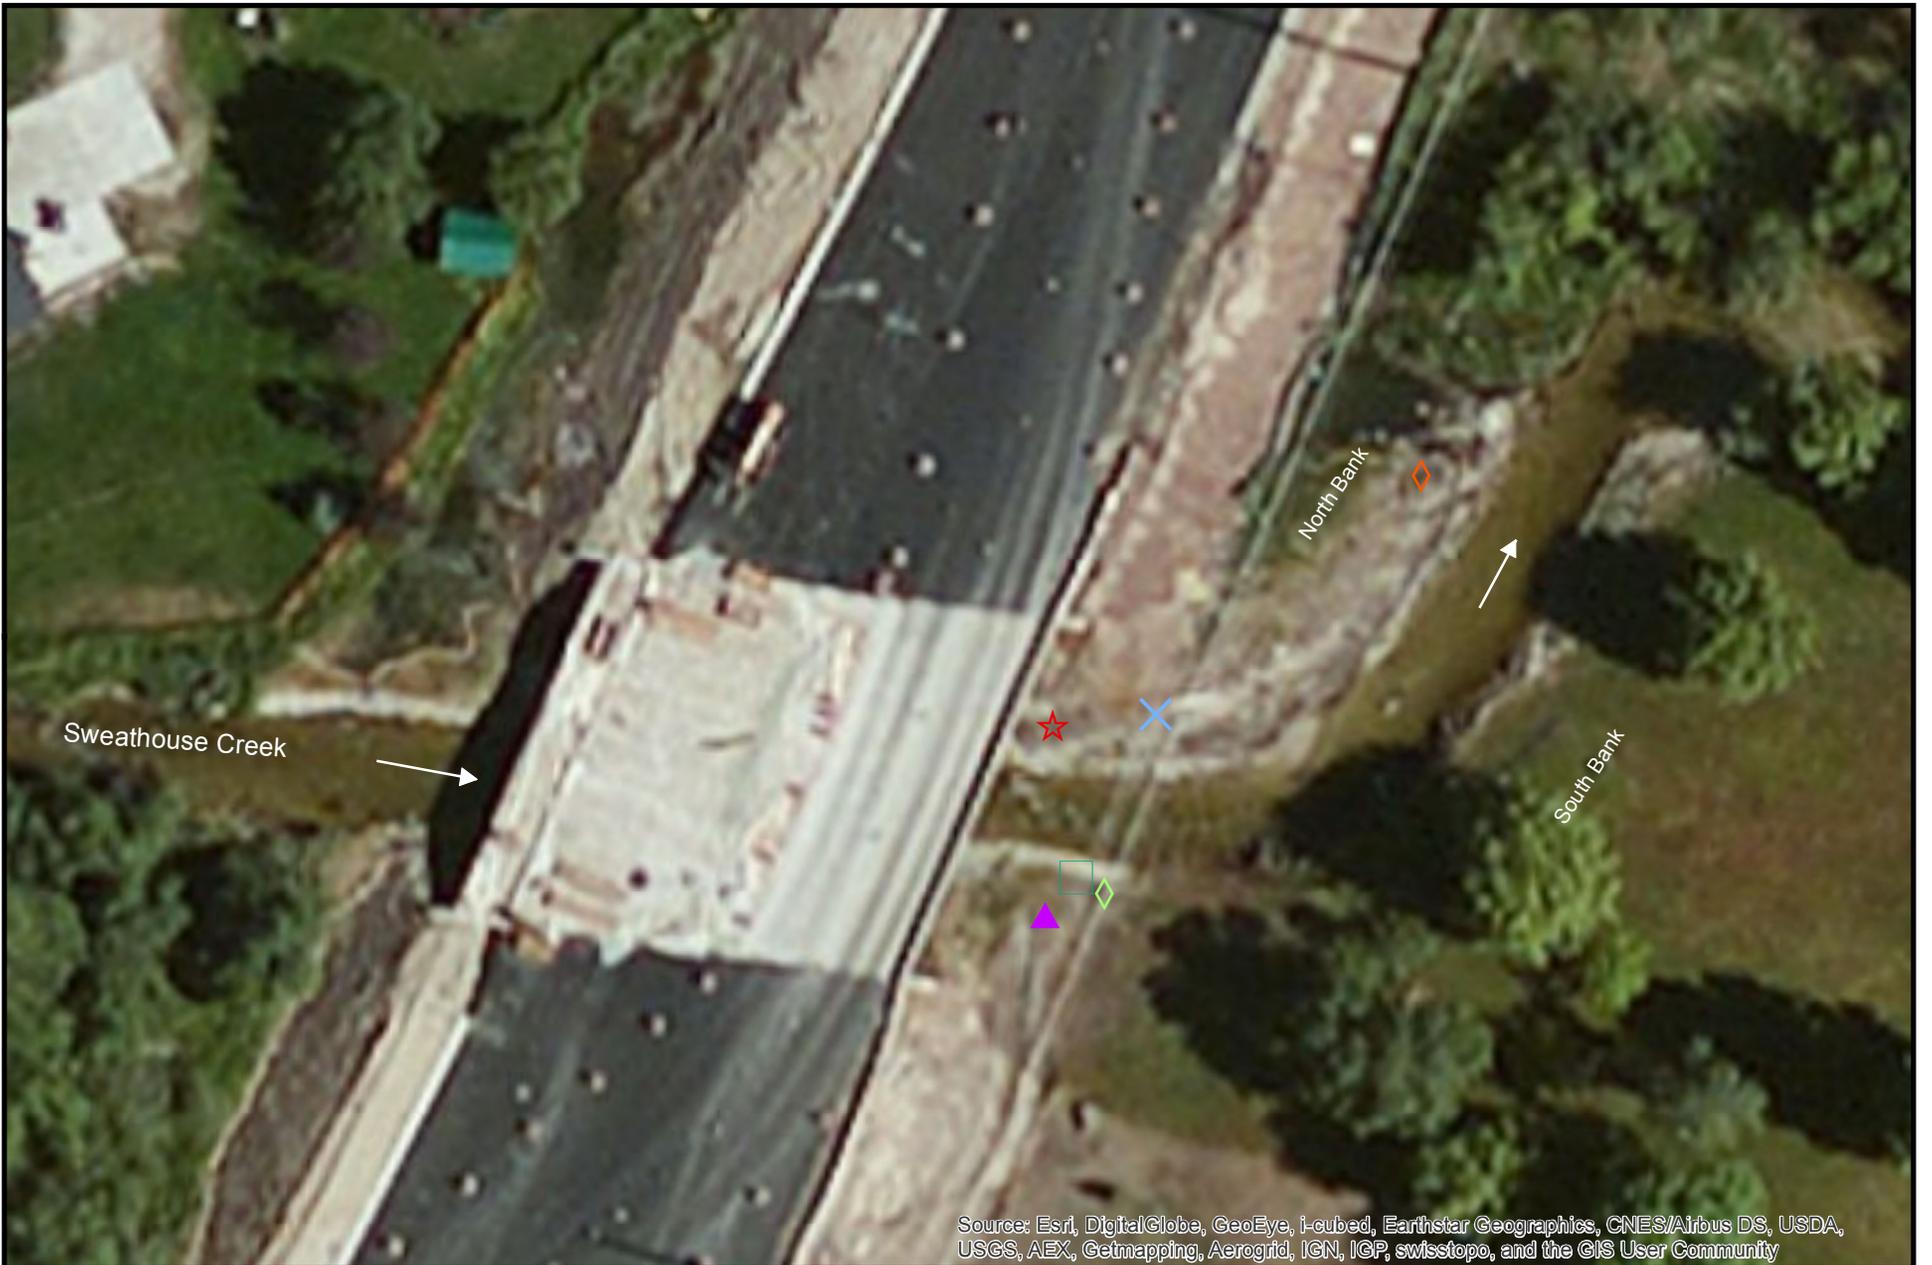
The vegetation inventory along Sweathouse Creek identified six Montana state-listed noxious weeds and one state-regulated species (Table 3). All noxious weeds were observed in trace amounts, with locations shown on Figure 3 in Appendix A.

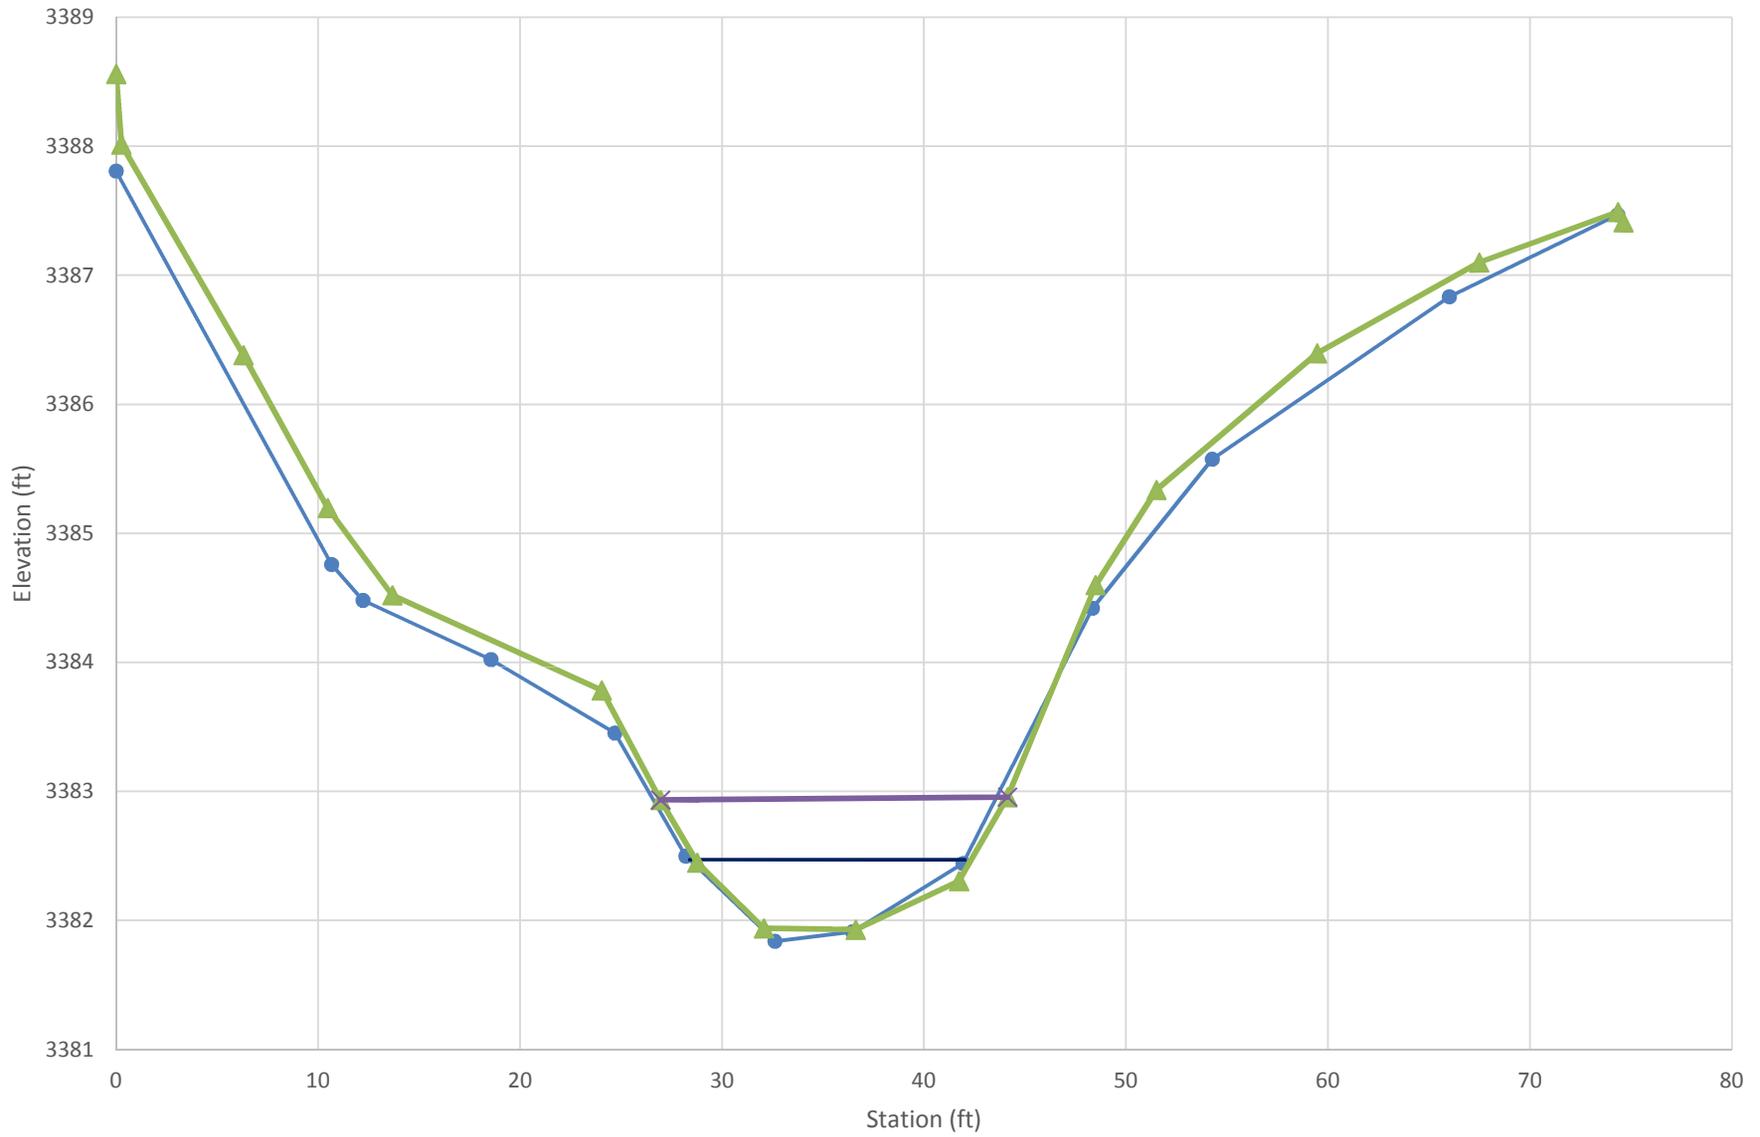
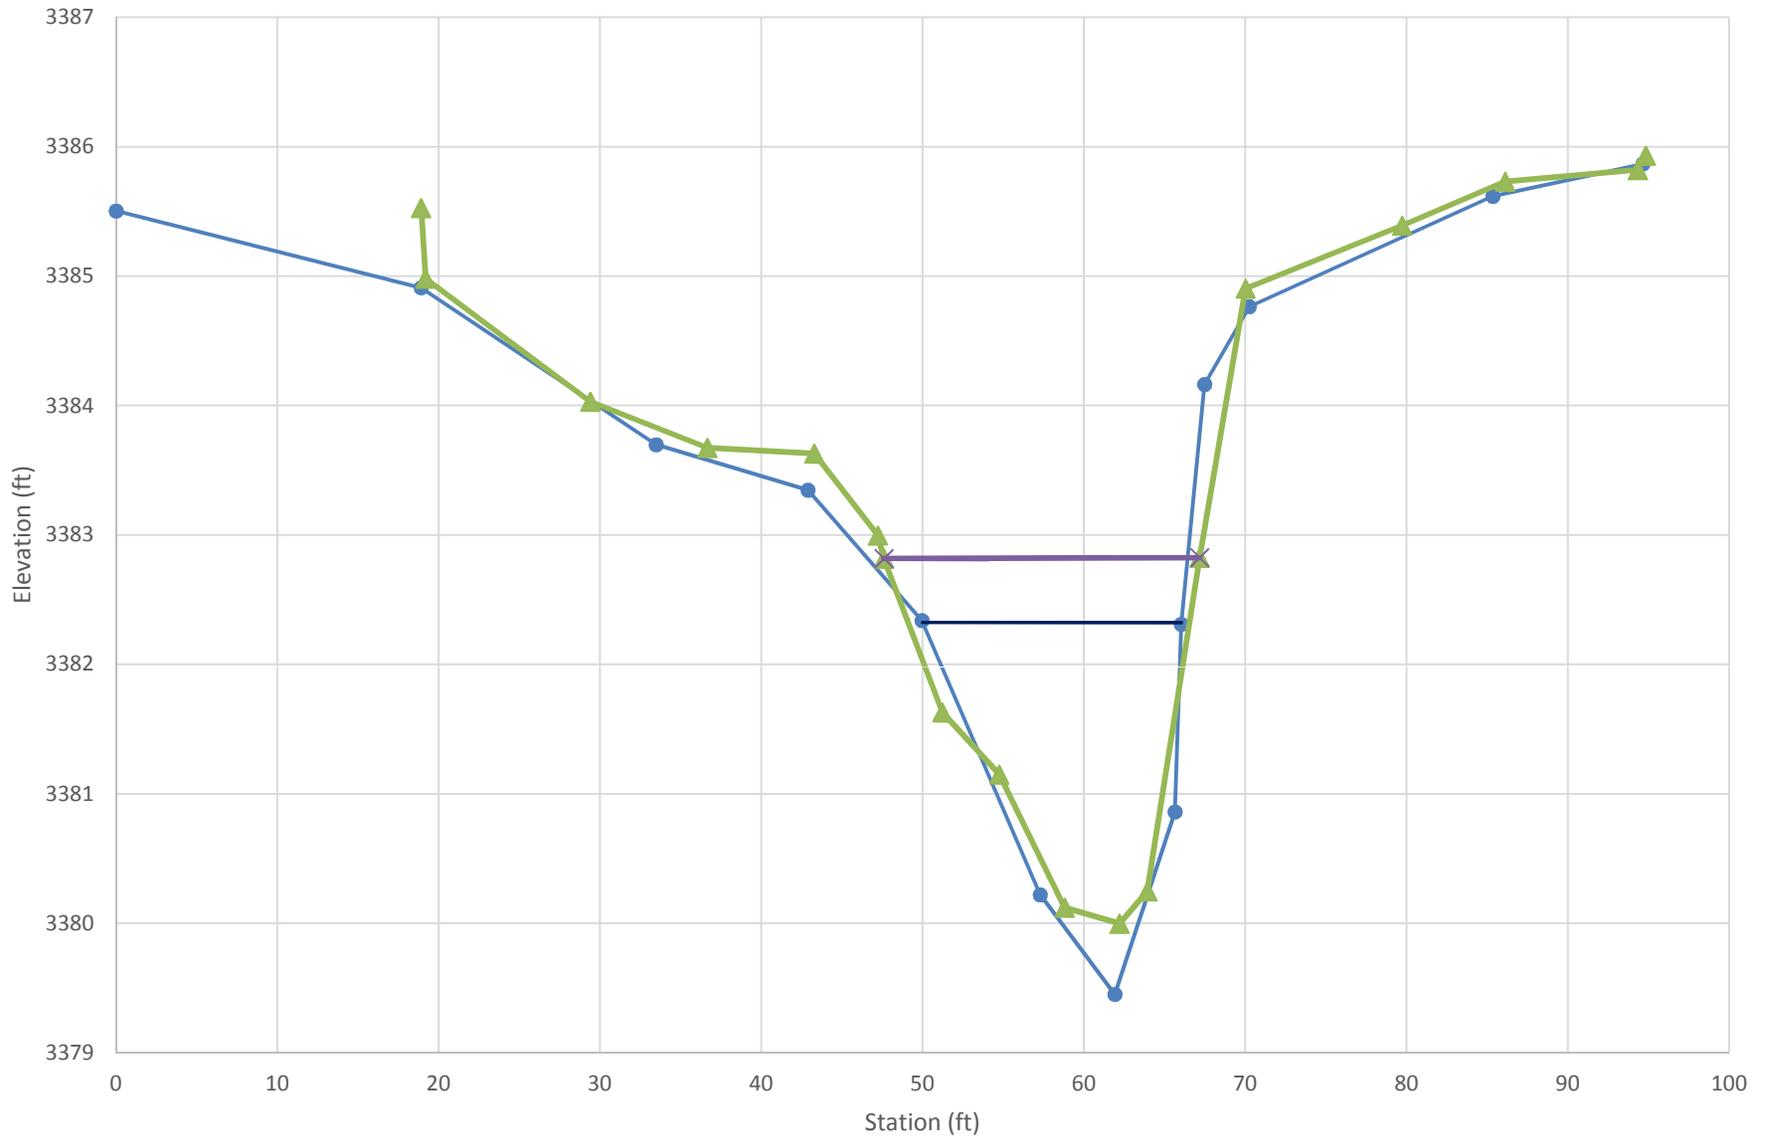
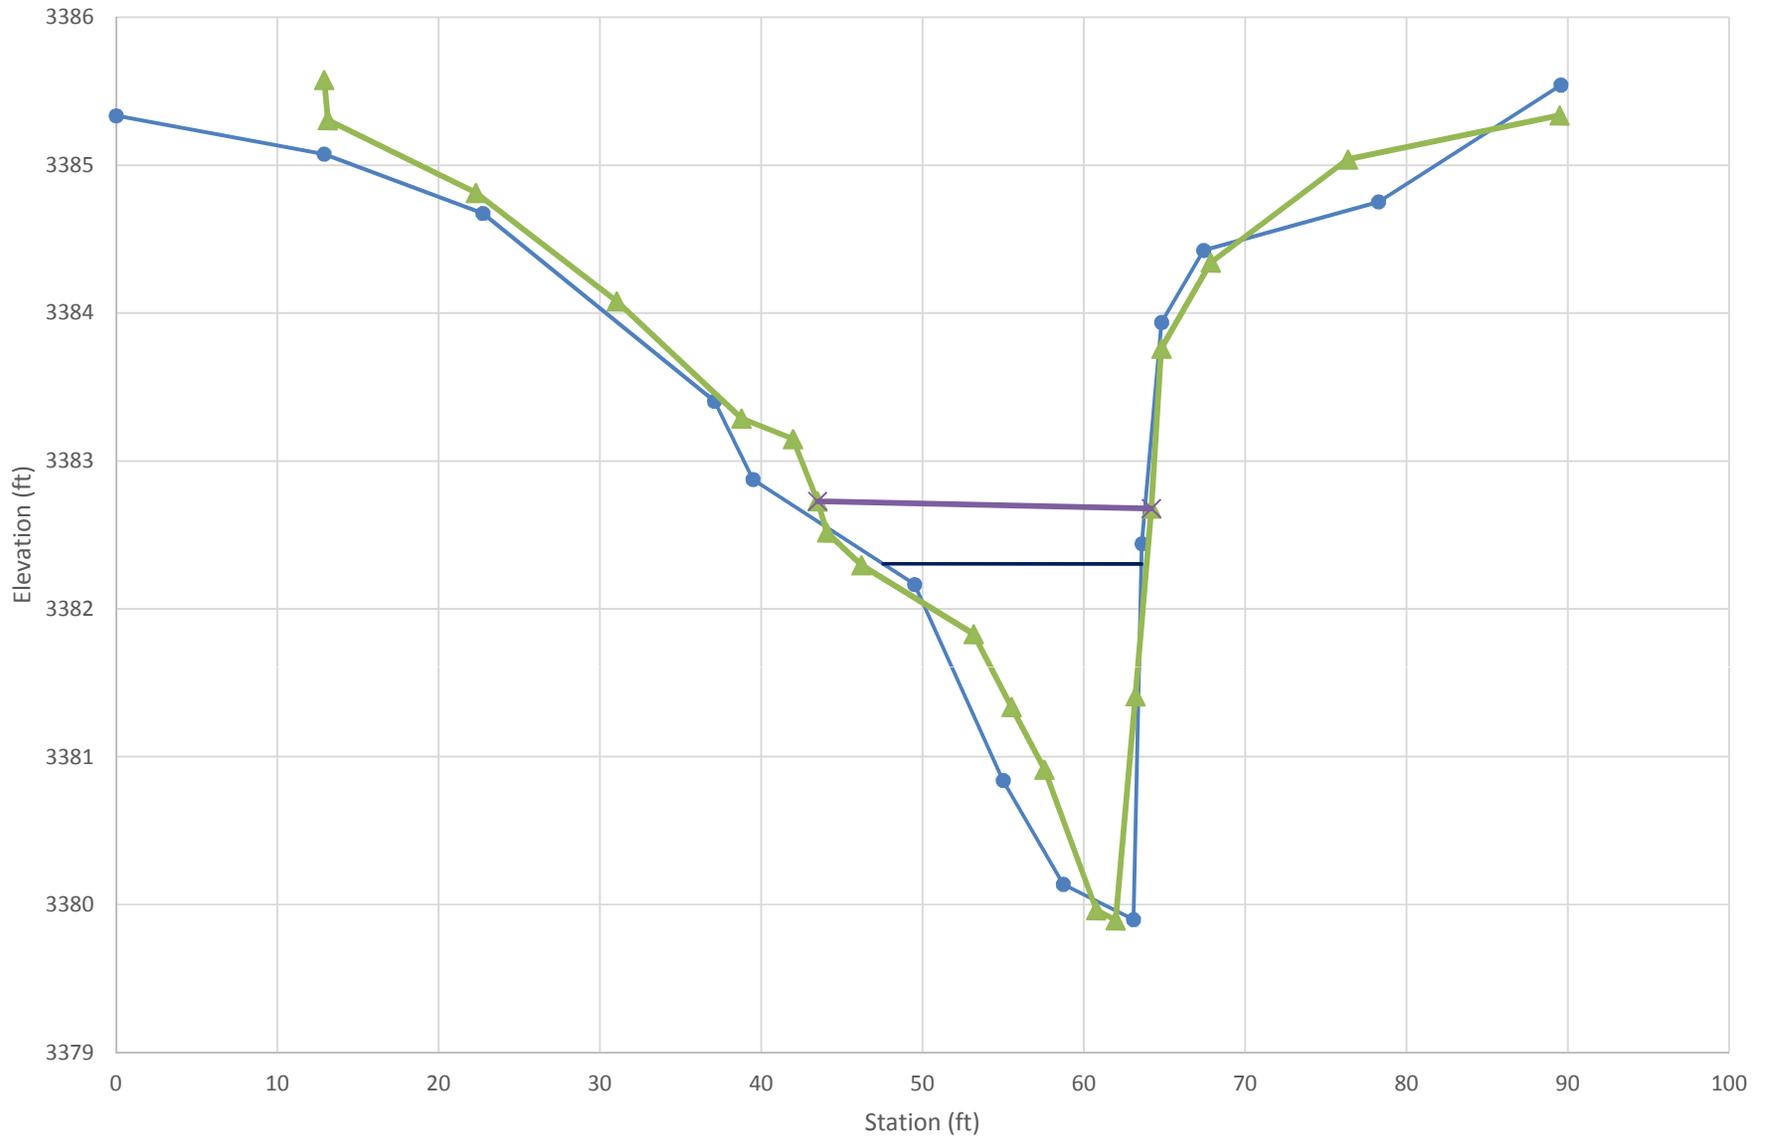
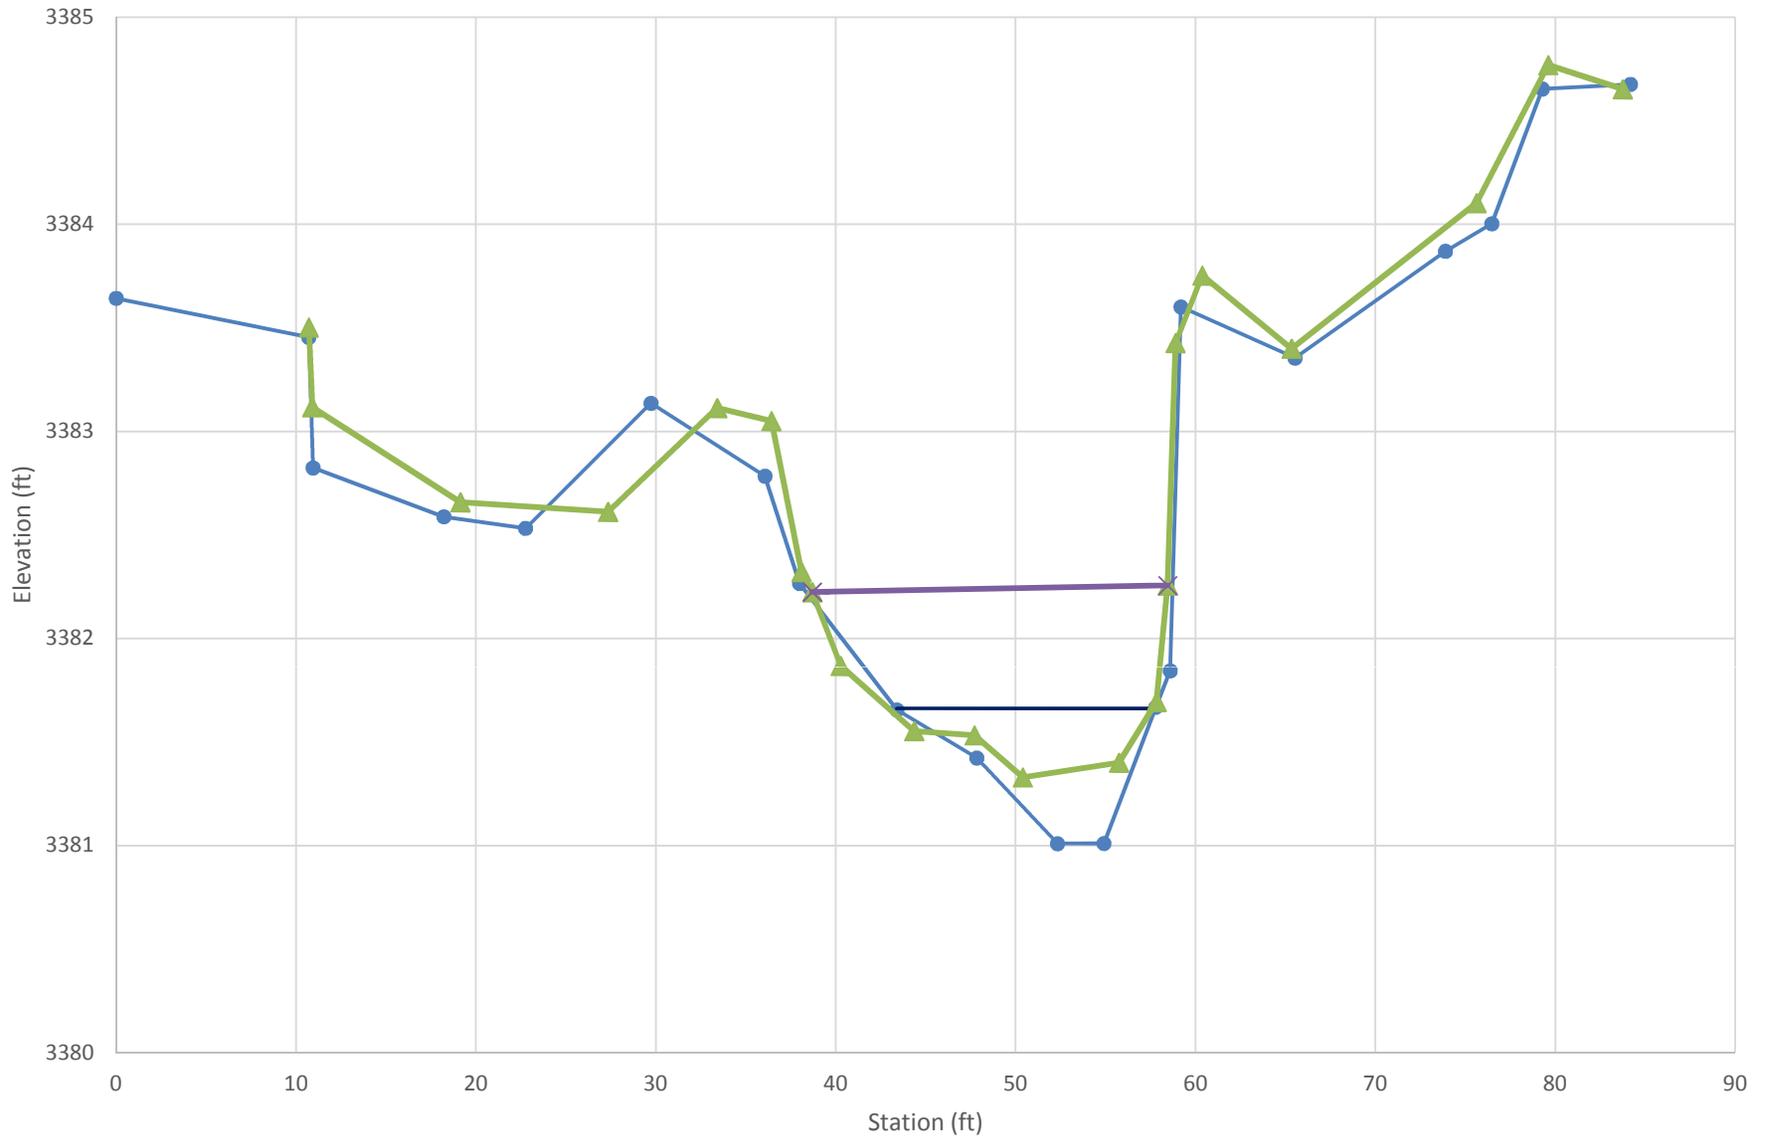
Four perpendicular transects within the project were re-surveyed, including two pools and two riffles. Plots for each surveyed transect are included in Appendix B. Repetition of these transects indicate relatively minor adjustments to the bed and banks. Both pools appear to be maintaining deeper water habitat by scouring against woody structures installed on the right bank. Riffles also largely maintained bed elevations and channel dimensions, indicating relatively good sediment and bedload transport. No evidence of erosion was noted at any of the surveyed transects. Perpendicular transects will be re-surveyed during subsequent monitoring events to document bar formation, pool depths, or lateral channel movements.

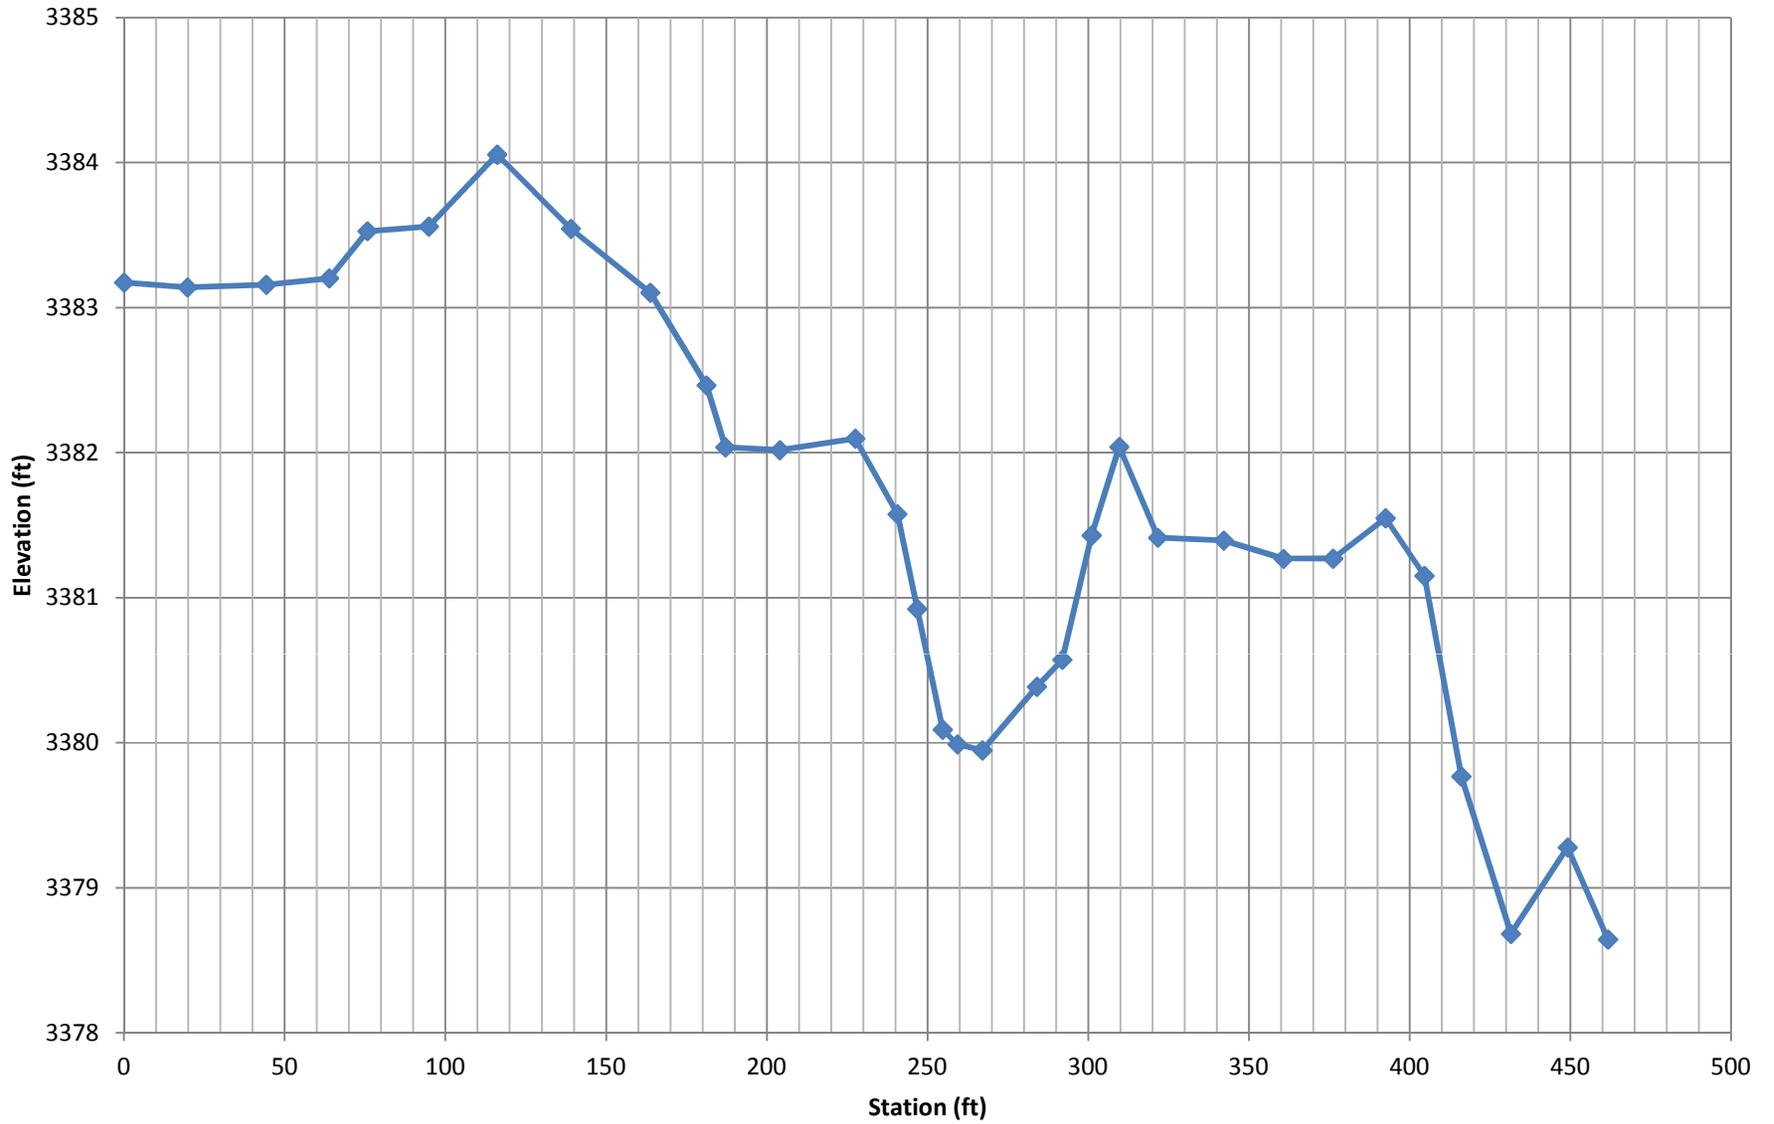
# Sweathouse Creek Longitudinal Profile

A longitudinal profile of the channel thalweg is also included in Appendix B, Inspection of this profile indicates the presence of one long pool extending from STA 2+30 downstream to STA 3+10. This section of the channel has several root wads installed along the bank to encourage scour and pool development. Both pool transects surveyed lie within this segment of the channel. A second pool is developing on the next meander bend downstream, where the longitudinal profile ends. Continued monitoring of the channel bed elevation will document whether and aggradation or degradation is occurring within the project reach.

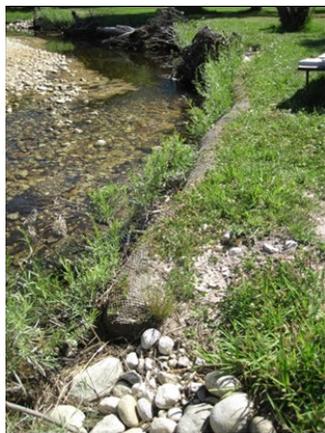
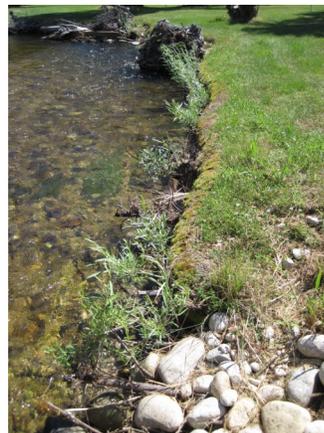
**Photo Point 2.1—2013**  
**Description:** View of un-keyed coir log on south bank  
**Compass:** 90 (East)

**Photo Point 2.1—2014**  
**Description:** View of un-keyed coir log on south bank  
**Compass:** 90 (East)

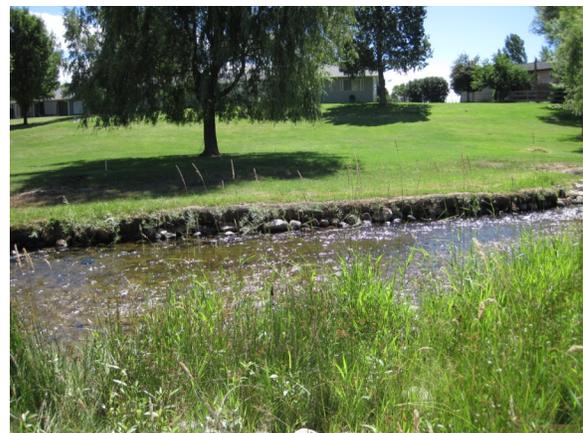
Monitoring observations noted the landowner south of the project reach is mowing all of the vegetation down to the stream bank (Photo Point 6.2). In order to maintain long term bank stability downstream of the bridge, it is important to maintain a healthy, unmowed vegetative buffer between the lawn and the stream bank to promote root growth and soil stability between and downstream of the root wads. It is recommended that MDT establish an agreement with the adjacent landowner to maintain a minimum buffer of 25' from the banks to encourage establishment of deep-rooted woody and herbaceous vegetation. In addition to erosion prevention, establishment of a riparian buffer would help protect water quality in Sweathouse Creek by filtering any adjacent herbicide or fertilizer applications.

**Photo Point 6.2—2014**  
**Description:** View of south bank looking across channel. **Compass:** 135 (Southeast)

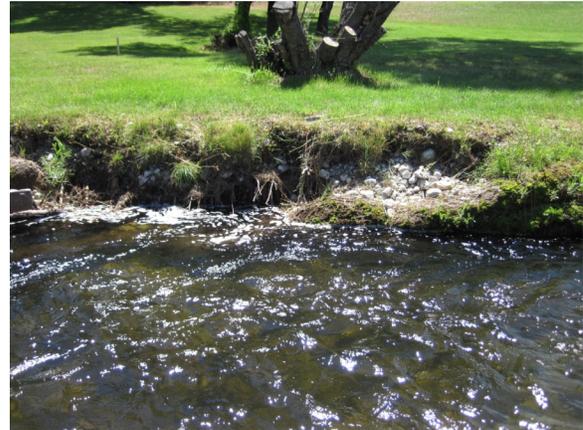
One eroding stream bank was documented along the right (south) bank between the first and second root wads downstream of the Highway 93 Bridge (Photo 4 in Appendix C). Erosion along this bank appeared due to scour of gravels and cobbles that had been placed beneath the coir logs to construct the bank. Movement of these cobbles has resulted in a 15-foot segment of the bank to undercut, loss of one coir log, and bank calving adjacent to a second coir log. Erosion along this bank is considered moderate due to a relatively short eroding segment and lateral migration rate. The top of the poorly vegetated bank is now exposed to stream flows that will continue to scour against this bank during high flows. Willow cuttings installed along the toe of this bank, as well as the entire length of the right (south) bank have been trimmed, and the herbaceous vegetation planted on the top of the bank has been consistently mowed. Trimming and mowing of all vegetation up to the stream bank was also noted in 2013. Trimming of willow cuttings can have a beneficial effect on establishing roots; however, trimming too much of the stem and leaves may result in reduced vigor and the inability of the cutting to effectively photosynthesize. Many of the cuttings appear to be establishing roots in the bank, which will help to provide long term stability.

One 15-foot section of Sweathouse Creek within the project reach showed signs of active erosion. This moderately eroding bank occurs between two root wads installed to protect the bank from lateral erosion. Coir logs placed to protect the upper bank have collapsed or been washed out, exposing the upper bank to active flows. Vegetation along this bank has been consistently mowed, and woody vegetation planted during the project's construction has only sparsely established along the bank toe. As a result of this bank, corrective actions are necessary to maintain 100% stability within the project reach.

**Photo 4—2014**  
**Description:** Eroding bank along right (south bank). **Compass:** 90 (East)
