EXPERIMENTAL CONSTRUCTION REPORT AND EVALUATION

3/8" ASPHALT CEMENT (AC) MIX PLACEMENT WITH NO CHIP SEAL (CS)

Project Name: Emerson Junction - Manchester

Project Number: IM 15-5(124)282

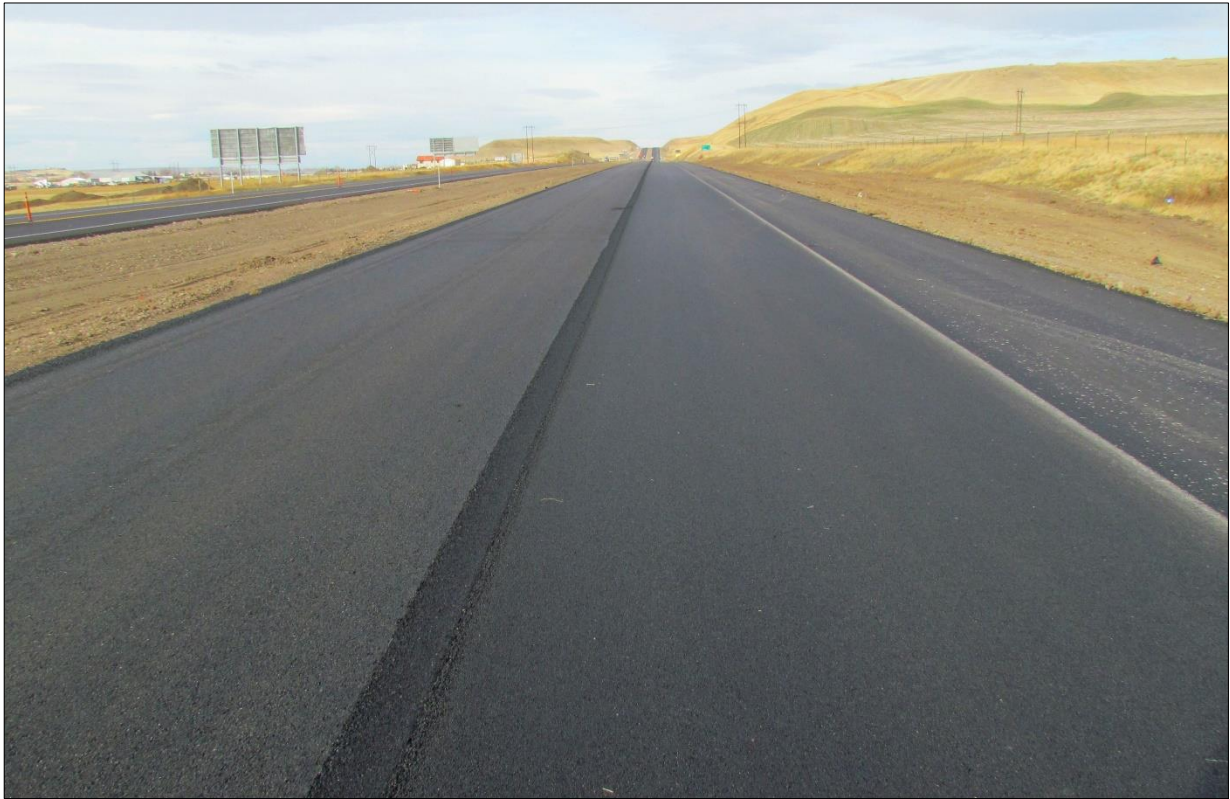
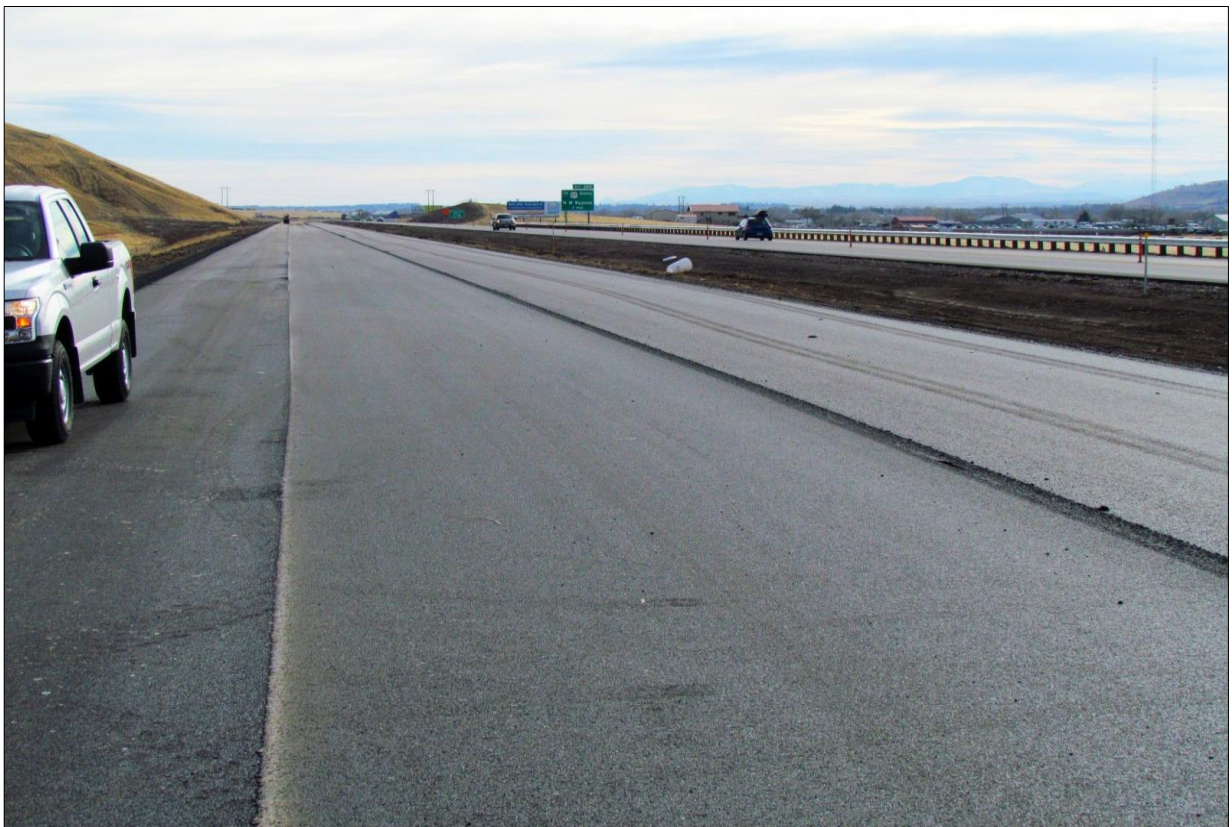
↕ Representative images of the 3/8" AC section at approximate reference point 282.5; upper view is northbound I-15 view north, lower image is northbound I-15 view south.

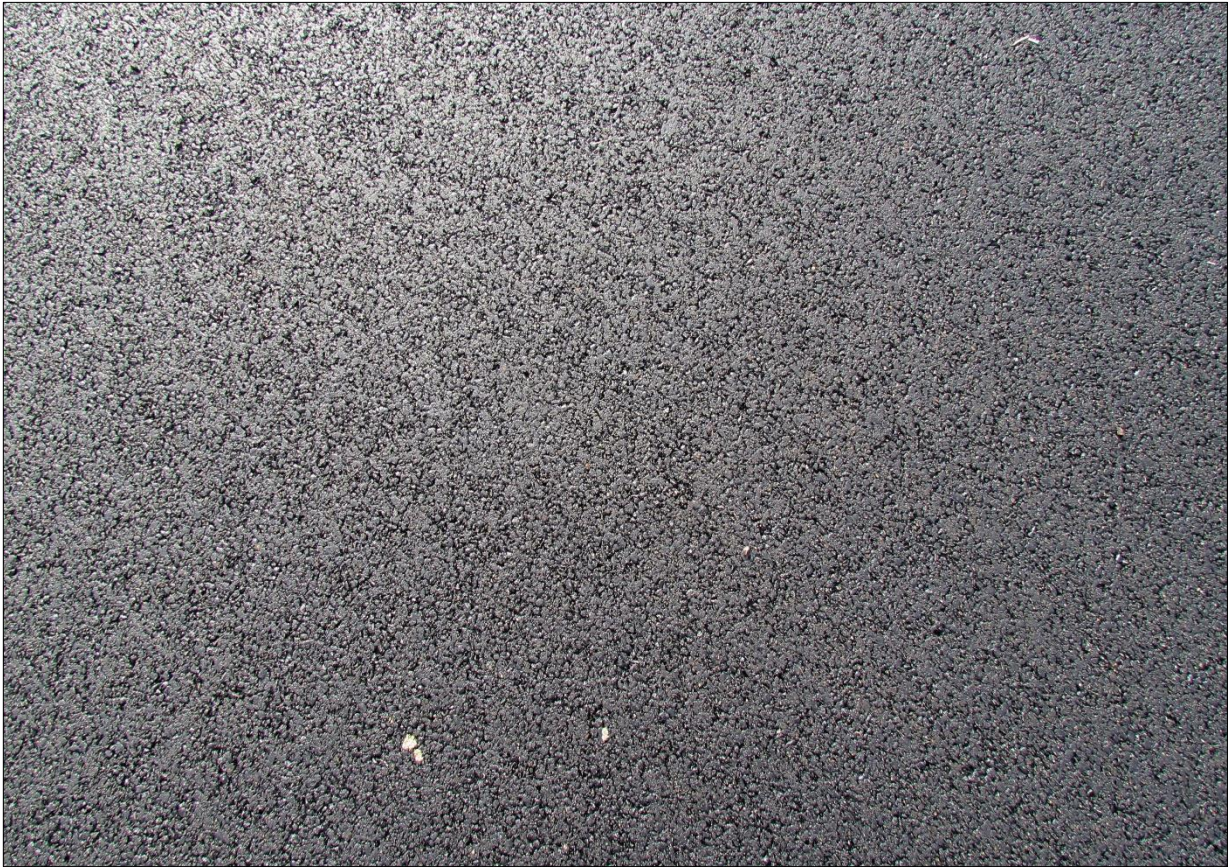
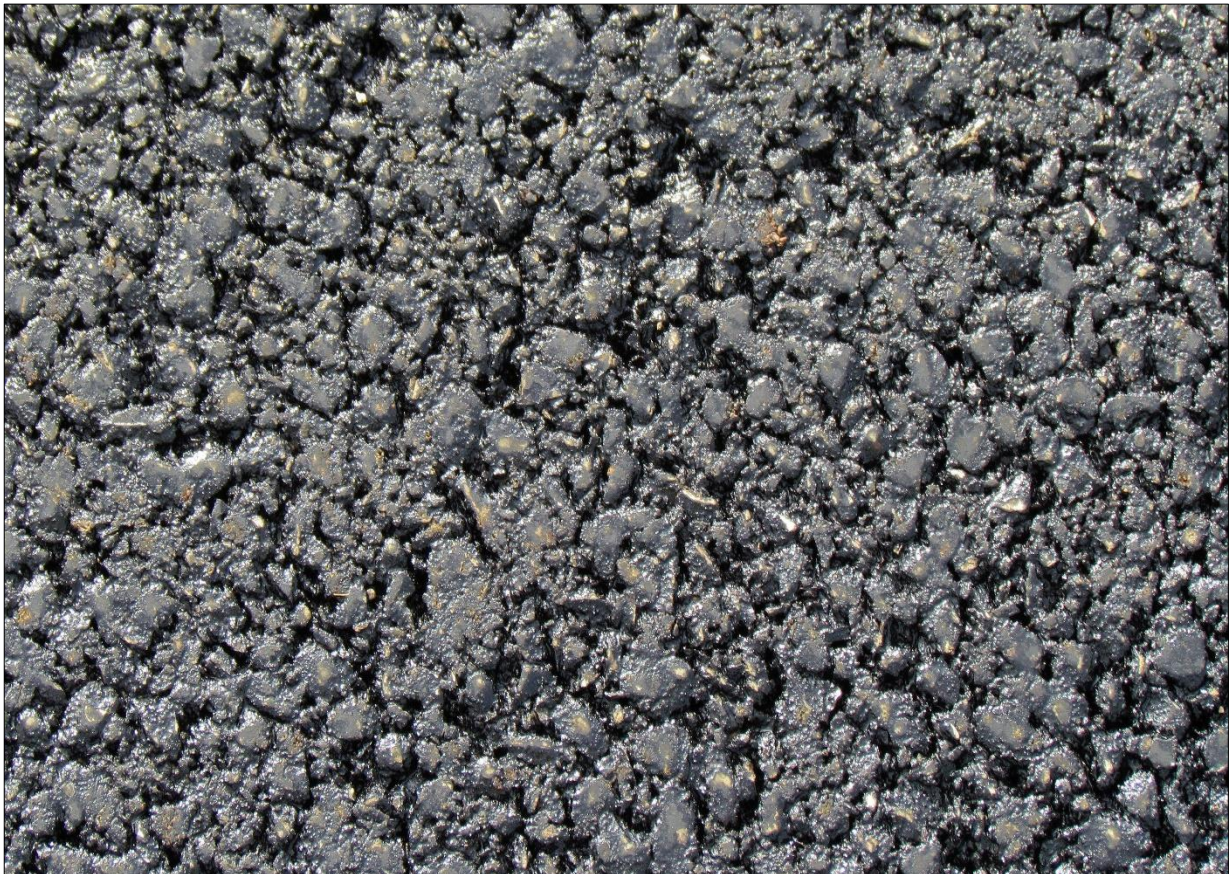
↑↓ Representative images of the 3/8" AC section pavement texture.

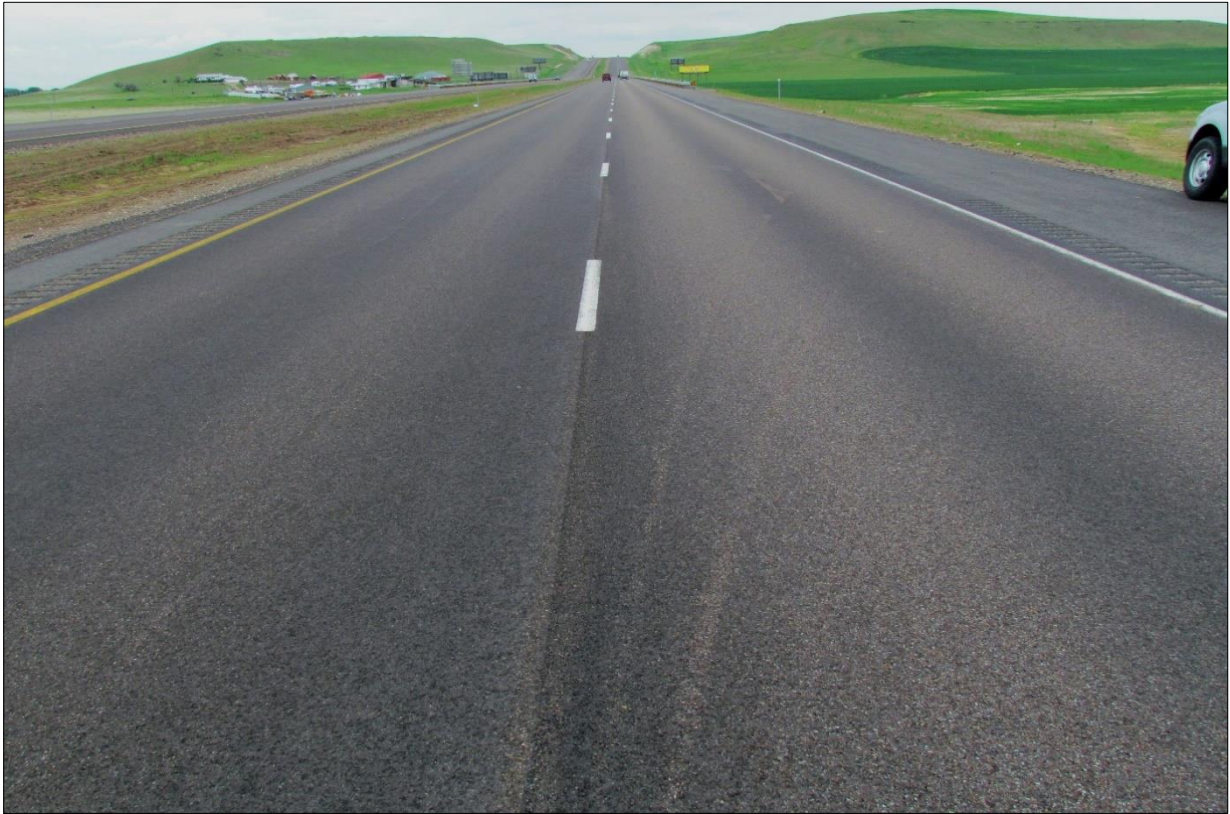
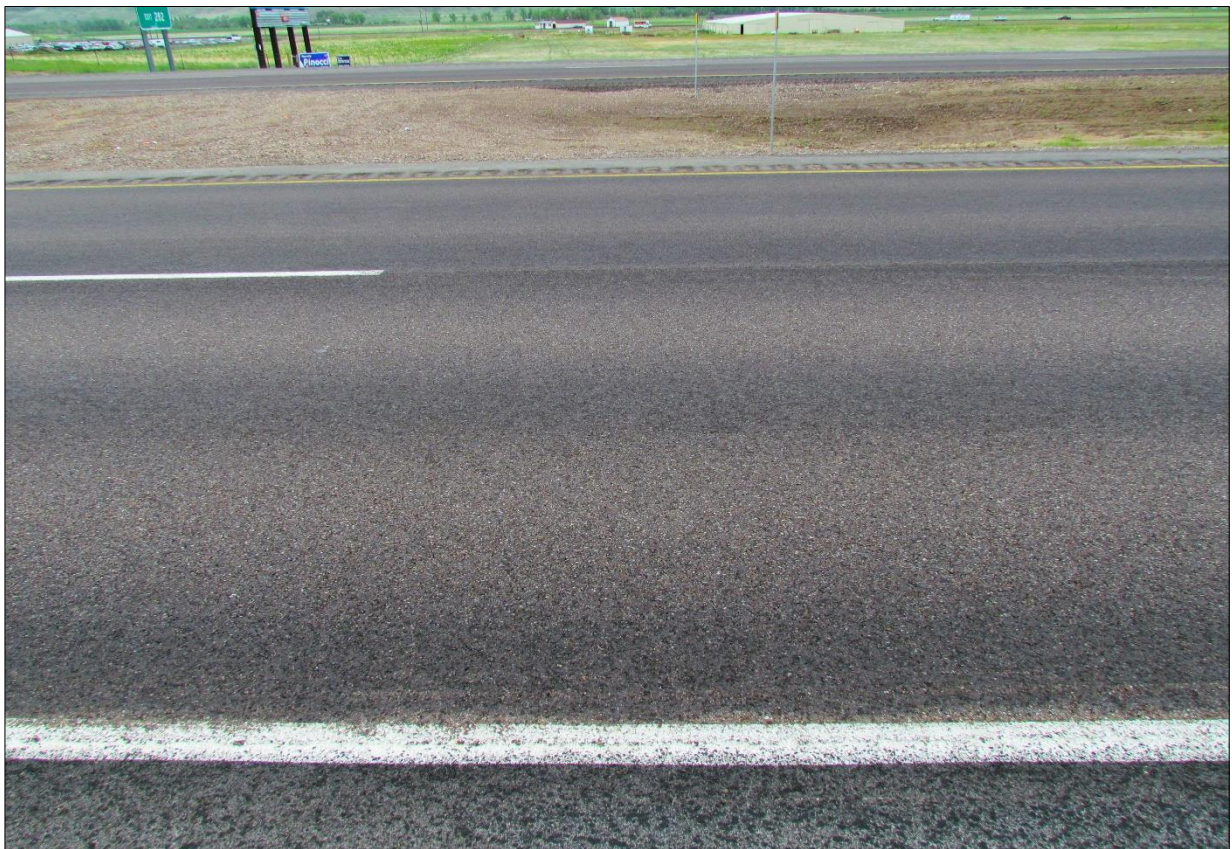
↑↓ Representative images of the 3/8" AC section at approximate reference point 282.5; upper view is northbound I-15 view north, lower image transverse view.

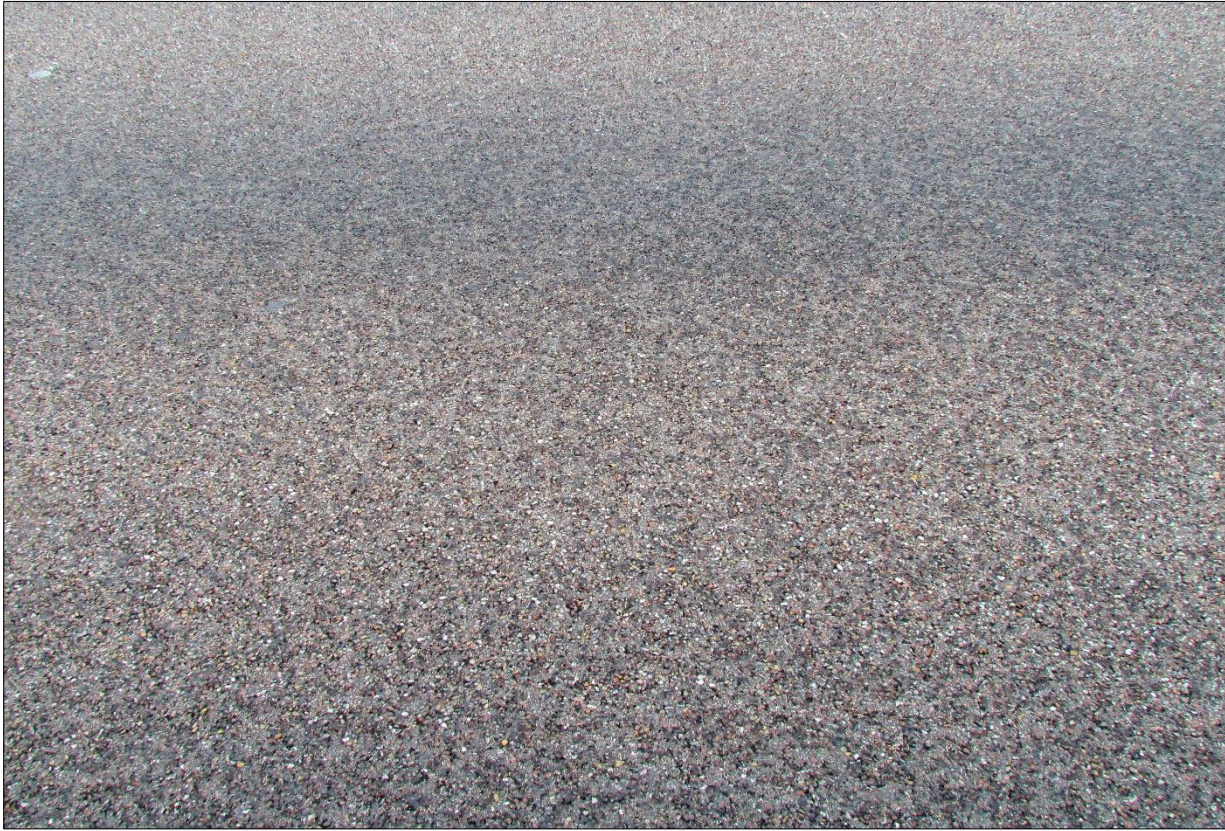
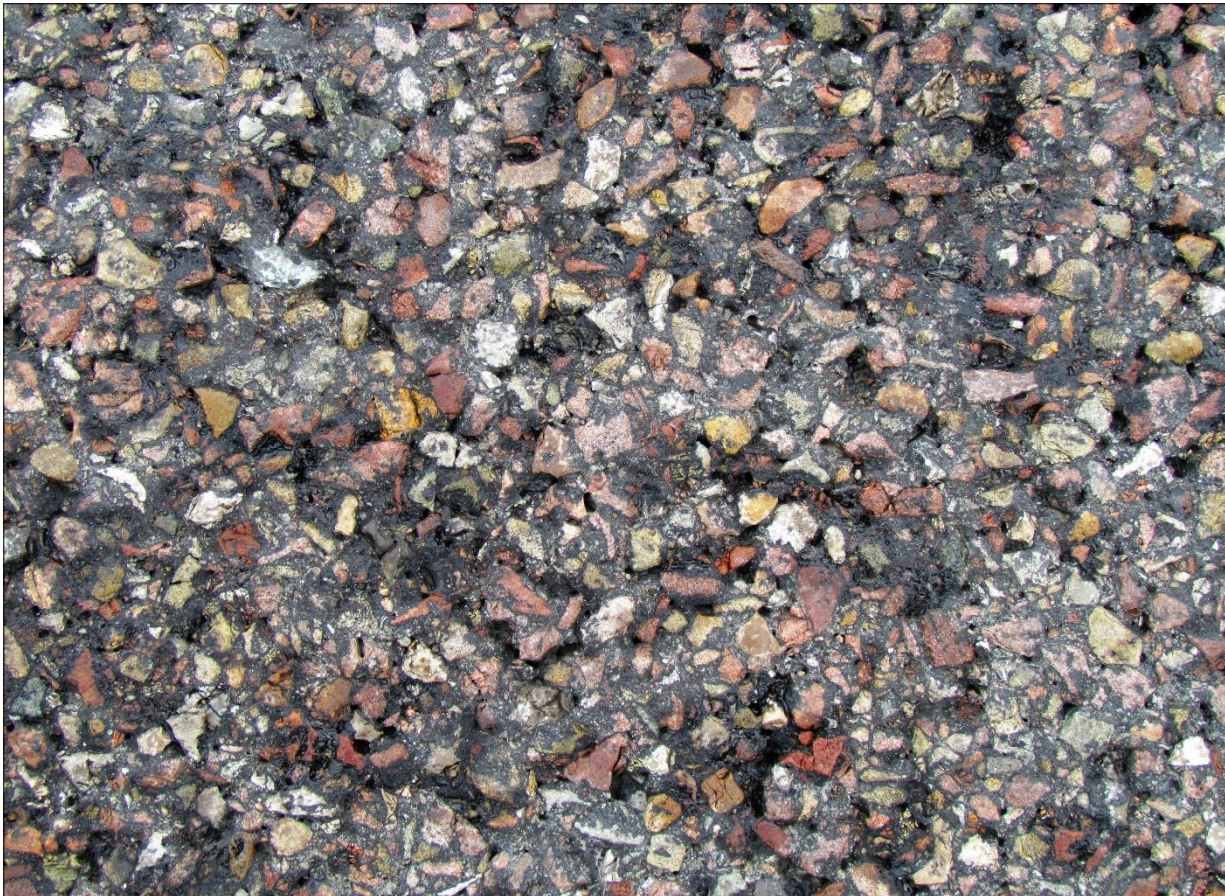
↑↓ Representative images of the 3/8" AC section pavement texture (surface was slightly wet).

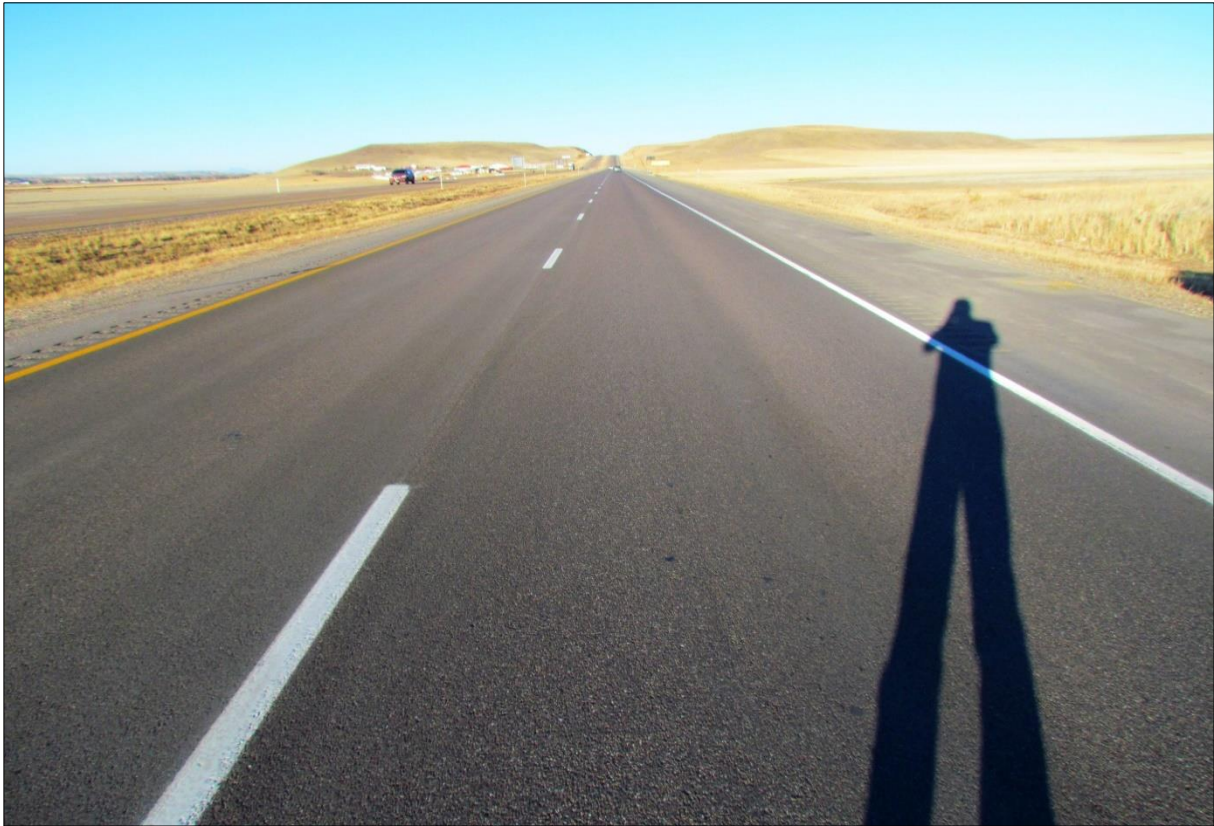
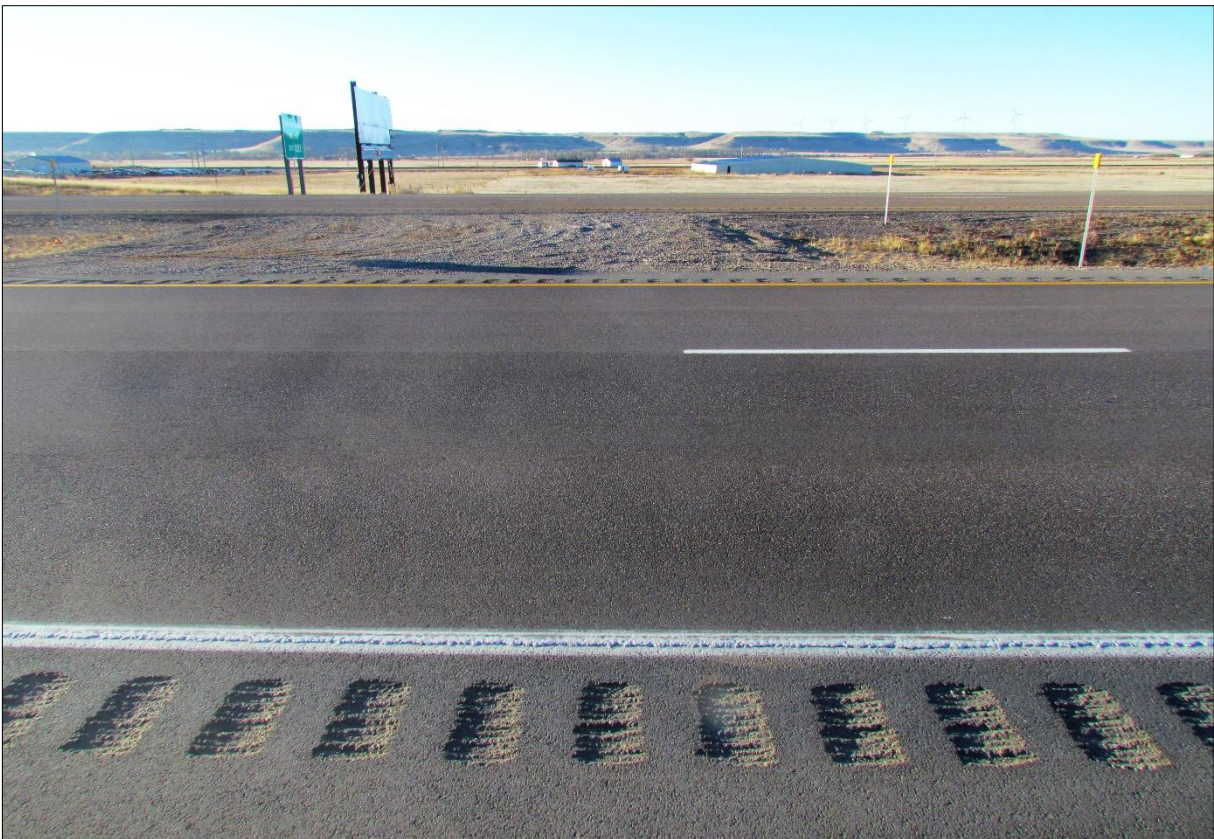
↑↓ Representative images of the 3/8" AC section at approximate reference point 282.5; upper view is northbound I-15 view north, lower image transverse view.

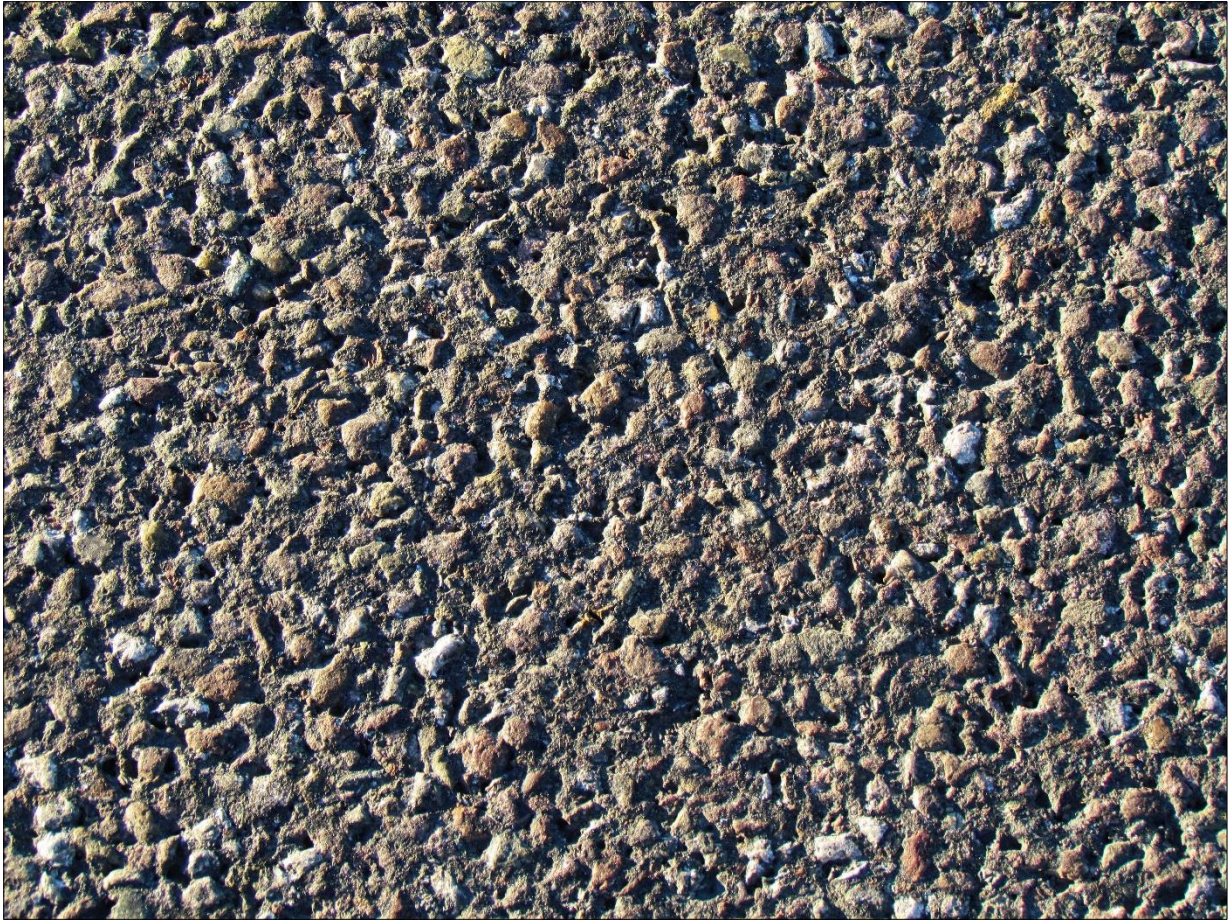
↑ Representative image of the 3/8" AC section pavement texture.

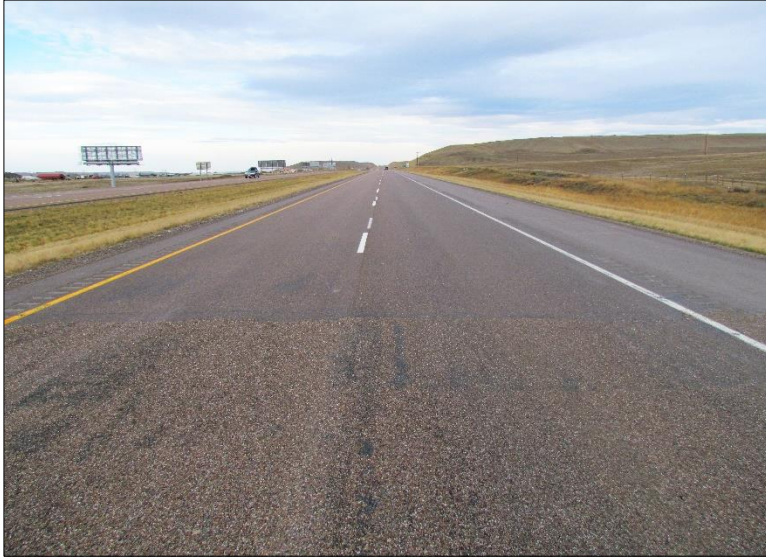
← View north at transition of chip seal and 3/8" section; approximate reference point 282.

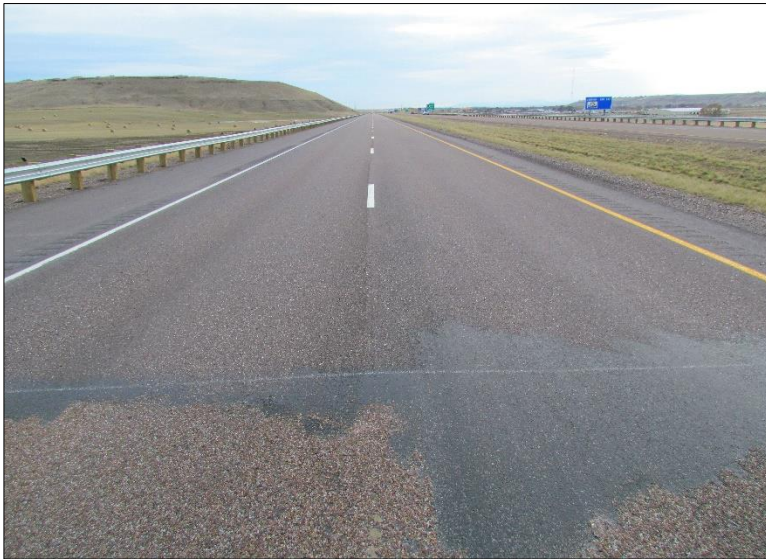
← View south at transition of chip seal and 3/8" section.

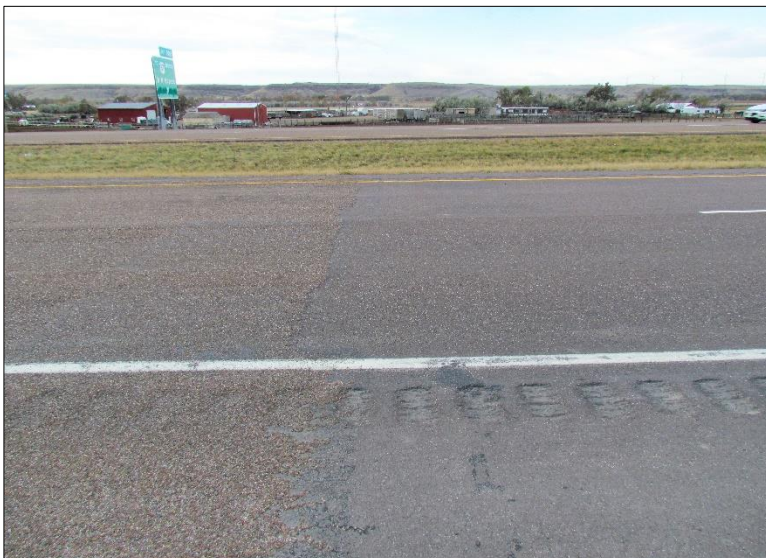
← Transverse view of 3/8" section (south end).

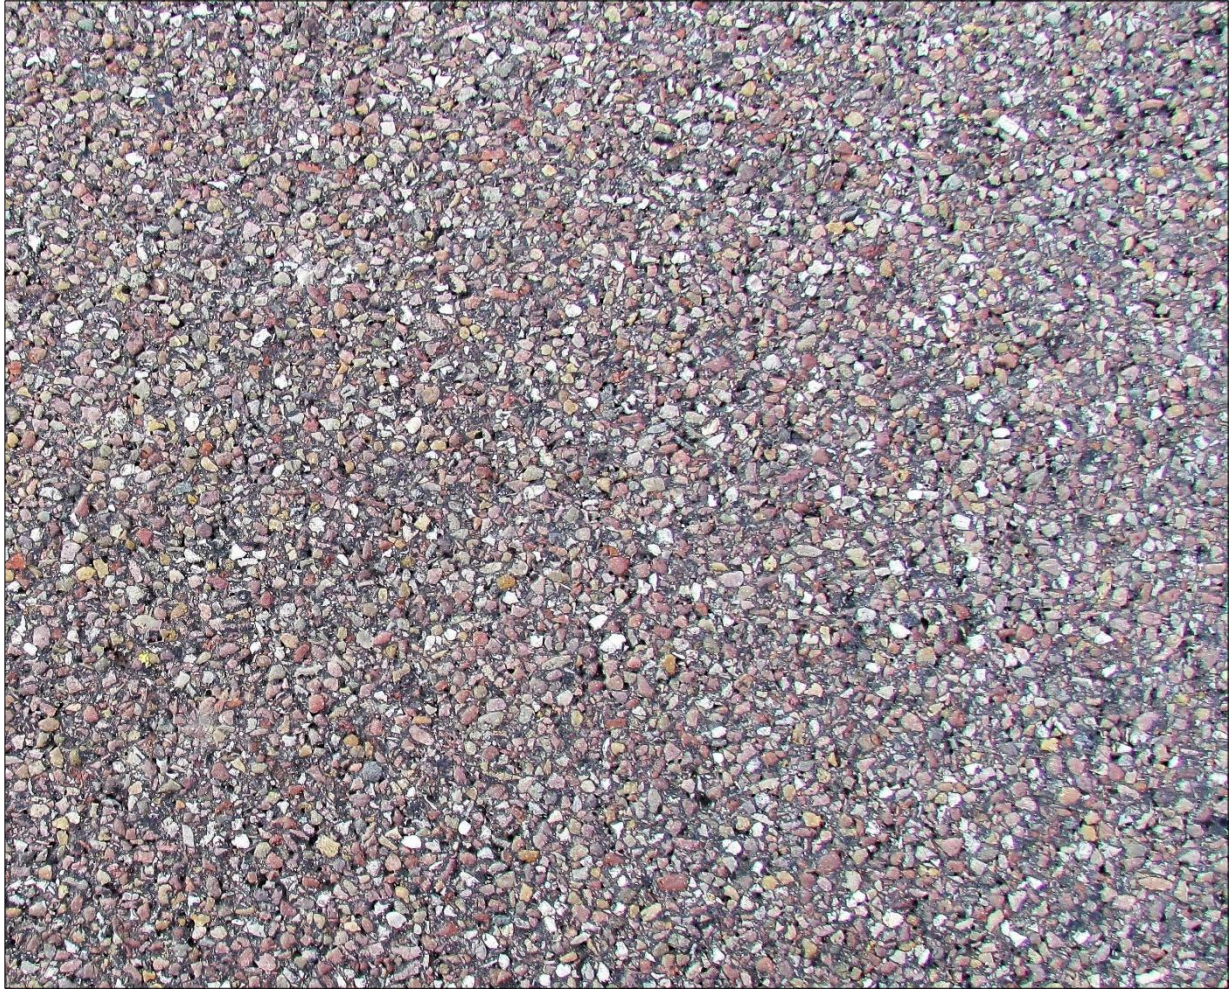
↑ Representative image of the 3/8" AC section pavement texture.

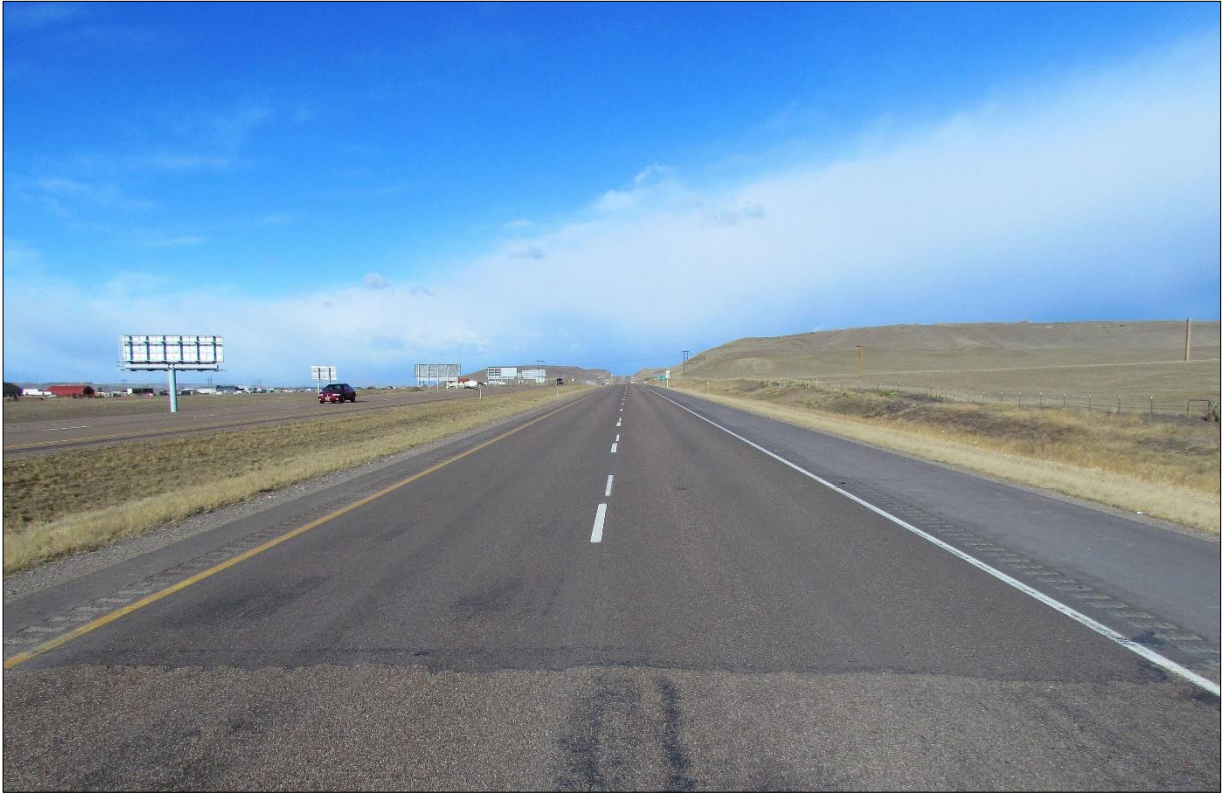
↑ Overview of project; south end view North.

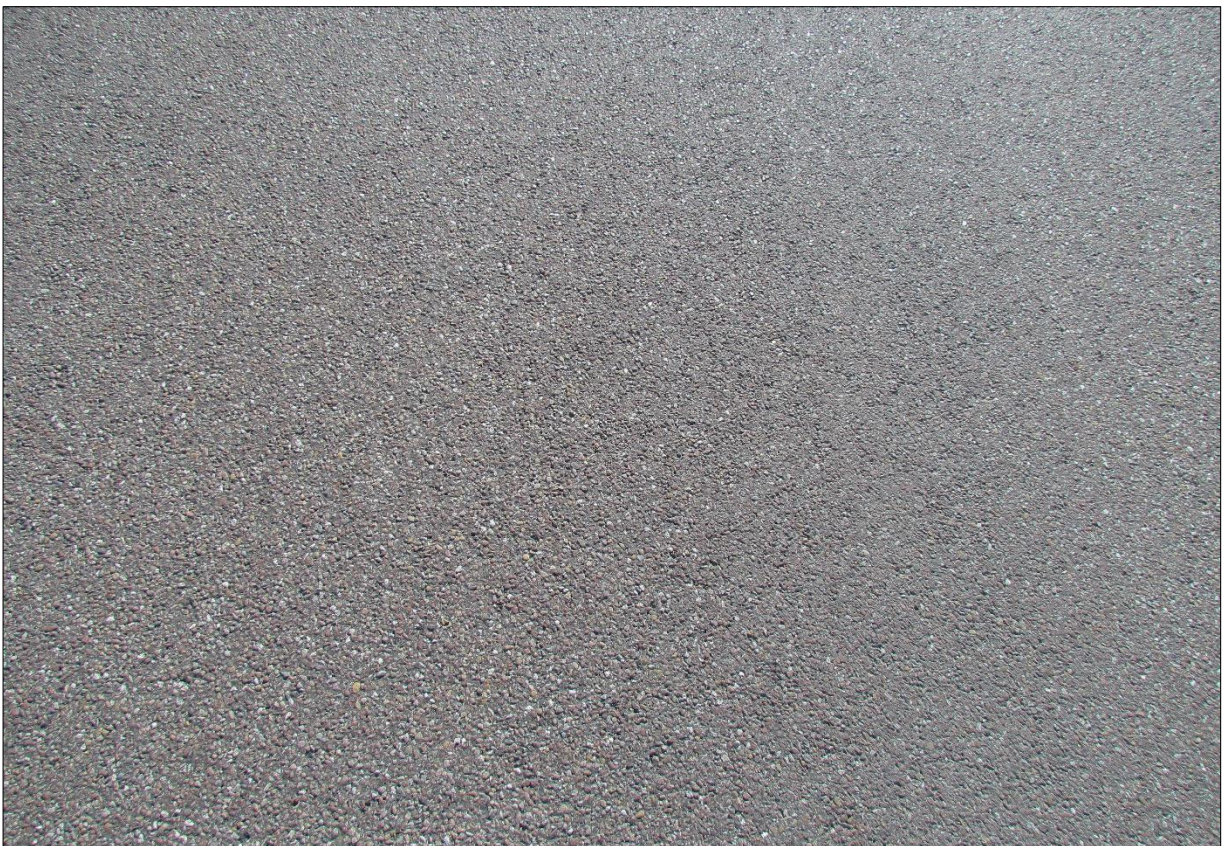
↓ Representative image of the 3/8" AC section pavement texture.

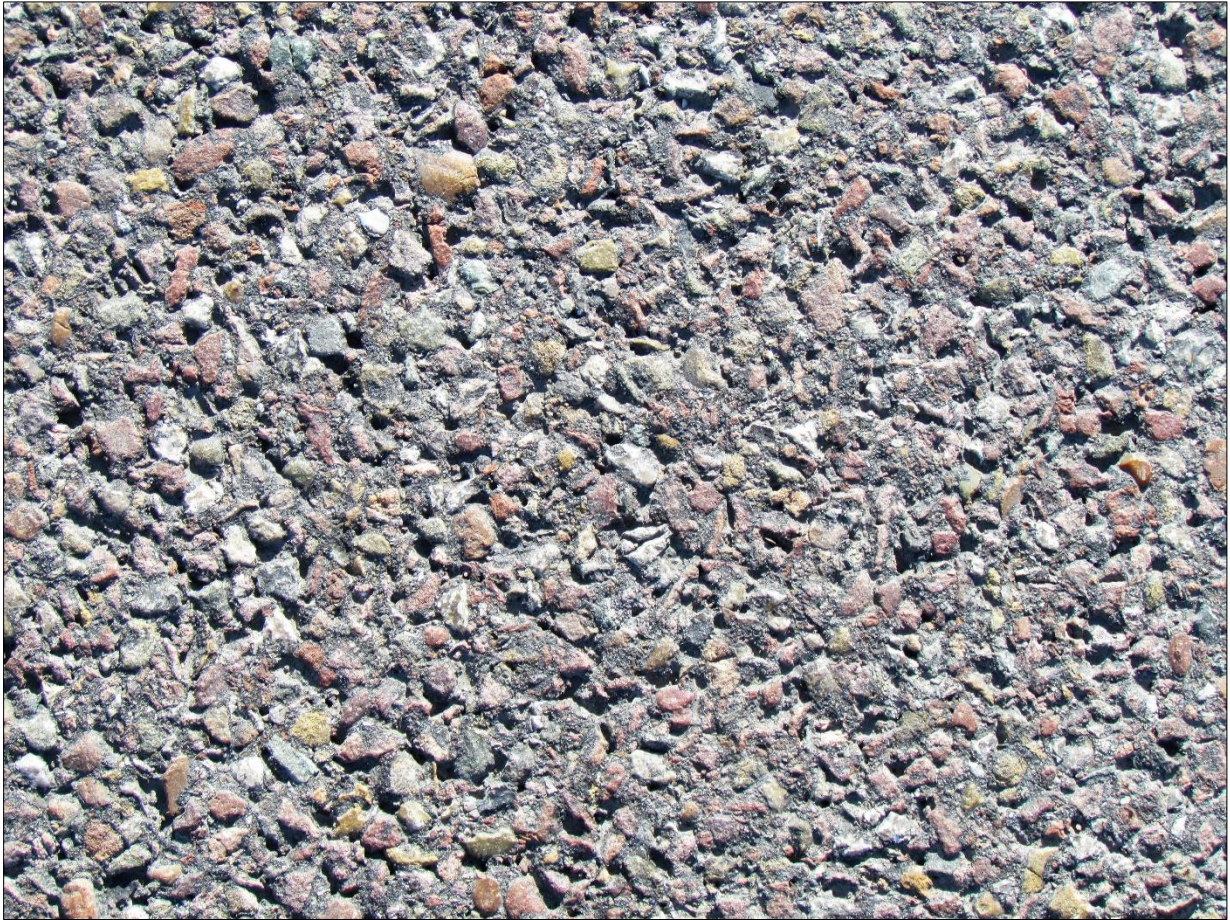
↑ Closer view of pavement texture.

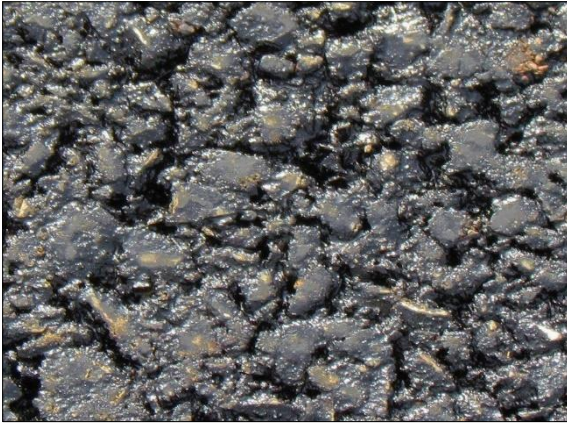
← Close-up of the 3/8" AC section pavement texture on **November 2017**.

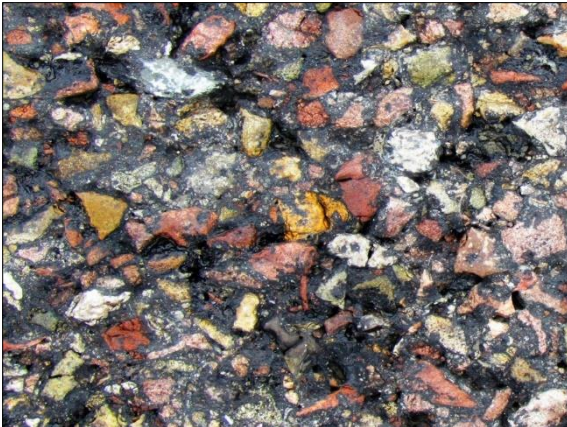
← Close-up of the 3/8" AC section pavement texture on **May 2018** (Note: pavement was damp when image was taken).

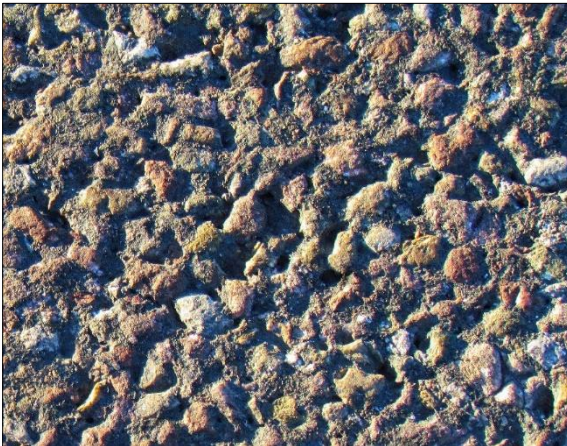
← Close-up of the 3/8" AC section pavement texture on **January 2019**.

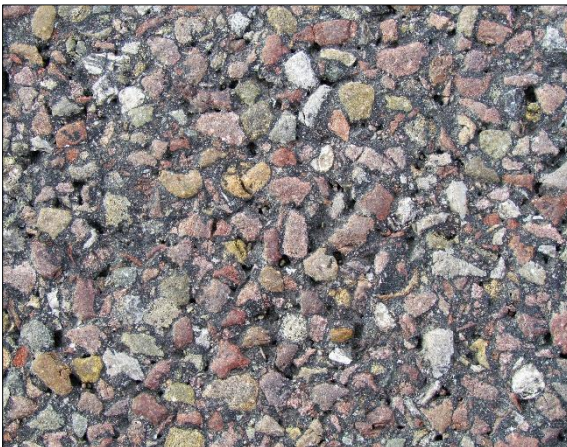
← Close-up of the 3/8" AC section pavement texture on **October 2019**.

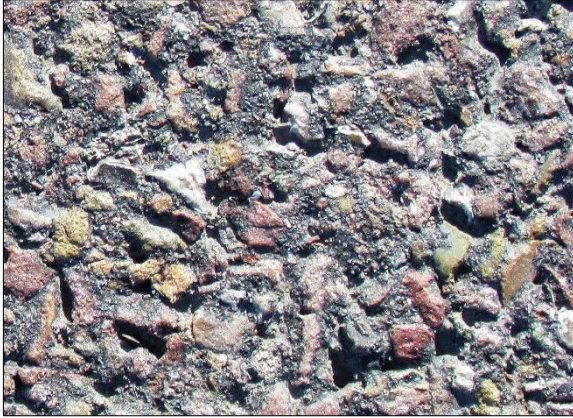
← Close-up of the 3/8" AC section pavement texture on **March 2020**.

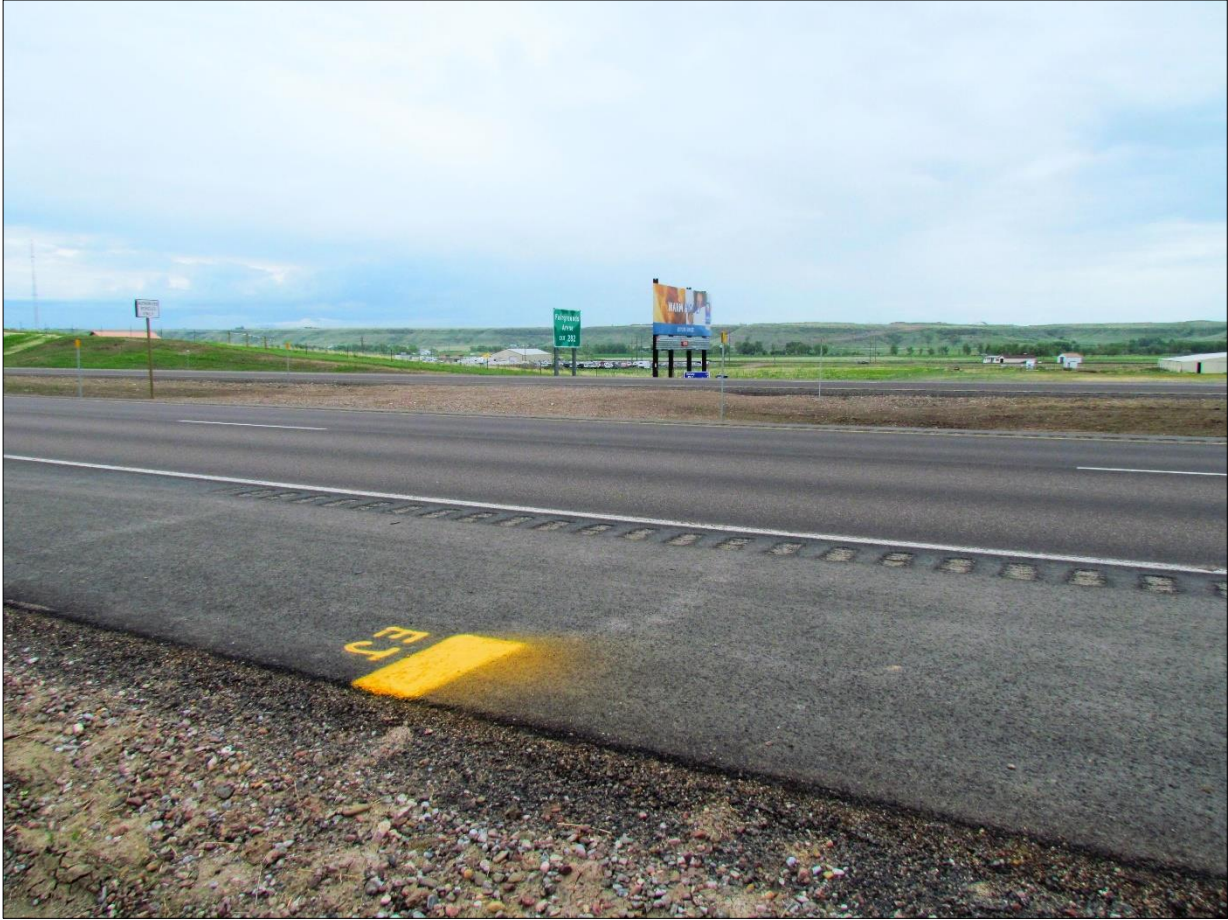
- ↑ The entire section of the 3/8" AC project will be inspected for any surface distress or anomalies which may occur during the timeframe of analysis and will be included in the ongoing project report.

The marking seen above is the static point (approximate RF 282.5) where most of the representative images of pavement condition will take place. During the May inspection the 3/8" AC section of the project had yet to be sealed. The site visit in January of 2019 delineated the sealed and unsealed sections.
