**Experimental Feature Evaluation  
 December 2022**

<b>Experimental Feature:</b>	Ace Fibers in Plant Mix Asphalt
<b>Location:</b>	Billings District, Yellowstone County, City of Billings, Division St and 6 <sup>th</sup> Ave N
<b>MDT Project Name:</b>	Division St – Billings & 6 <sup>th</sup> Ave N – 27 <sup>th</sup> to 32 <sup>nd</sup>
<b>MDT Project Number:</b>	UPPIP 1017(2)7[9003] & UPPIP 1029(4)[9004]
<b>Experimental Project Number:</b>	MT-18-03
<b>Principle Investigator:</b>	Chad DeAustin, Experimental Project Manager, (ExPM)
<b>Construction Date:</b>	July 2018
<b>Date of Inspections:</b>	April 2019, April 2020, May 2022

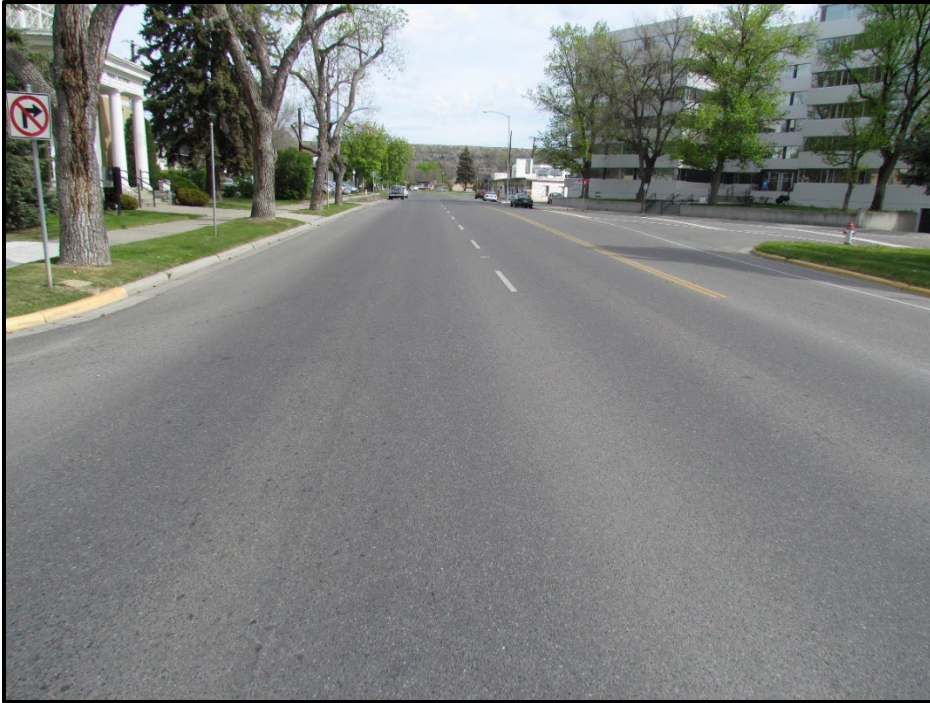
The surface shows little change from previous visits. There is surface wear but that is expected on a highly urban route. There were a few cracks found using the Pathweb web application but not seen during the site visit.

↑ Division St and Burlington Ave, view north.

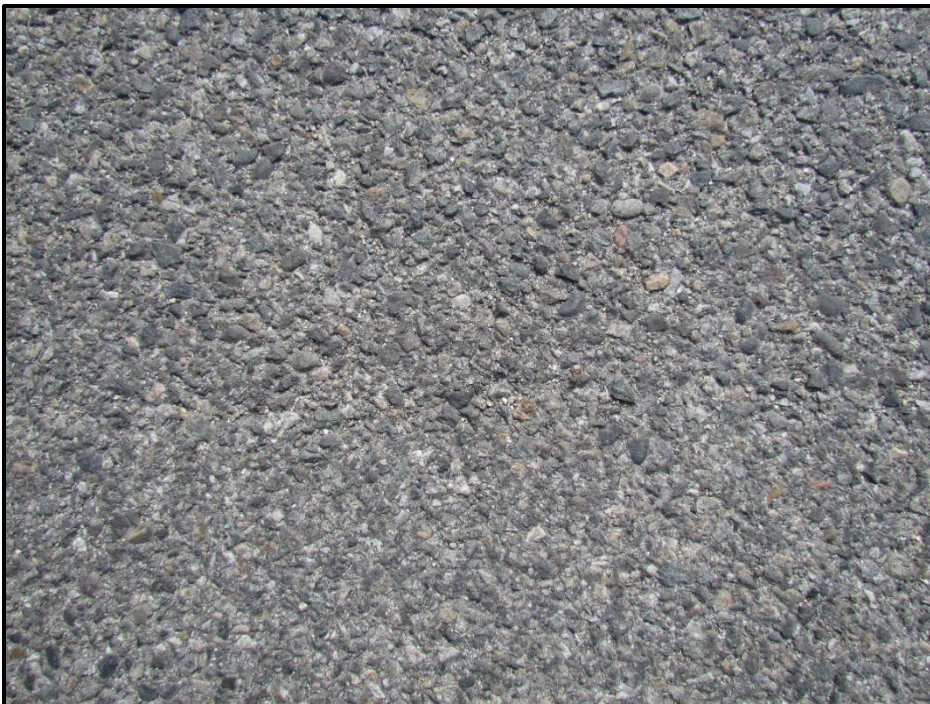
↑ Close-up of surface on Division St.

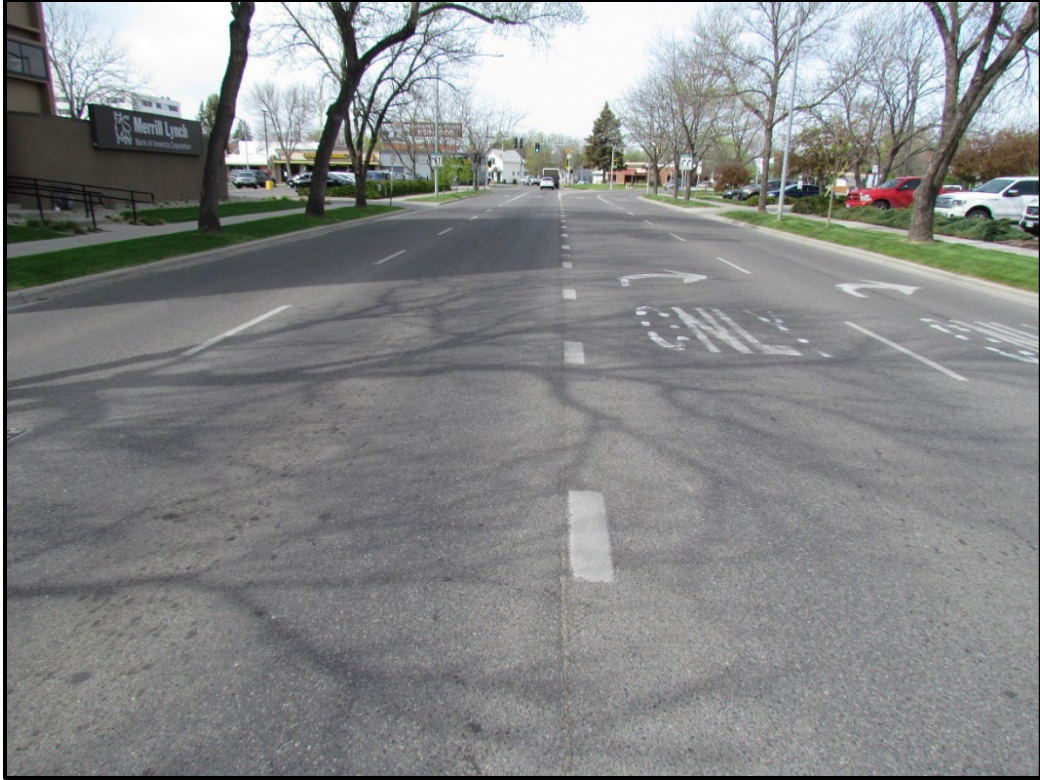
↑ 6<sup>th</sup> Ave N and N 31<sup>st</sup> St, view west.

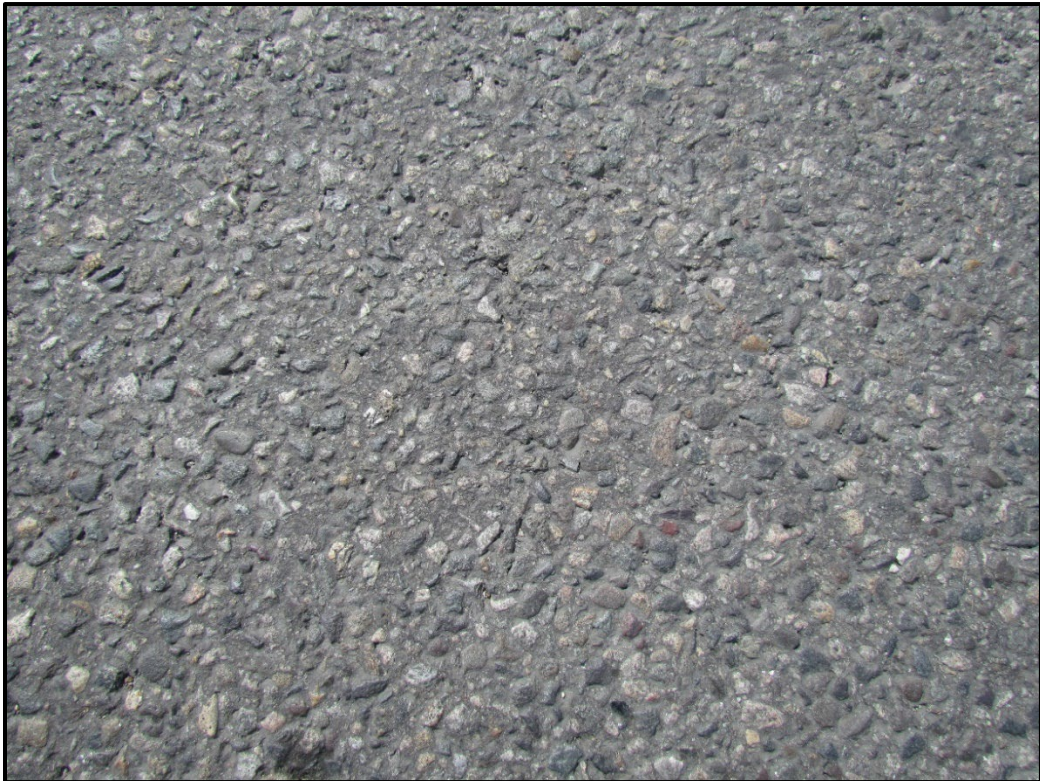
↑ Close-up of surface on 6<sup>th</sup> Ave N.

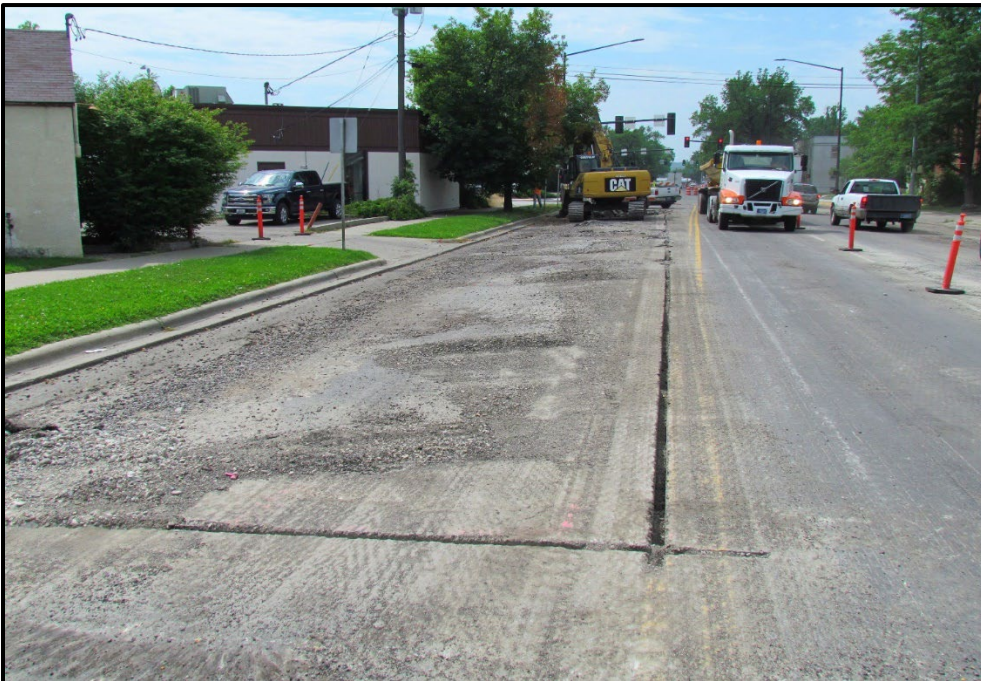
↑ After milling, several sections of pavement needed full depth replacement.

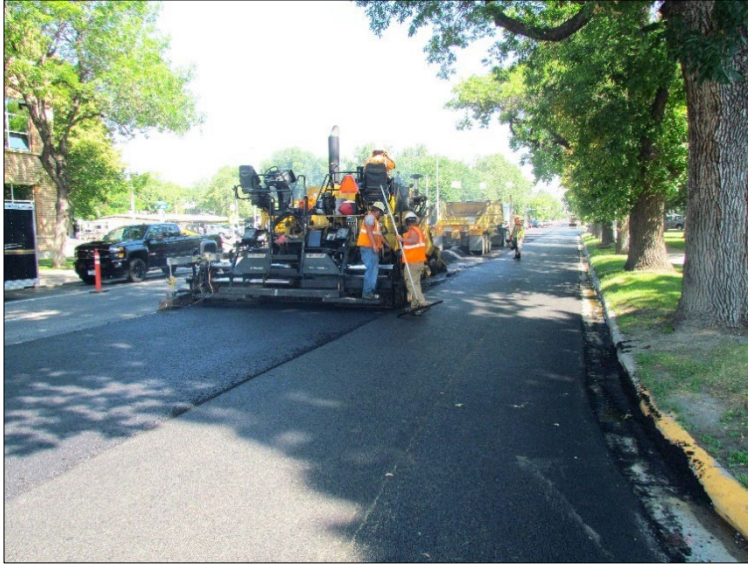
← Division St, view north. Representative image of the paving phase. The paver operators stated no perceived issues with the altered PMS during the paving process. Workers handling rakes at the paving edges did state the mix felt somewhat sticky.

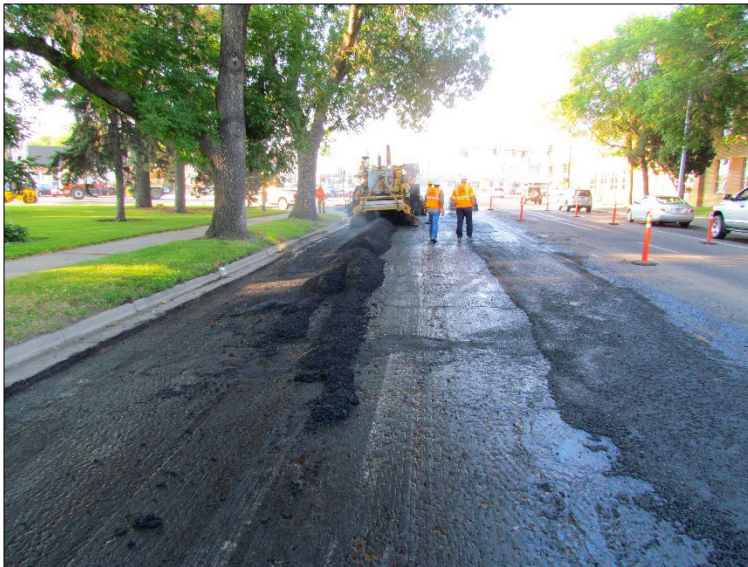
← Additional image of FRAC paving on Division St, view south. Note the area to the right in the image which required a patch after milling. It was stated that all sections repaired prior to paving included the fiber reinforcement.

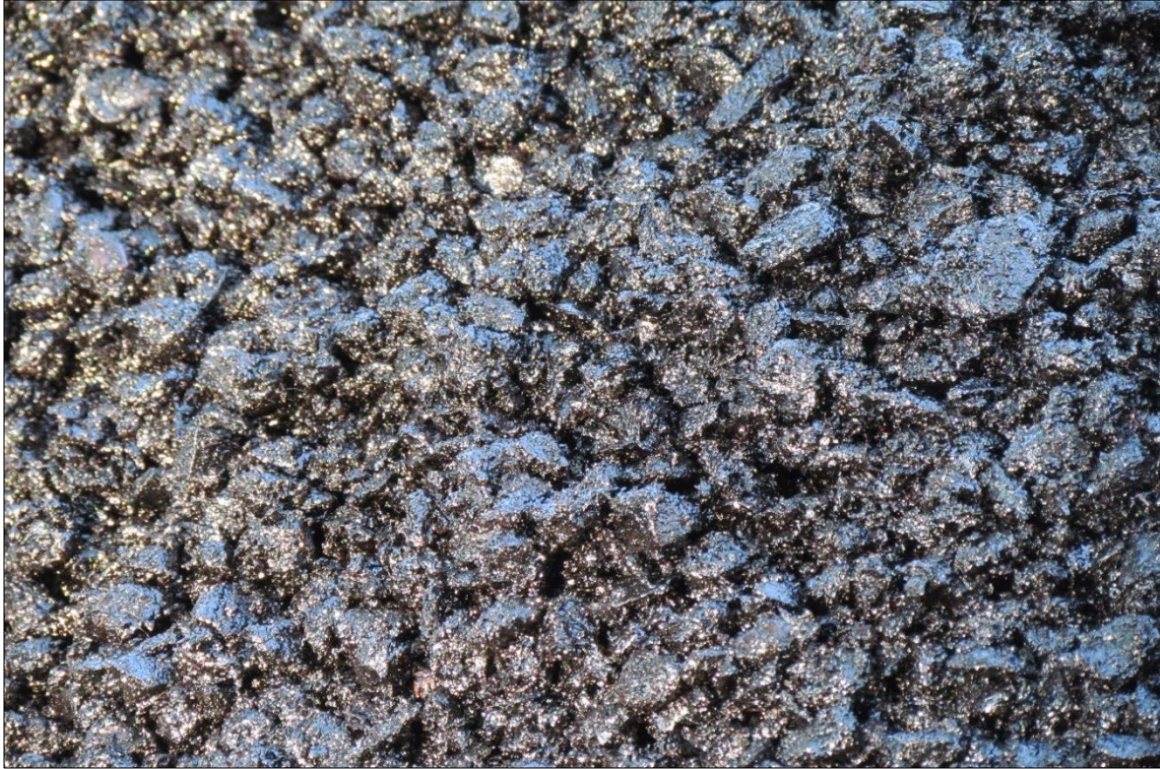
↑ Close-up of uncompactied FRAC. The fibers were not noticeable in the mix, however if you handled and separated the aggregate, the fibers were visible.

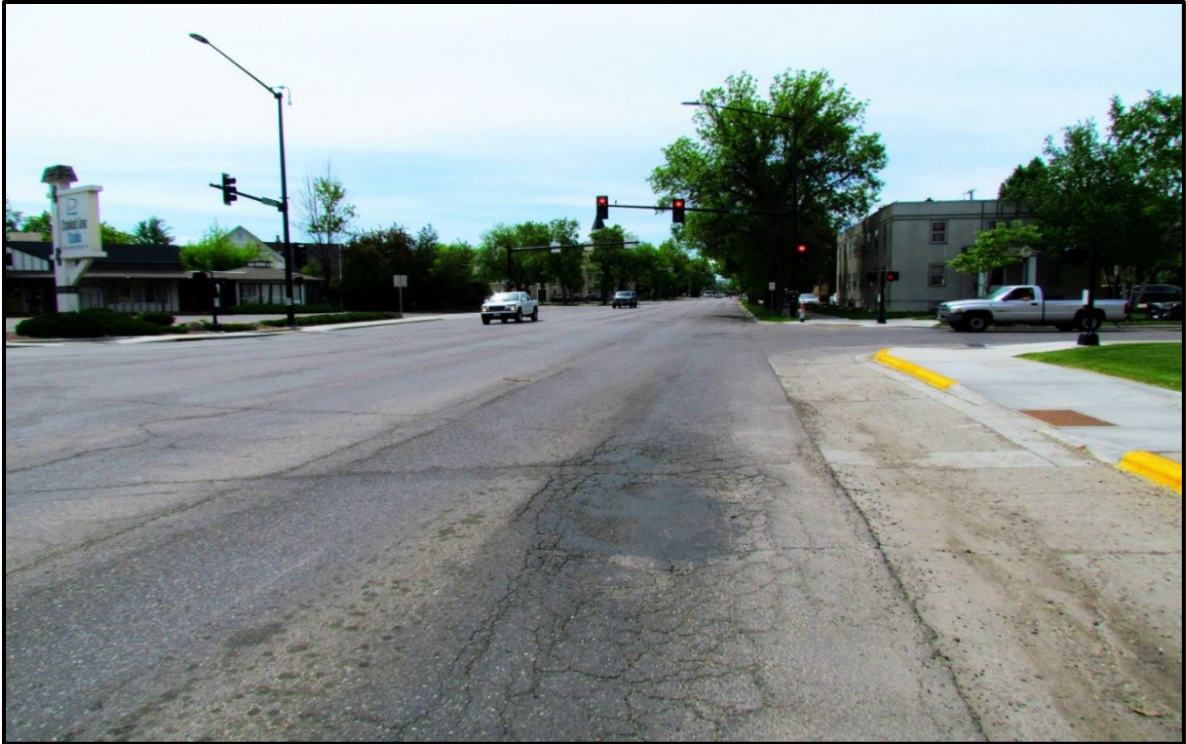
↑ Representative pavement distress in areas on Division St. of fatigue cracking (view south near Lewis Ave).

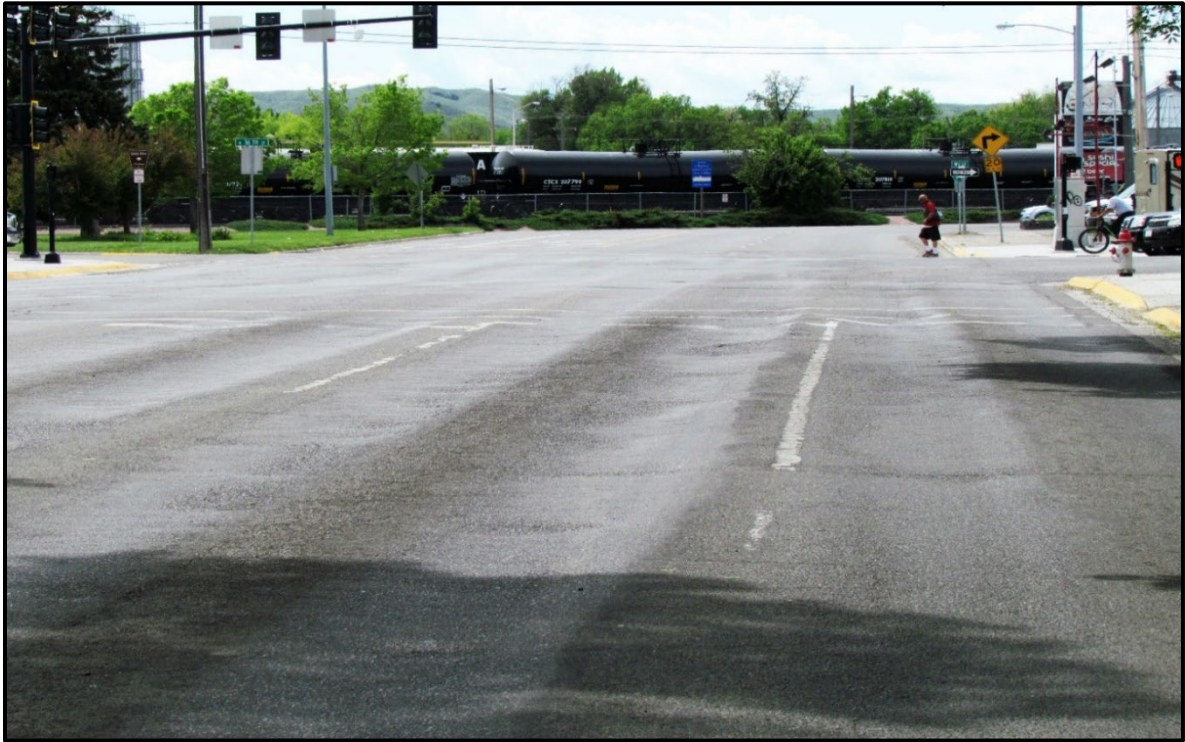
↑ Heavy rutting at the intersection of Division St. & Broadwater Ave. (view south).

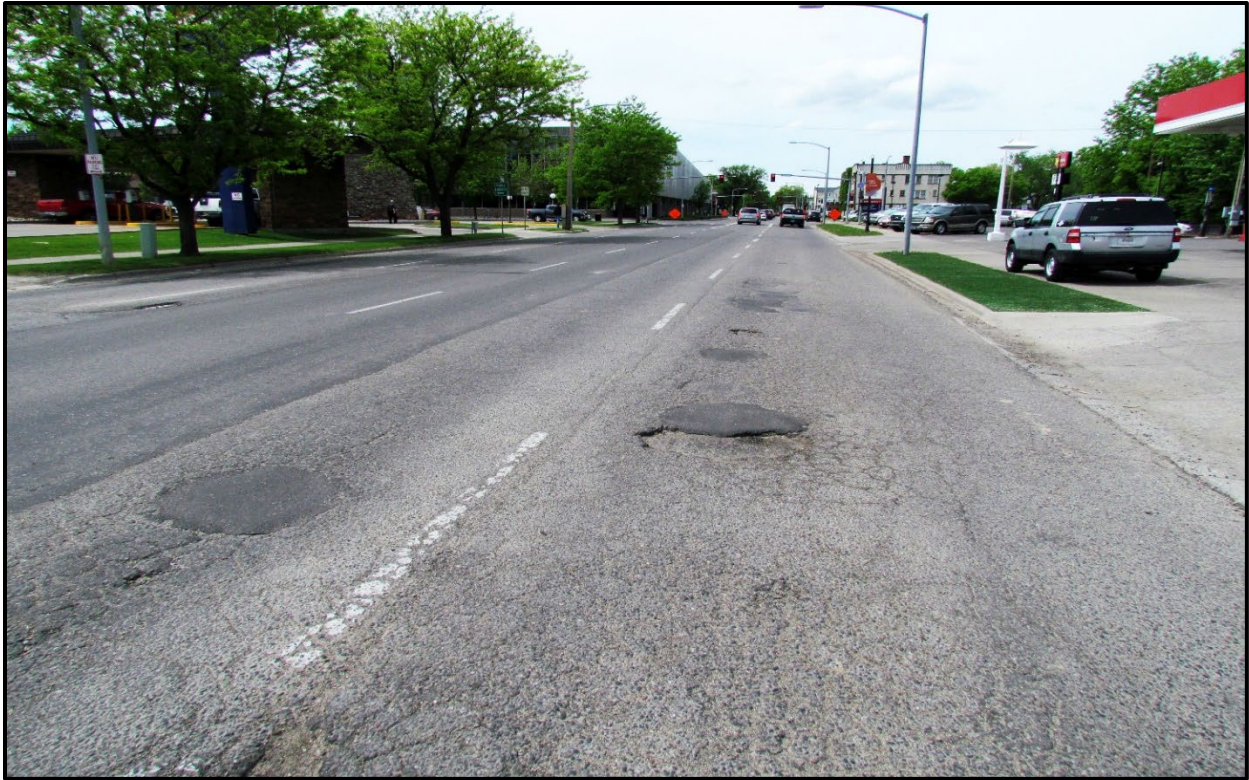
↑ Pavement distress on 6<sup>th</sup> Ave N. specifically fatigue cracking and previous patching (view west).
