Experimental Feature Construction Report July 2023

Experimental Feature:	Plant Mix Reinforcing Paving Fibers
Location:	Missoula District, Flathead County, City of Kalispell, US
	Hwy 93, RP 114.9 – 115.9
MDT Project Name:	Grandview Dr – Reserve Dr (Kal)
MDT Project Number:	NH 5-3(154)115[9862]
Experimental Project Number:	MT-22-02
Principle Investigator:	Chad DeAustin, Experimental Project Manager, (ExPM)
Technical Contact:	Oak Metcalfe, Materials Engineer
Construction Date:	July 2022

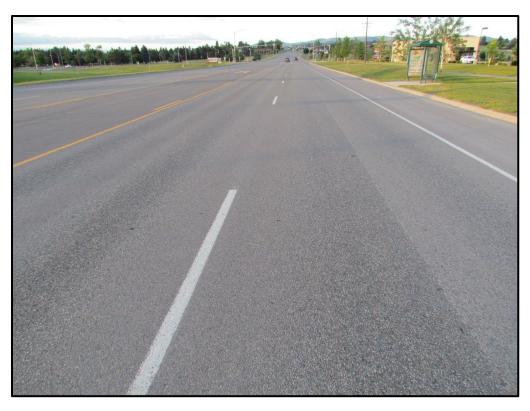
The roadway showed normal wear for a relatively high-volume urban roadway in Montana. The wheel paths had more visible wear on the surface.

↑ View south of southbound lane. Nothing was noticed that wasn't ordinary pavement wear.

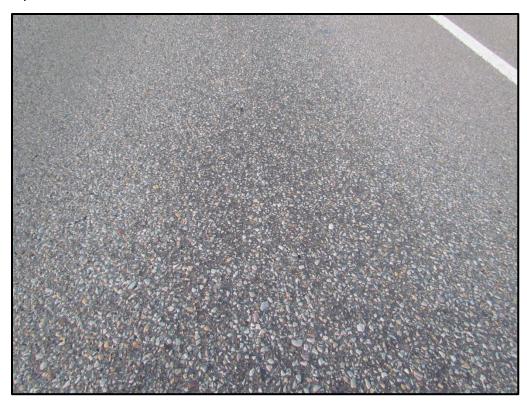
$\ensuremath{ \uparrow \! \! \! \! \! \! \uparrow}$ Close up view of the southbound lane in the wheel path.

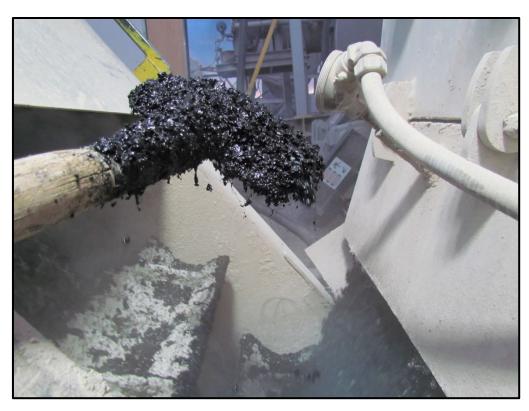
$\pmb{\uparrow}$ Example of the plant mix surfacing deposited out of the hot plant. Notice the fibers hanging from the mix.

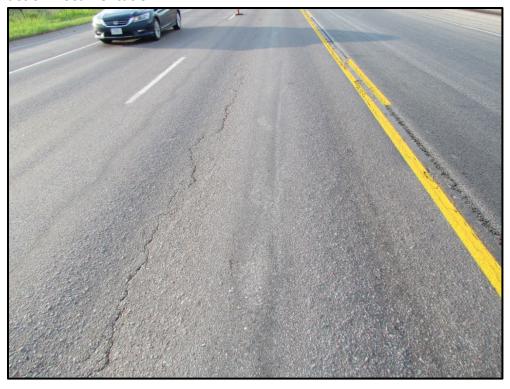
♠ Example of preconstruction conditions. There was a fair amount of longitudinal and transverse cracking.

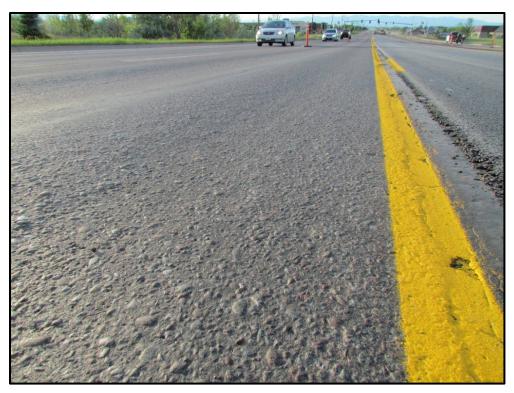
$\ensuremath{ \uparrow \! \! \! \! \! \! \uparrow}$ Close-up view of the existing surface. There was significant wear and rutting.
