**Experimental Feature Evaluation
 December 2022**

Experimental Feature:	PCCP Bondbreaker
Location:	Glendive District, Richland County, Fairview, MT Hwy 200, RP 62.1 – 63.9
MDT Project Name:	MT 200 – Fairview
MDT Project Number:	NHIP 20-2(32)62[8168]
Experimental Project Number:	MT-20-05
Principle Investigator:	Chad DeAustin, Experimental Project Manager (ExPM)
Construction Date:	Spring 2020
Date of Inspections:	May 2021, September 2022

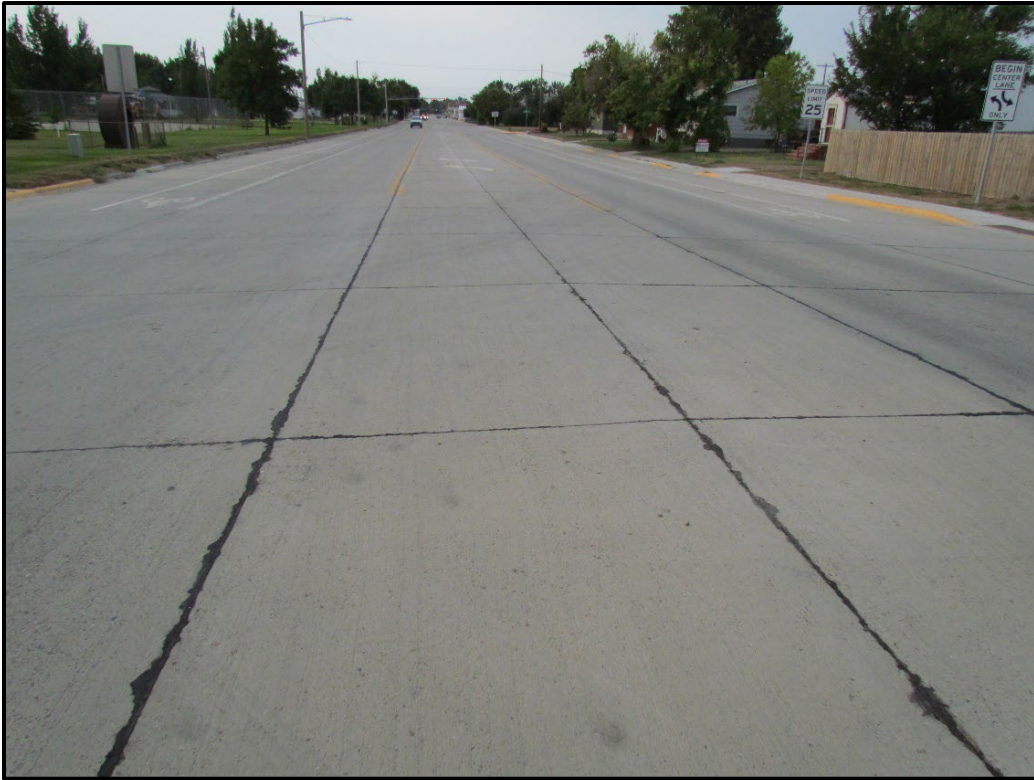
No issues or changes were noticed to the concrete surfacing during the site visit. Little surface wear is noticed even with high volumes of commercial vehicle traffic.

↑ MT Hwy 200 and 2nd St N intersection, control section, view south.

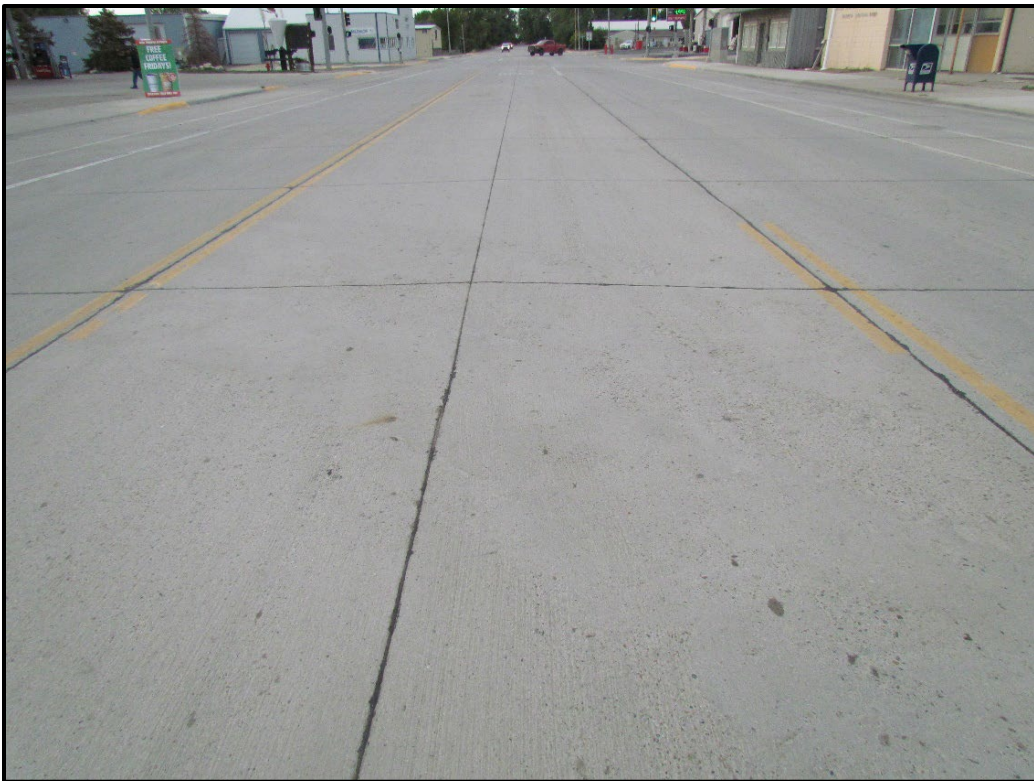
↑ MT Hwy 200 and 6th St intersection, test section, view south.

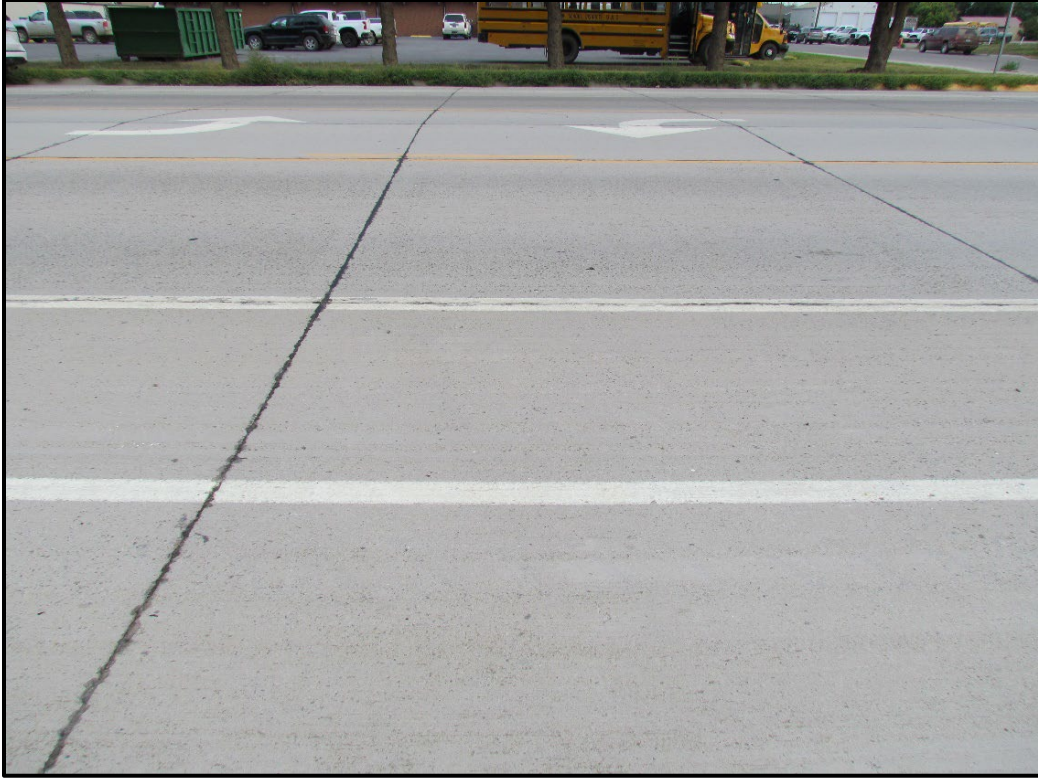
↑ MT Hwy 200 and Western Ave intersection, test section, transverse view

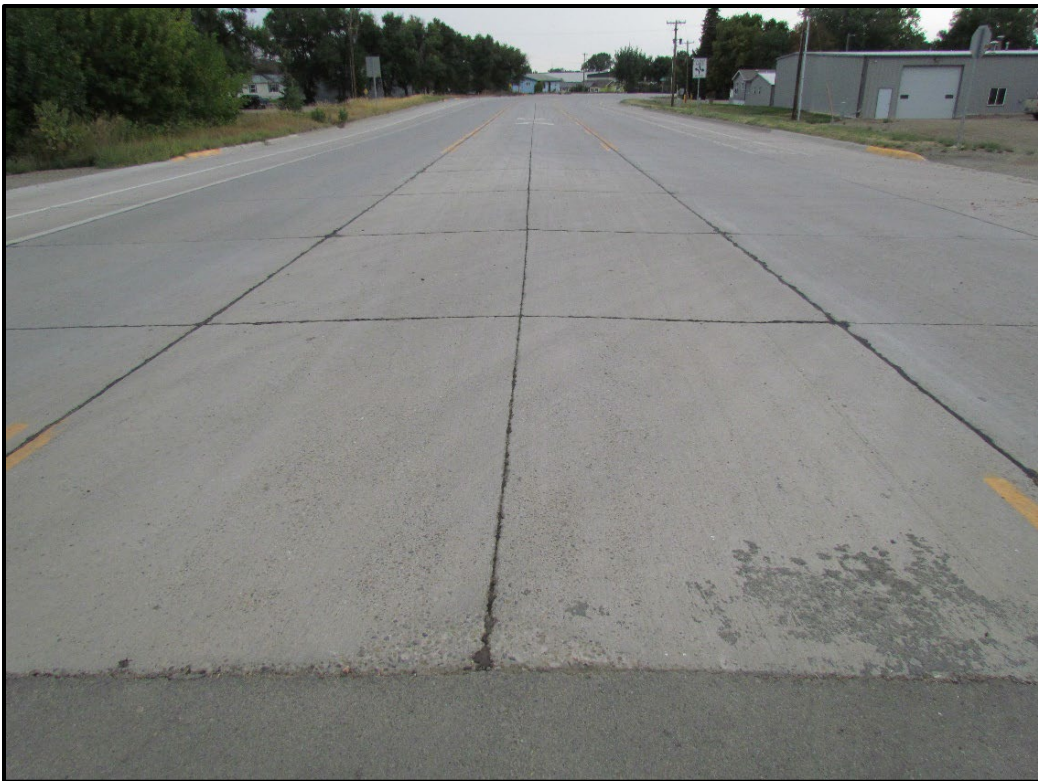
↑ South end of project, view north.

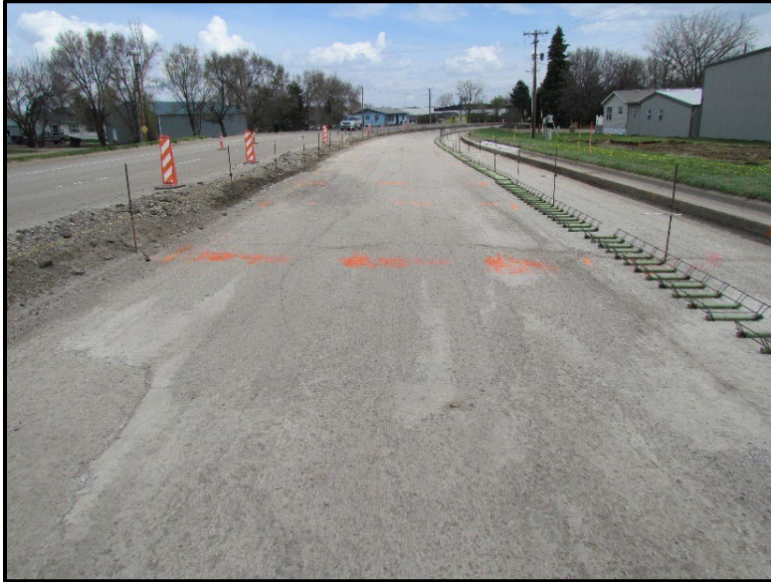
← The CTB is prepped and marked out for the SKAPS GT116 fabric. This CTB has several microcracks throughout the project.

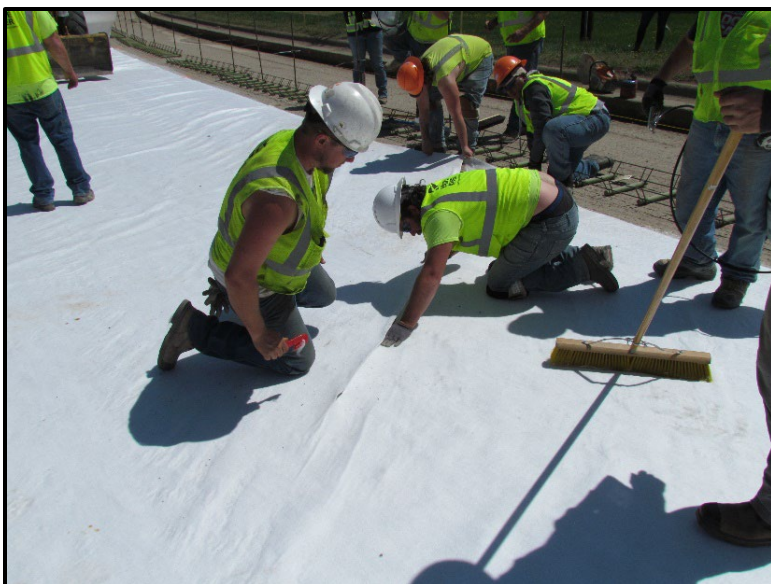
← The contractor had issues with folds in the fabric when coming through curve sections. The contractor decided to fix folds that had a greater than 3 in. apex point. There were some small wrinkles that the vendor and contractor said is normal. The contractor cut down along the apex point of this fabric fold. This is the start of the fabric fold repair.

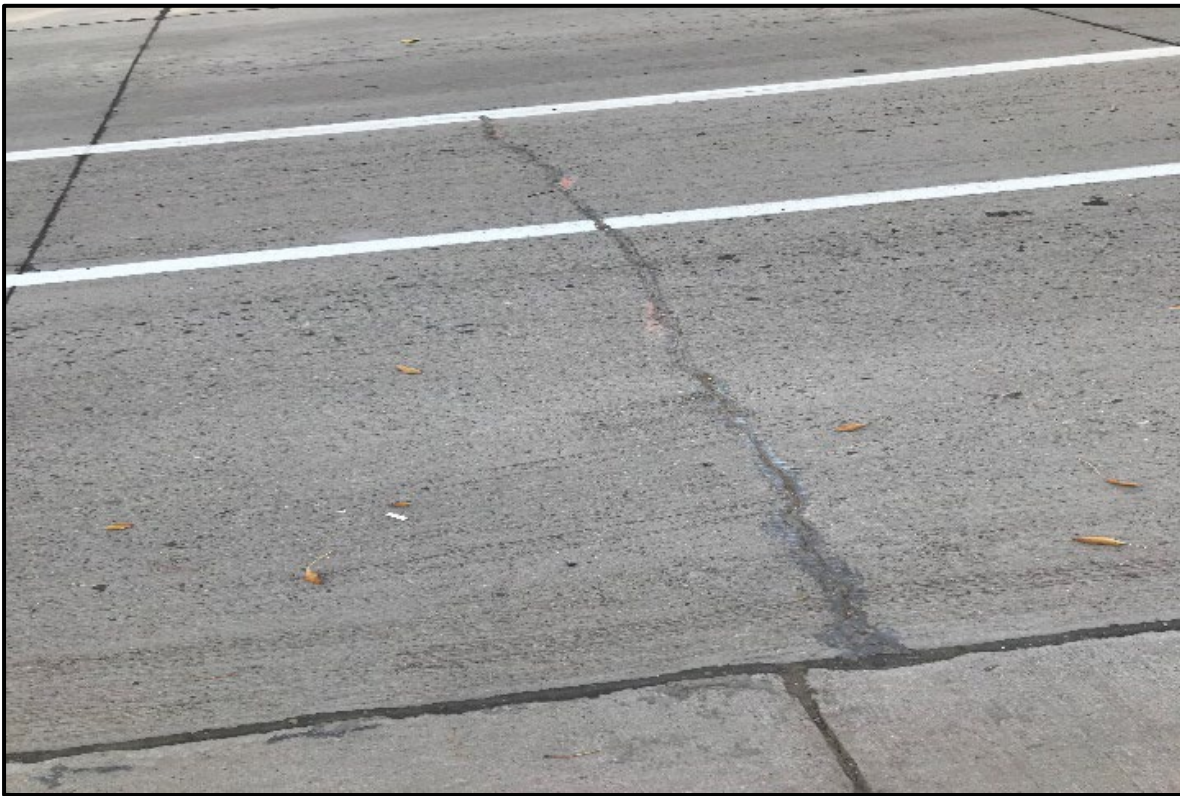
↑ Example of a crack that developed during curing process. Crack was sealed. No issues in compressive strength test results and no on-site material issues reported.

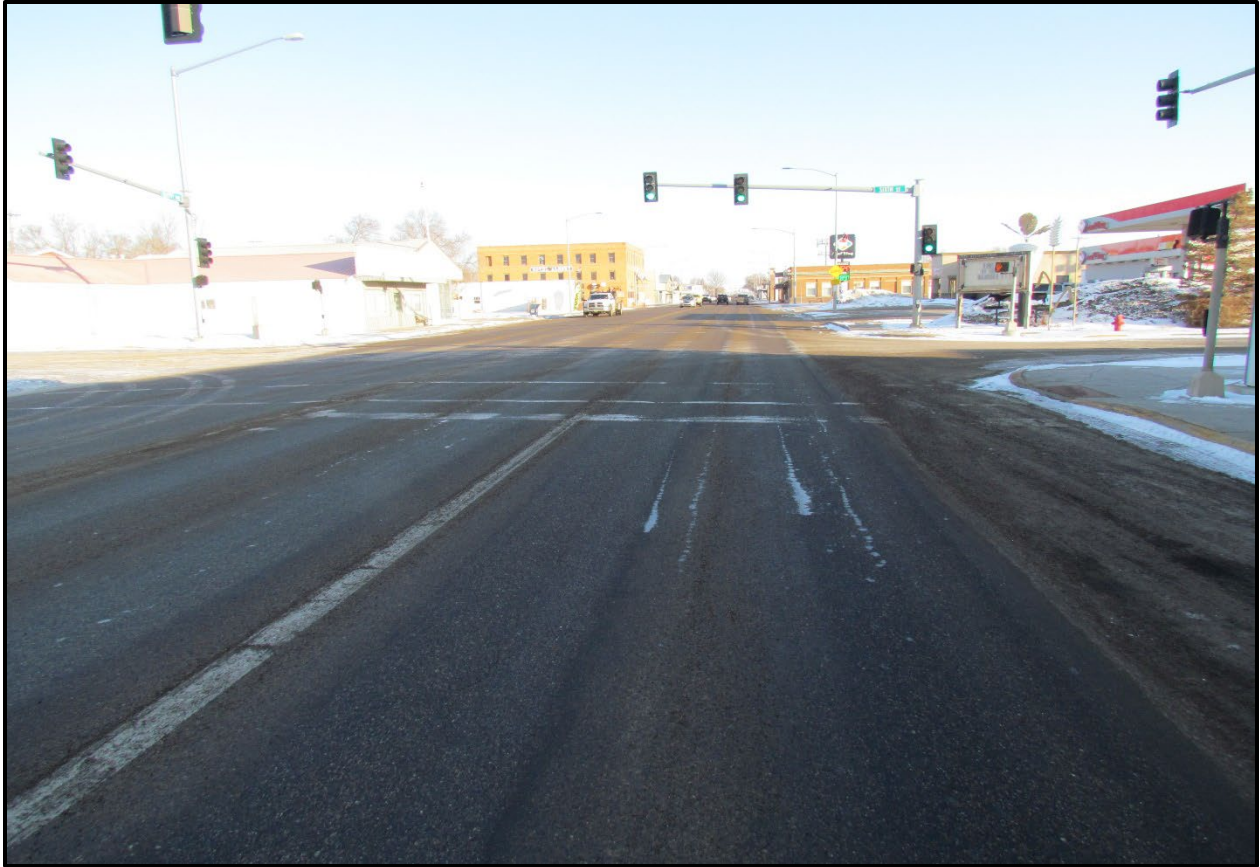
↑ The existing condition of the road surface prior to construction. PCCP will replace the asphalt due to heavy rutting and shoving that has taken place with the existing asphalt pavement. The road is subjected to a high volume of loaded haul trucks.
