EVALUATION OF A CONVENTIONAL CHIP SEAL UNDER AN OVERLAY TO MITIGATE REFLECTIVE CRACKING (INFORMAL)

Final Report

Project name: St. Xavier N & S

Project Number: SFCS 313-1(18)22

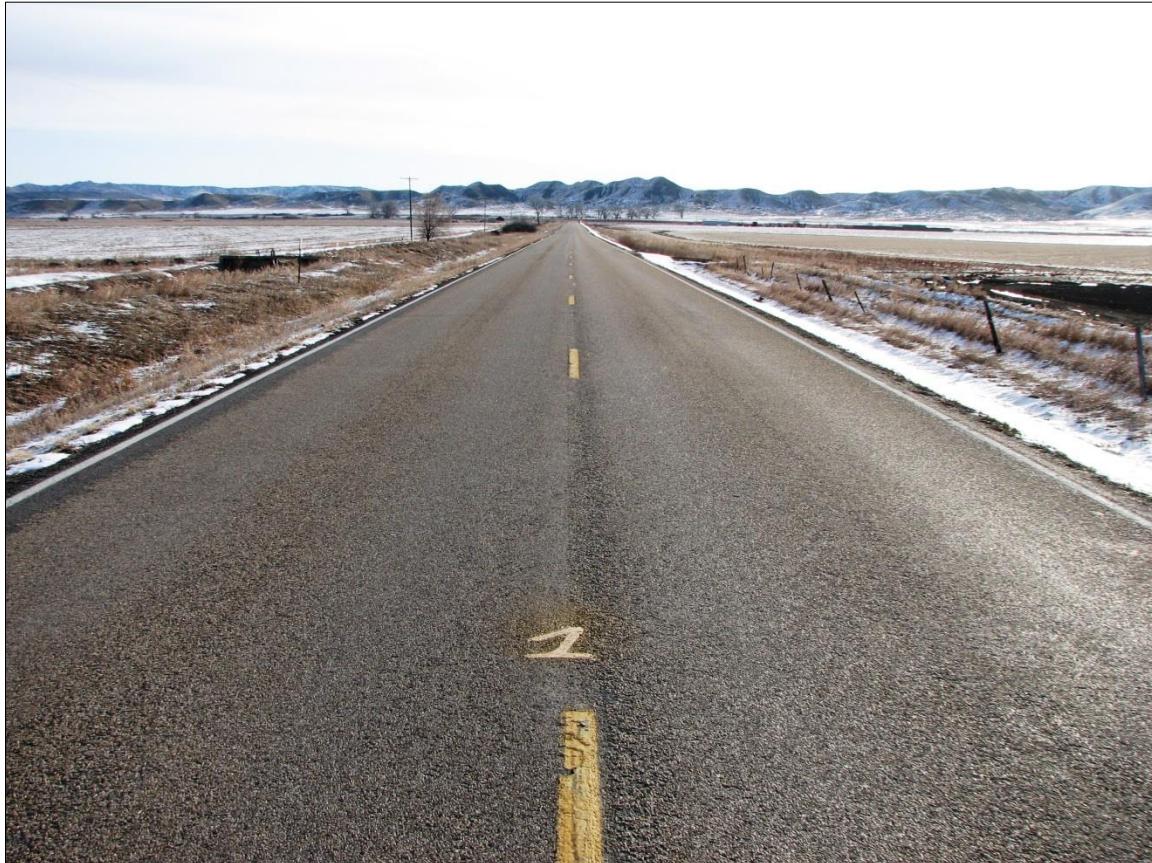
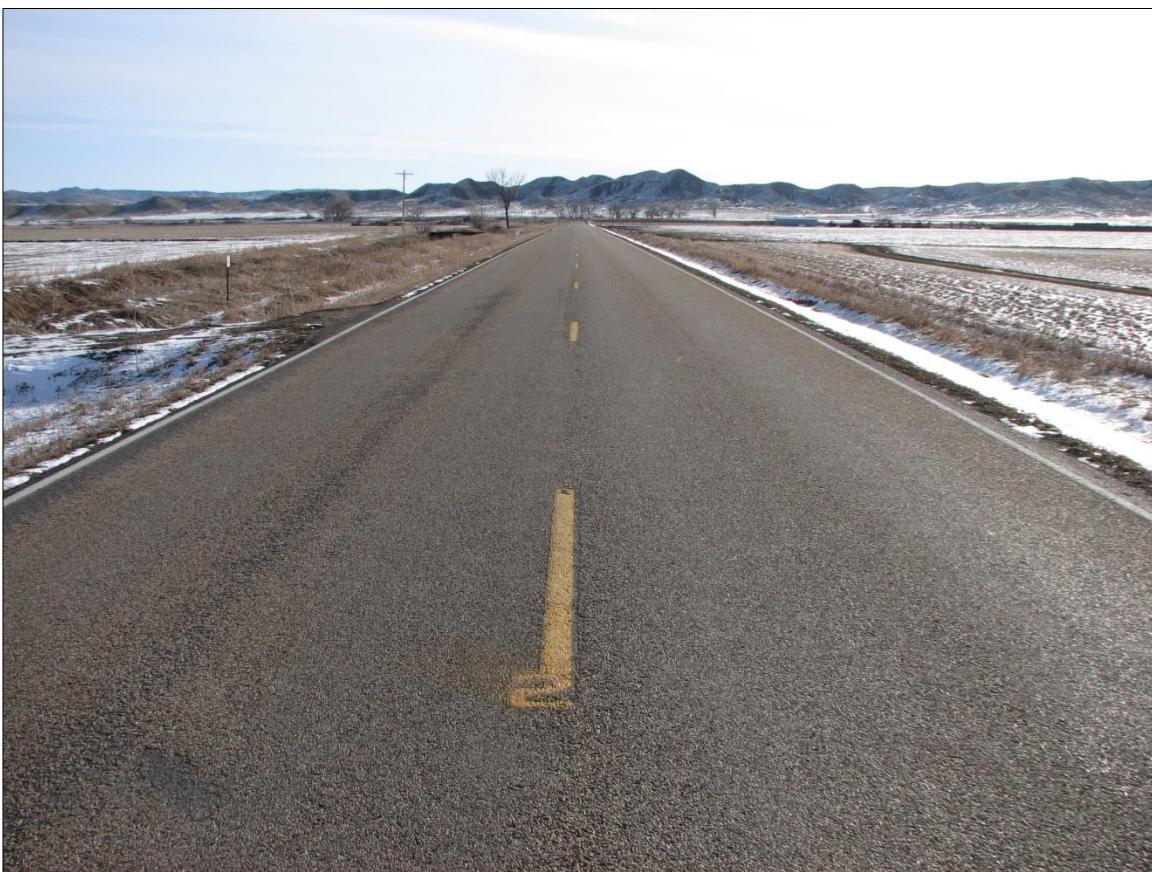
March 2015: Sections 1 & 2 (views east)

During the March 2015 inspection it was found the control section 1 had formed two (2) transverse cracks rated as moderate severity ($>1/2"$ - $<3/4"$). No cracks were visible on test section 2.

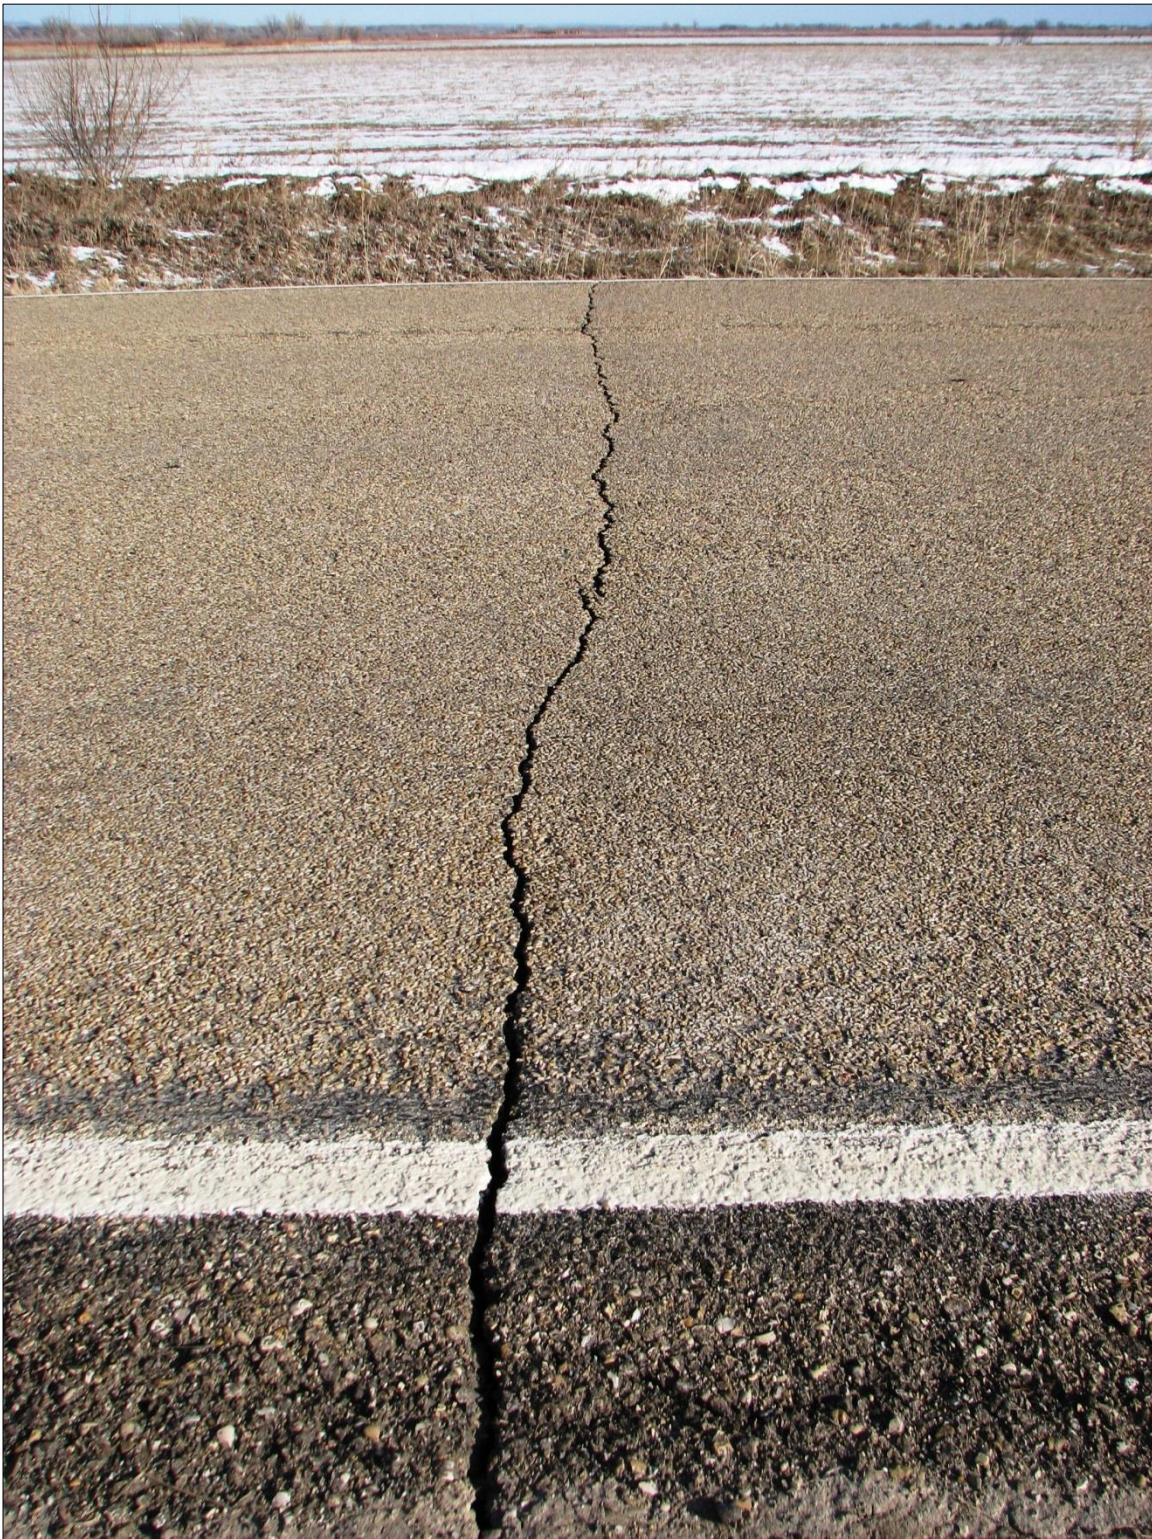
March 2015: Control Section 1 – Example of Moderate Severity Cracking

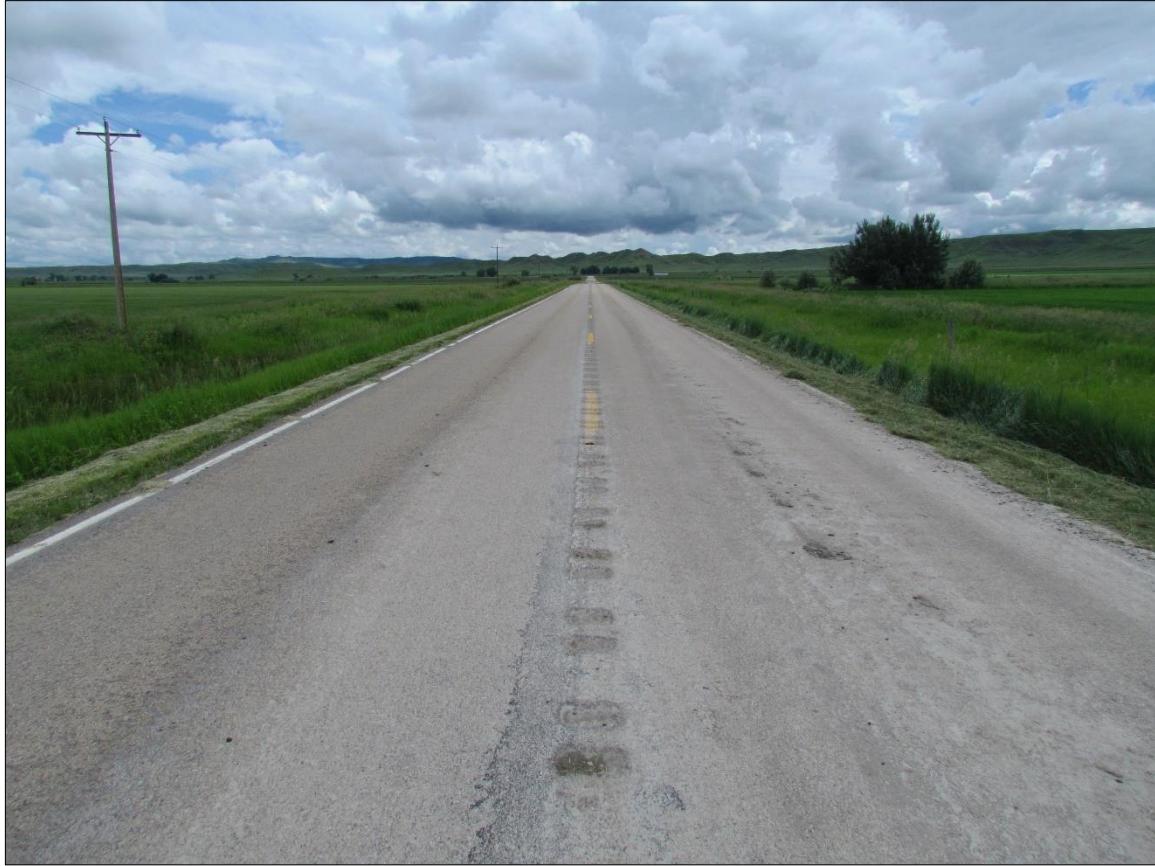
July 2018: Site Inspection

July 2018 – Final Inspection: No additional visual distress (transverse crack) has occurred since 2015. Since installation in 2008; only two low-severity cracks were documented (2015) located in section 1 (control).

↑ Overview of project near section 2 (view east).
