Experimental Feature Evaluation
December 2022

Experimental Feature:	Longitudinal Joint Void Reducing Asphalt Membrane (VRAM)
Location:	Missoula District, Missoula County, MT Hwy 83, Reference Post 31.5-45.8
MDT Project Name:	Condon – North & South
MDT Project Number:	STPP 83-1(40)32[9500]
Experimental Project Number:	MT-20-06
Principle Investigator:	Chad DeAustin, ExPM
Technical Contact:	Mike Dodge, Materials Reviewer
Construction Date:	July/August 2020
Date of Inspections:	September 2021, June 2022

2022 Update – May

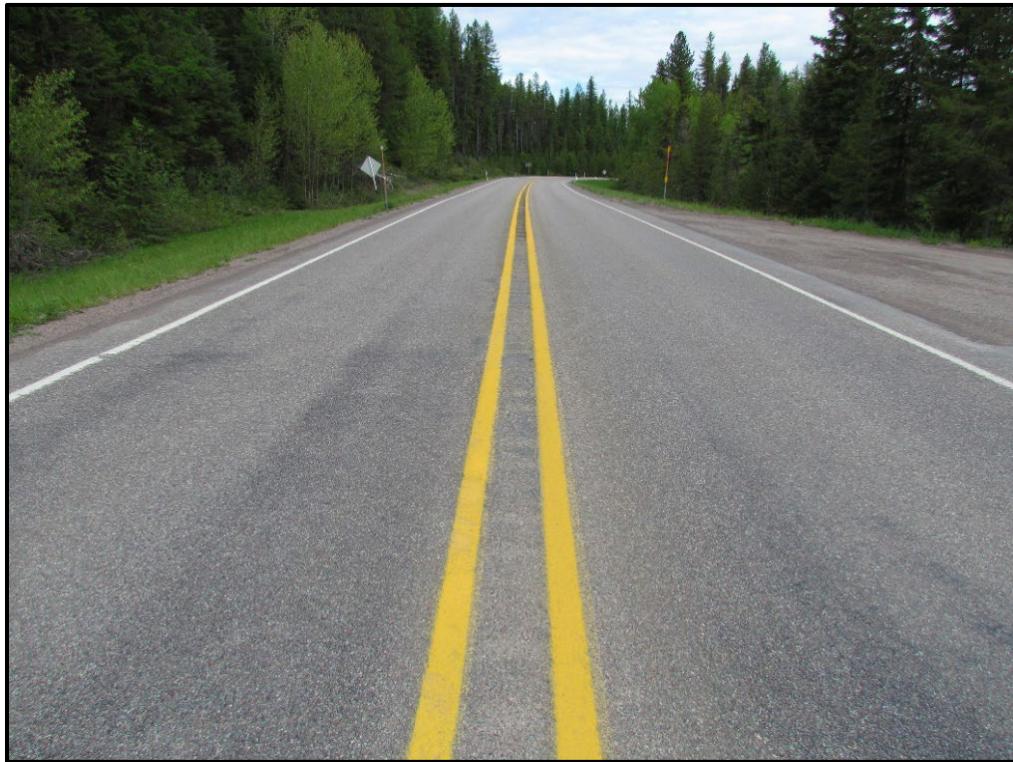
During the site visit in 2022, bleeding of the JBAND was noted throughout the project, which was also noticed in 2021. In the photos on the next few pages, the bleeding can be seen as a darker color along the rumble strips. Upon discussion with others at MDT, the thought is that this is the product working bottom up to fill the voids in the longitudinal paving joint. Also noted that the bleeding is not causing chip loss but is instead flooding the chips. Both situations will be monitored in the coming visits.

↑ RP 31.5, view north. Conditions at the south end of the project.

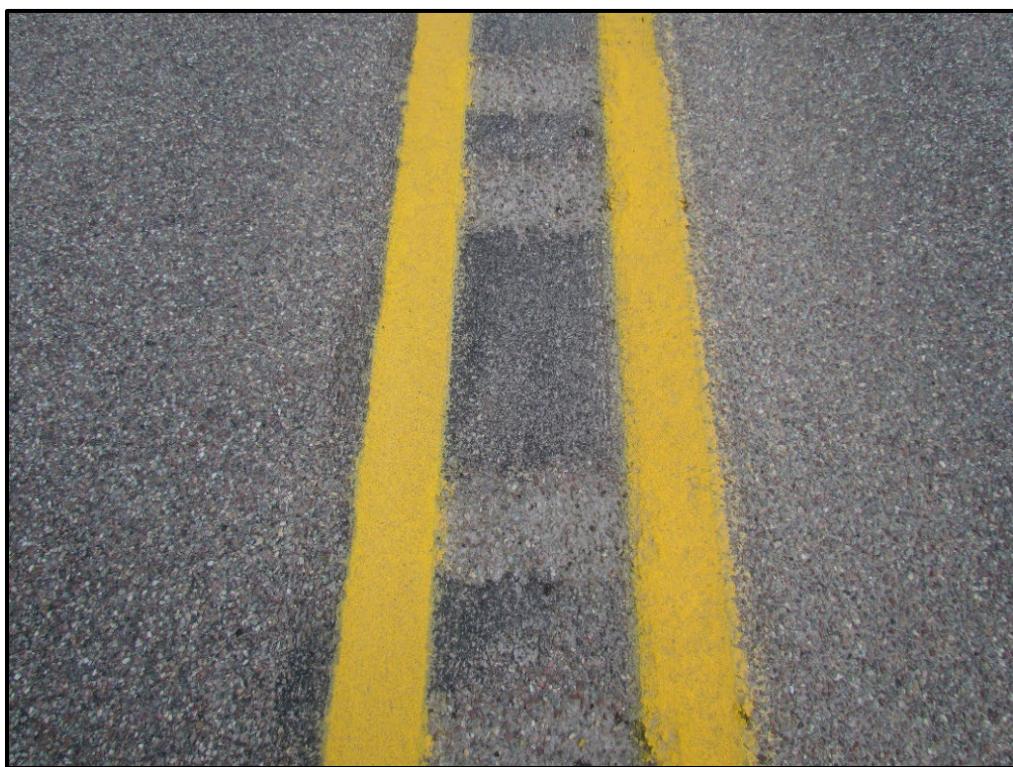
↑ RP 31.5, close-up view. VRAM bleeding evident but contained at centerline.

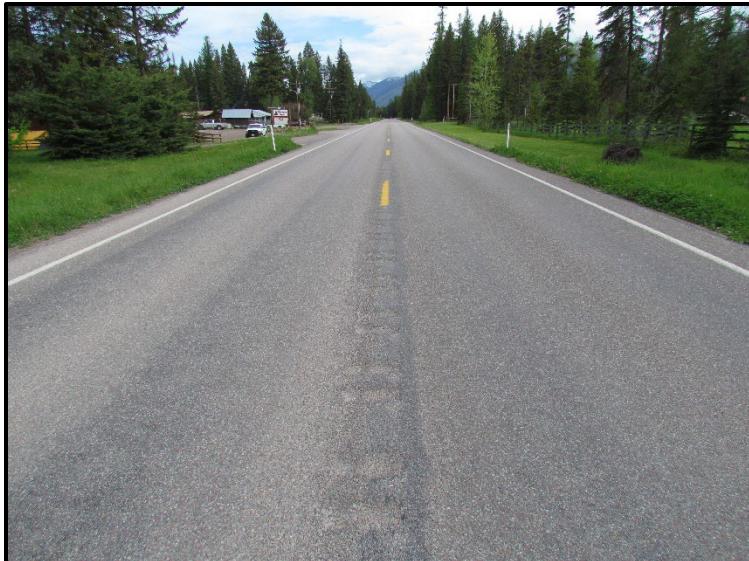
◀ RP 38.3, view north. Area where the VRAM bleed through is a little more noticeable.

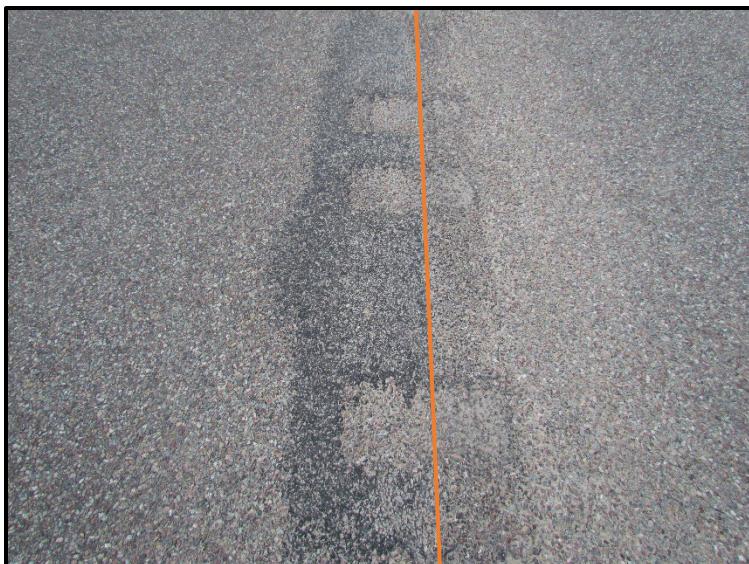
◀ RP 38.3, close-up. The orange line highlights, most likely, the centerline joint seam.

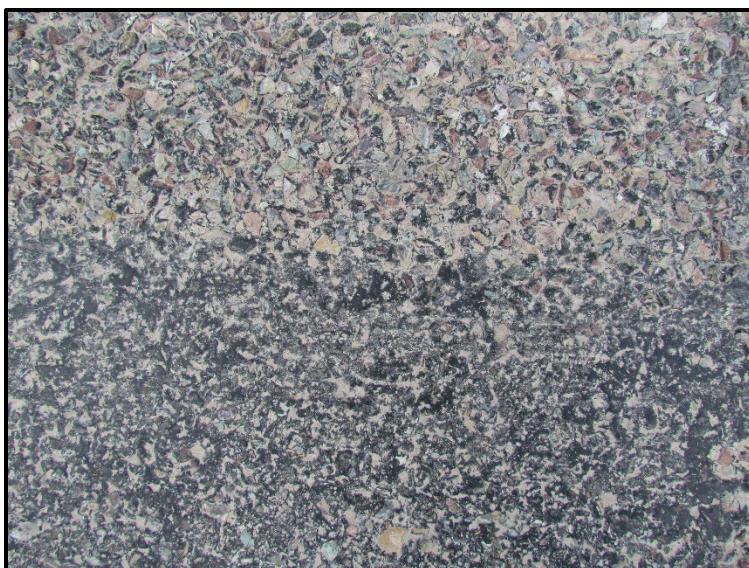
◀ RP 38.3, close-up. Closer view of the seam from the photo above.

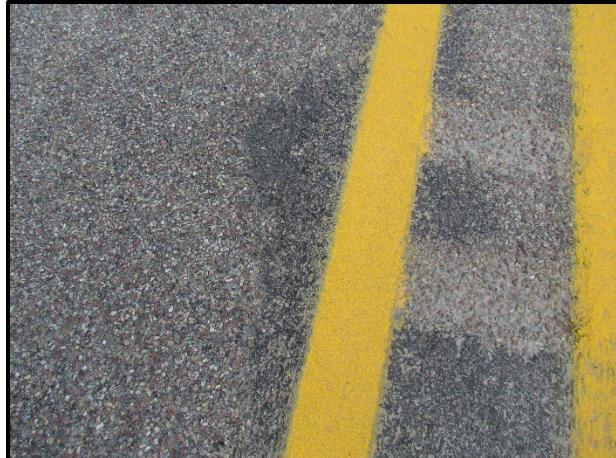
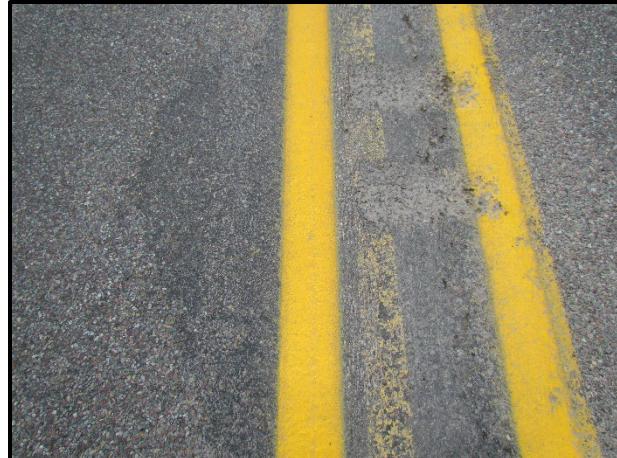
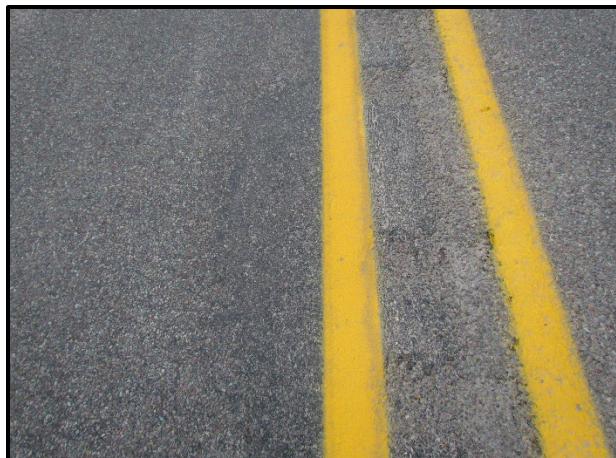
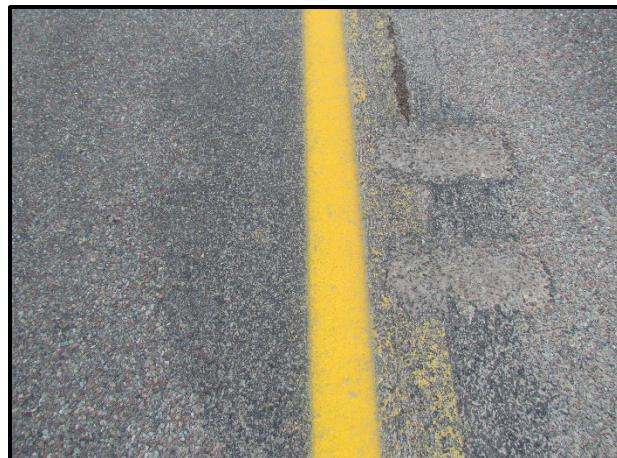
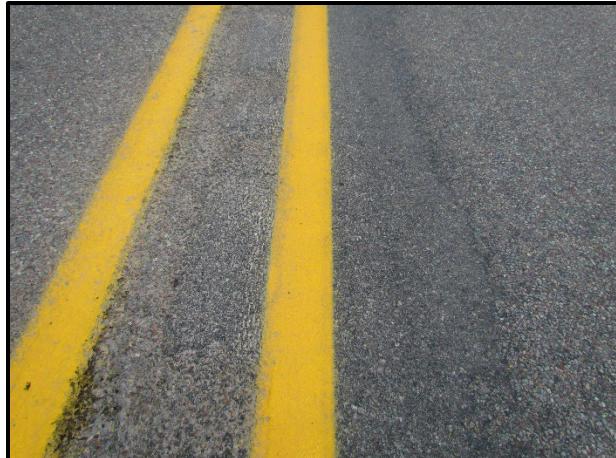
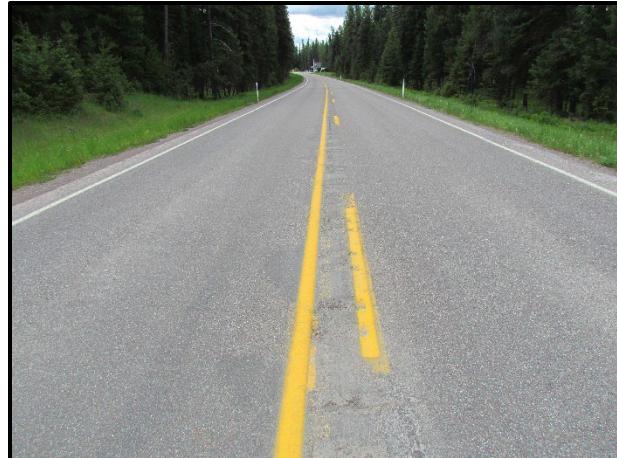
Most of the VRAM bleed through was within the width of the double solid yellow centerlines through the project. The photos below highlight some of the wider areas of bleed through to be watched closely as it is beginning to encroach on wheel paths.

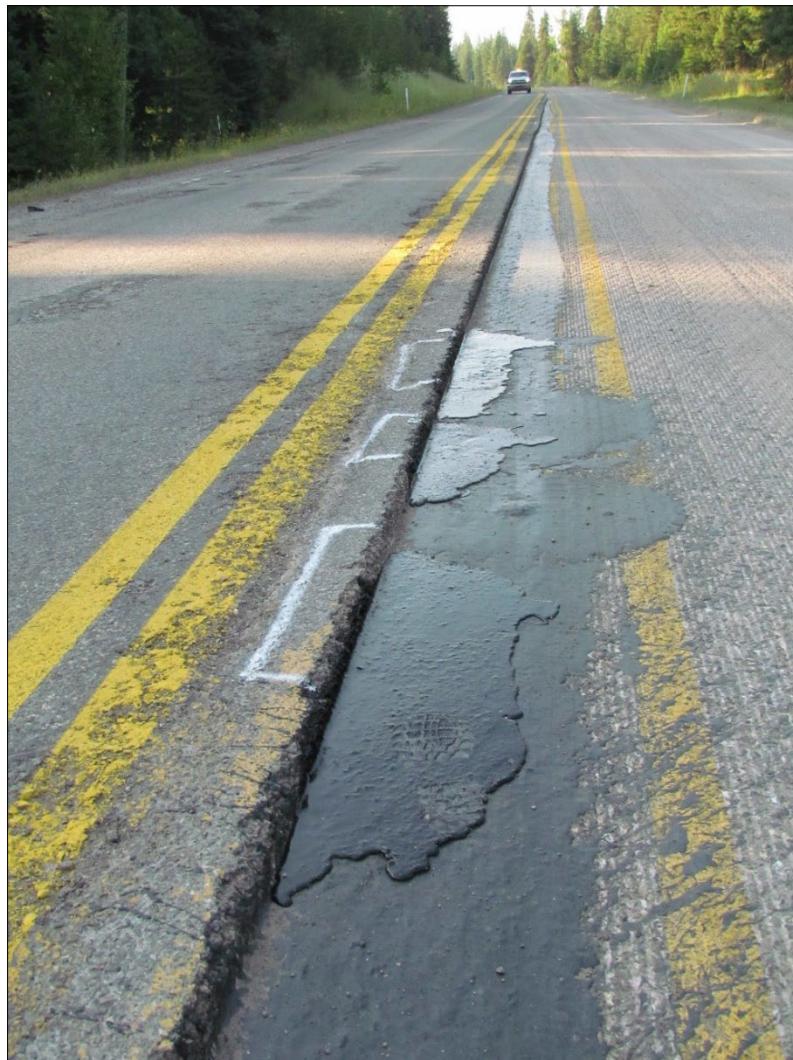
◀ Areas of VRAM placement considered under applied, or vehicle movement may have separated the product from the pavement, were field marked and reapplied by hand.

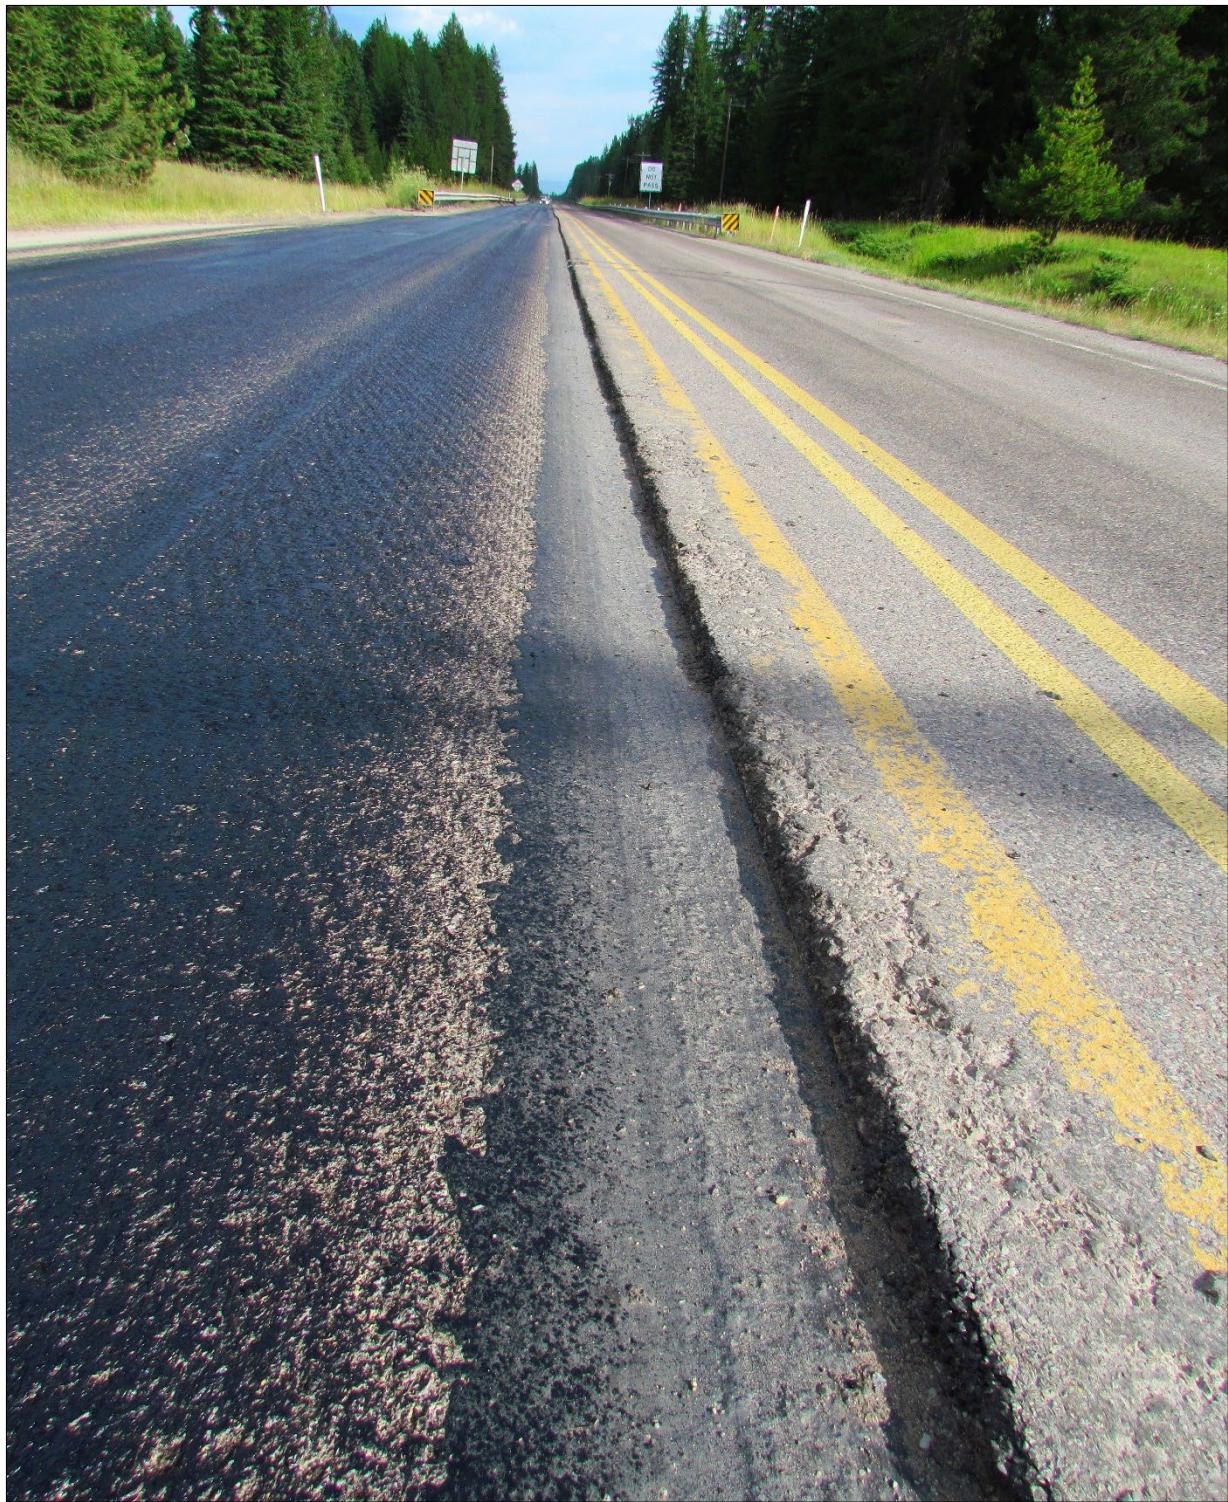
↑ Initially the tack coat was applied over the VRAM, it was reported there were instances where vehicles driving over the VRAM pulled or tore the strip. It was felt the tack may be causing the VRAM to become too sticky and this process was changed to tacking just prior paving.

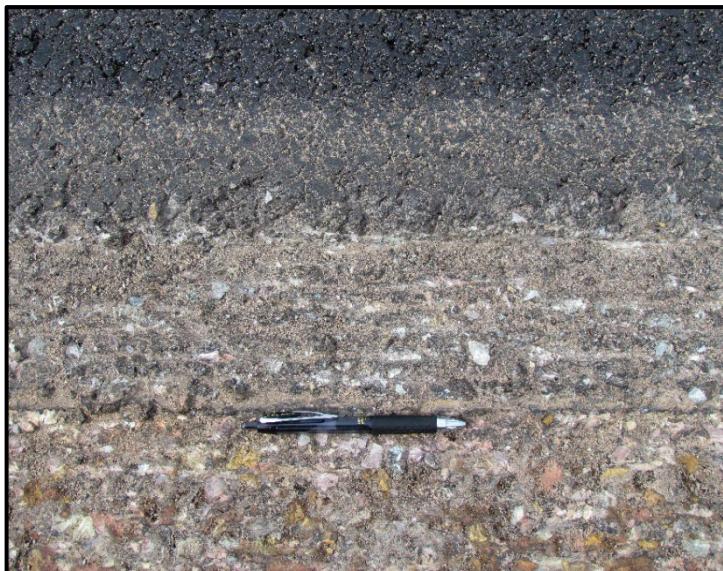
◀ This image shows the mill pass that has cut into the southbound lane JBAND strip. The pen marks the edge of the JBAND strip.

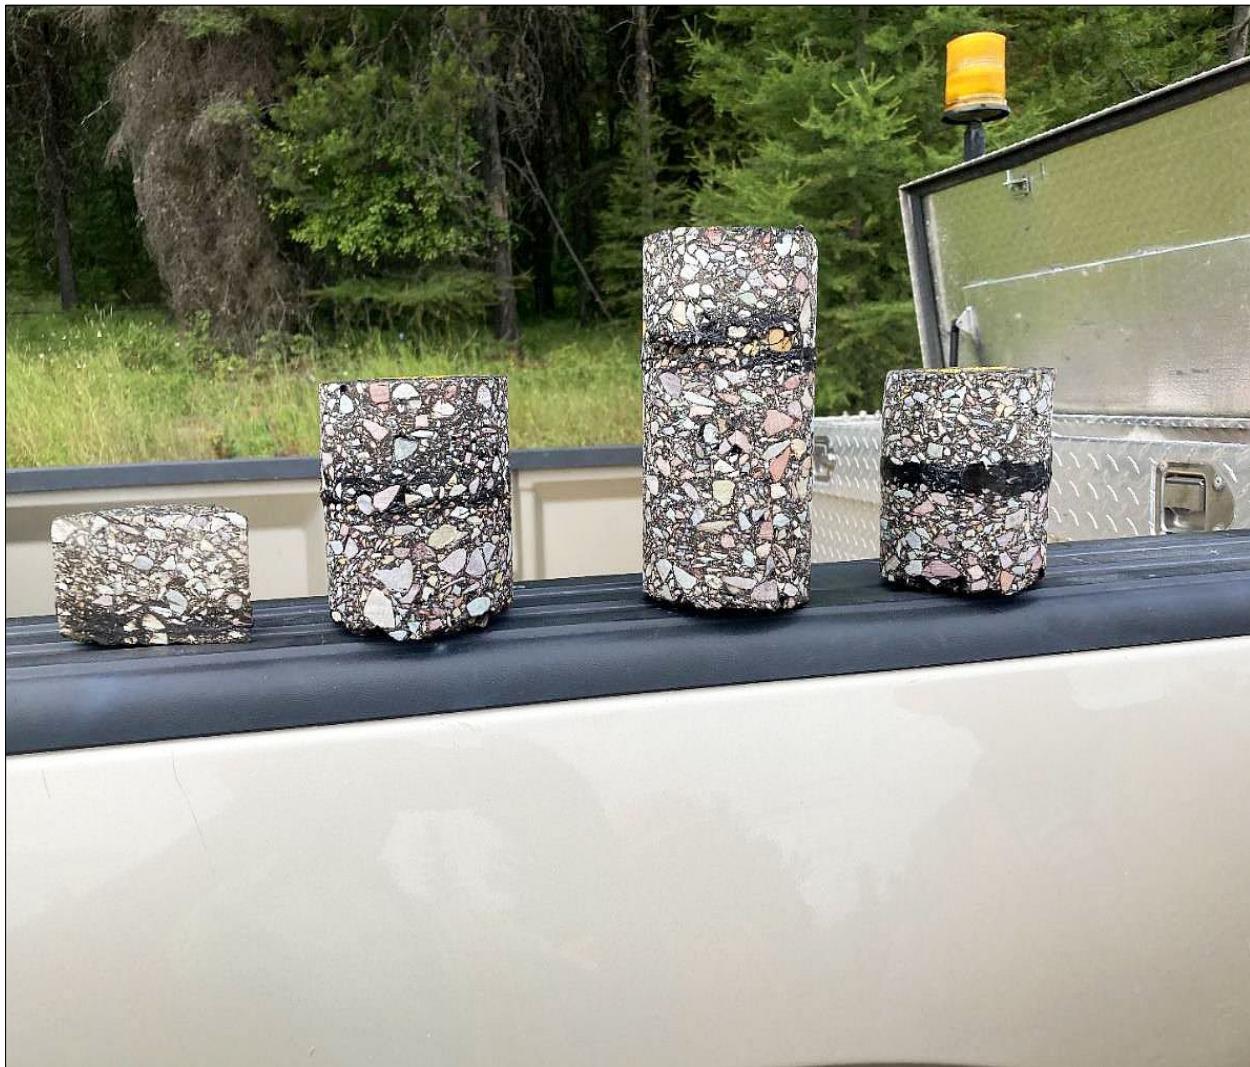
↑ Several core samples taken from the projects centerline which shows the extent of the VRAM migration into the AC matrix. The core on the far left is split. Image courtesy of CES Review Section.

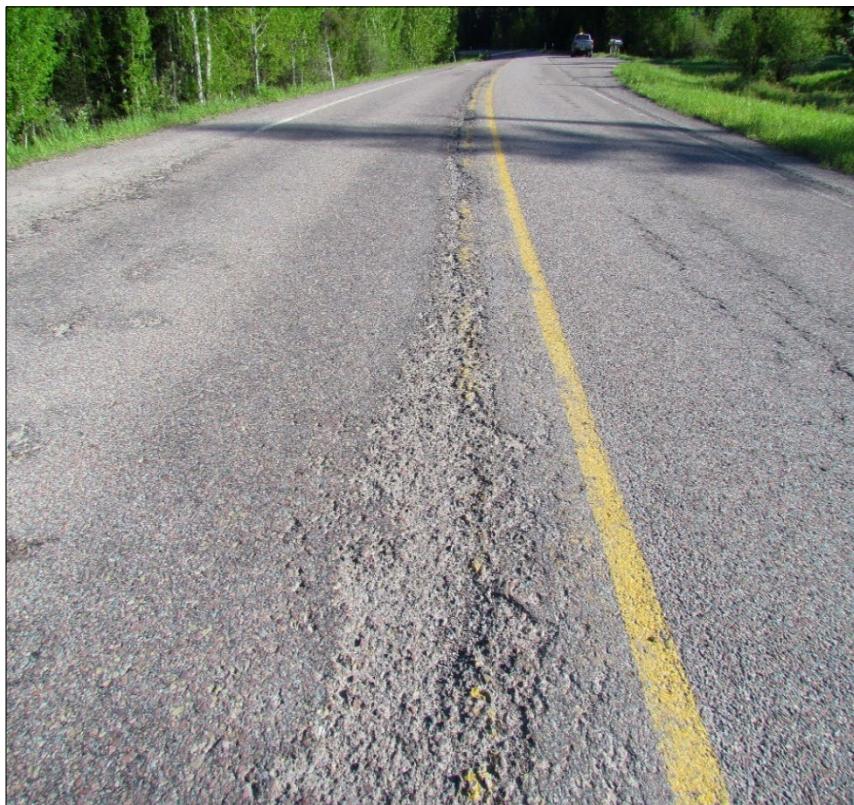
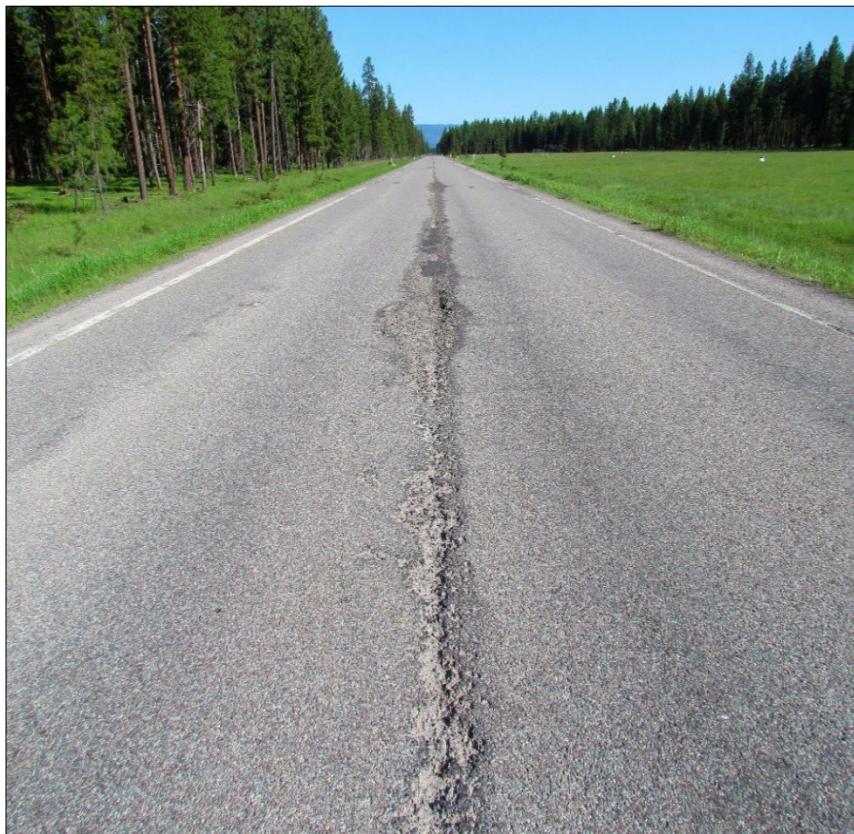
◀↓ Several examples of centerline joint condition prior to start of project.
Top image is near RP 32, lower is near RP 43.
