**Experimental Feature Construction Report & Evaluation  
 September 2021**

<b>Experimental Feature:</b>	Longitudinal Joint Void Reducing Asphalt Membrane (VRAM)
<b>Location:</b>	Missoula District, Missoula County, MT 83, Reference Post 31.5-47.8
<b>MDT Project Name:</b>	Condon – North & South
<b>MDT Project Number:</b>	STPP 83-1(40)32[9500]
<b>Experimental Project Number:</b>	MT-20-06
<b>Principle Investigator:</b>	Chad DeAustin, ExPM
<b>Technical Contact:</b>	Jason Livingston, EPM, Kalispell Construction
<b>Construction Date:</b>	July/August 2020
<b>Date of Inspections:</b>	September 2021

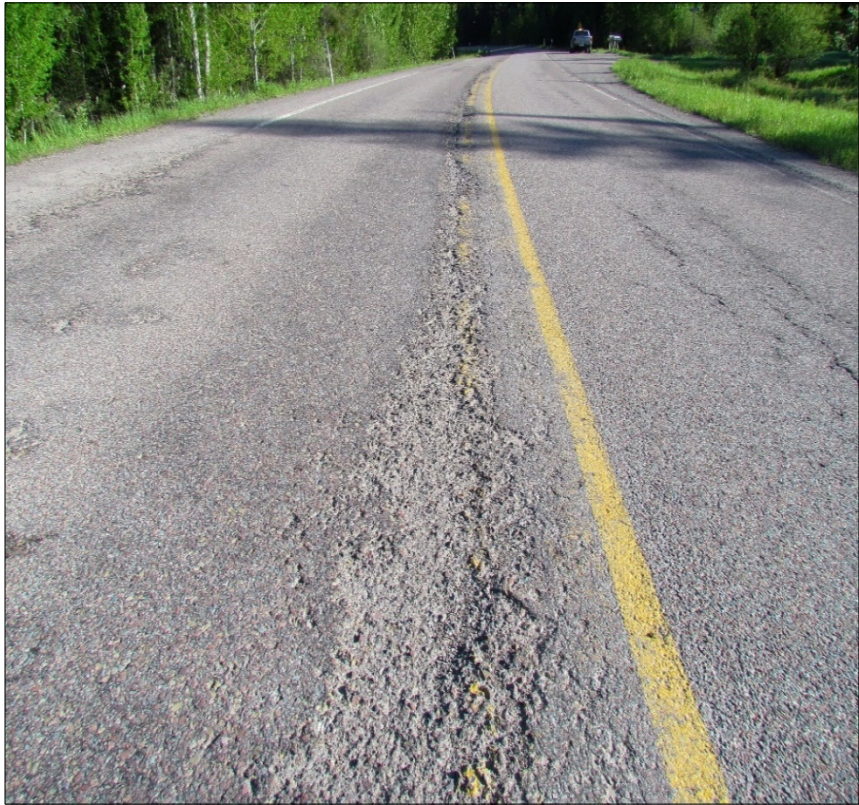
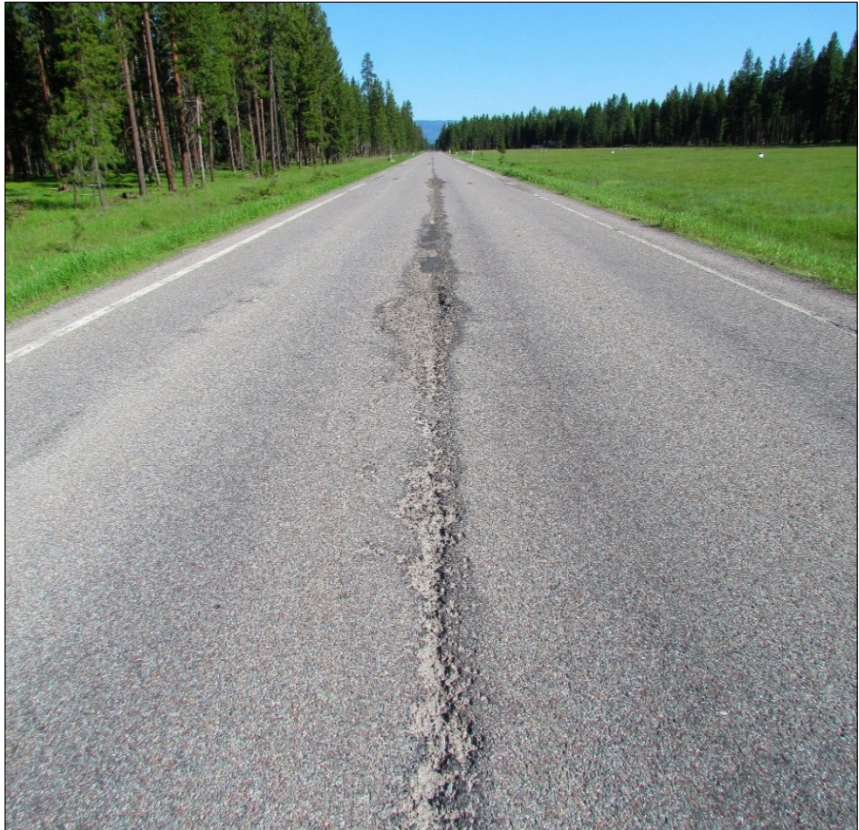
↩️⬇️ Several examples of centerline joint condition prior to start of project. Top image is near RP 32, lower is near RP 43.

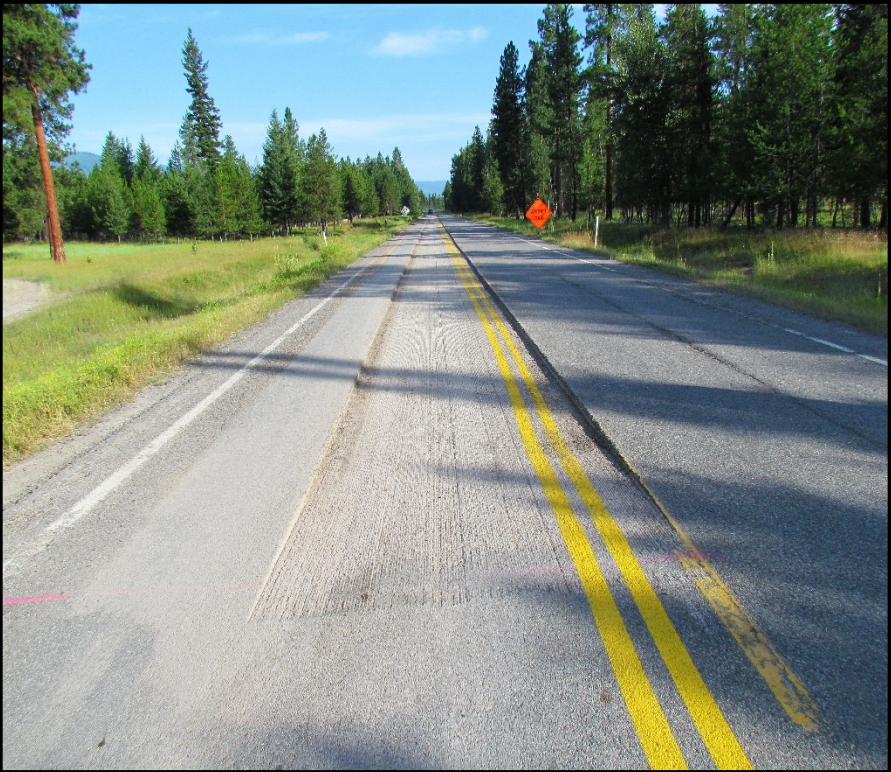
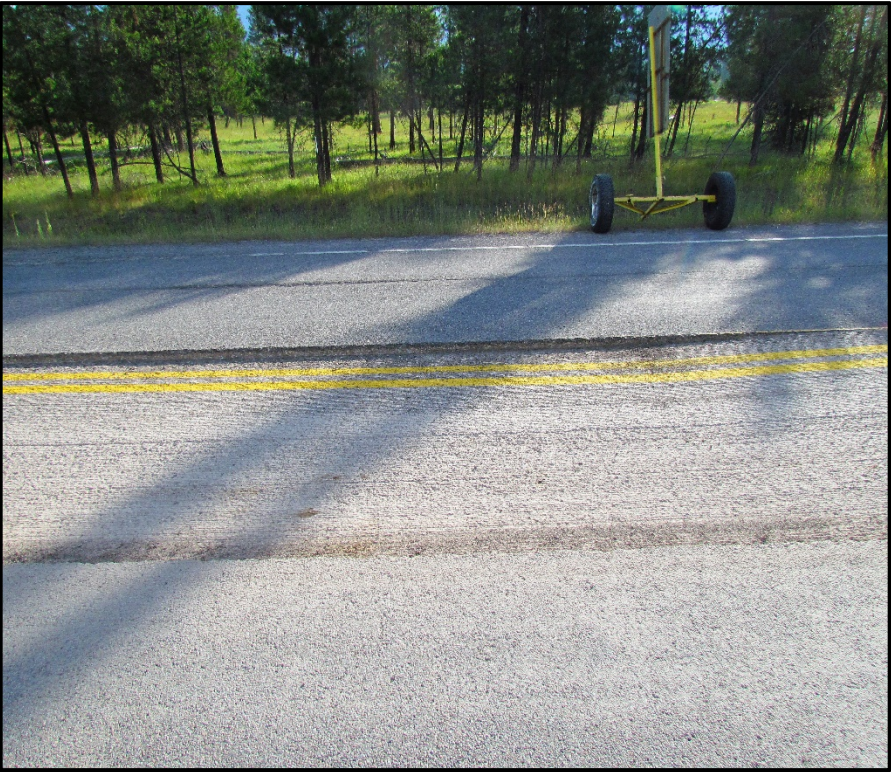
↙↘ Several images of the first milling pass on the southbound lane. Prior to the VRAM application the milled area was broom swept then a hand-held blower was used at the centerline.

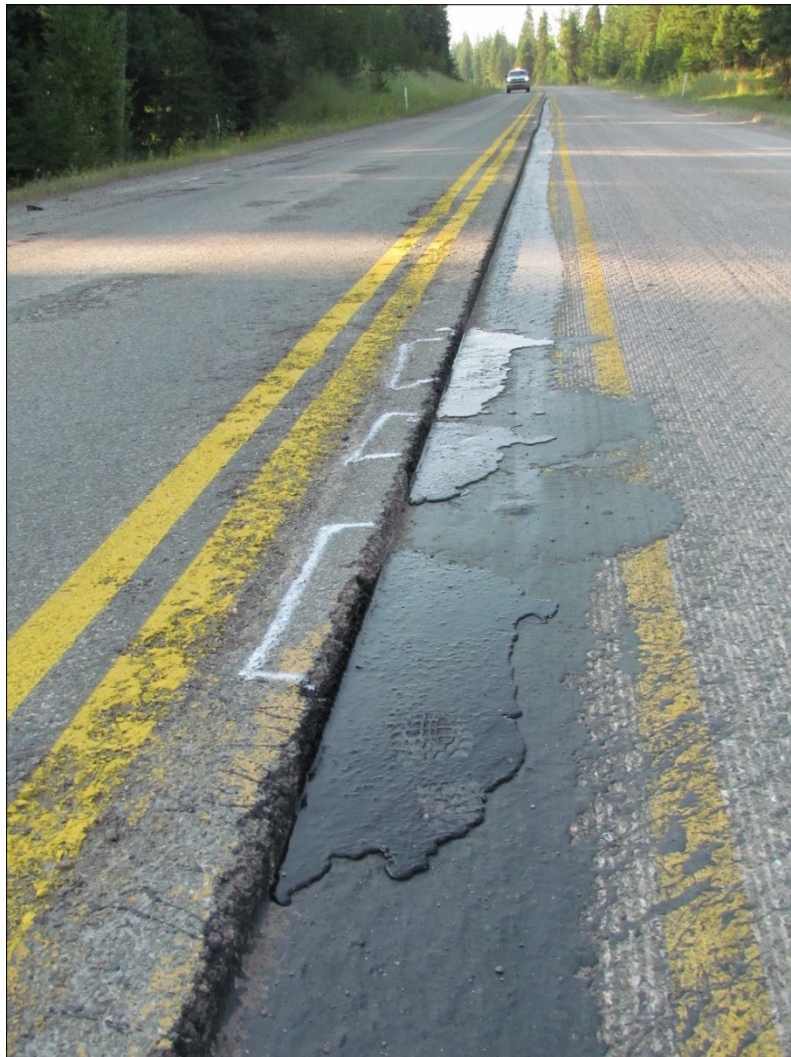
← Areas of VRAM placement considered under applied, or vehicle movement may have separated the product from the pavement, were field marked and reapplied by hand.

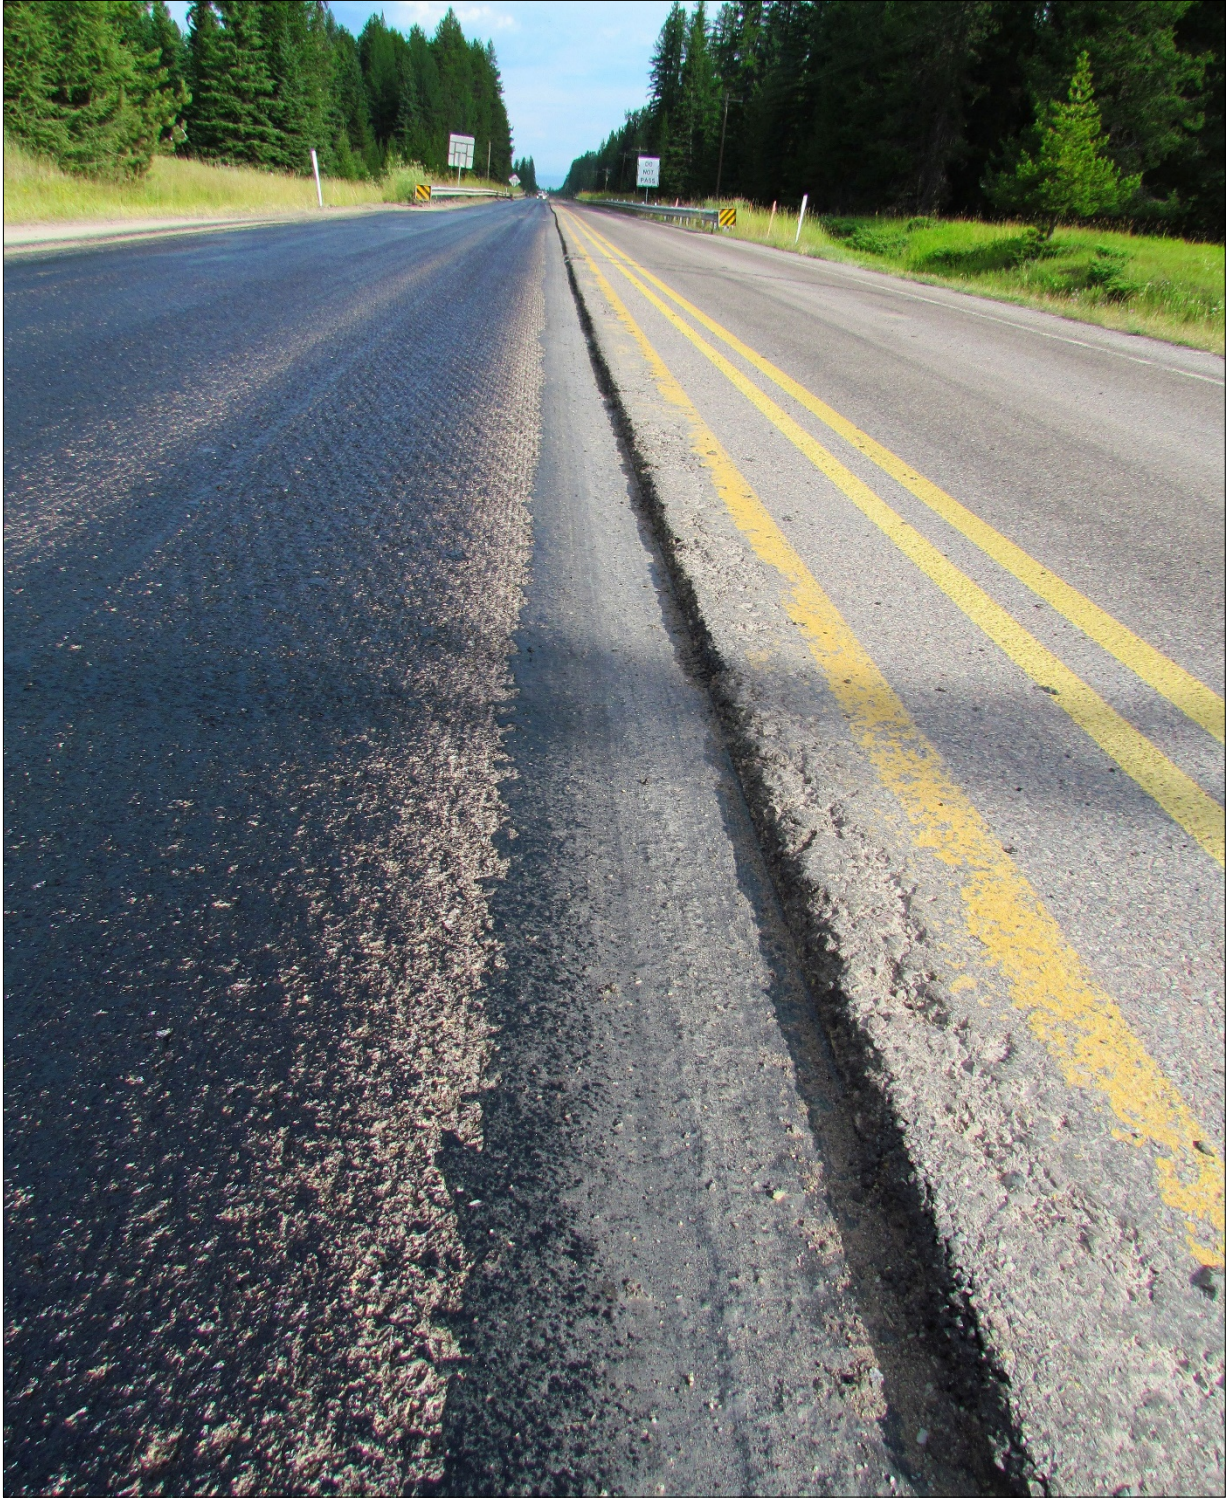
↑ Initially the tack coat was applied over the VRAM, it was reported there were instances where vehicles driving over the VRAM pulled or tore the strip. It was felt the tack may be causing the VRAM to become too sticky and this process was changed to tacking just prior paving.

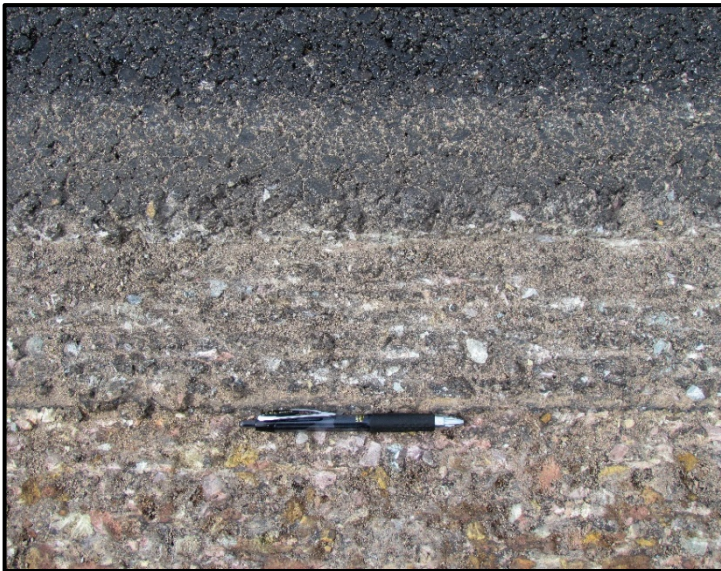
← This image shows the mill pass that has cut into the southbound lane JBAND strip. The pen marks the edge of the JBAND strip.

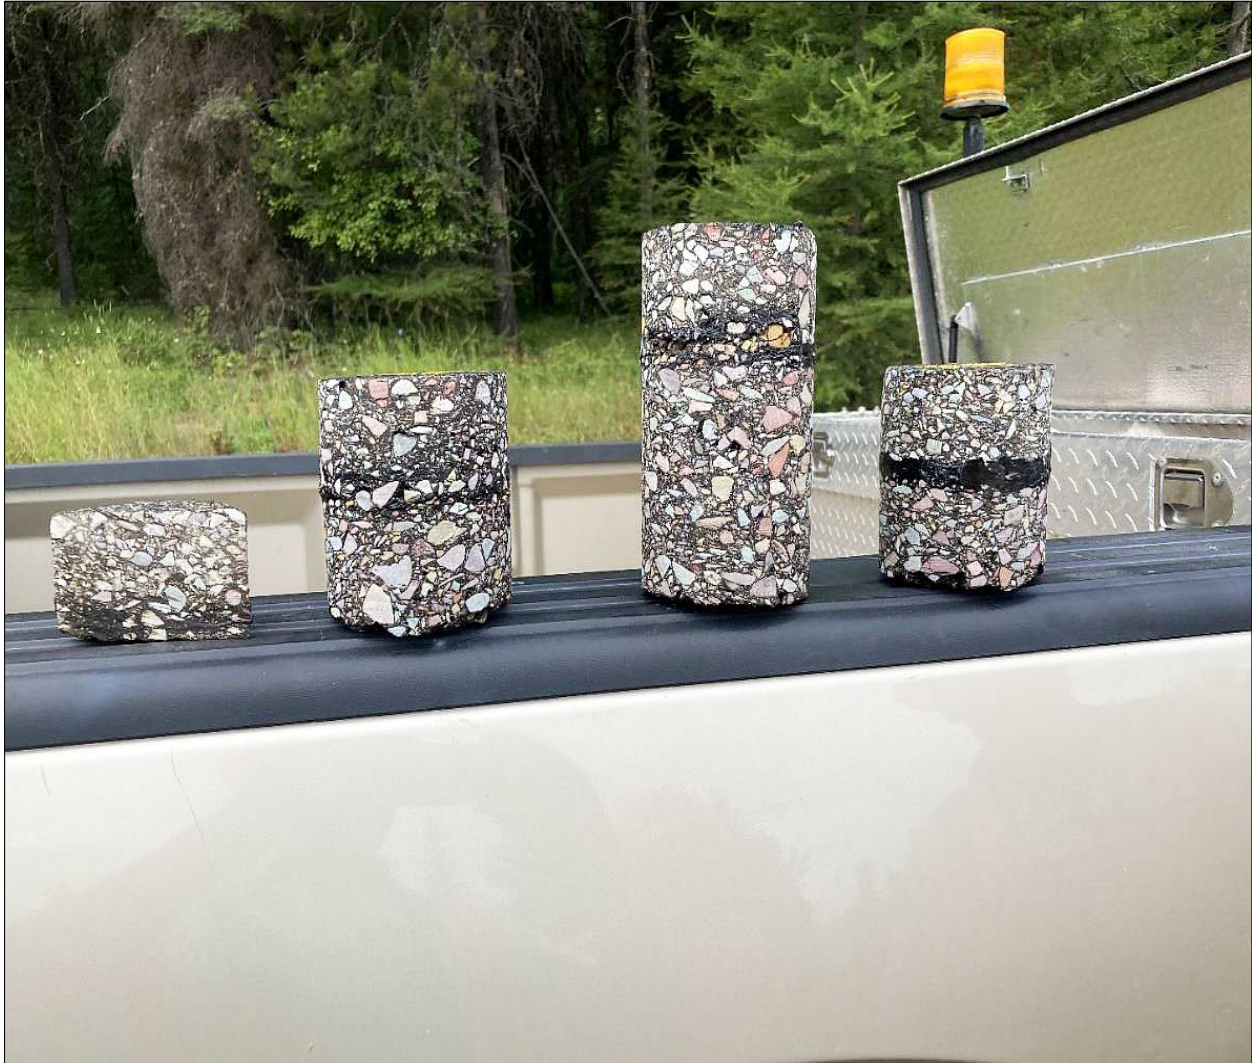
↑ Several core samples taken from the projects centerline which shows the extent of the VRAM migration into the AC matrix. The core on the far left is split. Image courtesy of CES Review Section.

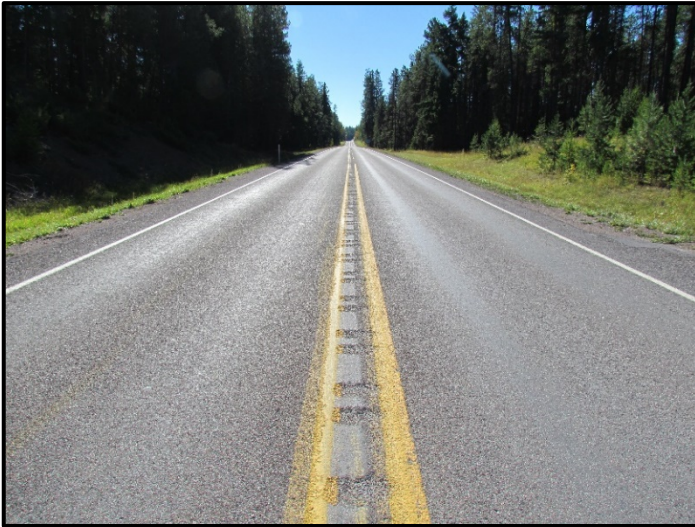
← View south near RP 34. It appears that the VRAM has begun to bleed through the chip seal. This was consistent throughout the project.

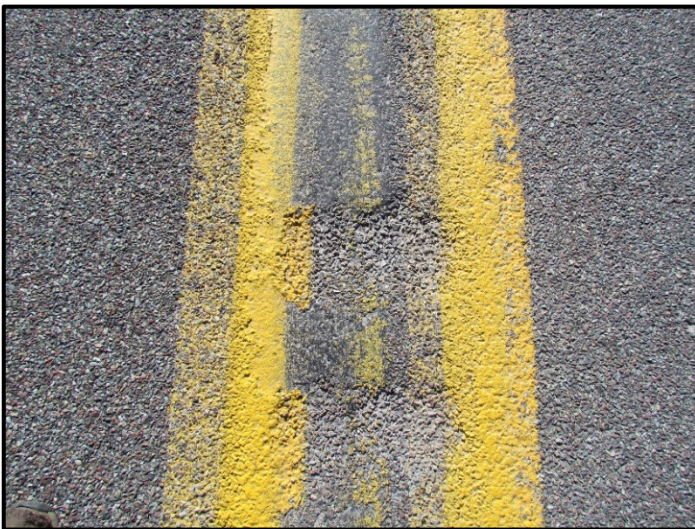
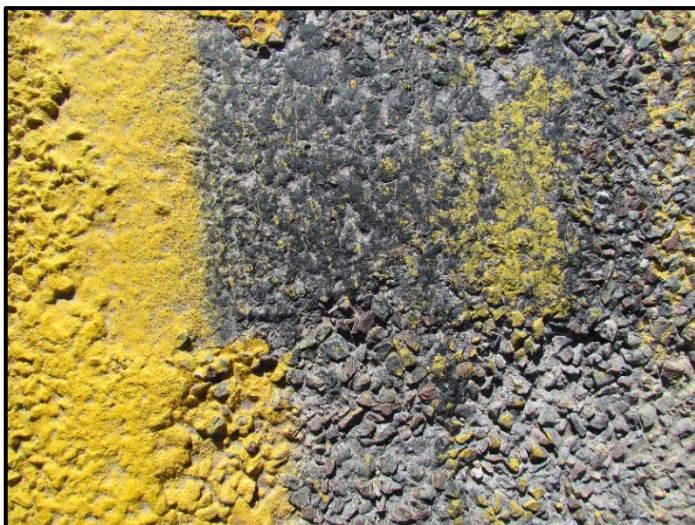
← ↓ Views from multiple distances of the centerline and bleed through of VRAM material.

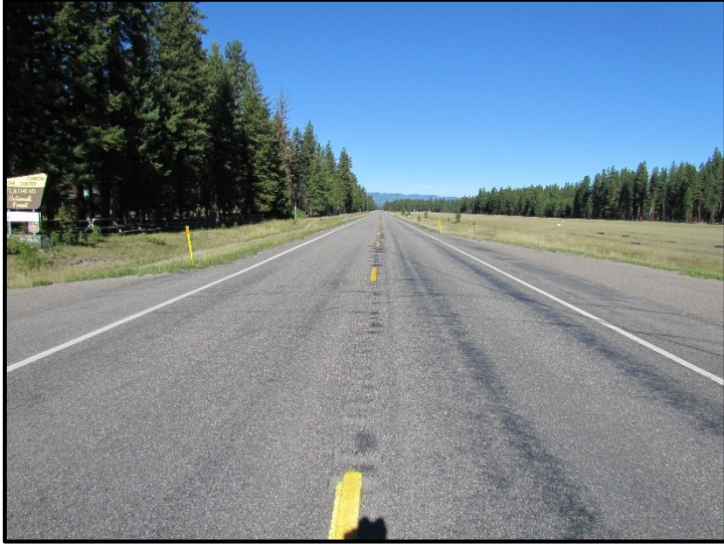
← View north near RP 43. More examples of the VRAM bleeding through chip seal at the centerline joint

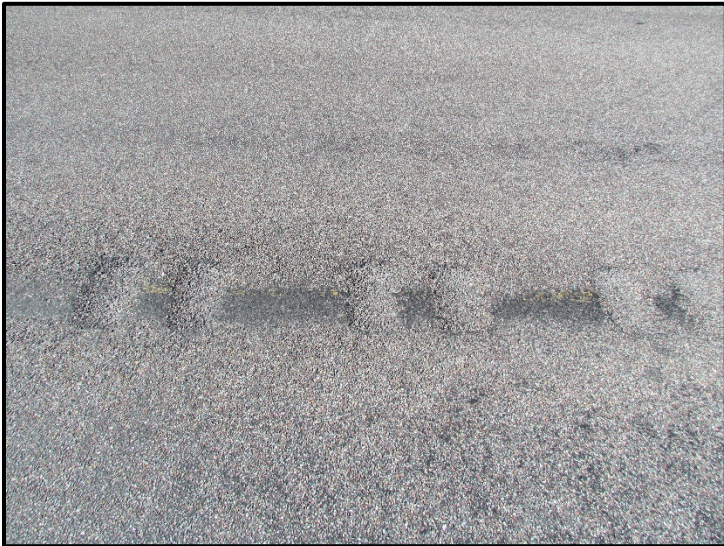
← The VRAM can be seen here bleeding through between the CLRS.

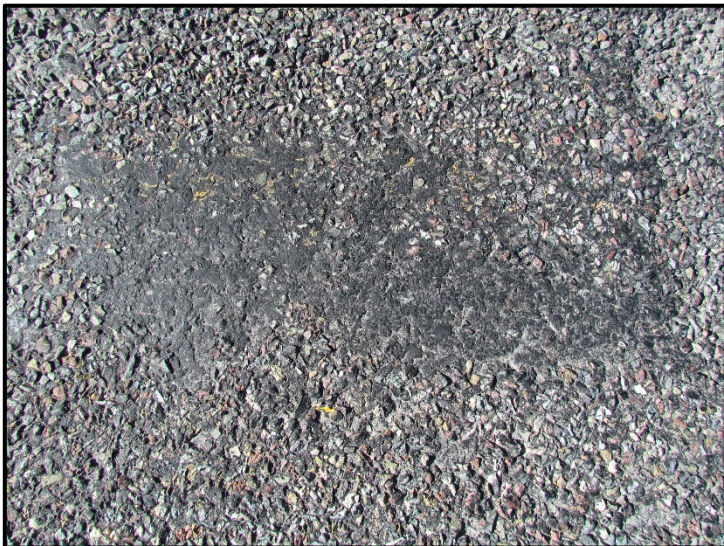
← As seen in this photo, the chips appear to be present but flooded with the VRAM.
