POST-WINTER EVALUATION REPORT

Detectable Warning Devices (Truncated Domes) for use by the Visually Impaired

Project No.: STPU 5201(11), 6th St. N. W.

Evaluation Date: April 2005

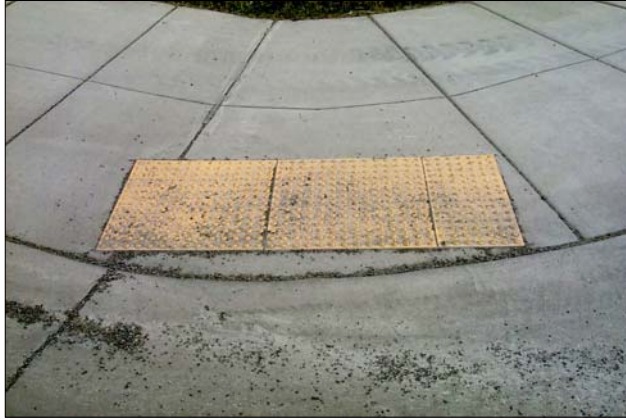
Installation 1A: Located on the northeast corner at the intersection of the east entrance to the Expopark adjacent to 5th Ave. N. W.

Adhesion tight. No dome loss. Minimum wear on domes. Color good.

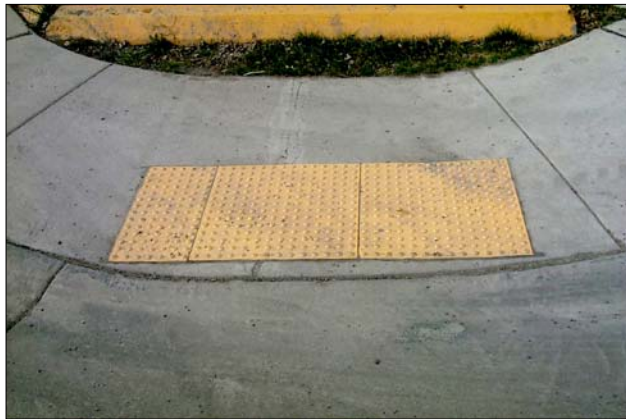
Installation 1B: Located on the southwest corner of the intersection 4th Ave. N. W. & 6th St. N. W.

Adhesion fair. West interior seam continues to curl and accumulate debris. Perimeter seam still tight. Color good. Minimum wear on domes.

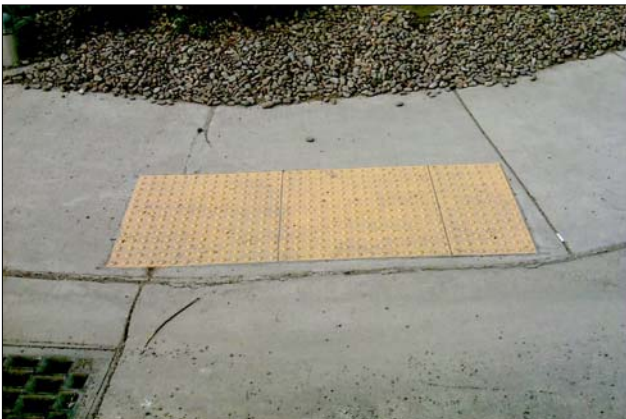
Installation 1C: Located on the southwest corner of the intersection 5th Ave. N. W. & 6th St. N. W. This treatment connects the east-west pedestrian walkway.

Same condition as 1B.

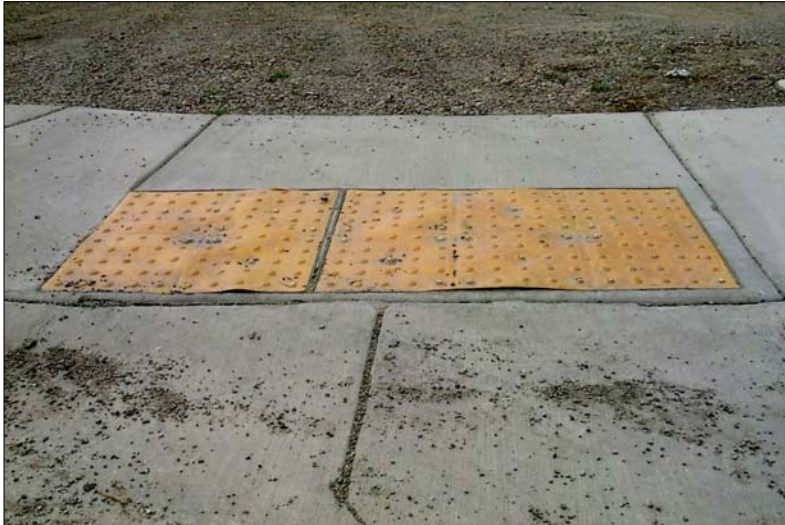
Installation 2: Located on the southwest corner at the intersection of 6th Ave. N. W. and 6th St. N. W.

This treatment performed poorly since construction. Approximately 35% of dome relief has been lost through use of a shovel or blade apparatus during the 2004-05 winter. Domes are wearing rapidly. The edges within the treatment and perimeter are beginning to lose adhesion. The tactile response is spongy, substantial air pockets beneath the mat, severe loss of adhesion. The setting pins are breaking off. Color is good. This treatment has been determined as a trip hazard and has been asked to be removed. Note that this device was improperly installed and most likely led to its premature failure.

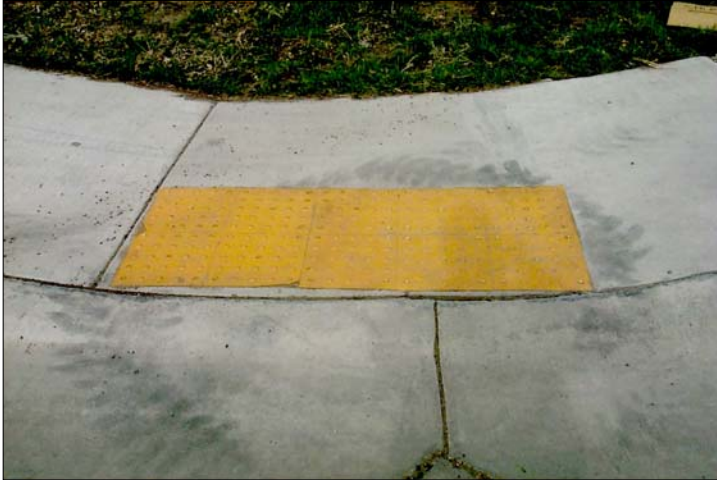
Installation 3A: Located on the northwest corner of the intersection of 5th Ave. N. W. and 6th St. N. W.

Installation 3A was in poor condition at the time of this inspection. Additional loss of domes due to suspected blade damage. Continued loss of adhesion at panel edges and interior seams. Color remains good. Many of the plastic setting pins have broken off. Evidence that an individual has taken a knife and cut the off the edges of the panel where it had lost adhesion. Installation 3B has failed and been removed.

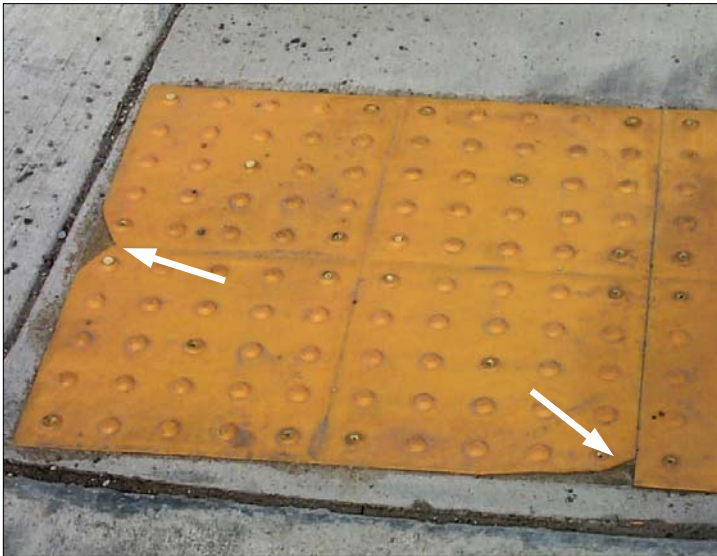
Installation 3A: Close-up of edges that have been cut away.

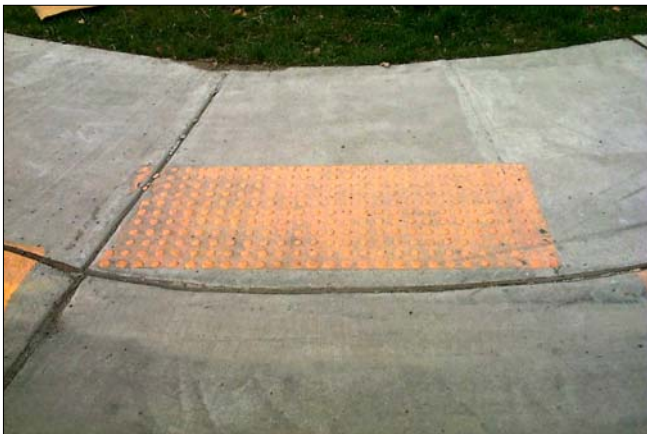
Installation 4B: Located on the northwest corner of 5th Ave. N. W. and 6th St. N. W.

South end of treatment deteriorating at mortar joint.

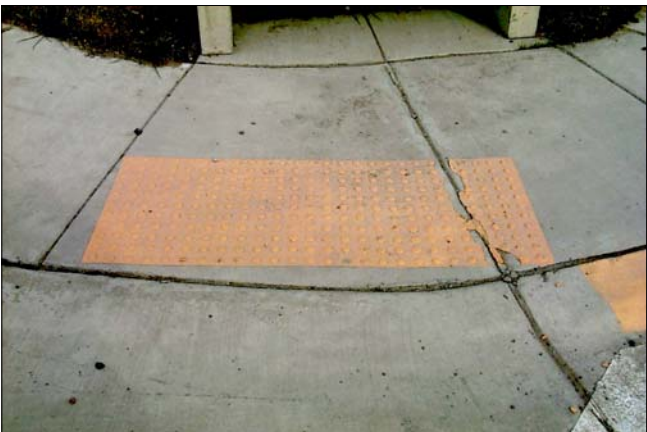
Installation 4C: Located on the northwest corner of 2nd Ave. N. W. and 6th St. N. W.

East mortar joint failing.

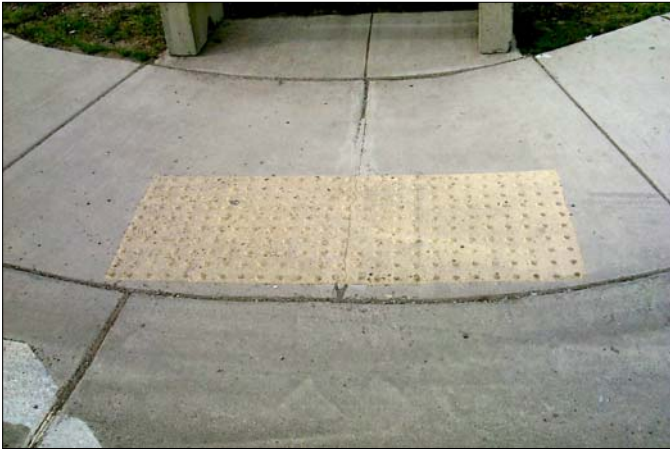
Installation 5B: Located at the southwest intersection of 3rd Ave. N. W. and 6th St. N. W.

Treatment displays substantial dome loss due to blade damage.

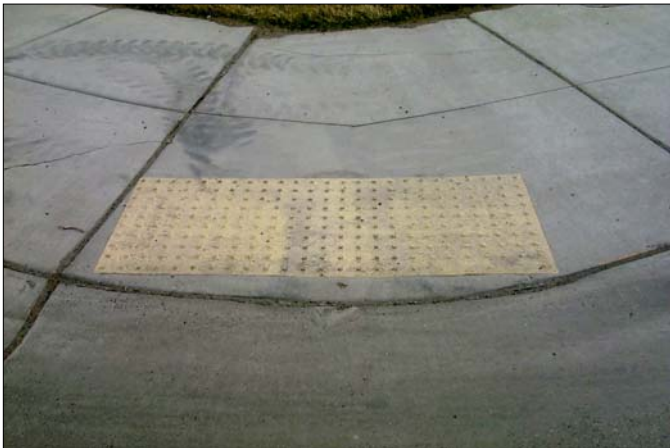
Installation 5C: Located on the southeast corner of the east Expopark entrance and 6th St. N. W.

Treatment displays dome loss since last inspection

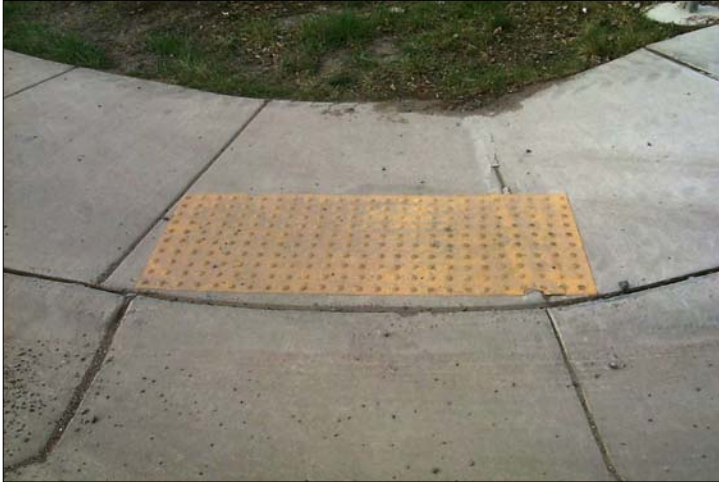
Installation 6A: located on the southwest corner of the intersection 2nd Ave. N. W. and 6th St. N. W.

All installations were in poor condition at the time of inspection. Treatment 6A is continuing to lose adhesion around the edges of the mat. The anti-skid coating over the top of the rubber domes with treatment 6A & 6B is continuing to flake off. It is unclear if this is a result of blade damage, sunlight deterioration or through the action of freeze-thaw.

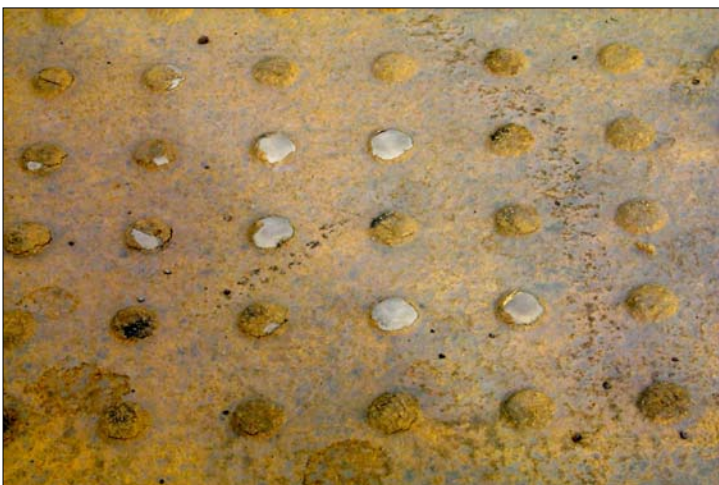
Installation 6B: Example of delaminating and cracking surface application of the rubber domes.

Although not seen as a slip hazard, this will facilitate future loss of domes.

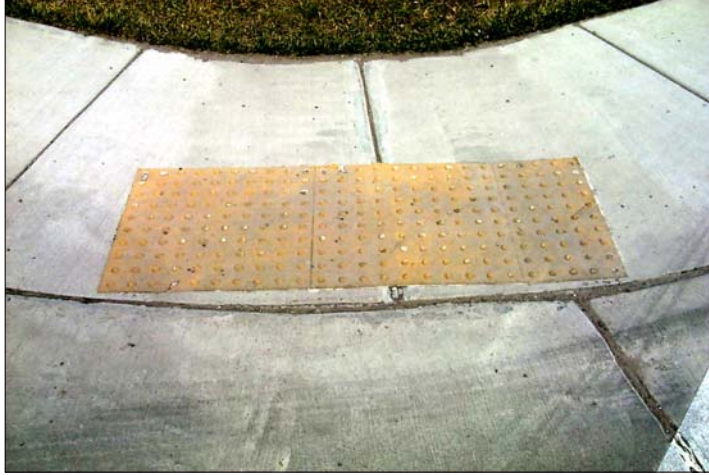
Installation 7: Located on the northwest corner of the intersection of 3rd Ave. N. W. and 6th St. N. W.

This treatment is failing rapidly. The surface of the mat has continued to rip and tear. There is additional dome loss since the pre-winter evaluation. Edges are losing adhesion. Color is fair. At this time it is not a trip hazard.

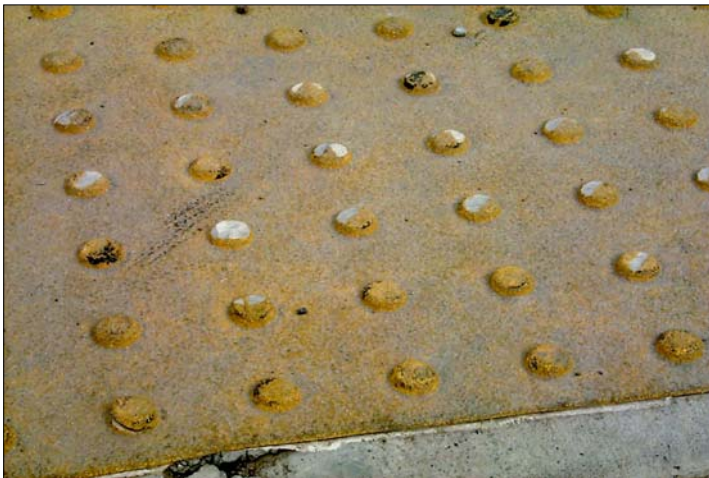
Installation 7: Close-up of damaged mat. Loss of domes and torn surface.
