Montana Department of Transportation  
Research Program  
Helena, Montana

**Annual Experimental Evaluation Report**  
(Informal)

Project: Fairfield North & South, STPP 3-1(15)18  
Location: Highway 89 (P-3), MP 18-28  
Evaluation Date: September 10, 2003  
Date Constructed: Fall 2001  
Project Description: 60 mm Cold In-place Recycle, CMS-2 – 60 mm Plant Mix Bituminous Surface  
Report Origin: Craig Abernathy, Experimental Project Coordinator

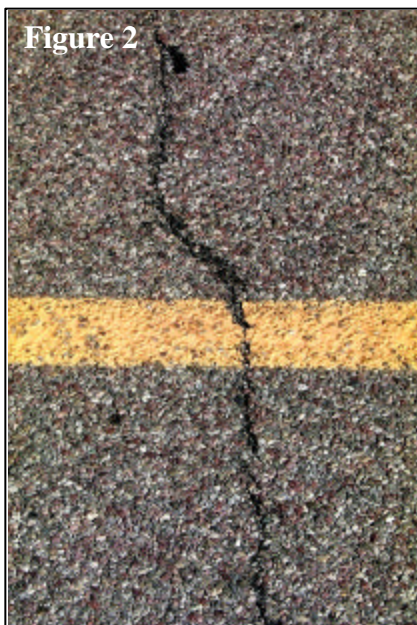
Average transverse cracking per mile (CPM) is 23 with a standard deviation of .99. Note that almost all transverse cracking observed was at milepost 28. Three transverse cracks across both lanes, less than 1/4" within the 300' data collection site. This amount of cracking is considered an anomaly and not representative of the entire project that has (at this time) exhibited minimum cracking. Figure 1 shows an example of one of the low-severity

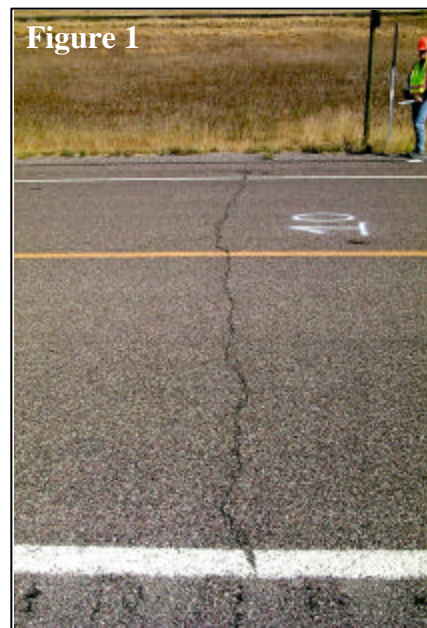
transverse crack at milepost 28. Figure 2 is a close-up of the crack.

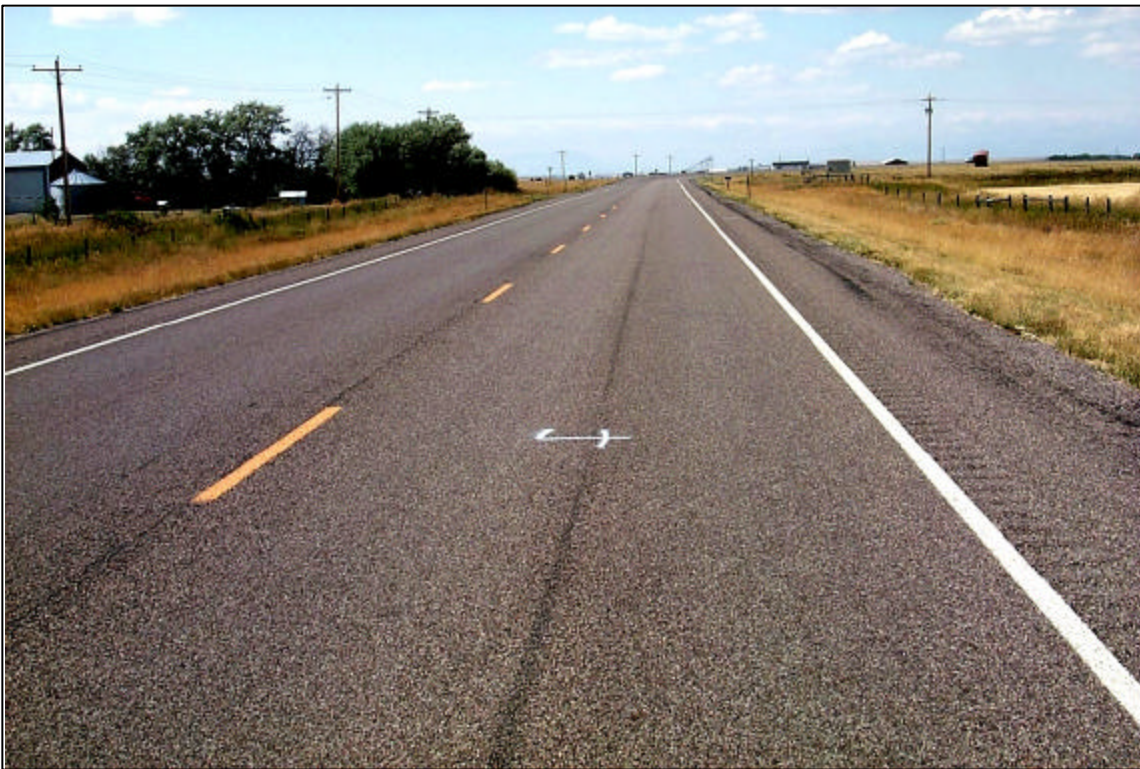
Overall, surface appearance of the project is tight and uniform. The image below is a sample representation of the pavement for the entire project (milepost 22). Based on the crack and rut data, this project has been rated as performing well. Additional information on this project is available at the MDT Research website:
