# **Experimental Feature Construction Report June 2022**

Experimental Feature:	Flexamat Vegetated Concrete Mat
Location:	Billings District, Petroleum County, Valentine Road
MDT Project Name:	Valentine Road Repair
MDT Project Number:	ER 35(21)[9745]
Experimental Project Number:	MT-20-03
Principle Investigator:	Chad DeAustin, Experimental Project Manager, (ExPM)
Technical Contact:	Dave Hedstrom, MDT Hydraulics Engineer
Construction Date:	November 2020

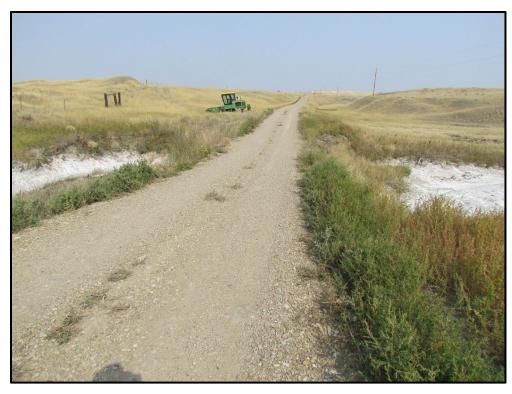
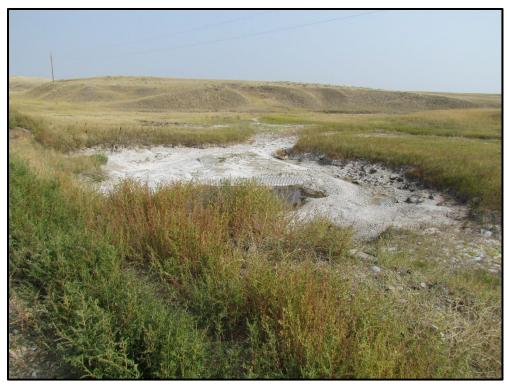
A 2010 storm event caused a dam upstream to fail and resulted in water flows higher than designed to flow through the culvert. This resulted in eventual failure of the culvert causing drainage issues and road washout.

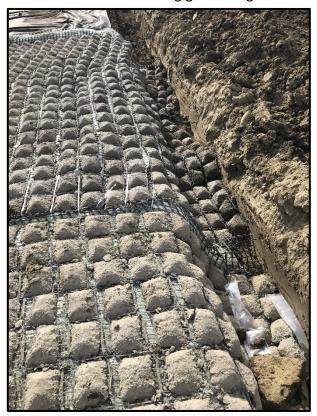
↑ View of how the Flexamat was anchored on the inlet side of the road.

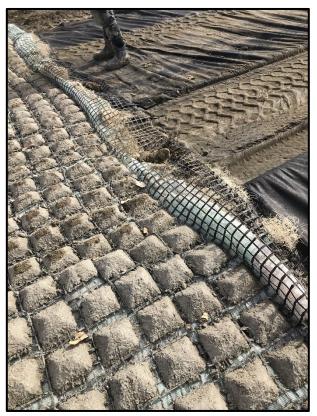
↑ View of the Flexamat being laid over the geofabric separating the subgrade and surfacing gravel.

In the right photo you can see the geogrid edge of the Flexamat. To connect multiple sections, the 2 pieces are overlayed and metal zip ties are used for connection. There is one of these seems shown in the left photo. U anchors are also used to keep the mat in place.

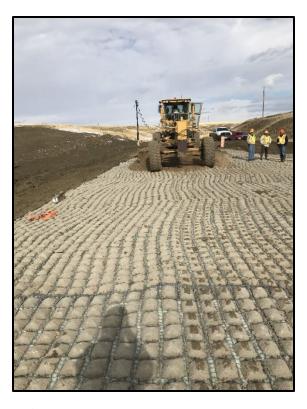
↑ Surfacing gravel being placed.

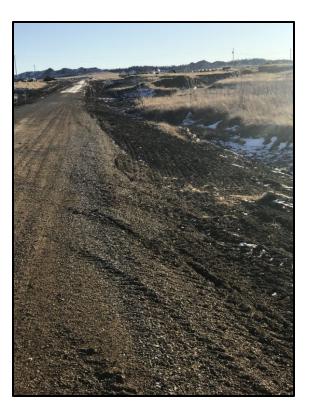
↑ Inlet side of roadway.

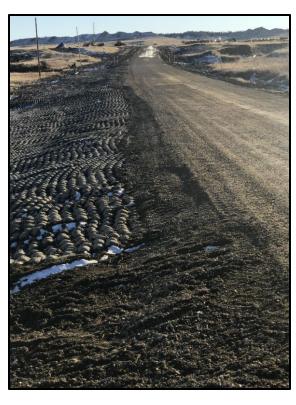
↑ Outlet side of roadway.

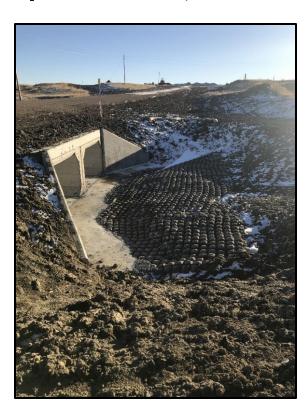
↑ Flexamat was also placed at the inlet and outlet of the box culverts.

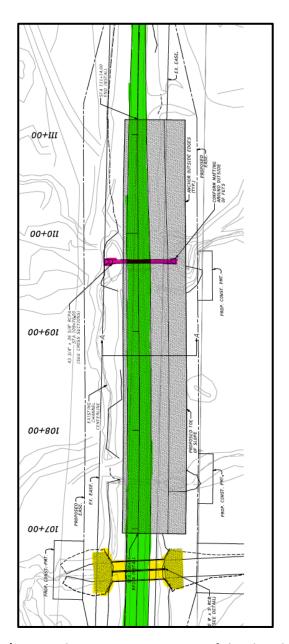
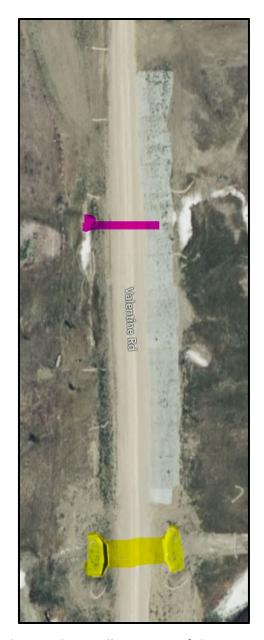
♠ Seen above is a comparison of the detail from the plans and a satellite image of the finished project. The yellow highlights the box culvert and pink is the location of an additional culvert. The Flexamat on the outlet side of the roadway is easily visible in the satellite image.
