**Experimental Feature Evaluation
 December 2022**

Experimental Feature:	Flexamat Vegetated Concrete Mat
Location:	Billings District, Petroleum County, Valentine Road
MDT Project Name:	Valentine Road Repair
MDT Project Number:	ER 35(21)[9745]
Experimental Project Number:	MT-20-03
Principle Investigator:	Chad DeAustin, Experimental Project Manager, (ExPM)
Technical Contact:	Dave Hedstrom, MDT Hydraulics Engineer
Construction Date:	November 2020
Date of Inspections:	May 2021, May 2022

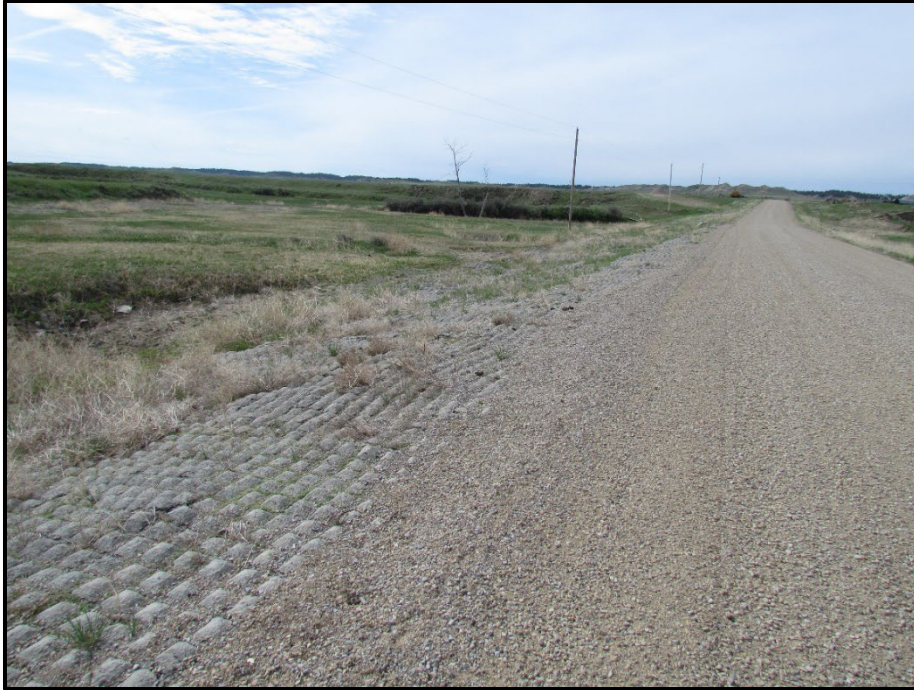
Significant plant growth in the flexamat sections at the box culvert and the bottom of the outlet side ditch. The flexamat appeared to be in good and working condition. A few damaged blocks were noticed most likely from installation. No erosion was noticed.

↑ Outlet ditch with Flexamat, view south.

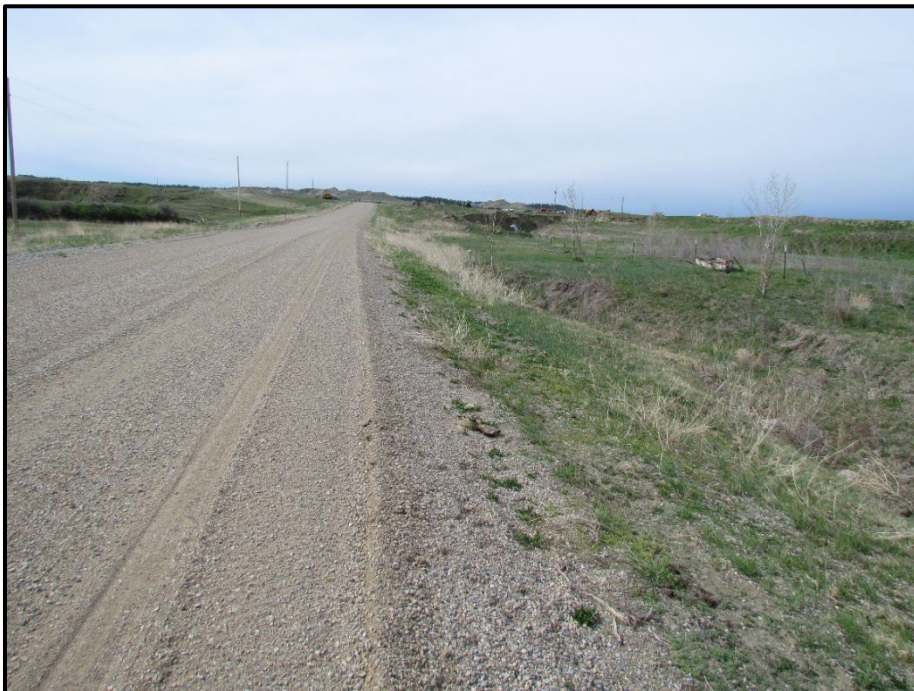
↑ Inlet ditch without the Flexamat, view south.

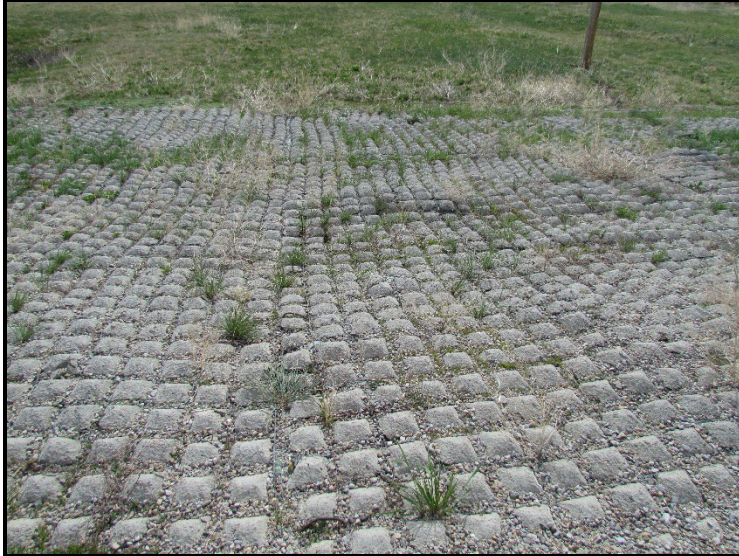
← View of some of the vegetation that has begun to grow through the Flexamat. Note that the bottom half of the ditch has more growth than the top.

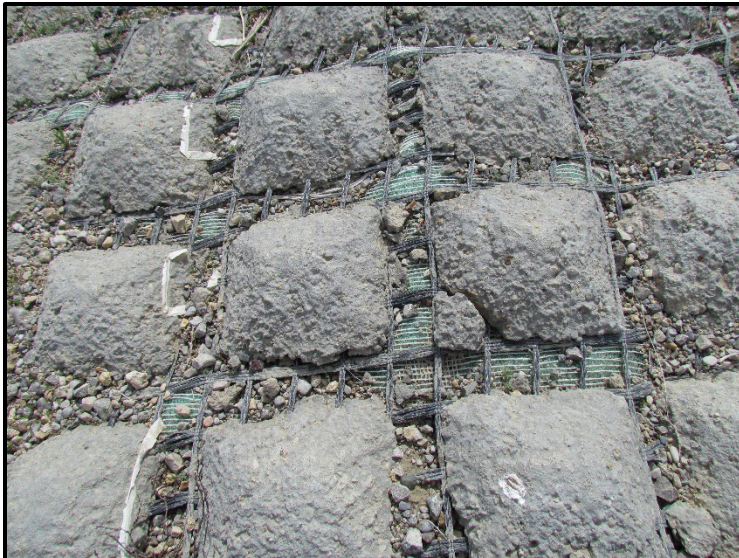
← Close-up view of the concrete blocks and geogrid making up the Flexamat in the outlet ditch. A few damaged blocks were noticed, most likely from installation.

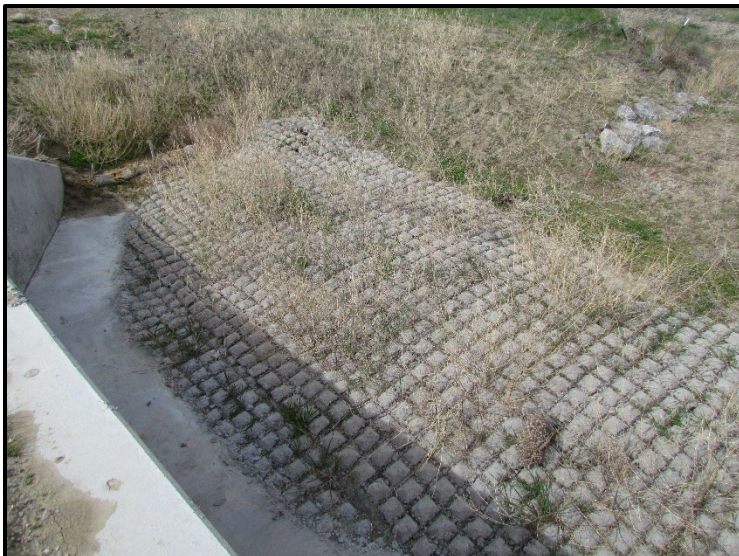
← Inlet side of the box culvert with noticeable plant growth through the Flexamat.

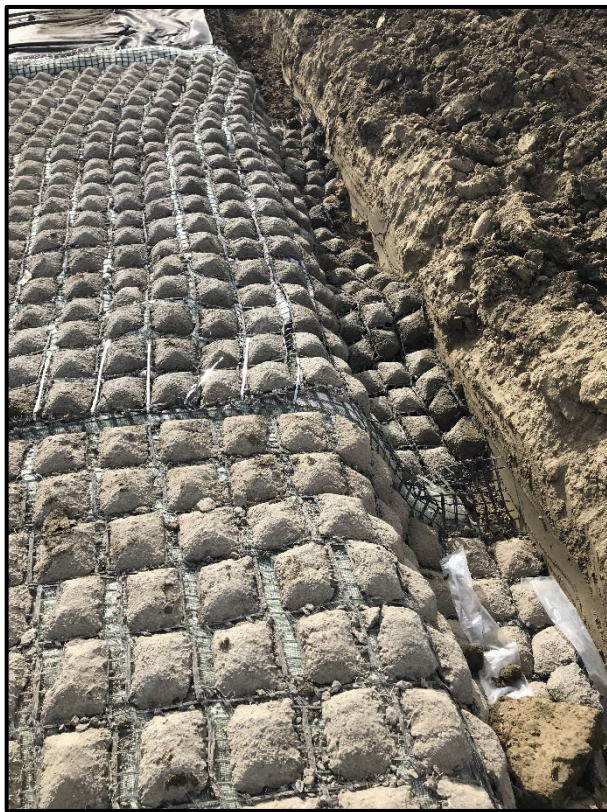
↑ View of how the Flexamat was anchored on the inlet side of the road.

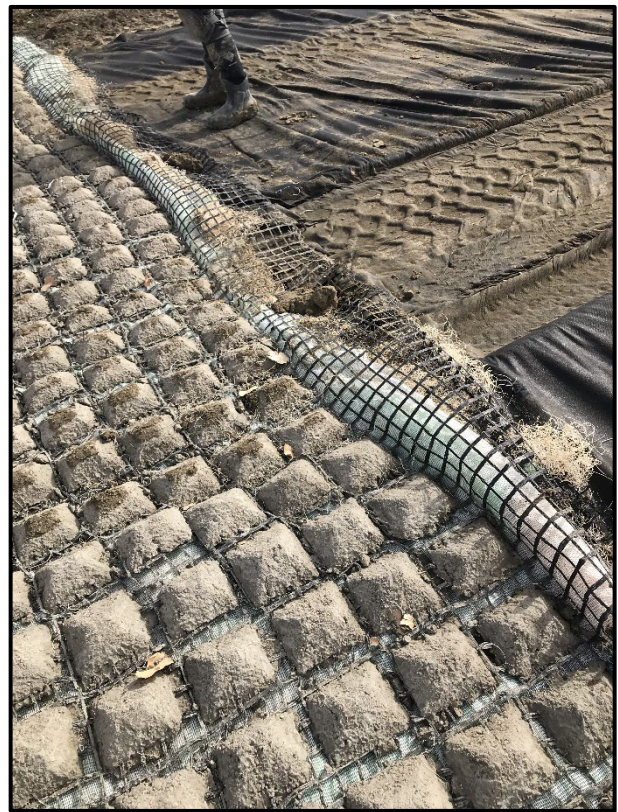
↑ View of the Flexamat being laid over the geofabric separating the subgrade and surfacing gravel.

In the right photo you can see the geogrid edge of the Flexamat. To connect multiple sections, the 2 pieces are overlaid and metal zip ties are used for connection. There is one of these seams shown in the left photo. U anchors are also used to keep the mat in place.

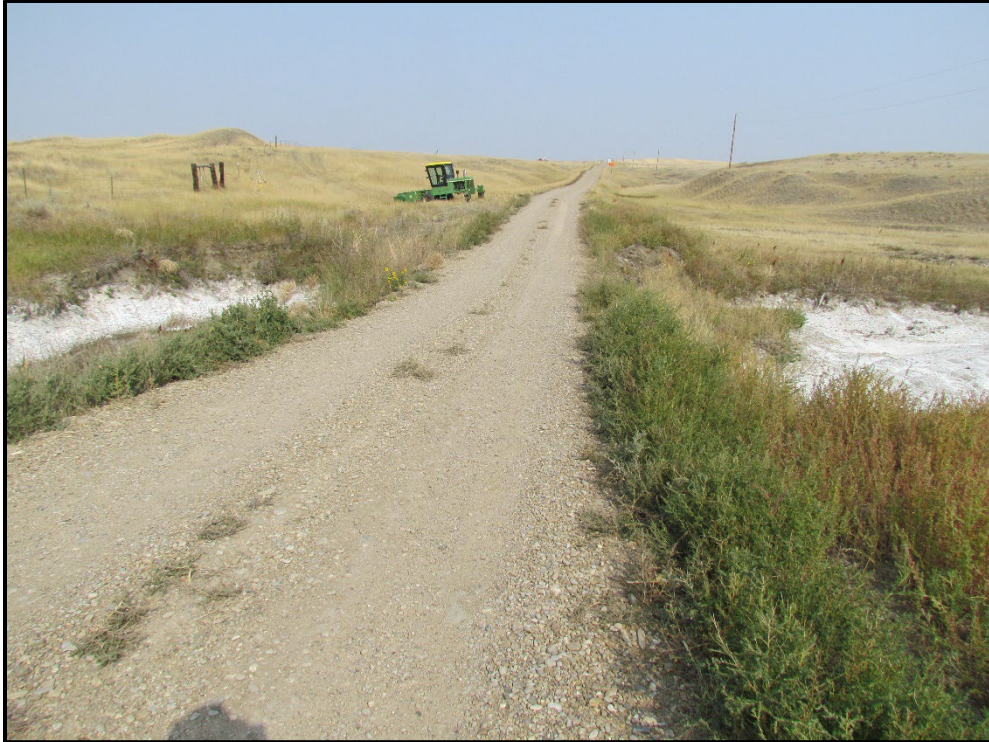
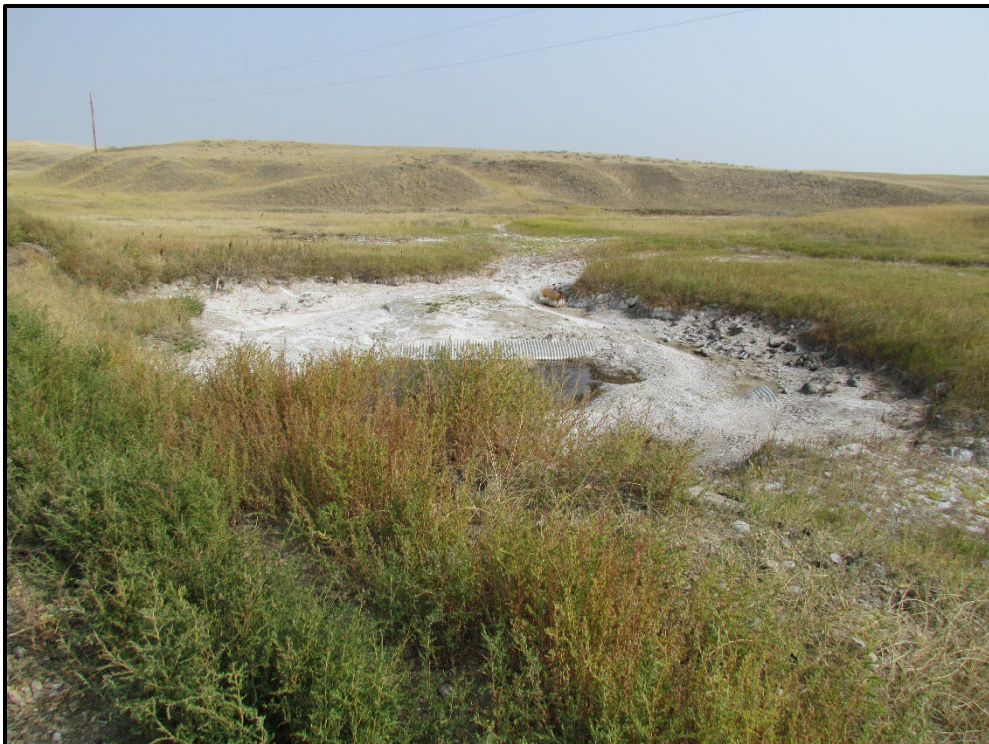
A 2010 storm event caused a dam upstream to fail and resulted in water flows higher than designed to flow through the culvert. This resulted in eventual failure of the culvert causing drainage issues and road washout.
