ANNUAL RESEARCH EVALUATION REPORT

Thin-Whitetopping Overlay Composite

Glendive, Montana – Dawson County

STPP 20-1(6)0 P-20

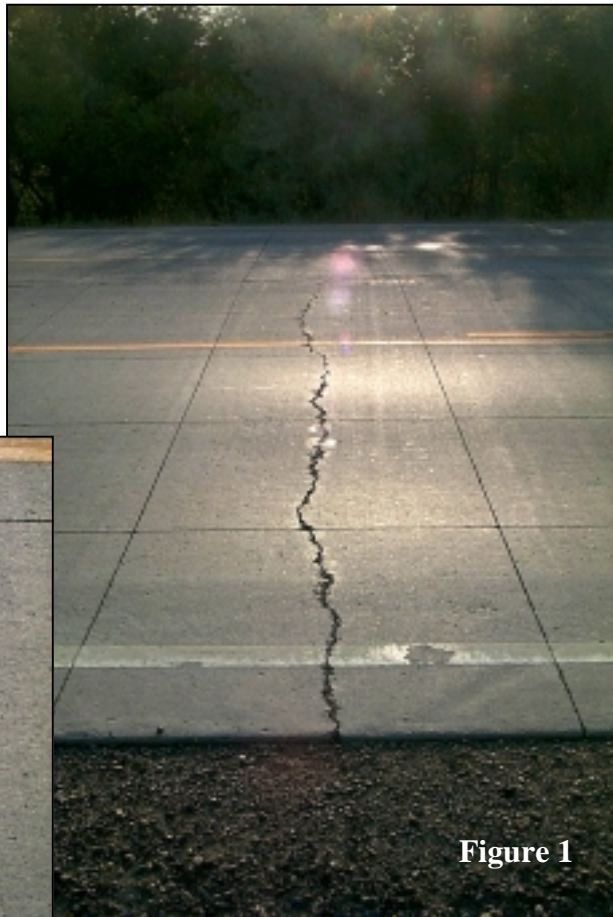
Currently three transverse cracks are present on this project, all in the southbound lane. Location as follows (footage counted from the south end of the project going north), #1 at 1244' (541m), #2 at 1380' (420m), and #3 at

1480' (451m). Note that these cracks developed soon after placement during construction, no additional transverse cracking has been documented. Figure 1 is showing the crack at location 1244', figure 2 shows a close-up of the crack. These cracks are widening rapidly since construction and are rated as severe in nature. Incompressible debris (rocks, friables etc,) is entering the cracks and

will accelerate the deterioration of the crack with freeze thaw events. It is suggested that these cracks be sealed in some manner to delay further damage.

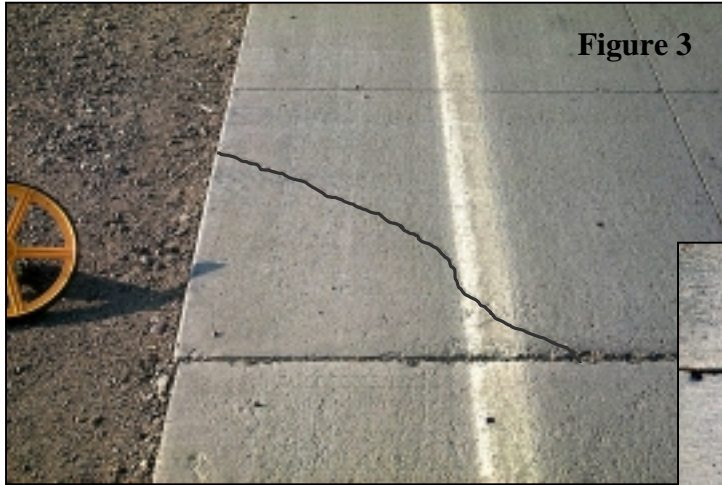
The rest of the project displayed minimal panel cracking. Three panels are affected at both the north and south end of the project and one panel midway in the southbound lane. The north end of the northbound lane had one panel crack indicative of this type of pavement treatment, without an autopsy of the panel it is difficult to determine the various causes of cracking; which could entail, debonding of the PCCP to the asphalt concrete, structural failure of the underlying AC layer or overloading of the PCCP panel. In addition, this panel has no curb support, which may have allowed cracking at this location. Figure 3 shows the cracked panel on the northbound lane; right side

approximately 250' south at the north end of the project (refer to the crack map for an estimated location), a dark gray line has been superimposed in the visual to better see the crack.

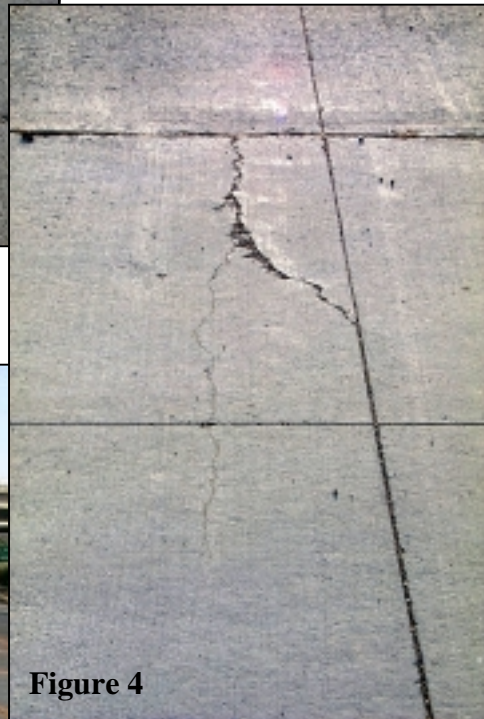
Figure 4

The mid-way crack in the southbound lane located at about 1322' (0' starting at the south-end of the lane) has the same characteristics as the previous crack (figure 4) save the fact it is located at the

southbound, east edge of the pavement. The east edge of the southbound pavement supported the

paver for the northbound placement of the PCCP. This may have exacerbated the cracking of the panel.

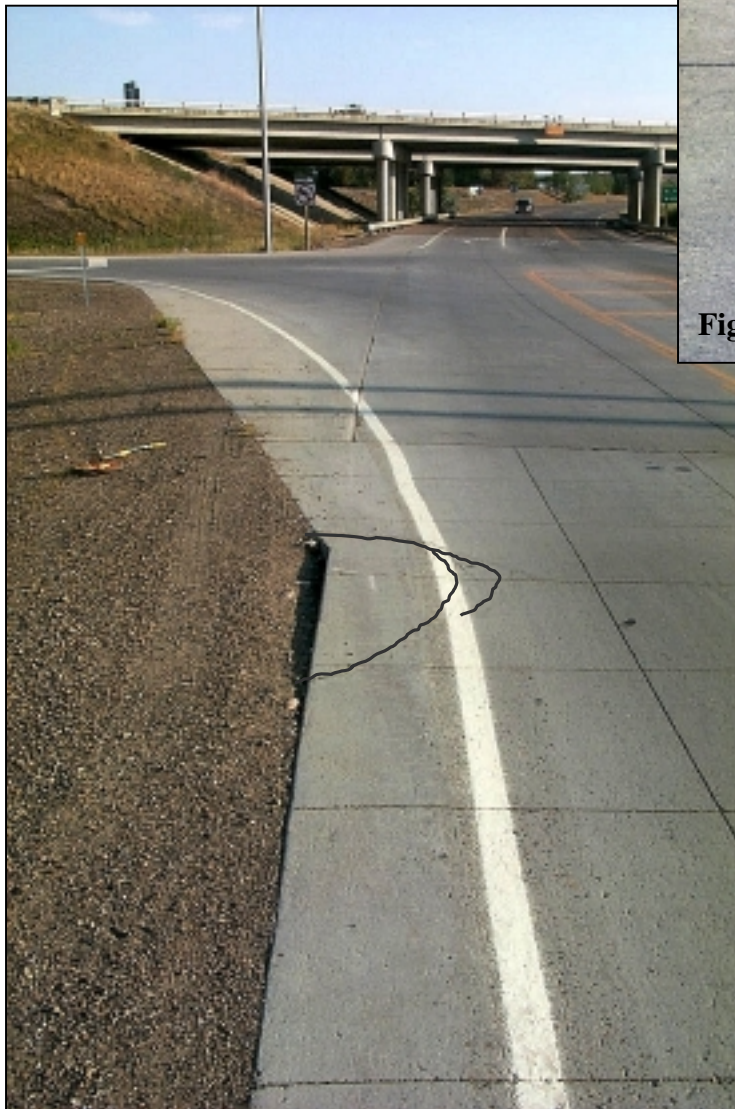
Additional panel cracking was located on the north end of the southbound lane on the west side of the road. It was observed that large truck traffic exiting off the interstate (due to the angle of turn) would roll over this section half on the pavement and partially on the gravel shoulder. Due to the lack of supporting shoulder and heavy loadings this section of pavement is experiencing may be the main reason for

cracking at this location. The cracking pattern also reflects lack of support. Figure 5 shows the area of cracking panels in relationship to the exit lane. Truck tire imprints can be seen in the gravel. The cracks have been superimposed with a dark gray line for better visibility. Figure 6 is a close-up of this area. Due to the nature and location of the cracking, this area will most likely deteriorate rapidly and will require spot repair of the pavement.

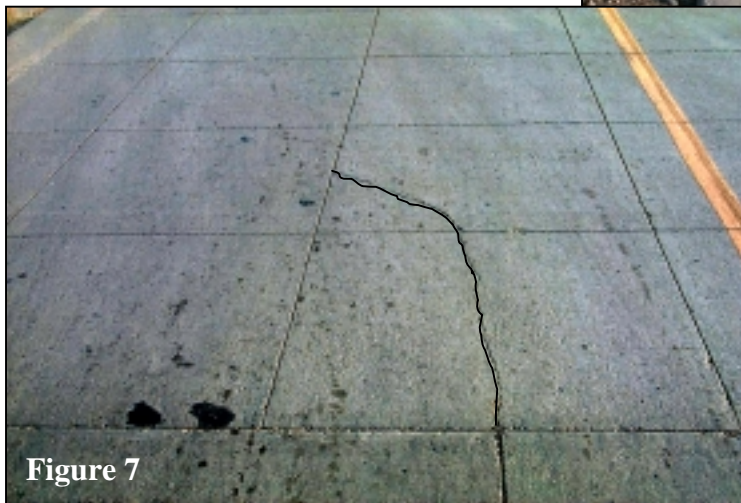
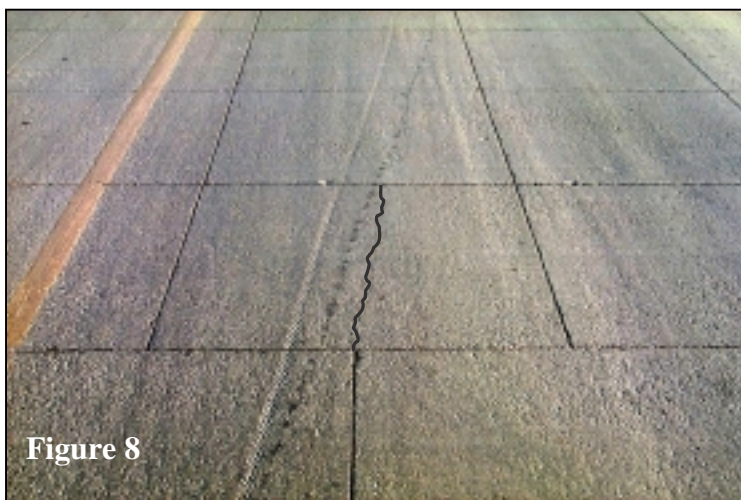
Cracking appeared at the south end of the project on both southbound and northbound lanes. This cracking was located adjacent to the full-depth PCCP at the Towne St. intersection (P-57). The cracks within these panels line up directly with the saw cuts on the full-depth PCCP. This cracking is sympathy stress from the

full depth pavement. Installing a bond breaker between the full depth and whitetop sections may have alleviated this condition or (if possible) matching up saw cuts with the whitetopping and full-depth pavements. Figures 7 & 8 shows the sympathy cracking, gray lines have been superimposed over the cracks.

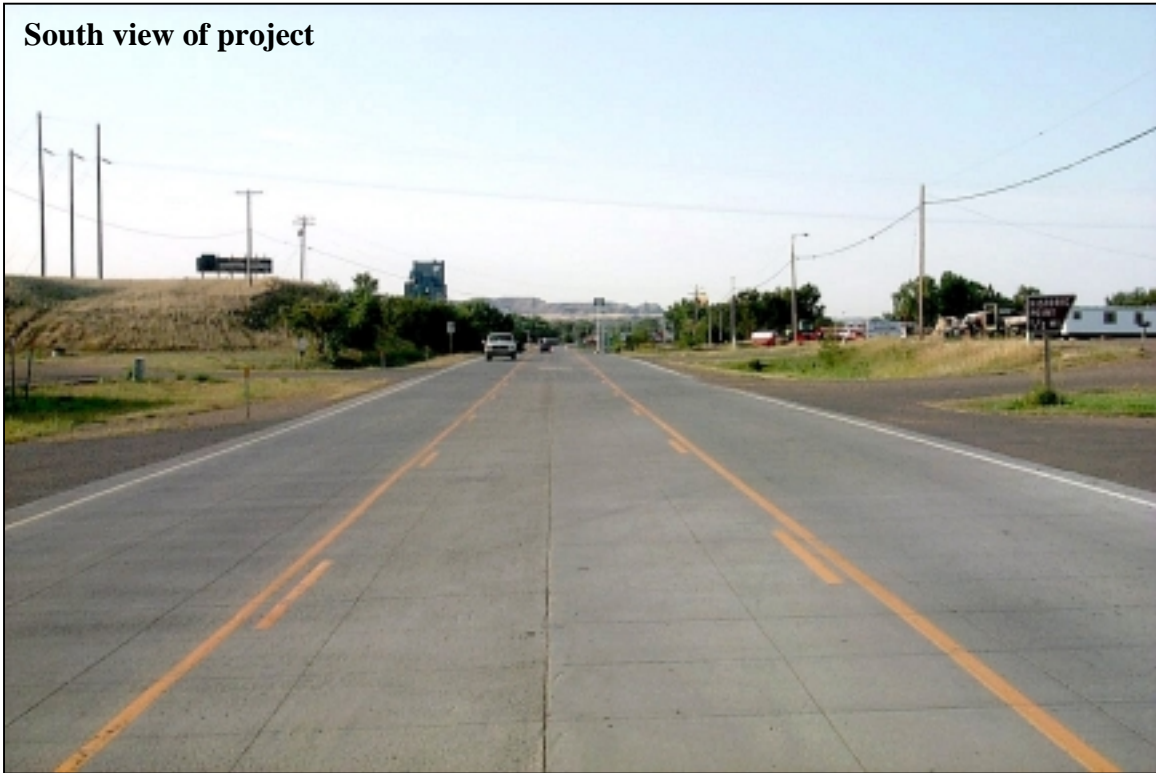
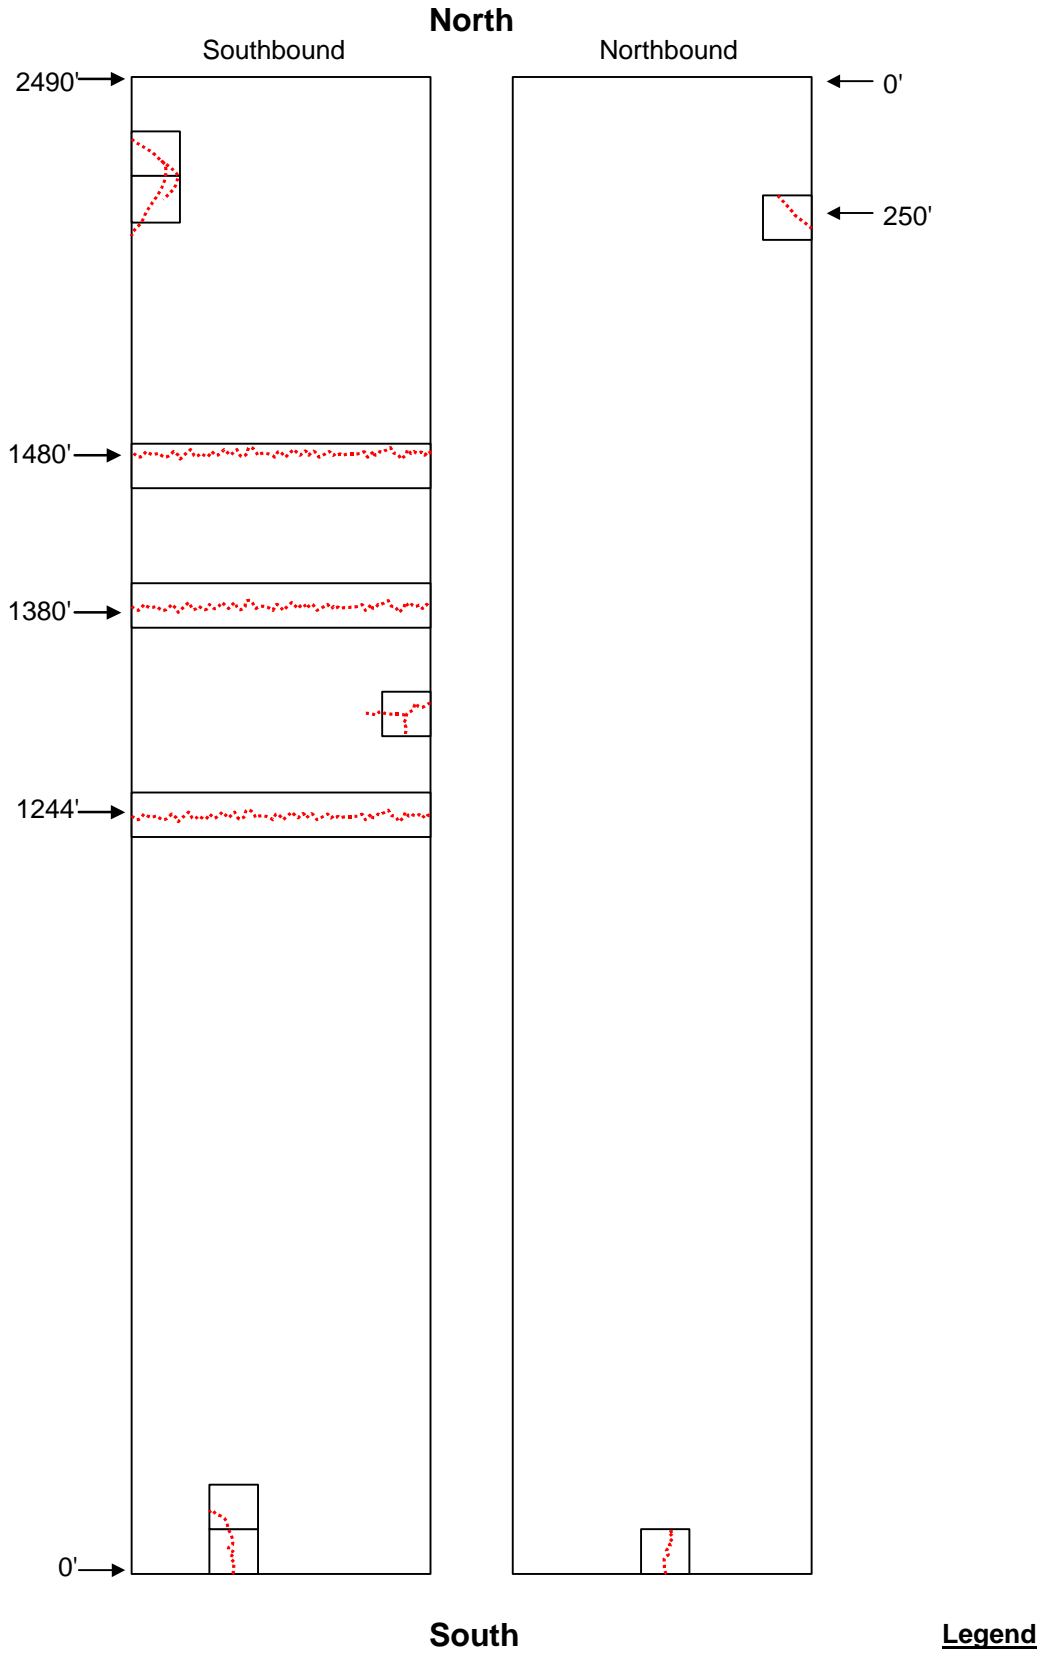
Glendive Whitetopping Representative Crack Map

Photographic documentation of the cracks as well as a representative crack map is included in this report.
