EXPERIMENTAL EVALUATION REPORT

Thin-Whitetopping Bonded Composite

Location: Glendive, Montana – Dawson County

Project No.: STPP 20-1(6)0, P-20, C000020; Highway 16, Milepost 0-0.6

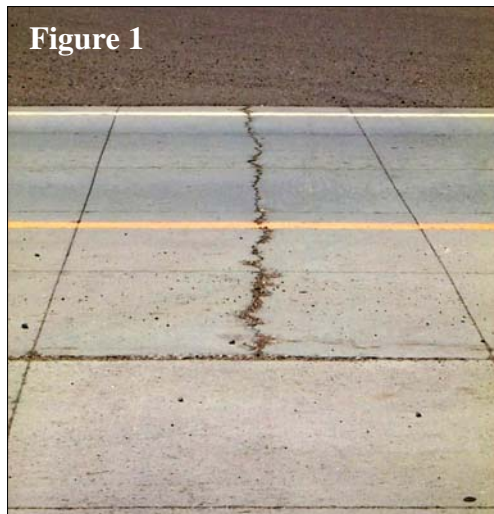
Figure 1

A visual inspection of the entire project was performed to document all types of surface cracking and distress. Photographic documentation of some of the cracks, recent repairs, as well as a representative crack map is included in this report. Note that the crack map is strictly an interpretation of progressive distress during the evaluation phase of the project, it is not to scale. Currently three transverse cracks are present on this project, all in the southbound lane. Location as follows (footage counted from the south end of the project going north), #1 at 1244' (541m), #2 at 1380' (420m), and #3 at 1480' (451m), see crack map at end of report. Note that these cracks developed soon after placement during construction. These cracks have widened since construction and are rated as severe in nature (example of crack in figure 1). Incompressible debris (rocks, friables etc.) is entering the cracks and will accelerate the deterioration of the fracture with freeze thaw events, however no debonding of the asphalt and PCCP layer was observed with any of the existing transverse cracks in this evaluation. No additional transverse cracking has occurred since construction.

A total of approximately eighteen panels have cracked since construction. A cracked panel does not necessarily mean a failure of the bond between the AC and PCCP layers. To date, no panel movement or deflection was noticed on any of the panels as traffic moved over them.

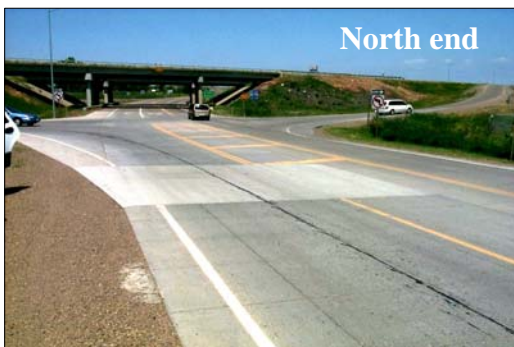
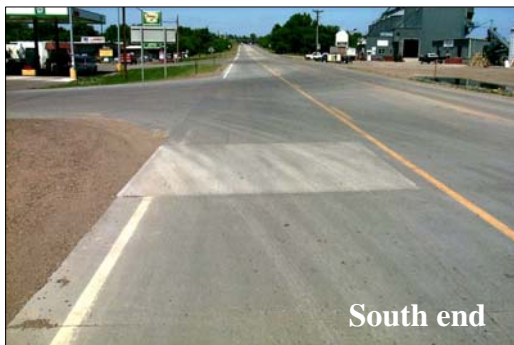
Fifteen panels were affected at the north and south end of the project on the southbound lane. In fall of 2005 both these areas were repaired due to the extent of the panel cracking. The repair involved removal of the existing PCCP and asphalt layers and replaced with full-depth PCCP. The images at left depict the repairs at the two area of the southbound lane.

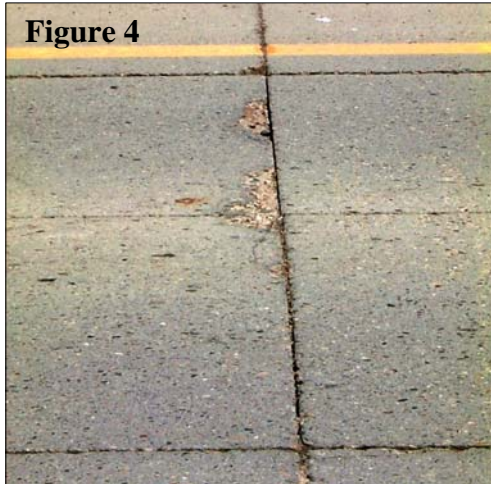
During this analysis only one additional panel has cracked, located at the north edge of the northbound lane of the whitetopping project. In this type of cracking which is indicative of this kind of pavement treatment, without an autopsy of the panel, it is difficult to determine the various causes of cracking. It could entail debonding of the PCCP from the asphalt concrete, structural failure of the underlying AC layer, which visually, has not been seen, or

possibly overloading of the composite panel or sympathy cracking. In addition, panels that have previously cracked are at or near the curb edge adjacent to areas where turning movements of heavy trucks are traveling onto the gravel curb and onto the edge of the PCCP pavement. The lack of support may have allowed cracking at these locations (refer to the crack map at the end of this document). The mid-way crack in the southbound lane located at about 1322' (0' starting at the south-end of the lane) has the same characteristics as the other cracked panels; save the fact, it is located at the east edge of the southbound pavement. The east edge supported the paver for the northbound placement of the PCCP. This may have acerbated the cracking of the panel.

The current Ride Index for the northbound lane is rated at 45 and for the southbound lane at 50, both grouped as being in the 'poor' ride category. The northbound lane is rougher than the southbound. This may have been caused by the type of paver that was used during construction. The contractor used an old style, Alan three-tube paver, which could have inadvertently (due to the back and forth action of the unit) created the undulation or 'rough ride' as indicated. In addition, since the paver rested on the east edge of the previously placed southbound lane during construction, it most likely accelerated the roughness aspect of the ride for the northbound lane. Several areas on the project are showing signs of wear and tear with slight spalling at panel saw cuts, to date minimum occurrences. Figure 4 is an example of the spalling.
