Montana Department of Transportation  
Helena, Montana 59601-1001

Documentation of Great Falls Experimental Whitetopping Repair Project

Location: Great Falls, Montana; Intersection of N. W. Bypass & 3<sup>rd</sup> St. N. W.  
(U5206 & U5203). Three southbound lanes of 3<sup>rd</sup> N. W.

Repair Date: March 28 & 29, 2001

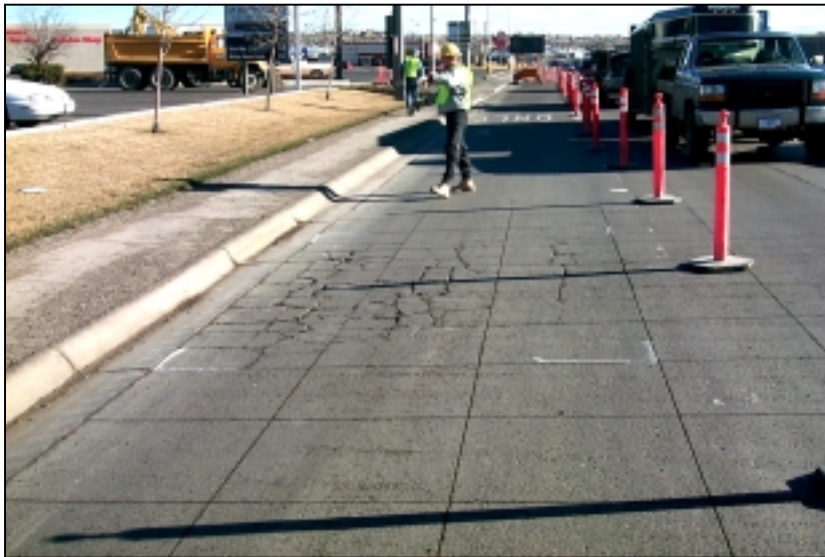
This Whitetopping project was initially constructed in fall of 1999 to alleviate the continued heavy rutting and shoving of the asphalt concrete at this intersection. During late summer of 2000, a small portion of the right-turn lane developed severe cracking. This was documented in the fall of 2000 evaluation report on this project. This failure of the pavement occurred at a rapid rate, estimated at 3-

6 weeks. The failed section comprised five panels longitudinally and three panels transversely, approximately 10' x 15'. This section went through the entire 2000-2001 winter in this condition, withstanding freeze-thaw cycles, traffic and maintenance snow removal.

United Materials Inc., and to ascertain the plausible reason(s) of this premature failure. The image of Whitetopping above shows the area (outlined with white paint) that has deteriorated to the extent that it must be removed and replaced with full-depth PCCP. A concrete saw was used to score a deep

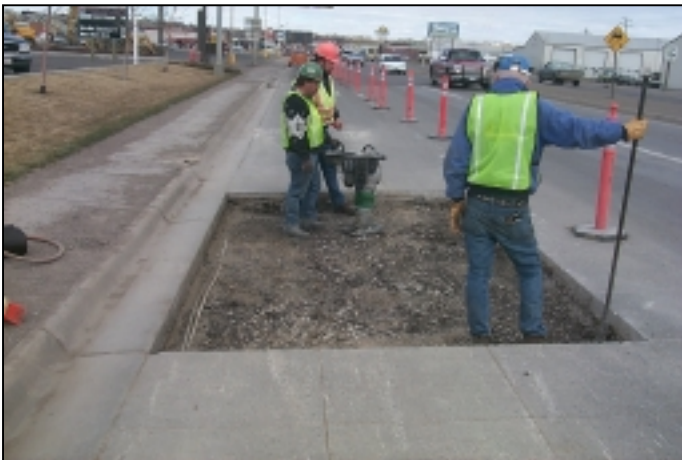
The contractor then used a compaction whacker to consolidate the sub-grade material. After about twenty minutes, he stopped work and asked the inspection team to stand behind the compactor as he operated in the pit. Substantial vibration could be felt throughout the entire surface area of the repair site. Standing in the area, you could feel and see the surface floating at your feet. This was a strong

indicator that the compaction device was drawing water toward the surface. With subsequent digging into the subgrade, an inordinate amount of moisture was in the ground at about twelve inches below grade. In one shovel full, you could actually squeeze water from the silty sandy material. It was also found that the top of the storm line was located approximately six inches below the surface of the subgrade (see photo below).

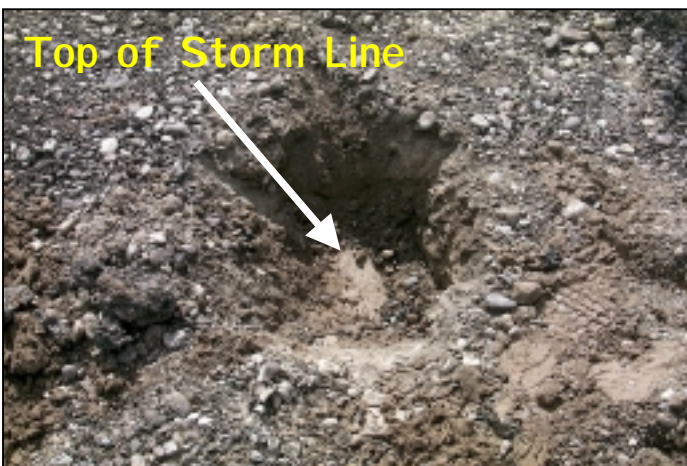
In consultation with the contractor and MDT Maintenance staff, it was decided there was too much moisture present in the subgrade. In addition, the subgrade material itself was not able to adequately support the structure. With the amount of water present, poor soil, and the close proximity of the storm line it was decided to remove several feet of the subgrade and replace it with 1.5" minus aggregate fill material. The contractor proceeded to re-compact the soil. There was a noticeable difference in the feel of compaction compared to the original material. The contractor noted the new material was

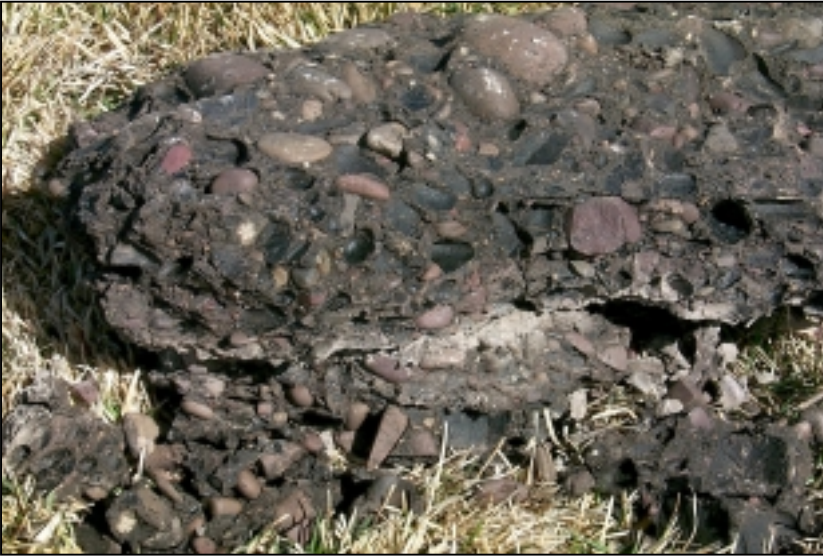
As stated earlier in the report, these panels failed in a relatively short period (3-6 weeks). On inspection of the underside of the PCCP layer, most of the AC was still attached in a thin layer of Asphalt cement and stone. This indicates that minimum debonding of the composite layer had taken place. The AC layer was very soft and pliable and could easily be broken apart. The

AC had a strong odor to it; some of the inspection team members called it a swampy and/or sewage-like odor. Visually the AC exhibited severe stripping. It was apparent that moisture had been a factor in the deterioration of the AC layer. A storm line runs longitudinally under the problem area. Two manhole covers were opened to inspect the line. The storm pipe was filled with sediment and water approximately fifty-

Regardless of the potential sources of moisture, the overall failure cause for this small section of whitetop panel is the lack of structural support by the underlying AC layer due to stripping.
