Great Falls Experimental Whitetopping Annual Evaluation

Great Falls, Montana, 3rd Street Northwest

Location: Great Falls, Montana; Intersection of N. W. Bypass & 3rd St. N. W.
(U5206 & U5203). Three southbound lanes of 3rd St. N. W.

Report Date: July 24, 2002

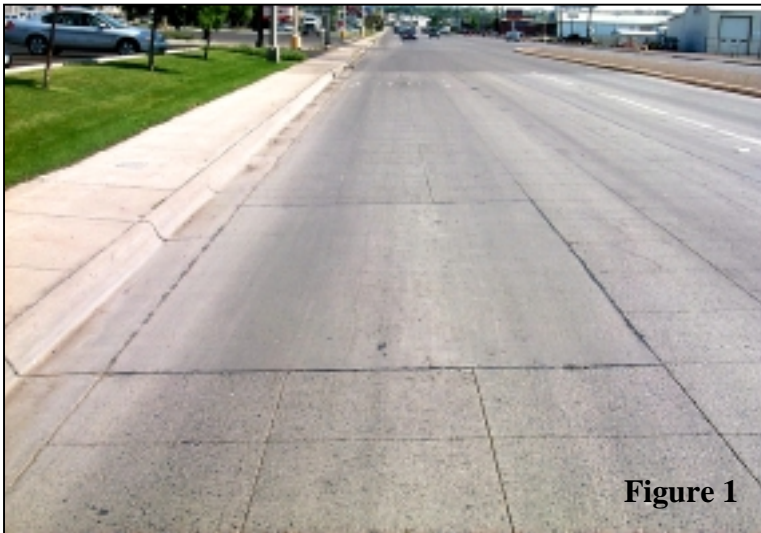
condition, withstanding freeze-thaw cycles, traffic and maintenance snow removal. The failed area was removed and repaired in the spring of 2001 (see construction/repair documentation report dated April, 30 2001- Research website). At the date of this report, no stress related faulting between the whitetop and full-depth was observed and no additional cracking around the repair (figure 1).

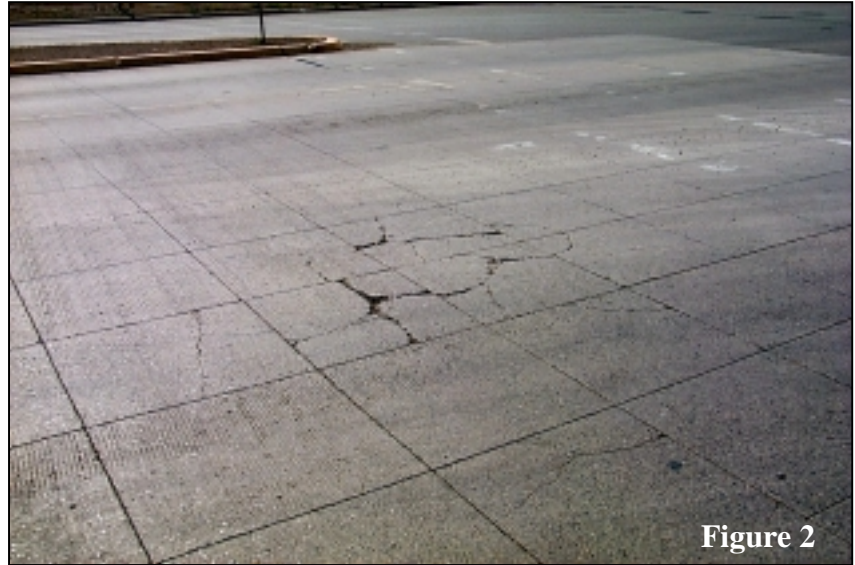
Since the 2001 evaluation, additional panel cracking was observed in the right-hand turn lane adjacent to the repaired area (south in the direction of travel - figure 2). This panel cracking may be an extension of the underlying AC stripping which was determined as the main factor of failure and consequential replacement of the 10' x 15' panels replaced in March 2001. The moisture

stripping the bottom AC layer may be attributed to the close proximity of the storm sewer line directly under the lane. Since the last evaluation, cracking has increased and approaching to severe in nature. However, no debonding of the individual panels was noticed during this inspection.

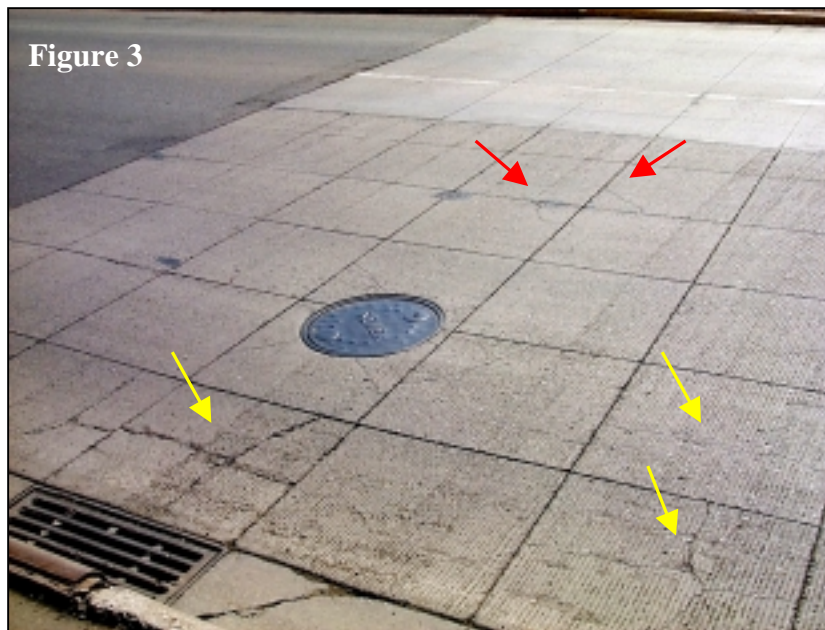
Additional cracking was observed in the same lane just before the repaired area (several feet north of the area). As in other sections of the right-lane, this may be an indication of AC stripping due to abnormal water infiltration or normal corner-cracking indicative of this type of pavement treatment. The red arrows (figure 3) point to new cracking, the yellow arrows show existing cracking that has increased in severity since the last evaluation.

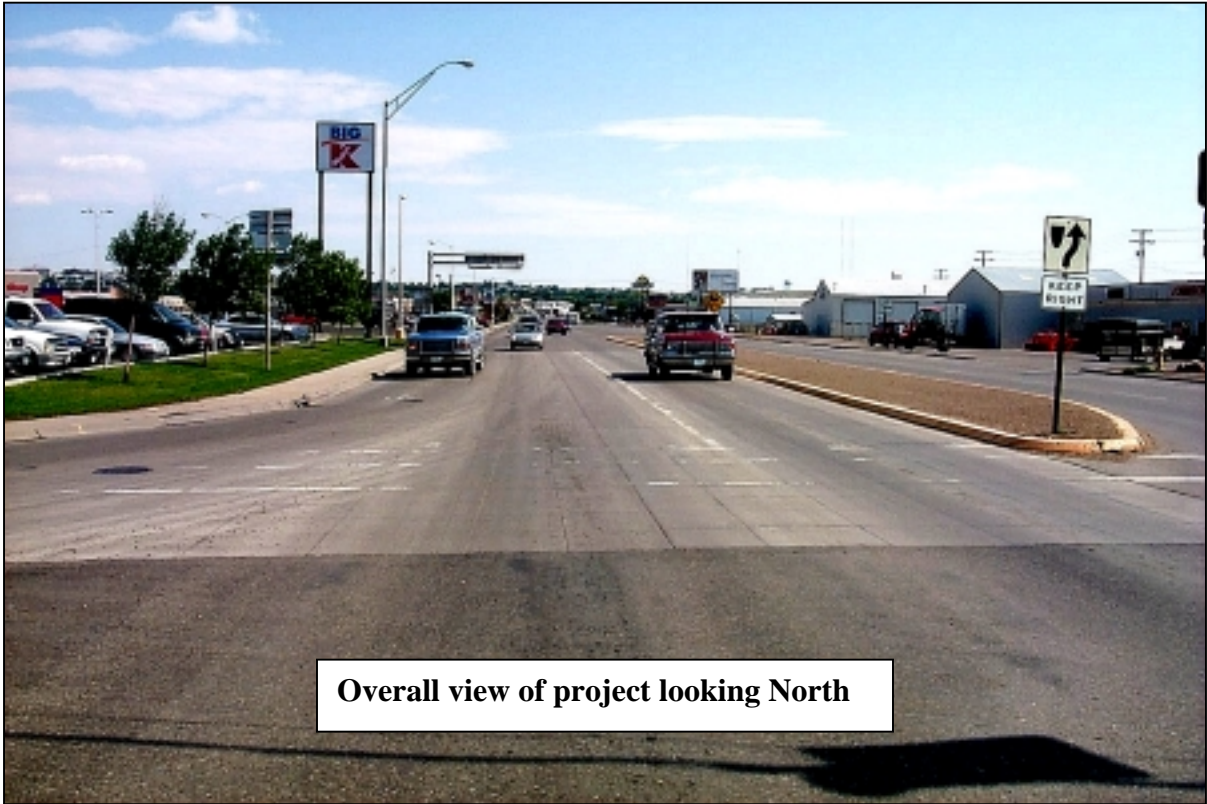
The (left-hand) through lane, at this evaluation, is showing no signs of cracking or any other visual deterioration. There are no apparent signs of panel delaminations on any of the panels in any area of this lane.
