Montana Department of Transportation
Helena, Montana
Research Program

Experimental Whitetopping Annual Evaluation

Location: Great Falls, Montana; Northwest Quadrant of Intersection of N. W. Bypass & 3rd St. N. W. (U5206 & U5203). Three southbound lanes of 3rd St. N. W.

Evaluation Date: July 24, 2003

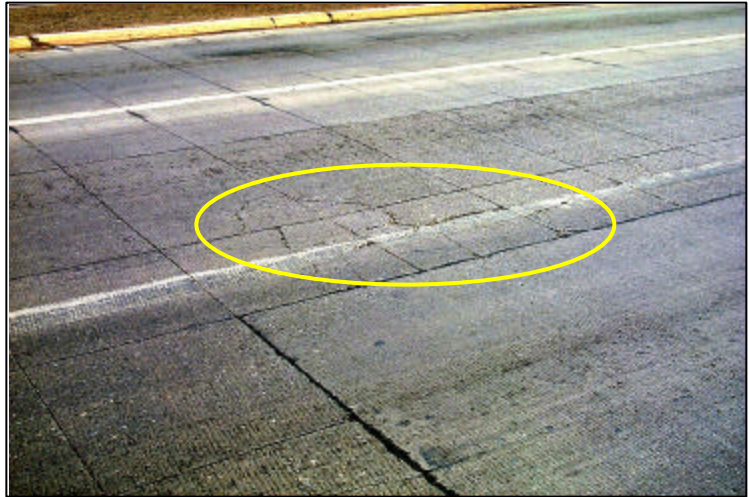
Since the 2002 evaluation, continuing panel cracking in the right-hand turn lane adjacent to the repaired area (south in the direction of travel – outlined in yellow in figure 1). This panel cracking may be an extension of the underlying AC stripping which was determined as the main factor of failure and consequential replacement of the 10' x 15' section replaced in March 2001. The moisture stripping the bottom AC layer may be attributed to the close proximity of the storm sewer line directly under the lane. Since the last evaluation, cracking has increased and approaching to severe in nature. No deflection or debonding of the individual panels was seen as traffic passed over.

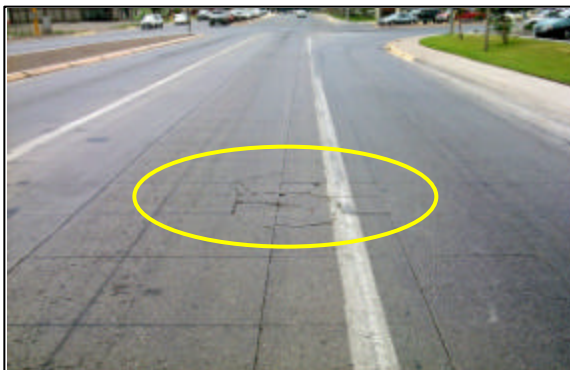
Additional cracking is located in the right side of the center lane approximately 40 ft. north of the repaired area. Since this cracking is near the storm line, it may be an indication of AC stripping due to abnormal water

infiltration causing structural failure (figure 2). Cracking has also appeared in the south-end of the right-hand turn lane, ten feet north of the manhole cover. The same scenario may be occurring at this site (figure 3).
