EXPERIMENTAL PROJECT DATA SHEET

NAME: Hays-North, 10 Miles North of Hays-North,South of Harlem  
 NUMBER: RTF 66-2(1)16, RTF 66-2(3)26  
 YEAR: 1996

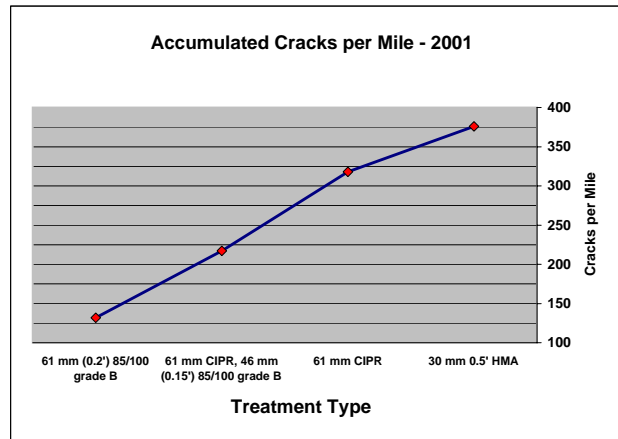
Treatment type	Cracks per Mile
61 mm (0.2') 85/100 grade B	132
61 mm CIPR, 46 mm (0.15') 85/100 grade B	217
61 mm CIPR	318
30 mm 0.5' HMA	376

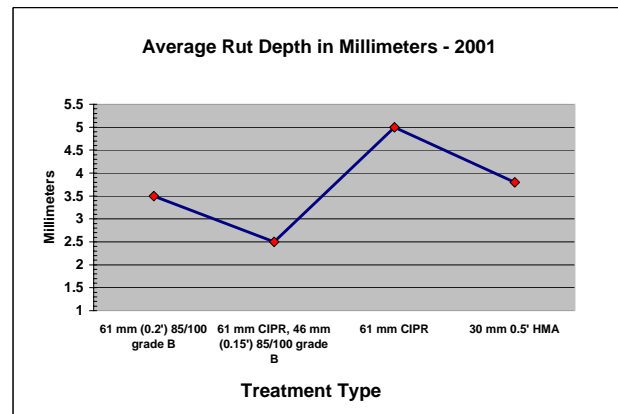
Treatment Type	Rut Depth
61 mm (0.2') 85/100 grade B	3.5
61 mm CIPR, 46 mm (0.15') 85/100 grade B	2.5
61 mm CIPR	5
30 mm 0.5' HMA	3.8
