RESEARCH PROGRAM ANNUAL EVALUATION REPORT

Thin-Whitetopping Overlay Composite

Location: Kalispell, Montana

Date of Evaluation: October 2001, First Inspection

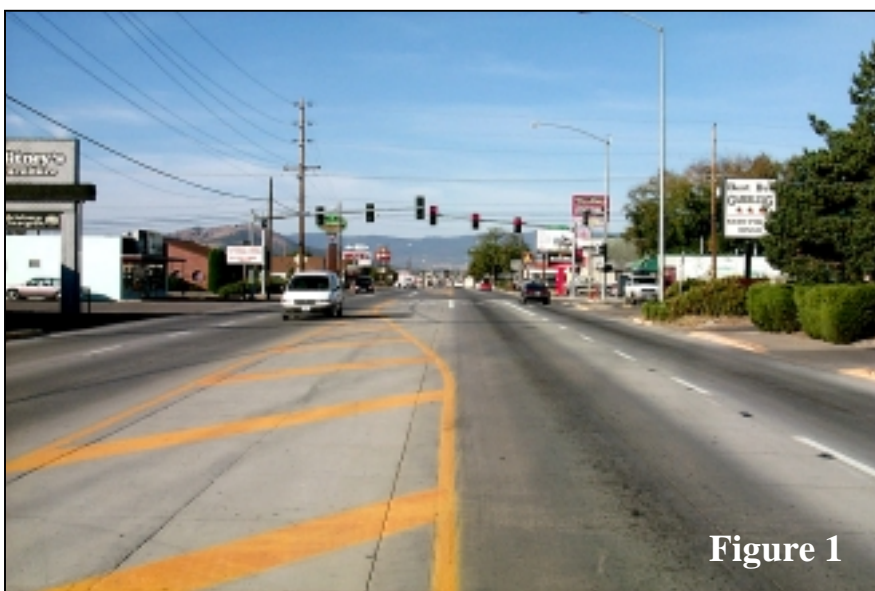
Figure 1 is an overview, looking west at the whitetopping section.

The overall appearance of the whitetopping is good. There seems to be some deterioration of the pavement markings. It was noticed that certain areas of the pavement had been scarified to promote better adhesion for the marking material to the pavement. At this time, it appears to be effective. Twelve panels were cracked throughout the entire project; all hairline in nature and no debonding of the composite panels were noticed as traffic drove over. At this

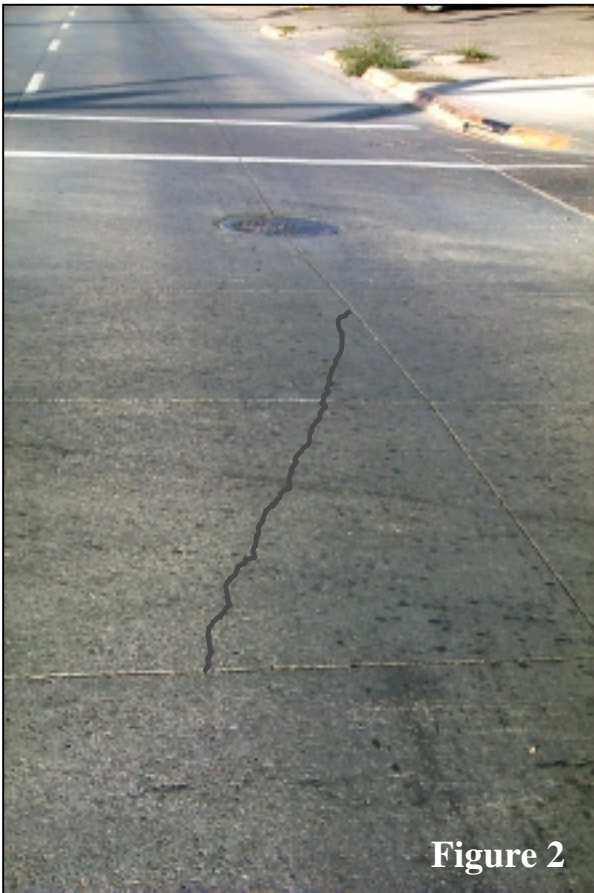
Figure 2

Figures 2 & 3 are examples of the in-lane cracking. A red line has been superimposed over the images to better see the lay of the crack; if this report is viewed

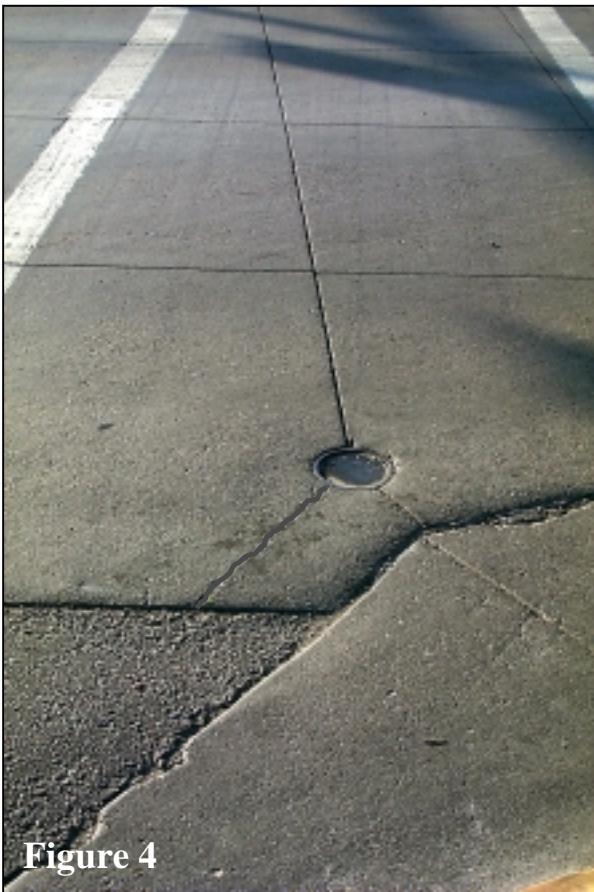
Figure 4 shows an example of cracking that is stemming from a utility cap access. This is a common problem with this type of pavement in dealing with utilities at the surface. Cracking may have been avoided if the sawing plan had incorporated additional cuts around the utility to compensate for load related cracking (if

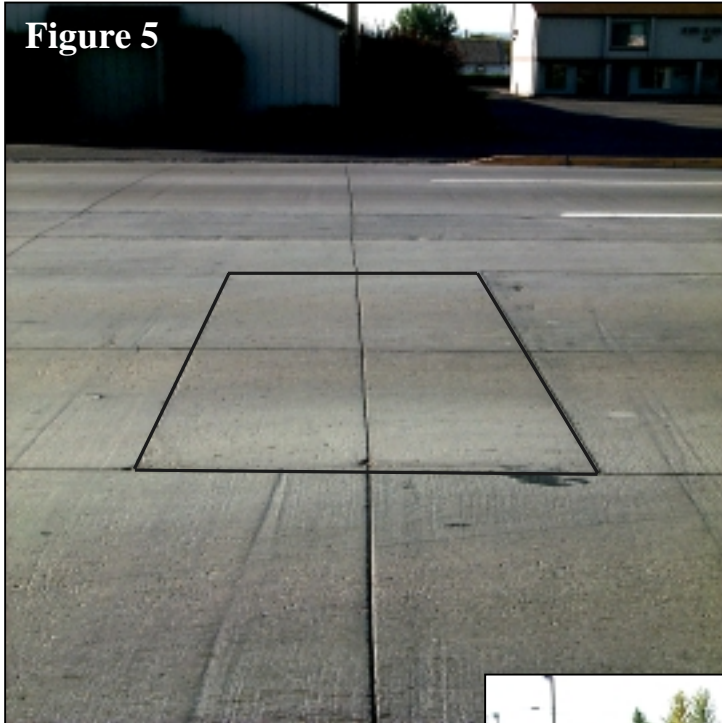
deemed cost effective to do so). Figure 5 shows the performance of the doveled PCC patch that was placed during construction due to un-consolidated concrete by lack of adequate vibration (documented in the 2001 fall construction report). The blue outline is the area of repair. Visual observation of traffic moving over this section display no faulting or movement of the slab. At this time, no visual surface distress was noticed. This repair is approximately located in the center section of the westbound lanes 2 meters past the intersection of Sixth Avenue EN and East Idaho St.

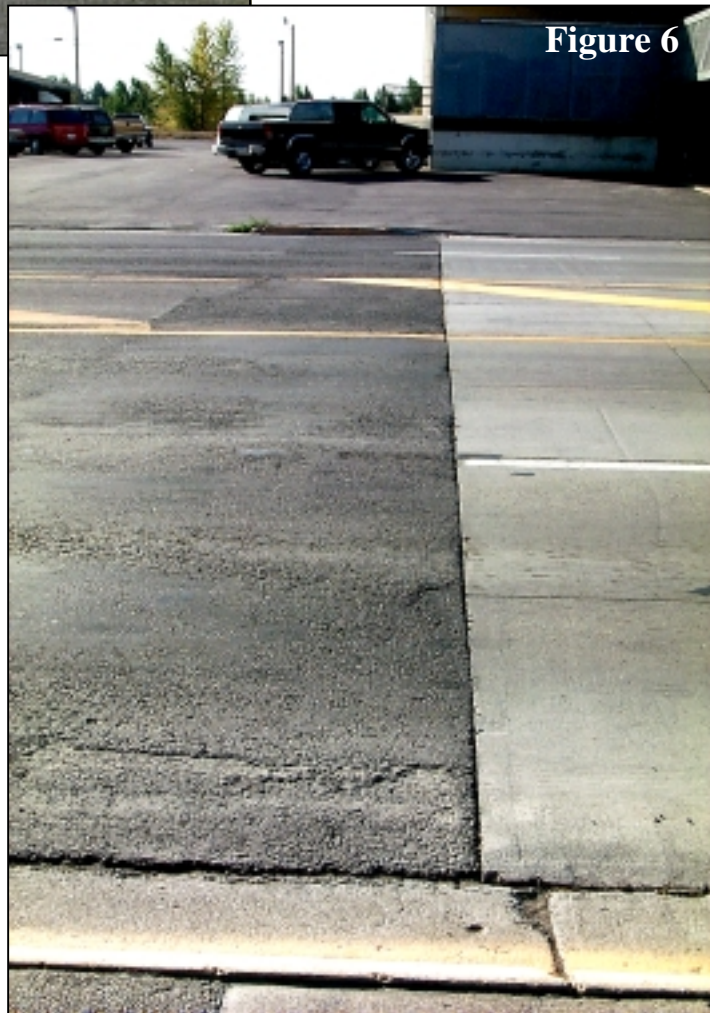
Figure 6 is showing the east-end transition area of the project. It is important to point this feature out due to the innovative way this approach was placed, please refer to the fall 2001 construction report for details. No evidence of spalling has been noticed during this evaluation.

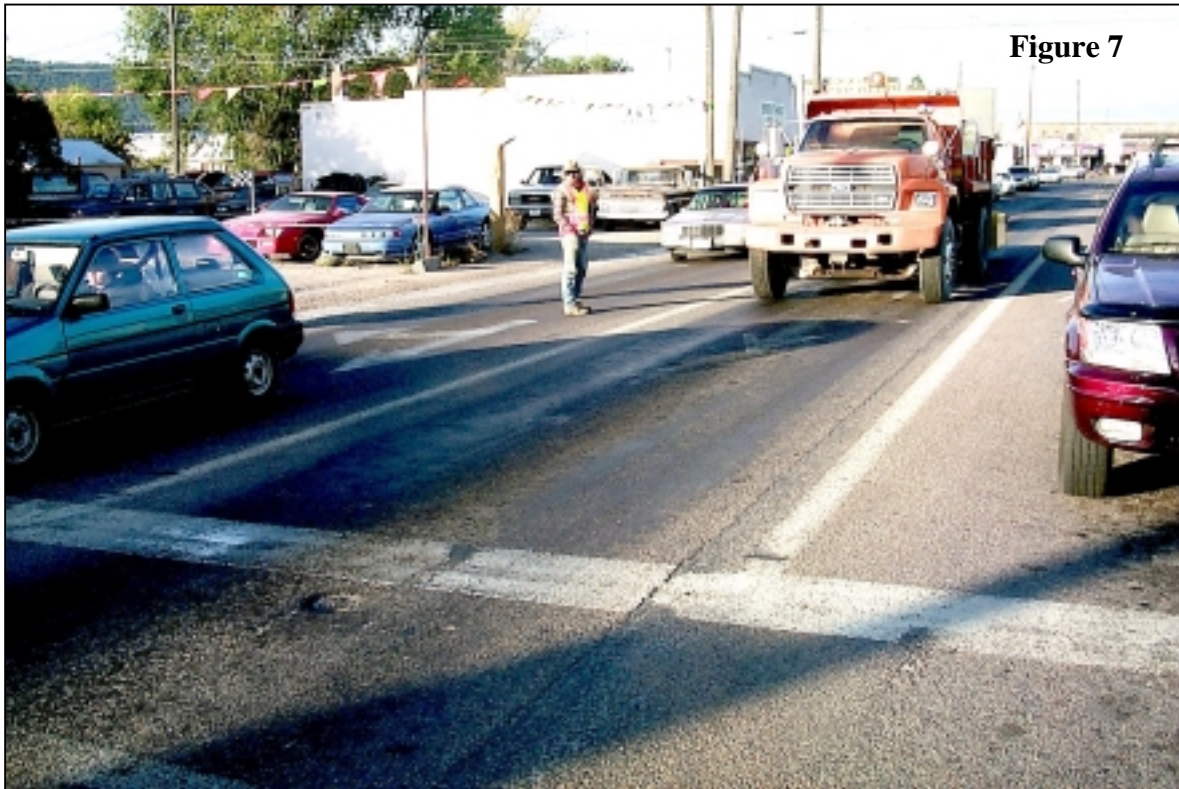
Figure 7 is a sample image on eastbound West Idaho of the Meridian intersection. It is

apparent that flushing of the surface has occurred prevalent at the proximity of the intersection. This severity of flushing was not noticed on the through section of the route.

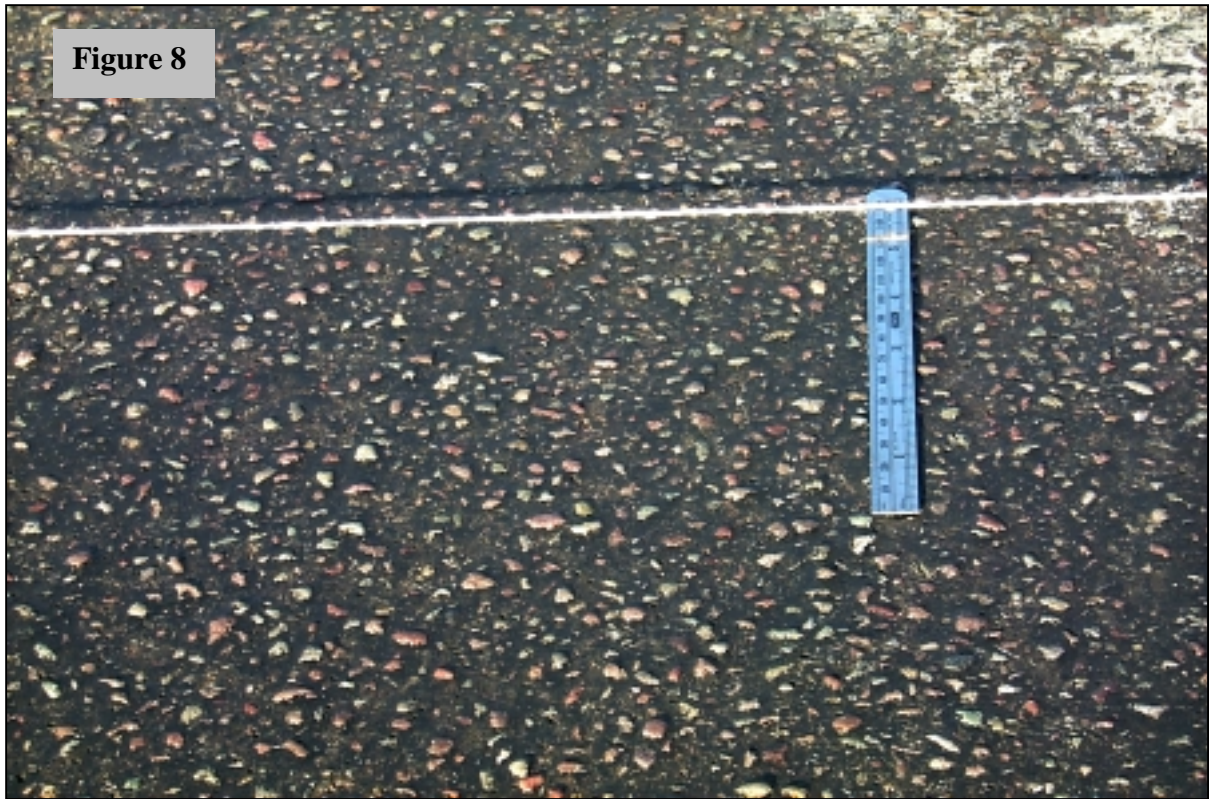
Figure 8 is a close-up of the string line of the inner wheel path (IWP) of the eastbound right lane at the intersection of 5th Ave. NE, where traffic is normally stopped. This particular site had a recorded rut of 20 mm.
