RESEARCH PROGRAM ANNUAL EVALUATION REPORT

Thin-Whitetopping Overlay Composite

Project No.: STPP 1-2 (93)121, East Idaho St.

Date of Evaluation: October 2002, Second Annual Inspection

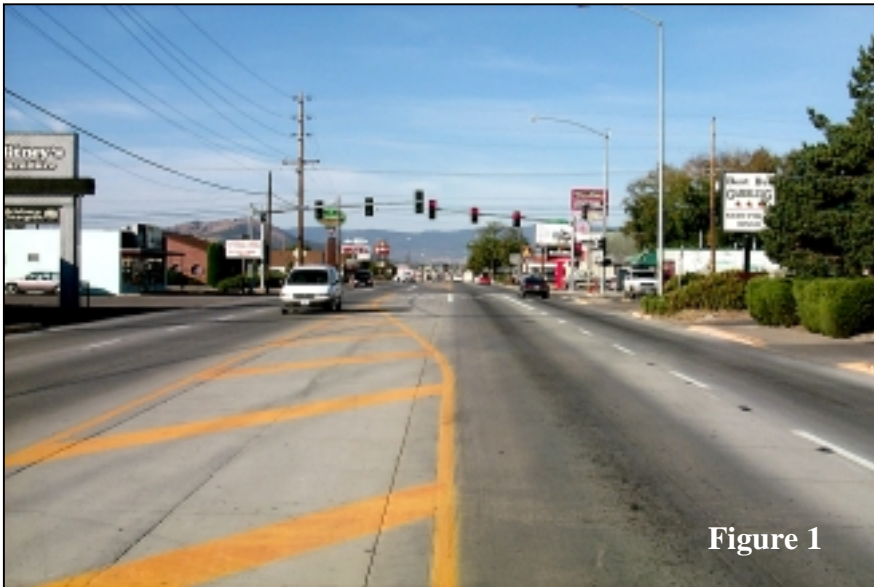
Figure 1 is an overview, looking west at the whitetopping section.

The overall appearance of the whitetopping is good. Twelve

cracked panels were documented in the 2001 report. Two additional panels were found during this inspection, making the estimated totals at (currently) fourteen cracked panels. All cracks are hairline in nature with no vertical displacement or debonding of the composite panels. At this time, there is no indication of a pattern or reasons for the

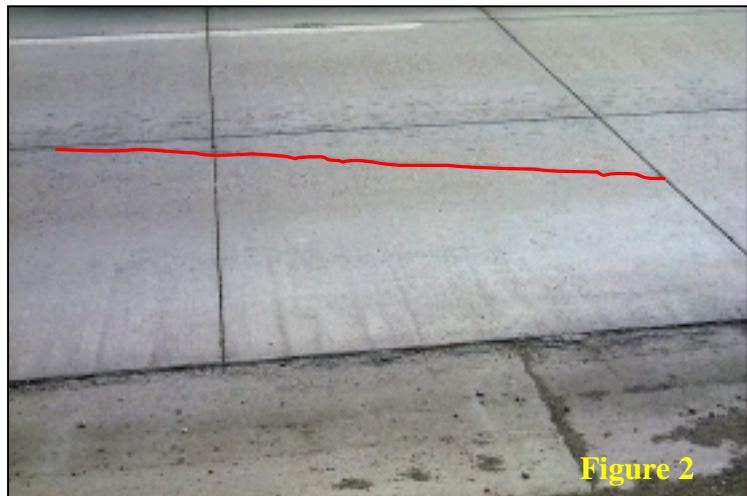
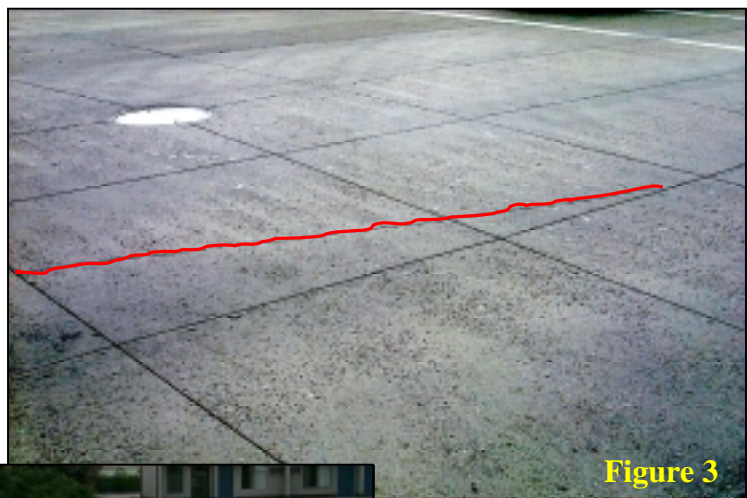
Figures 2 & 3 are examples of the in-lane cracking. A red line has been superimposed over the images to better see the lay of the crack; if this report is viewed in black and white, they will appear as dark gray over the pavement.

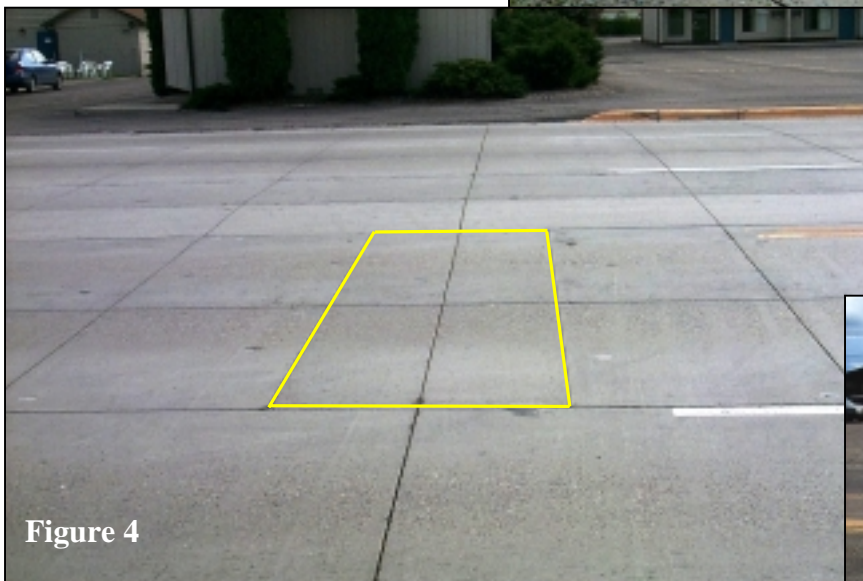
Figure 4 shows the performance of the doweled PCC patch placed during construction due to

un-consolidated concrete by lack of adequate vibration (documented in the 2001 fall construction report). The yellow outline is the area of repair. Visual observation of traffic moving over this section display no faulting or movement of the slab. At this time, no visual surface distress was noticed. This repair is approximately located in the center section of the westbound lanes 2 meters past the intersection of Sixth Avenue EN and East Idaho St. Figure 5 is showing the east-

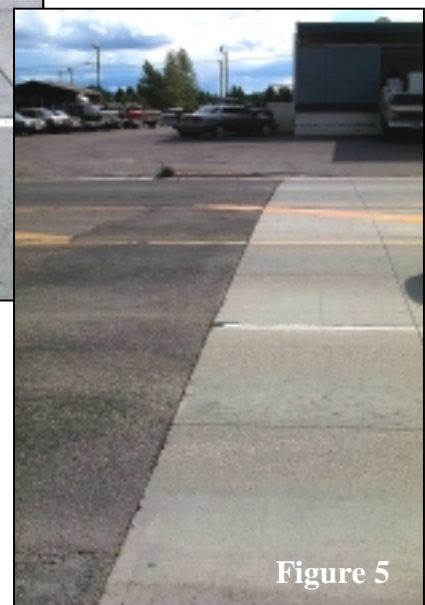
Figure 5

end transition area of the project. It is important to point this feature out due to the innovative way this approach was placed, please refer to the fall 2001 construction report for details (that report can be located on the MDT Research intranet website at http://mdtinfo/research/projects/kal_whitetopping.html). No evidence of distress to the transition was noticed during this evaluation.

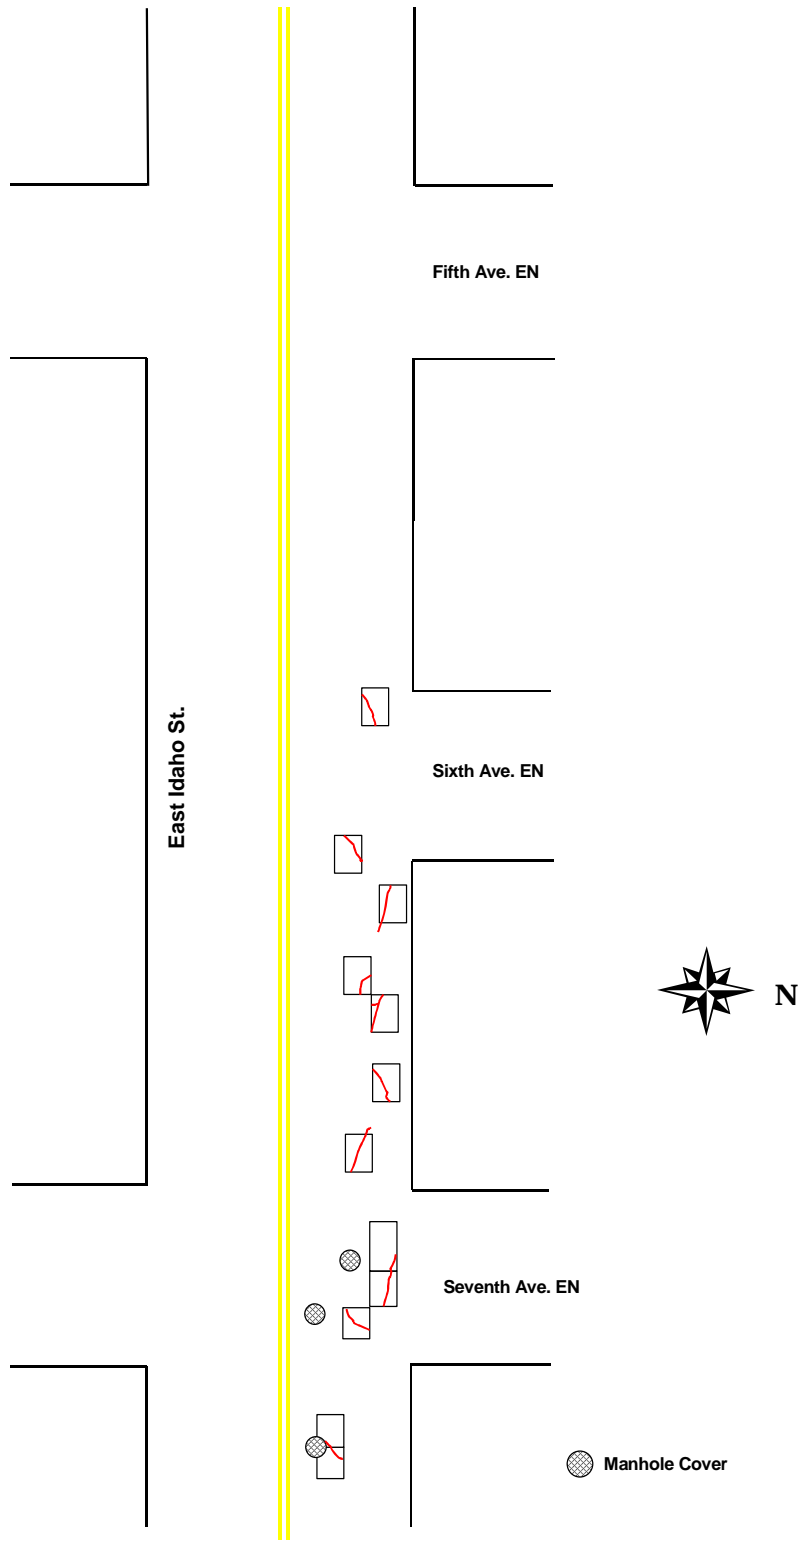
Thin-Whitetopping Overlay Composite - STPP 1-2(93) East Idaho St., Kalispell Montana
Representative Project Crack Map

randomness of the cracked panels; therefore, it is premature to attempt to ascertain a cause. It should be noted that the majority of the cracking occurs on the north half of the project (which was placed first) between the streets of 8th Ave. EN and 6th Ave. EN. The south half of the project is exhibiting almost no cracking at all. Refer to the crack map at the end of this report for a general representation of cracked panel locations and the relationship of how the crack is located within

the panel itself. The crack map is strictly an illustration of crack locations within the project, it is not to scale.
