**ANNUAL EXPERIMENTAL EVALUATION REPORT**

**Thin-Whitetopping Bonded Composite**

Project No.: STPP 1-2 (93)121, East Idaho St.

Evaluation Date: July 2004

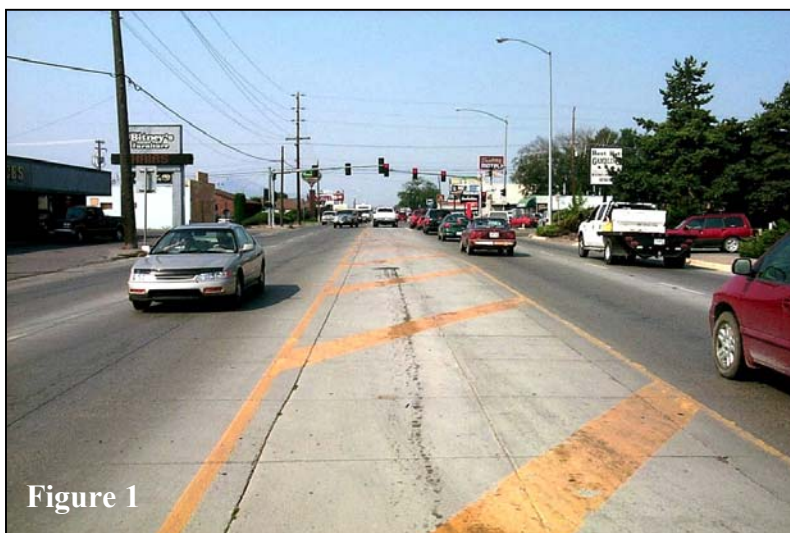
Figure 1 is an overview, looking west at the whitetopping section.

The overall appearance of the whitetopping is good. Fifteen cracked panels were documented in the 2003 report. No additional cracking was observed during this evaluation. All cracks are hairline in nature with no vertical displacement or debonding of the composite panels. At

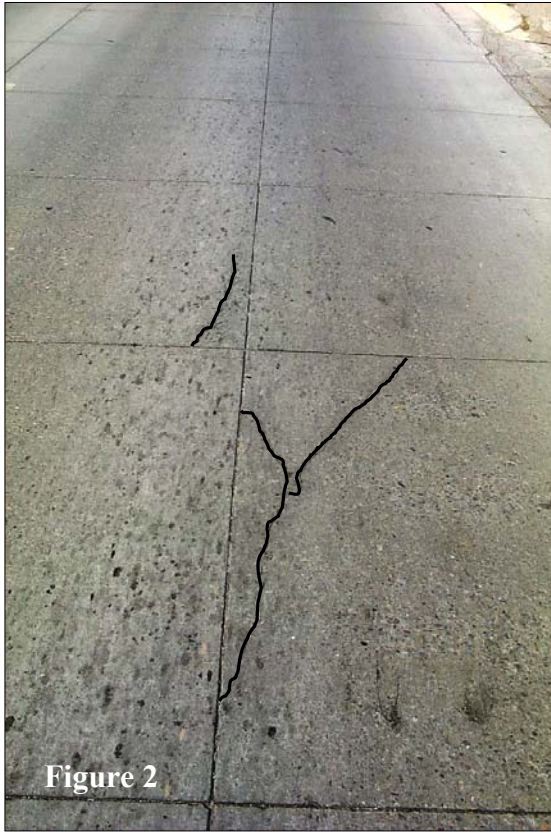
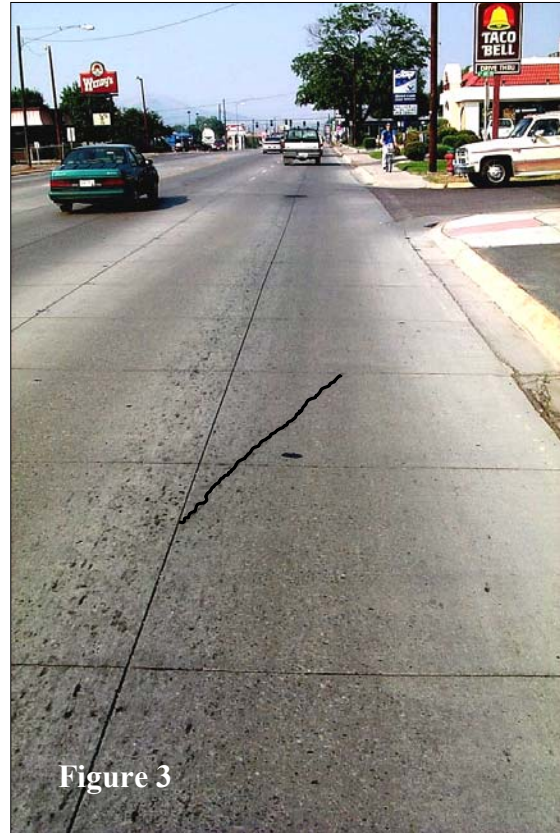
this time, there is no indication of a pattern or reasons for the randomness of the cracked panels; therefore, it is premature to attempt to ascertain a cause. It should be noted that the majority of the cracking occurs on the north half of the project (which was placed first)

between the streets of 8<sup>th</sup> Ave. EN and 6<sup>th</sup> Ave. EN. The south half of the project is exhibiting no cracking at all. Refer to the crack map at the end of this report for a general representation of cracked panel locations and the relationship of how the crack is located within the panel itself. The crack map is strictly an illustration of approximate crack locations within the project. It is not to scale.

Figures 2 & 3 are examples of the in-lane, hairline cracks. A black line has been superimposed over the images to better see the lay of the crack. It has been estimated this project contains over 4200 sawed panels with only fifteen panels exhibiting minor cracking.

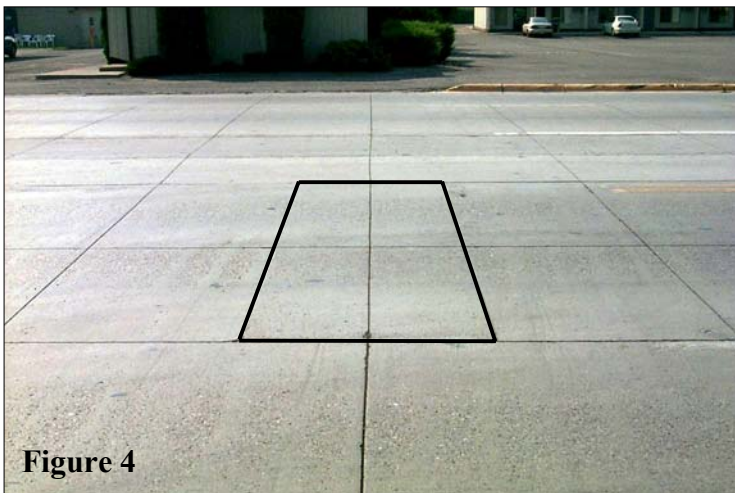
Figure 4 shows the performance of the doweled PCCP patch placed during construction due to un-consolidated concrete by lack of adequate vibration (documented in the 2001 fall construction report). The black outline is the area of repair.

Visual observation of traffic moving over this section display no faulting or movement of the slab. At this time, no visual surface distress was noticed. This repair is approximately located in the center section of the westbound lanes 2 meters past the intersection of 6<sup>th</sup> Avenue EN and East Idaho St.

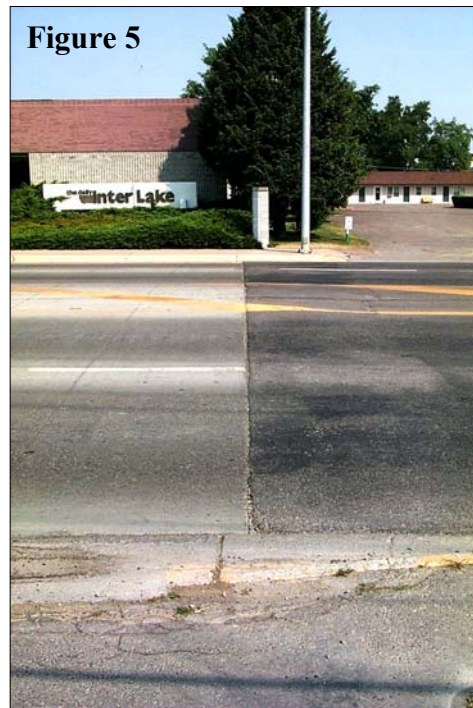
Figure 5 is showing the east-end transition area of the project. It is important to point this feature out due to the innovative way this approach was placed, please refer to the fall 2001 construction report for details. That report and additional information can be located on the MDT Research intranet website at:

<http://mdtinfo/research/projects/epsl.shtml>. No evidence of distress to the east or west transitions was noticed during this evaluation.

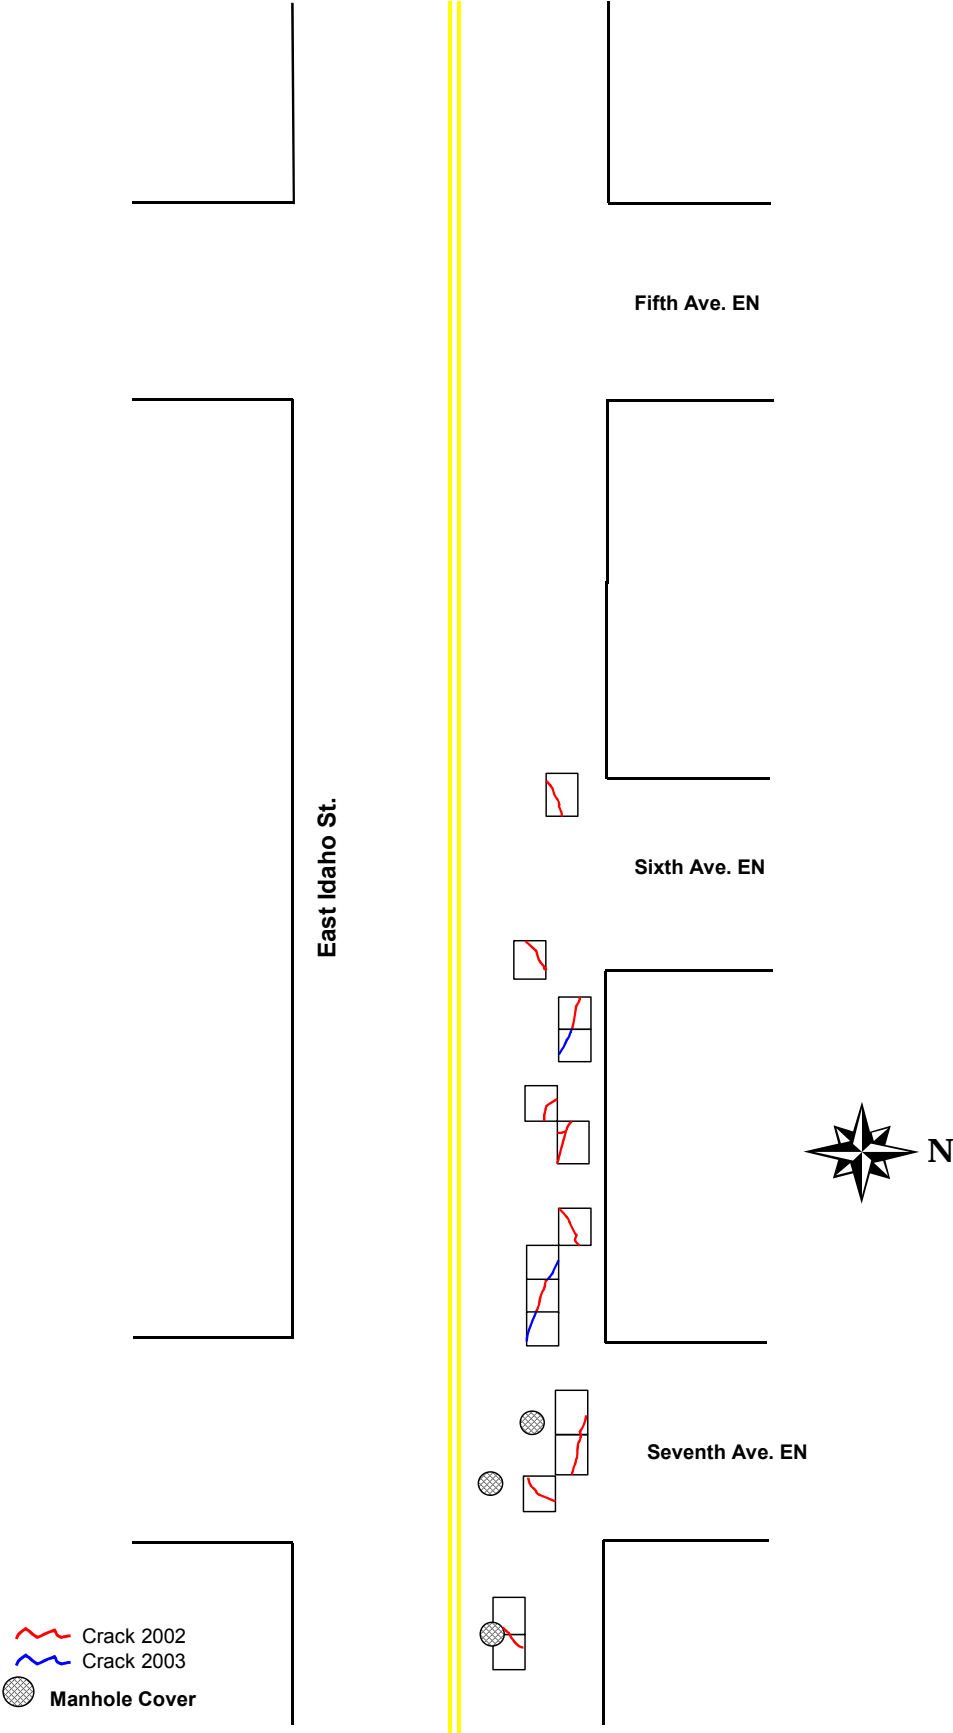
Thin-Whitetopping Overlay Composite - STPP 1-2(93) East Idaho St., Kalispell Montana  
Representative Project Crack Map - Approximate Location

The whitetopping project is rated as performing well. The next evaluation will be held in the fall of 2005. The following page is the representative crack map. Note that the map shows only that portion of the project that currently contains cracked panels. As noted earlier, there were no noticeable additional cracking since 2003.
