ANNUAL EXPERIMENTAL EVALUATION REPORT

Thin-Whitetopping Bonded Composite

Project No.: STPP 1-2 (93)121, East Idaho St.

FHWA No. MT 00-02

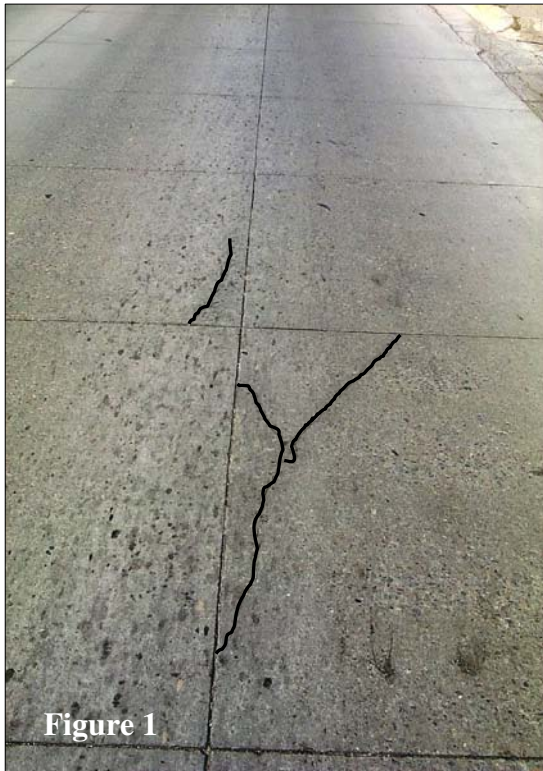
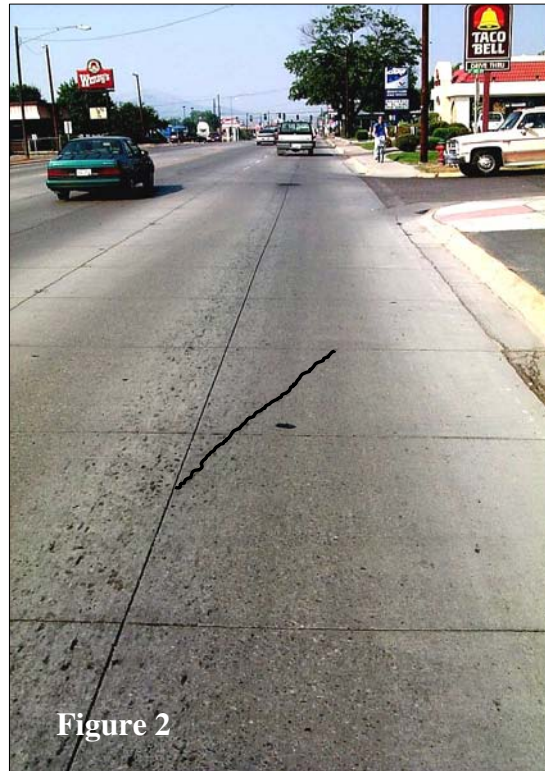
The overall appearance of the whitetopping is good. Twenty-two cracked panels were documented in the 2006 report. Nine additional panels were documented during this evaluation. All cracks are hairline in nature with no vertical displacement or debonding of the composite panels. At this time, there is no indication of a pattern or reasons for the randomness of the cracked panels; therefore, it is premature to attempt to ascertain a cause. It should be noted that the

Figures 1 & 2 are examples of the in-lane, hairline cracks. A black line has been superimposed over the images to better see the lay of the crack. It has been estimated that this project contains over 4200 sawed panels with an approximate Thirty-one (31) panels exhibiting minor cracking since construction which represents a .007% of the entire project.

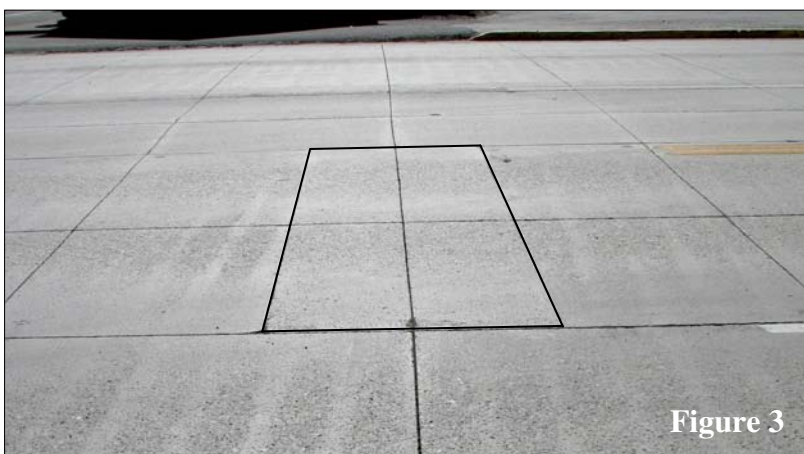
Figure 3 shows the performance of the doweled PCCP patch placed during construction due to un-consolidated concrete by lack of adequate vibration (documented in the project construction report). The black outline is the area of repair. Visual observation of traffic moving over this section displayed no

faulting or movement of the slab. At this time, no visual surface distress was noticed. This repair is approximately located in the center section of the westbound lanes 2 meters past the intersection of 6th Avenue EN and East Idaho St.

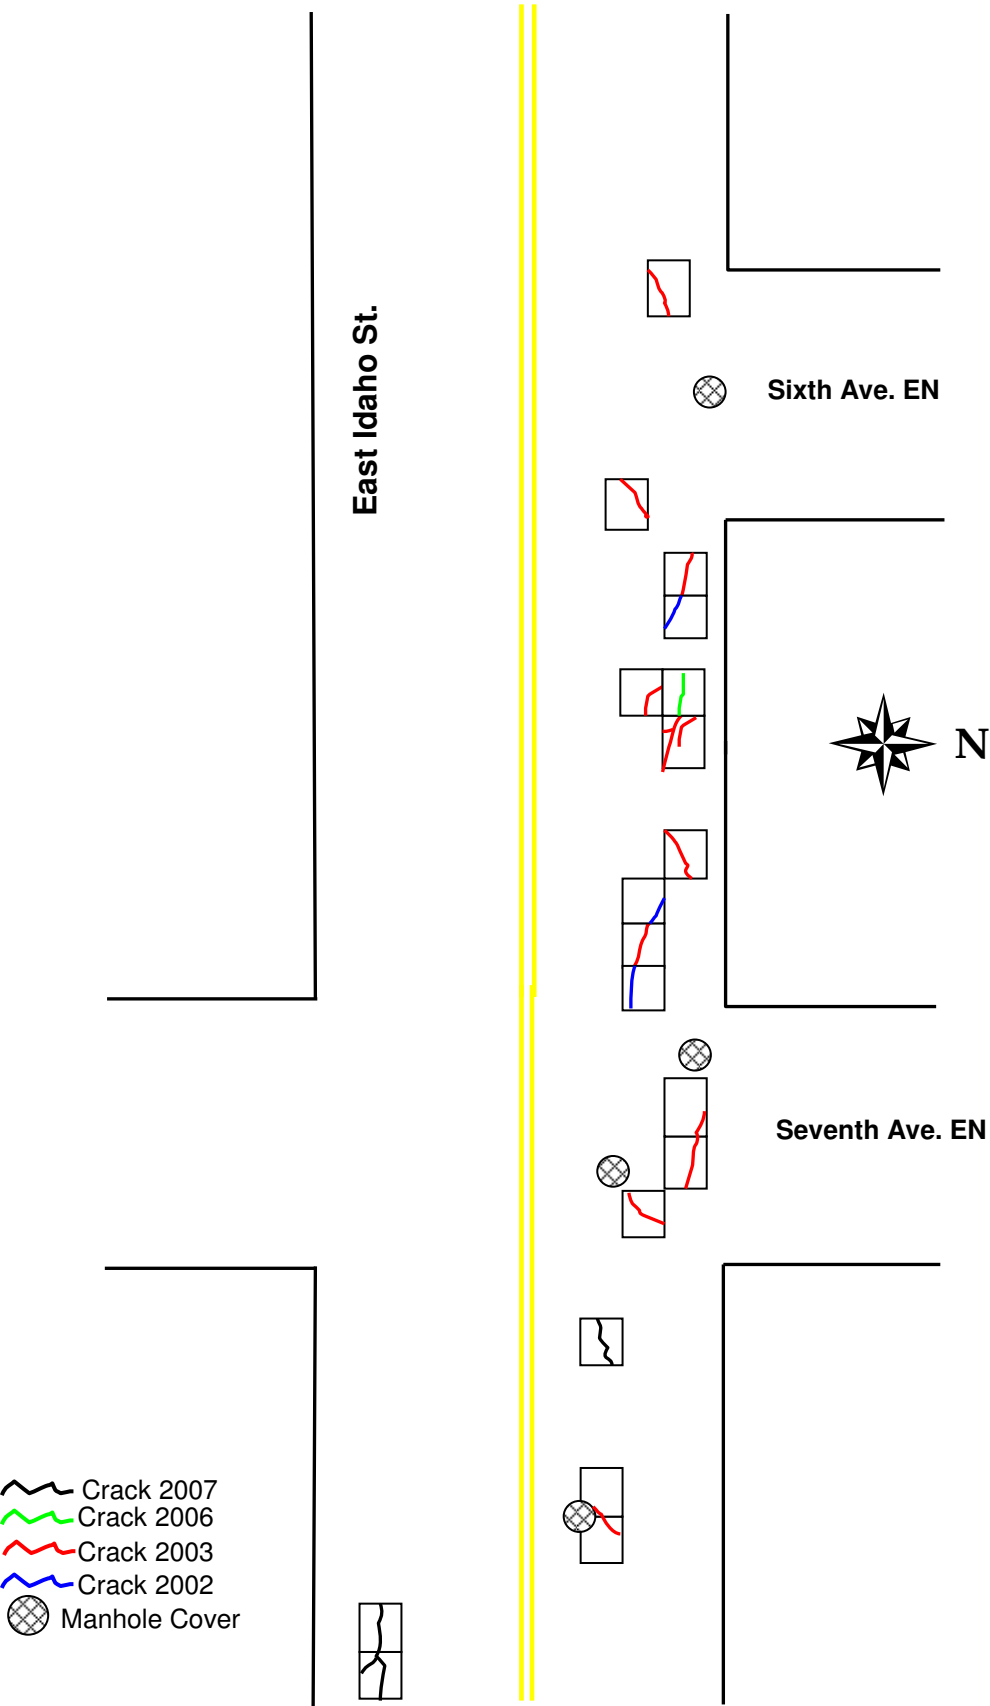
Thin-Whitetopping Overlay Composite - STPP 1-2(93)121 East Idaho St., Kalispell Montana
Representative Project Crack Map - Approximate Location - Not to scale
Note: Crack map only shows portion of project which contains distress information

majority of the cracking occurs on the north half of the project, west-bound (which was placed first) between the streets of 8th Ave. EN and 6th Ave. EN. The south half of the project has just begun to exhibit panel cracking. Refer to the crack maps at the end of this report for a general representation of cracked panel locations and the relationship of how the crack is located within the panel itself. The crack map is strictly an illustration of approximate crack locations within the project. It is not to scale.
