**Experimental Feature Evaluation  
 July 2023**

<b>Experimental Feature:</b>	Polymer Overlay on PCCP
<b>Location:</b>	Missoula District, Flathead County, Kalispell, US Hwy 2, RP 118
<b>MDT Project Name:</b>	SF 139 – Dern/Spring Creek Reconstruct
<b>MDT Project Number:</b>	HSIP-NH 1-2(193)118
<b>Experimental Project Number:</b>	MT-21-05
<b>Principle Investigator:</b>	Chad DeAustin, Experimental Project Manager, (ExPM)
<b>Technical Contact:</b>	Oak Metcalfe, Materials Engineer
<b>Construction Date:</b>	June 2022 (Polymer Overlay Install)

## 2023 – June Review

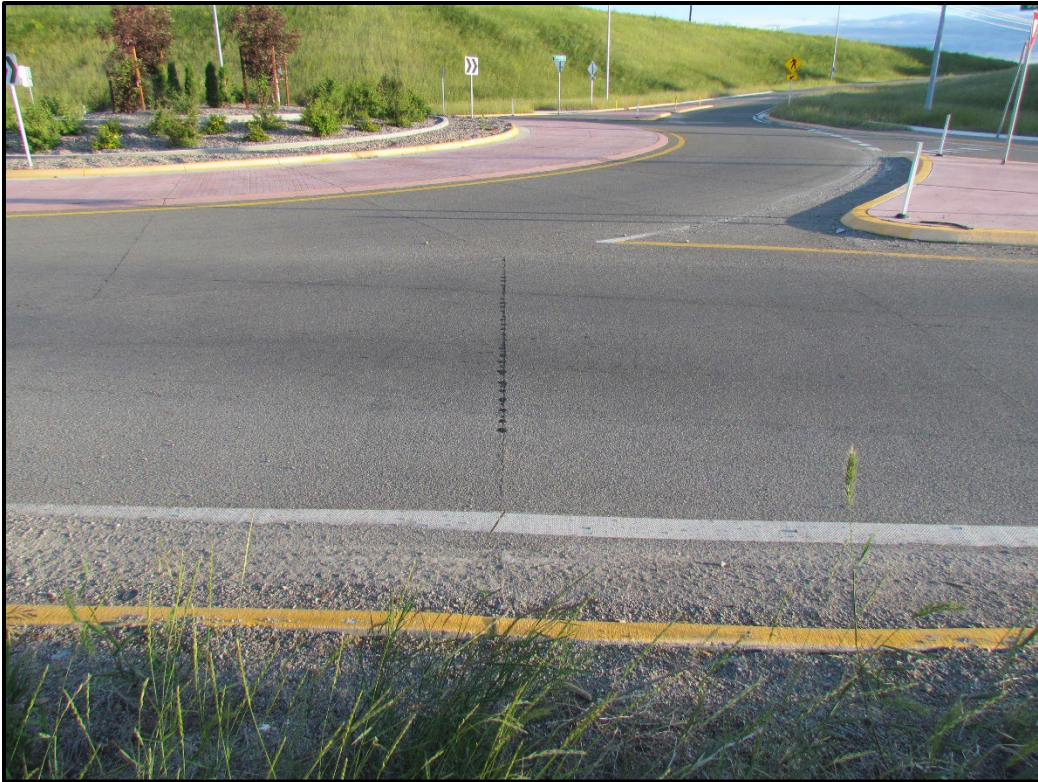
The polymer overlay and concrete show no signs damage besides expected wear. All areas of concern from the construction documentation are performing as expected. The concrete expansion joints are all visible through the polymer overlay. This could create an area for the polymer overlay to wear off the concrete surface.

↑ View north of the main section of the roundabout.

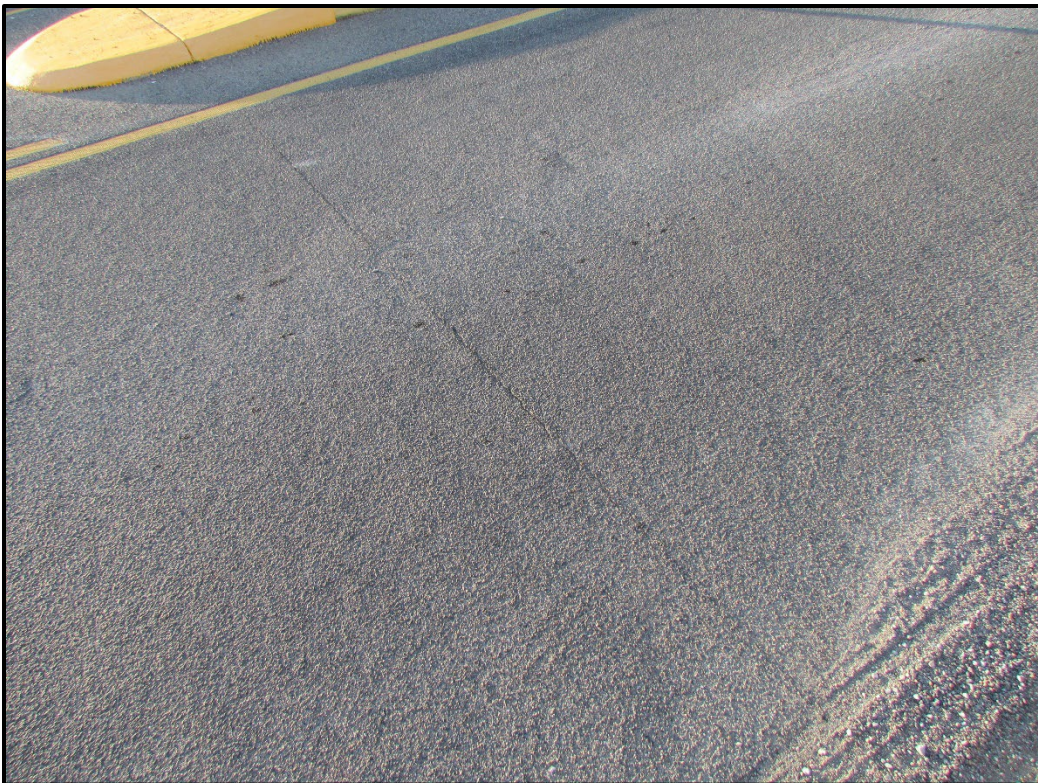
↑ Close up view of the surface and texture of the polymer overlay.

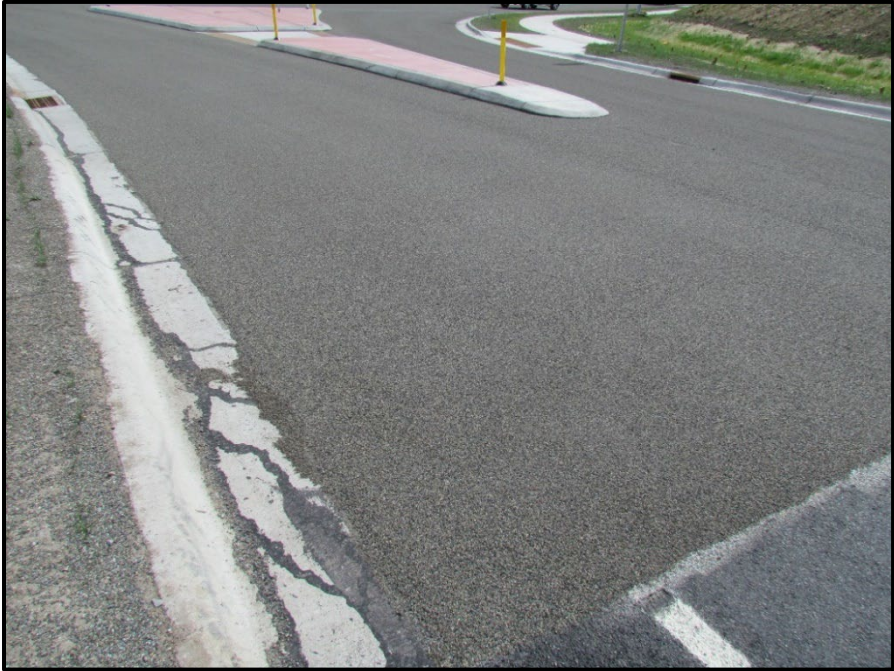
↑ Closer view of polymer overlay in northbound exit onto Spring Creek Road.

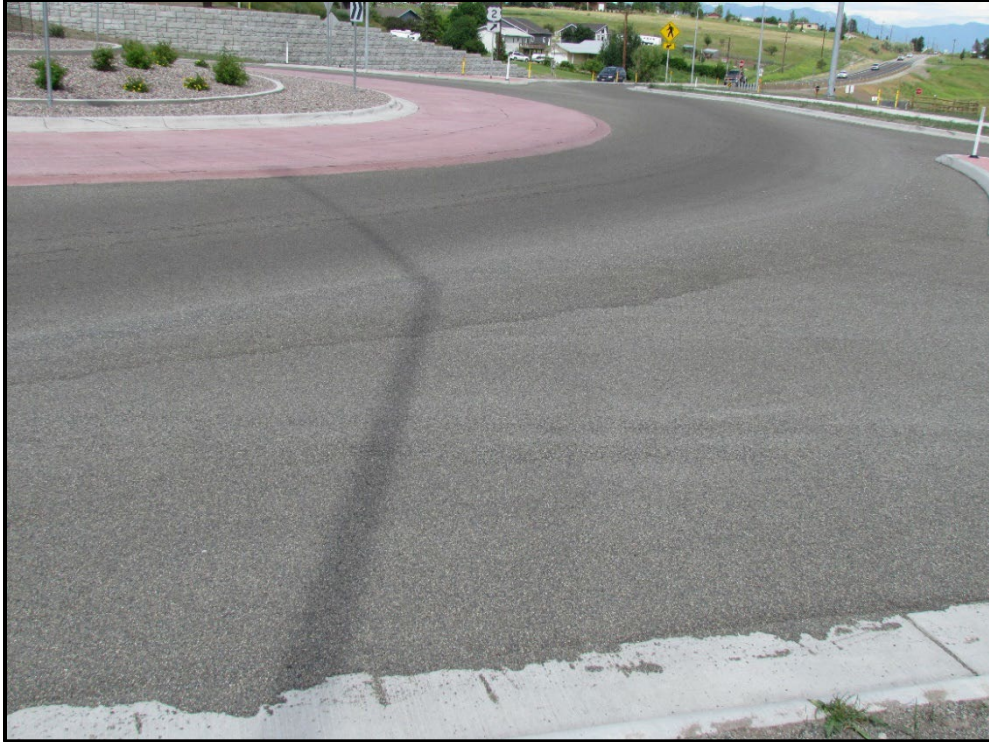
↑ Because of the shape, the exits and entrances of the roundabout were sealed with the polymer overlay first with the inner circle being placed after. This created a noticeable edge that is considered an area to watch.

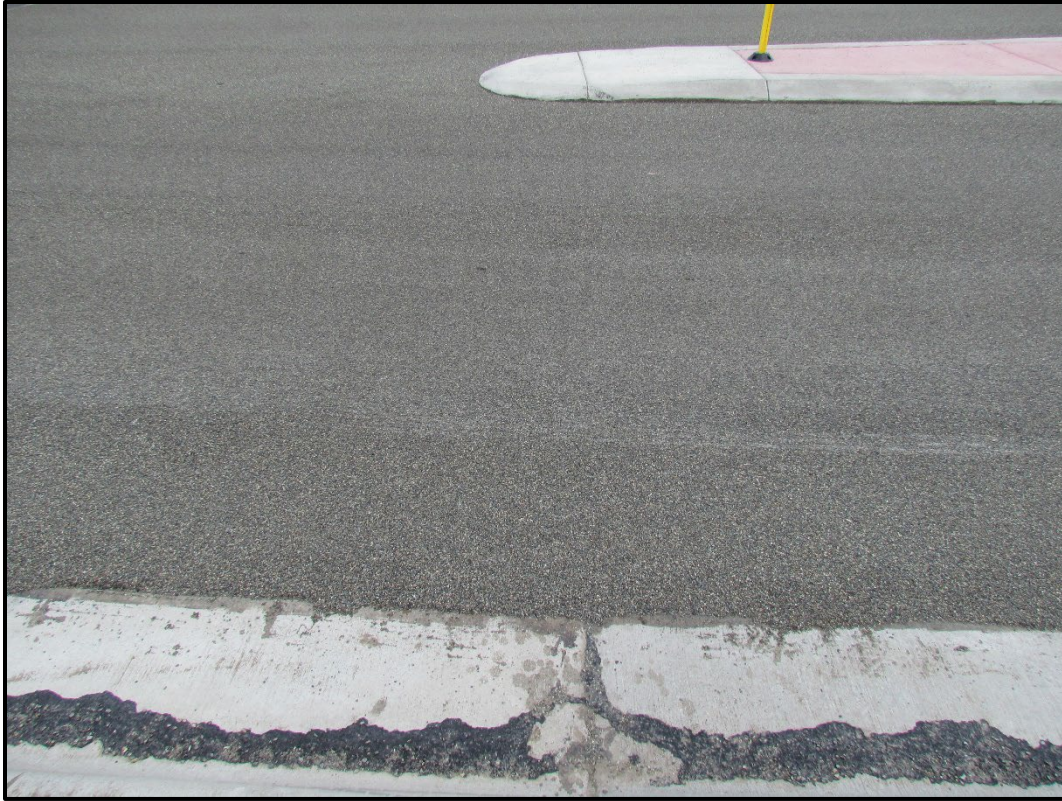
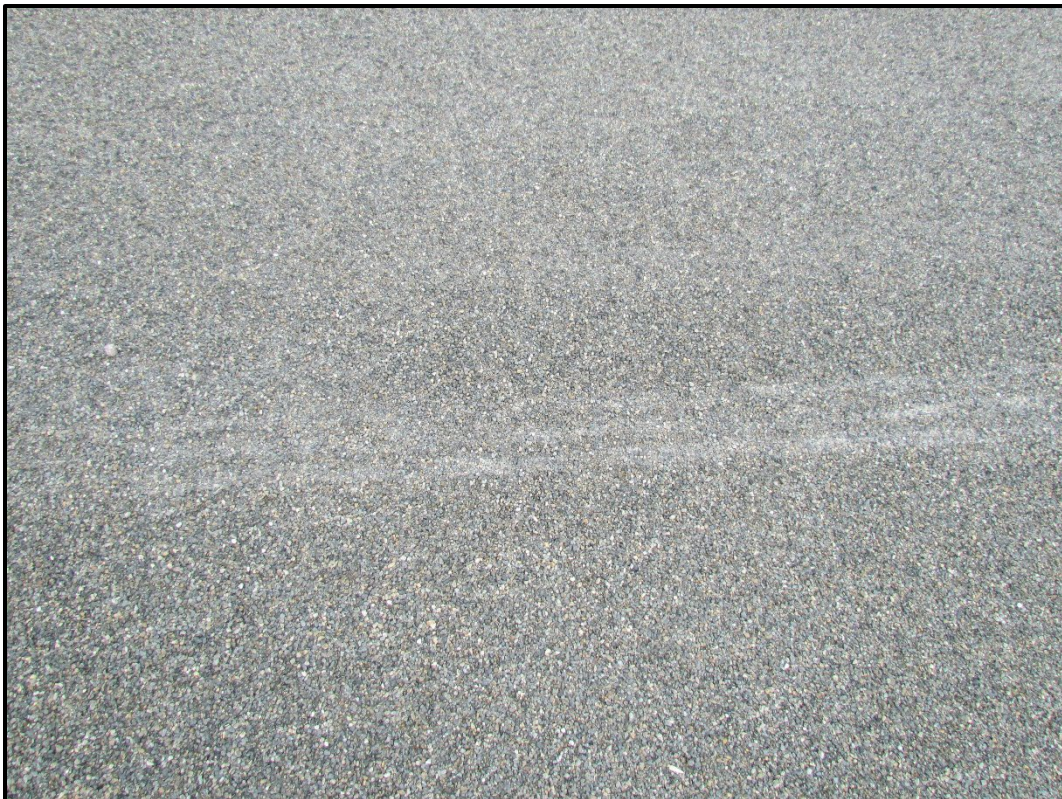
↑↓ Area to watch in the southbound lane of Spring Creek Road. There is a small section that the polymer overlay failed or experienced damage of some kind.
