CONSTRUCTION REPORT – SITE EVALUATIONS

APPLICATION OF SEAL COAT ASPHALT EMULSION (OR FOG COATING) OVER EXISTING CHIP SEAL FOR IMPROVED CHIP RETENTION

Project Name: Beavertail Road Chip Seal

Project Number: MT 10-05

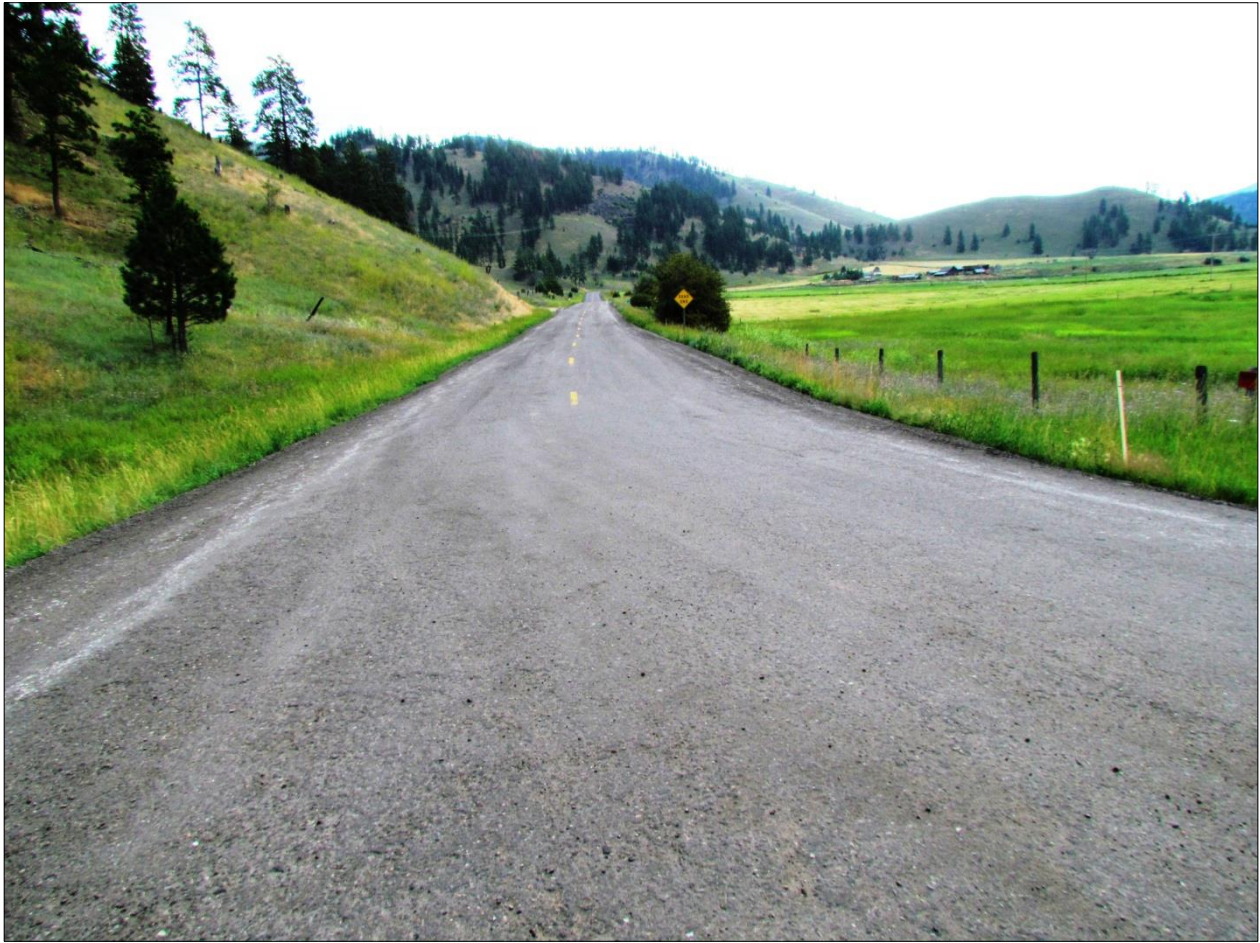
↑ Above image shows roadway with the compacted millings laid down in May of 2011.

This shot taken at the junction of Beavertail Rd. and Cook Ln., looking east at approximately mile point one.

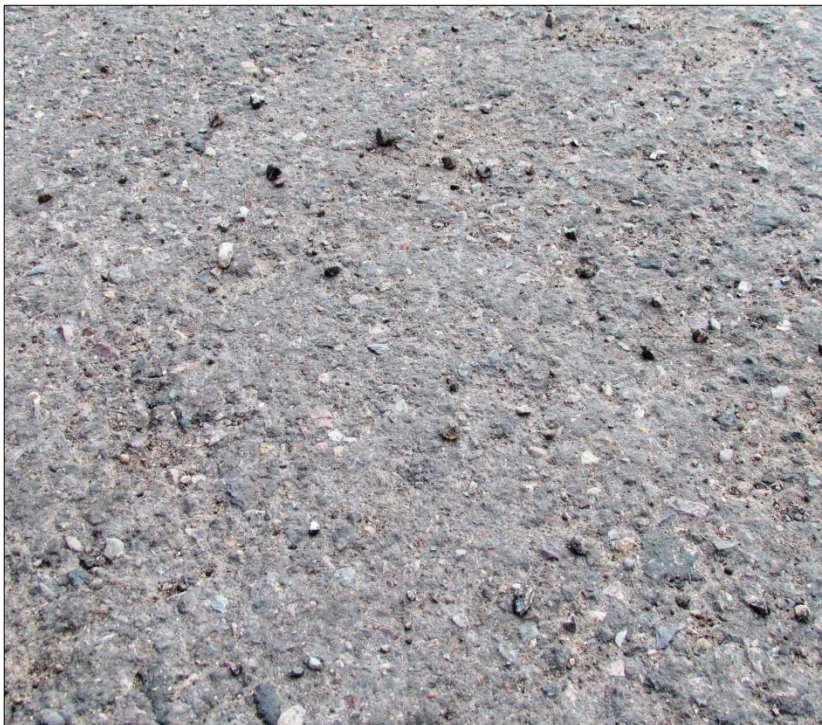
← Close-up of pavement surface.

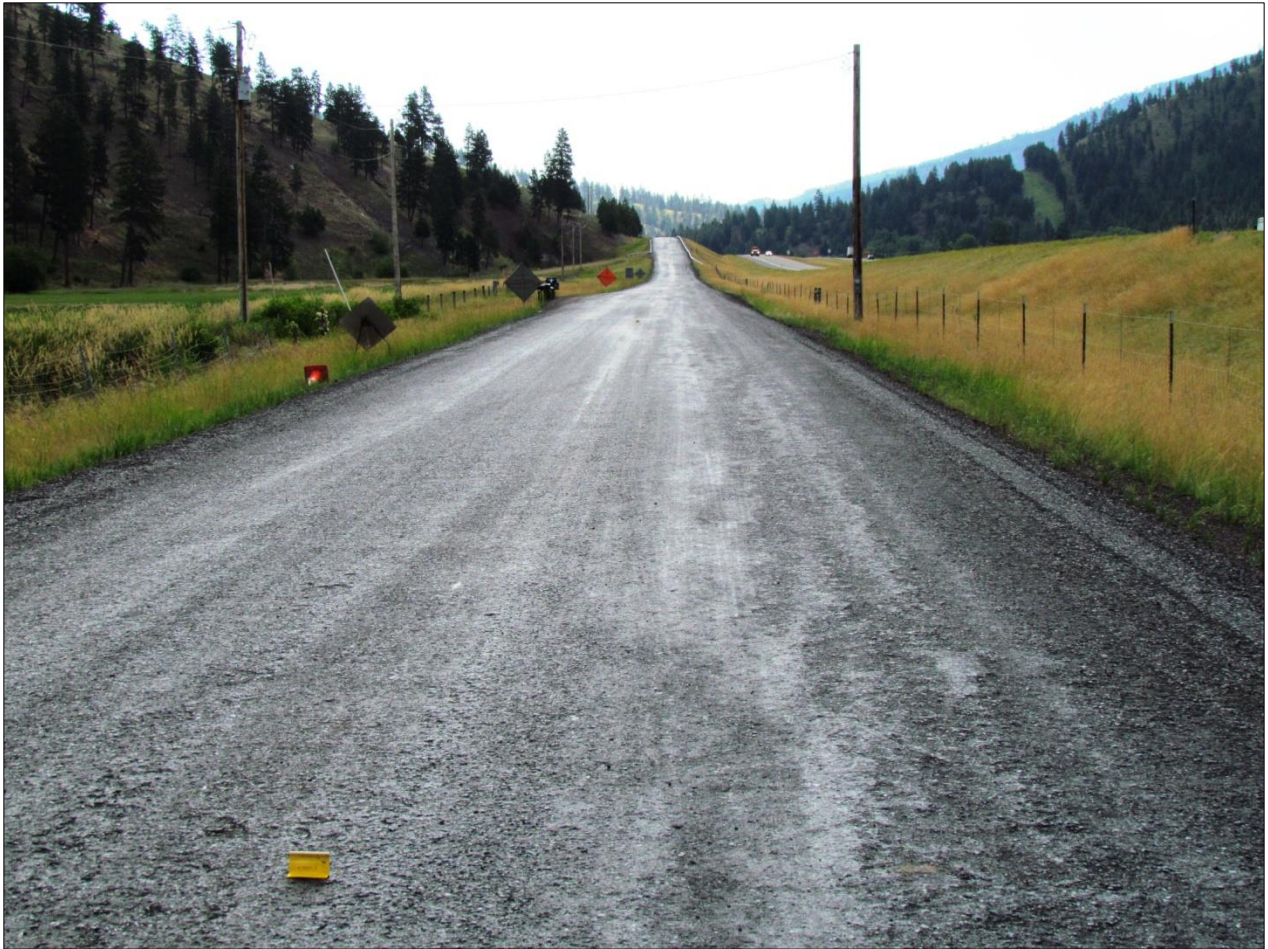
↑ Above image shows roadway with applied tack coat prior to chip seal looking east. The tack was allowed to set for several days prior to chipping.

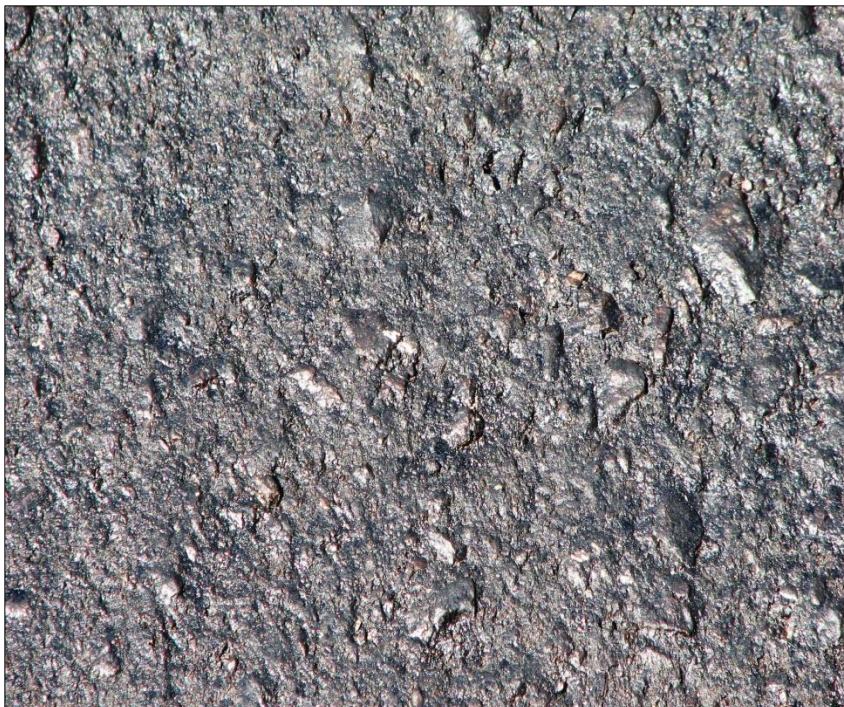
← Tack coat close-up.

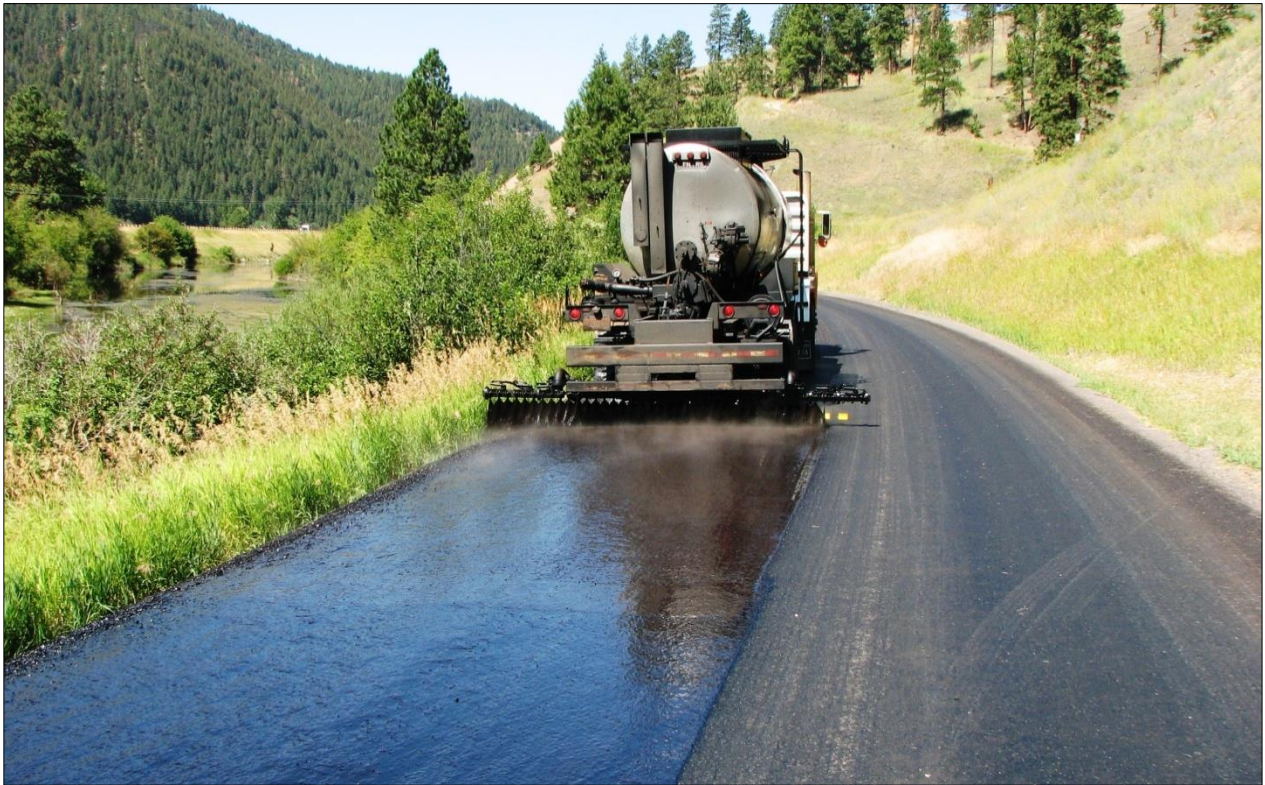
↑ Application of AC emulsion at approximately 150°F (66°C).

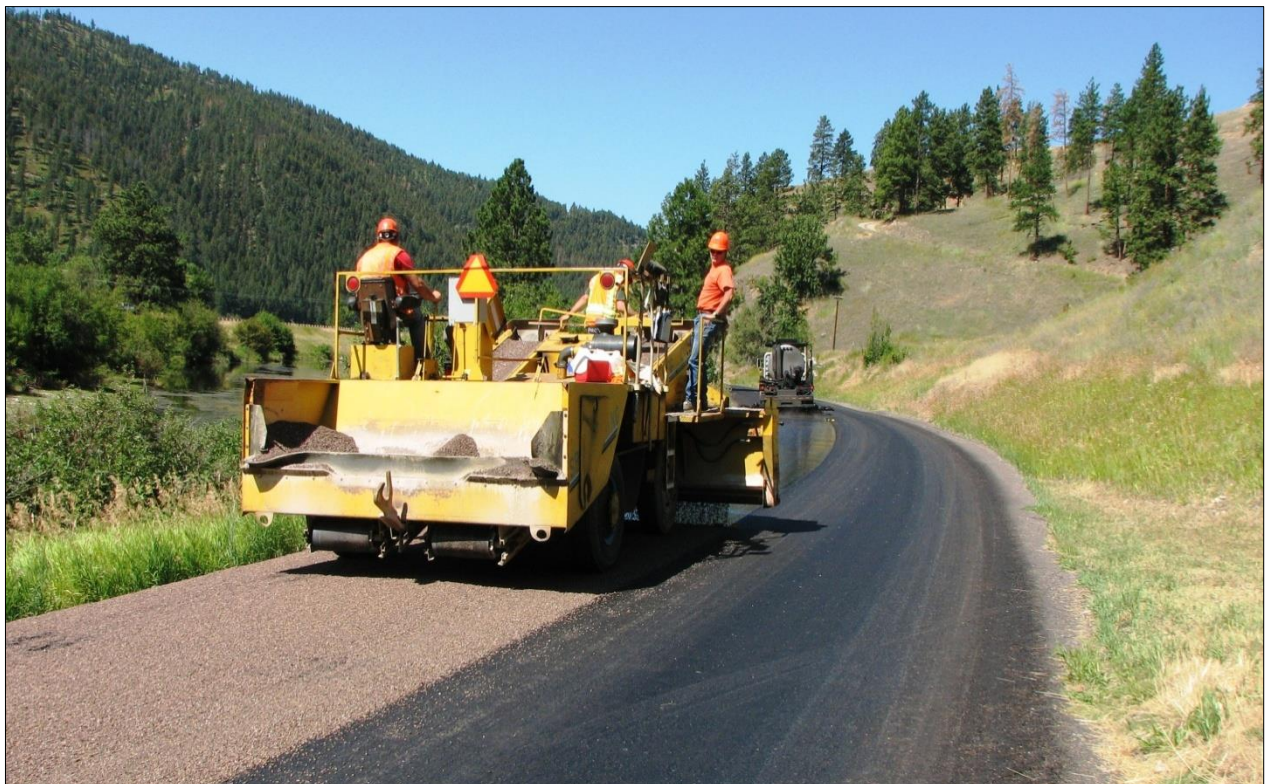
↓ Application of chips.

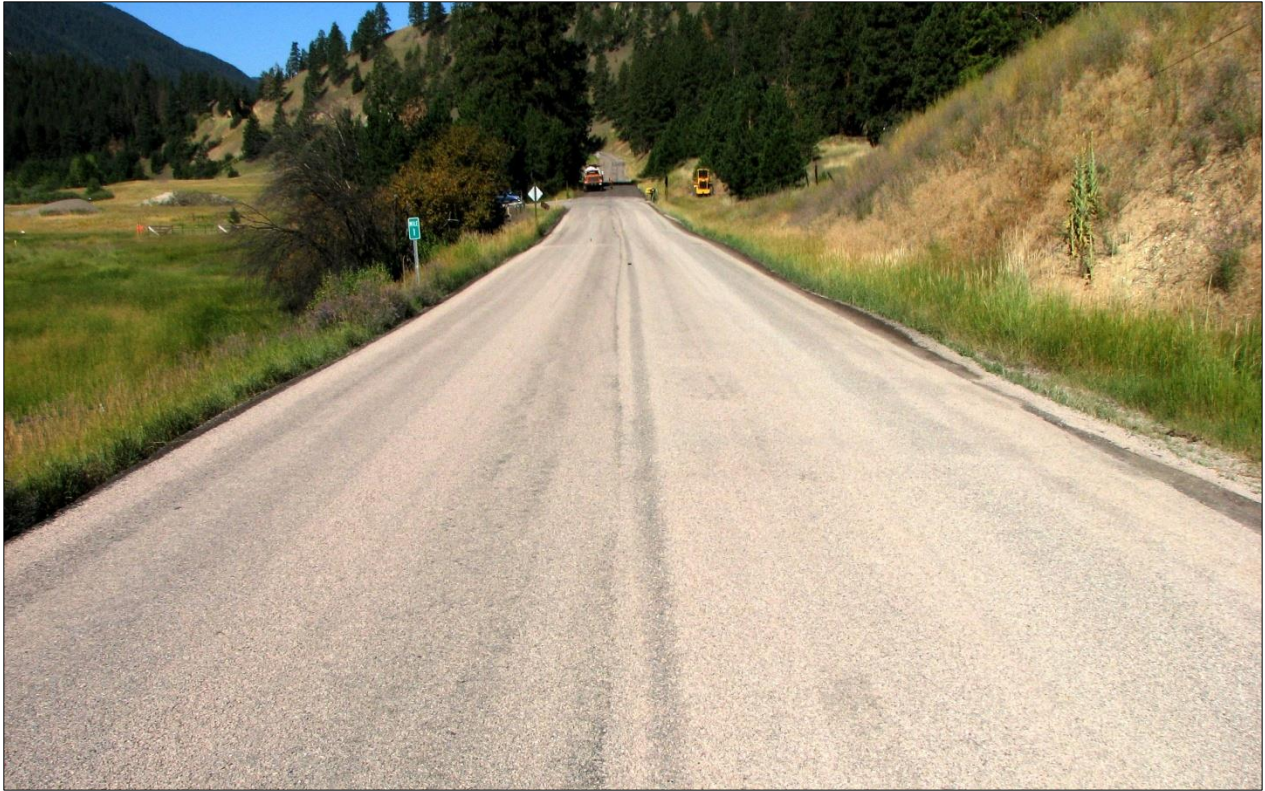
↑ Completed chip seal.

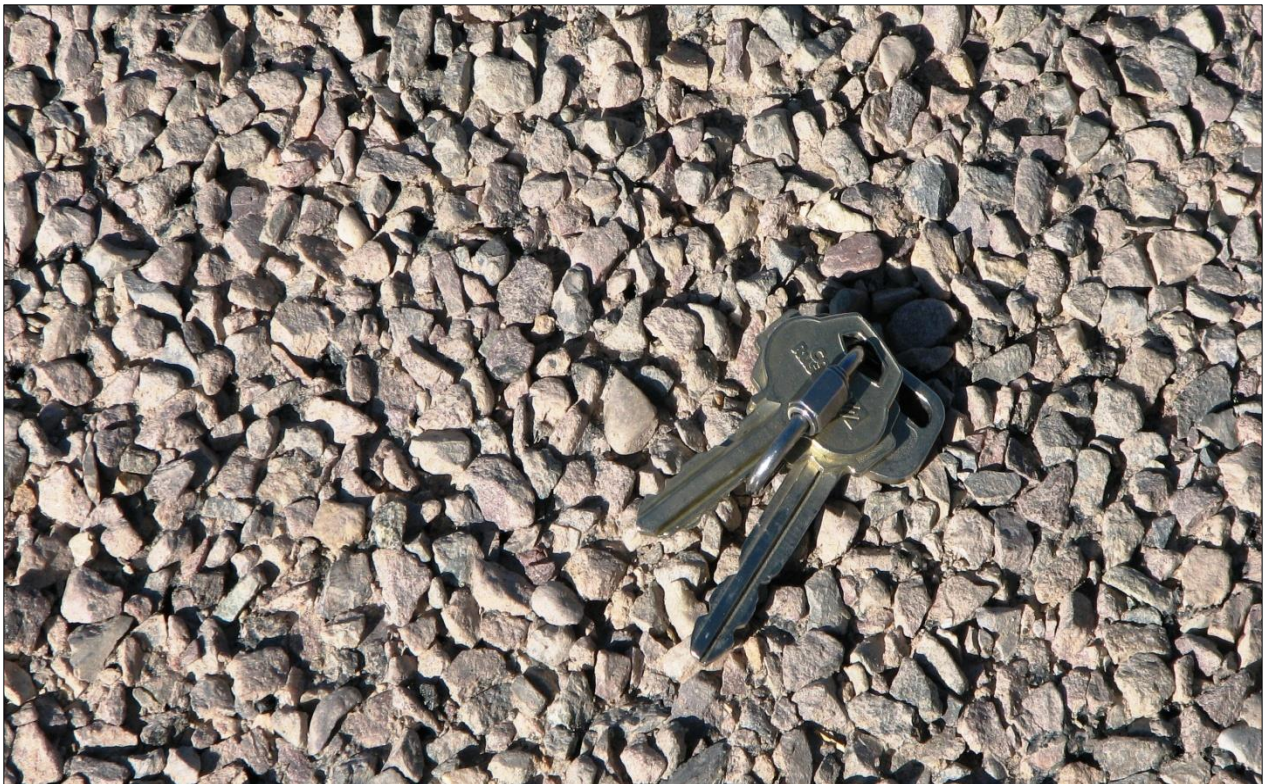
↓ Close-up of pavement surface.

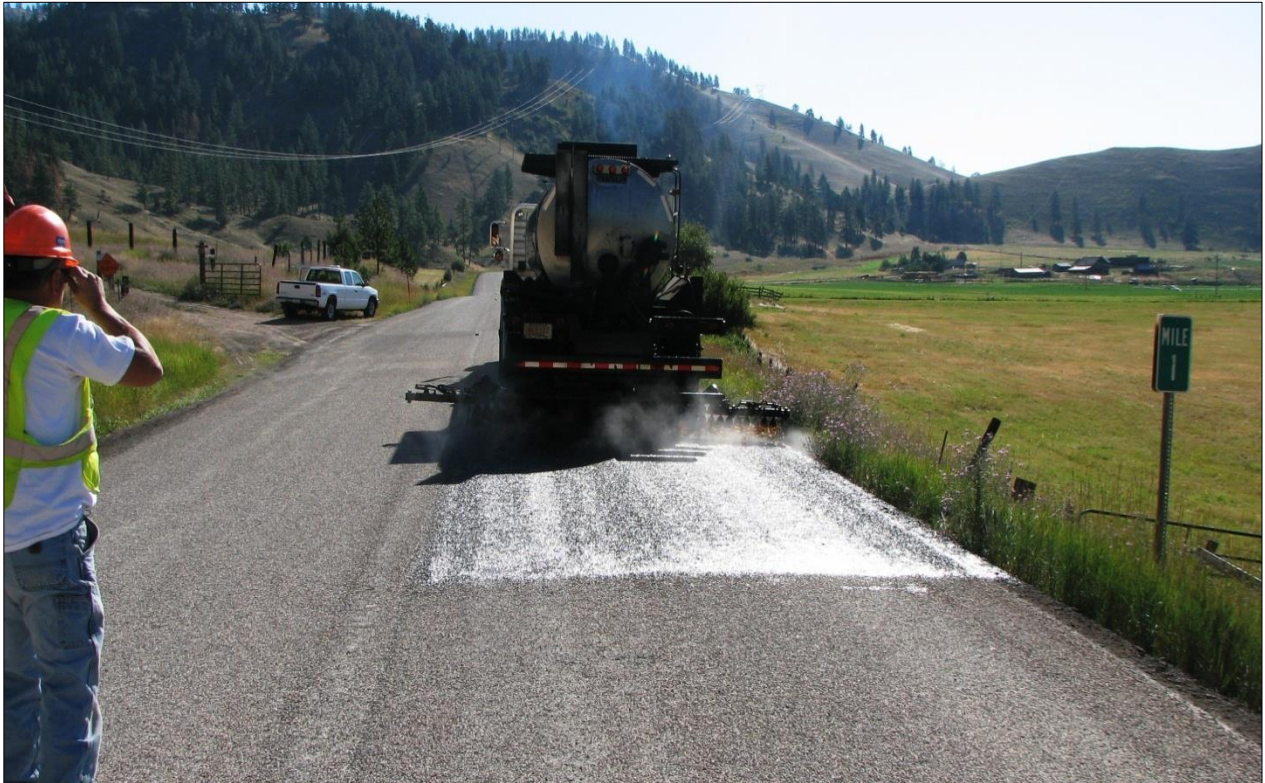
↑ Beginning of the Test Section 1 run of the SS1 at .1 gallon per sq. yd. concentration.

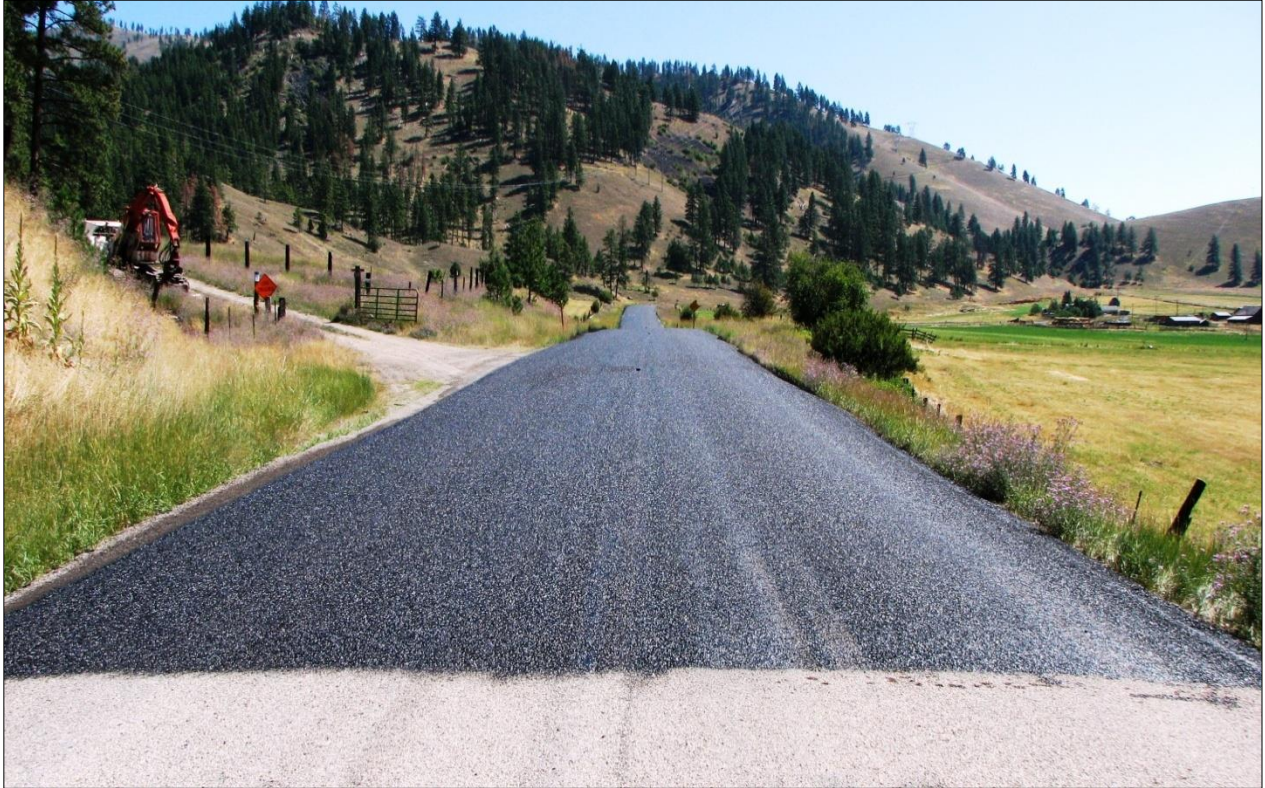
↓ Completed Section1.

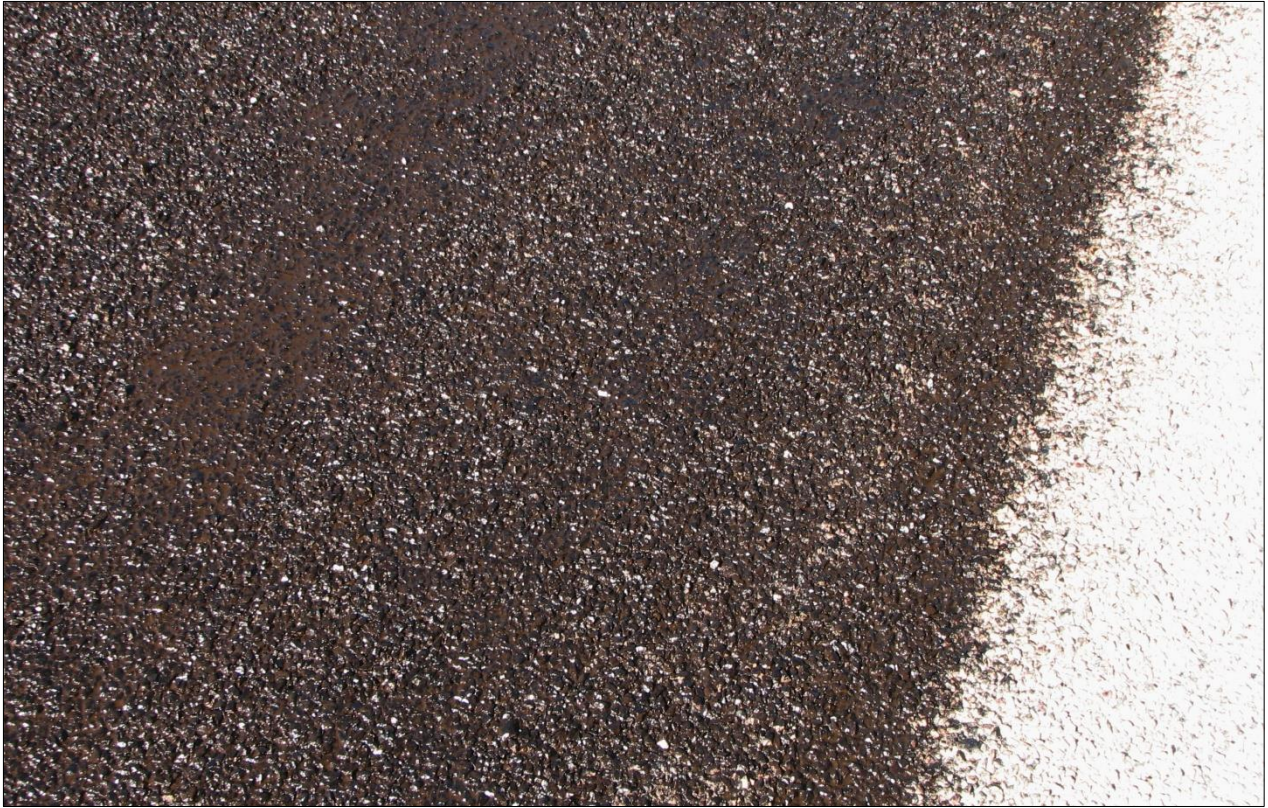
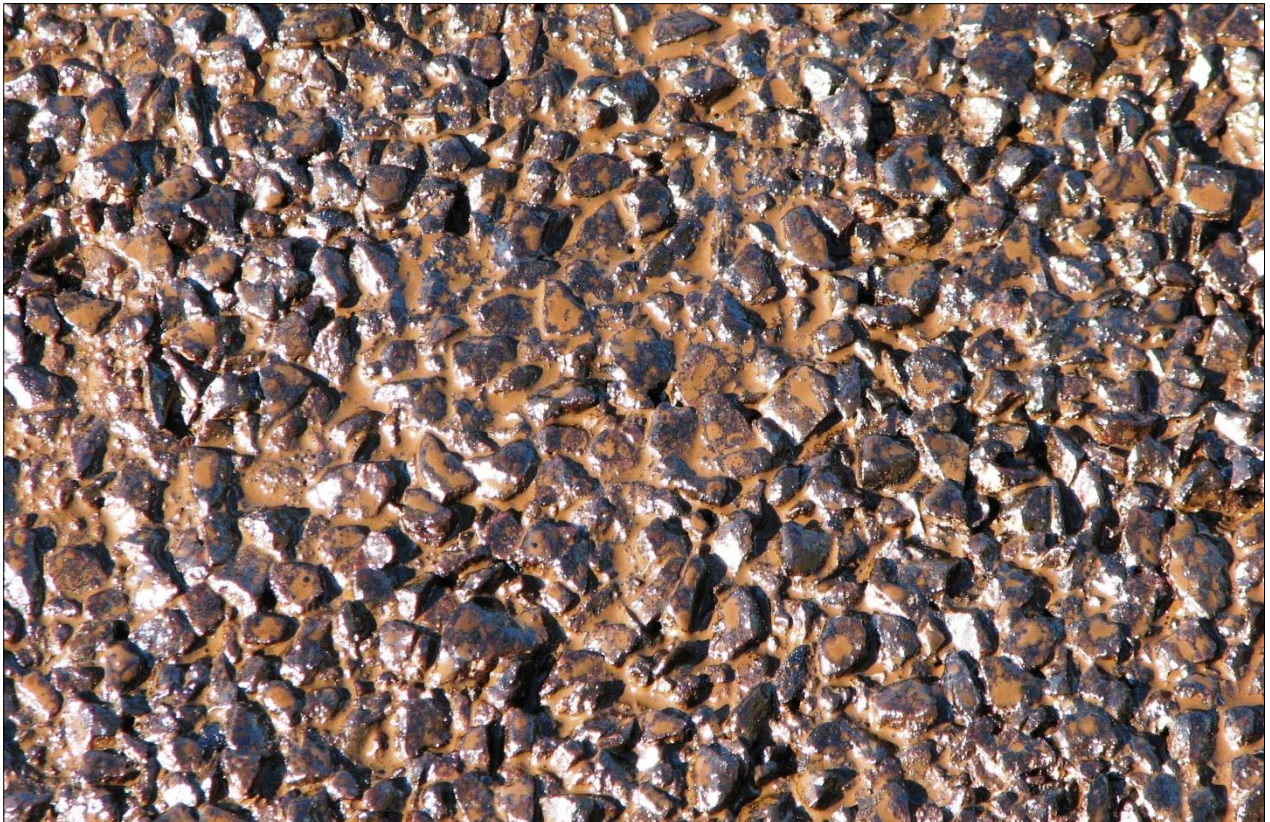
↕ Several close-up images of the Section 1, SS1 application directly after placement.

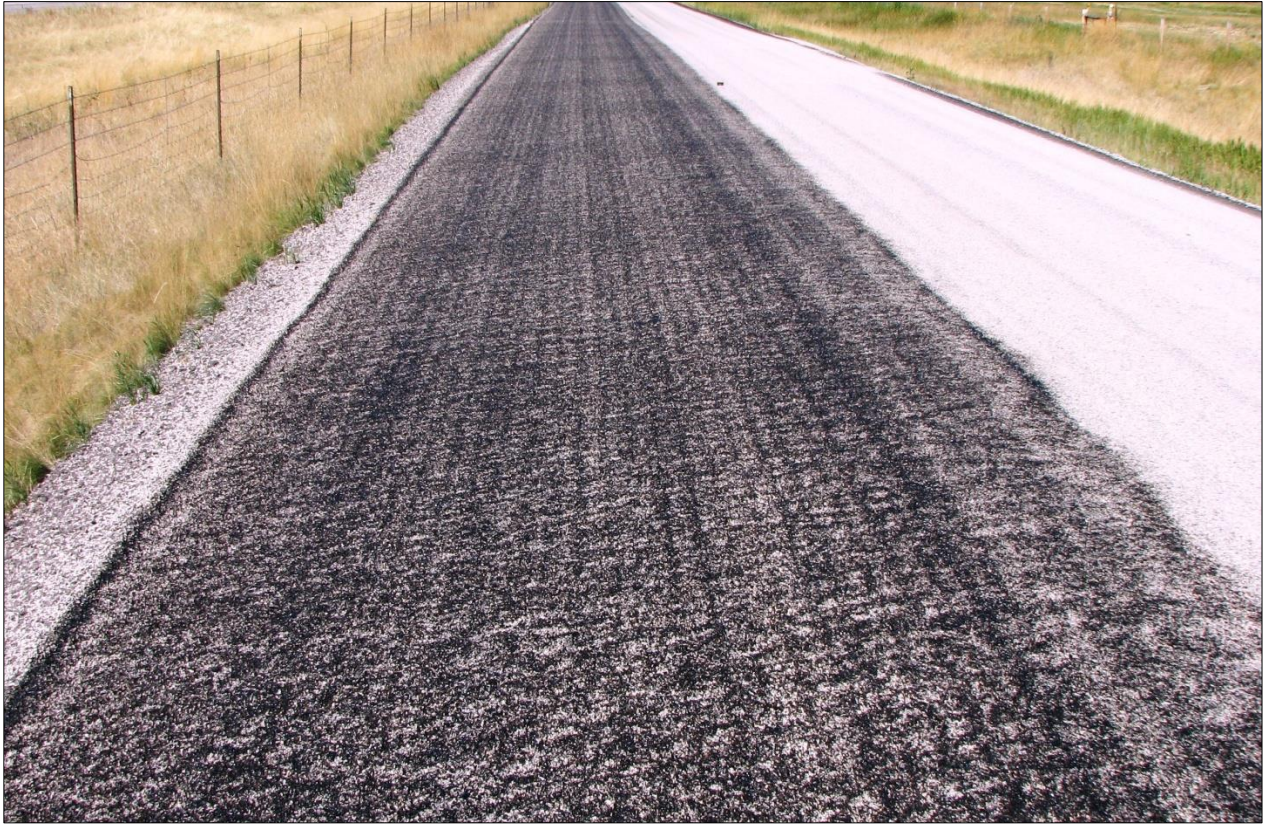
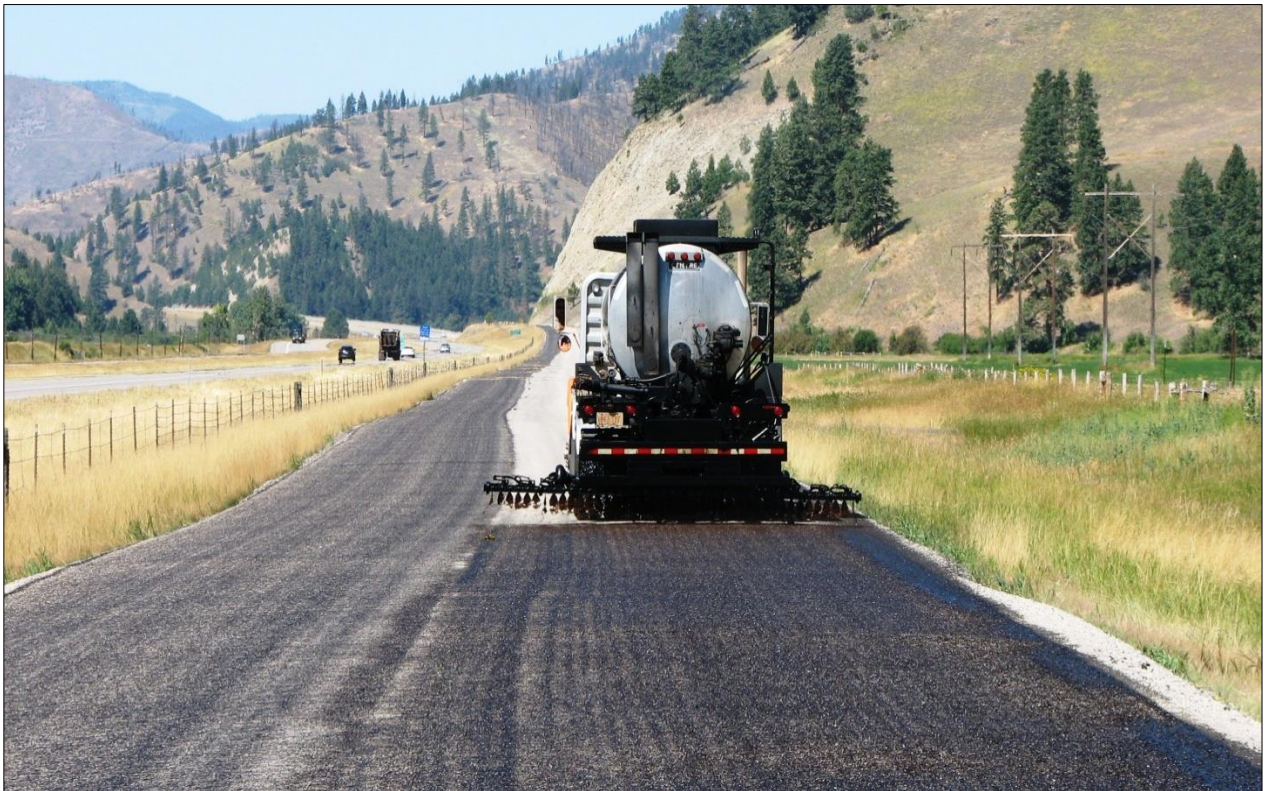
↑↓ Images of the Test Section 2 application, (SS1 .05 gallon per sq. yd.). Both views looking west.

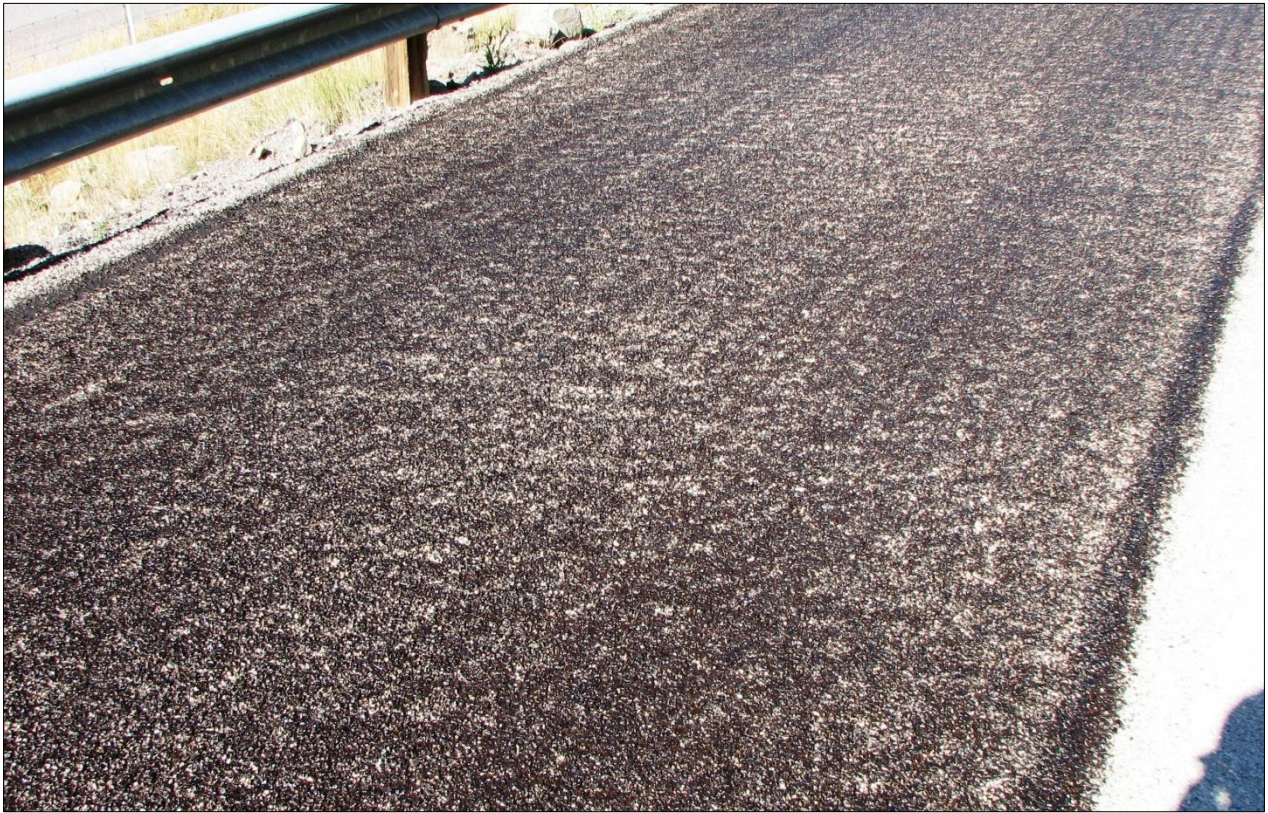
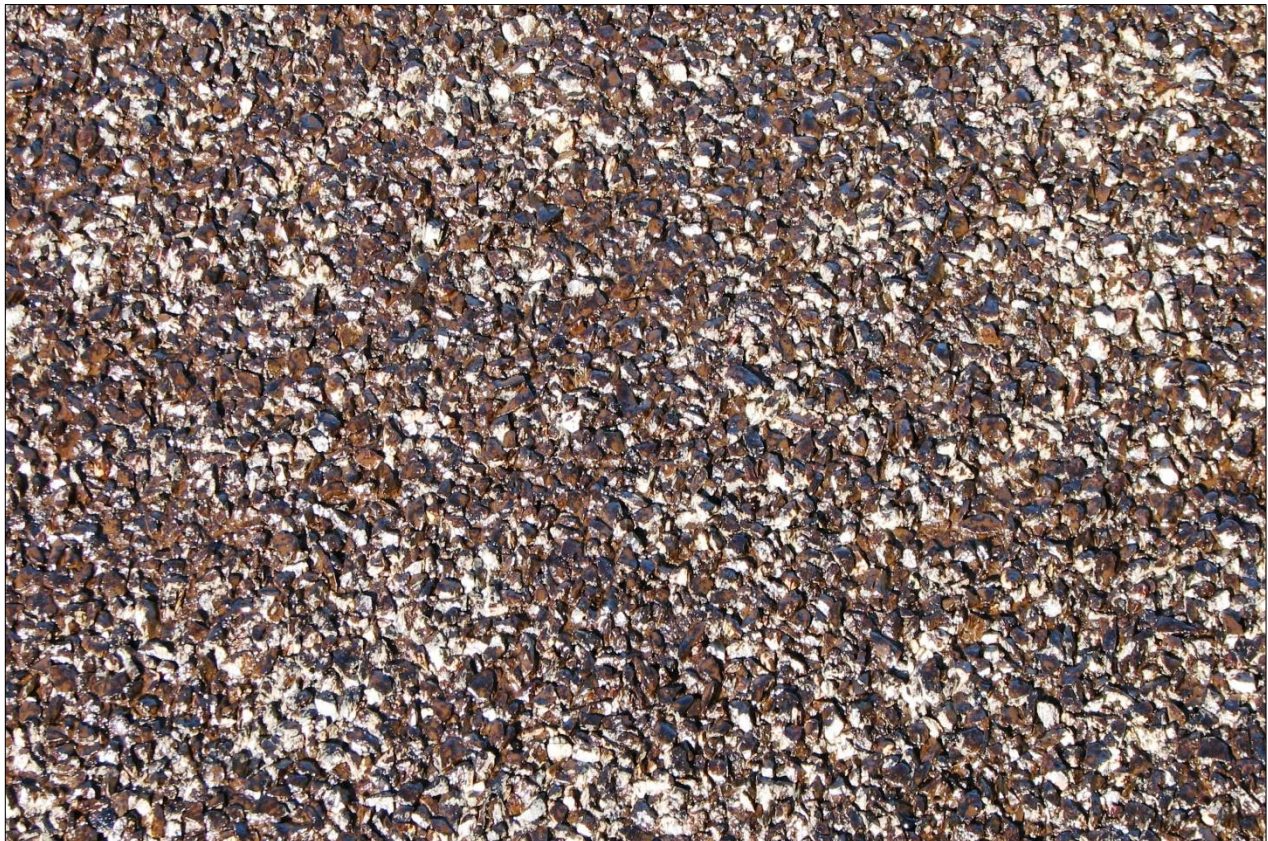
↑↓ Several close-up images of the Section 2, SS1 application.

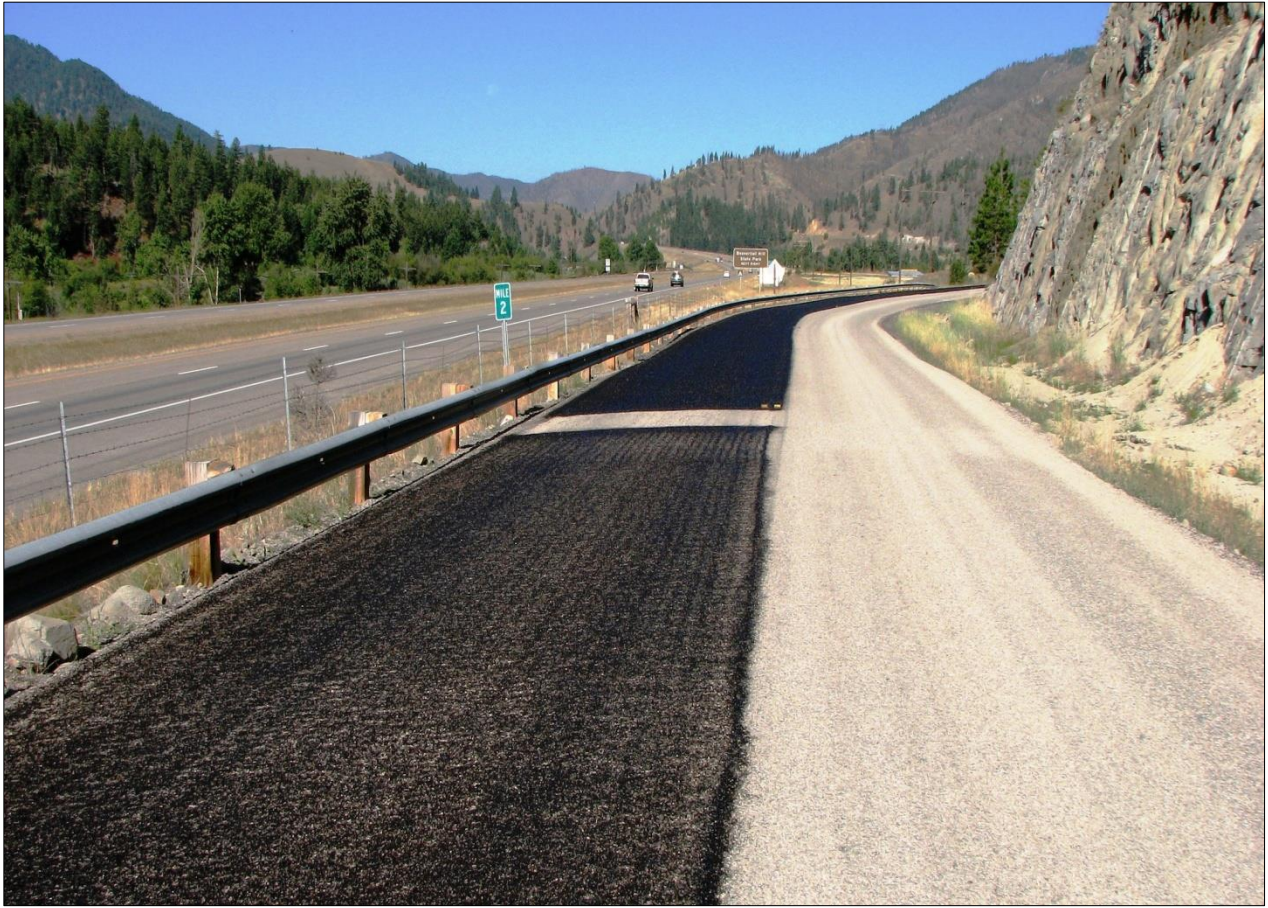
↑ View of the Test Sections 1 & 2 transition at mile marker 2, view west.

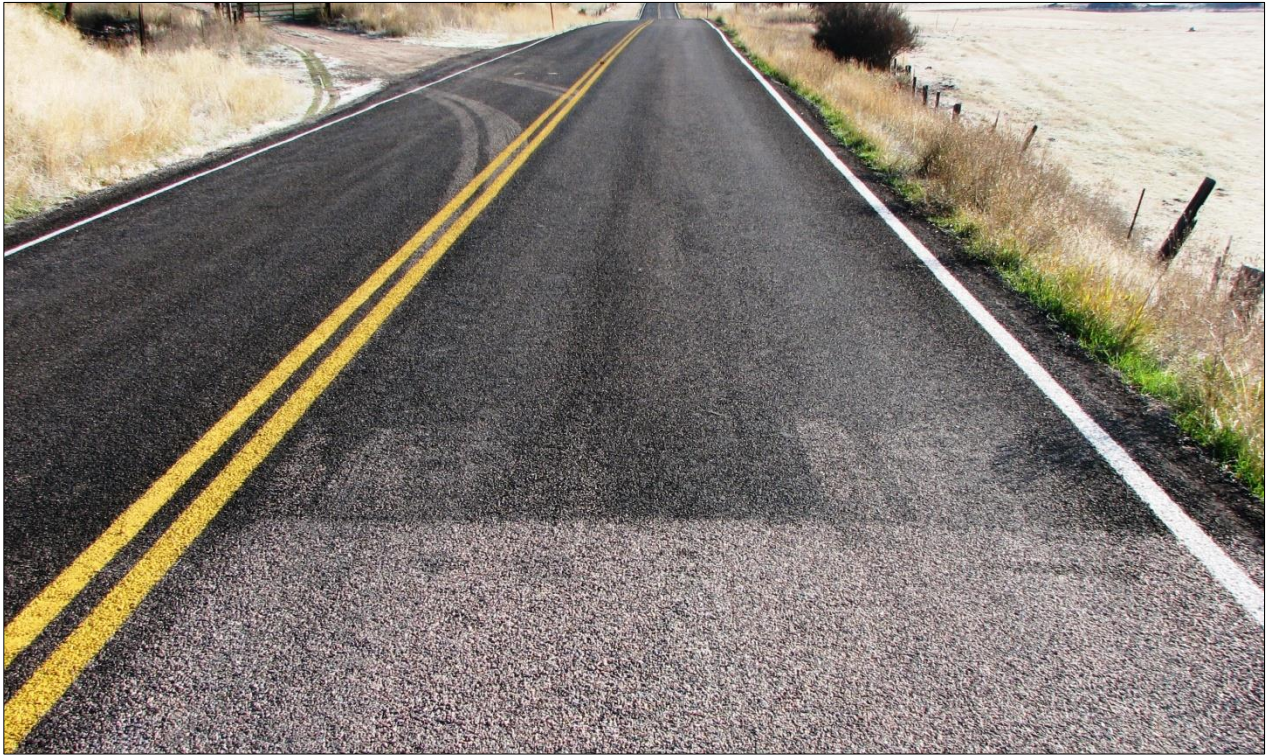
↑ View east of Test Section 1 at beginning of application, mile point 1.

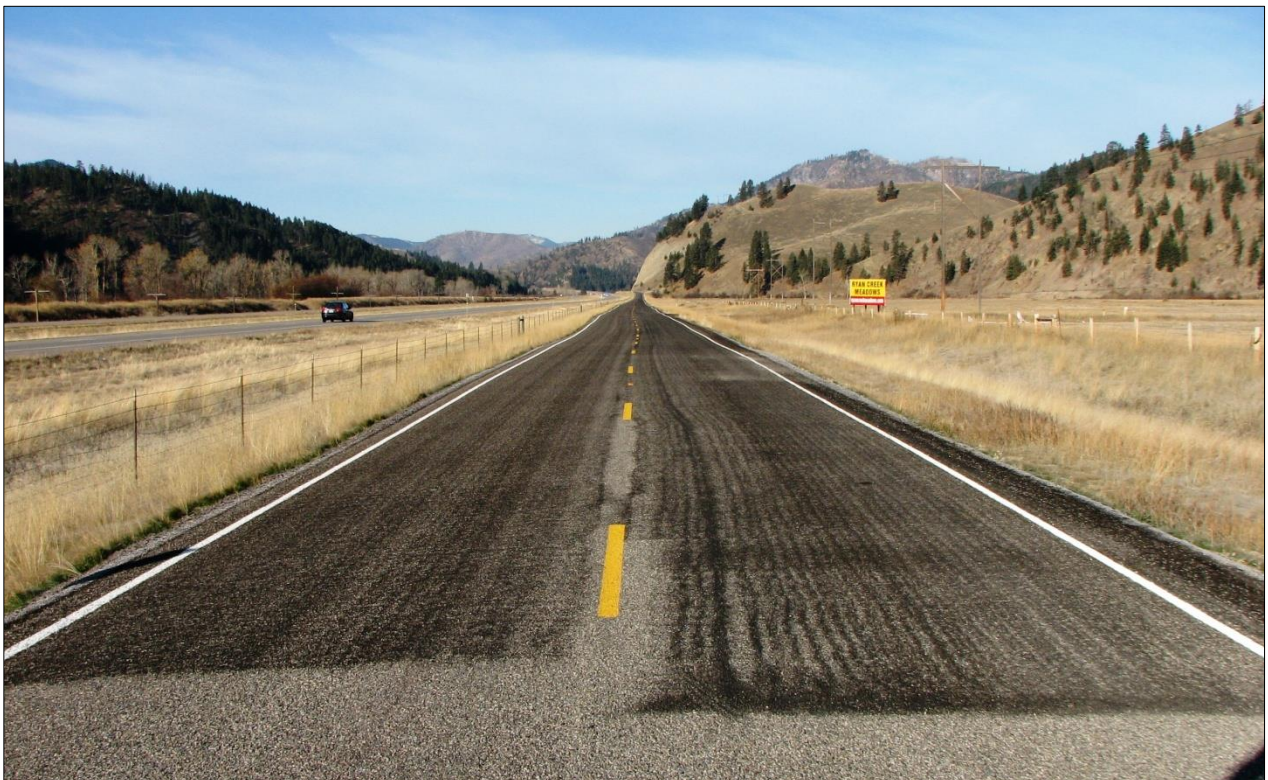
↓ View west of Test Section 2 at end of application, mile point 3.

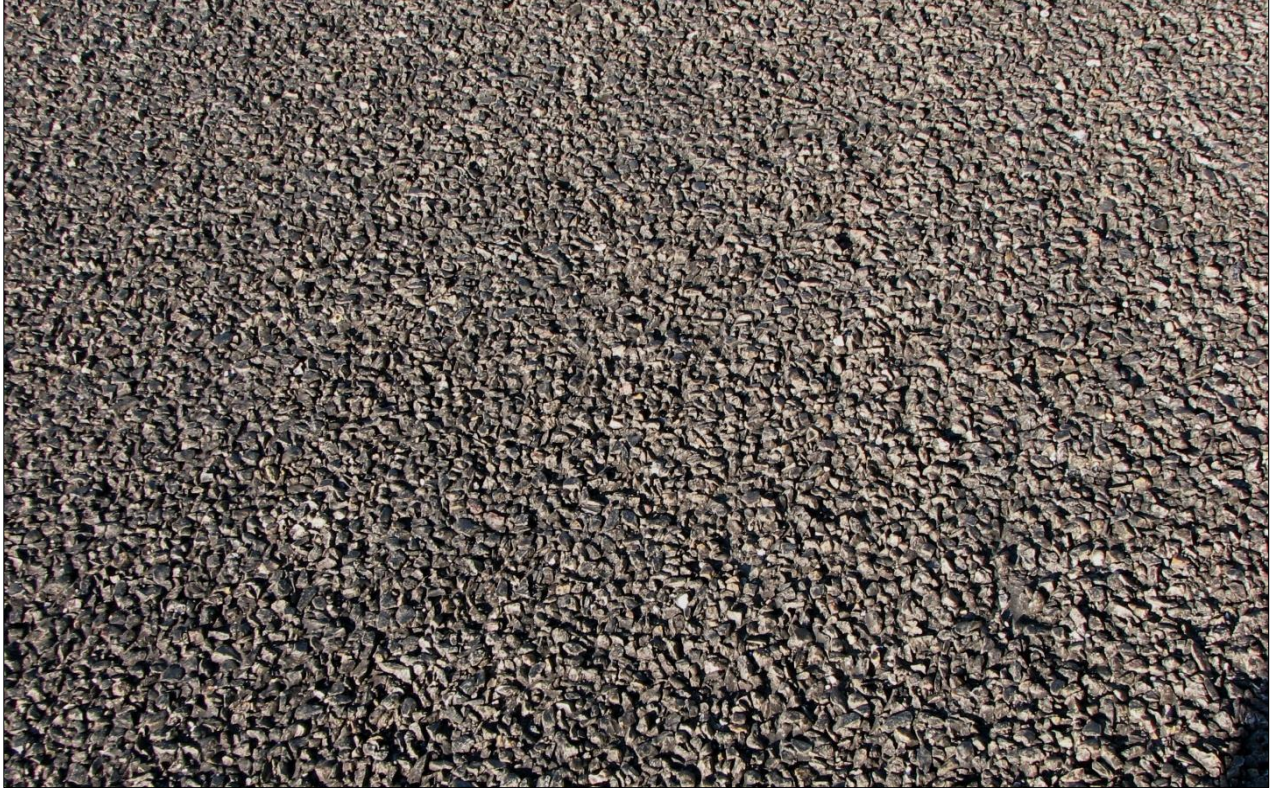
↑ Closer view of pavement texture of Test Section 1.

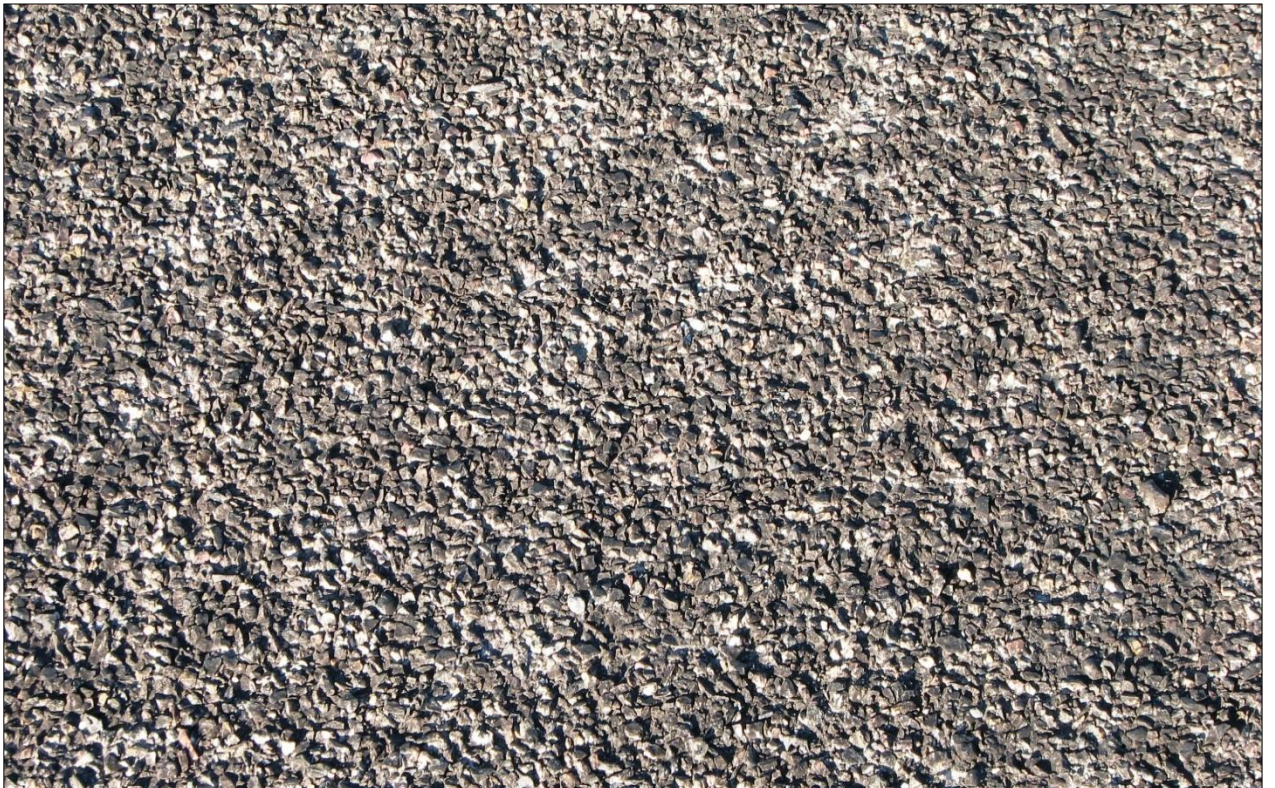
↓ Closer view of pavement texture of Test Section 2.

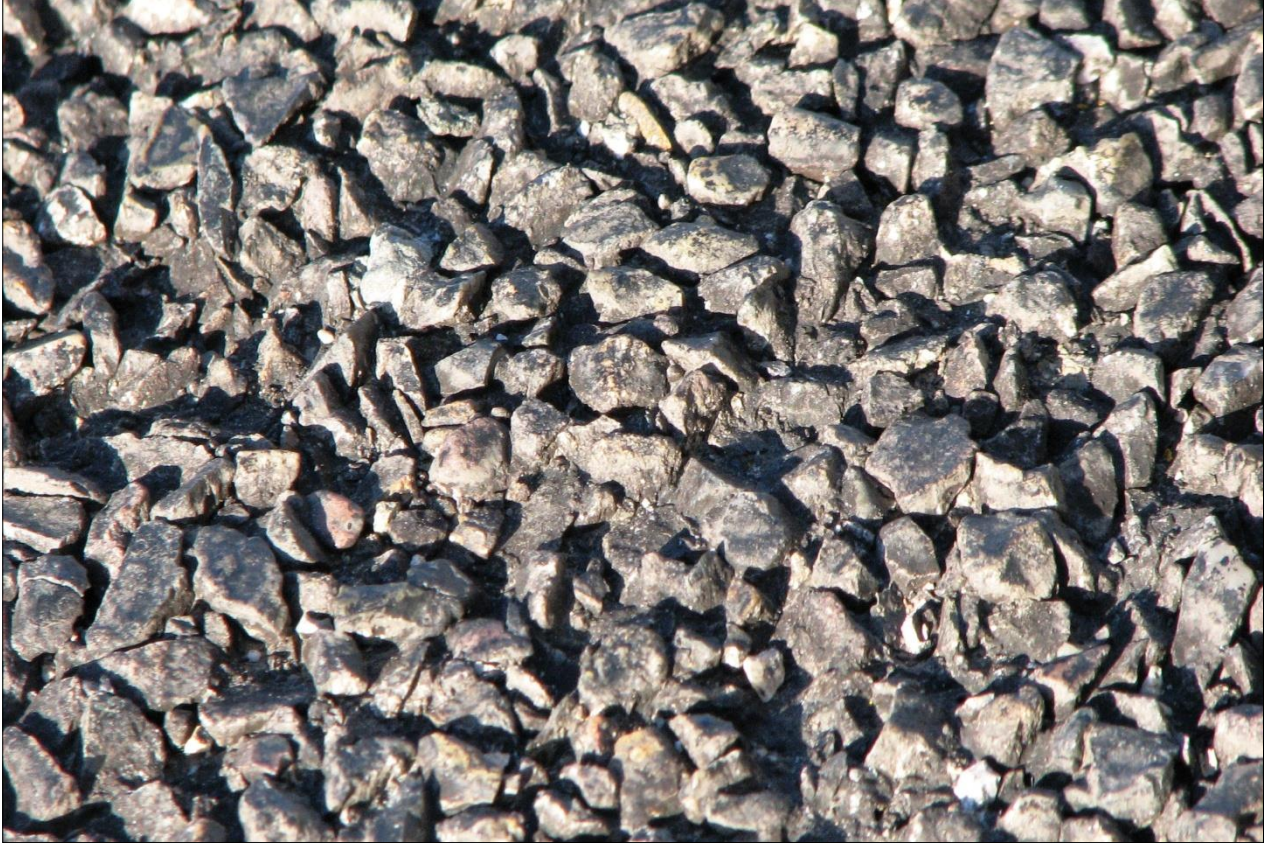
↑ Close-up of chipped surface of Test Section 1.

During the initial placement in August, and compared with the site visit conducted in November, the residual AC (locally specific to the top exposed aggregate), is beginning to display minor stripping due to either environmental elements, traffic to date, or a combination of both. This is considered normal and visually the road surface will lighten or become grayer over time.

Upon close examination of chip embedment with the AC as compared to the project control (section of the east end of the road which did not receive the post seal) the amount of AC that encompassed the test section aggregate was more prevalent than the control, and homogeneous penetration with the initial SS1 application (prior to chipping) and the post SS1 application. This was determined by using a small hand chisel to remove a small area of the seal to expose the relief.

To date the topical application of the SS1 (or fog seal) appears to have efficiently locked in the chips than compared to the control which may promote a more durable seal. Future evaluations will determine if this supposition is valid.
