CONSTRUCTION REPORT – SITE EVALUATIONS

APPLICATION OF SEAL COAT ASPHALT EMULSION (OR FOG COATING) OVER EXISTING CHIP SEAL FOR IMPROVED CHIP RETENTION

Project Name: Beavertail Road Chip Seal

Project Number: MT 10-05

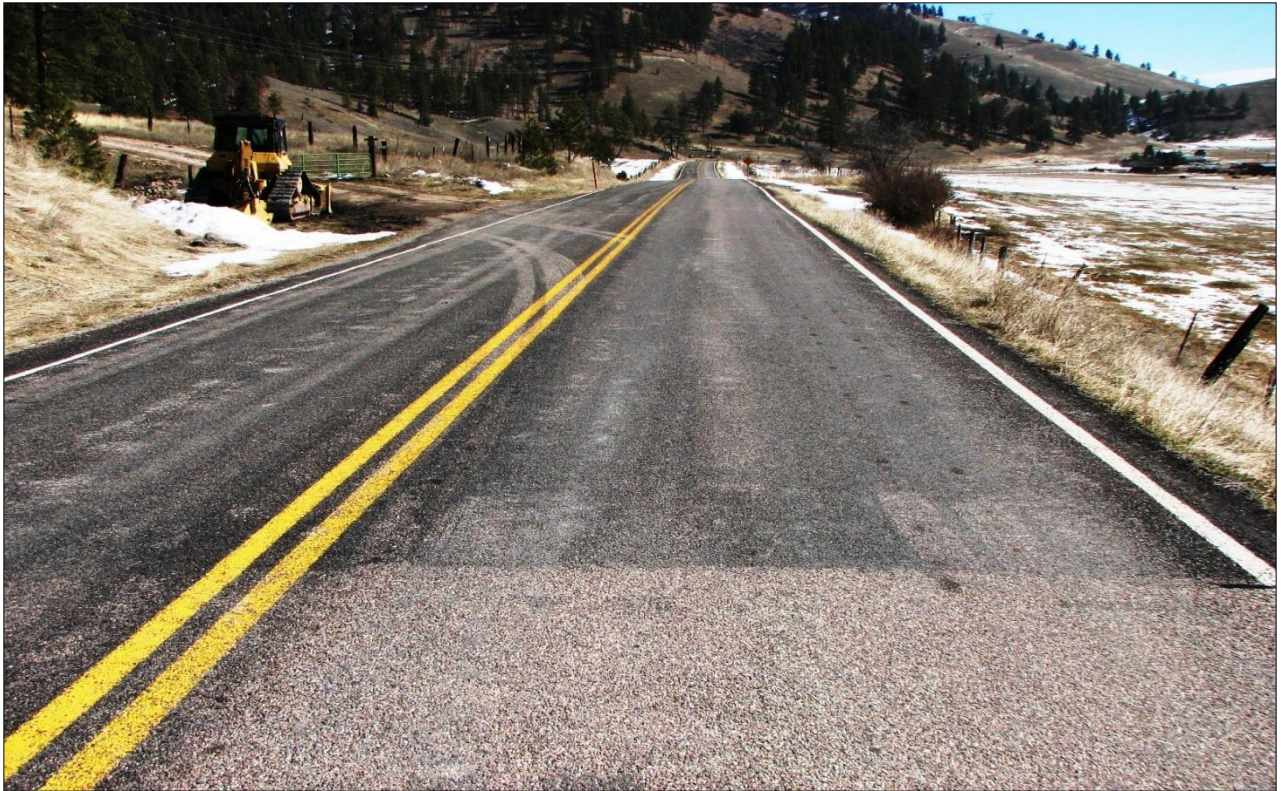
↑ Test Section 1: SS1 of .1 gallon per sq. yd. – Mile point 1 looking east.

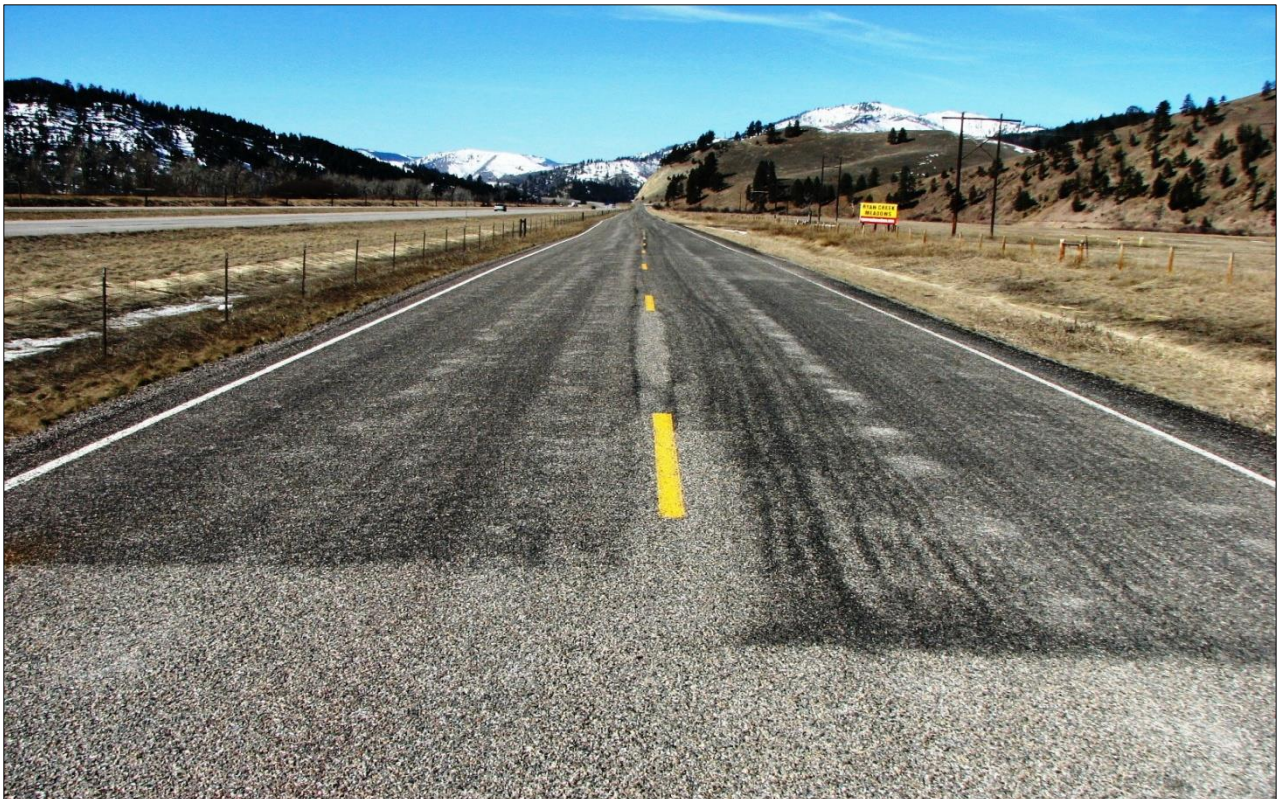
↓ Test Section 2: SS1 of .05 gallon per sq. yd. – Mile point 3 looking west.

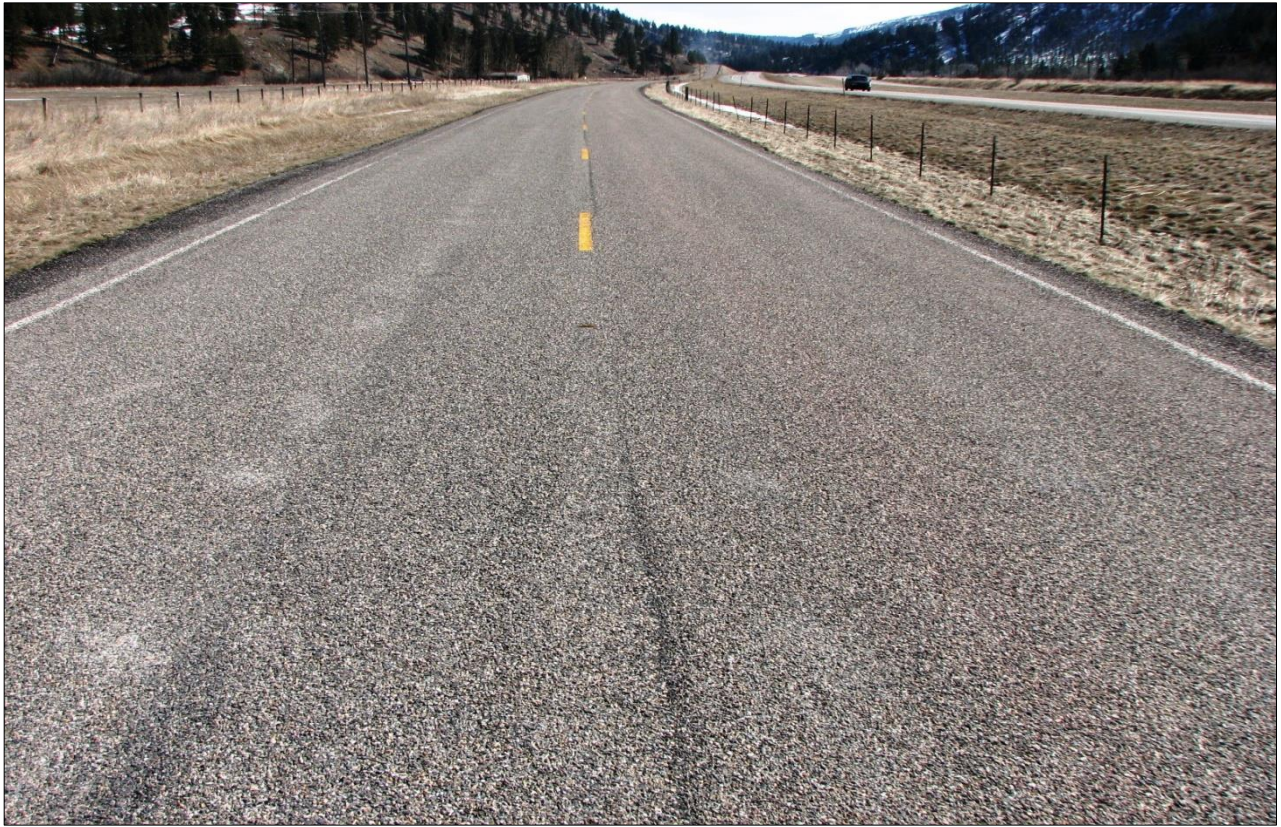
↑ Control Section: Conventional Chip Seal – Mile point 3 looking east.

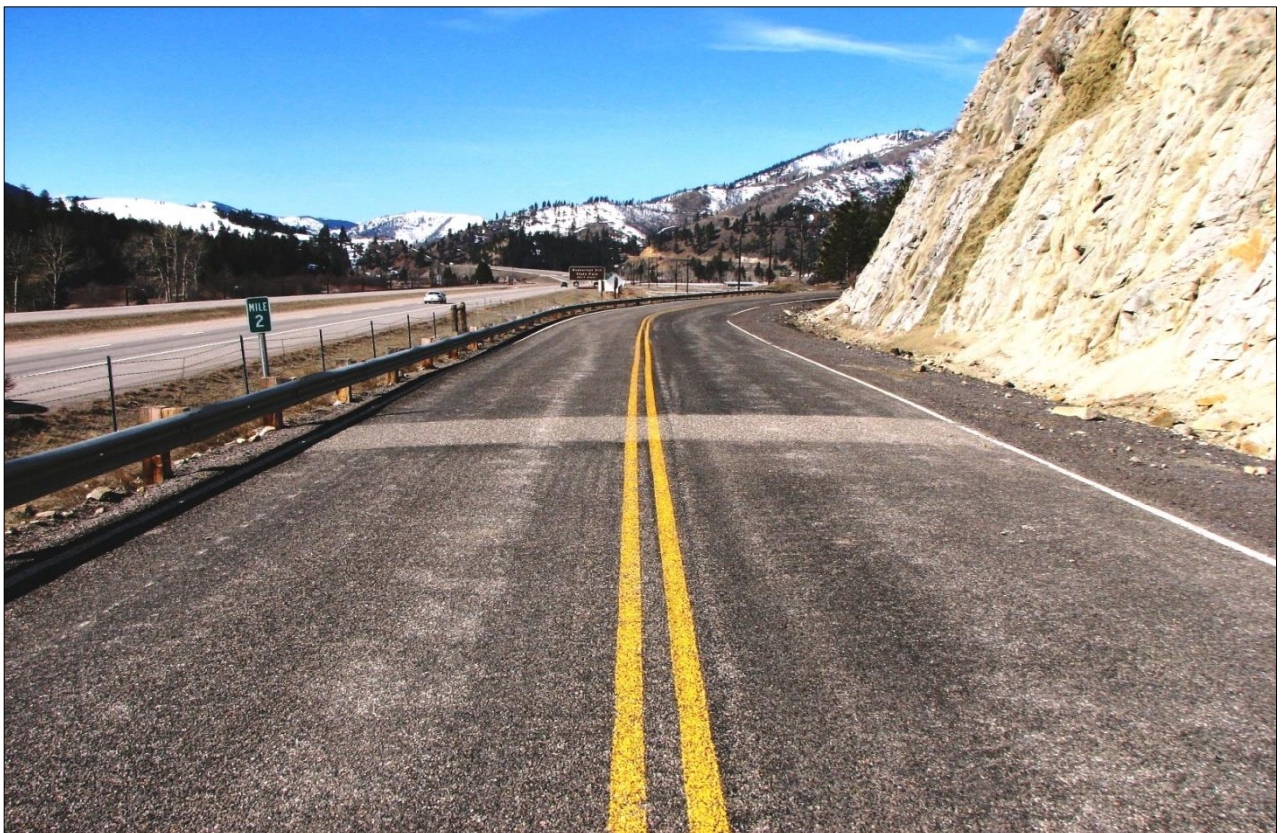
↓ Separation of test sections 1 & 2 – Mile point 2 looking west.

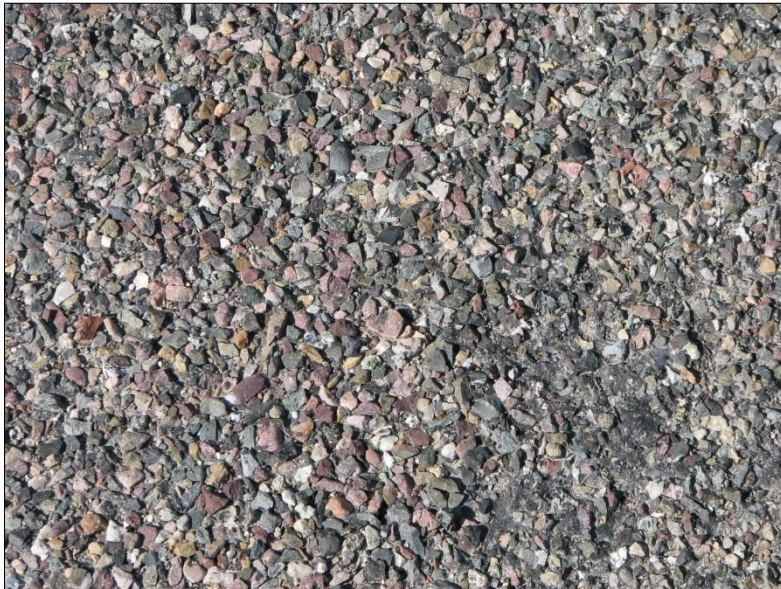
← Control section close-up of surface aggregate.

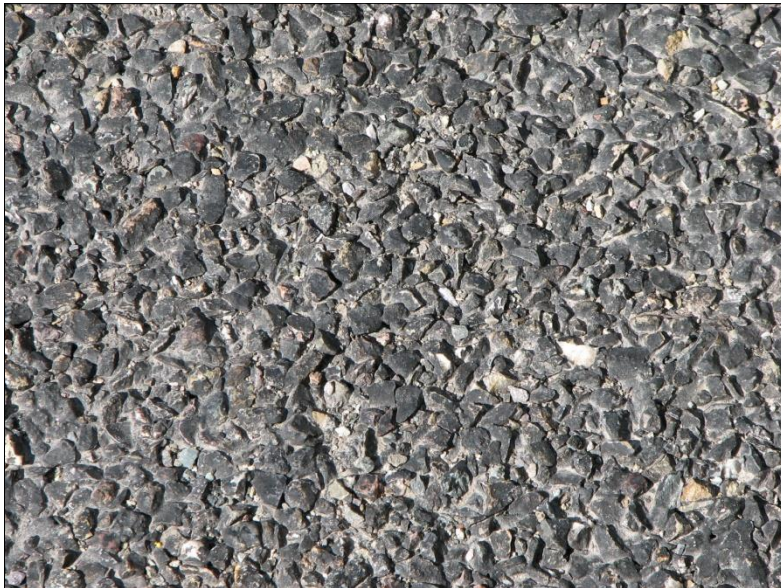
← Test section 1 close-up of surface aggregate.

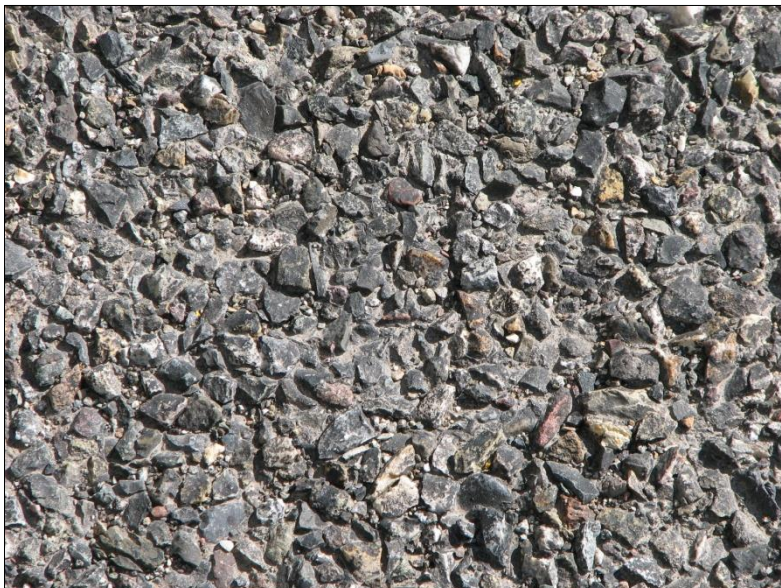
← Test section 2 close-up of surface aggregate.

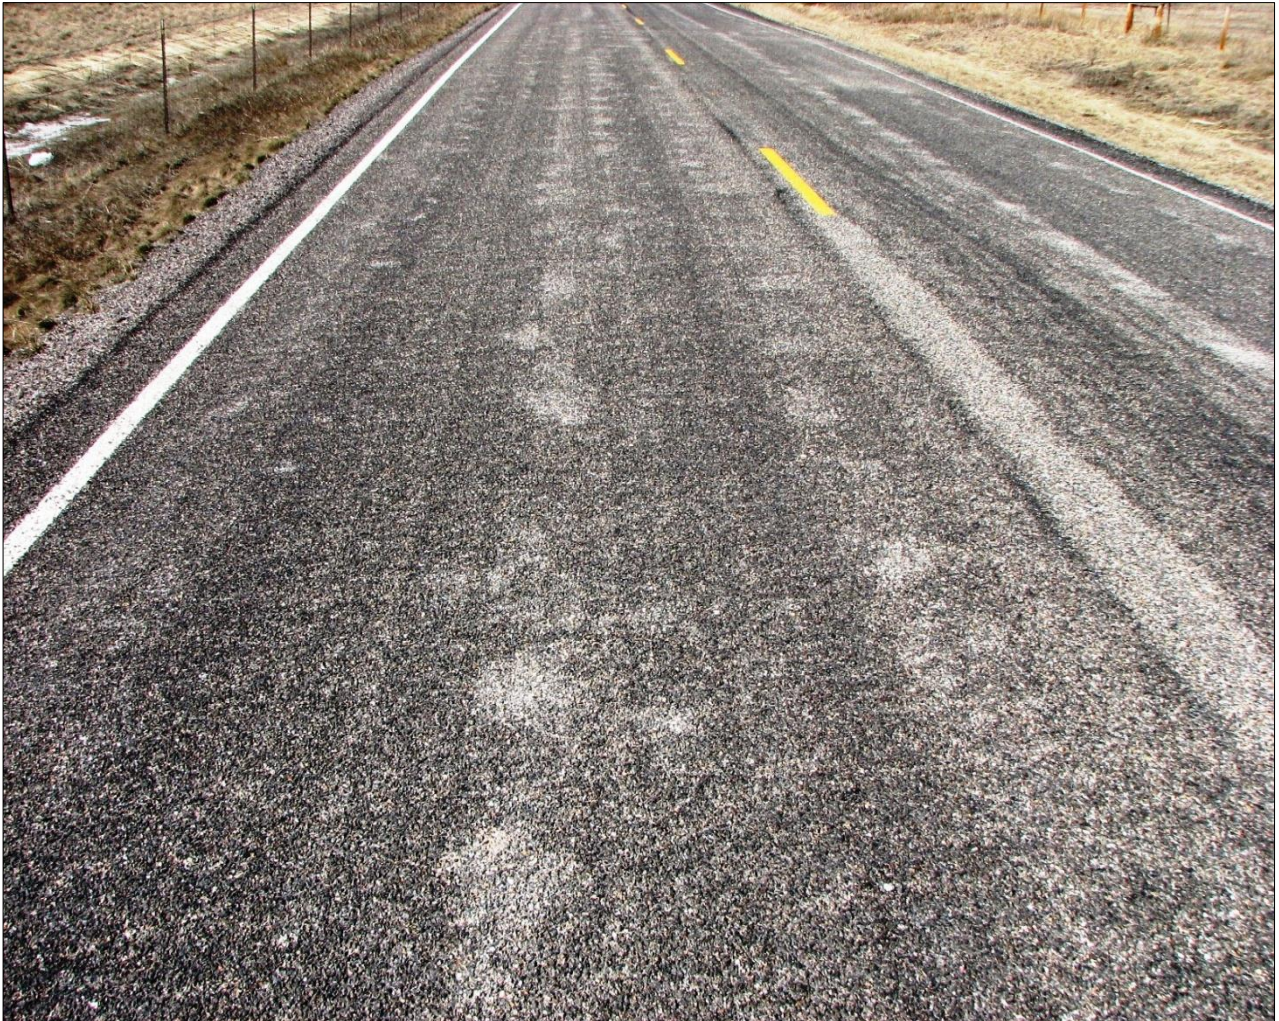
↑ The spotty appearance (lighter shading) of the road bed is predominant on all sections of the project including the control, but not as visible due to the lack of SS1 application. This condition primarily is located away from the wheel paths. This may indicate minor rutting. The lighter areas indicate possible snow plow chatter and the subsequent scouring of the top of the chip seal layer.

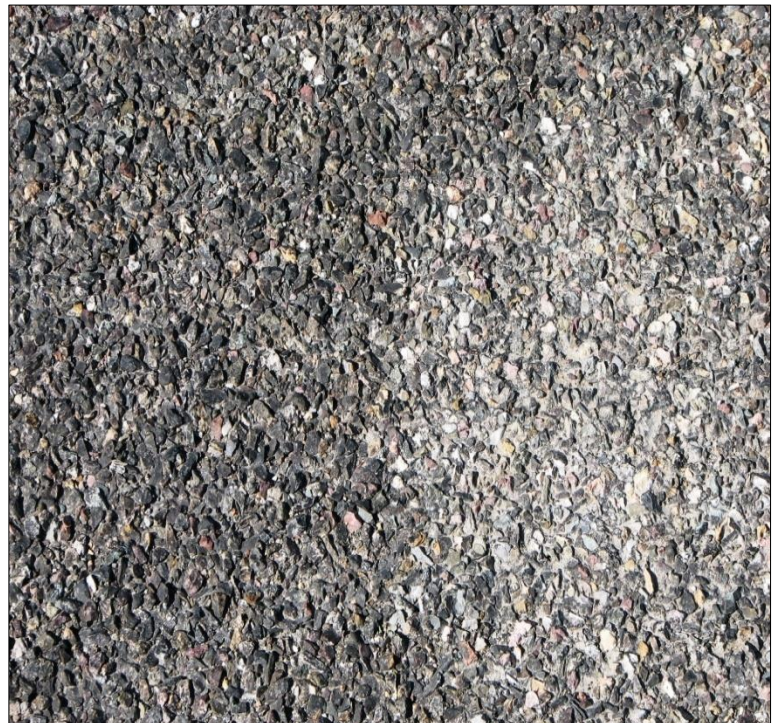
➔ On closer inspection these areas appear to have loss the topical application of SS1 and some minimum removal of higher relief chips.

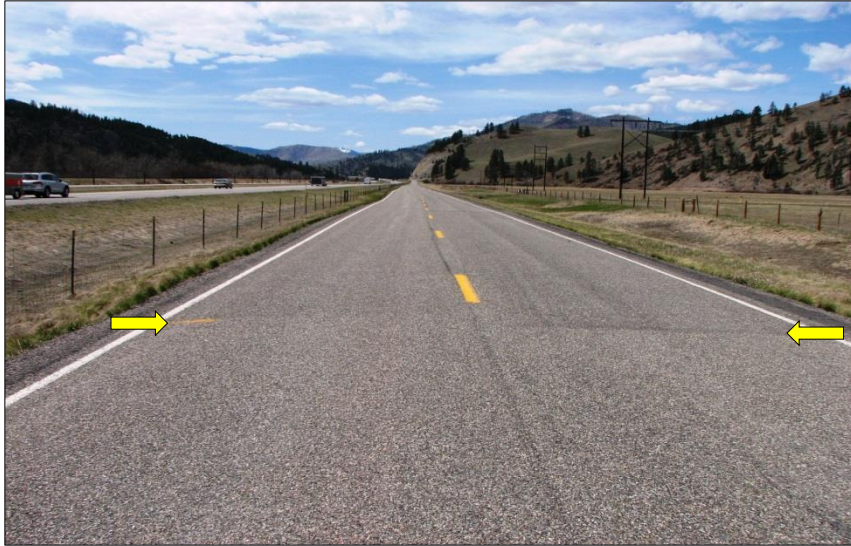
← Transition of control section and TS2 at mile post 3; view west.

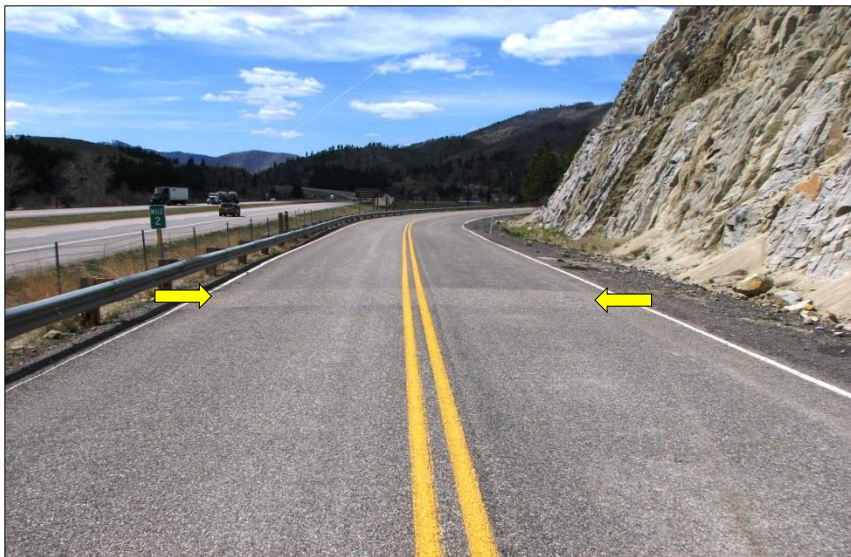
← Transition of TS2 and TS1 at mile post 2; view west.

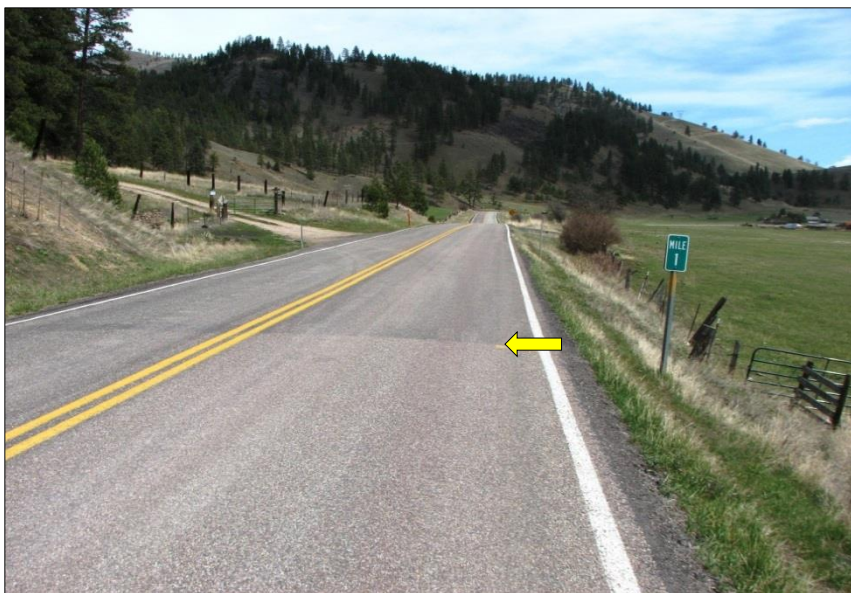
← Beginning of TS1 at mile post 1; view east.

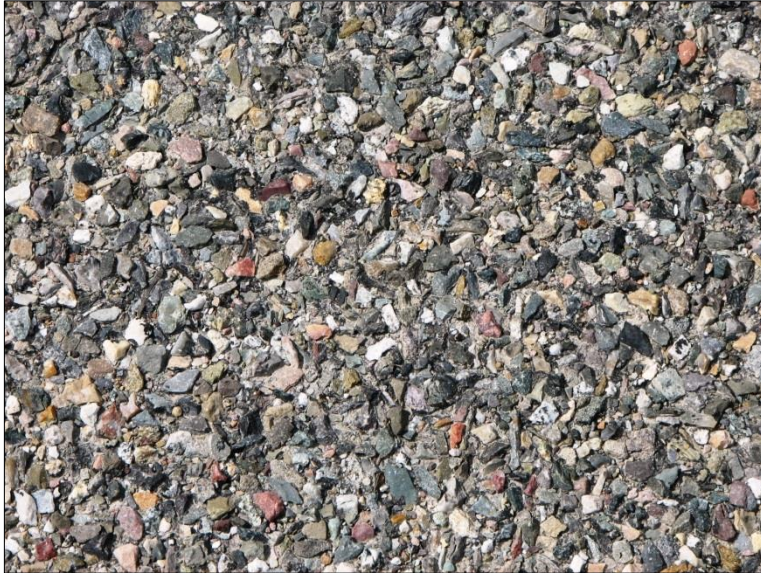
← Control section close-up of surface aggregate.

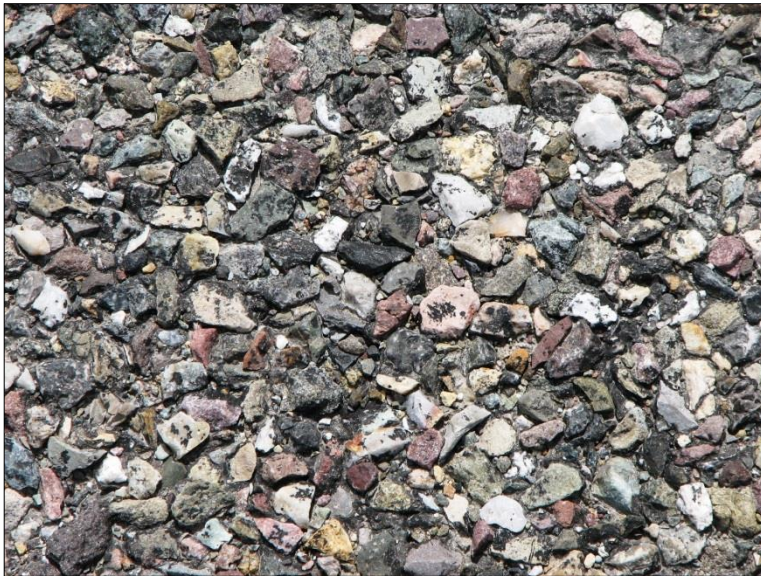
← Test section 2 (.05 gallon per sq. yd.), close-up of surface aggregate.

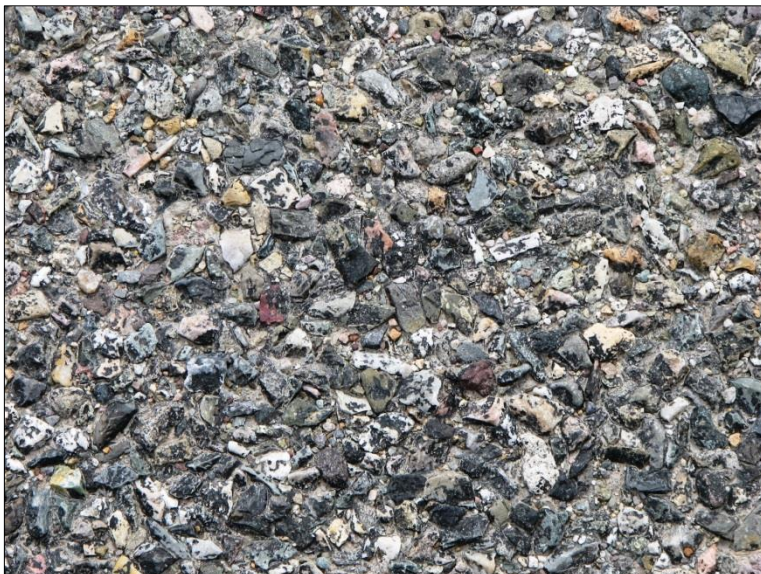
← Test section 1 (.1 gallon per sq. yd.), close-up of surface aggregate.

In comparing all three treatments, TS1 appears to have a tighter mat, rock embedment is firm and the SS1 application is evident.

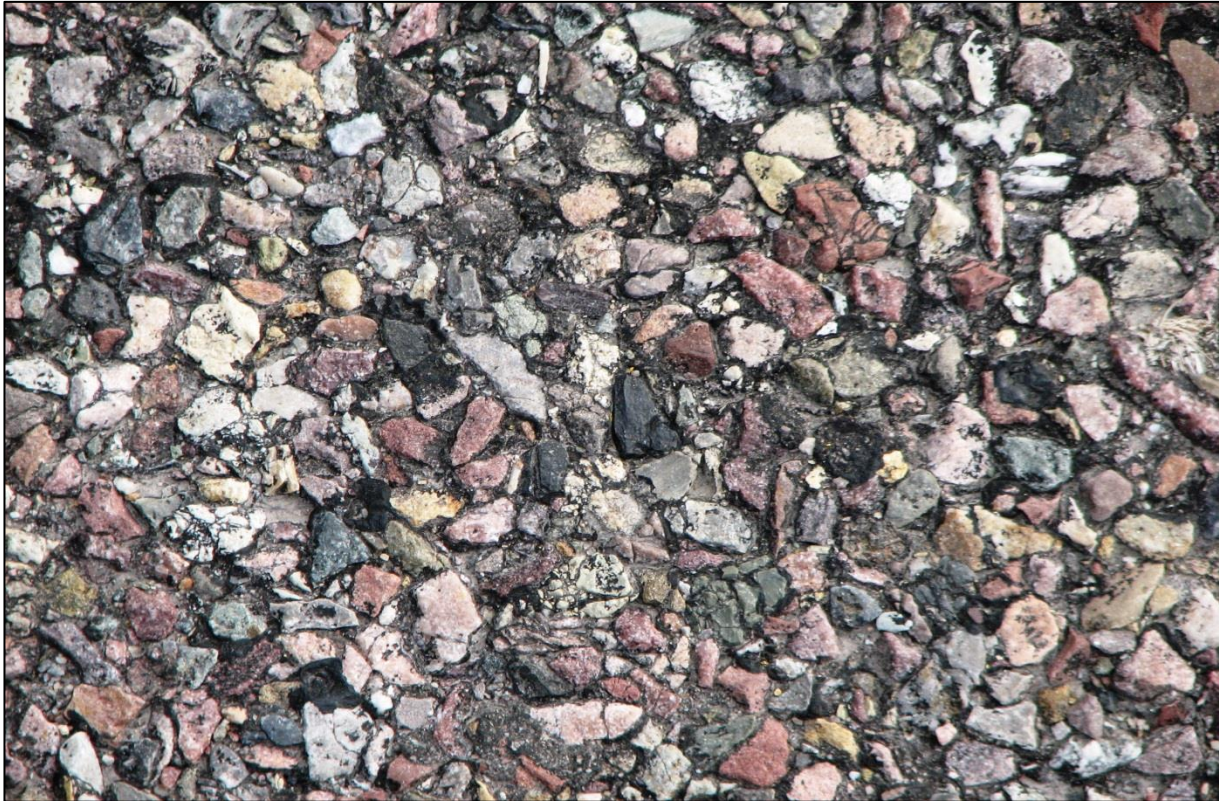
The images on page twenty-two (22) of the report attempts to show the average texture of embedded chip within the residual bitumen binder (RBB) on each of the test sections and control. The level of objective relief (the visual appearance of the ratio of binder to the exposed vertical area of the aggregate - example a seen in diagram below) is lesser in TS1, more apparent in TS2; and greater relief in the control. Basically stating (per visual observation); TS1 may have a tighter bond with the RBB.

↑ Section TS1 (.1 gallon per sq. yd.) close-up of surface aggregate.

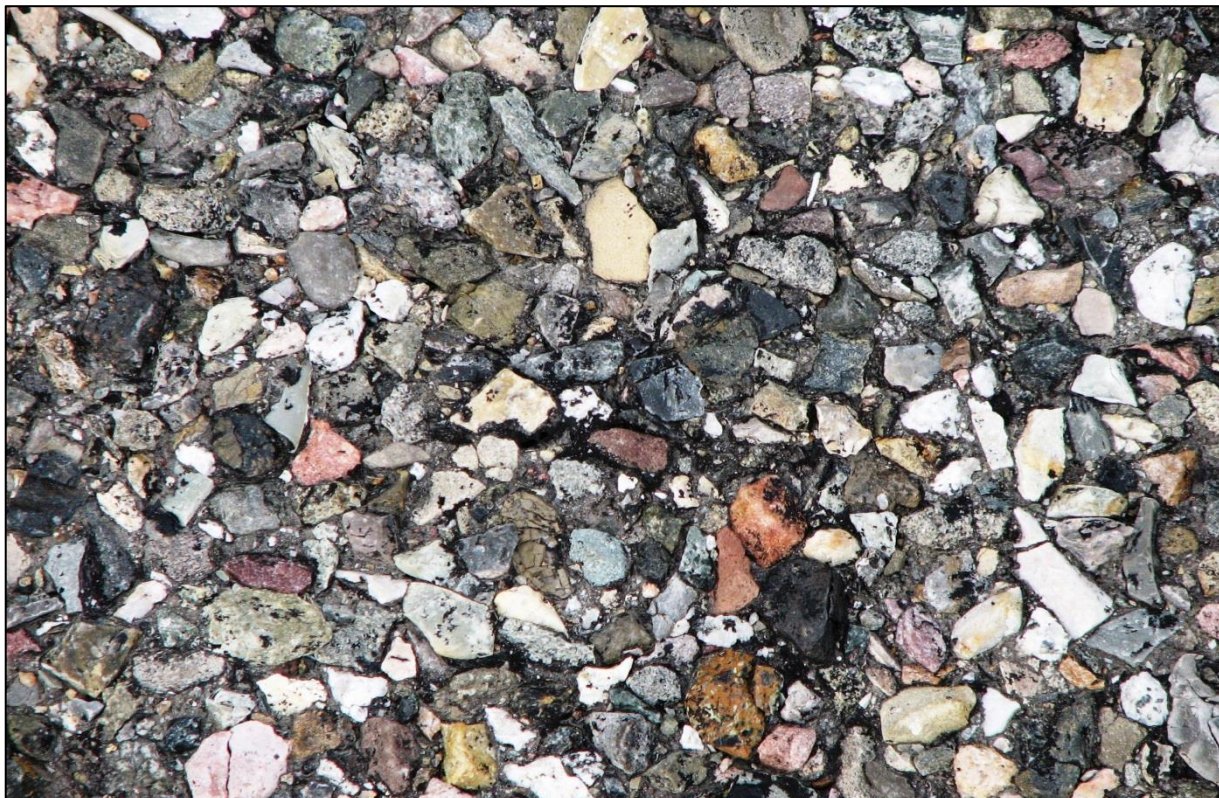
↓ Section TS2 (.05 gallon per sq. yd.) close-up of surface aggregate.

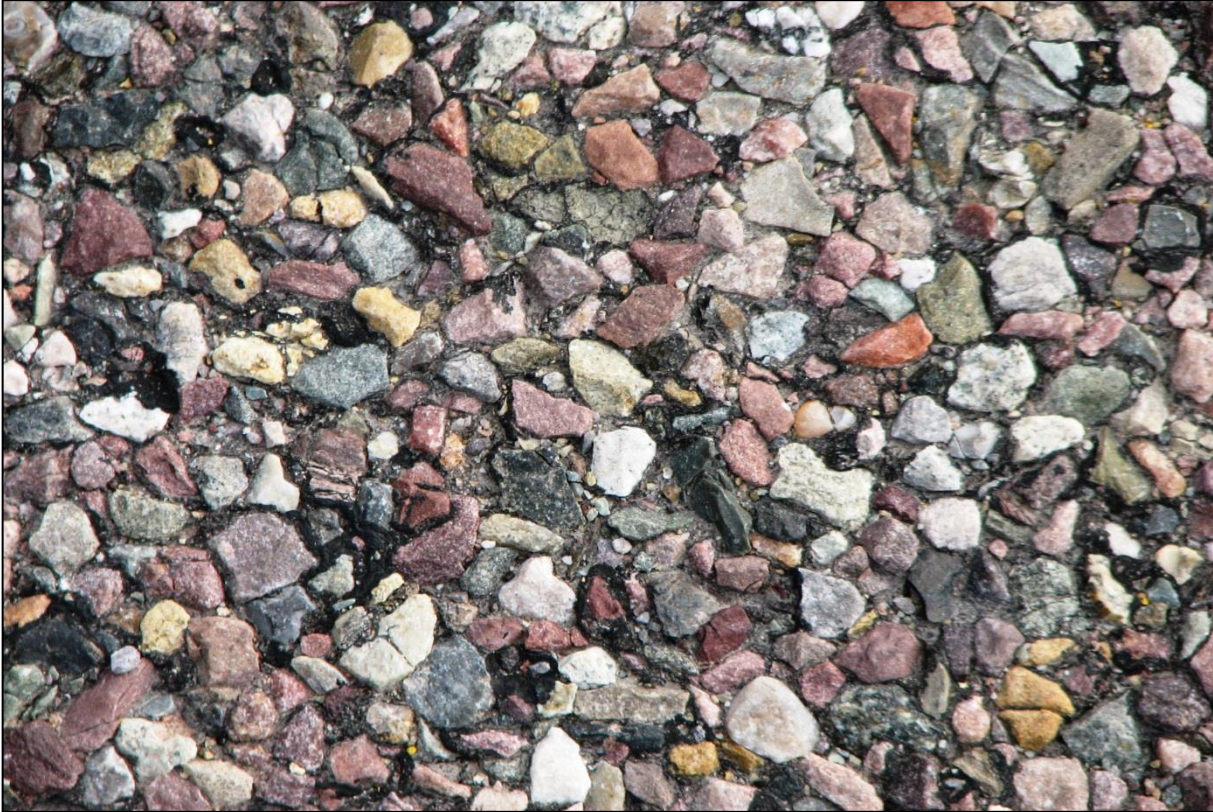
↑ Control Section: close-up of surface aggregate.

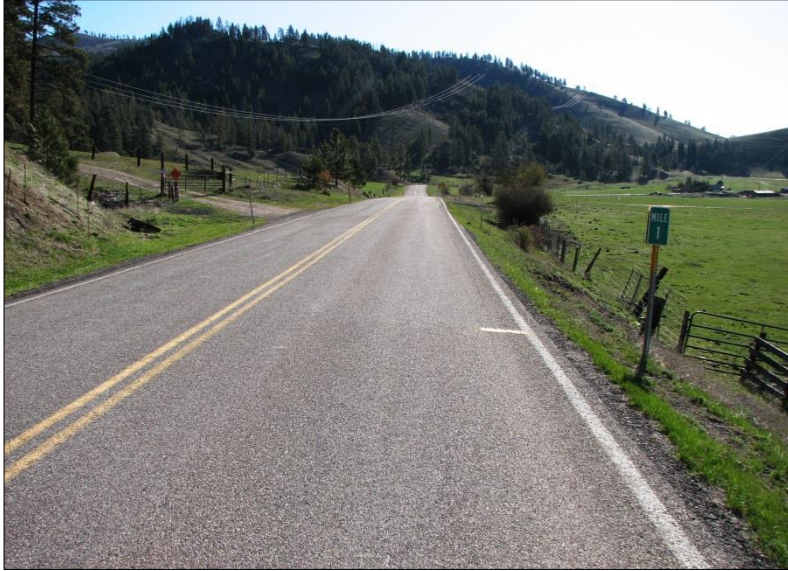
-Milepost 1: Beginning of TS1, view east.

At this date all sections have uniform appearance in visual consistency.

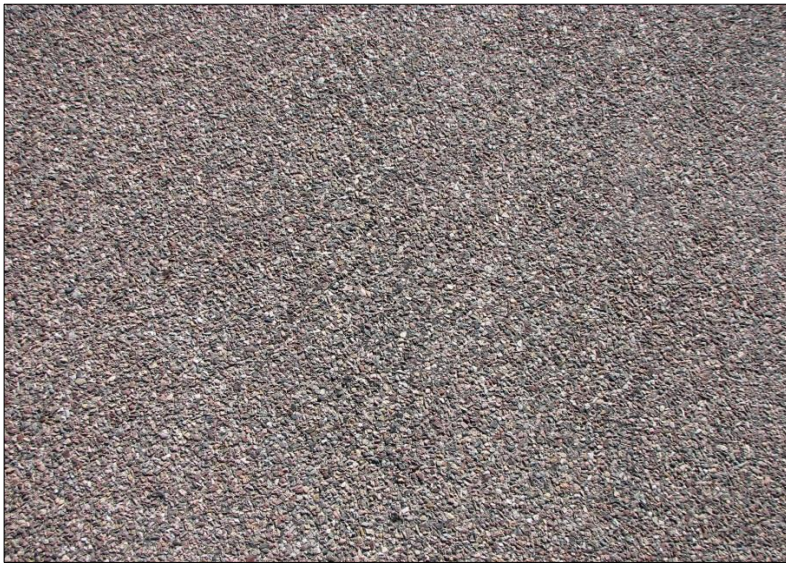
← Test section 1 (.1 gallon per sq. yd.), general appearance.

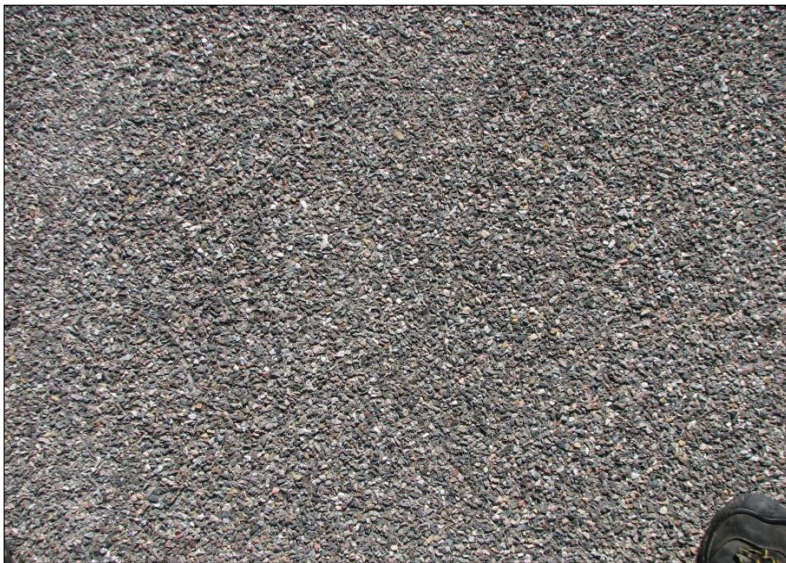
← Test section 2 (.05 gallon per sq. yd.), general appearance.

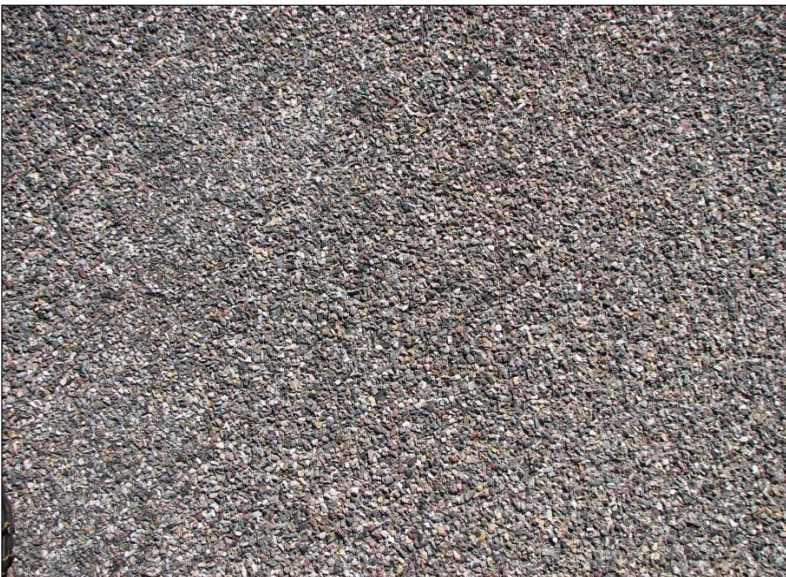
← Control section, general appearance

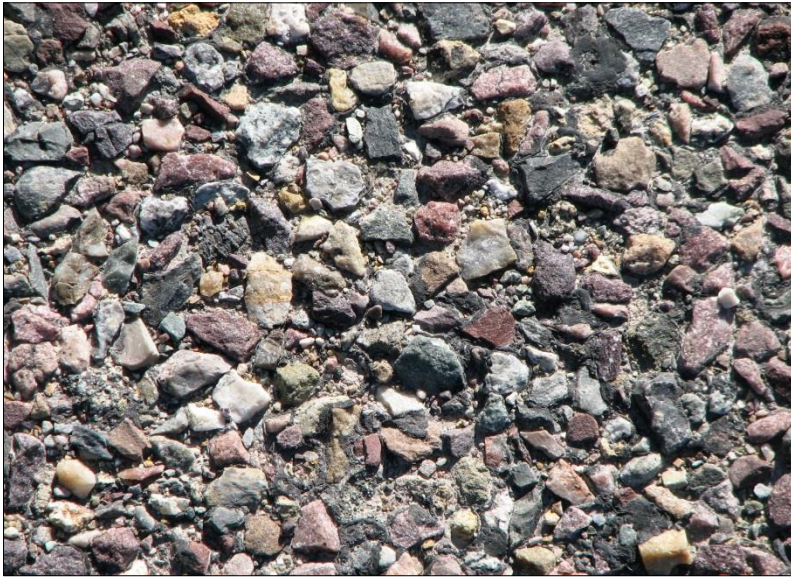
← Test section 1 (.1 gallon per sq. yd.), close-up of surface aggregate.

In comparing all three treatments, although subjective; **TS1** appears to have a tighter texture, rock embedment is firm. **TS2** also exhibits a tight mat however displays a slightly higher relief of exposed aggregate to binder as does the control.

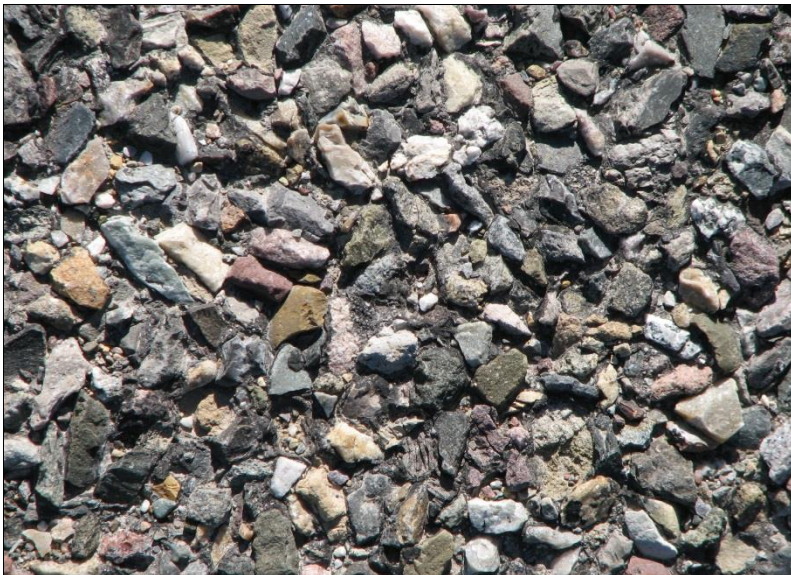
← Test section 2 (.05 gallon per sq. yd.), close-up of surface aggregate.

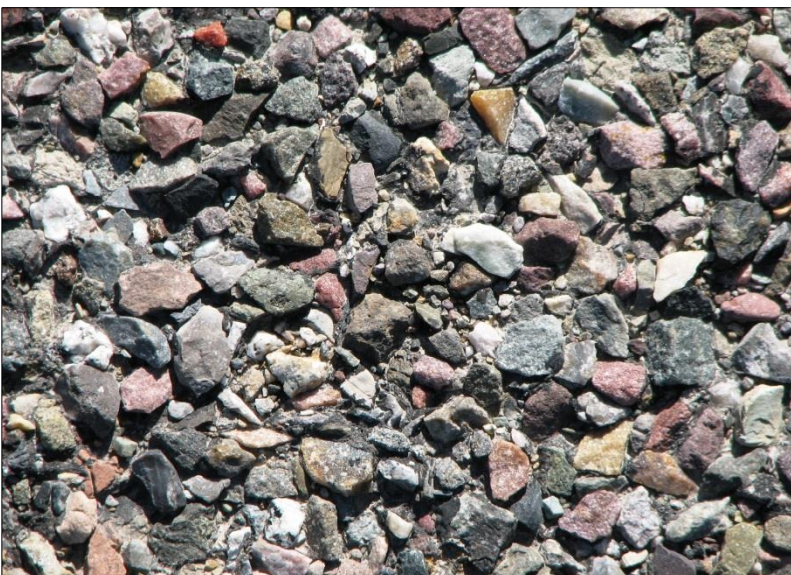
← Control section close-up of surface aggregate.

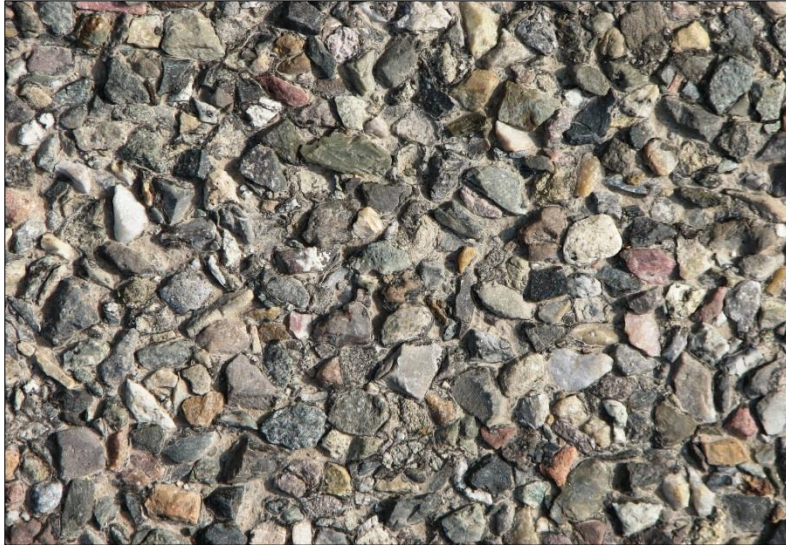
← Test section 1 (.1 gallon per sq. yd.), close-up of surface aggregate.

In comparing all three treatments, although subjective; all treatments are in good visual shape with minimum aggregate loss to report to date.

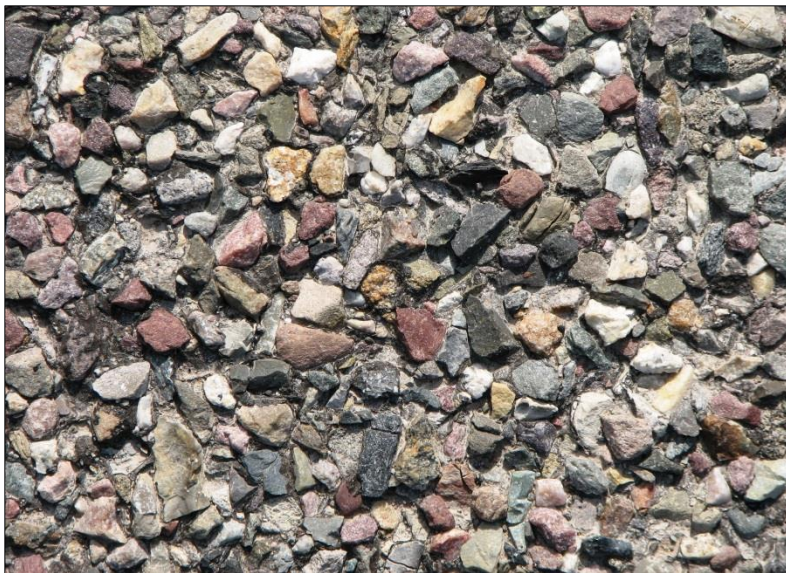
← Test section 2 (.05 gallon per sq. yd.), close-up of surface aggregate.

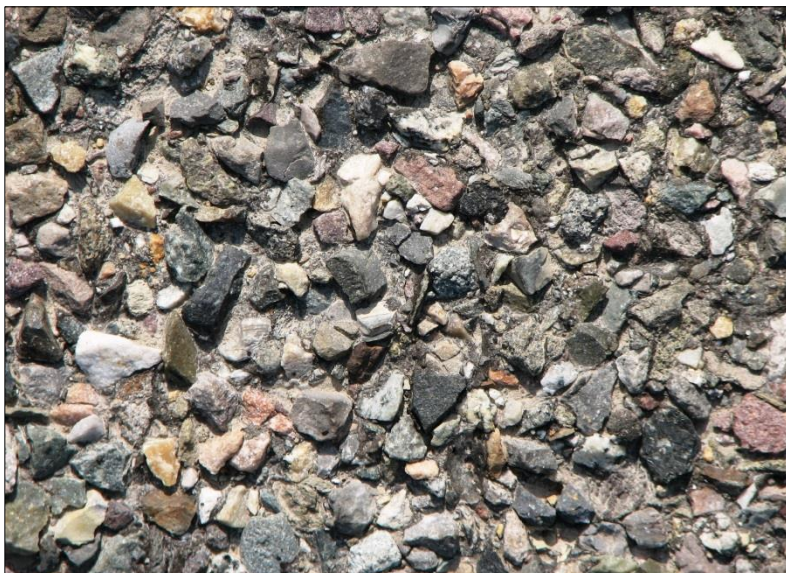
← Control section close-up of surface aggregate.
