FINAL EVALUATION REPORT

FIBER-REINFORCED POLYMER (FRP) PULTRUDED DECKING MATERIAL AND HELICAL ANCHORING SYSTEM FOR USE IN SNOW FENCE APPLICATIONS

Project No.: IM90-7(63)33, Interstate 90, MP-332

FHWA No.: MT 00-01

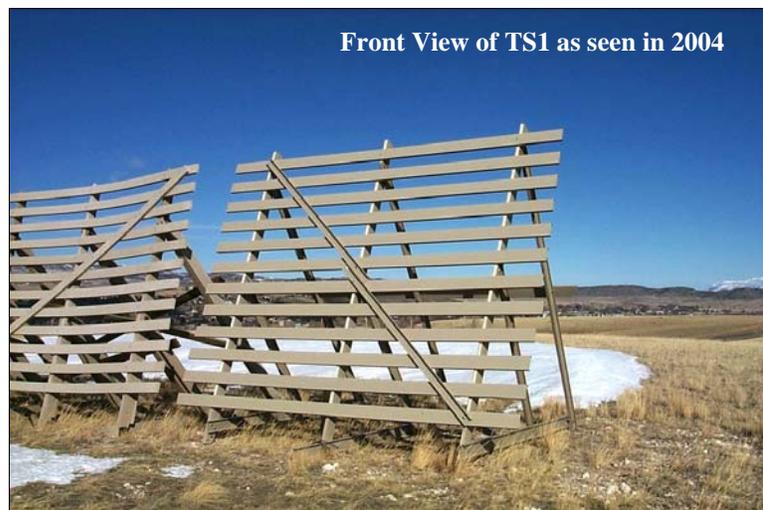
state of Montana. In addition, this experiment was to compare a new design as submitted by the contractor. The modified design deleted the interior rear supports (Test Section 1 [TS1] vs. Test Section 2 [TS2]), as explained in the November 1999 construction report (document address located at the end of this report). As noted in the May 2001 report, TS2 was found collapsed, which was assumed a structural-related failure due to the three rear (sole) supports buckling or snapping in high winds.

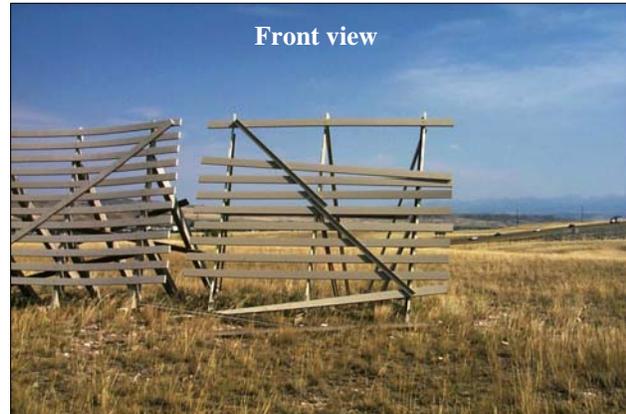
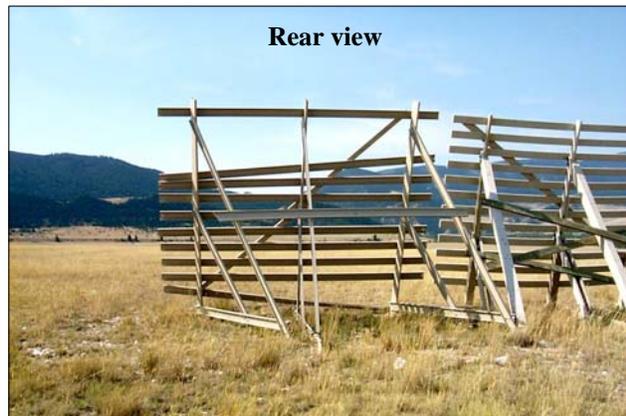
This inspection found TS1 partially collapsed. The remaining rear helical anchor bolt had snapped allowing two of the three rear supports to bow away from the center. Several front planks had broken away from the bolted attachments and fallen to the ground. In a visit several weeks later, TS1 was totally collapsed. The FRP planking material itself remained unaffected from the failure, it seemed to be the attachment hardware and bracketing that succumbed to the harmonics and force of the wind. The helical anchors have remained intact during the entire 60-month experiment. The images on the right show the front and rear of the damaged section.

The main cause of failure seemed to be the way this section was constructed rather than the strength of the main FRP planking. The bolts, which held the bottom support to the helical anchors, had snapped. The bracket attachment that the planking was connected to, over time, visually showed accumulative wear and tear. The small screw which assisted in holding the plank to the bracket proved too weak. This material, when compared to conventional wood or plastic products have one-third the weight, this may have also been a causal factor in this premature failure as well.

Due to the possibility of high winds blowing the loose material towards the interstate, the Department has removed TS1.
