EXPERIMENTAL PROJECTS CONSTRUCTION REPORT AND ANNUAL EVALUATION

Sprayroq-SprayWall Polyurethane Applied Lining for Culvert Rehabilitation

Location:	Mineral County-Missoula District: Interstate 90, Reference Point (RP) 59; Nemote Creek Crossing
Project Name:	I-90 Nemote Creek Culvert
Project Number:	IM 90-1(205)59 – Work Type 312: Structure Safety
Experimental Project:	MT-13-14
Type of Project:	Culvert Rehabilitation
Principal Investigator:	Craig Abernathy: Experimental Project Manager (ExPM)
Date of Installation:	January-February 2017
Site Inspection:	April 2017/2018, January 2019, March 2020

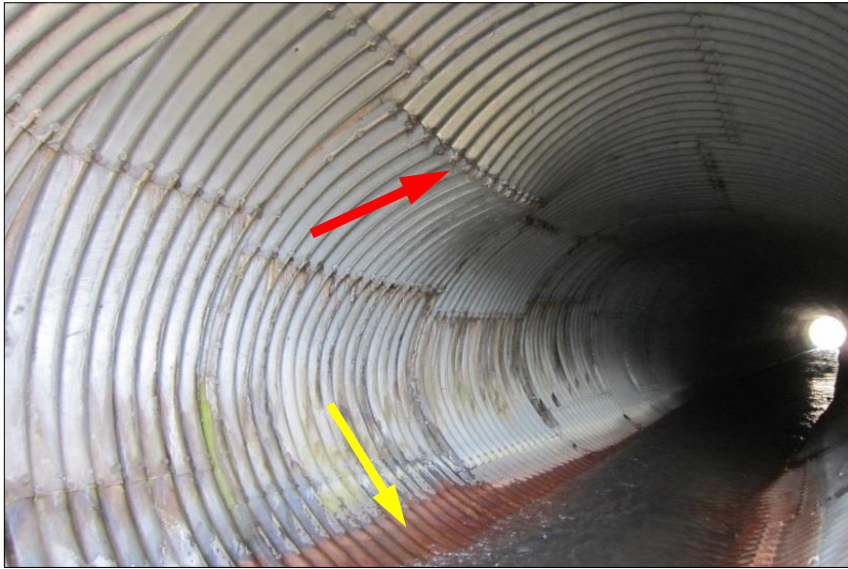
Bulging and sagging of the steel plated panels located near the east end of the culvert were noted in 2006, and recommended for remedial action in May 2013. Maximum deflection within areas of deformation was roughly estimated to be six inches located in the upper plates of the pipe (refer to page 4). The purpose of the rehabilitation effort is to improve the structural capacity of the pipe to reduce the chance of a culvert failure that would impact the I-90 roadway.

← Representative image of the observed sagging in the top panels of the steel plate arch culvert. Deflection estimated at six (6) inches as inspected in 2014 (red arrow).

Corrosion also apparent at the base of the culvert (yellow arrow).

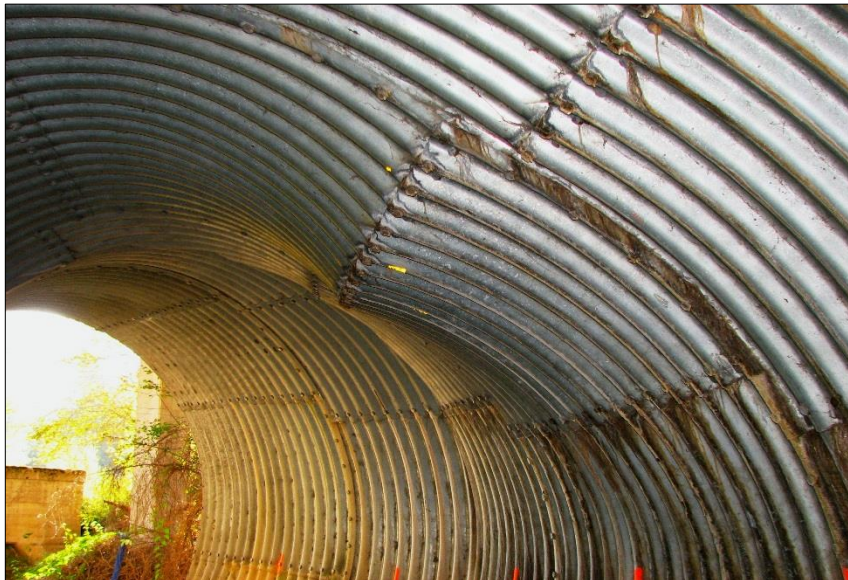
← Interior view of extent of steel plate deflection.

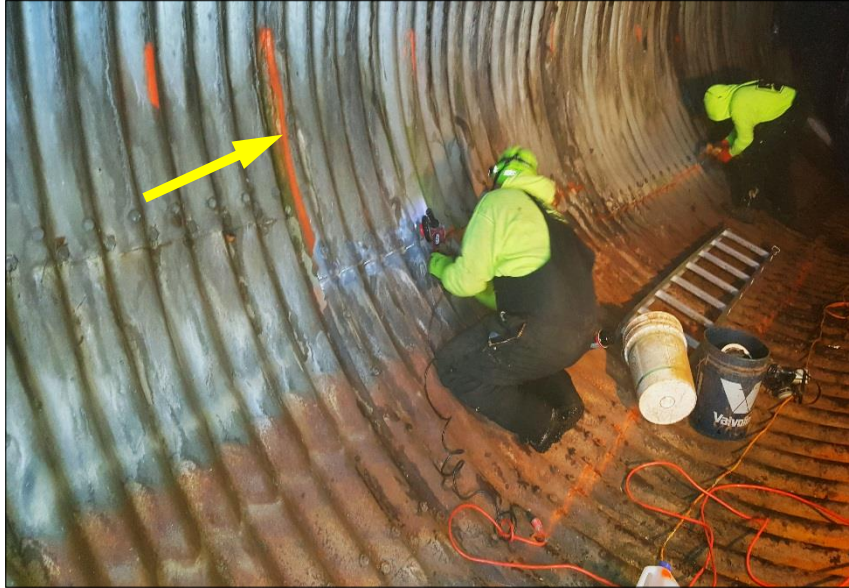
As seen here areas of the pipe (mostly at seam connections), that needed grinding to remove deleterious material were spray painted orange (yellow arrow).

← Surface prep is the key to any successful polymer application. For maximum adhesion of the SprayWall liner, the interior surface of the culvert needs to be (as possible,) free of debris, rust, scale, moisture, etc.

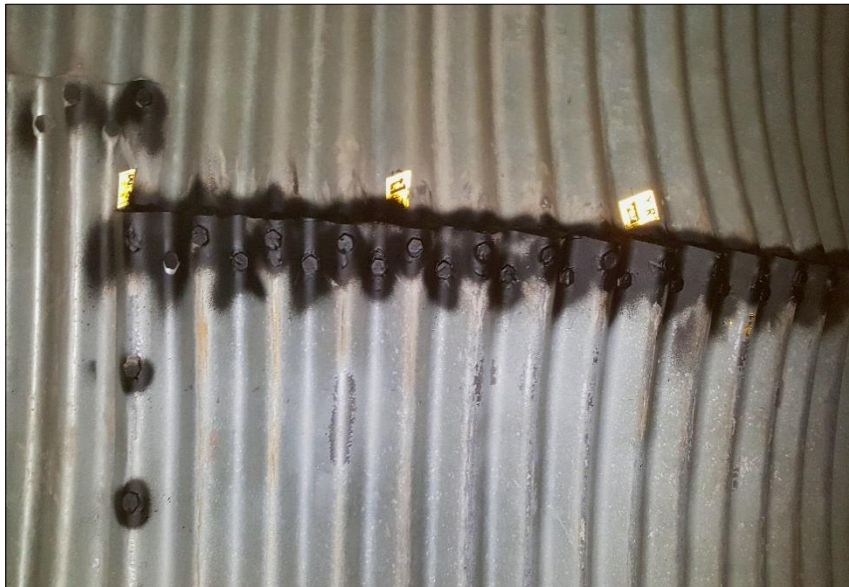
← ↓ To prevent oxidation and/or moisture seepage, Flex Seal aerosol (liquid rubber sealant), is applied to all plate seams and bolts.

In areas where moisture still permeated the sealant, a product called Speed Dry was also used to minimize moisture infiltration.

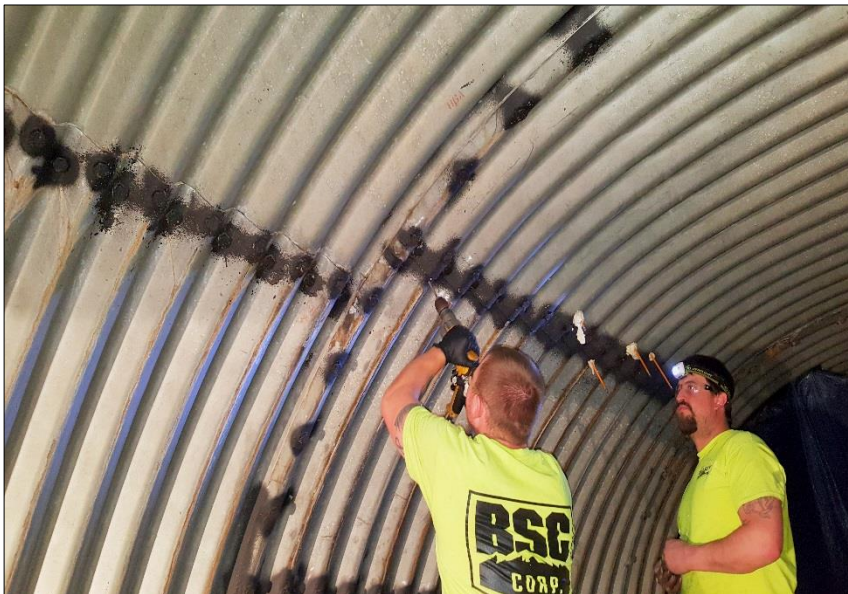
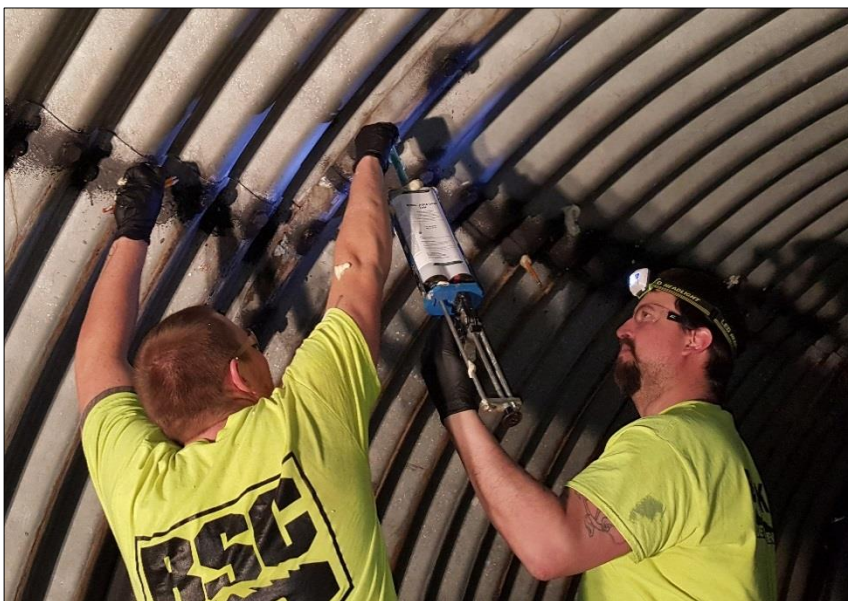
← ↓ Although the application of the rubber sealant did mitigate moisture intrusion, due to the internal heating of the culvert moisture that was inherently frozen around the pipe, began to melt and seep through at various plate joint connections.

MDT inspectors stated the applied sealants was not 100% effective in mitigating the moisture intrusion.

In an effort to mitigate the water seepage the contractor would drill near the seam and inject a two-part hydroscopic polyurethane, (Dural Aqua-Dam 200F) which expands to create a waterproof seal.

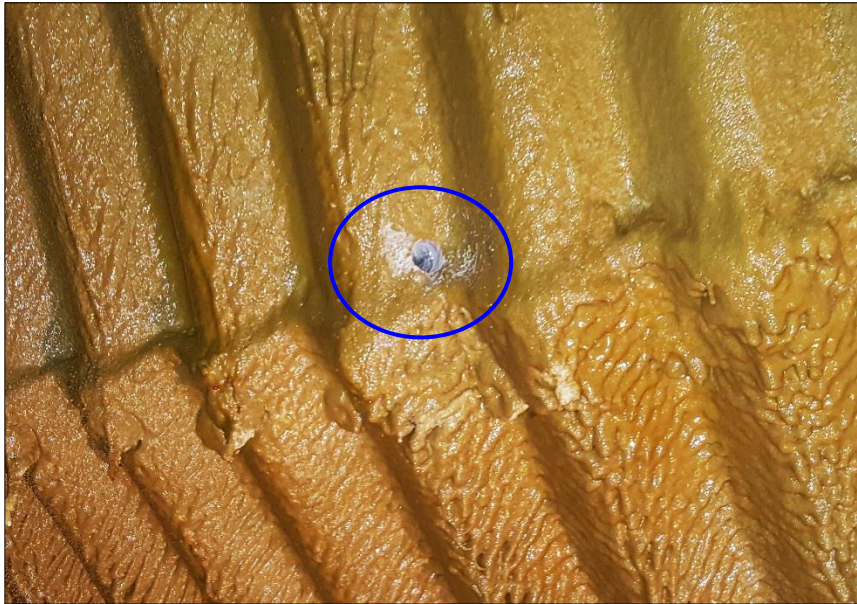
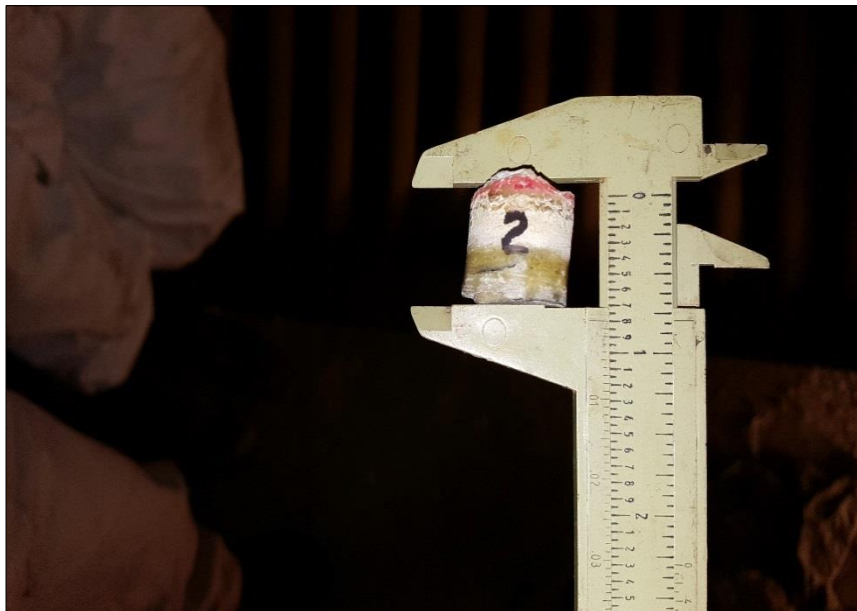
← Several quality controls tests were performed; as seen here, a coring was performed to measure product thickness.

The image below shows a core sample taken near the pipe deflection seam at approximately 7/10th or 3/4".

Other inspections such as pull testing and spark testing were performed with satisfactory results.

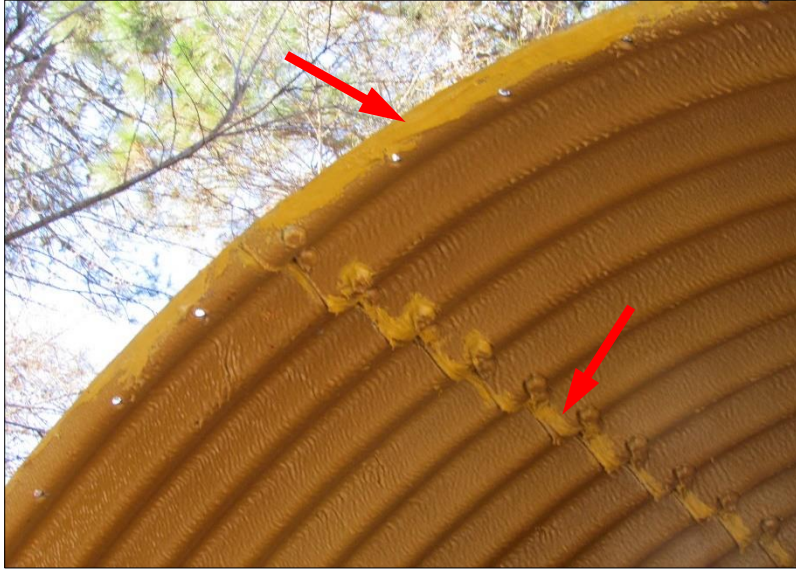
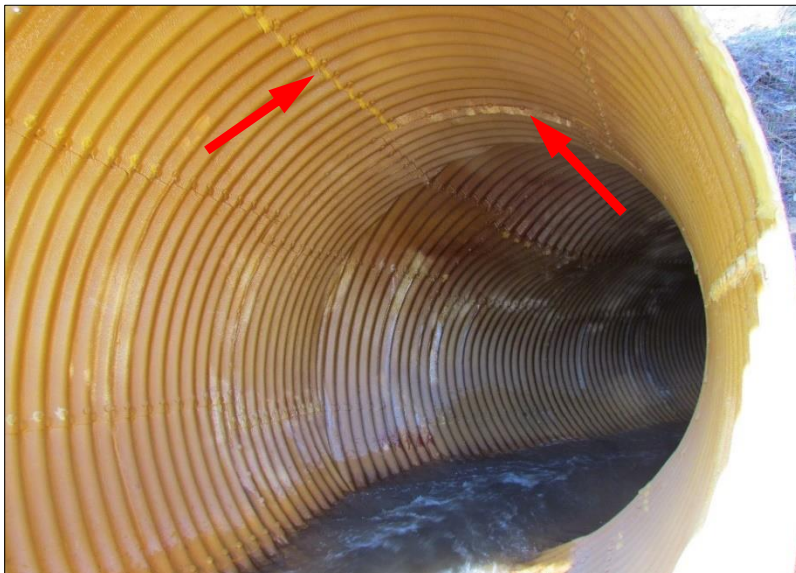
During this inspection it was noted that areas of the steel plate seams and bolt connections received an additional (apparently hand-applied) application of SprayWall.

Information from District staff states the issue of moisture seepage (a condition evident in the culvert preparation phase; page 9), was observed after the initial SprayWall application was completed and required spot patching to eliminate the migration of moisture. Although the contractor attempted to check the leaks through the use of expanding sealants; 100% containment was not possible.

↙ During the spring inspection after the culvert lining completion; it was noted that areas of the steel plate seams and bolt connections received an additional (apparently hand-applied) application of SprayWall.

Information from District staff states a minor issue of moisture seepage was observed after the initial SprayWall application.

The red arrows point to some of the areas that received the post-patch.

A spot treatment was applied to those areas which visually showed potential seepage areas.

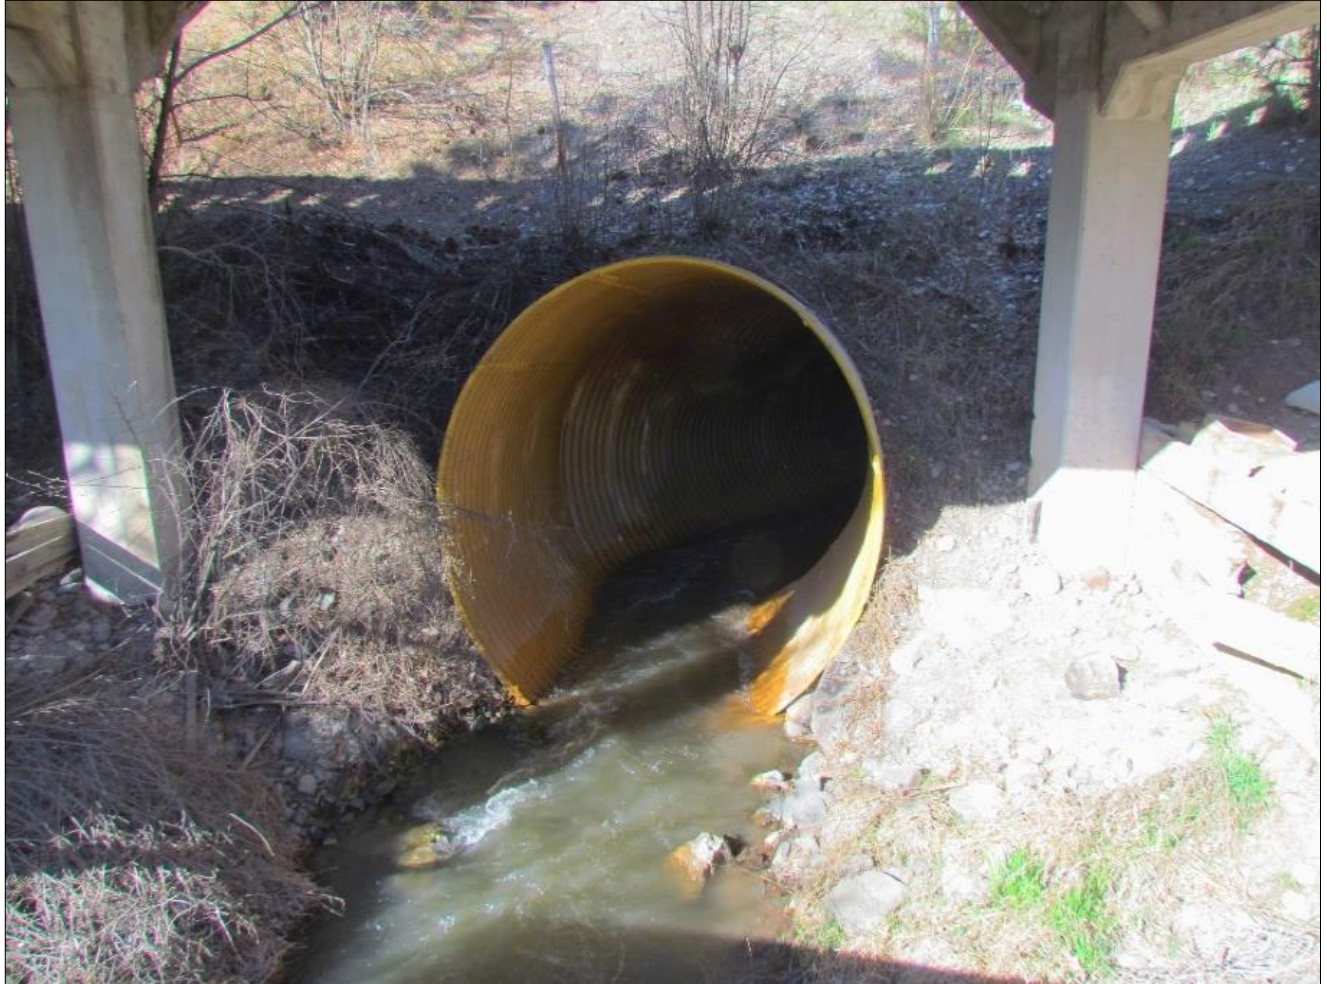
↑ Spring 2018: no visual issues were detected with the SprayWall culvert coating during this inspection.

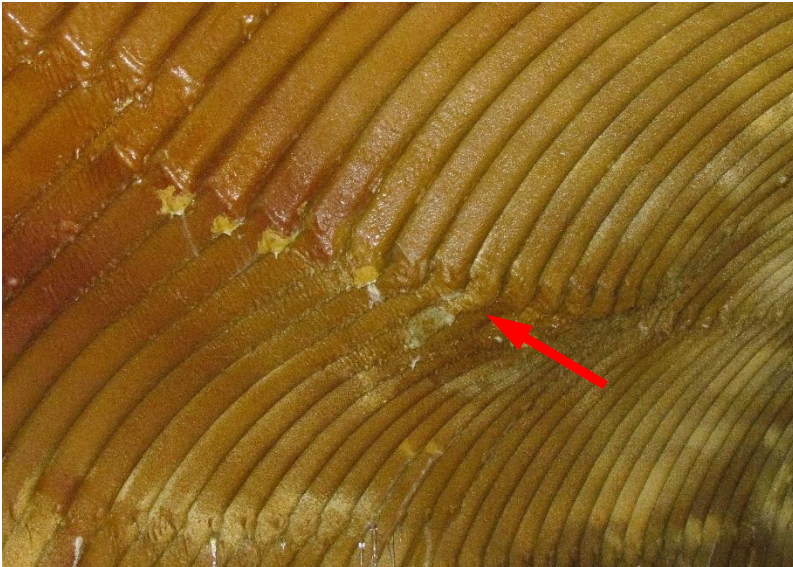
← Area of culvert deflection.

Although difficult to see in this image, there was some ice coating the culvert plate seams (red arrow).

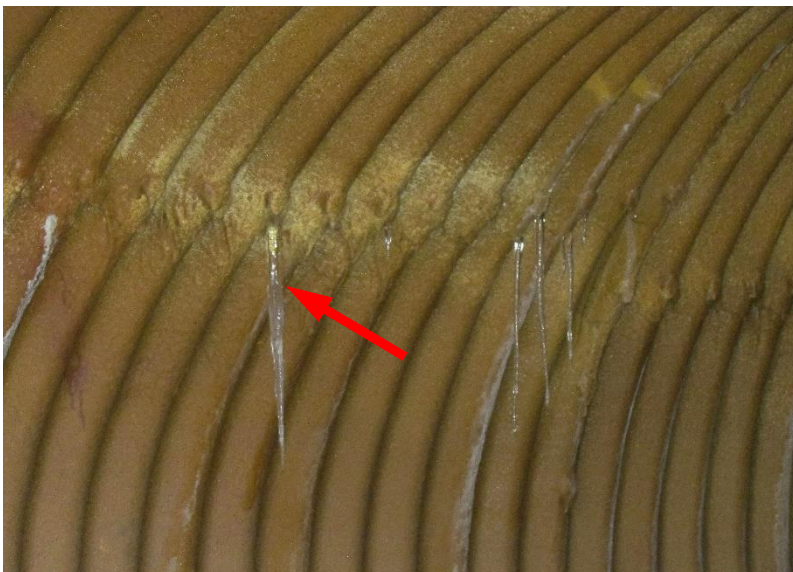
Visually the interior of the culvert has the same appearance as noted on the 2019 site evaluation. One noted event was active icicles forming at the bolt plate connections. The area of plate deflection did have some ice forming at the bolt connections as well. See page 17.

← This is the steel plate seam just below the area of plate deflection.

Noticeably there are icicles extruding from the plate bolt connections. (example-red arrow).

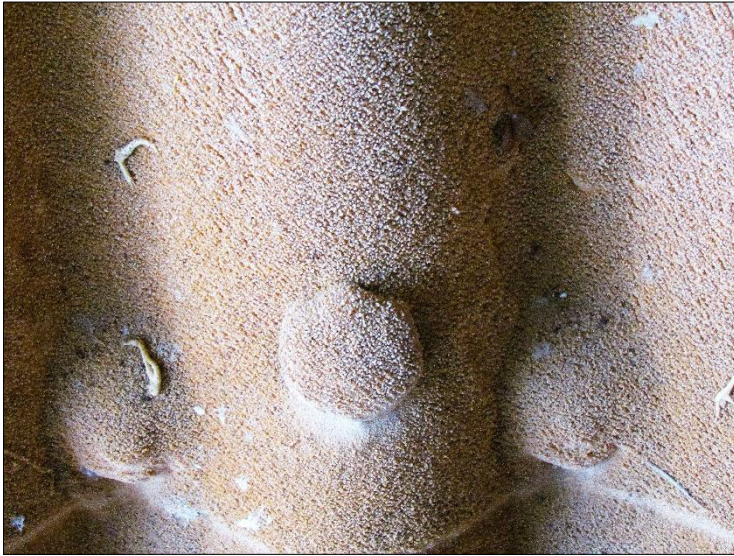
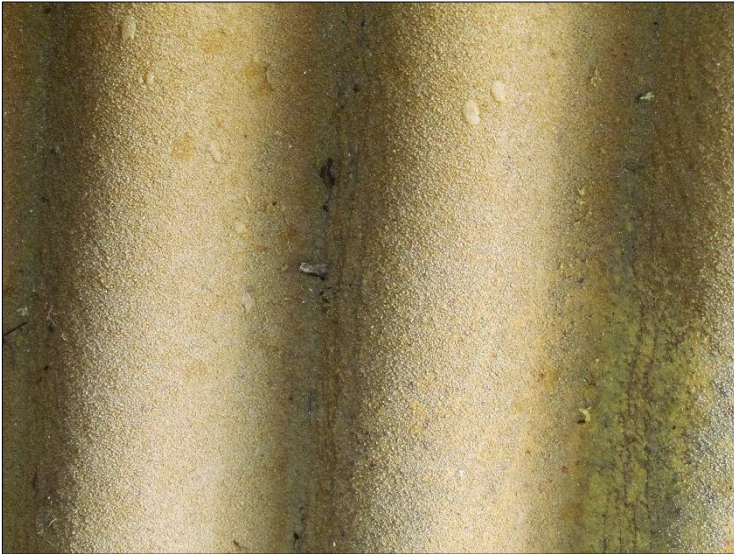
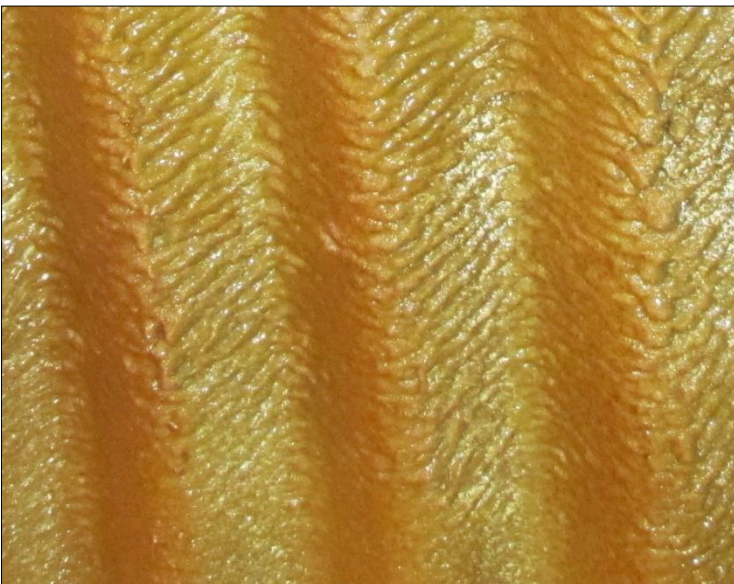
This inspection did reveal some irregular visual aspect of the lining such as the lower 1/4th of the culvert has developed a sandpaper texture and a small area of the liner has reflective cracking through the SprayWall. (see supplemental pages 16, & 19-21). Discoloration of the SprayWall is apparent.

↙ During the **January 2019** site inspection, it was noticed that (approximately) the lower 1/4th diameter section of the culvert had developed a grainy, sandpaper like texture (top and center image). In contrast as compared to the lower image which represents the texture further up the culvert lining.

Sprayroq representative states this may be an issue of overspray during initial application.

If able, Mr. Capehart will visit the site in the spring of 2019 to take core sample for further analysis.

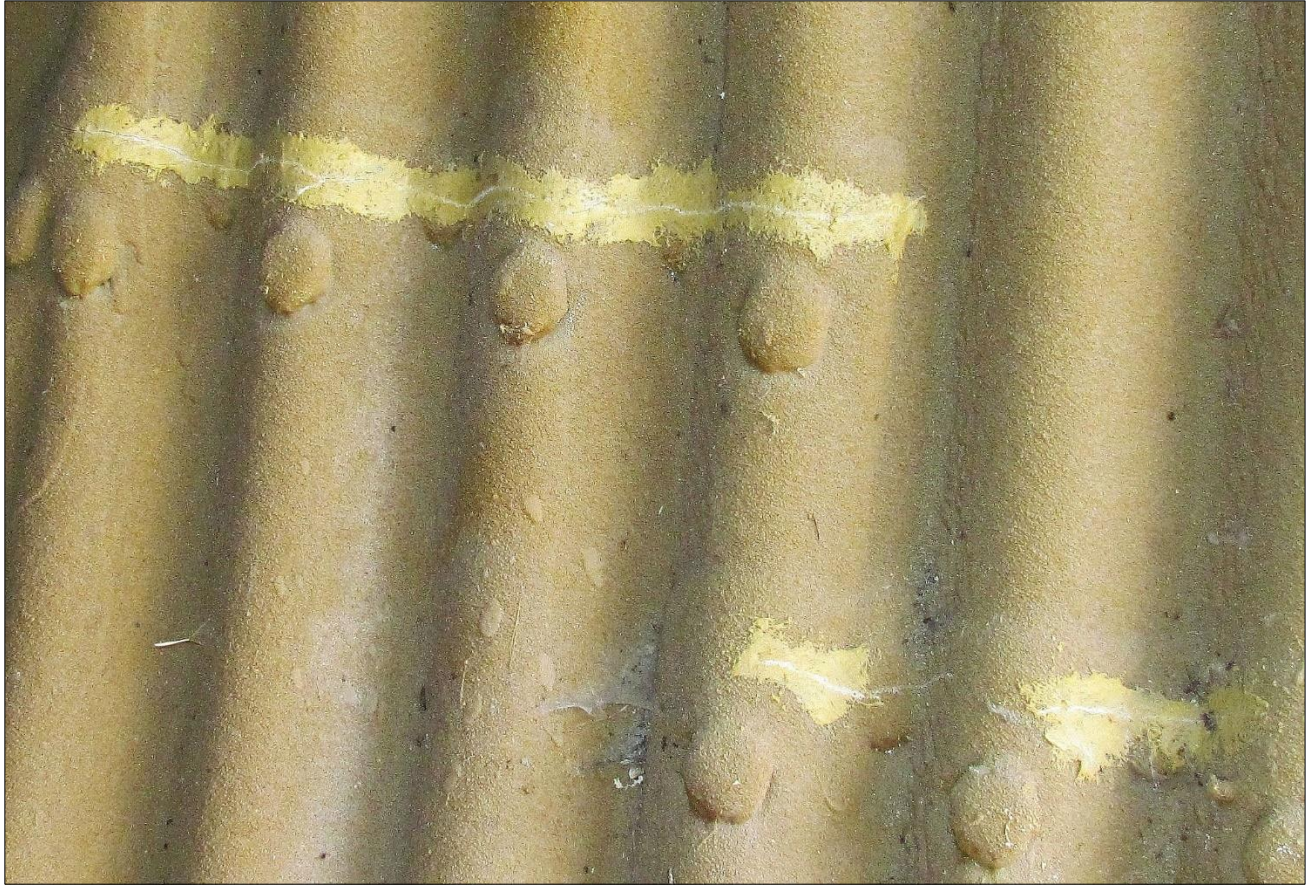
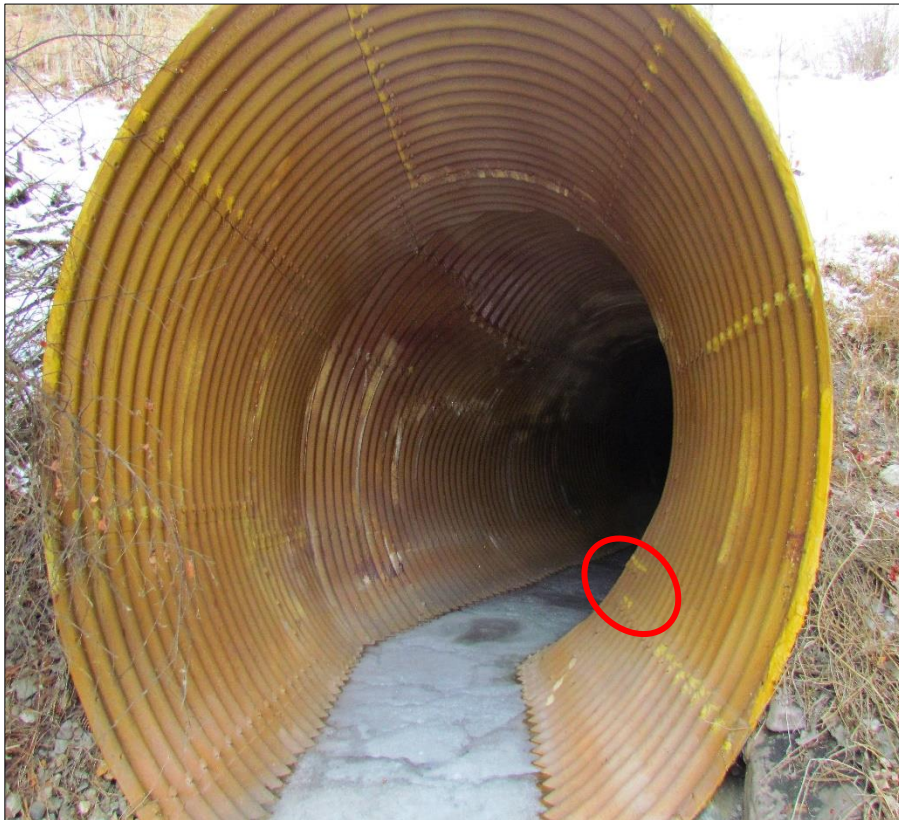
↑ Also seen in the January 2019 site inspection was a small section of previously patched liner with cracks reflecting through the SprayWall after patching.

← The red circle denotes the location of liner crack.

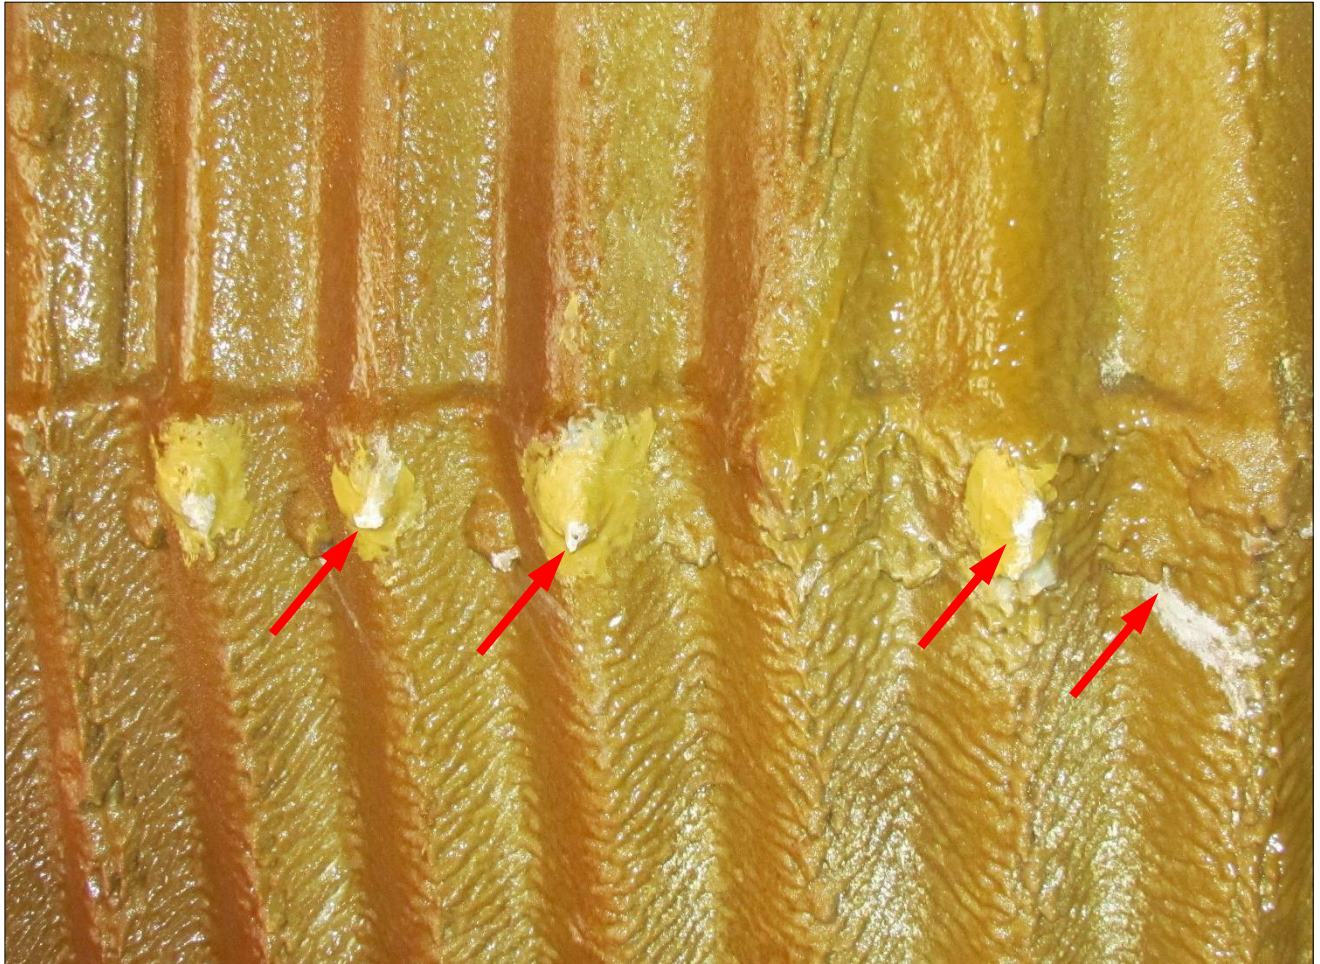
↑ The above image (as seen in 2019) is the apex of the deflected steel plate panel (refer to page 4). It appears that precipitates (apparently from mineralized water solutions) may be forming through small holes or cracks near the bolt plate connections; some that had been patched after the SprayWall application.

Update: During the 2020 site evaluation icicles had formed at bolt plate connections.
