**Experimental Feature Construction Report
 December 2022**

Experimental Feature:	TENAX LBO 220 Geogrid
Location:	Billings District, Big Horn County, MT Hwy 313, RP 1.3 – 7.8
MDT Project Name:	Hardin – South
MDT Project Number:	STPS 313-1(17)1[5793]
Experimental Project Number:	MT-21-03
Principle Investigator:	Chad DeAustin, Experimental Project Manager (ExPM)
Construction Date:	2021 & 2022

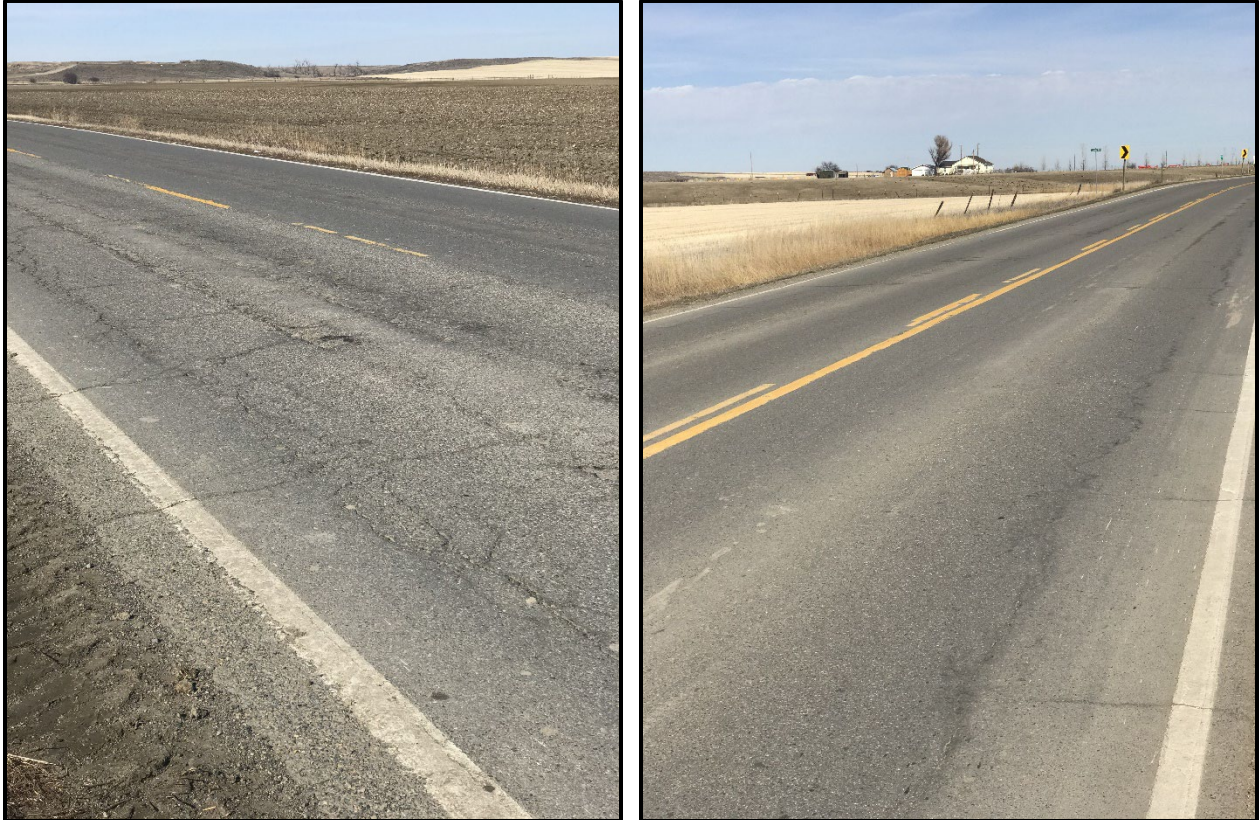
↑ Examples of preconstruction roadway conditions. Left photo is view south and right is view north. There is heavy rutting as well as longitudinal and transverse cracking. Per the project manager, the northbound lane experiences higher amounts heavy commercial truck traffic due to sugar beet operations in the area.

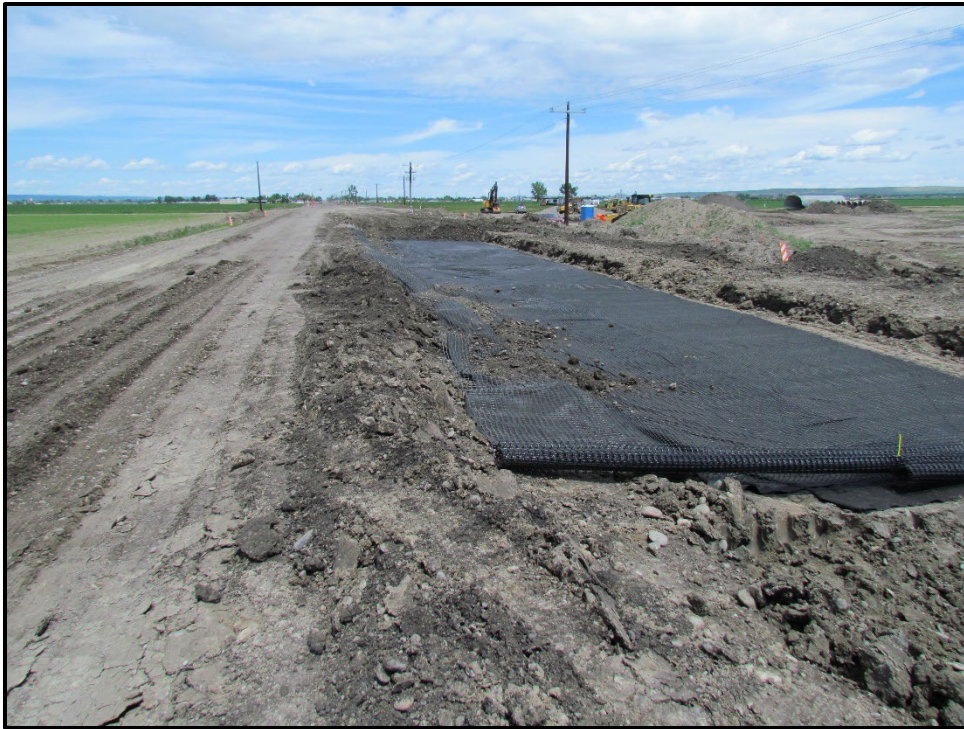
↑ During subgrade and pulverization work, some soft areas were addressed. The material was removed, fabric and geogrid were laid and then material was placed and compacted. This was a dig out near station 60+00.

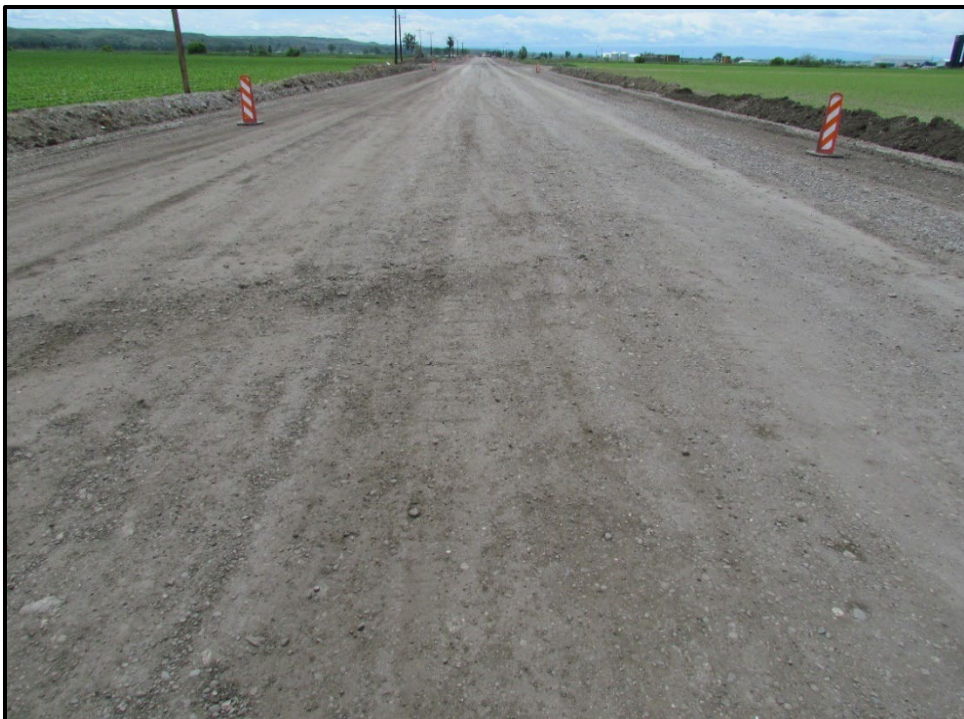
↑ Completed subgrade work near station 70+00.

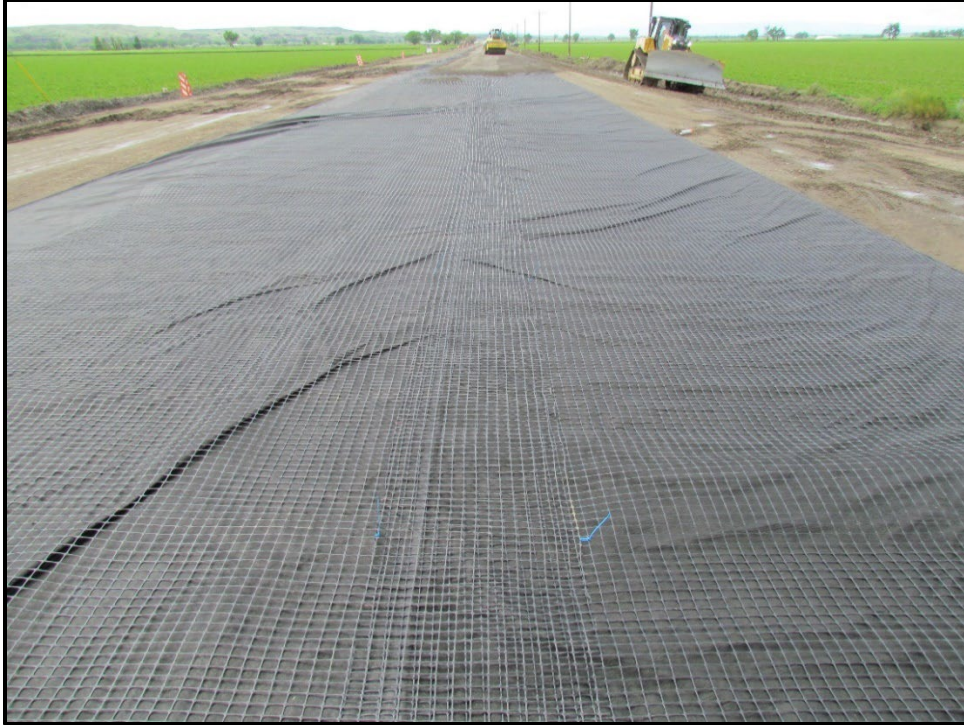
↑ View of the geogrid and fabric. Note that the grid was being tied together with zip ties and laid in accordance with the special provision. Every 10' on the longitudinal joint and 4' for transverse joints. Near station 82+00.

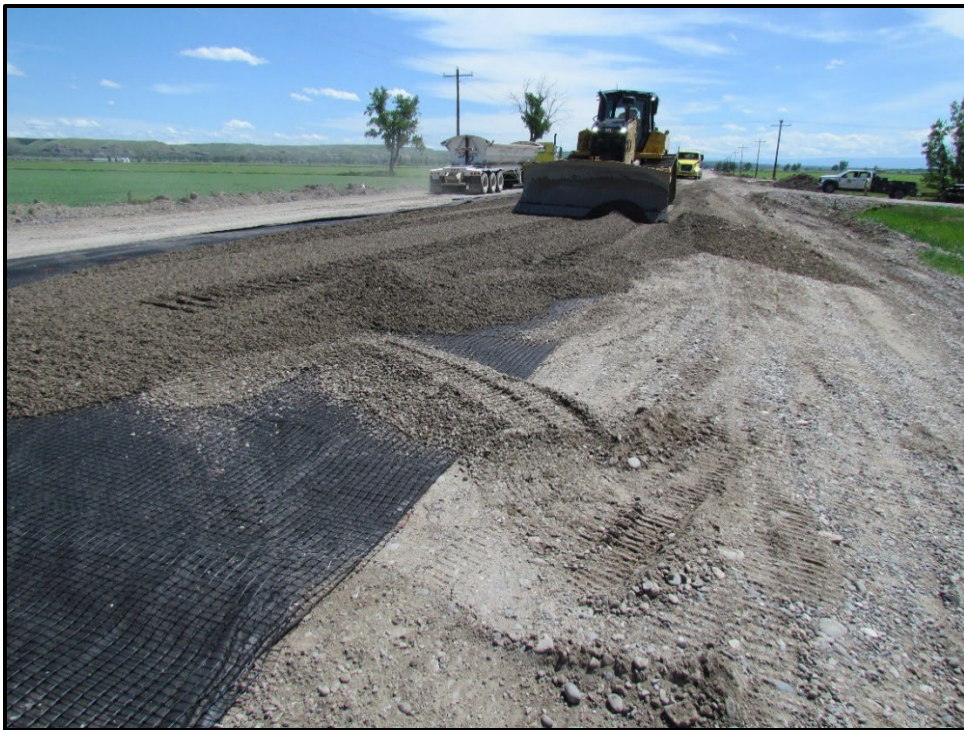
↑ The contractor opted to use a dozer for CAC placement rather than a grader to avoid causing damage due to excessive tire activity on the geogrid. Near station 78+00.

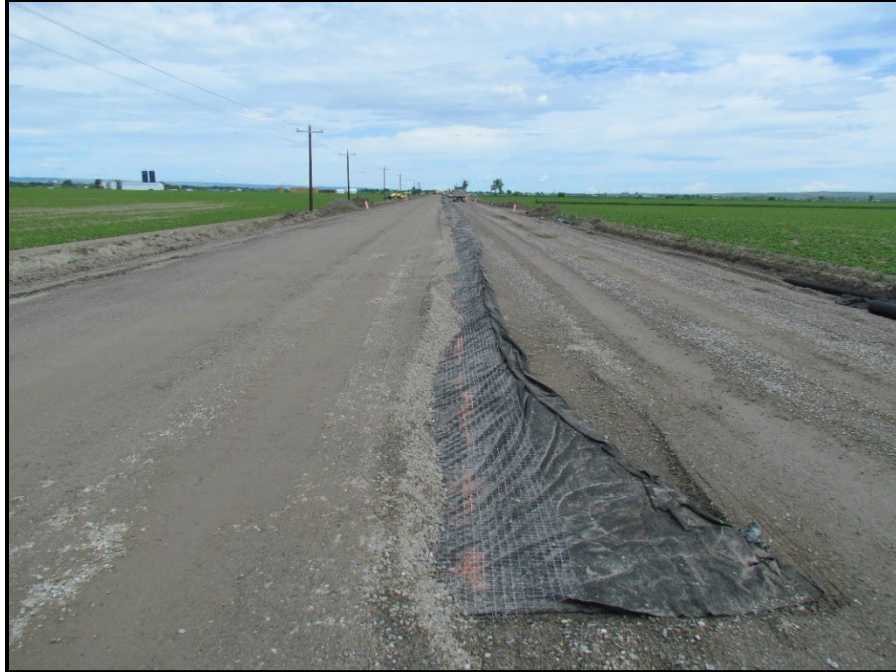
↑ Completed southbound lane of CAC surfacing after spreading and during compaction. Note that enough grid was exposed to meet the 24" overlap required in the special provisions. Near station 90+00, view north.

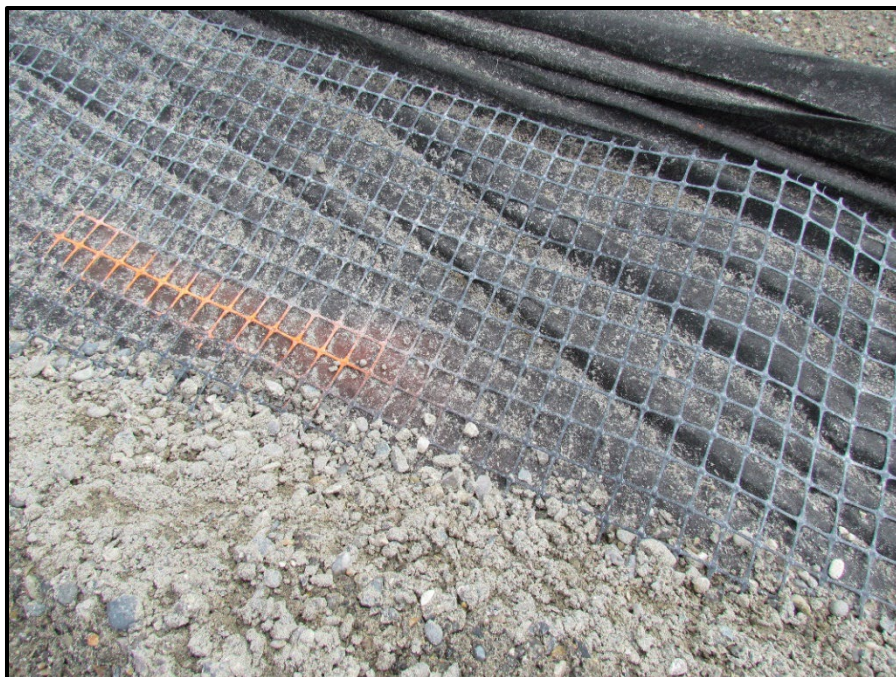
↑ Close up view of the grid. There was slight waviness in the product but was being mitigated as well as possible. MDT inspectors stated it might have helped to require anchors for the grid but upon reviewing the product information from the supplier, when using anchors, the waviness issues were harder to eliminate.

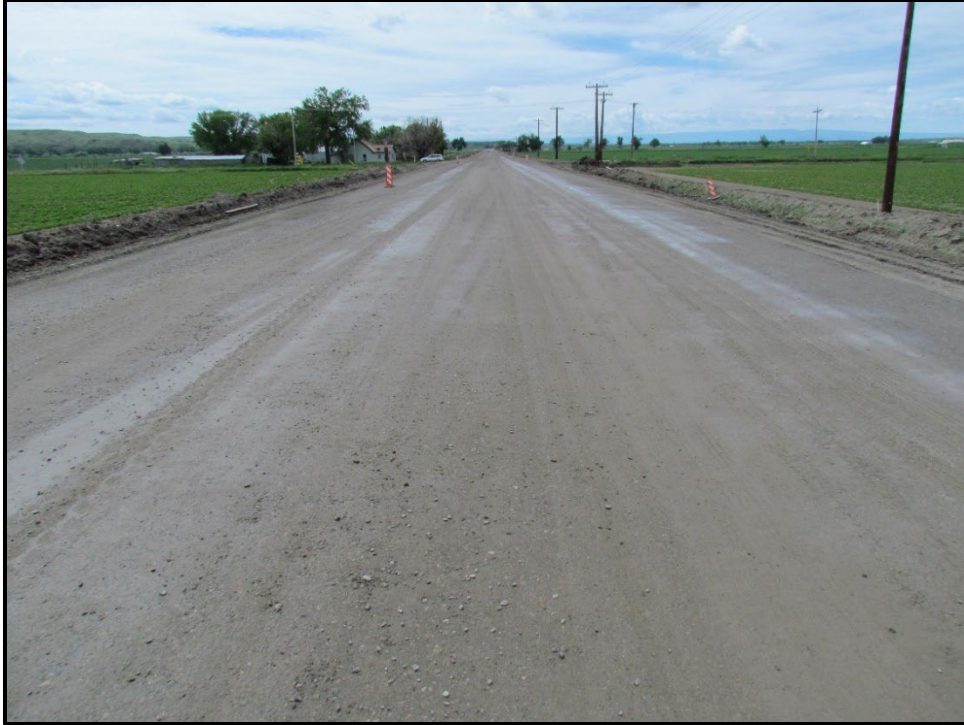
↑ Completed CAC surfacing after compaction. Approximately station 92+00, view south.

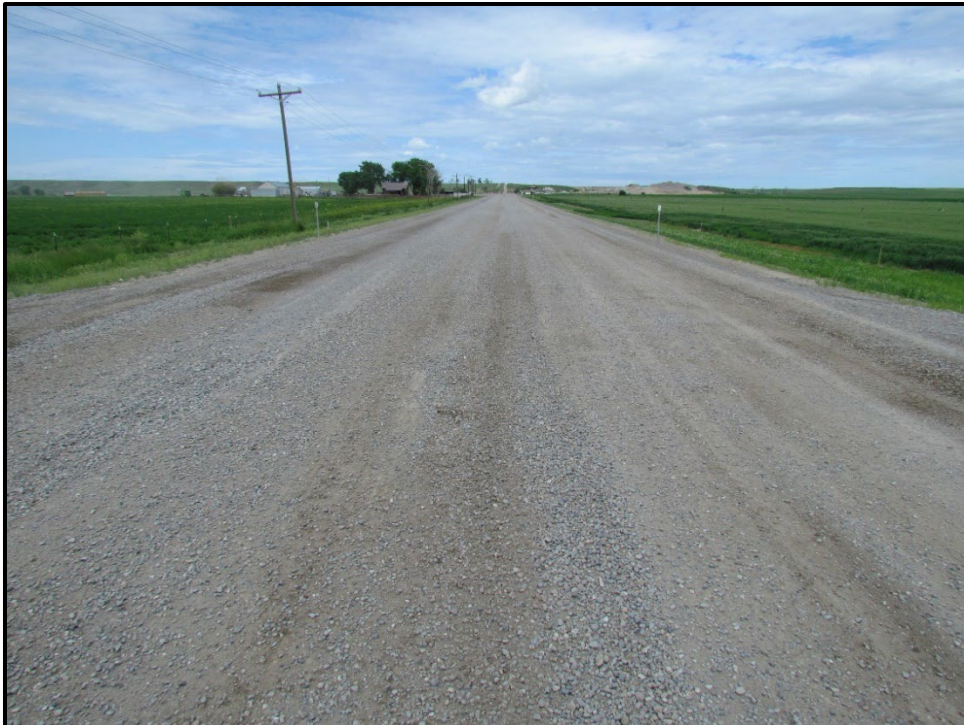
↑ Between stations 343+17 (south end of project) to 196+23, geogrid, fabric and CAC work was completed in the late summer and fall of 2021. This is an example of that section near station 275+00, view south. Per the MDT inspection crew, the material held up well through the winter and snowplow activities.

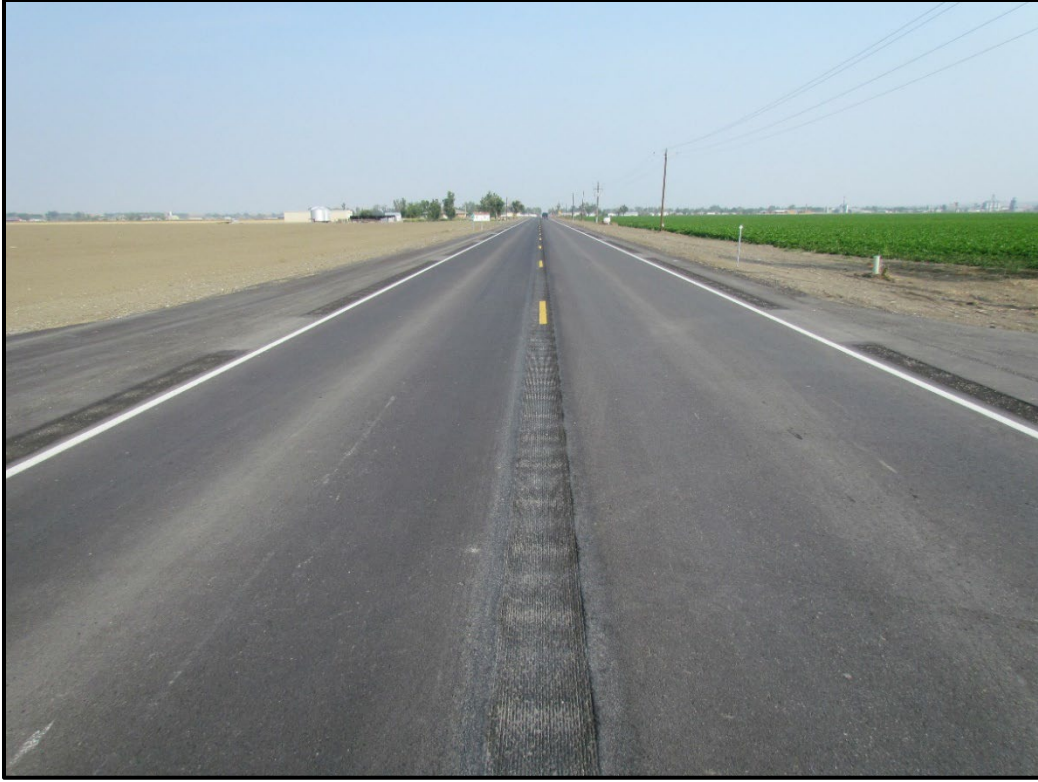
↑ RP 2.0, Sta 44+17, view north. Completed plant mix surfacing.

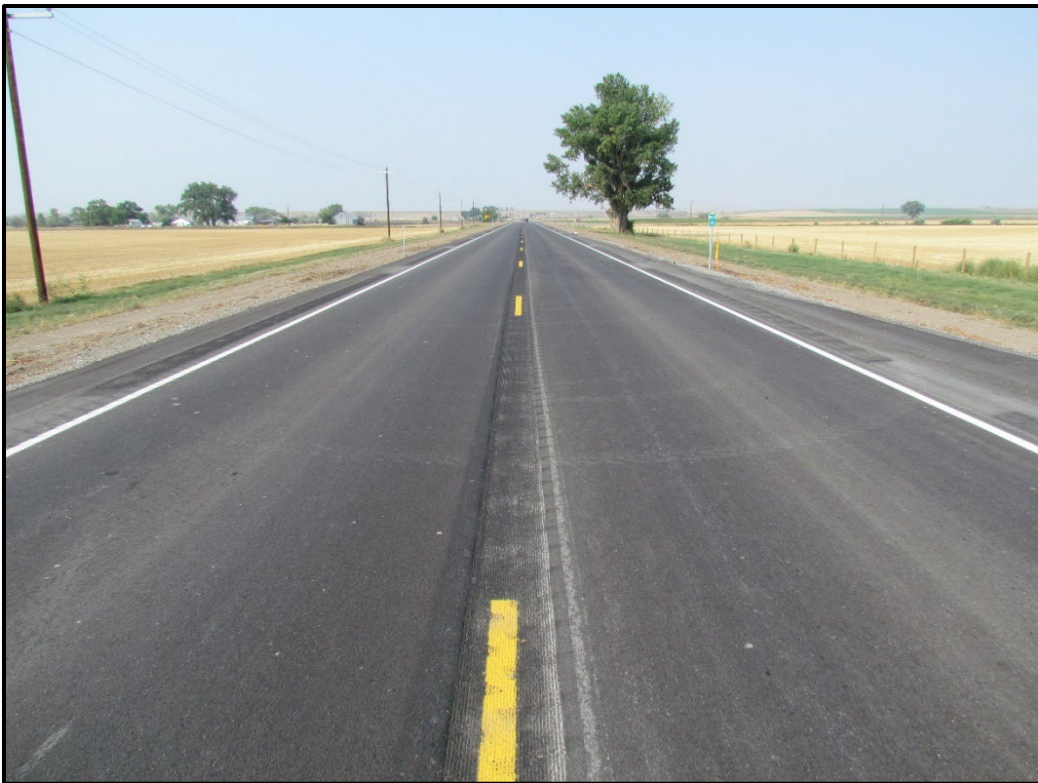
↑ RP 6.0, Sta 255+37, view west. Completed plant mix surfacing.
