**PRELIMINARY GEOTECHNICAL CORRIDOR STUDY  
11 KM NORTH OF LIBBY – NORTH  
PROJECT STPS 567-1(4)7  
CONTROL NO. 4789  
LIBBY, MONTANA  
TETRA TECH, INC.  
PROJECT NO. 6570885**

SUBJECT: Preliminary Geotechnical Corridor Study  
11 km North of Libby – North  
Project STPS 567-1(4)7, CN 4789  
Libby, Montana

At your request, we have completed our preliminary geotechnical corridor study for the Montana Department of Transportation (MDT) 11 km North of Libby – North Project referenced above. The report that follows describes in detail our study, summarizes our findings, and presents our Preliminary Geotechnical Evaluation (460).

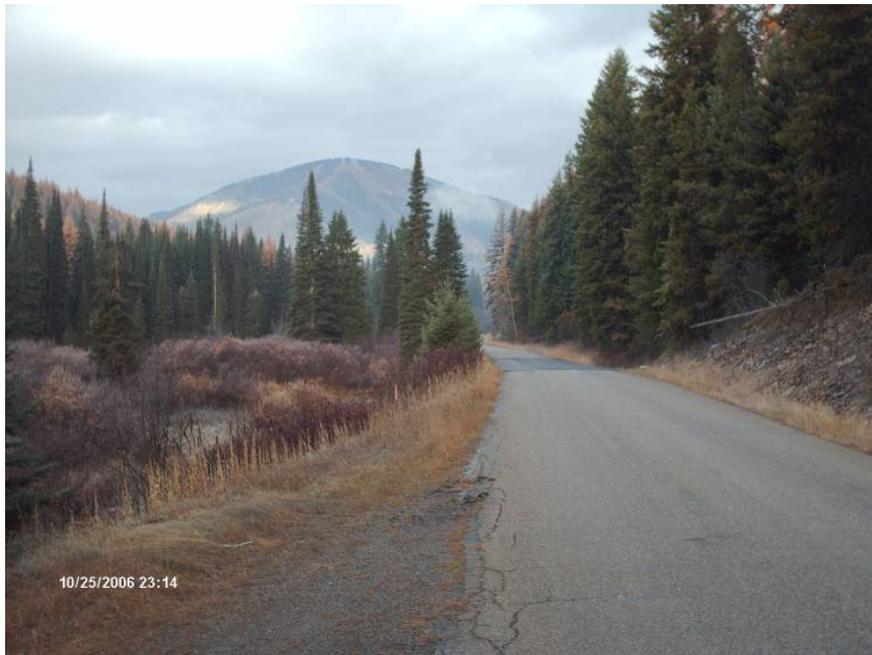
The project is located in a forested canyon area and terrain varies from relatively flat to slightly sloping in the creek bottom transitioning to gently rolling or very steep in the mountainous terrain (Photo 1).

Photo 1. Looking north at approximate RP 15.2, Pipe Creek to left, and Turner Mountain in background.

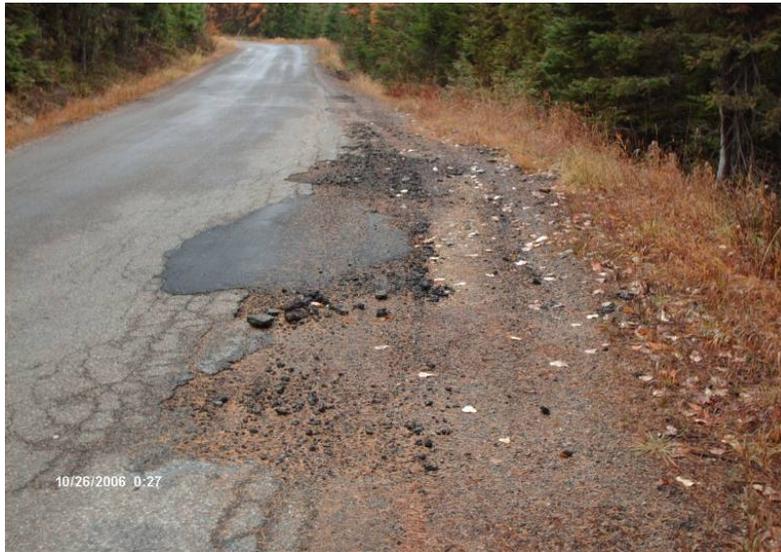
The road was originally constructed with a gravel surface which was later improved through application of bituminous surface treatments, asphalt concrete pavement, and chip sealing. In general, the existing roadway surface is in poor to fair condition respective to the age of the surface treatments, with areas of alligator cracking, occasional rutting and settlement features, potholes, patched areas, and raveling edges. Along the project route the road has minimal shoulders, minimal and deficient guardrail, and no traffic striping (Photos 1, 2, and 3). Several sections of roadway along the project length were recently overlaid with new asphalt concrete pavement, generally matching the former existing roadway width and with a maximum thickness of approximately 3 inches. The overlays varied in length from approximately 50 to 1500 feet and the existing pavement widths varied from approximately 15 to 26 feet. Drainage along borrow ditches appeared to be adequate evidenced by no standing water or severe erosion downcutting the ditch profile.

Photo 2. Looking northwest at approximately RP 19.5; example of pavement cracking and raveling.

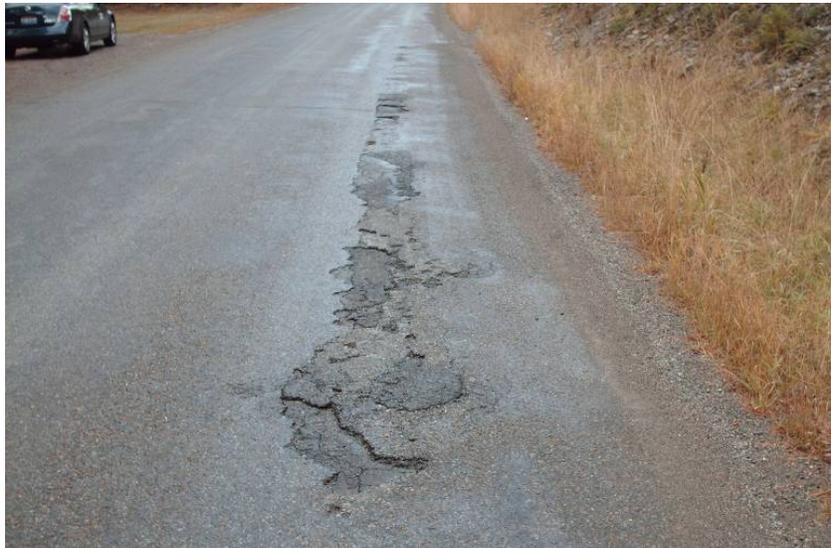
Photo 3. Looking north at approximately RP 7.2; example of pavement surface raveling.

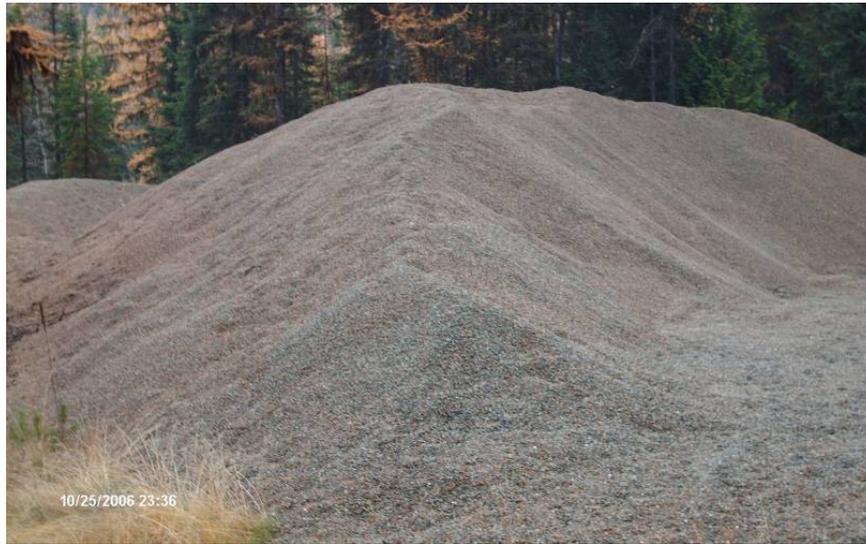
An existing aggregate source was observed at approximate RP 15.8, northeast of the intersection with Forest Road 68X with several piles of stockpiled material (Photo 4). An existing aggregate source and hot mix plant was also observed south of the project area at approximate RP 1.0.

Photo 4. Stockpiled material at existing aggregate source near approximate RP 15.8.

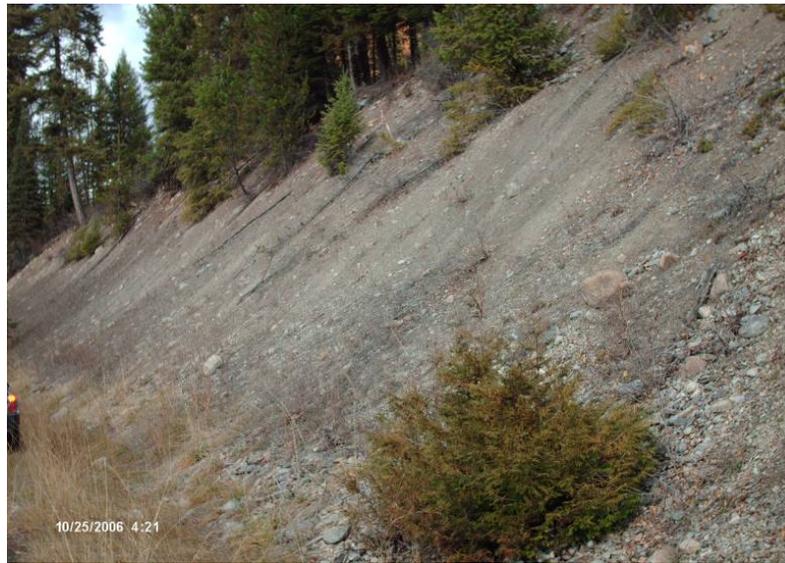
Existing cut slopes in the alluvial and glacial soil deposits were observed to have maximum slopes on the order of 2:1 with a maximum height of approximately 65 feet, and several of the slopes indicated surface raveling and erosion (Photo 5). Minor slope instability was observed on a large cut slope at approximate RP 19.7 (Photo 6). In our opinion, these types of slope instabilities are indicative of slopes consisting of granular soils standing at their angle of repose. Cut slopes within the weathered areas of the bedrock were also observed to have surface raveling and erosion. Measurements of strike and dip of the bedrock bedding planes and orientations of joint discontinuities were recorded at bedrock outcrop locations using a Brunton compass to determine their influences on the rock mass strength and slope stability. Fill slopes are vegetated with grass and weeds, and appeared to be in good condition and constructed of local materials.

Photo 5. Looking north at cut slope at approximate RP 12.3.

- Possible slope improvements or treatments may include slope flattening or benching, slope revegetation or erosion fabric placement to prevent surface erosion, presplitting, and rockfall catchment ditches.

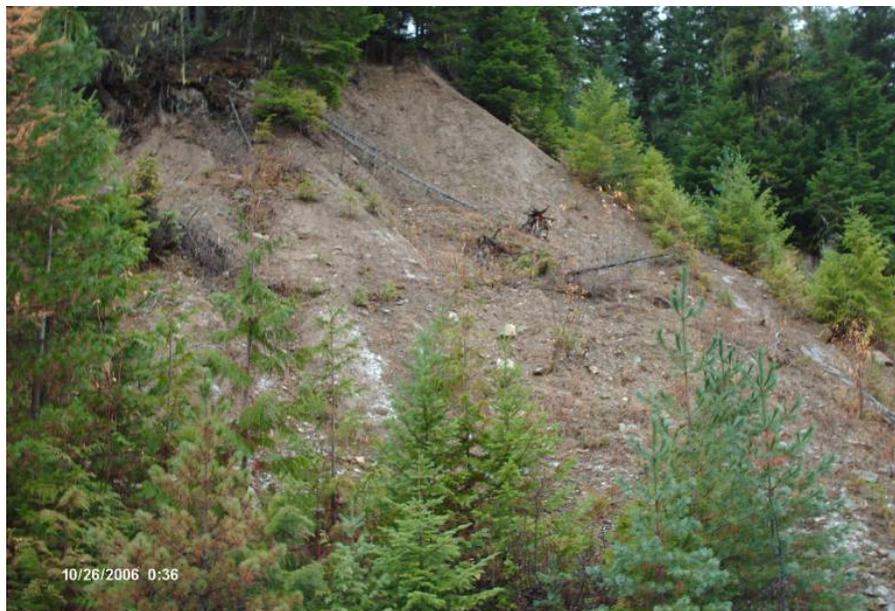
Photo 6. Looking northwest at cut slope at approximate RP 19.7.

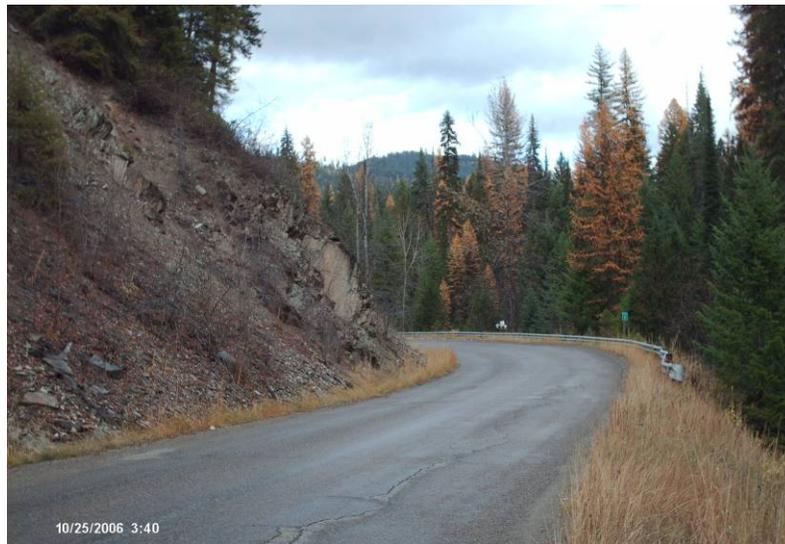
A major area of potential rock slope instability was observed at approximate RP 11.0 (Deadman's Curve), which encroaches on Pipe Creek to the east (Photos 7 and 8). The rock cut slope is located on a tight curve west of centerline, with discontinuities forming a distinct block failure pattern along the length of the cut when viewed in outcrop exposure.

Photo 7. Looking north towards RP 11.0 (Deadman's Curve).

Slope stabilization and rockfall mitigation techniques will be required for rock cut slopes along the project. Such techniques may include slope flattening, rock bolting, rock netting, rockfall catchment ditches, and barrier fences. Actual placement and selection of the rockfall mitigation measures will depend on a complete field investigation and geotechnical study including stereographic and geomechanical analysis of potentially unstable slopes during the design phase.

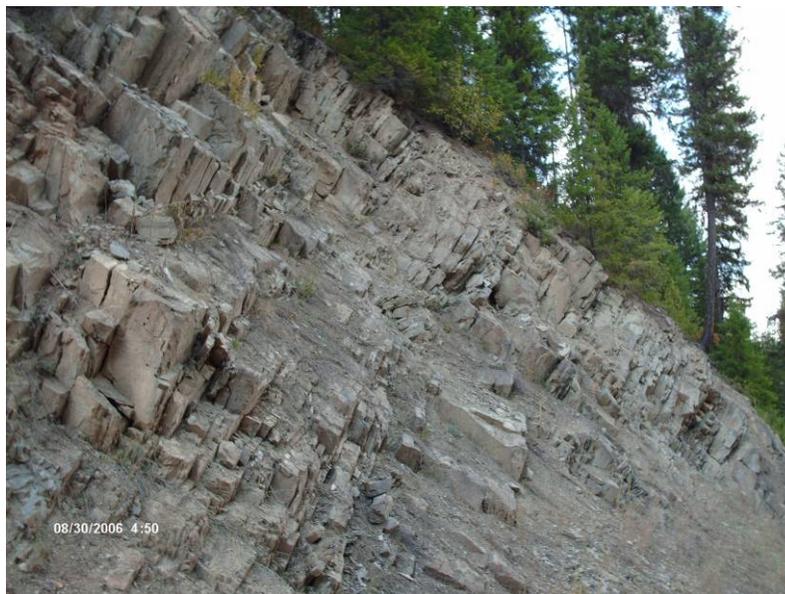
Photo 8. Rock cut at RP 11.0, note blocky pattern formed by discontinuities.

Stereographic analysis and field observation of the existing slope performance indicates a high probability of wedge type failures in the rock mass. Considering the fact that the rock slope at Deadman's Curve is located on a curve, the orientation of the cut slope changes through the curve, and a detailed analysis will need to be performed to design a safe slope configuration.

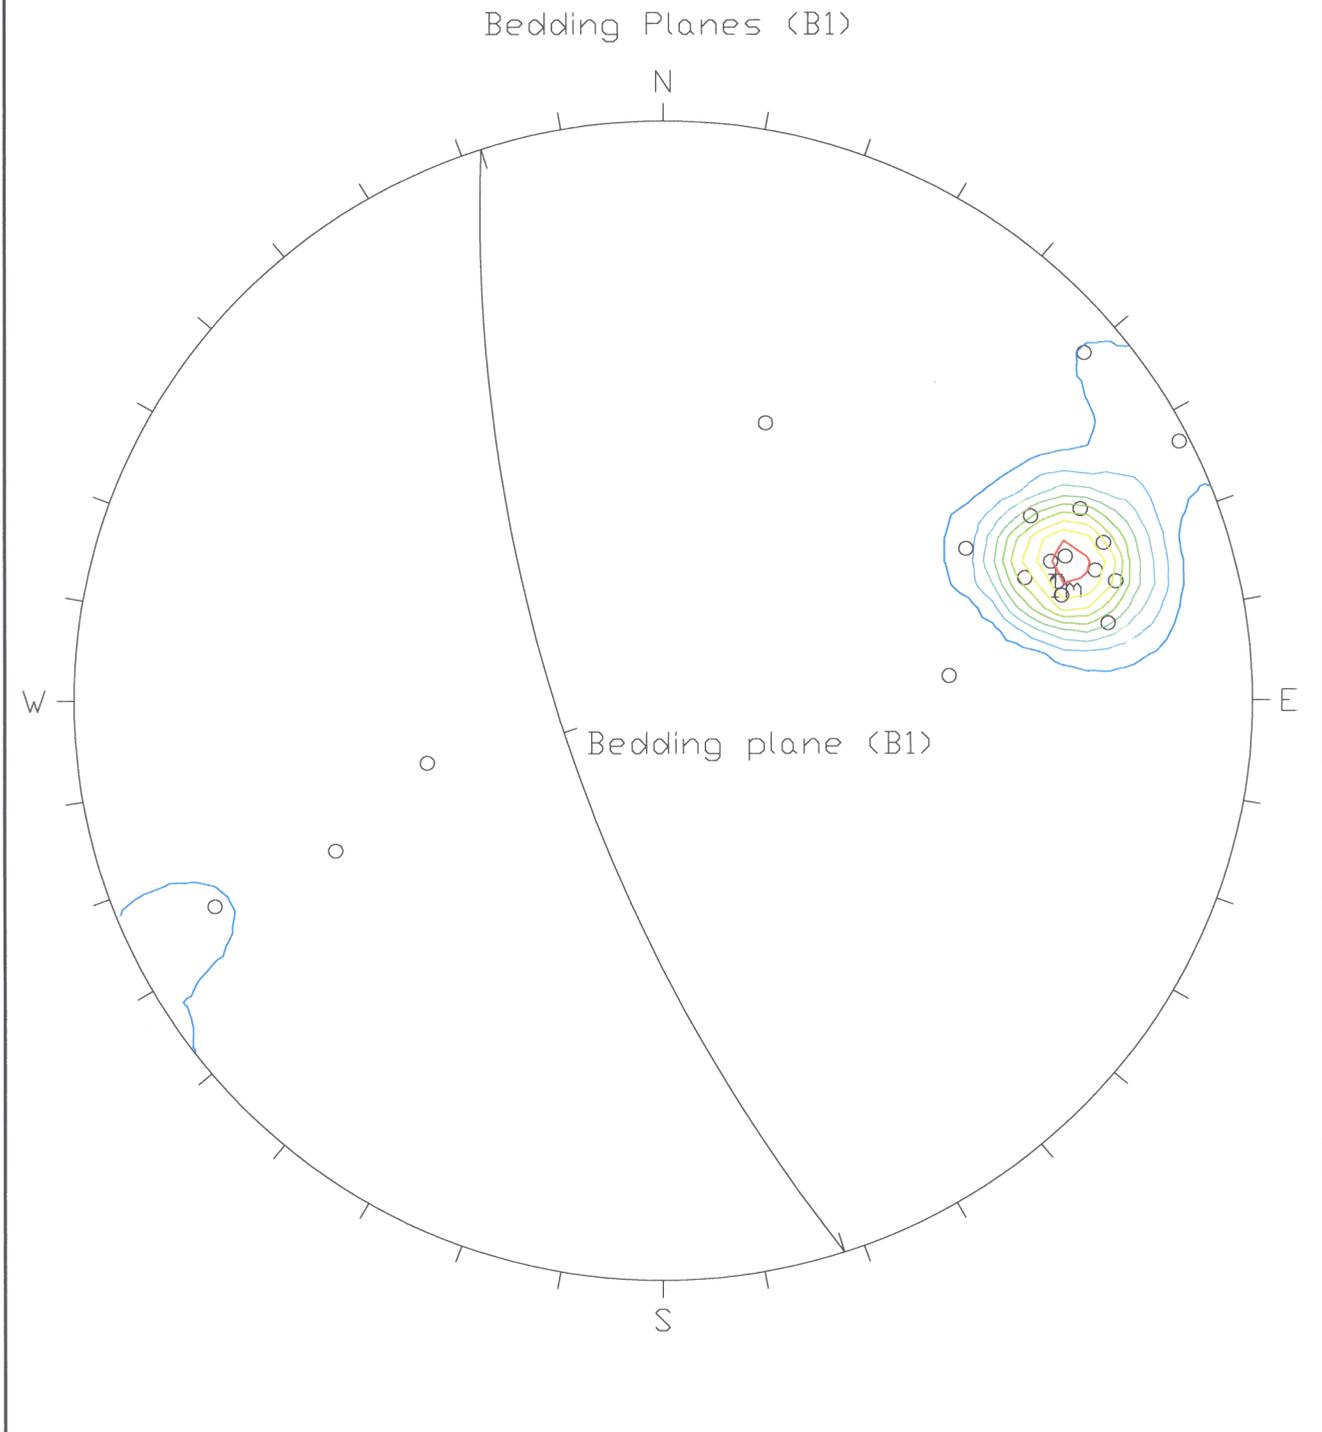
Bedding Plane Pole Plot

Strike and dip orientations of bedrock bedding planes and major joint sets were recorded during our site reconnaissance at various outcrops along the existing alignment. Bedrock bedding inclinations were measured in the range of 45 to 89 degrees, generally dipping towards the southwest, with occasional areas dipping to the northeast, and an approximate strike range of N5° W to N70° W. The measured bedding planes have a mean strike and dip of N23° W, 62° SW, with the majority of the bedding planes

having a mean strike and dip of N18° W, 70° SW. The respective pole populations of the bedding planes were plotted on an equal area stereonet and then statistically contoured (Figure 2).

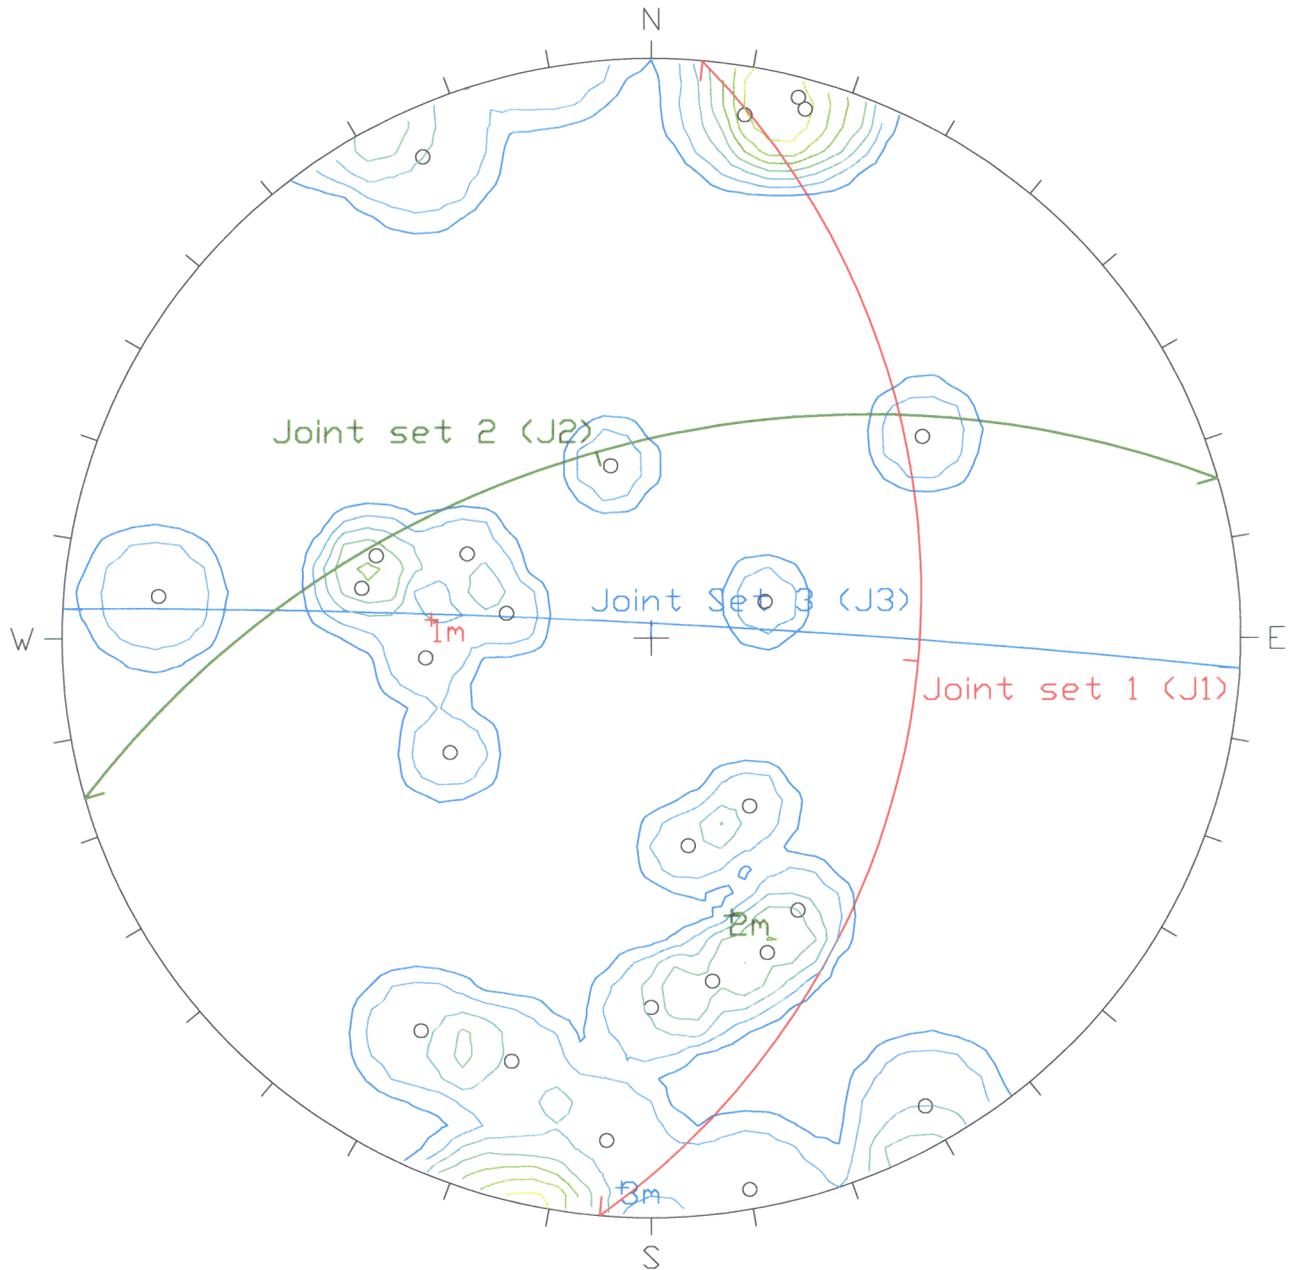
Joint Set Planes Pole Plot

The respective pole populations of the weakness planes were also plotted on an equal area stereonet and then statistically contoured (Figure 3). Contouring techniques identified three major systems of discontinuities (joint sets) having preferred orientations throughout the rock mass with the following mean strikes and dips:

Joint Set (J1), N 5° E, 41° SE

Joint Set (J2), N 74° E, 53° NW

Joint Set (J3), N 87° W, 87° NE

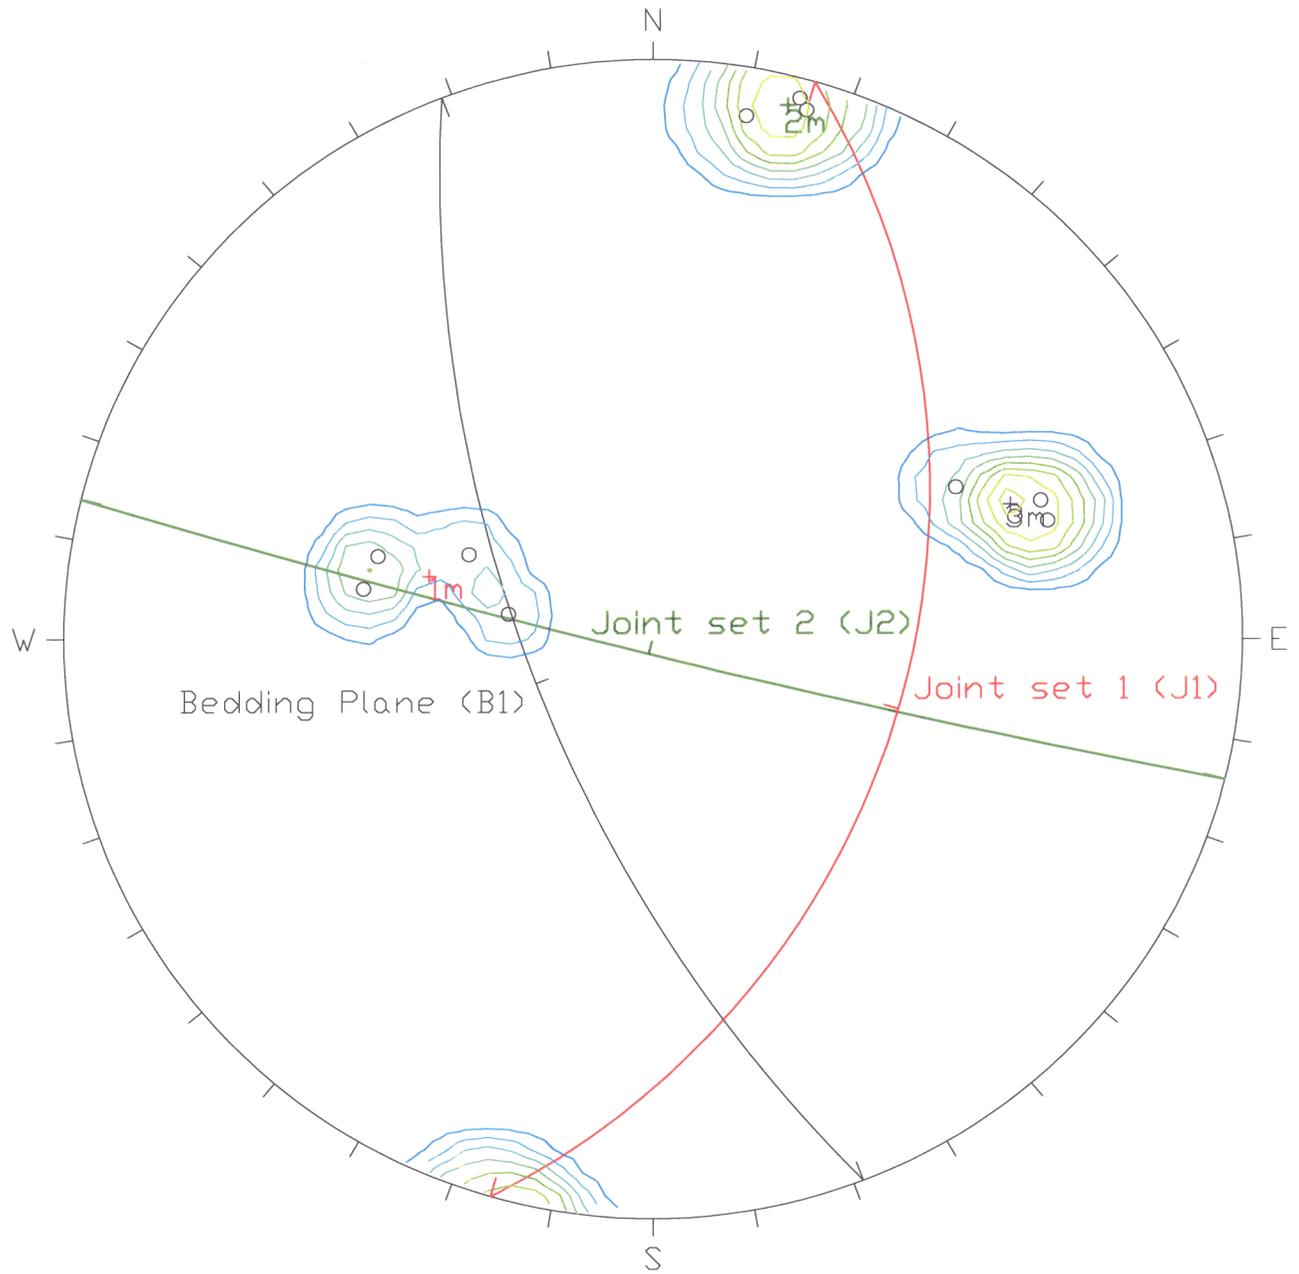
Equal Area, Lower Hemisphere Stereonet  
 Bedding and Joint Sets Pole Plot - Deadman's Curve  
 11 km North of Libby - North  
 Project STPS 567-1(4)7, CN 4789

The respective pole populations of the weakness planes along the rock cut at Deadman's Curve were plotted on an equal area stereonet and then statistically contoured (Figure 4). Contouring techniques identified three major systems of discontinuities (bedding plane and joint sets) having preferred orientations throughout the rock mass with the following mean strikes and dips:

Bedding Plane (B1), N 21° W, 66° SW

Joint Set (J1), N 16° E, 43° SE

Joint Set (J2), N 76° W, 87° SW

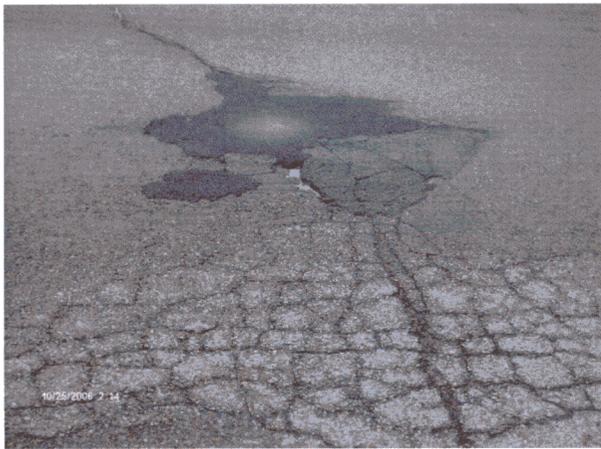
**PHOTOGRAPH 3** RP 7.0, pavement cracking.

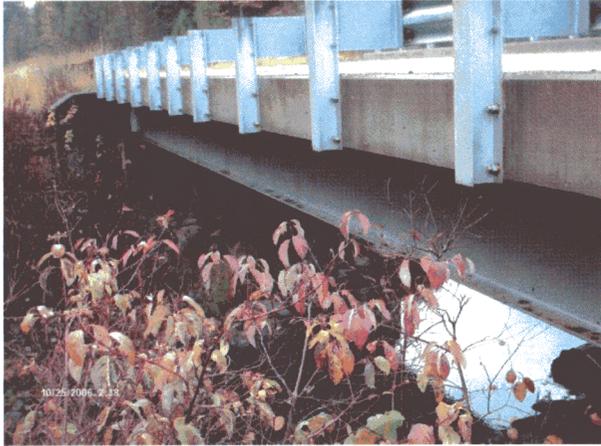
A single-span, concrete deck and steel girder bridge over Pipe Creek is located at approximate RP 7.6 and was observed to be in good condition (see Photographs 6 and 7, Appendix B). The bridge is approximately 34 feet wide and approximately 60 feet long. No other bridges were observed along the project route. Several culverts of varying type, size, and condition were observed at tributary drainage crossings (see Photographs 34, 50, and 51, Appendix B).

**PHOTOGRAPH 7** RP 7.6, looking south on east side of bridge over Pipe Creek.

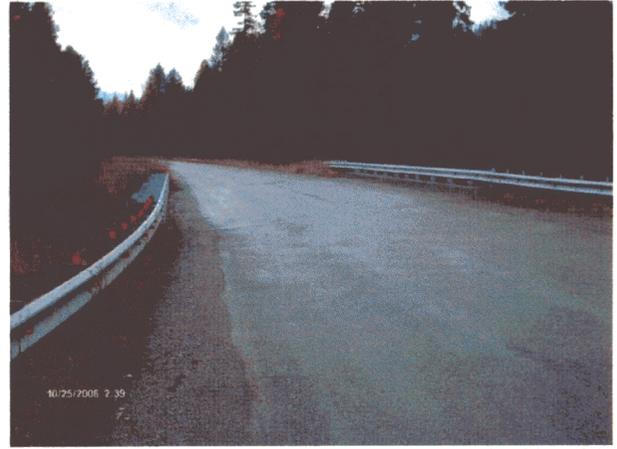
**PHOTOGRAPH 8** RP 7.6, looking south across bridge over Pipe Creek.

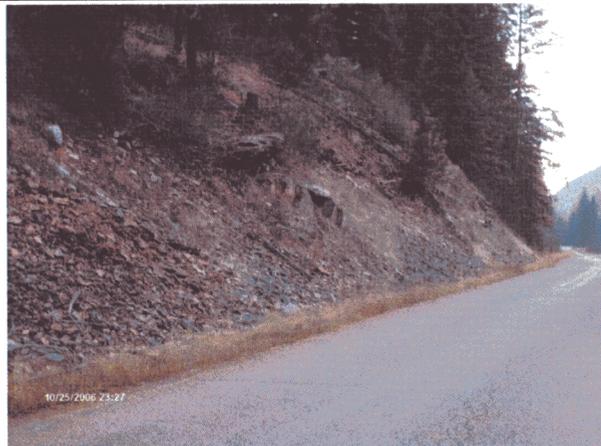
**PHOTOGRAPH 41** RP 15.4, looking south at weathered, highly fractured rock outcrop on east side of road.

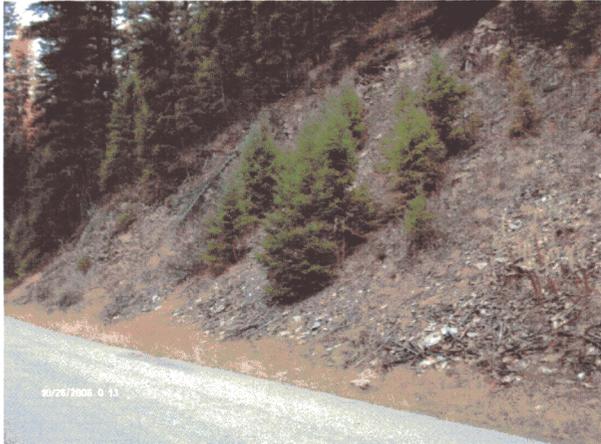
**PHOTOGRAPH 49** RP 18.2, looking northeast at highly fractured rock slope on east side of road.
