Montana Department of Transportation Stream Mitigation Monitoring Report

NORTH FORK BEAR CREEK MITIGATION SITE

Monitoring Year: 2020

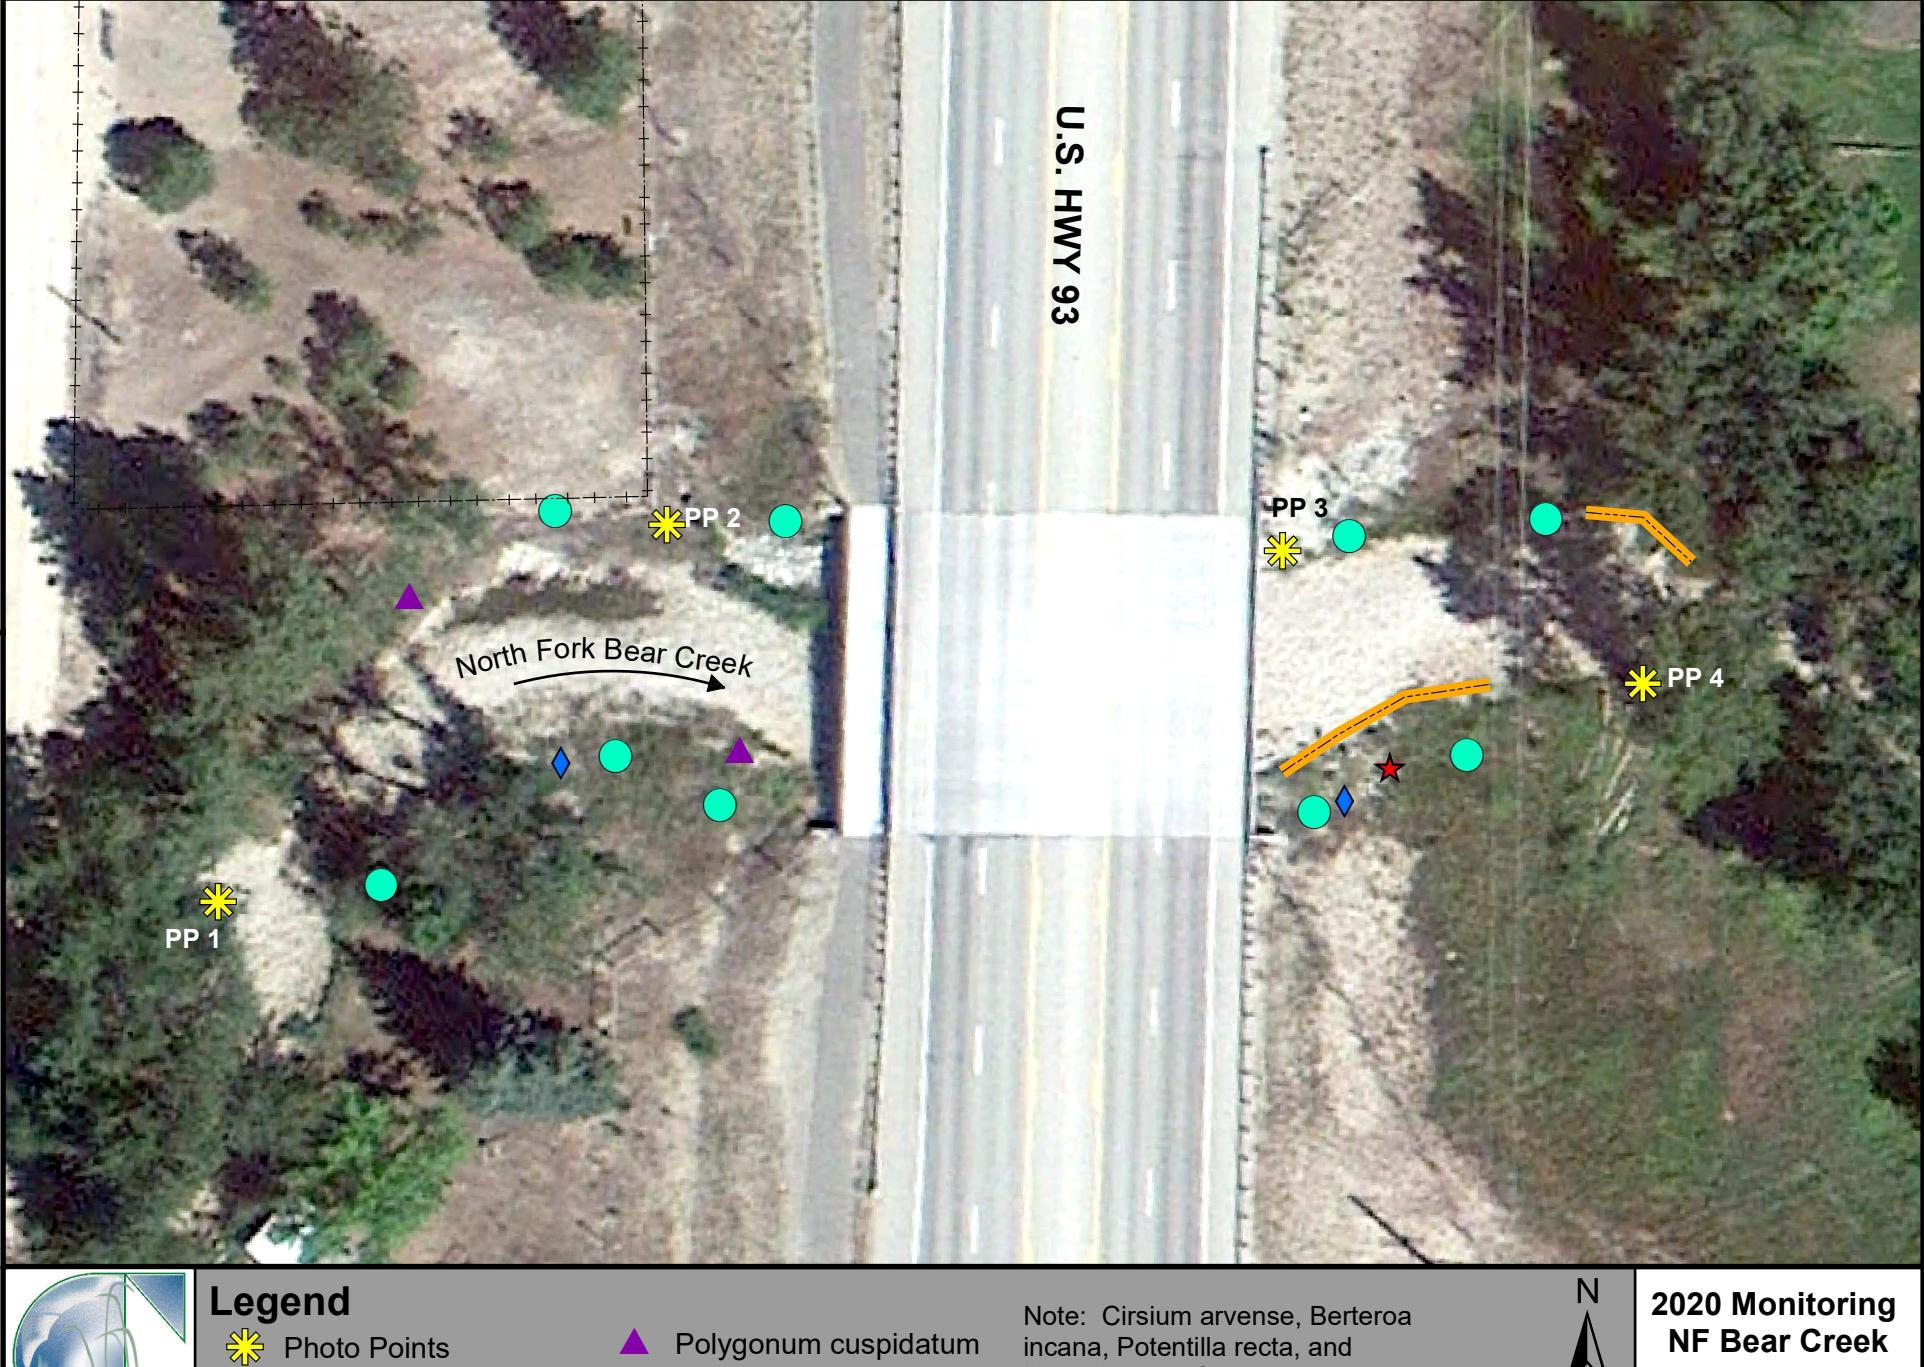
Twelve infestations of Montana Listed Priority 2B noxious weeds were observed on both private land and within the MDT right-of-way (ROW) in the project area, all of which were classified as a low cover class (1-5%) (Table 3; Figure 2, Appendix A). Two infestations of Priority 1B noxious weeds were identified within the riparian corridor and were also considered a low cover class (Table 3; Figure 2, Appendix A). Two noxious weed species originally observed in 2014 (*Convolvulus arvensis* and *Cynoglossum officinale*) have not been observed during the past five monitoring events, and as a result, they are no longer considered present within the reach.

An estimated 20% areal coverage of noxious weeds was observed during the 2020 monitoring event. Weeds were observed on both stream banks upstream and downstream of the Highway 93 Bridge. Although each individual weed infestation is relatively small in extent, the area of all infestations combined warrants concern and must be addressed to achieve the success criterion for riparian cover. While previous weed spraying efforts by MDT may have reduced areal coverage of noxious weeds, the 20% percent cover by eight noxious weed species remains a concern at this site.

The length of eroding stream bank increased from 6% to 17% between the 2019 and 2020 monitoring events. Erosion was previously noted on the right bank of the reconstructed reach downstream of the Highway 93 Bridge. The eroding bank length has doubled from 25' to 50' since the 2019 monitoring event. No lateral migration was observed along this bank in 2020, but the bank has become undercut and the undercut has entrained two small cottonwood trees. On the downstream end of the project area, a 25' section of the left bank had also eroded since 2019. The root wads that were placed along this bank to provide stability are still intact and in place, but the gravel and cobble surrounding the root wads has been scoured away. Lateral retreat of this bank was approximately 3-4 feet over the past year, excluding the areas occupied by the root wads.

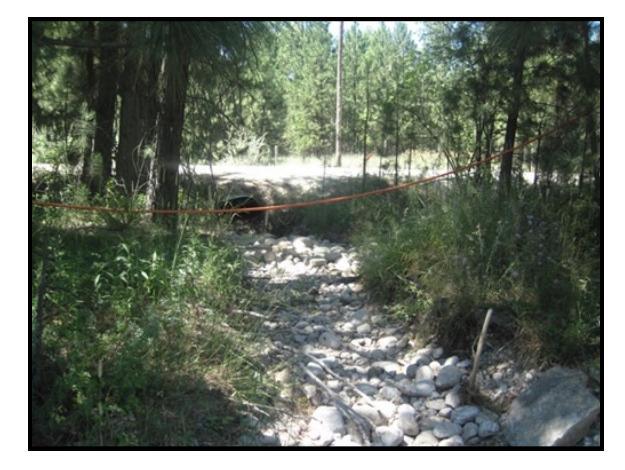
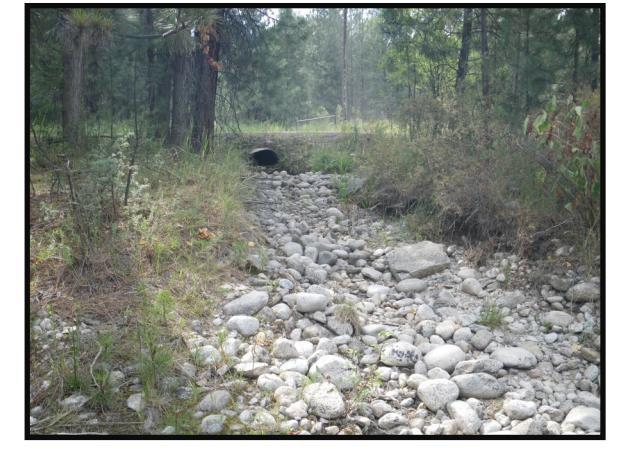
2013 2020 Photo Point 1.1: View of tributary/culvert entering from west. Compass: 270 (West)

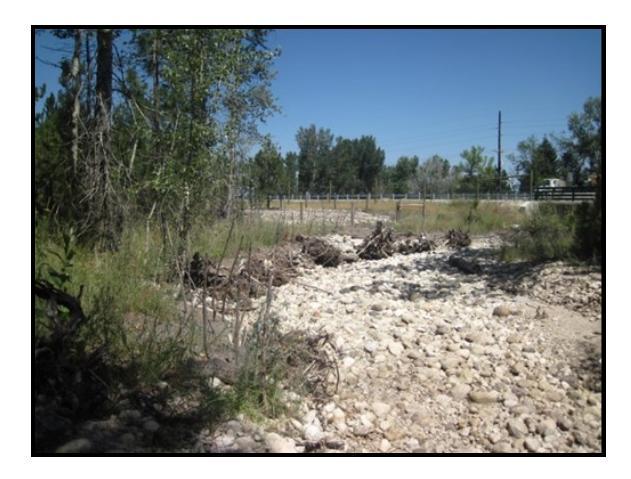
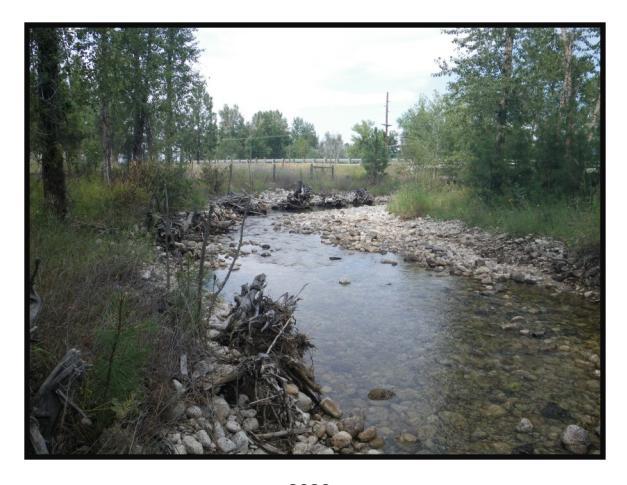
2013 2020 Photo Point 1.2: View of north streambank looking downstream. Compass: 45 (Northeast)

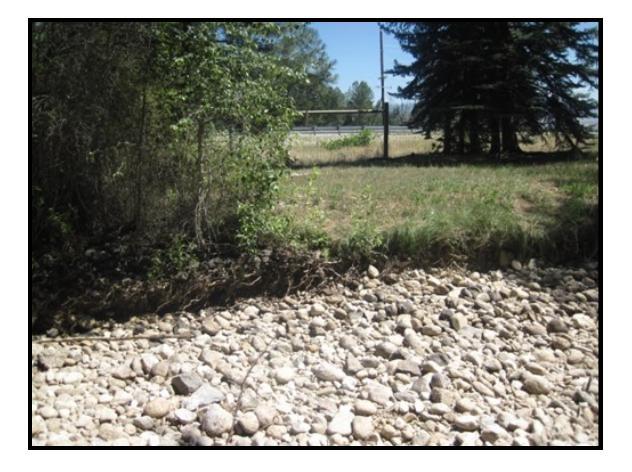
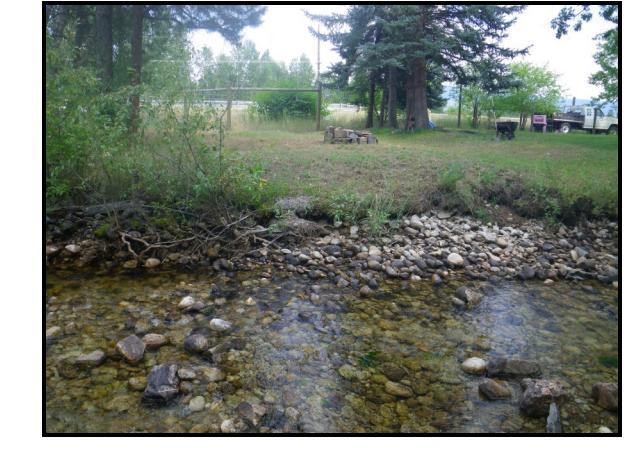
Photo Point 1.3: View of south streambank. Compass: 90 (East)

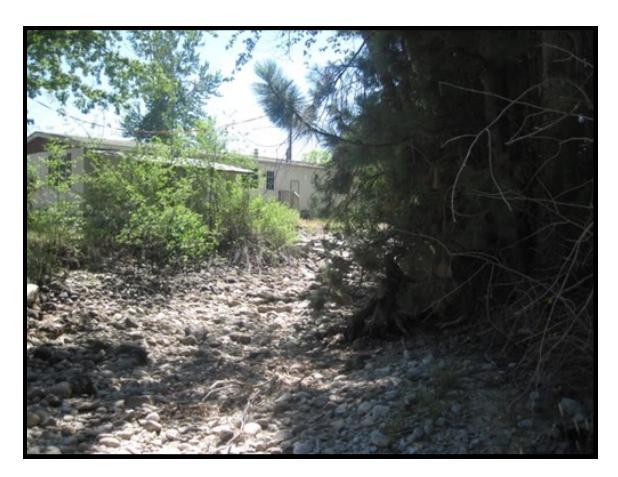
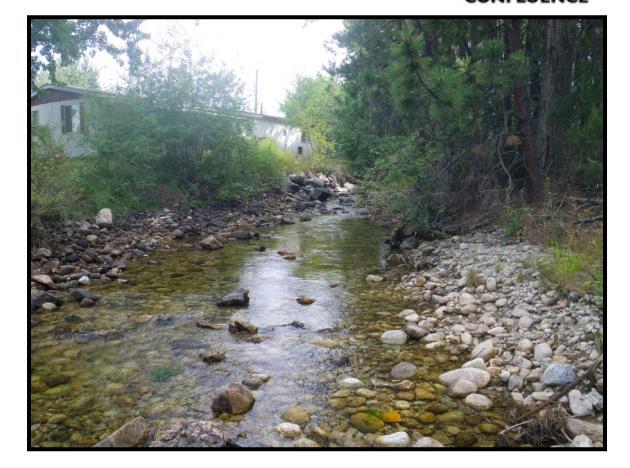
2013 2020 Photo Point 1.4: View of dry channel looking upstream. Compass: 230 (Southwest)

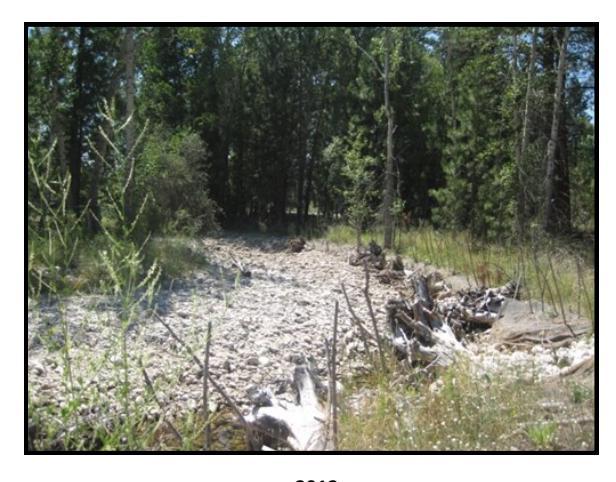
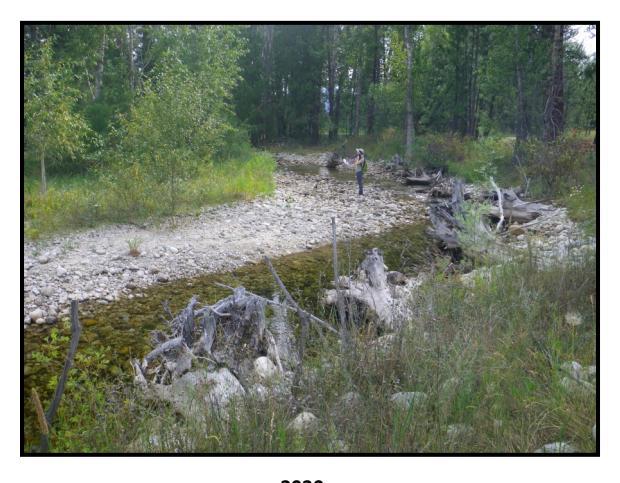
2013 2020 Photo Point 2.1: View of root wads on north bank. Compass: 225 (Southwest)

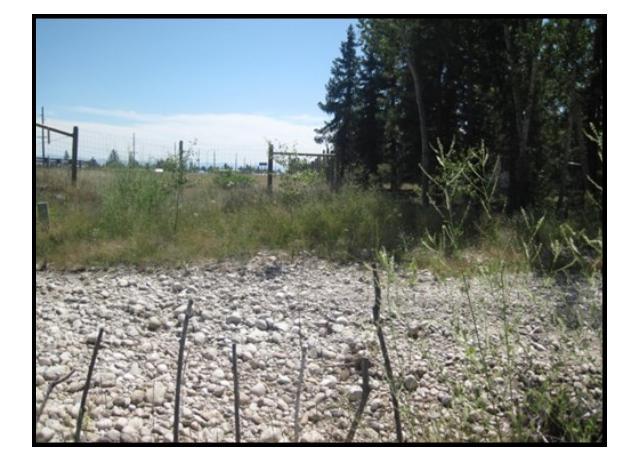
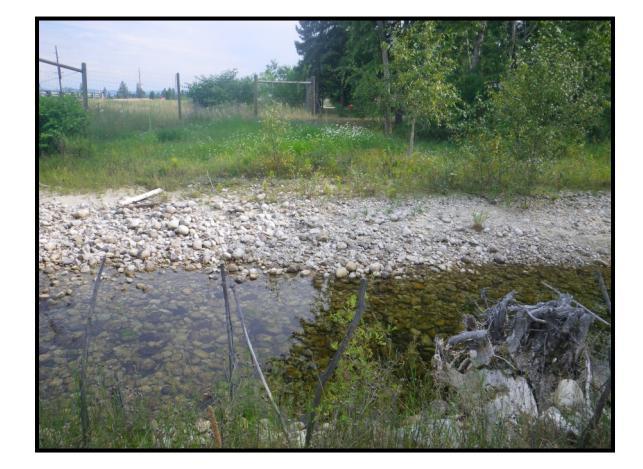
2013 2020 Photo Point 2.2: View across channel of south streambank. Compass: 180 (South)

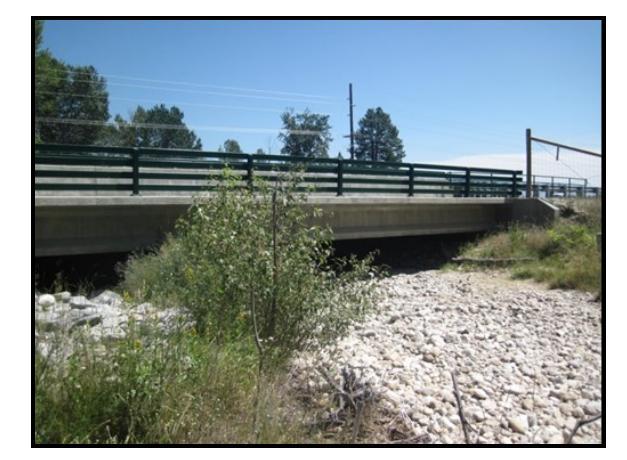
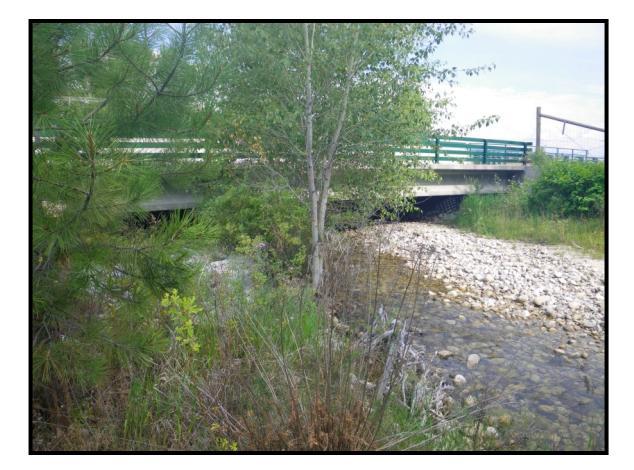
2013 2020 Photo Point 2.3: View from north bank looking across channel. Compass: 135 (Southeast)

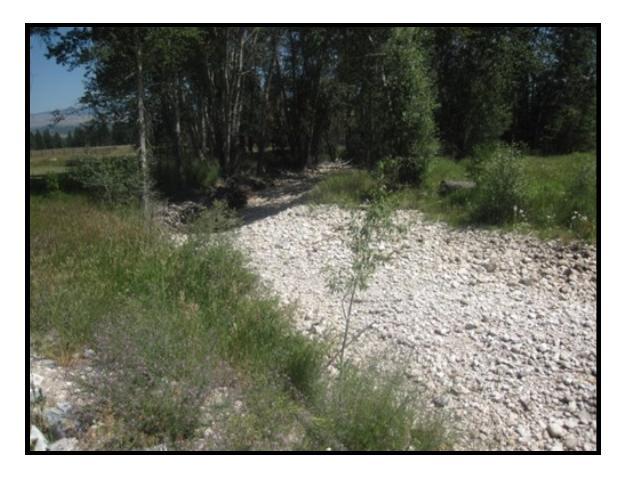
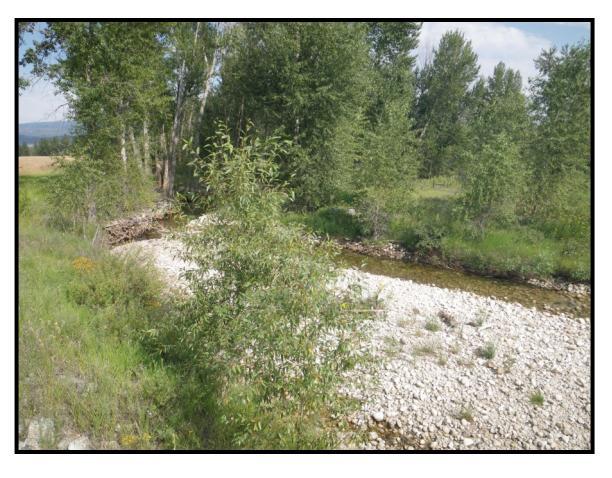
2013 2020 Photo Point 3.1: View downstream from north bridge abutment. Compass: 90 (East)

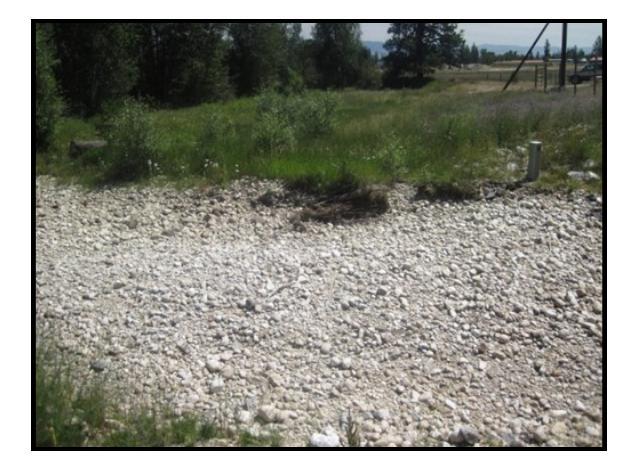
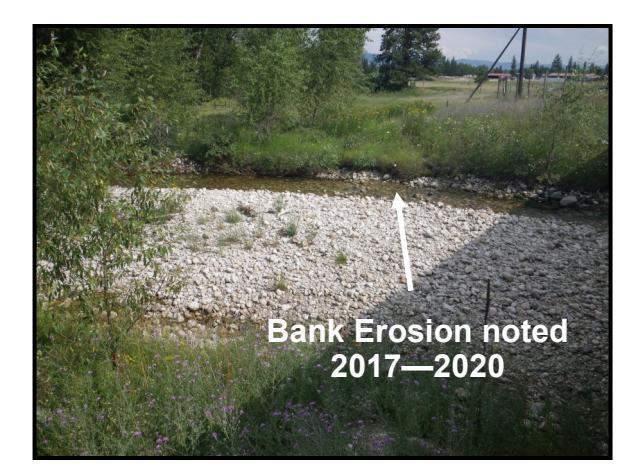
2013 2020 Photo Point 3.2: View of south streambank from left abutment. Compass: 135 (Southeast)

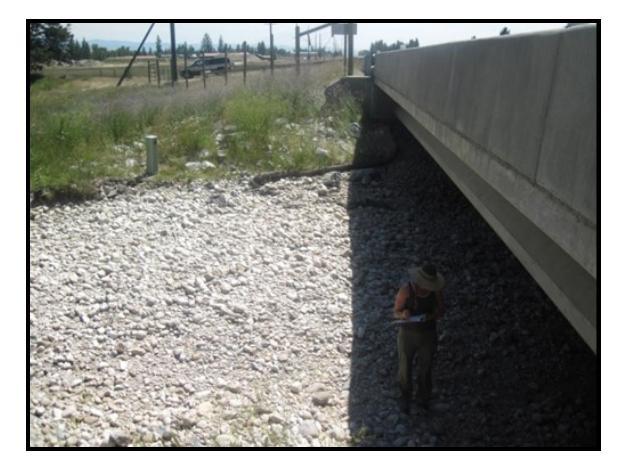
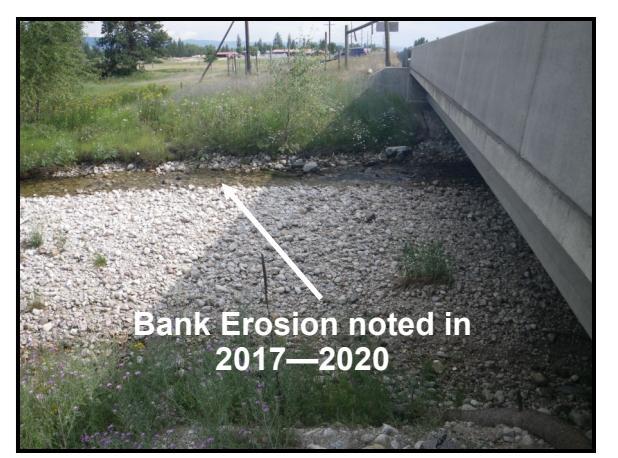
2013 2020 Photo Point 3.3: View across channel of south bank from north bridge abutment. Compass: 180 (South)

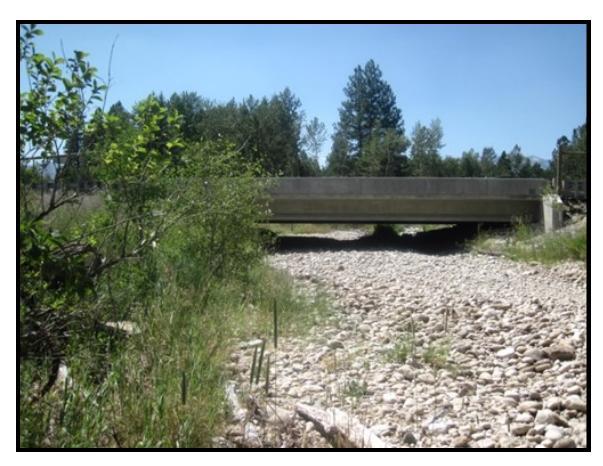
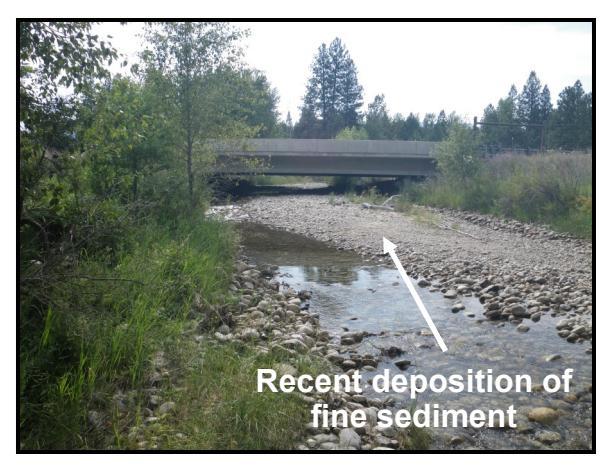
2013 2020 Photo Point 4.1: View from south bank looking upstream from downstream extent. Compass: 270 (West)

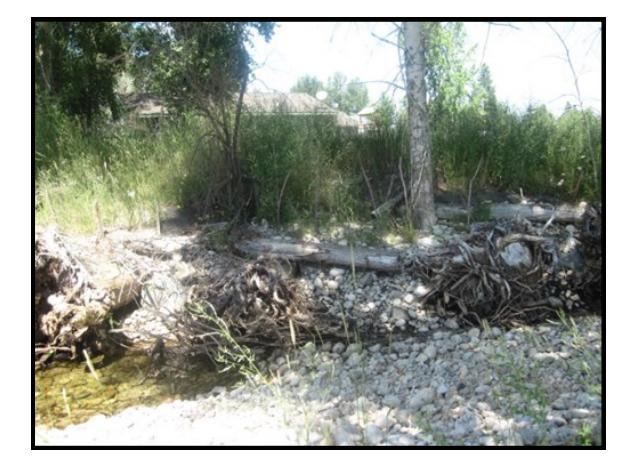
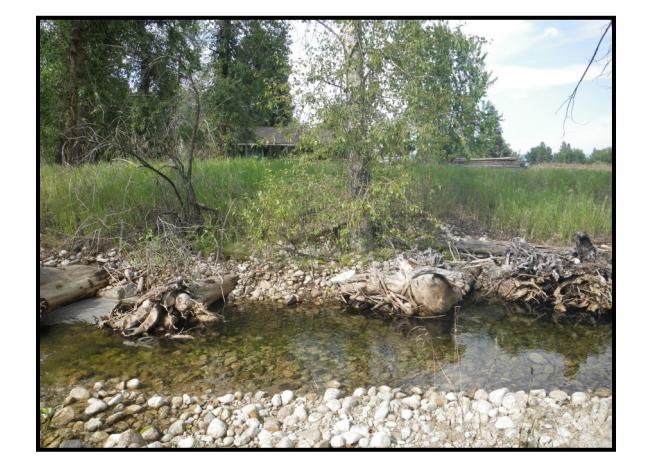
2013 2020 Photo Point 4.2: View of root wads on north bank downstream of bridge. Compass: 0 (North)

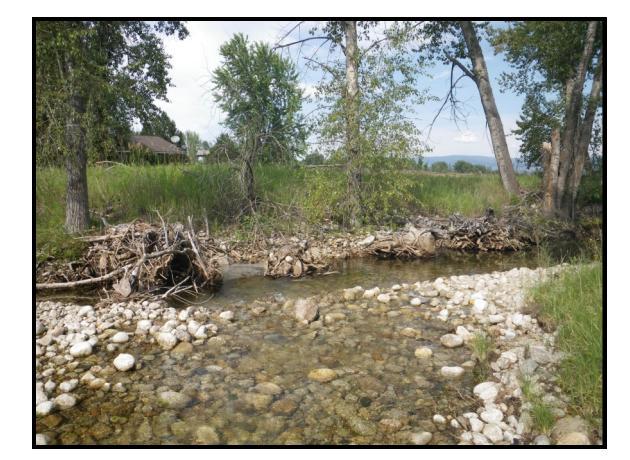
Significant changes in channel form, likely the resulting from one or more large-magnitude flow events, were observed in 2020. Evidence of overbank flooding, including drift debris and gravel deposits on the floodplain both upstream and downstream of the bridge were observed along with new mid-channel and point bar depositional features. Deposition of sand, gravel, and cobble was most notable under and downstream of the Highway 93 Bridge. Just upstream of the bridge, the channel overtopped the bank and began to form a secondary channel behind a group of small cottonwood trees that were planted during construction. This side channel quickly rejoined the main channel under the bridge. Evidence of increased scour was observed on the left bank upstream of the bridge, where cottonwood roots have become exposed, and new scour pools have formed around root wads that were keyed into the bank during construction. Scour pools were also noted around roots wads on the left bank at the downstream end of the project area (see photos, Appendix B).

Additional Photo 1: Looking downstream at exposed root wads on the left bank at the downstream end of the project area.

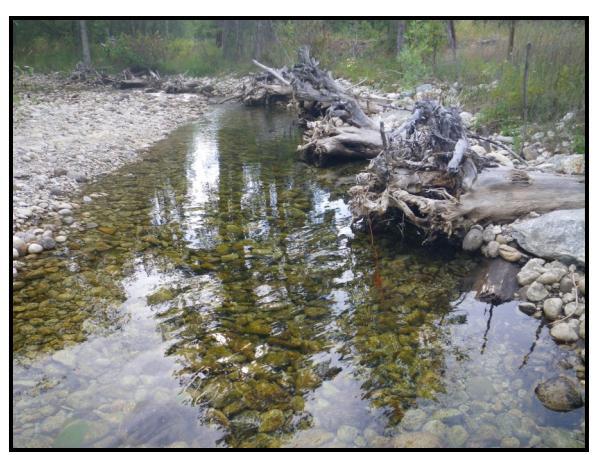
Additional Photo 2: Looking upstream at exposed root wads on the left bank upstream of the bridge where increased scour was observed in 2020

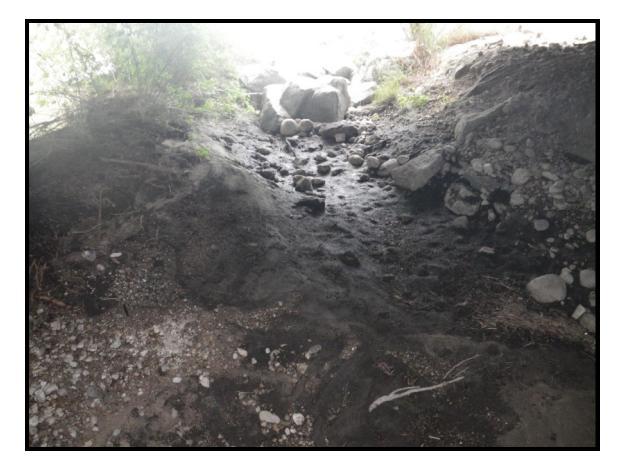
Additional Photo 3: Looking upstream at a side channel that from under the bridge during recent high flow events.

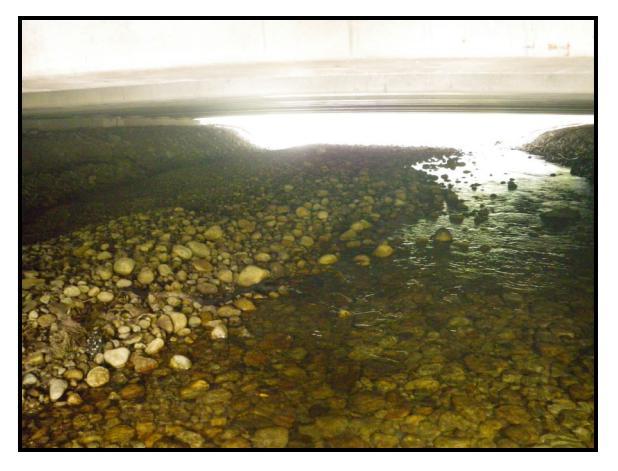
Additional Photo 4: Looking downstream at gravel and cobble recently deposited under the bridge.

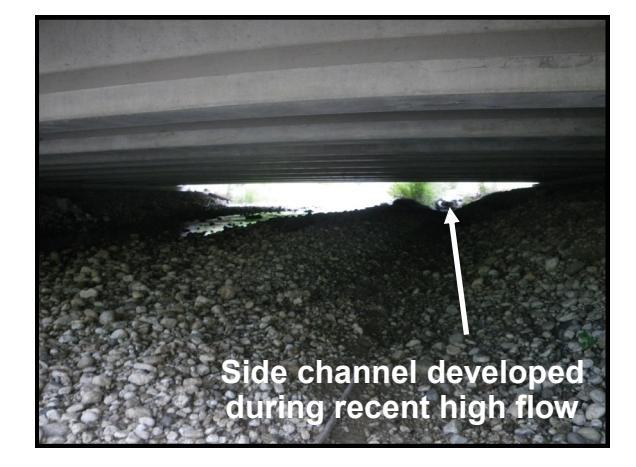
Additional Photo 5: Looking upstream under the bridge at recently deposited gravel and cobble and the side channel that developed during recent high flows.

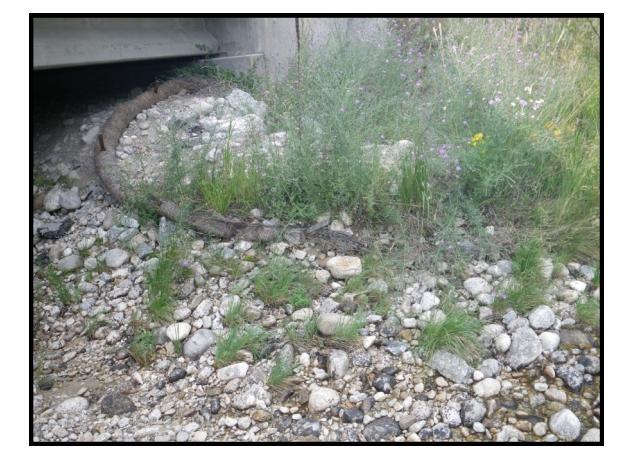
Additional Photo 6: Looking at the left bank downstream of the bridge at a wattle was installed as a part of utility installation project has become exposed.

Specific recommendations for additional corrective actions: Continue weed treatment in 2021. Wattles on the downstream side of the bridge that were installed during a previous underground utility project are exposed and at risk of being captured by the creek (additional photo 6, Appendix B). The vegetation upgradient of the wattles is stable enough that the wattles could be partially or entirely removed. Wattled removal is advised.
