VISION ZERO

zero deaths
zero serious injuries

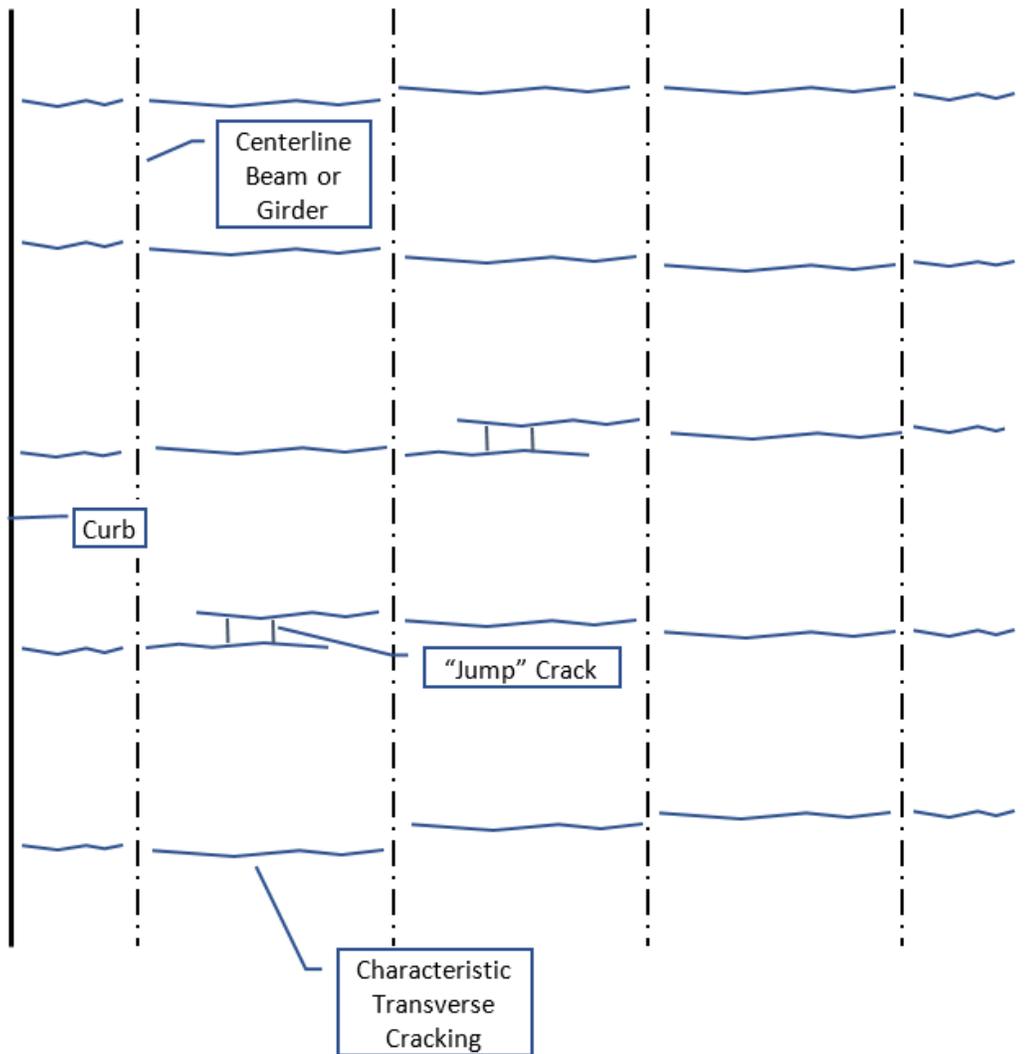
Figure 1. Sketch of Transverse and Jump Cracks

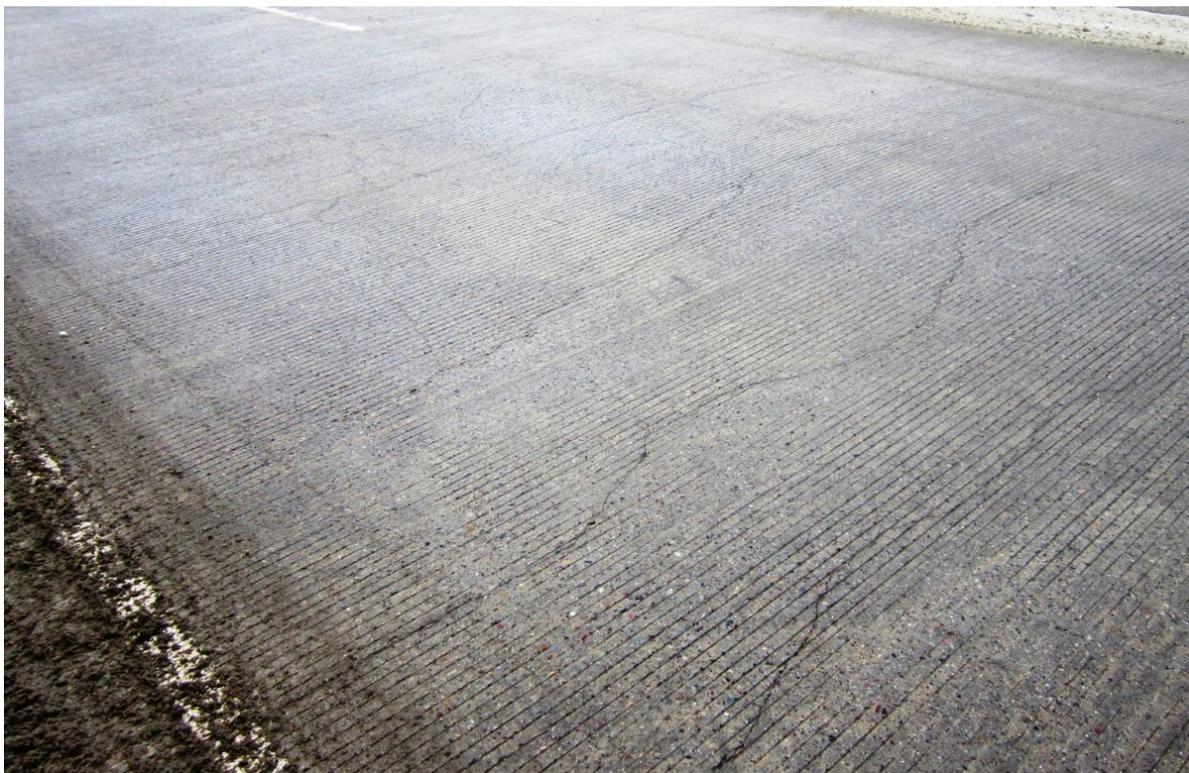
Figure 2. Transverse Cracks in Bridge Deck

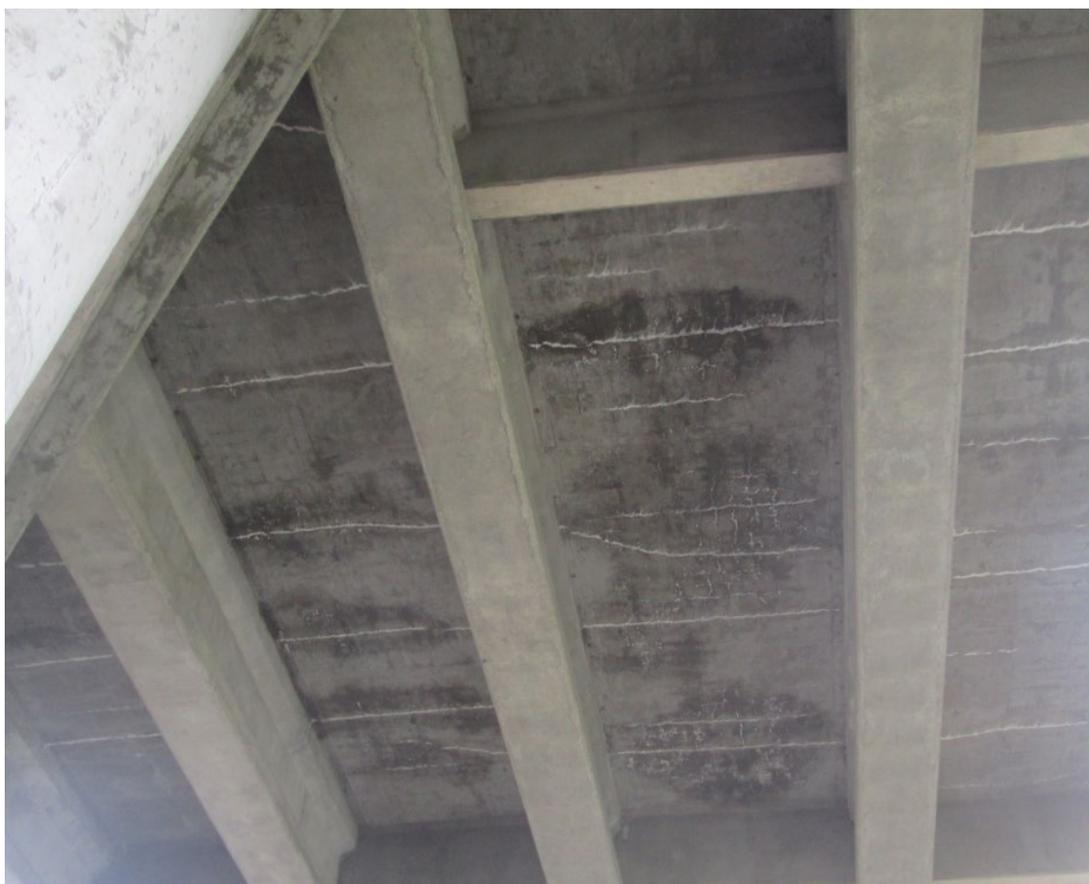
Figure 3. Typical Transverse Cracks Seen From Underneath

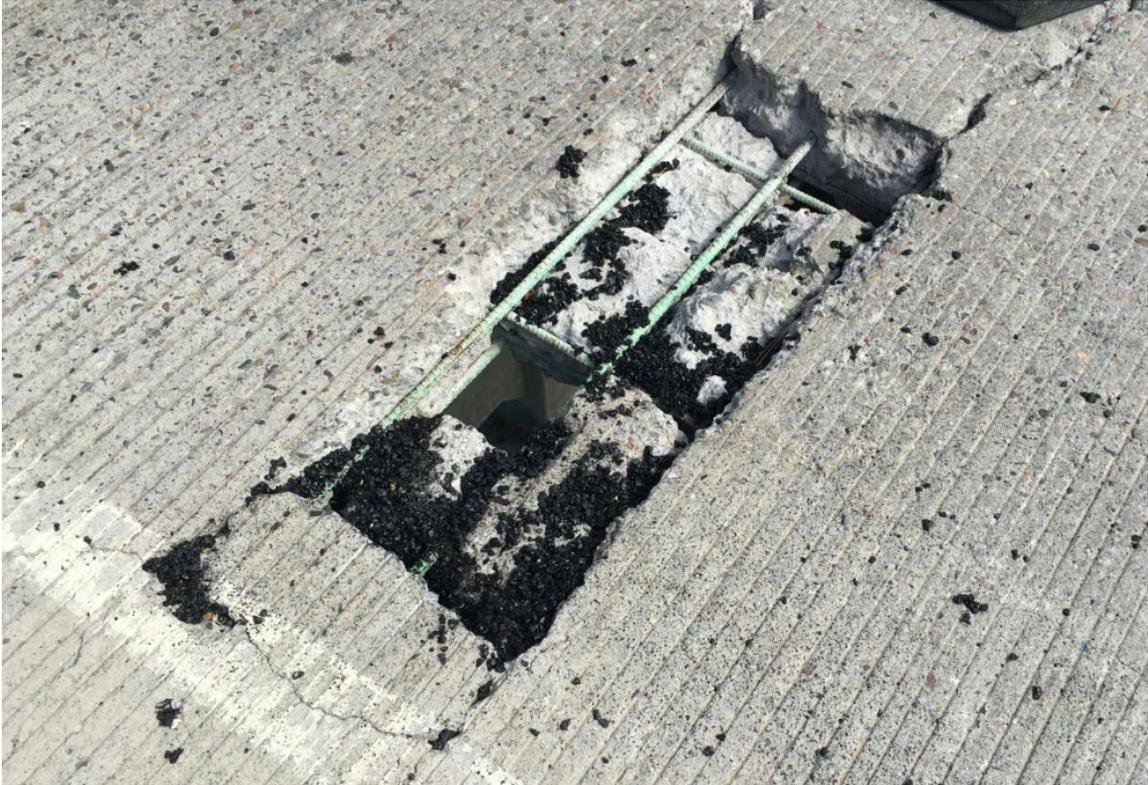
Figure 4. Holes in Bridge Deck. Note the longitudinal jump cracks that create the rectangular “island” of concrete. The “island” continued to crack until full depth chunk or “island” fell out, creating the hole.

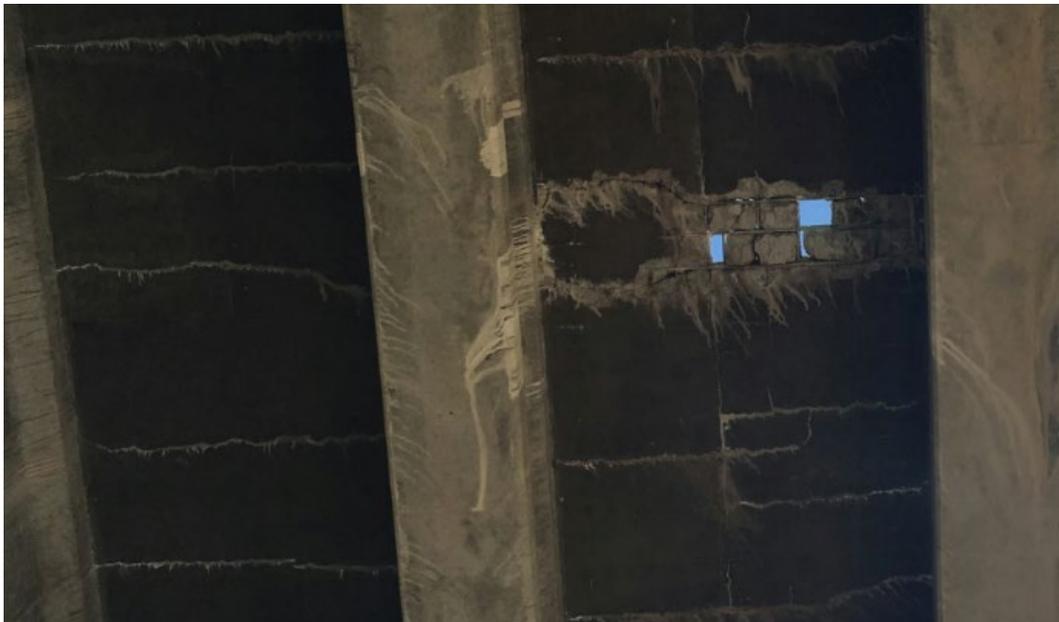
Figure 5. Same hole as Fig. 4 as seen from Underneath. Note the heavy staining on the soffit and girders from leakage in the cracks around the hole and in nearby transverse cracks. Note, little or no staining in cracks in adjacent girder bay. Note jump cracks with beginning staining at another location not far from the hole.

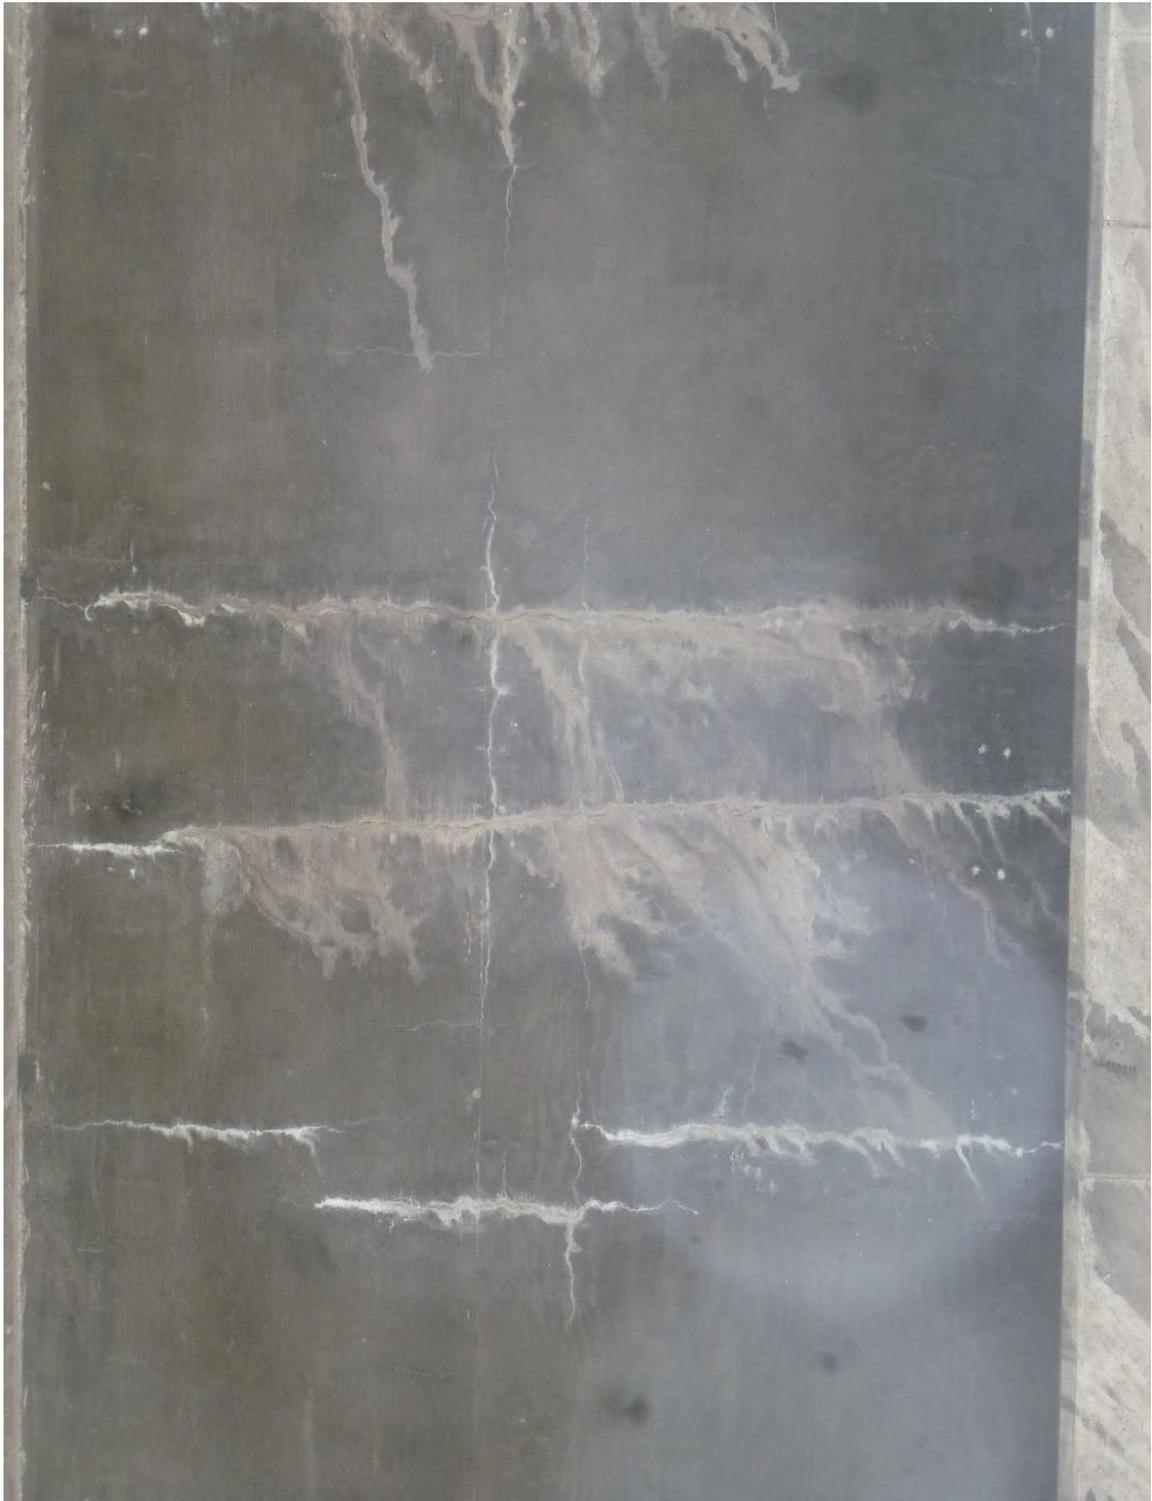
Figure 6. Example of Heavy staining from water leakage. Note the contrast between the gray efflorescence in the upper 2 transverse cracks (evidence of concrete movement around crack and heavy water leakage) and the white efflorescence in the bottom transverse cracks. Note the longitudinal jump crack with light white efflorescence.

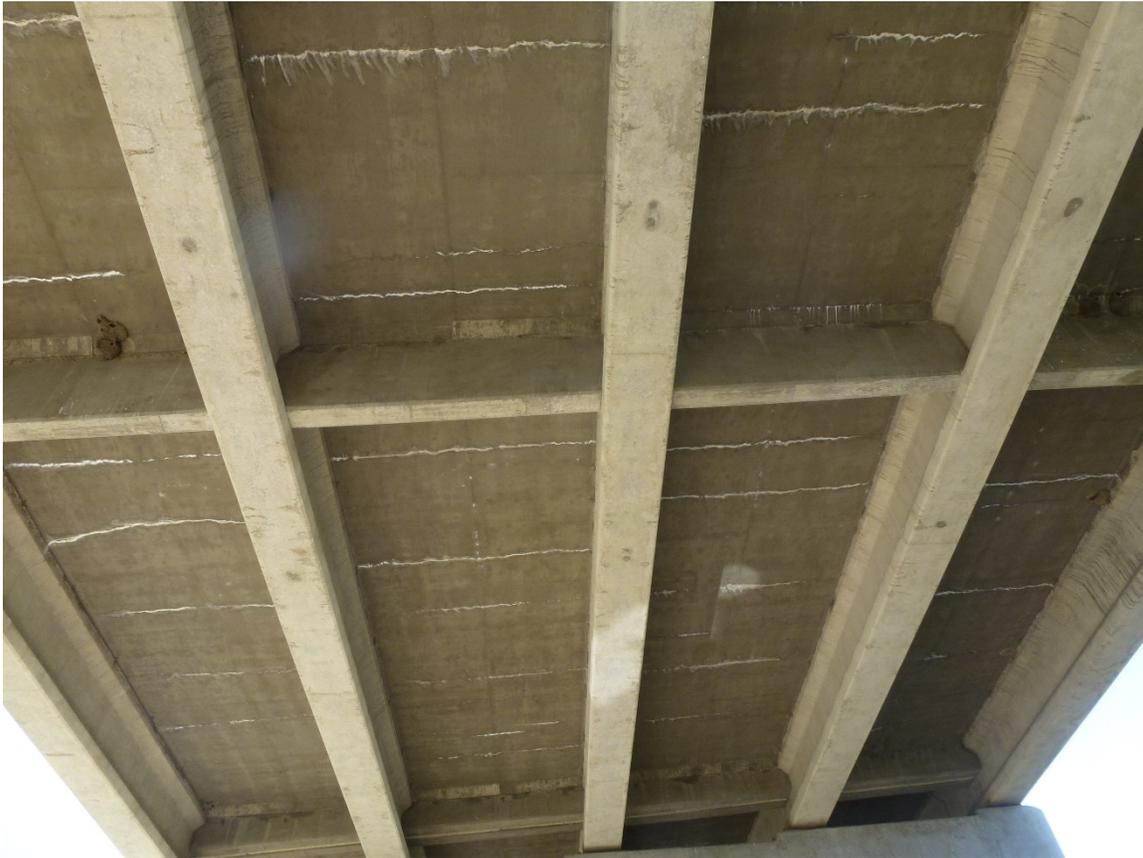
Figure 7. When to not use the transverse pattern cracking defect. Use the deck cracking defect only. Transverse cracking is present but sporadic. Note the wide crack spacing, the lack of staining, and no longitudinal jump cracks. All efflorescence is white.

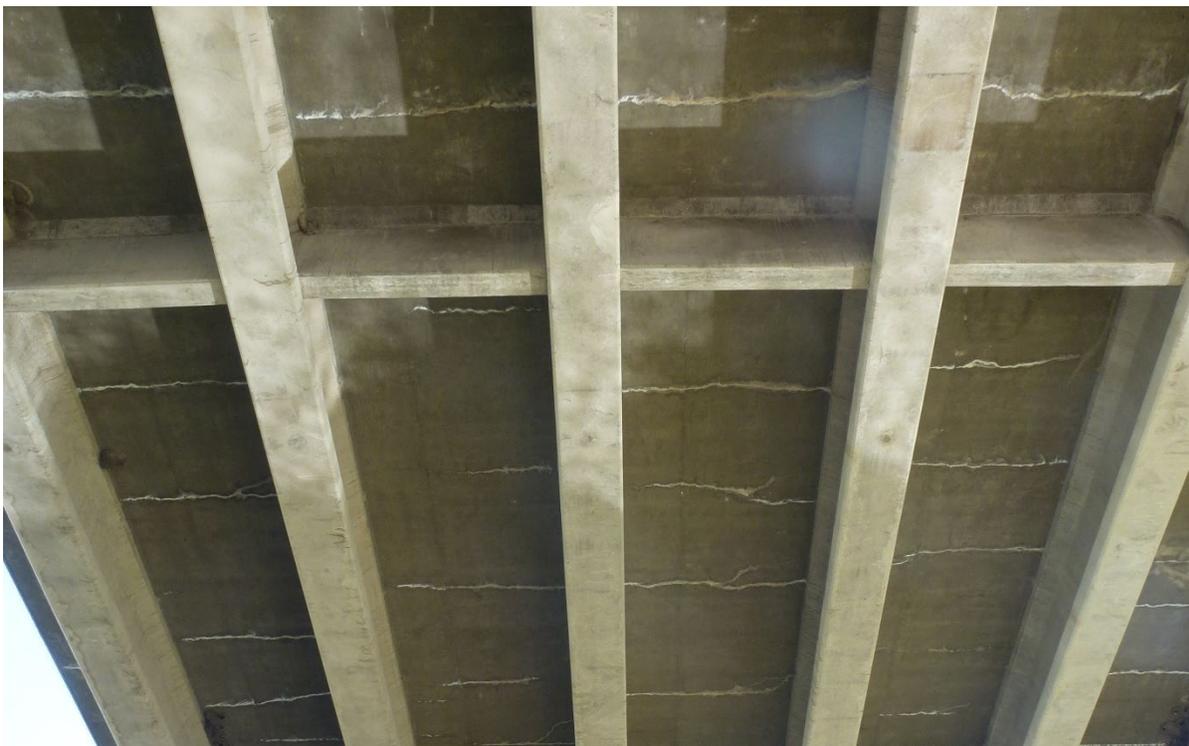
Figure 8. Example of Condition State 2. Note possible beginning jump cracks

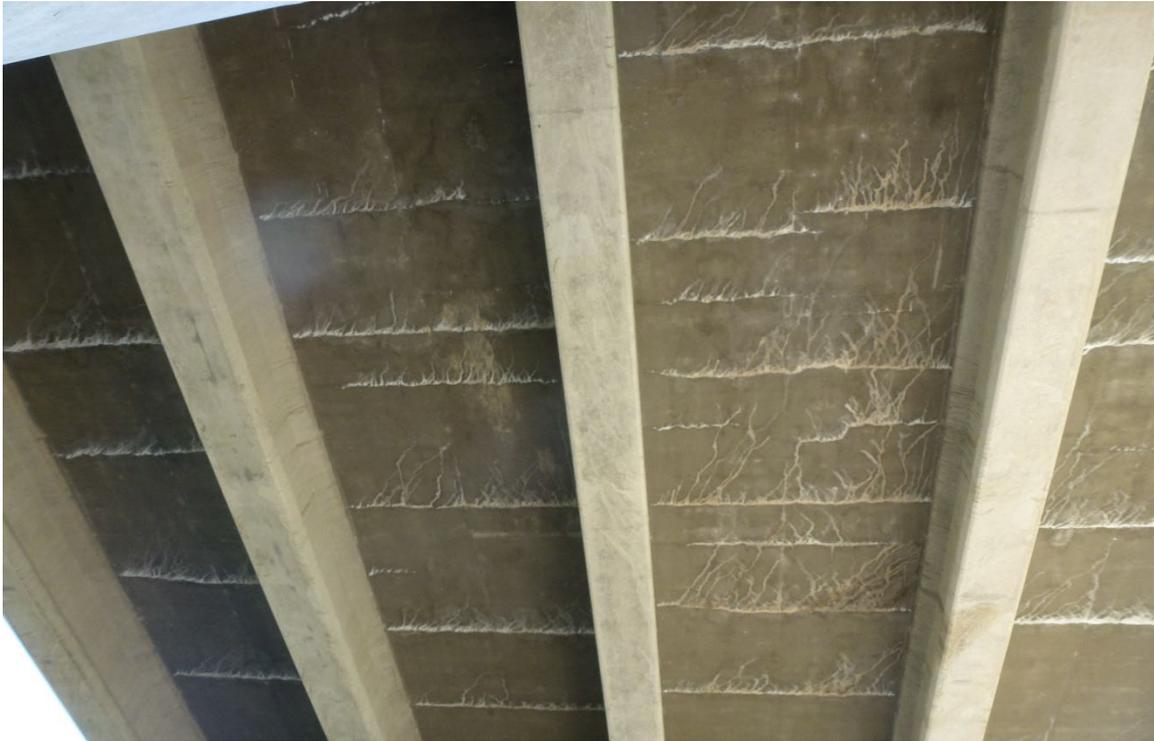
Figure 9. Example of Condition State 3. Note the tight spacing (12" to 18") of some of the transverse cracks, along with evidence of heavy leakage and some gray efflorescence. Also, small jump cracks evident.

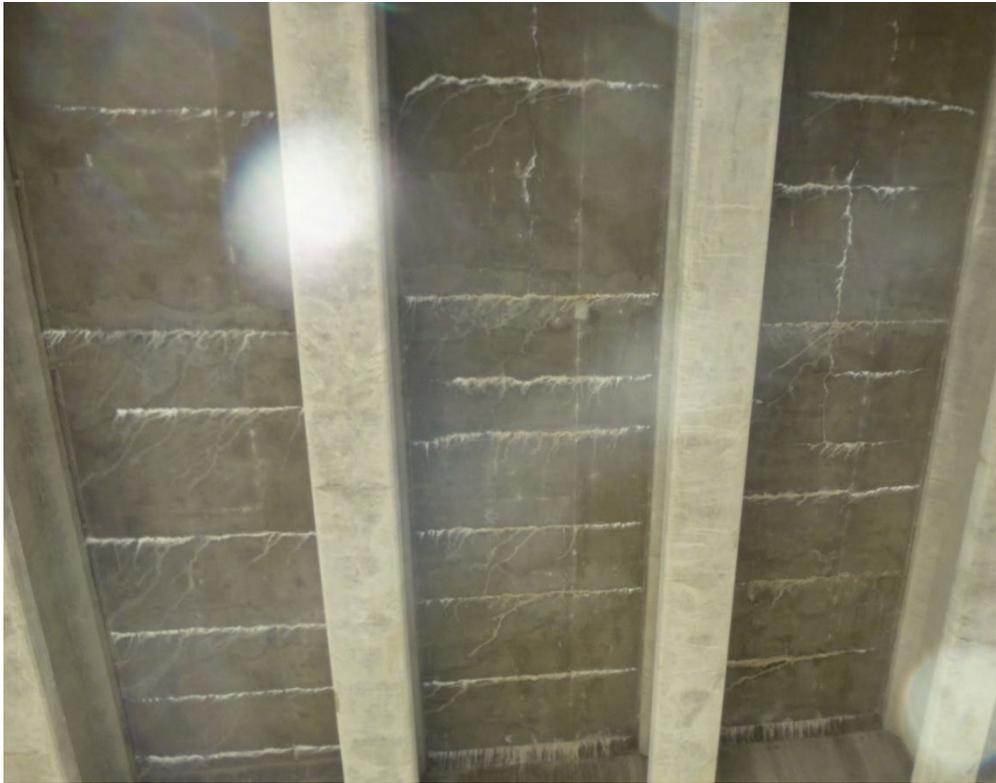
Figure 10. Example of Condition State 3. Tight spacing, jump cracks, some light staining from leakage, and some gray efflorescence.

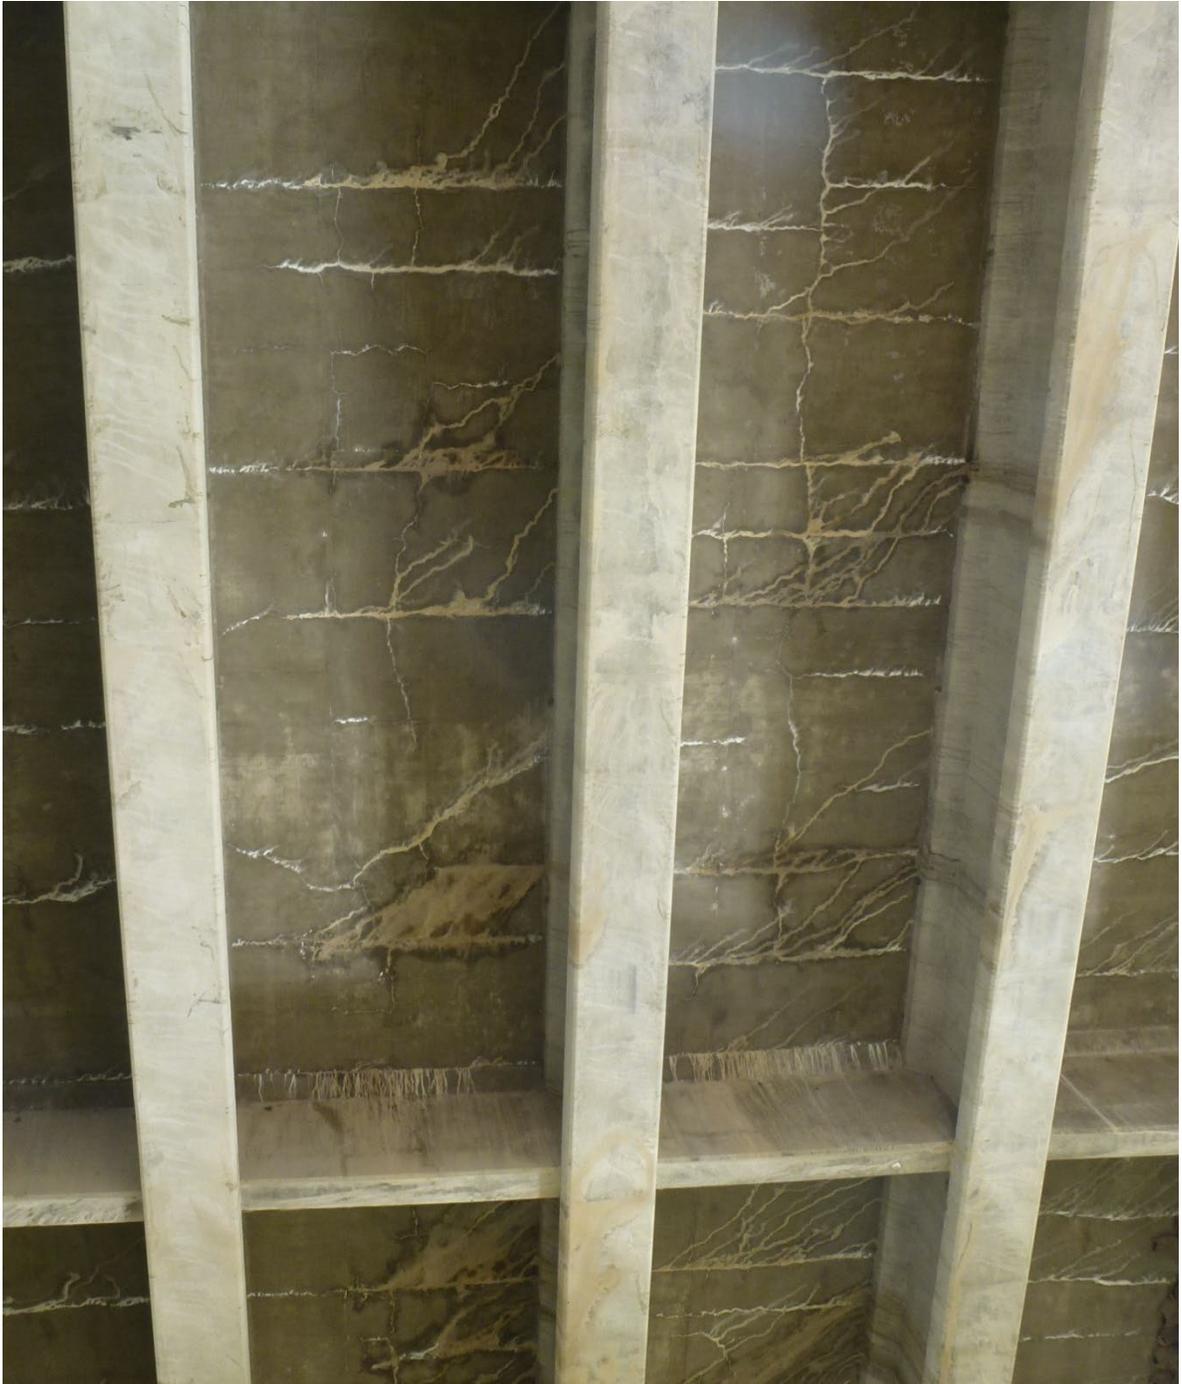
Figure 11. Example of Condition State 4. Note the tight spacing, multiple jump cracks (some creating the concrete "islands"), very heavy gray staining and efflorescence.

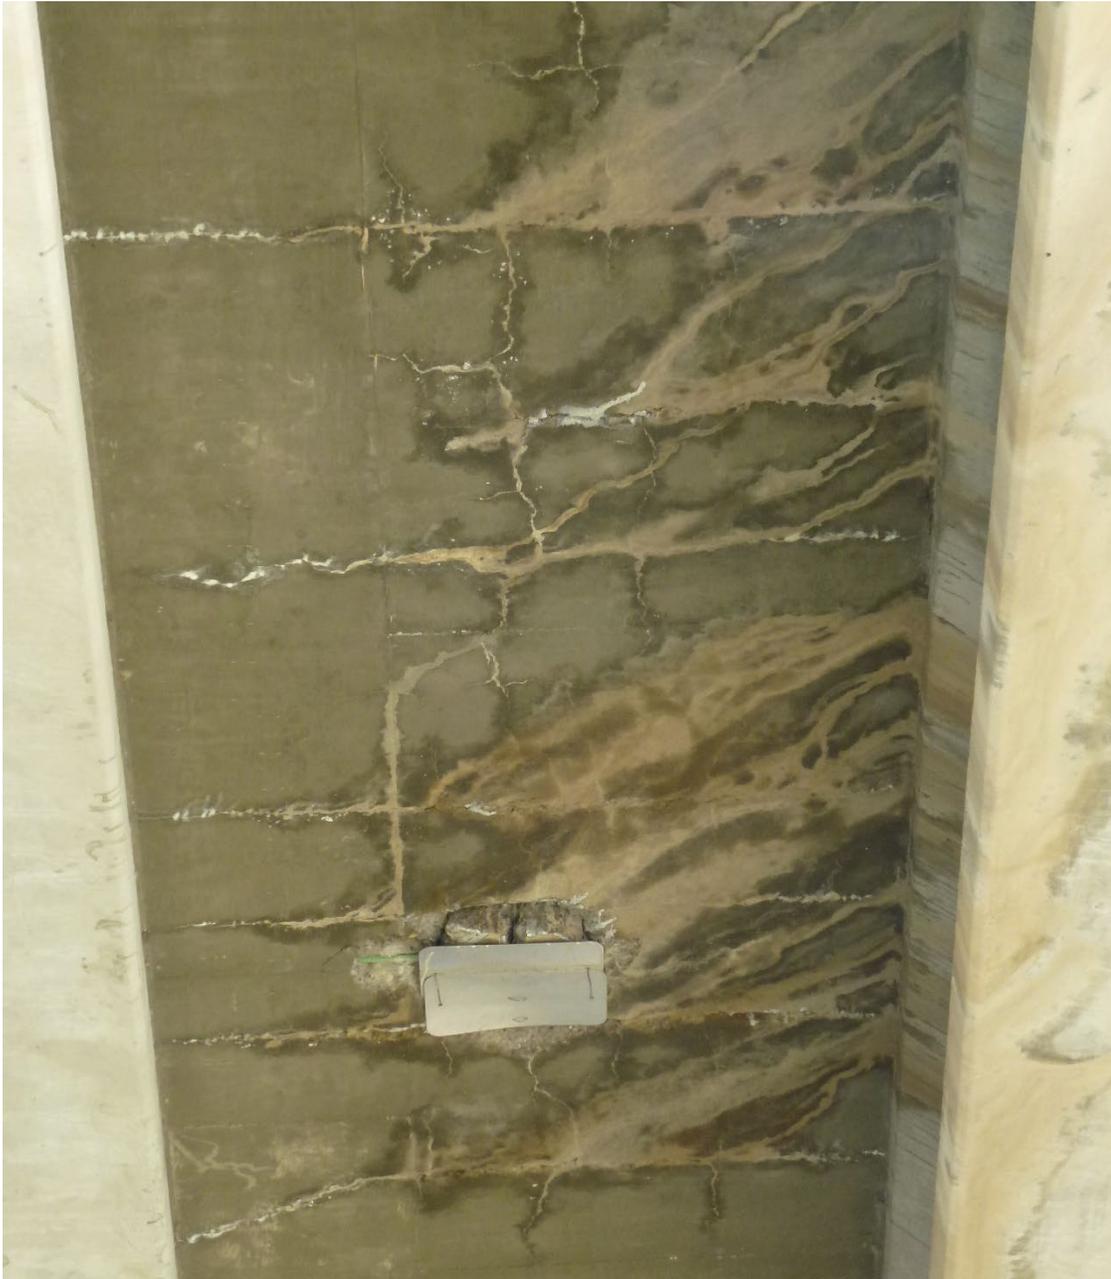
Figure 12. Example of Condition State 4. Tight spacing, jump cracks, "islands", grey colored efflorescence present, very heavy water staining, repaired hole.
